| <br><b>Civil &amp; Environmental Consultants, Inc.</b><br>5899 Montclair Boulevard - Cincinnati, OH 45150<br>513-985-0226 - 800-759-5614<br>www.cecinc.com | | DUKE ENERGY<br>LINE D000B PIPELINE REPLACEMENT PROJECT<br>CINCINNATI, HAMILTON COUNTY, OHIO | |
| RUNNING BUFFALO CLOVER SURVEY MAP | | | |

**APPENDIX A**

**REFERENCE POPULATION –**  
**DINSMORE WOODS STATE NATURE PRESERVE**

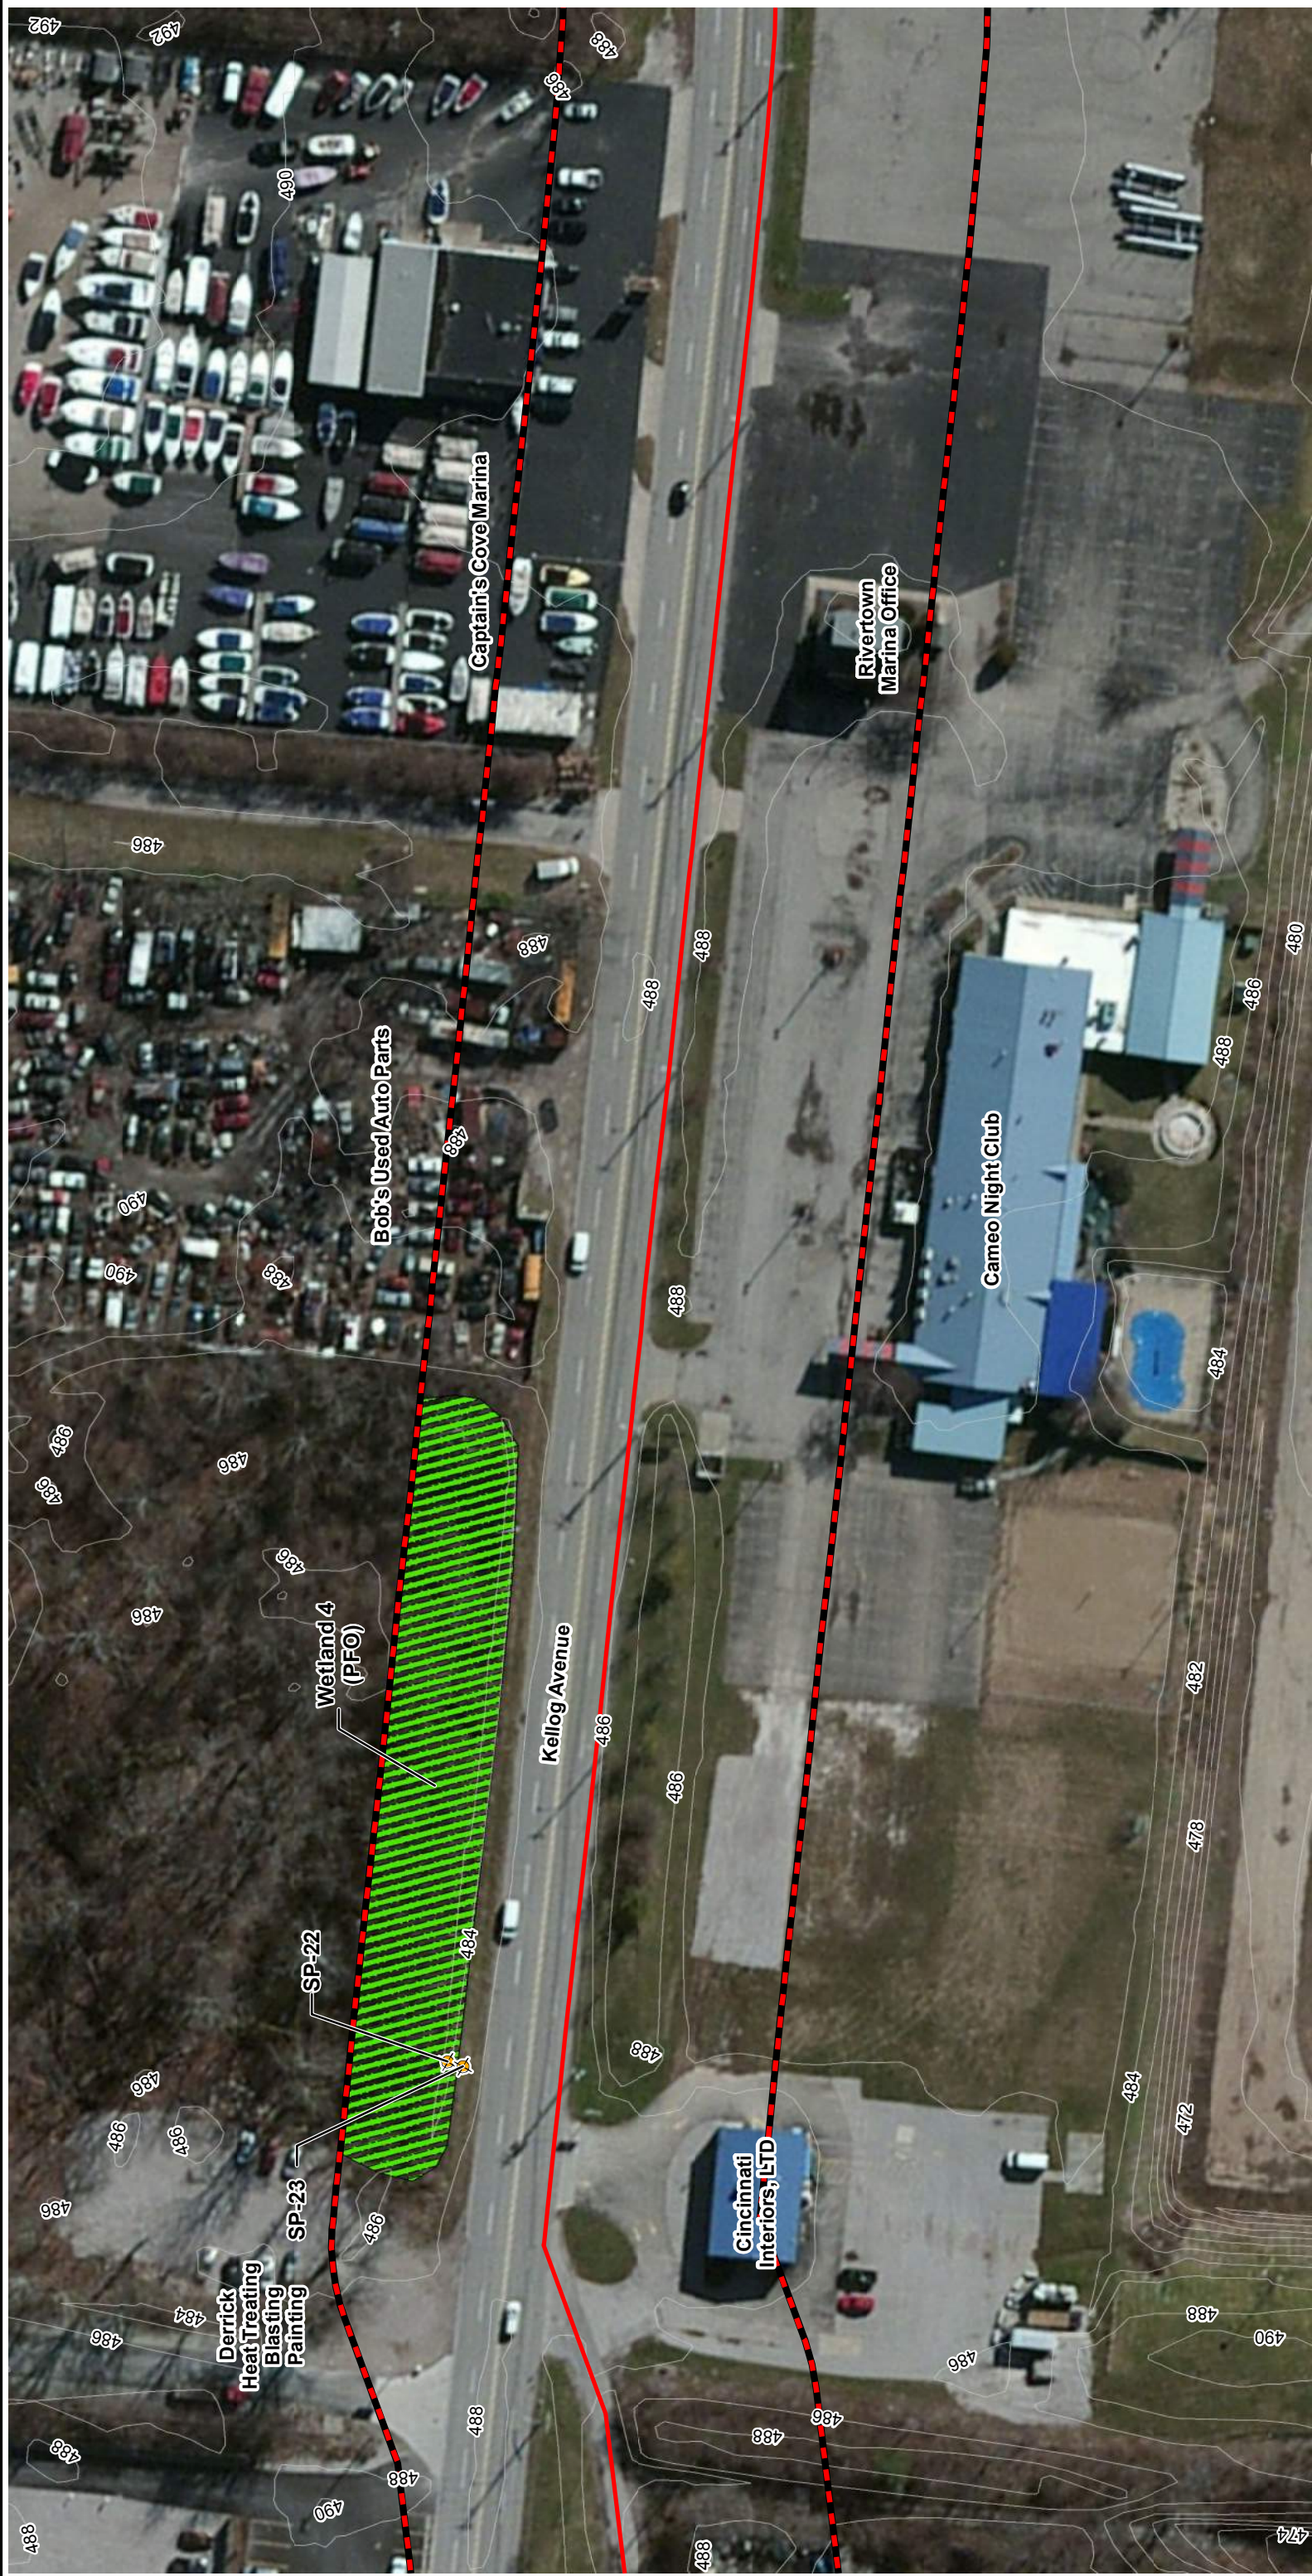
NOTES: FULL EXTENT OF STUDY CORRIDOR IS WITHIN 100-YEAR FLOODPLAIN.  
NO STREAMS OR WATERBODIES WERE IDENTIFIED WITHIN THE STUDY CORRIDOR.

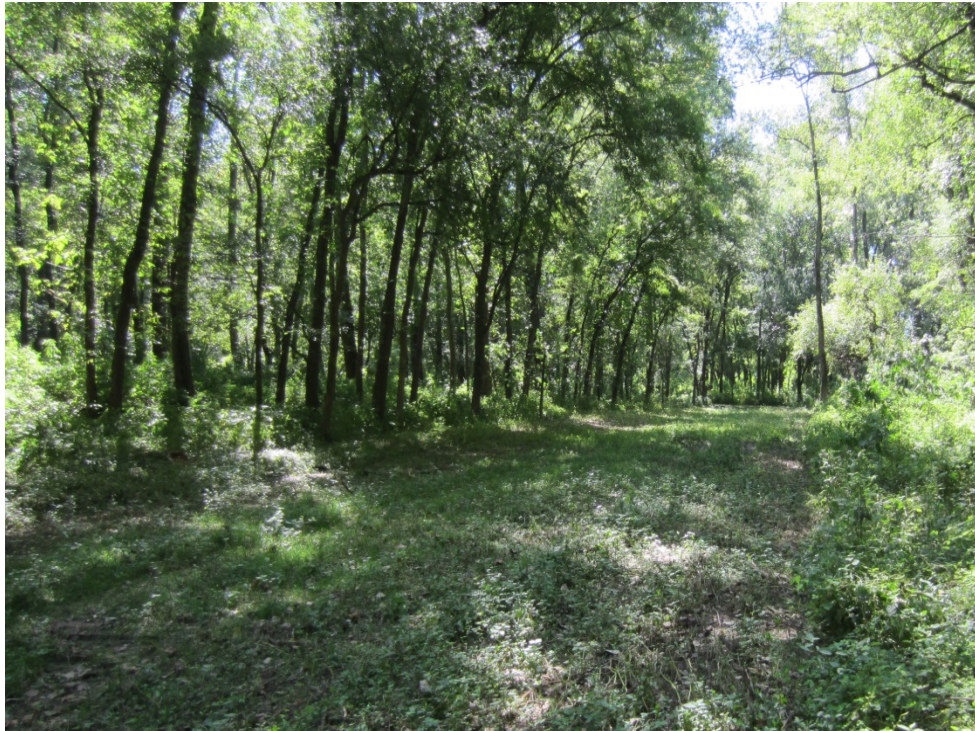
Photograph 6. View of maintained Line D000B ROW, south of proposed southern terminus of Project. Photograph taken facing south-southeast.

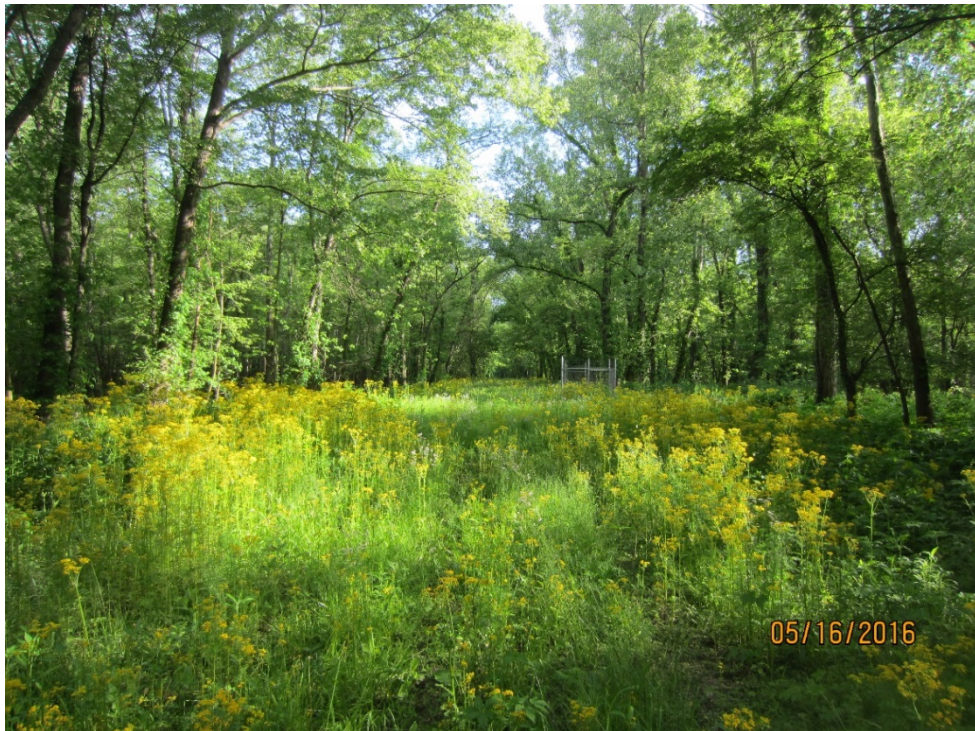
Photograph 7. View of existing Line D000B ROW at the southern terminus of study corridor. Photograph taken facing south.

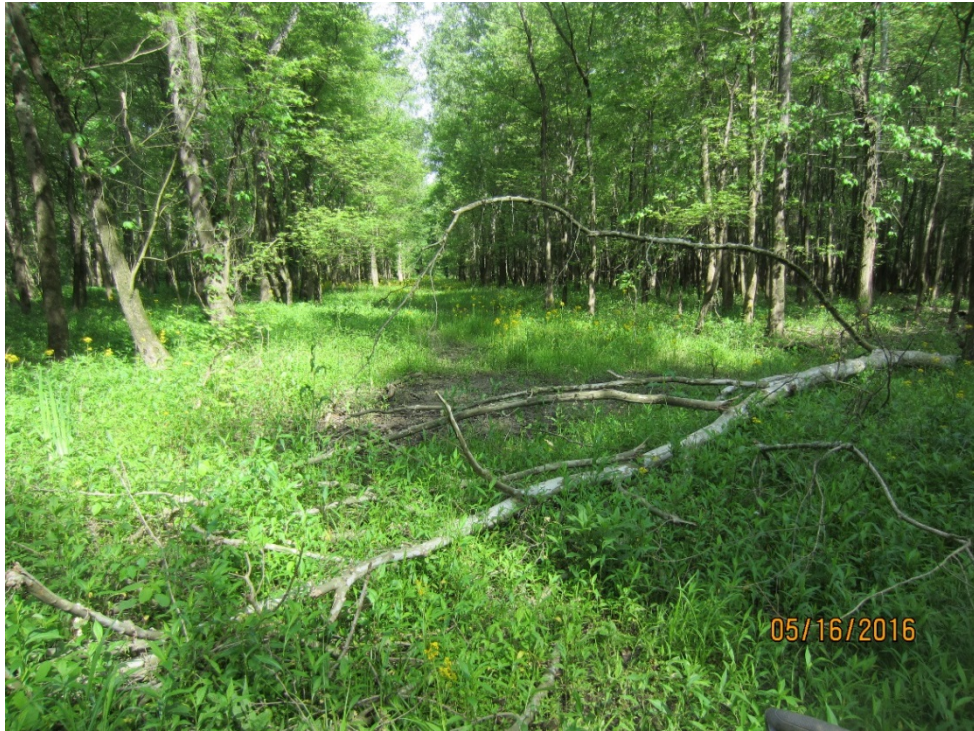
Photograph 8. Representative view of the PEM portion of Wetland 1. Photograph taken facing north-northwest along existing, maintained utility ROW.

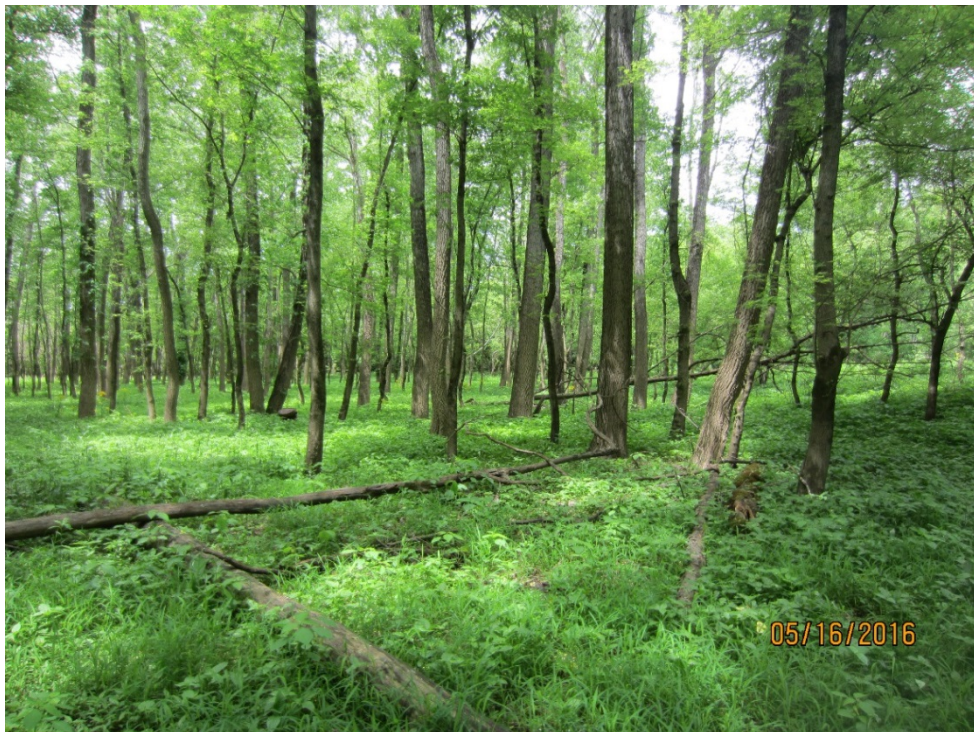
Photograph 11. View of the PFO portion of Wetland 1 along the west side of the Line D000B ROW near the southern terminus of the Project.  
Photograph taken facing west.

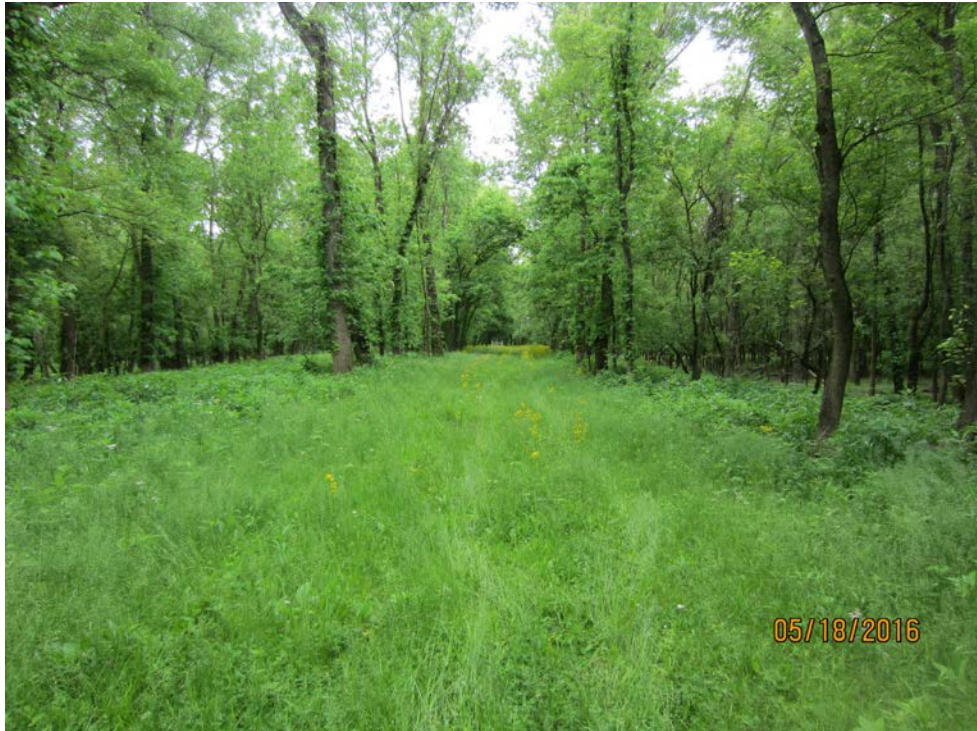
Photograph 12. Representative view of elevated and maintained ROW, bisecting Wetland 1 at wetland determination SP-6. Photograph taken facing south.

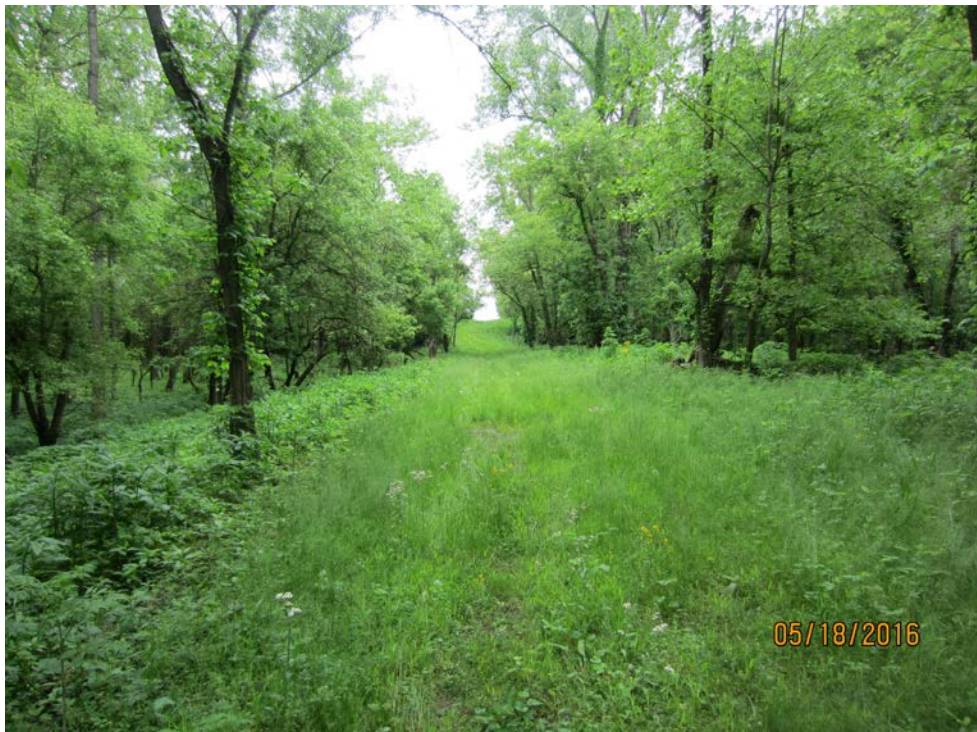
Photograph 13. Representative view of elevated and maintained Line D000B ROW, bisecting Wetland 1. Photograph taken facing north.

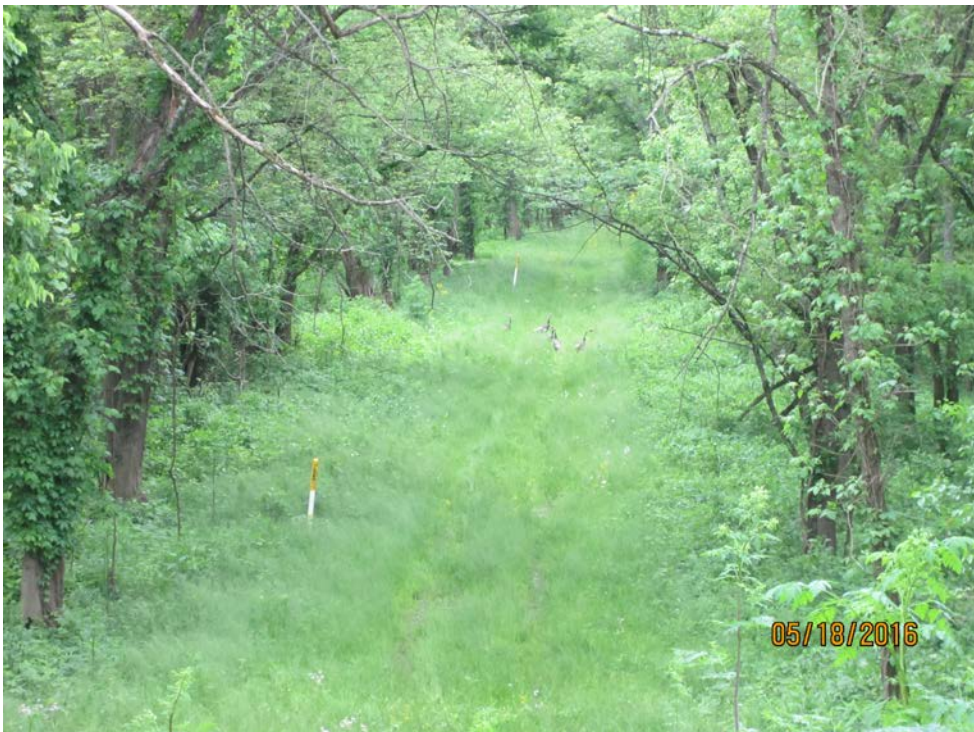
Photograph 15. Elevated view of existing bermed, maintained Line D000B ROW, bisecting Wetland 1. Photograph taken facing south.

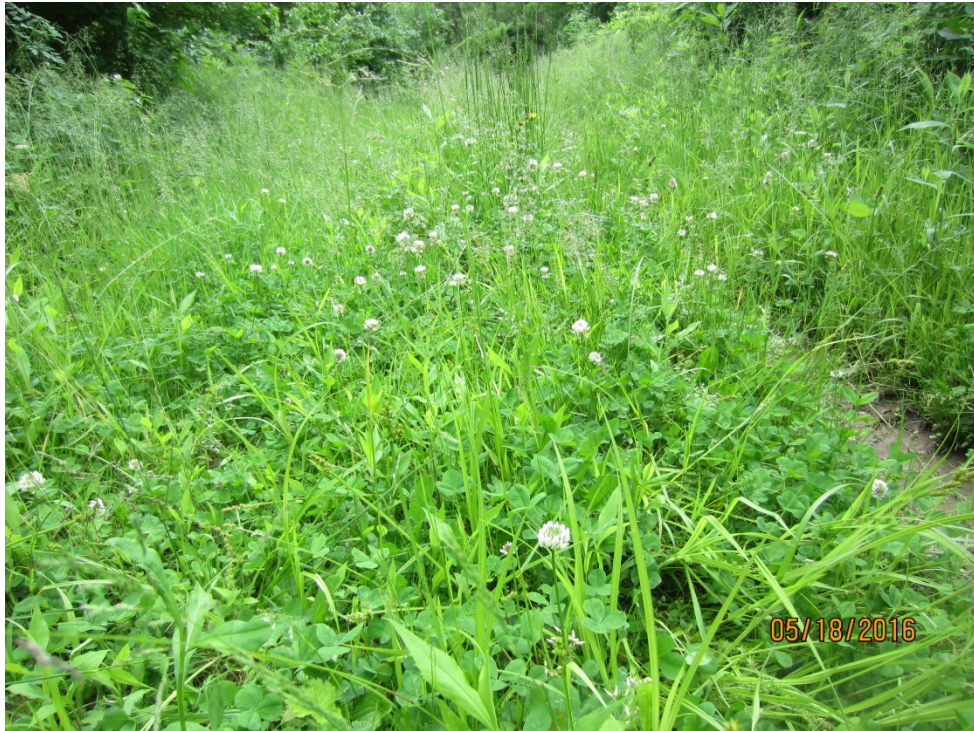
Photograph 16. View of white clover and other herbaceous vegetation growing along trail or two track that is located on an embankment that formerly functioned as railroad corridor, facing southwest.

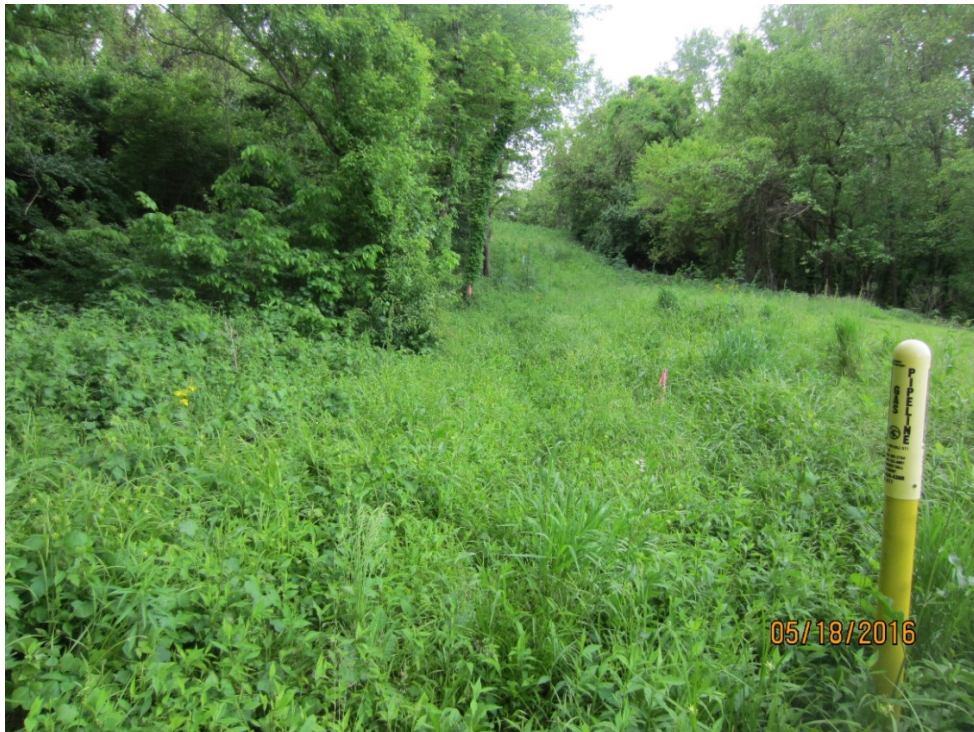
Photograph 17. View of the PEM portion of Wetland 2, facing south.

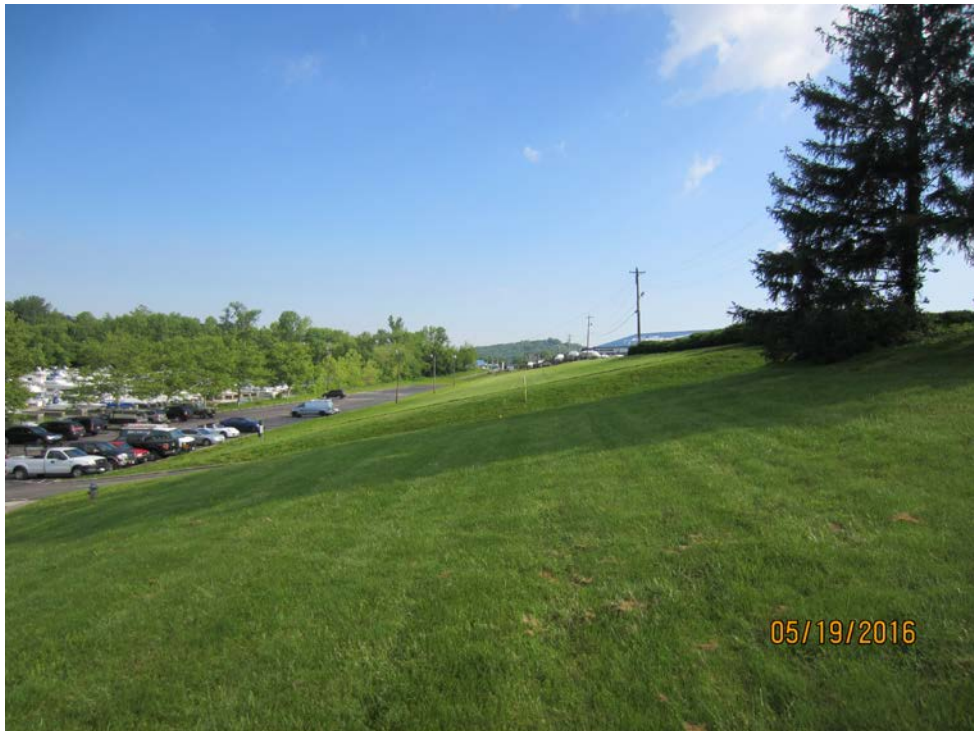
Photograph 18. View of maintained Line D000B ROW, east of Four Seasons Marina.  
Photograph taken facing south-southeast.

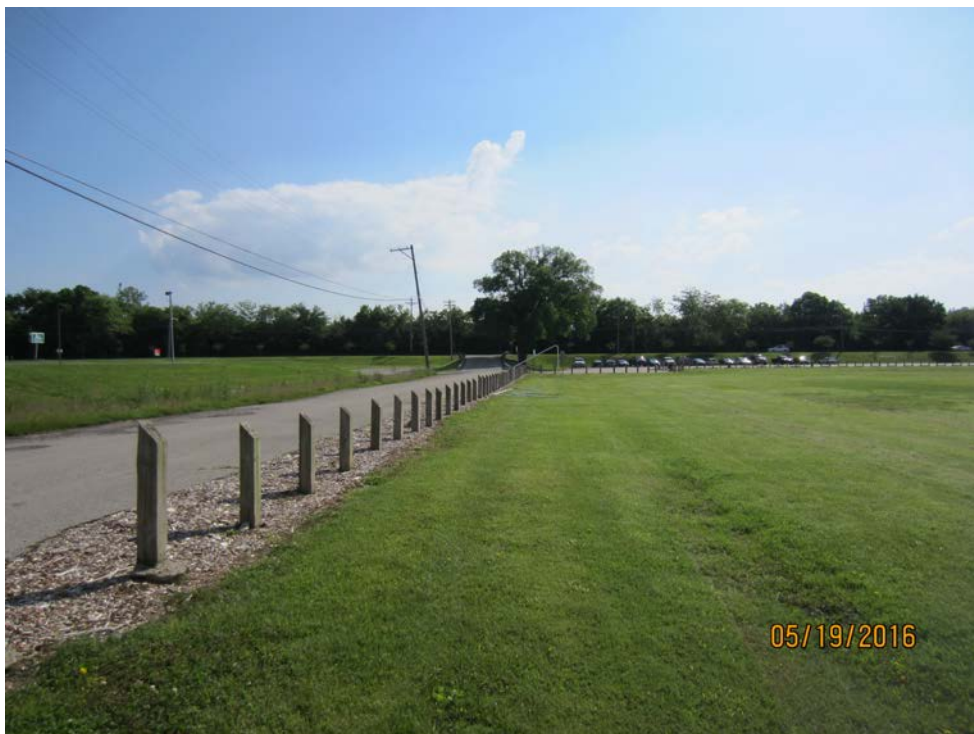
Photograph 19. View of maintained Line D000B ROW, along Kellogg Avenue Park and Stites Road. Photograph taken facing east-northeast.
