RE: Case No. 17-2109-EL-BLN
In the Matter of the Letter of Notification Application of AEP Ohio
Transmission Company, Inc. for a Certificate of Environmental
Compatibility and Public Need for the Trimble 138kV Transmission
Line Extension Project

LETTER OF NOTIFICATION for the Trimble 138 kV Transmission Line Extension Project

PUCO Case No. 17-2109-EL-BLN

AEP Ohio Transmission Company, Inc.'s Trimble 138 kV Transmission Line Extension Project.

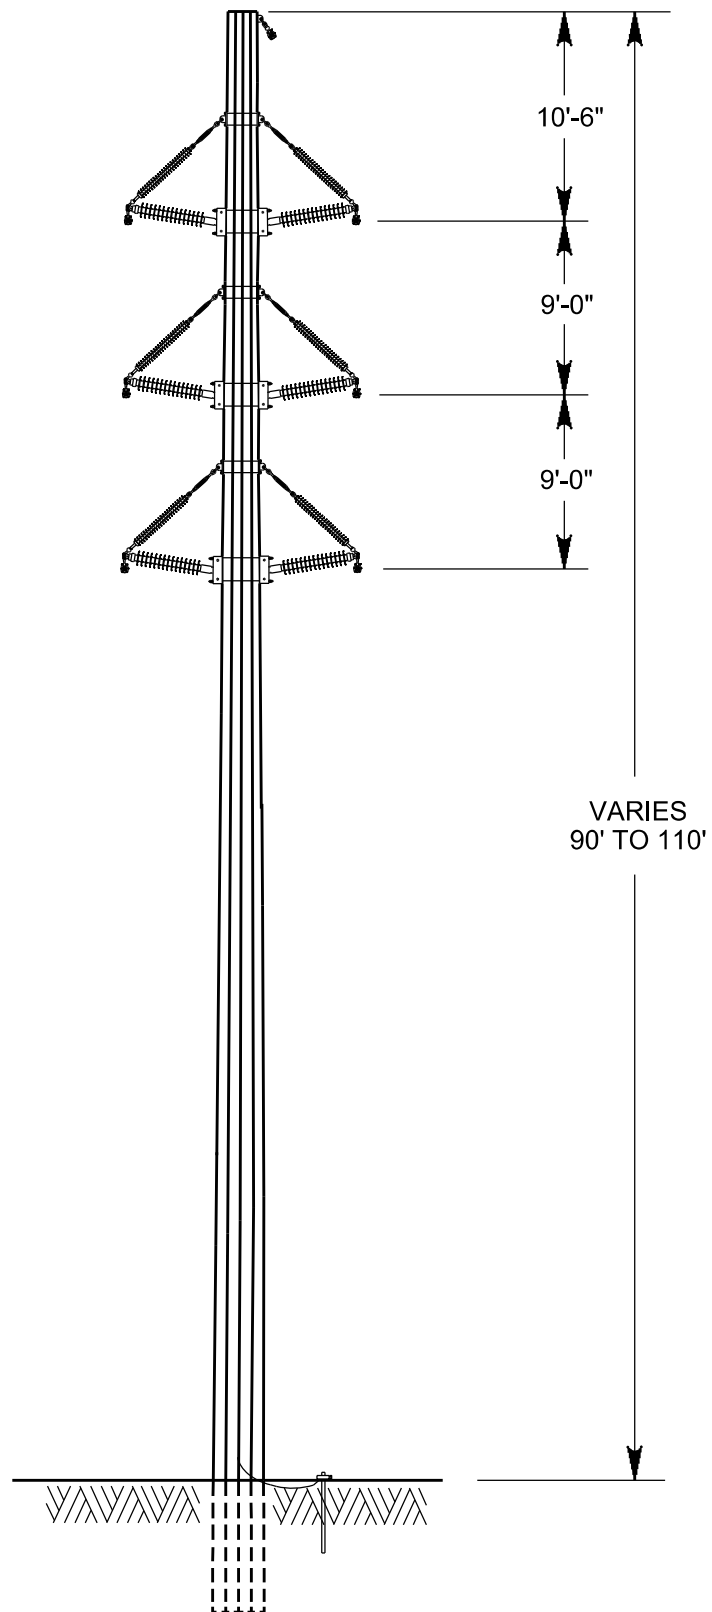
FIGURE 1

TRIMBLE 138kV
EXTENSION

TYPICAL TANGENT STRUCTURE
TUBULAR STEEL
BRACE POST

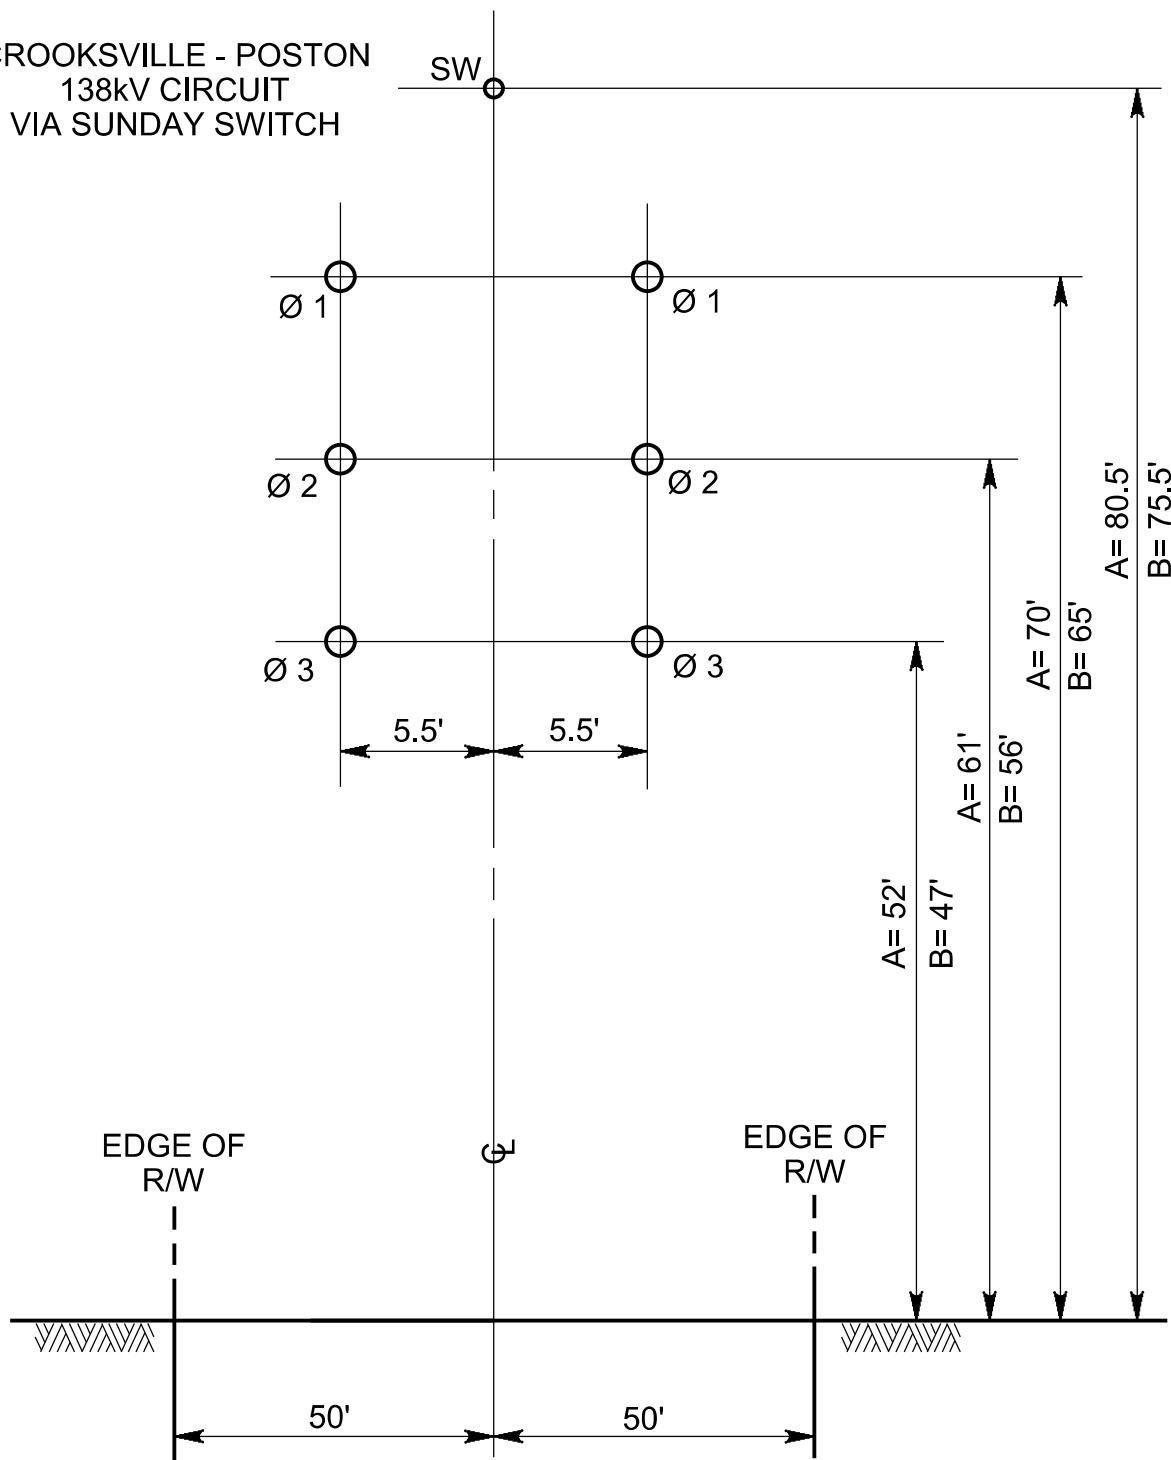
CROOKSVILLE - POSTON
138kV CIRCUIT
VIA SUNDAY SWITCH

DIMENSION "A" - DOUBLE CIRCUIT - VERTICAL CONFIGURATION.
(UNDER EMERGENCY & NORMAL MAX. LINE LOADING)

DIMENSION "B" - DOUBLE CIRCUIT - VERTICAL CONFIGURATION.
(UNDER WINTER NORMAL
CONDUCTOR RATING)

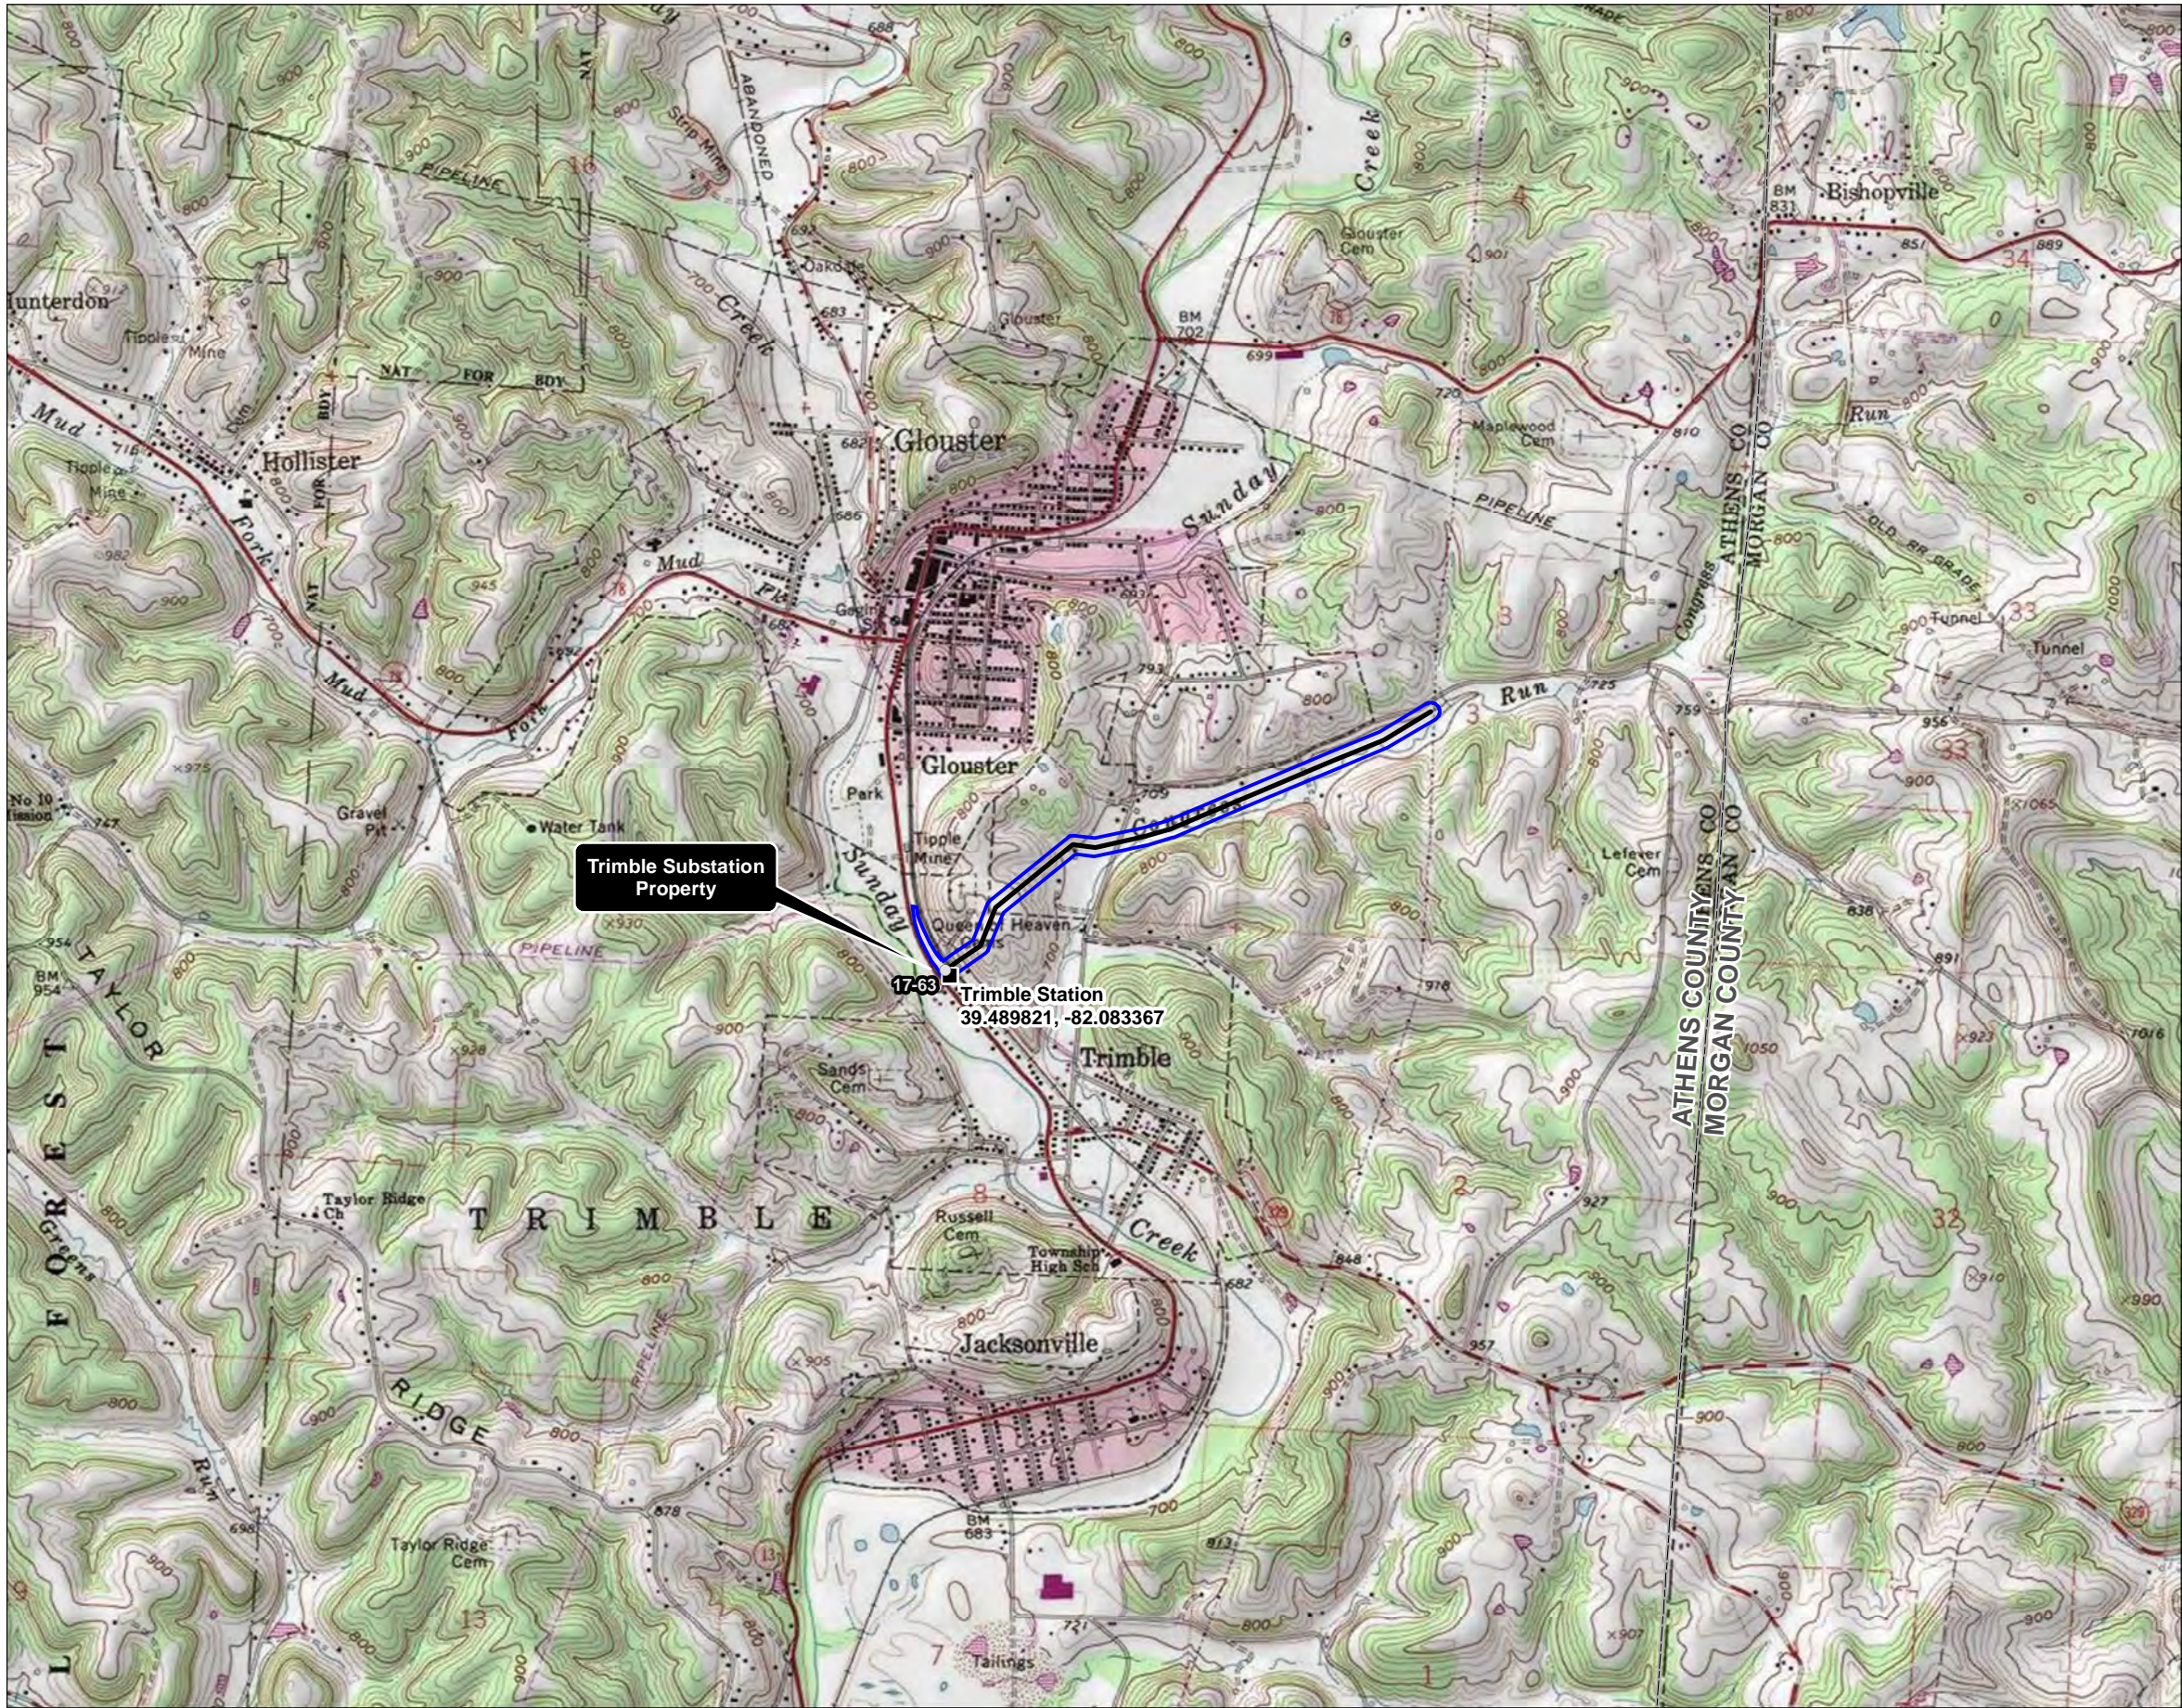
Figure No. 1

A.1 FIGURE 1 – PROJECT LOCATION MAP

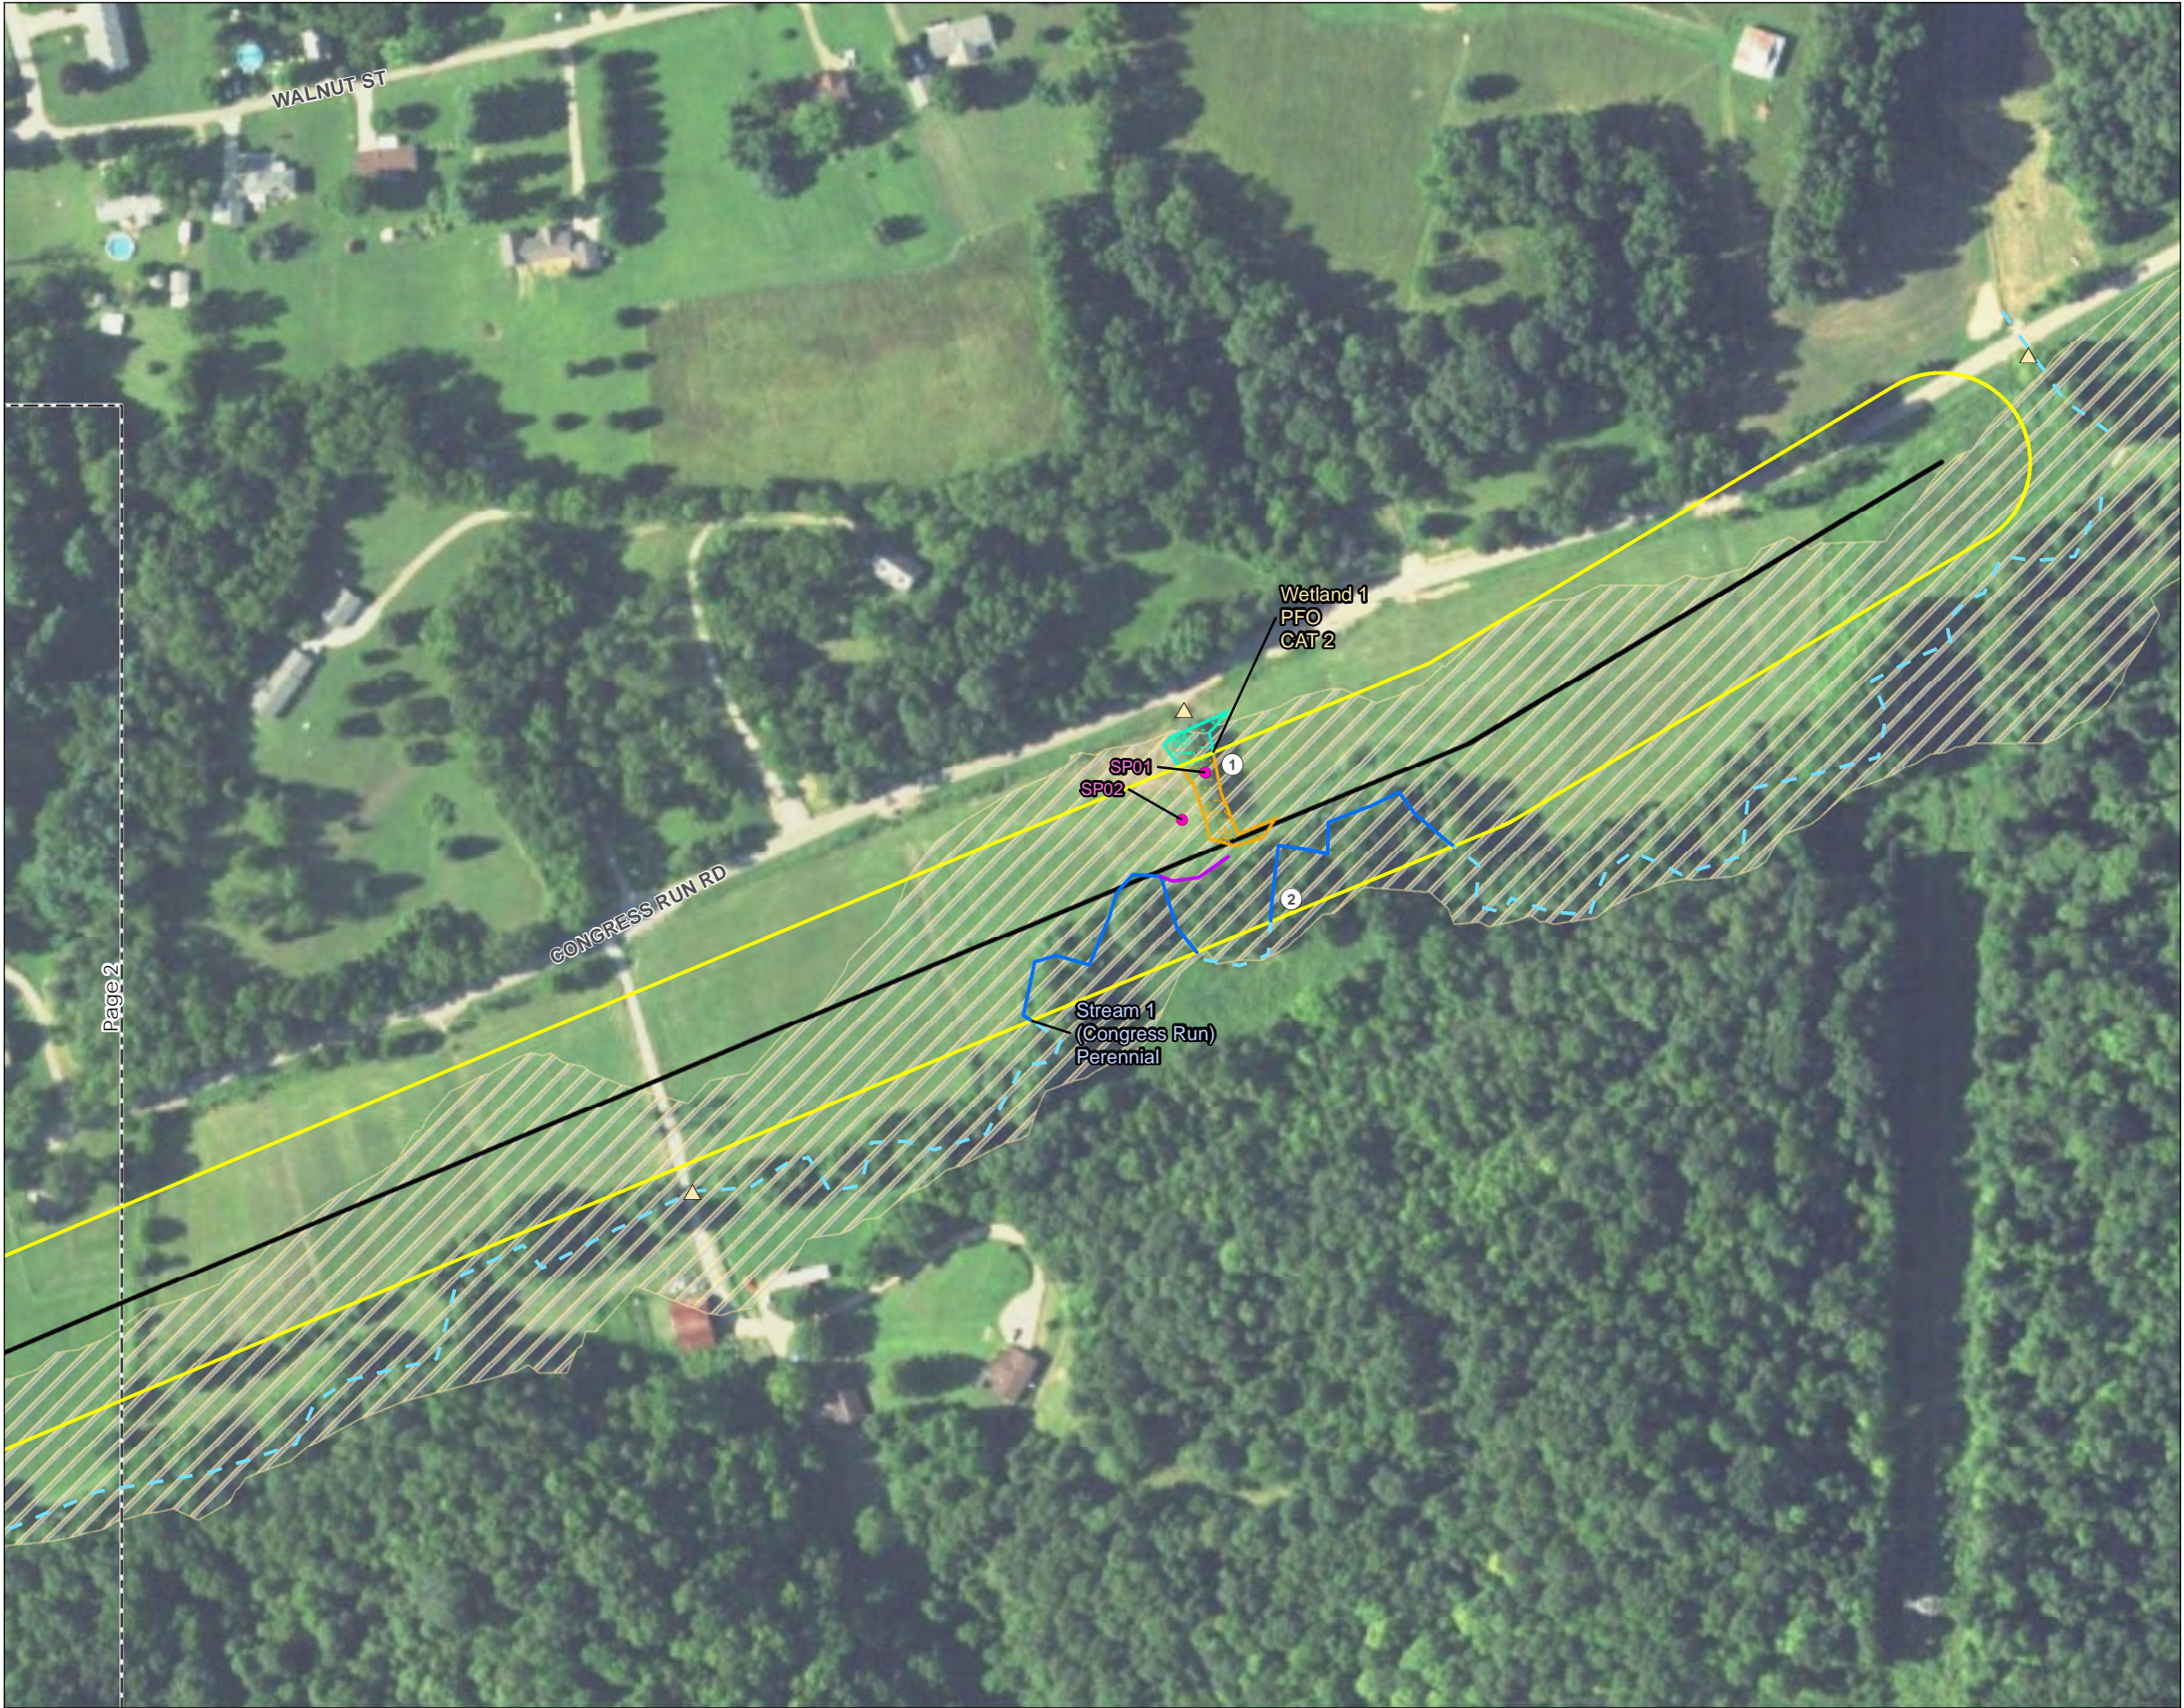
Figure No.
2

Title
Wetland and Waterbody
Delineation Map

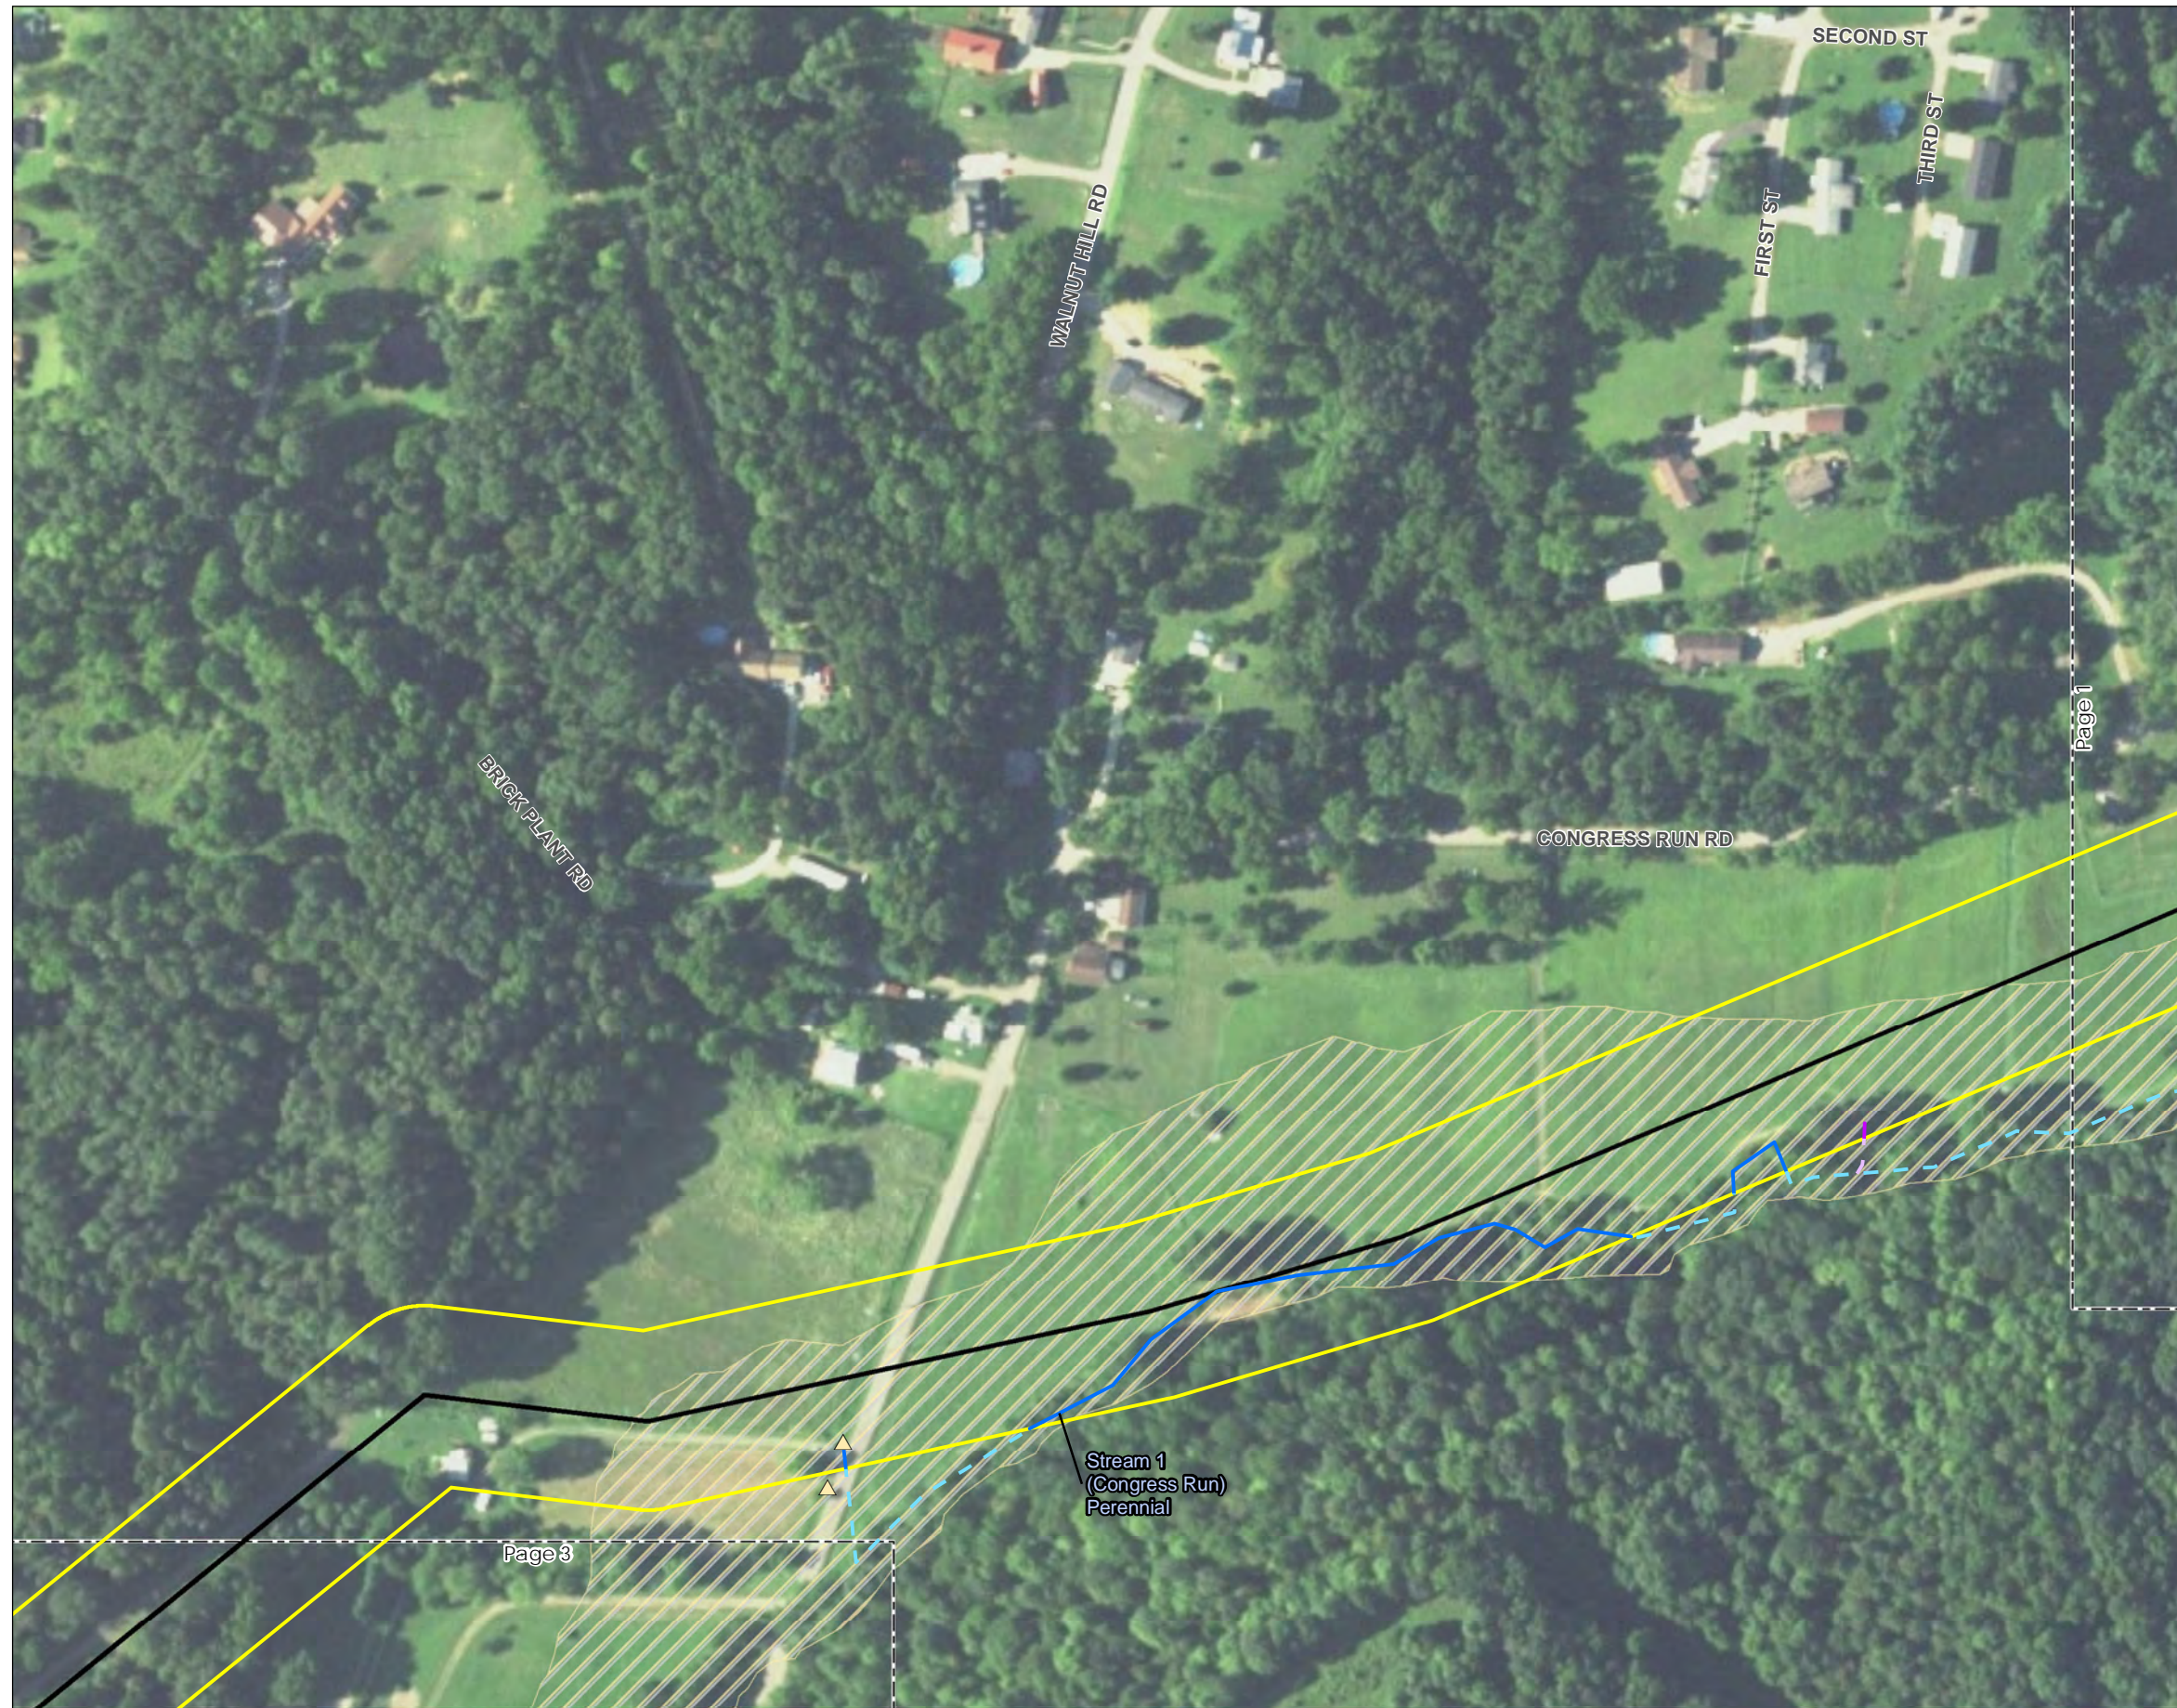
Figure No.
2

Title
Wetland and Waterbody
Delineation Map

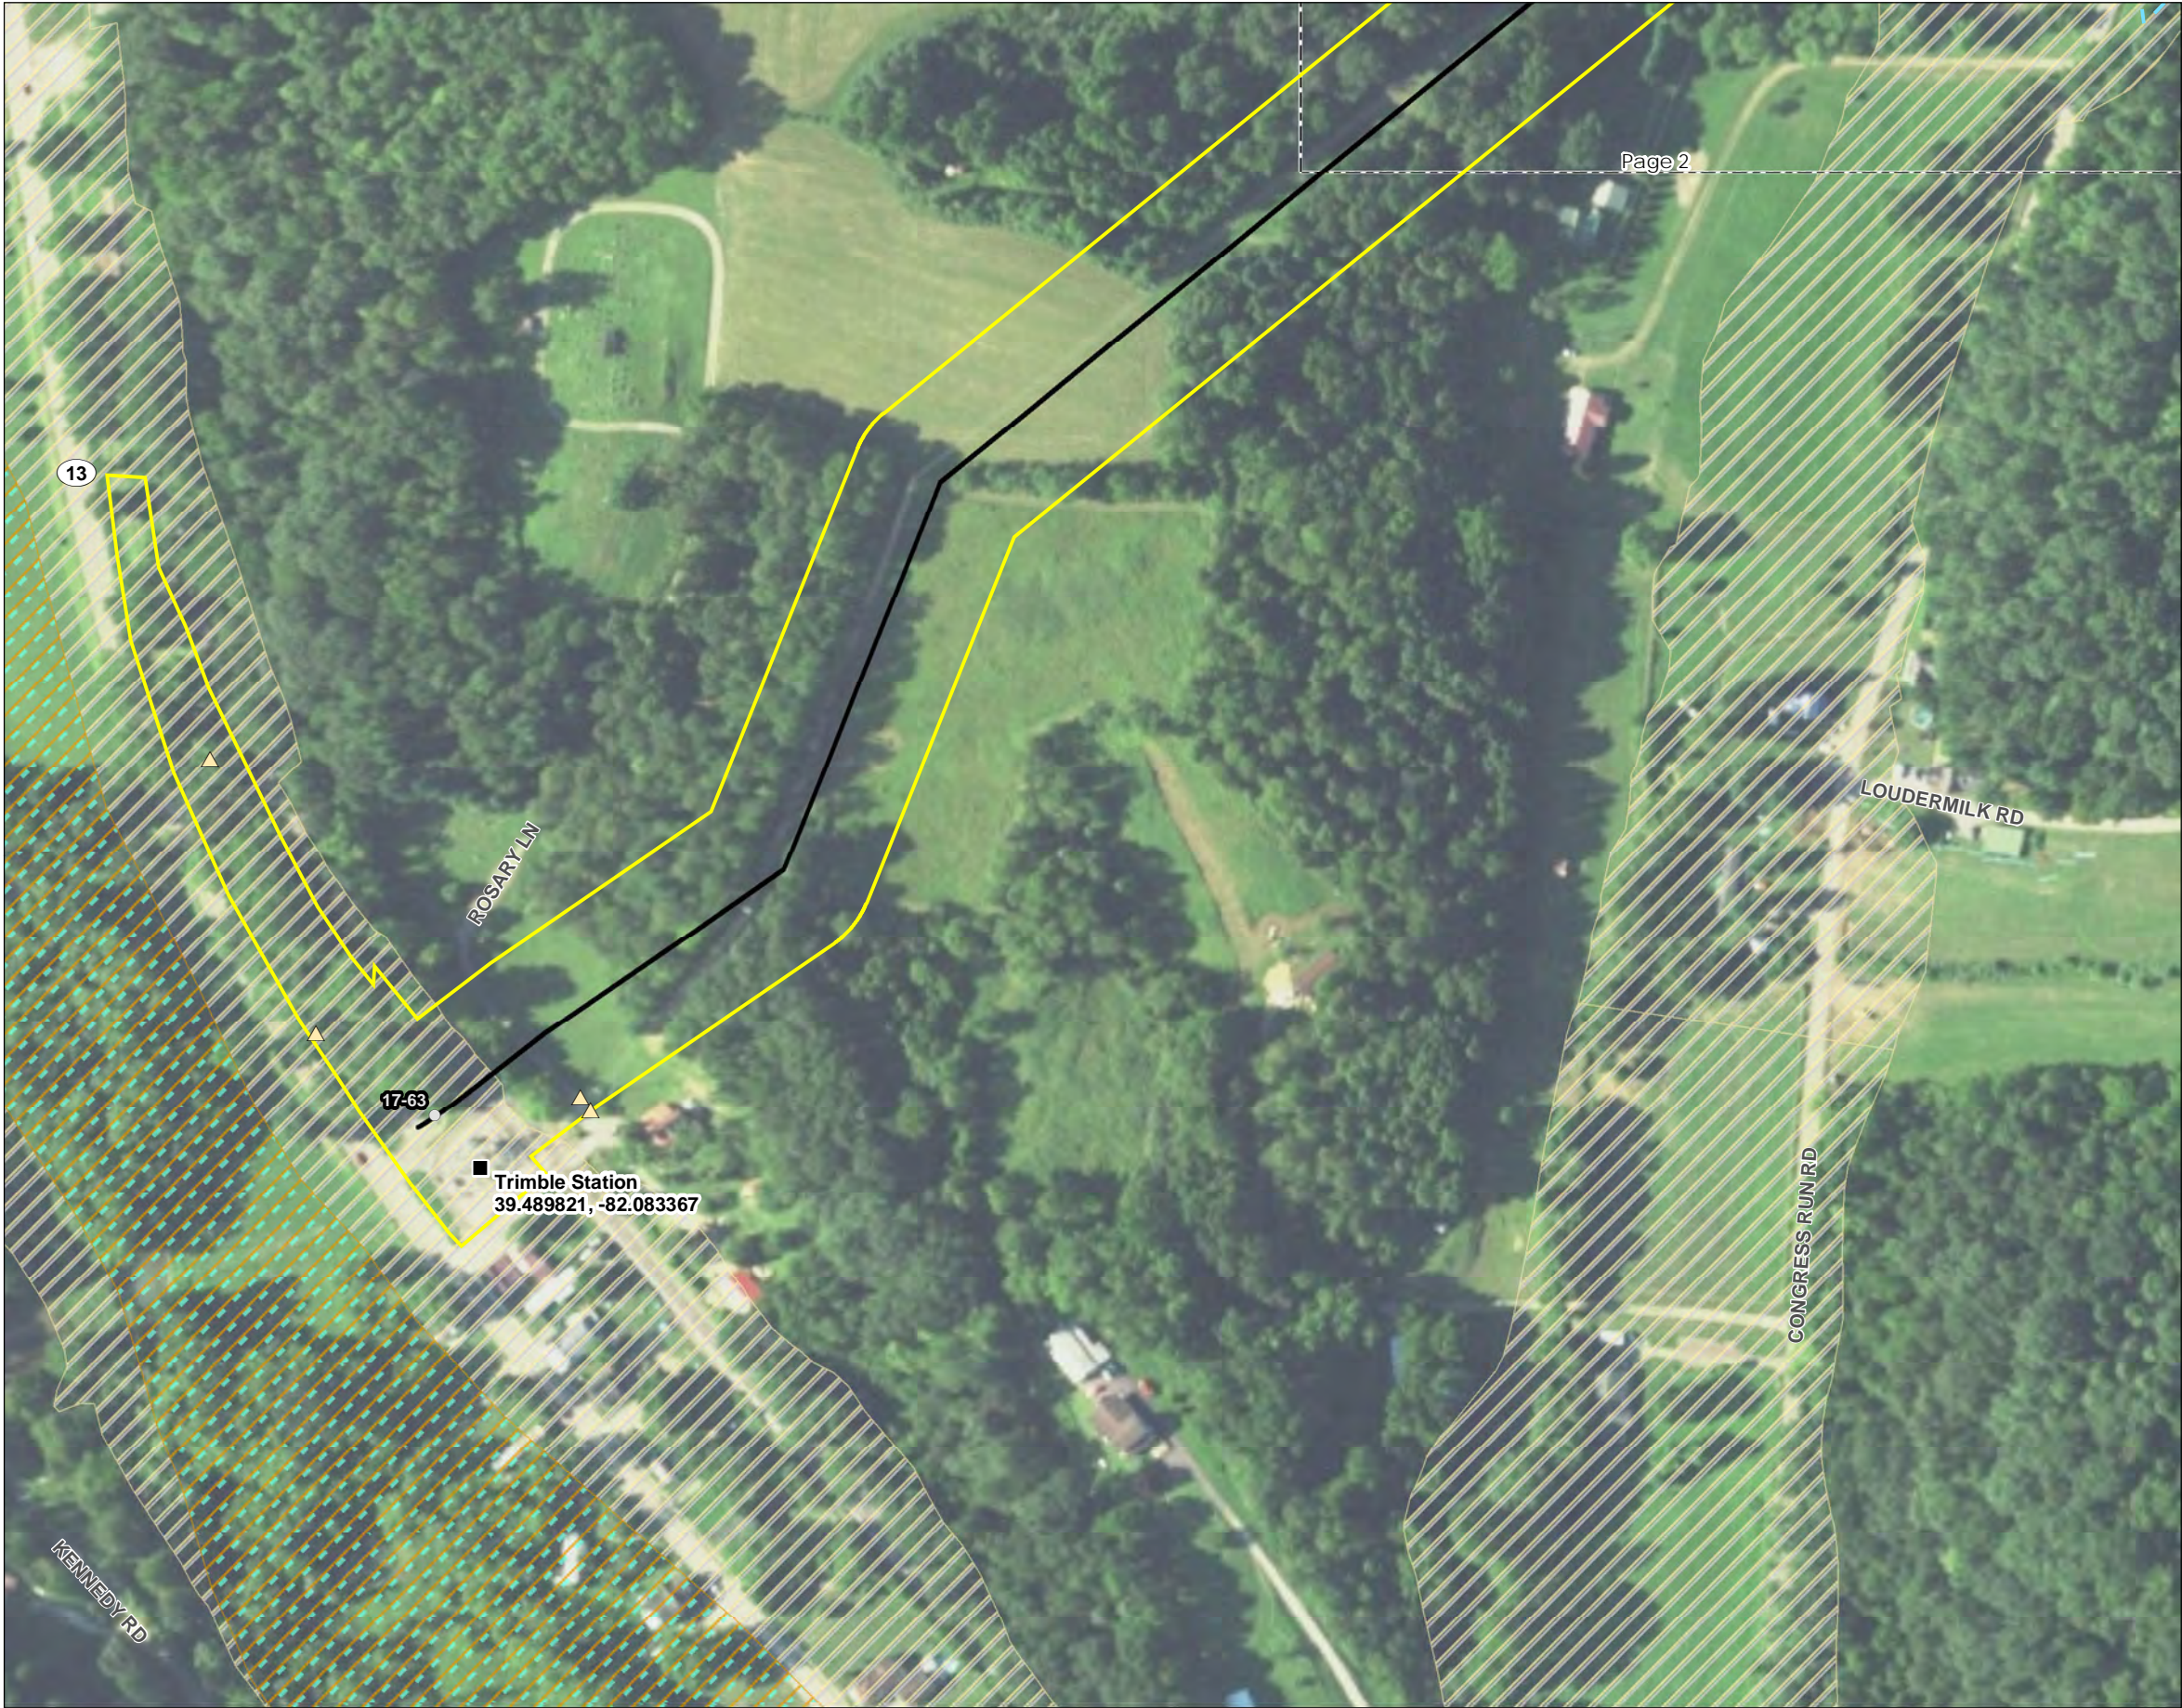
Figure No.
2

Title
**Wetland and Waterbody
Delineation Map**

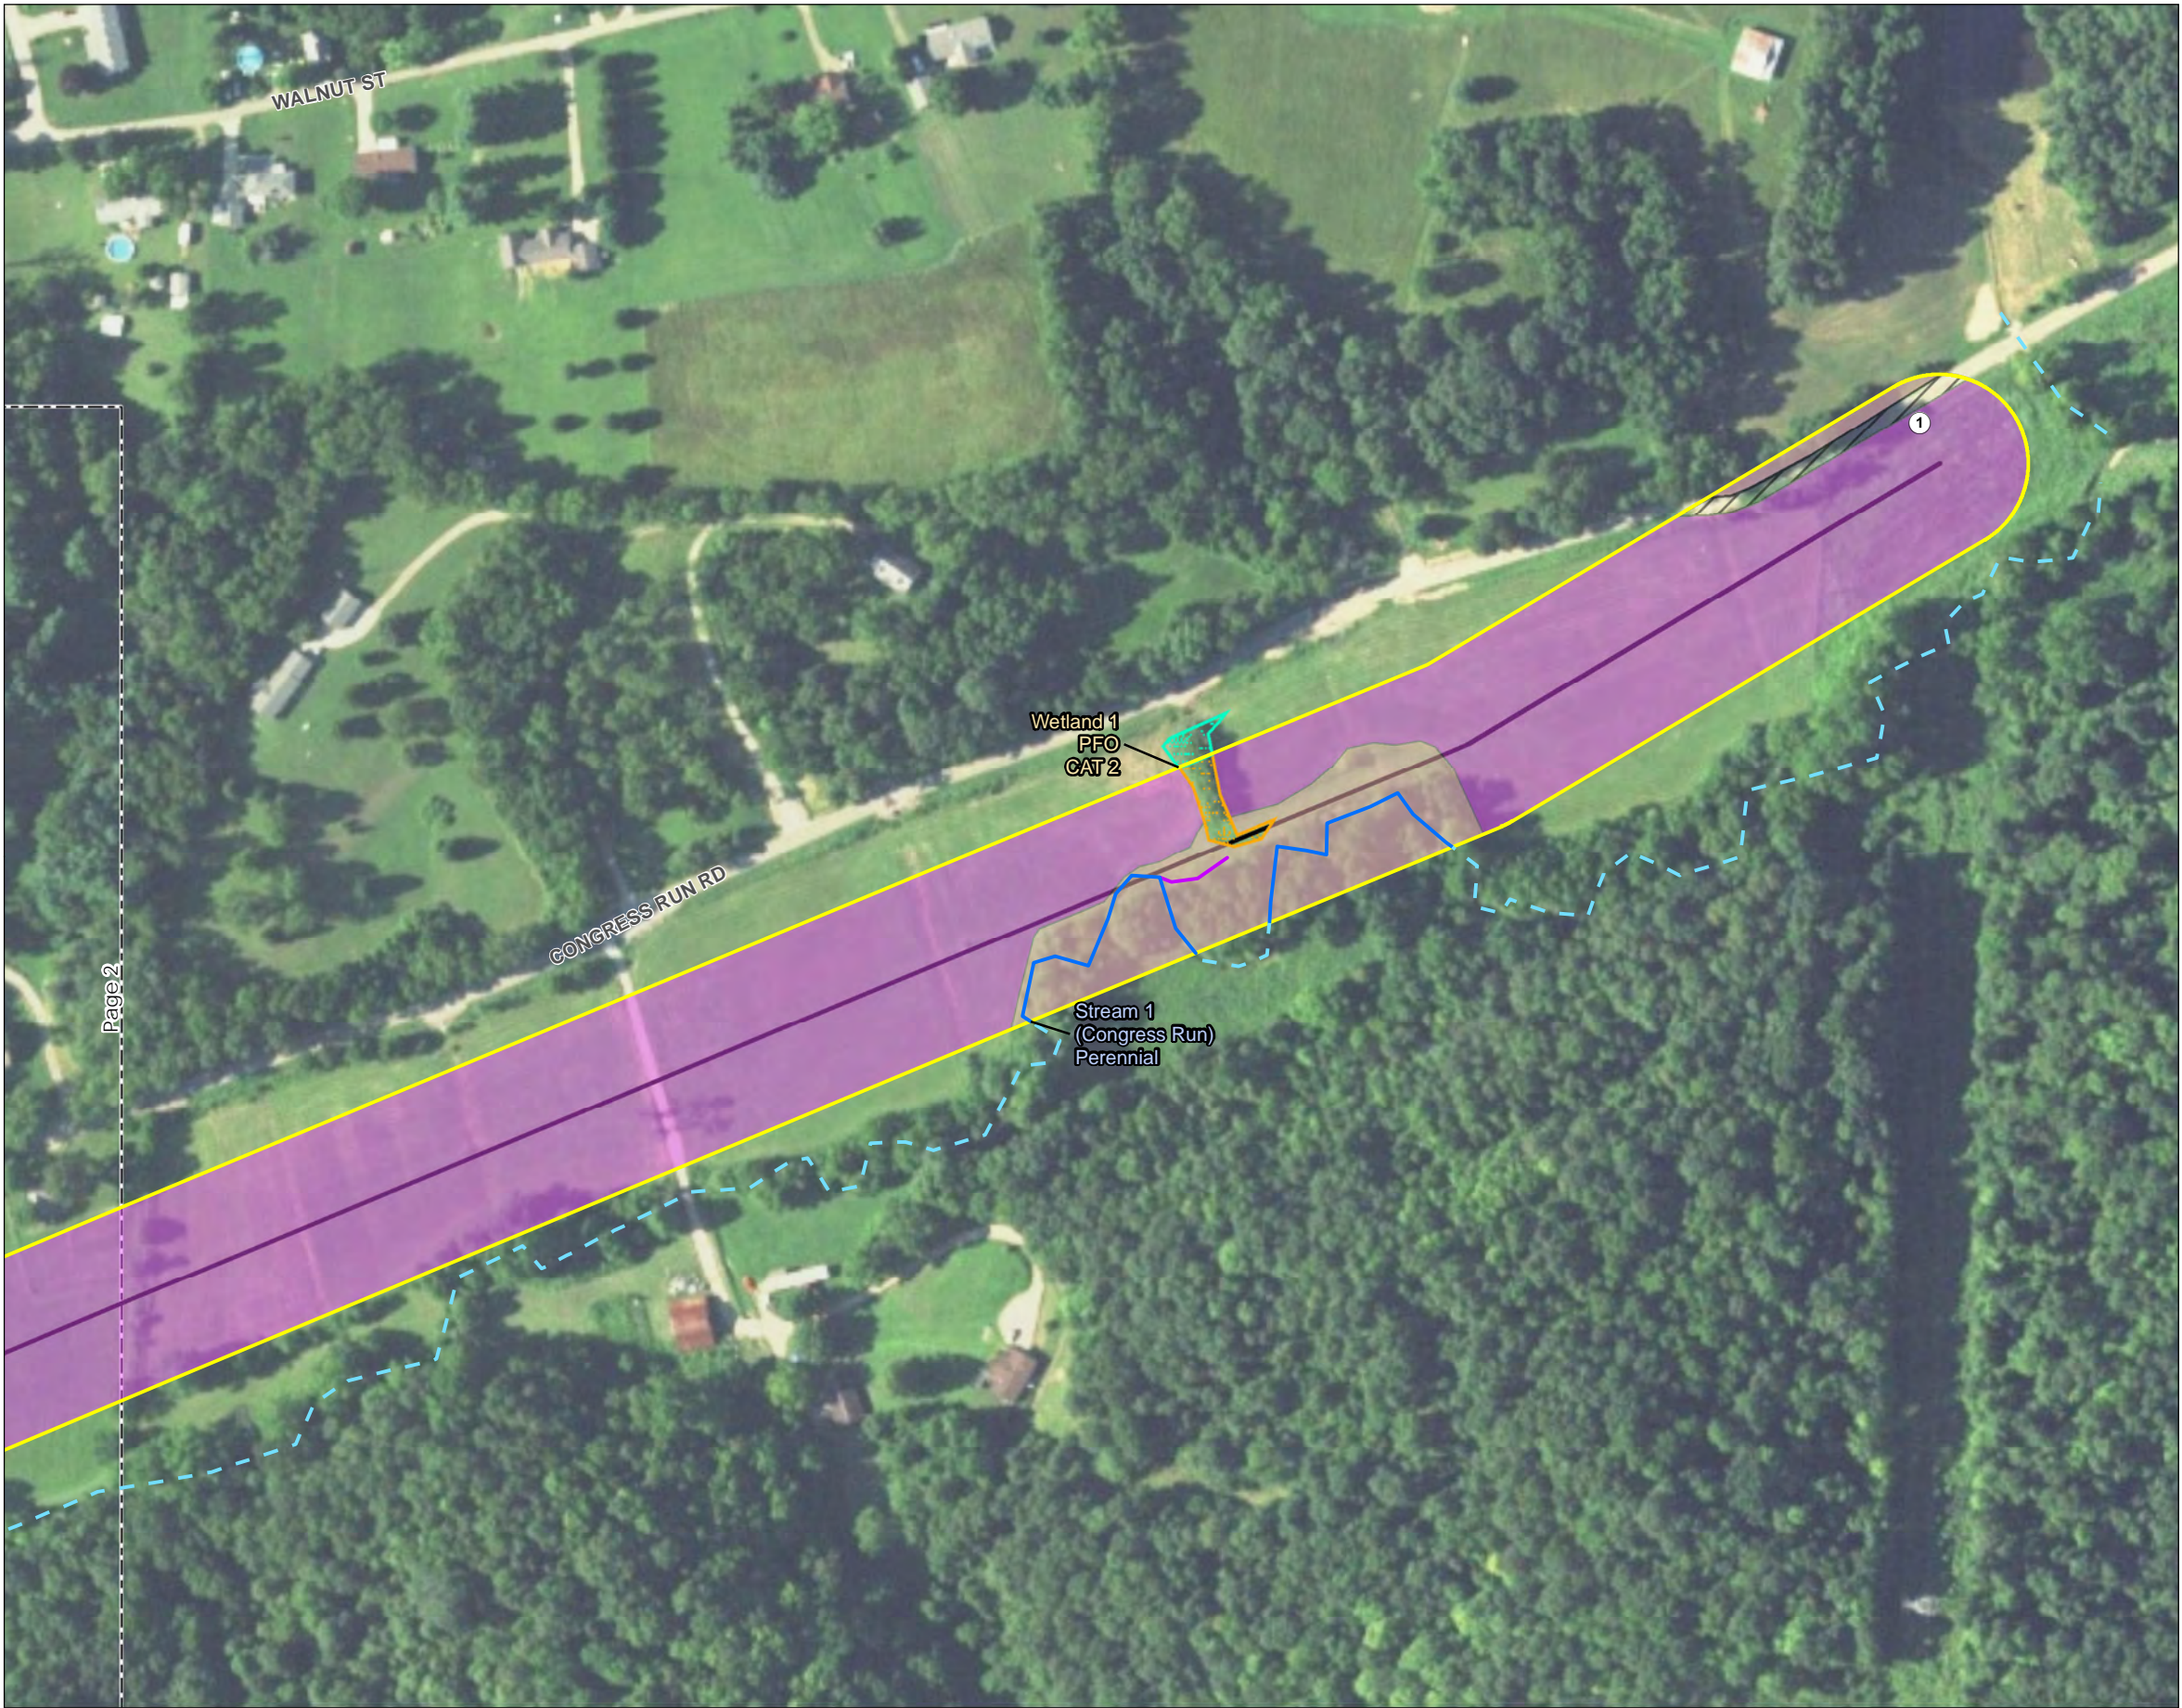
Figure No.
3
Title
Habitat Assessment Map

A.3 FIGURE 3 – HABITAT ASSESSMENT MAP

Stantec completed field surveys within the Project area on June 14, 2017, for threatened and endangered species or their habitats. Figure 3 (Appendix A) shows vegetation communities and the locations of any identified rare, threatened or endangered species habitat observed within the Project area. Representative photographs of the identified vegetative communities/habitats are included in Appendix C of this report (photo locations are shown on Figure 3, Appendix A). Information regarding the vegetation communities/habitats is provided in Table 1.
