RE: Case No. 17-2109-EL-BLN
In the Matter of the Letter of Notification Application of AEP Ohio
Transmission Company, Inc. for a Certificate of Environmental
Compatibility and Public Need for the Trimble 138kV Transmission
Line Extension Project

LETTER OF NOTIFICATION for the Trimble 138 kV Transmission Line Extension Project

PUCO Case No. 17-2109-EL-BLN

AEP Ohio Transmission Company, Inc.'s Trimble 138 kV Transmission Line Extension Project.

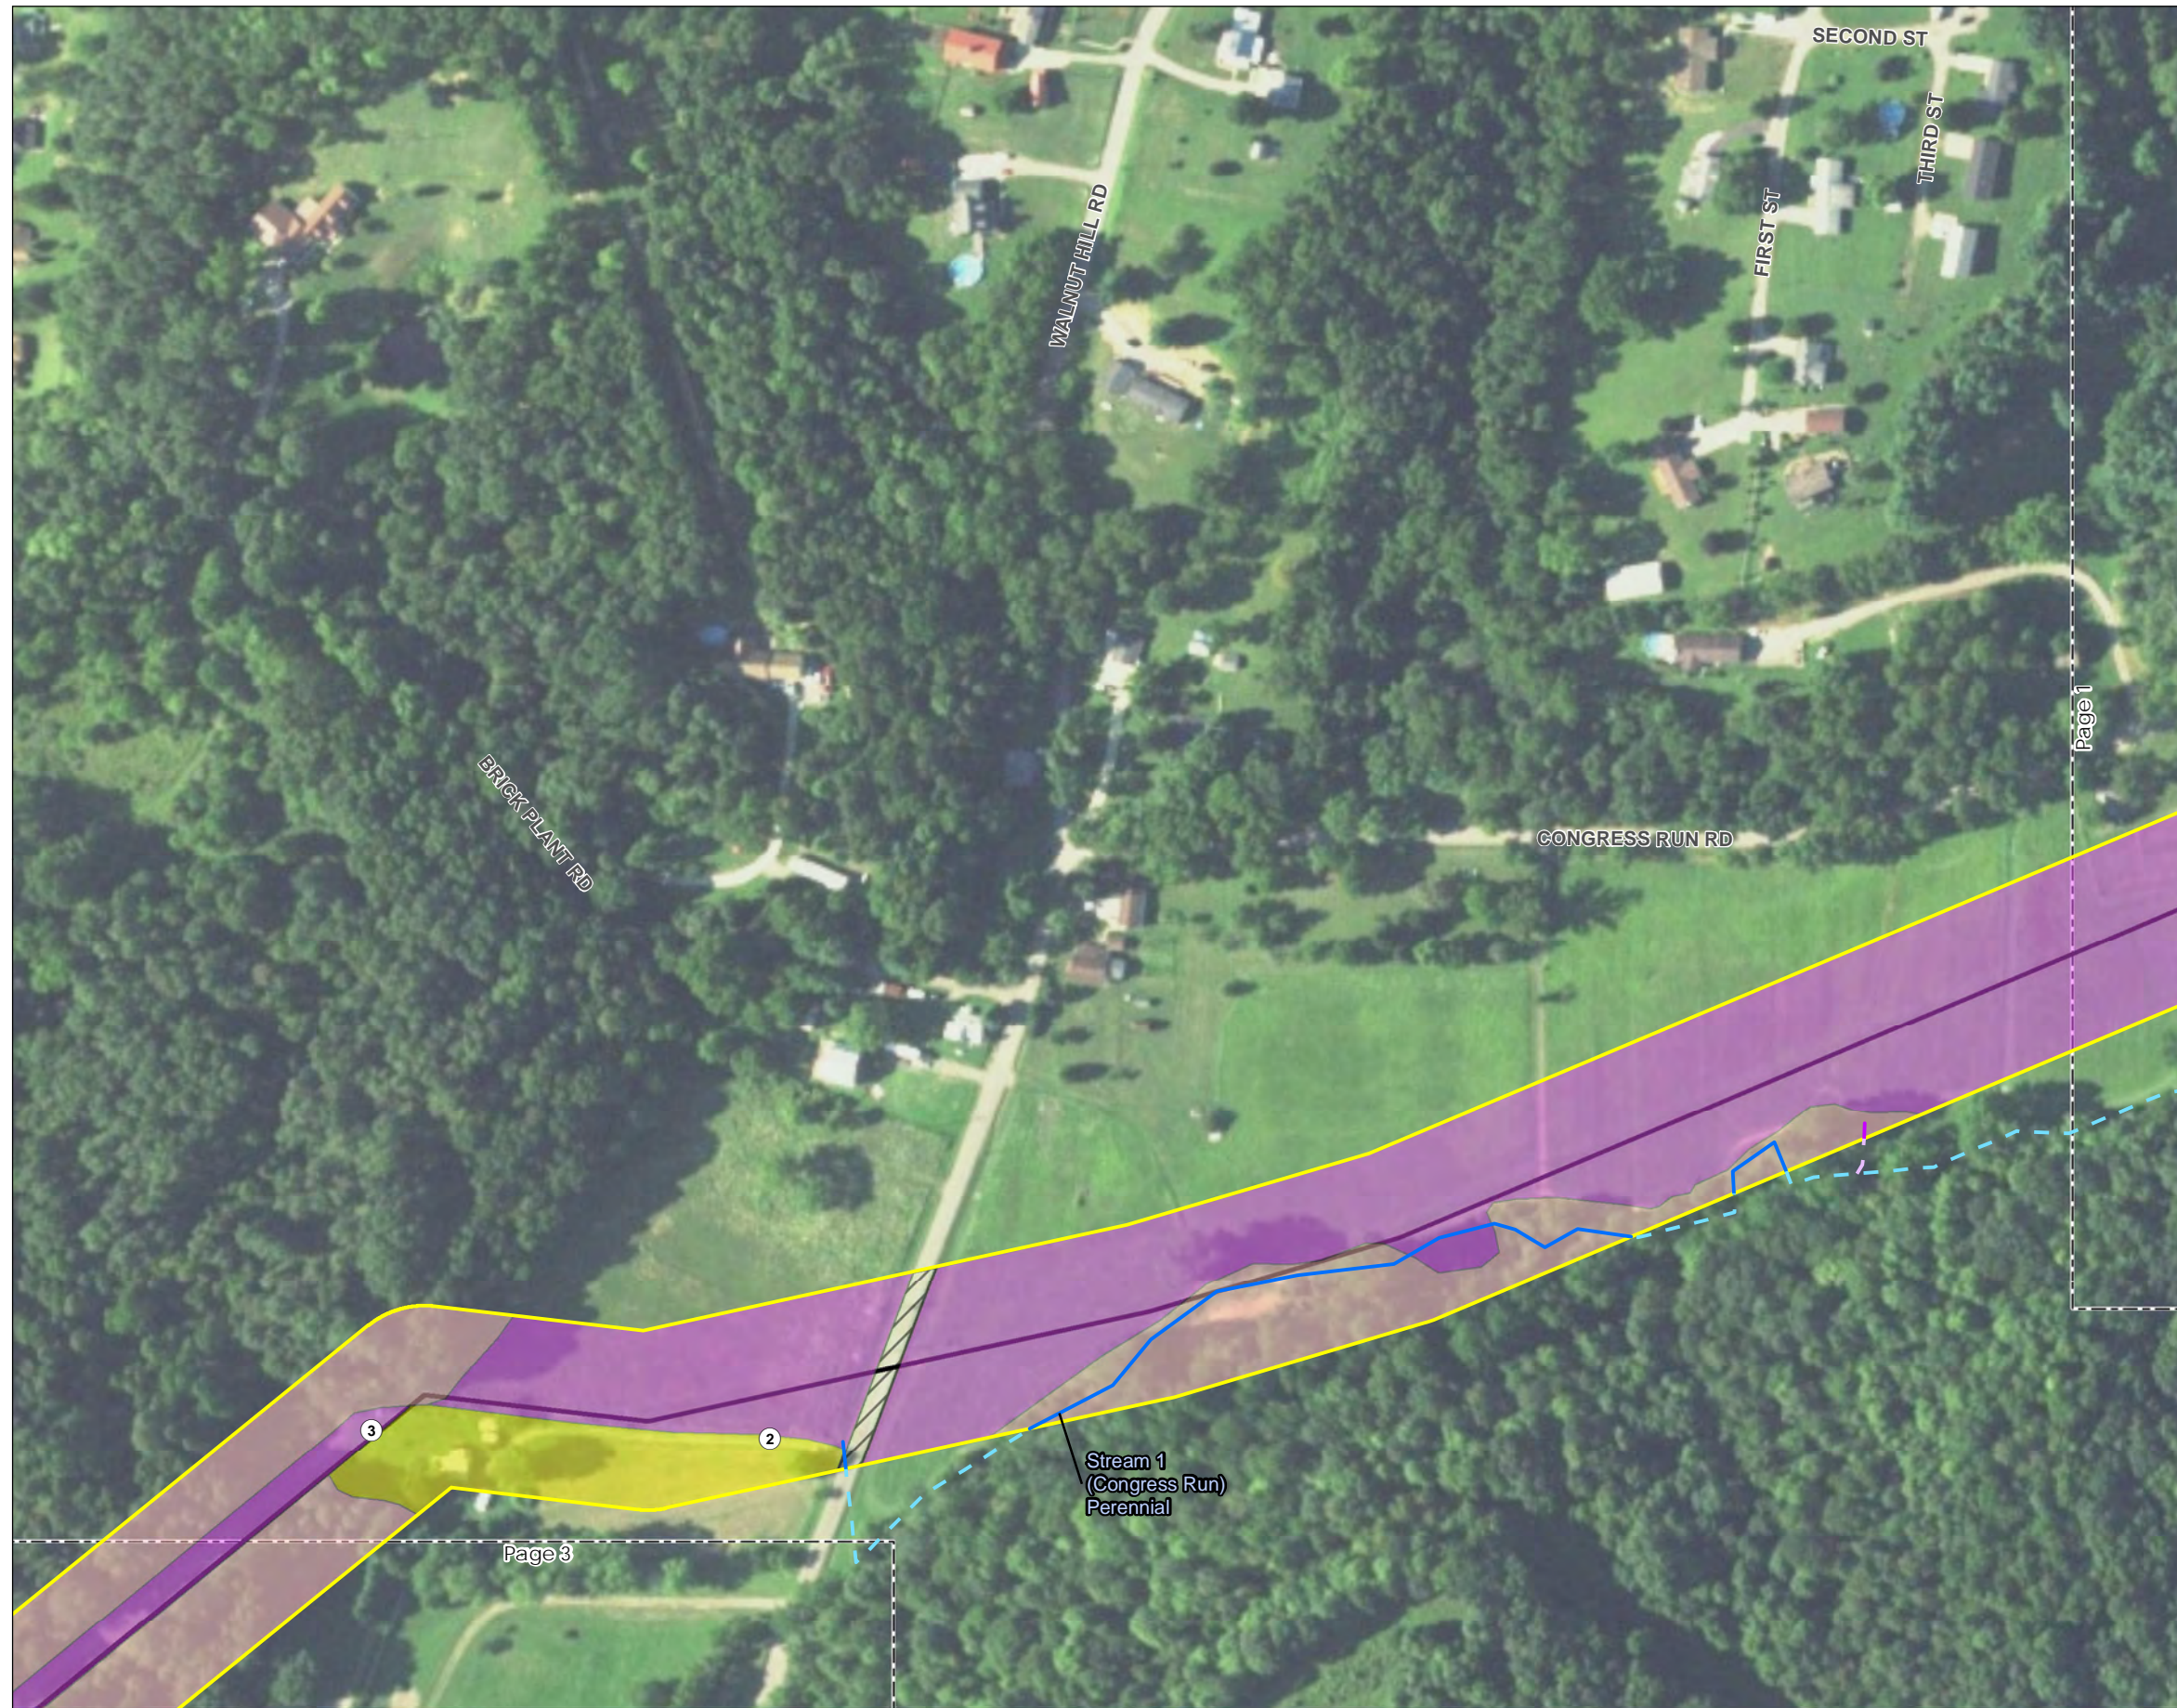
Figure No.	3
Title	
Habitat Assessment Map	
Client/Project	
AEP Ohio Transmission Company, Inc. Trimble 138 kV Transmission Line Extension Project	
Project Location	193705300
Athens County, Ohio	Prepared by JH on 2017-10-10 Technical Review by HDB on 2017-10-11 Independent Review by MJT on 2017-10-12

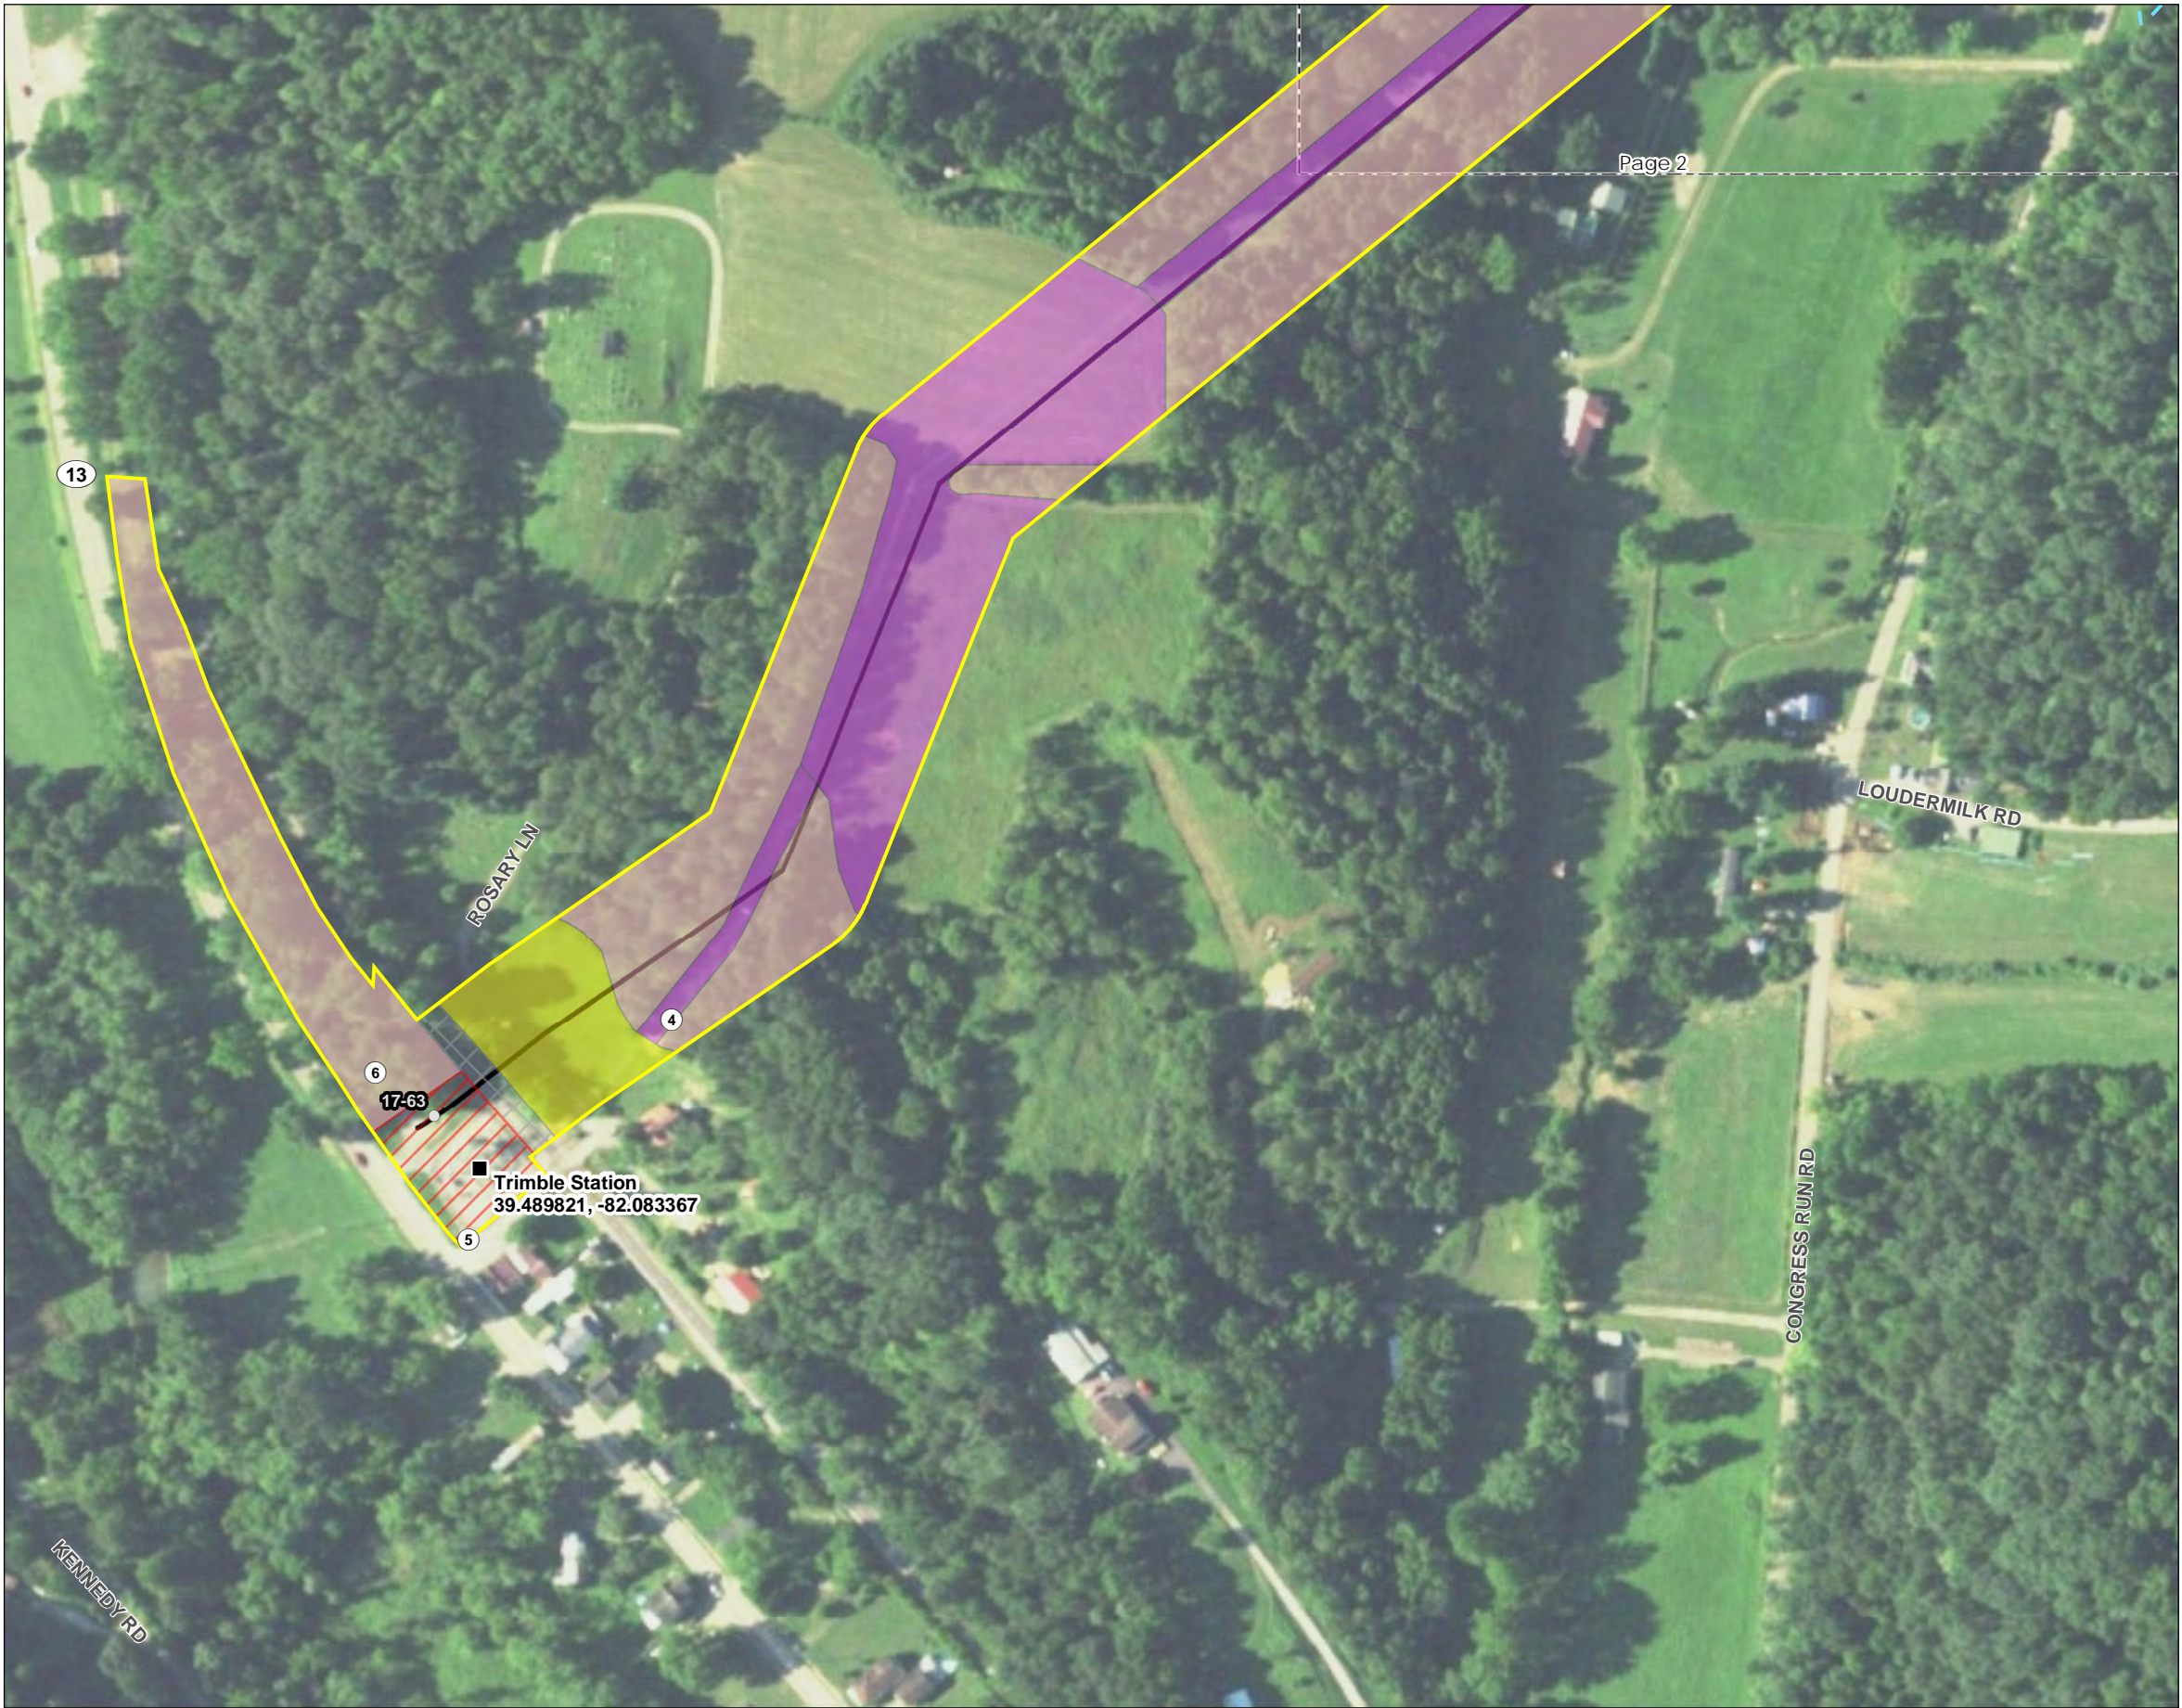
Figure No.
3

Title
Habitat Assessment Map

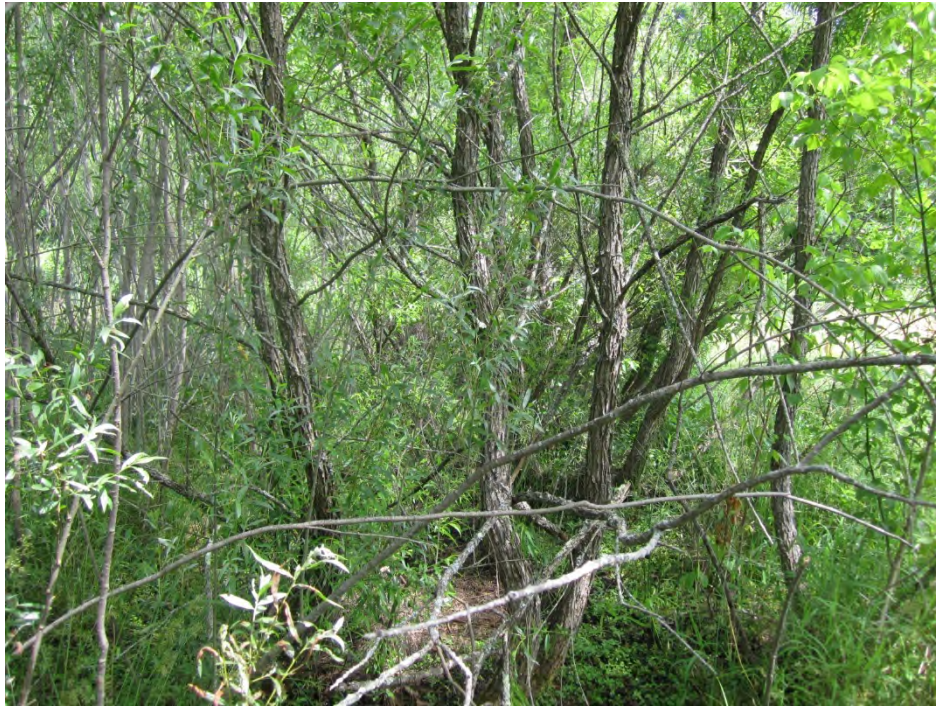
Photo Location 1. View of Wetland 1. Photograph taken facing north.

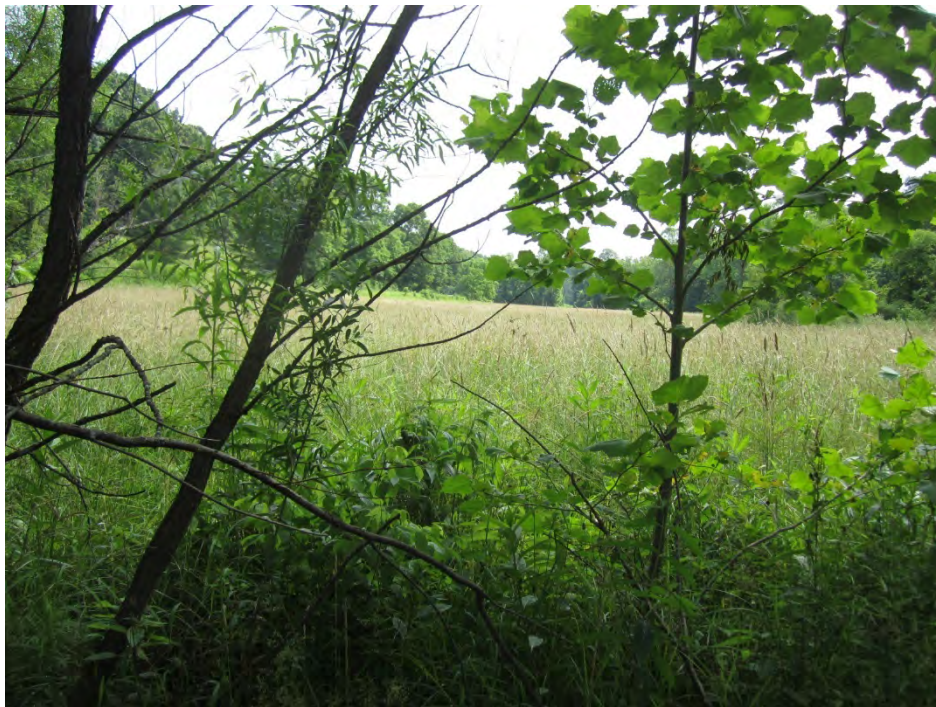
Photo Location 1. View of Wetland 1. Photograph taken facing east.

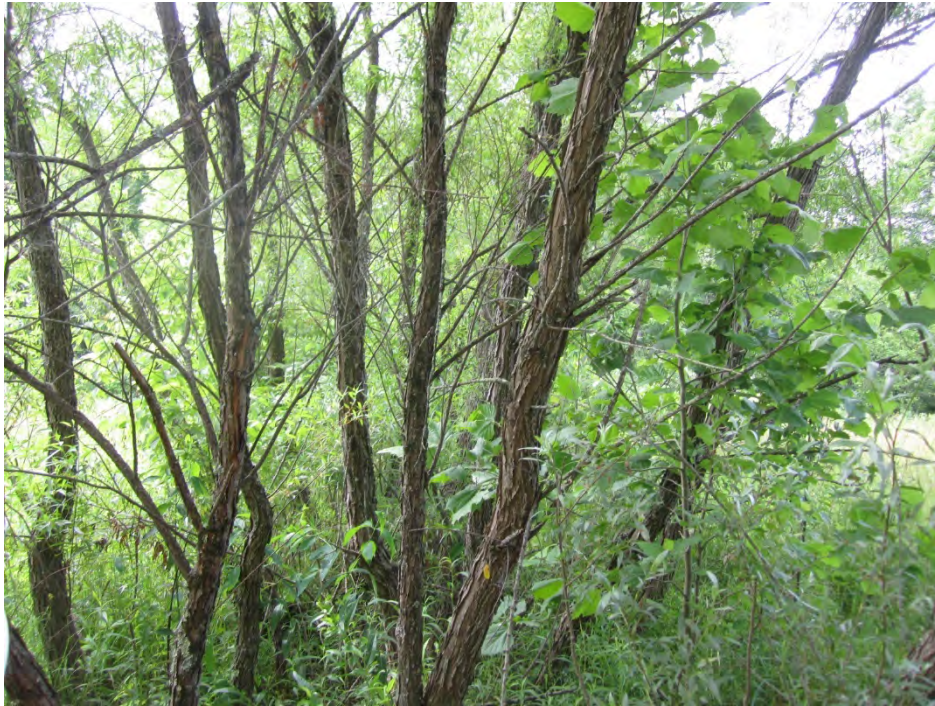
Photo Location 1. View of Wetland 1. Photograph taken facing south.

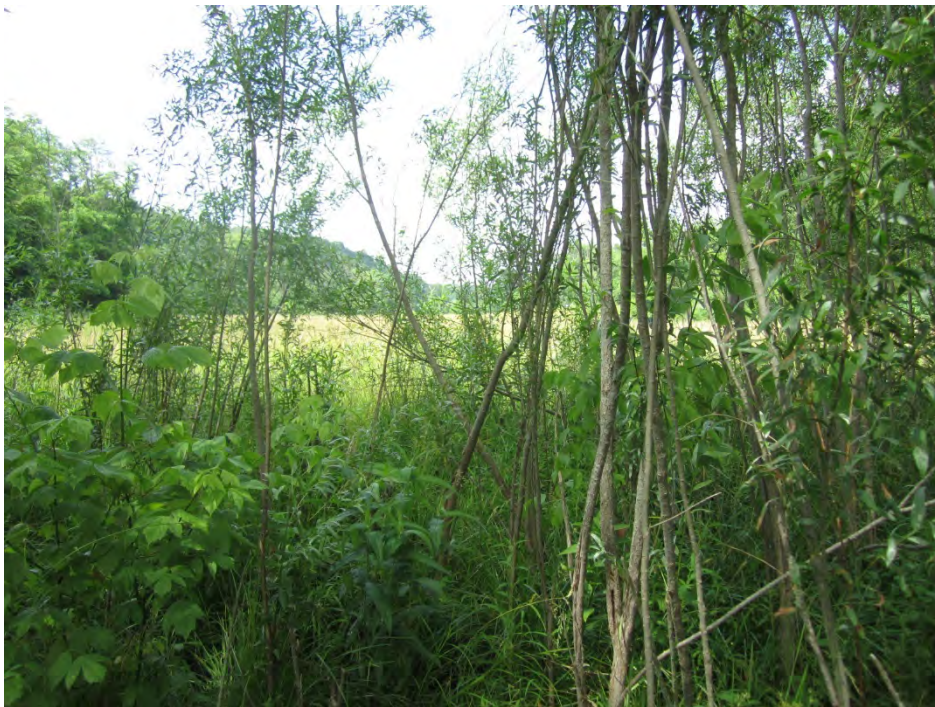
Photo Location 1. View of Wetland 1. Photograph taken facing west.

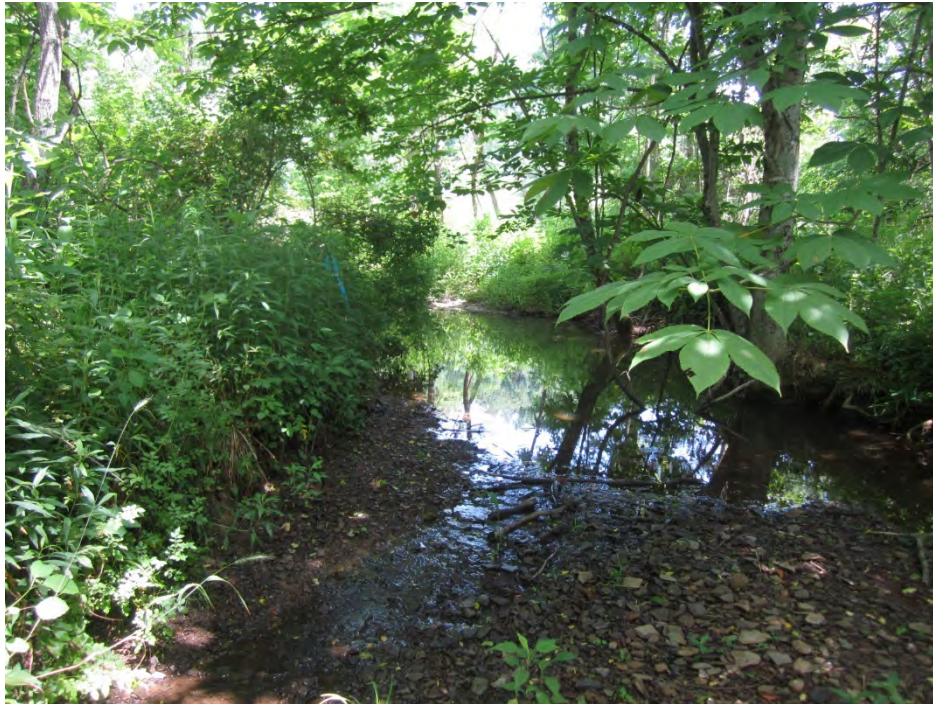
Photo Location 2. Upstream view of Stream 1. Photograph taken facing north.

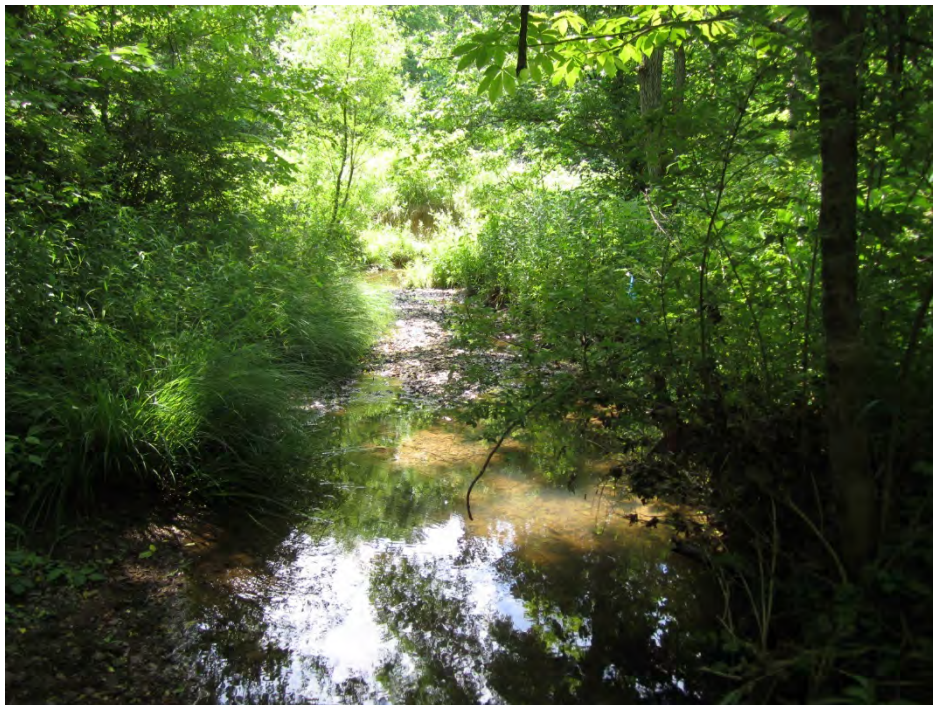
Photo Location 2. Downstream view of Stream 1. Photograph taken facing southeast.

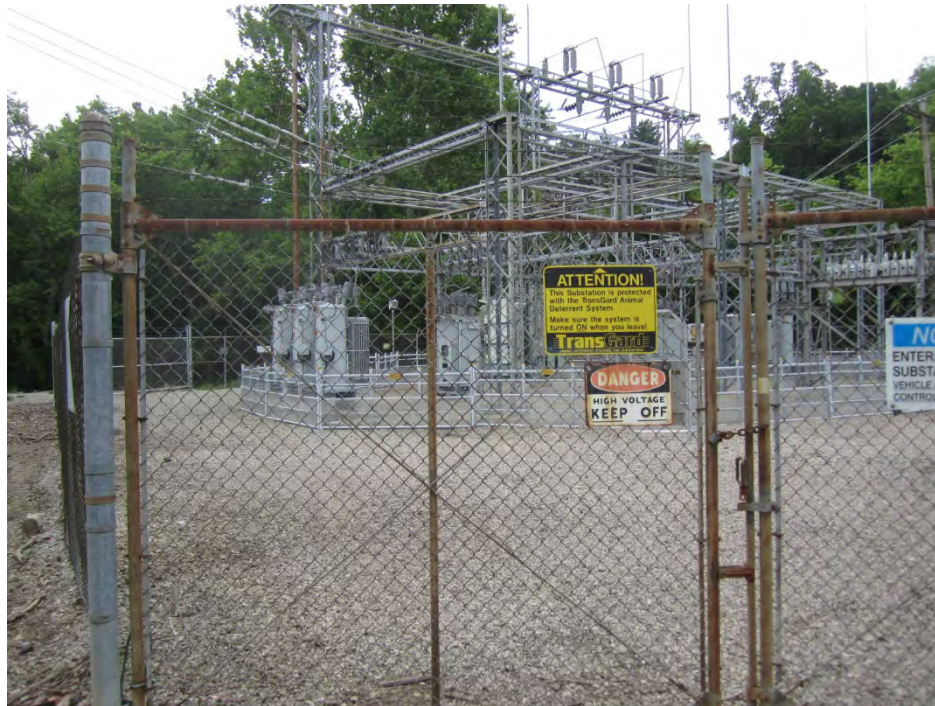
Photo Location 5. View of industrial habitat (Trimble Station). Photograph taken facing north.

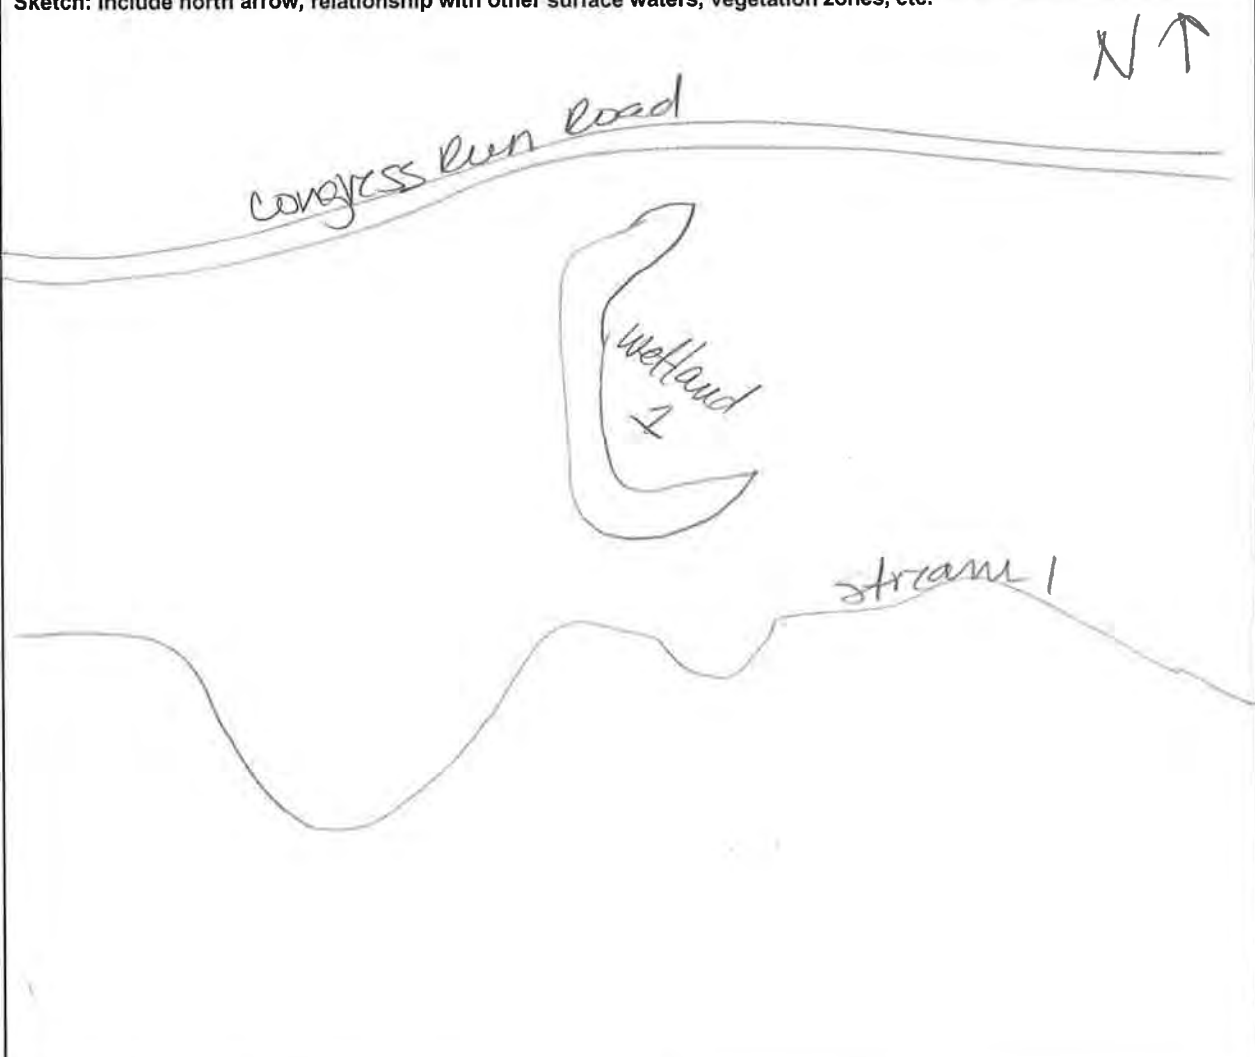
Name of Wetland: <u>Wetland 1</u>	
Wetland Size (acres, hectares): <u>0.49</u>	
Sketch: Include north arrow, relationship with other surface waters, vegetation zones, etc.

Comments, Narrative Discussion, Justification of Category Changes:	
Final score : <u>54</u>	Category: <u>2</u>
