**Re: Case No. 17-2439-EL-BLN Request for Expedited Treatment:
In the Matter of the Letter of Notification for the
Lemaster-Lick 138kV Transmission Line Extension Project Update**

Letter of Notification for Lemaster-Lick 138 kV Transmission Line Relocation Project Update

LETTER OF NOTIFICATION FOR LEMASTER-LICK 138 KV TRANSMISSION LINE RELOCATION PROJECT
UPDATE

**Lemaster-Lick 138 kV Transmission
Line Relocation Project, Athens
County, Ohio**

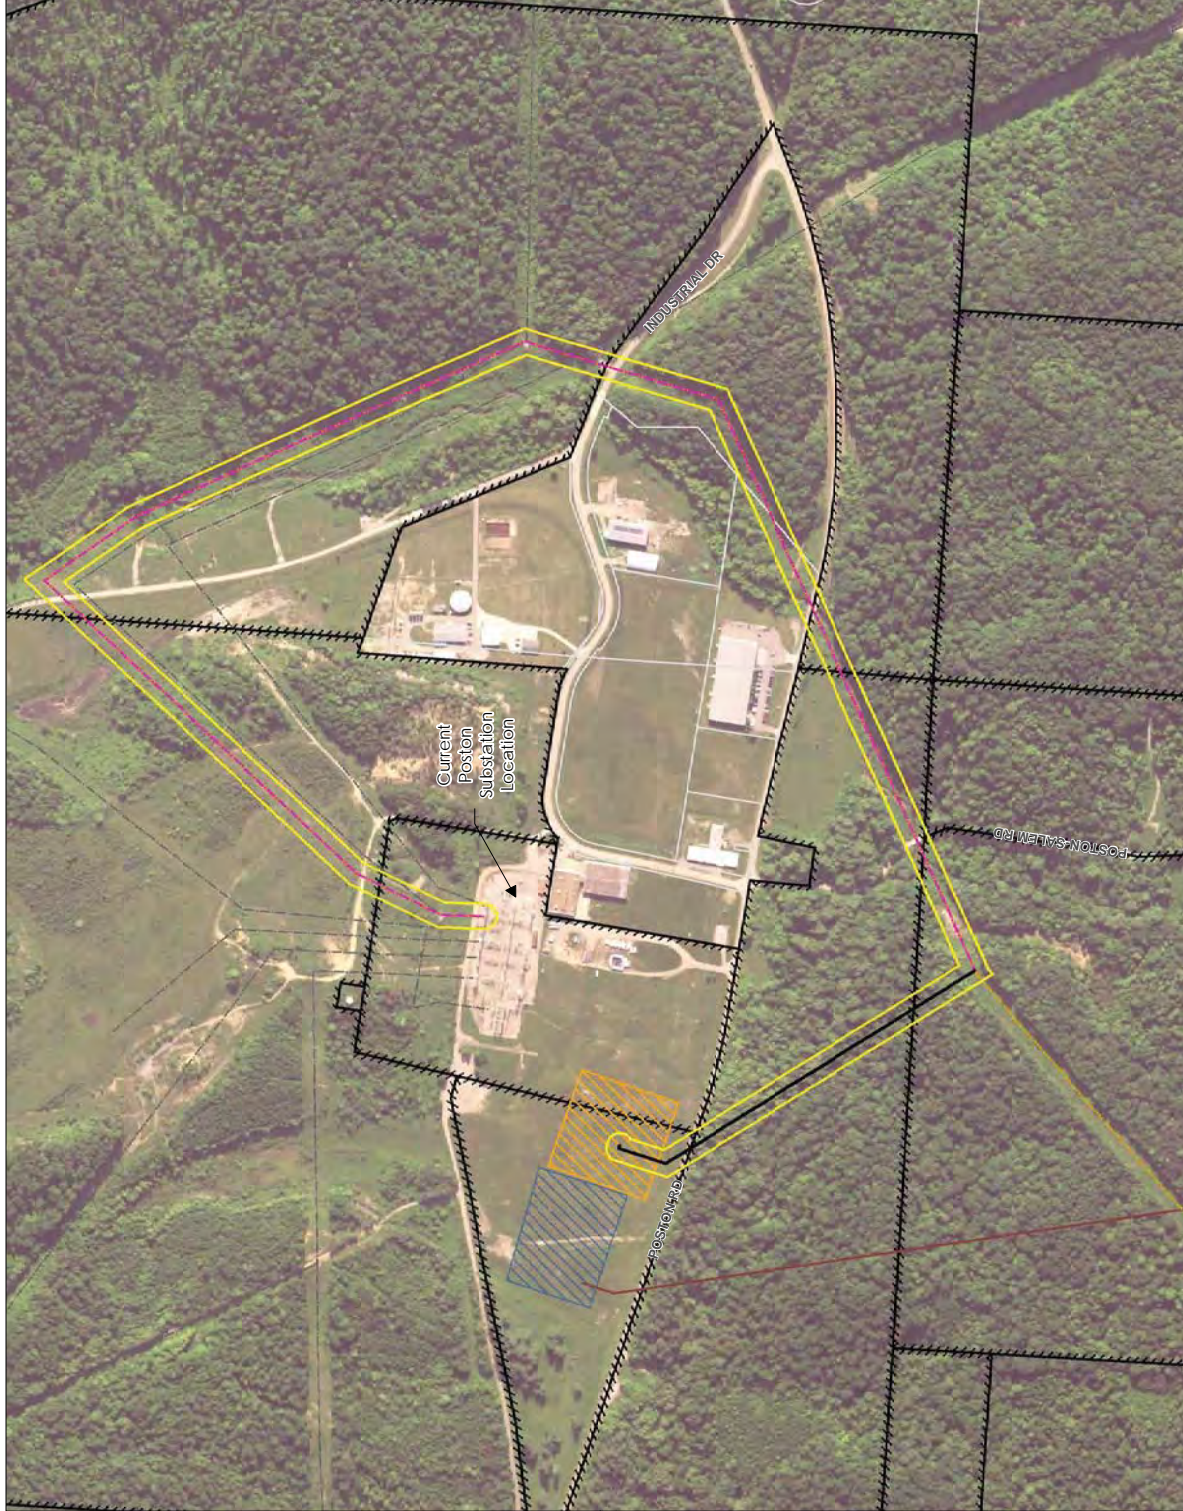
Figure No.
1.3

Title
Land Use Map

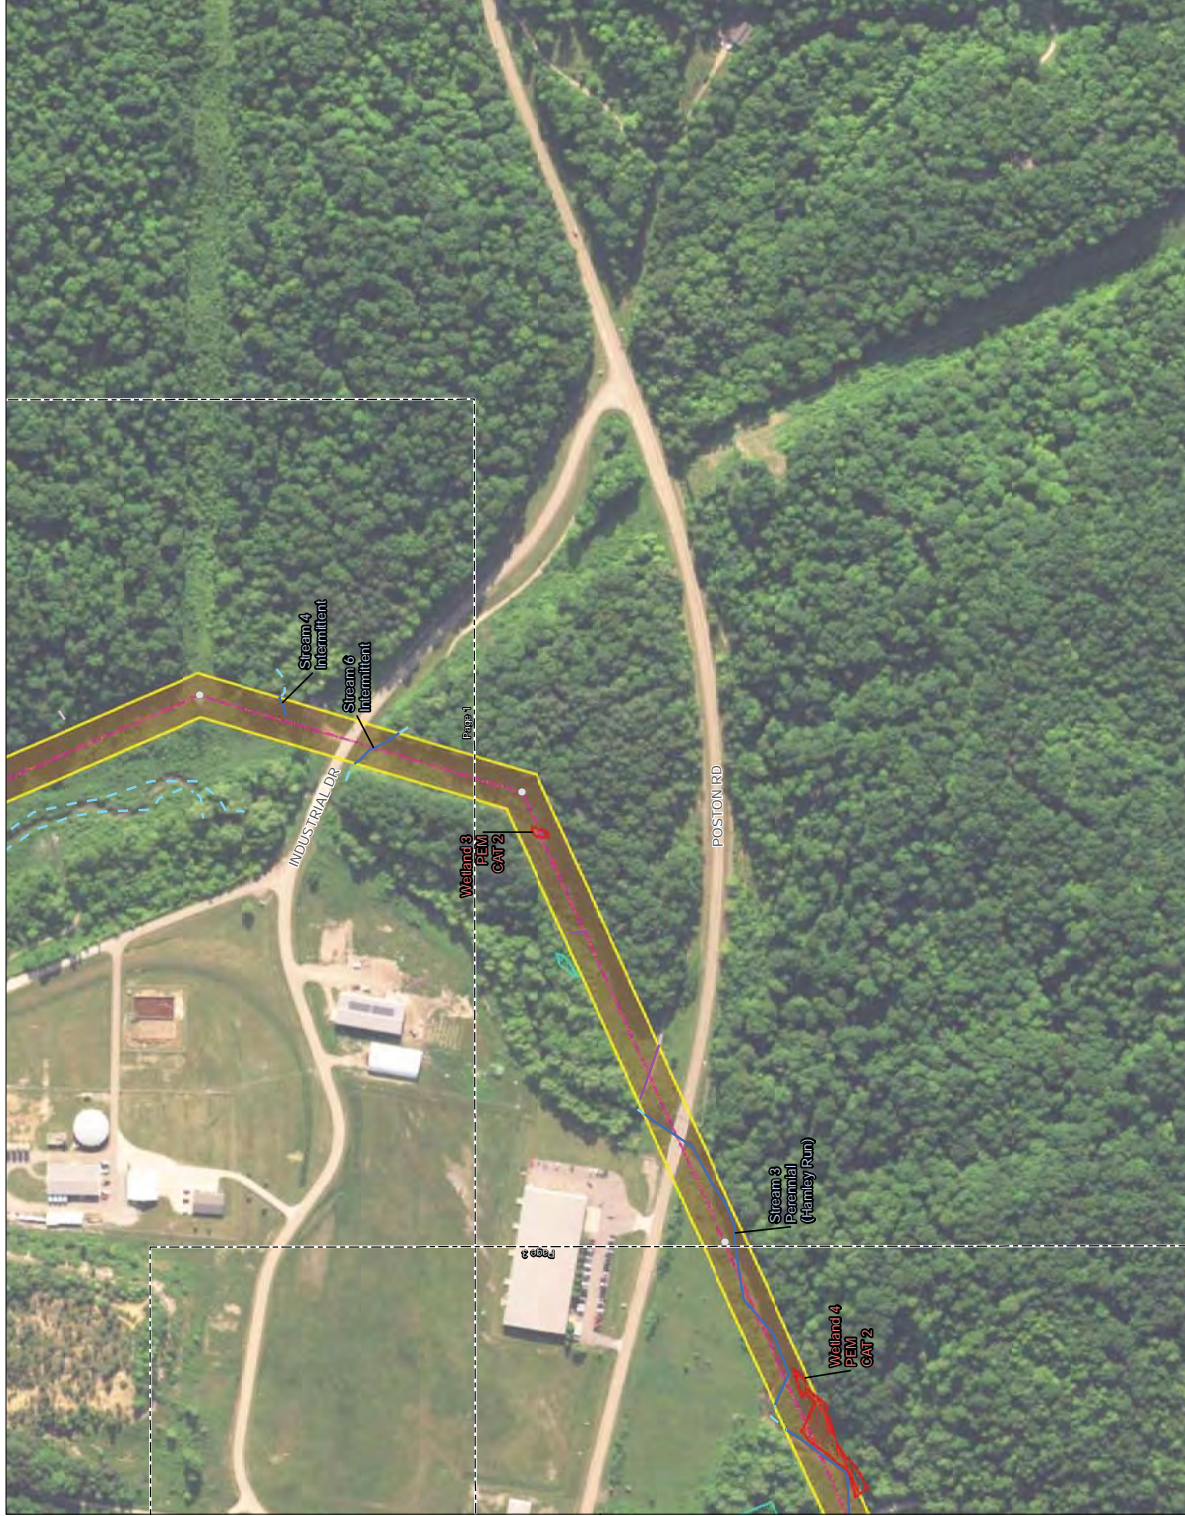
A.3 FIGURE 3 – HABITAT ASSESSMENT MAP

Habitat Assessment Map

Stantec completed field surveys within the Project area on November 7-8, 2016, February 10, 2017, and November 10, 2017, for threatened and endangered species or their habitats. Figure 3 (Appendix A) shows the vegetation communities/habitats and locations of any identified rare, threatened or endangered species habitat observed within the Project area. Representative photographs of the vegetation communities/habitats identified within the Project area are included in Appendix C of this report (photo locations are shown on Figures 2 and 3, Appendix A). Information regarding the vegetation communities/habitats identified within the Project area is provided in Table 1.

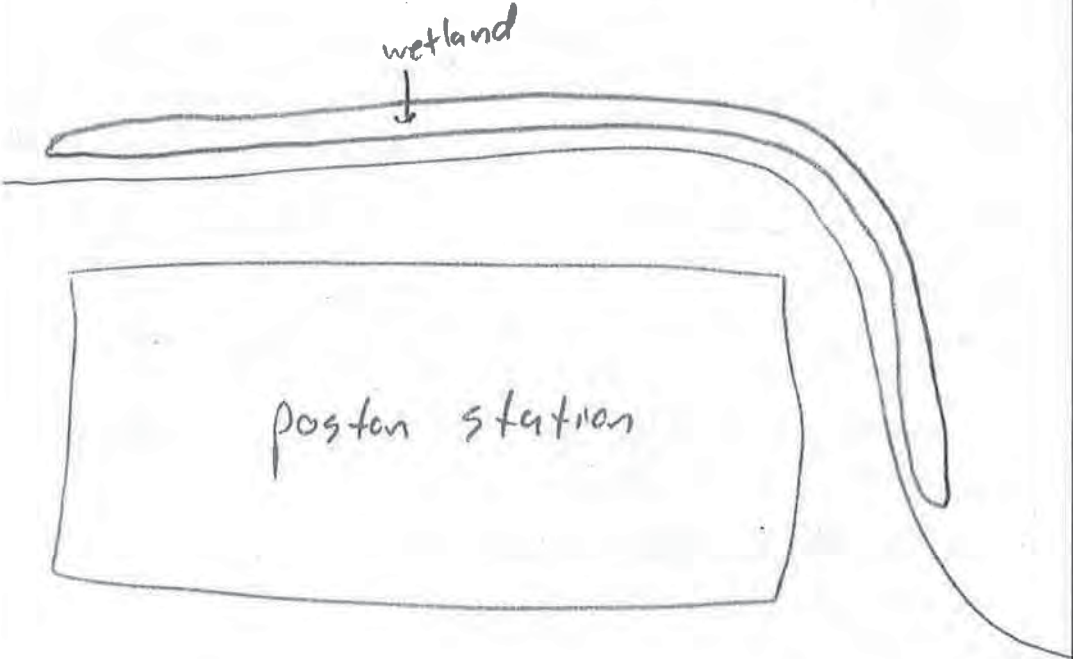
Name of Wetland: <u>Wetland 1</u>	
Wetland Size (acres, hectares): <u>0.06 ac</u>	
Sketch: Include north arrow, relationship with other surface waters, vegetation zones, etc.

Comments, Narrative Discussion, Justification of Category Changes:	
Final score : <u>12</u>	Category: <u>1</u>

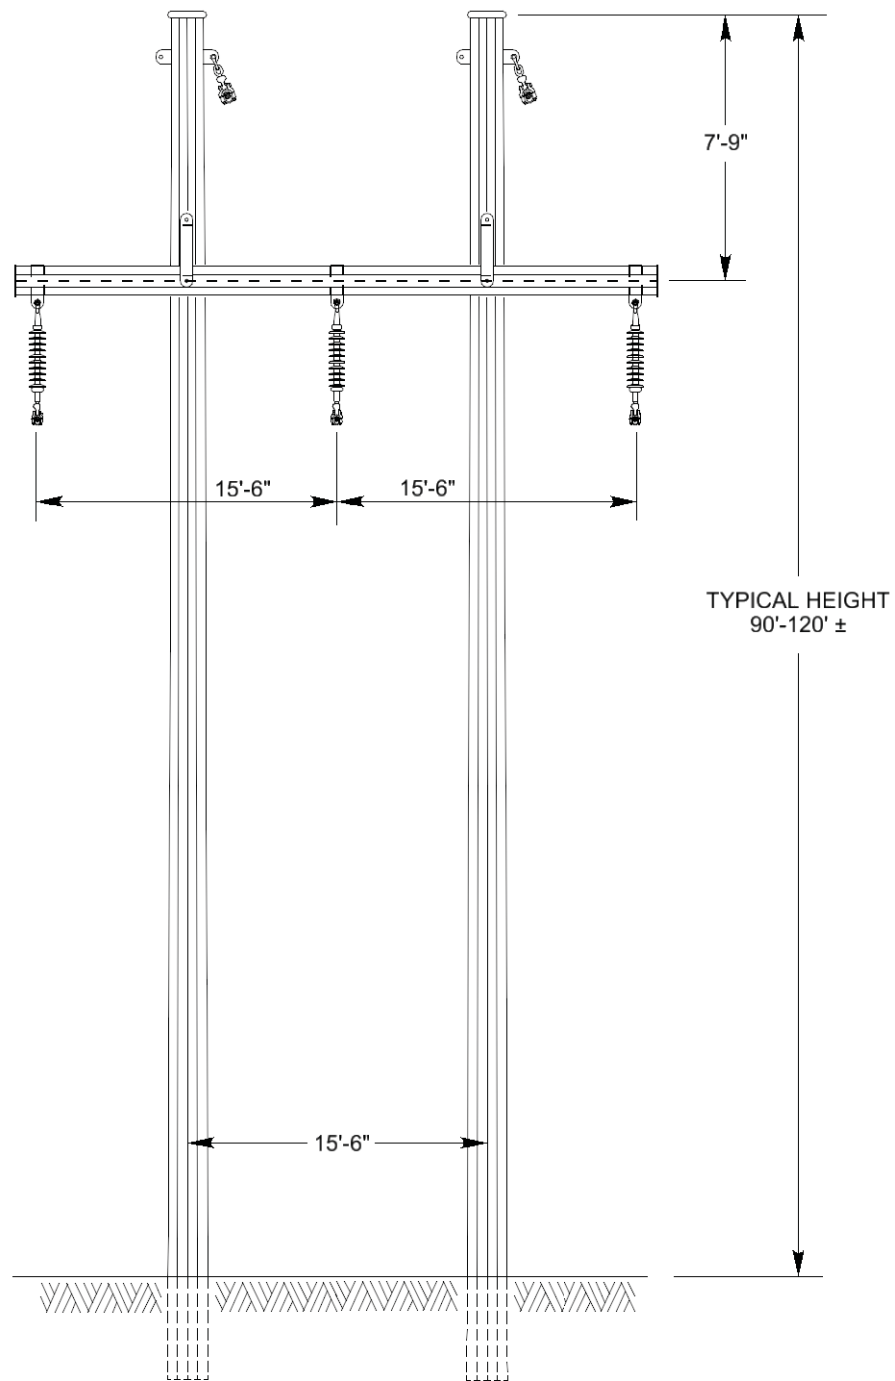
FIGURE 1

LEEMASTER - LICK
138kV LINE

TYPICAL TANGENT STRUCTURE
TUBULAR STEEL
H-FRAME SUSPENSION

The proposed Project will remove five existing H-frame pole structures, five existing guyed three-pole structure, two lattice tower structures, and approximately 1.47 miles of existing 138 kV single circuit transmission line. The existing conductor type is 636 KCM ACSR 26/7 “Grosbeak” and the existing shield wire is 3/8 EHS steel. The Project will include the installation of four new steel pole structures and 0.32 miles of new single-circuit 138 kV transmission line, new 636 KCM ACSR 26/7 “Grosbeak” conductors, along with a 7#8 alumoweld shield wire. All deadends will utilize pier foundations with anchor cages. The design and operating voltage will be 138 kV. Structure design and phasing diagrams are presented in Appendix C.

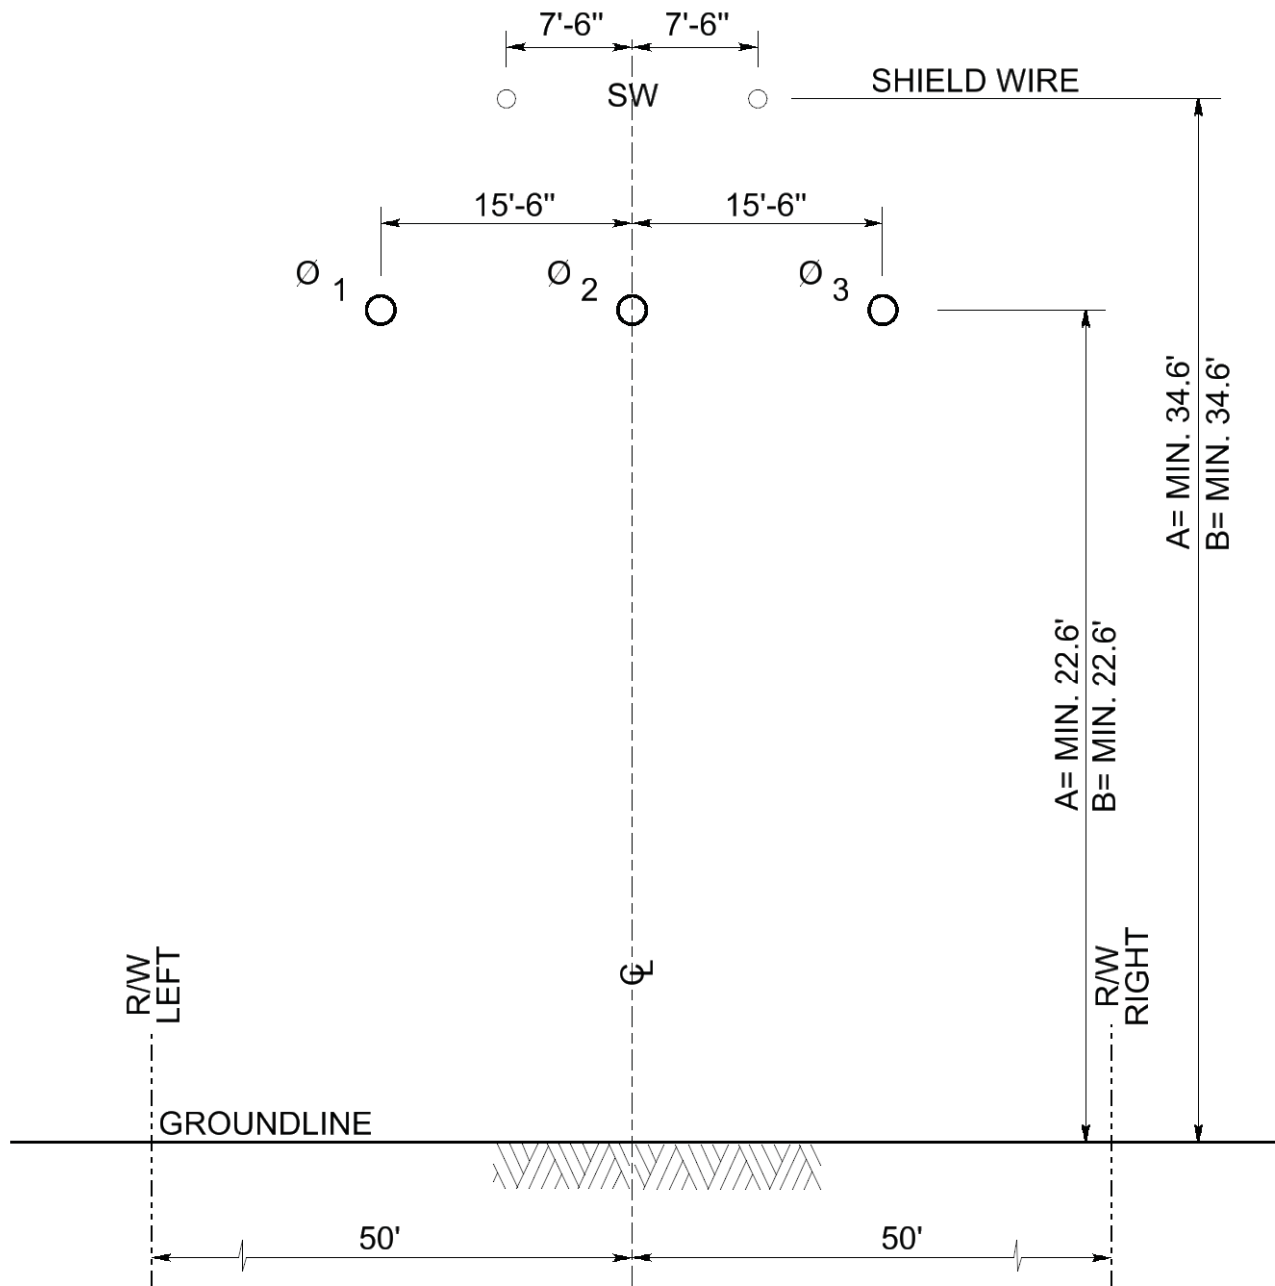
DIMENSION "A" SINGLE CIRCUIT - HOR. CONFIGURATION (STEEL POLE)
(UNDER EMERGENCY & NORMAL MAX. LINE LOADING)

DIMENSION "B" SINGLE CIRCUIT - HOR. CONFIGURATION (STEEL POLE)
(UNDER WINTER NORMAL CONDUCTOR RATING)
