| REV | DESCRIPTION | BY | DATE | | TRANSMISSION LINE STANDARDS<br>DRILL LOCATIONS<br>POLYMER - 138KV HEAVY SUSPENSION<br>W/CORONA RING,<br>H-FRAME, GALVANIZED STEEL | | |

**Summerfield-Berne 138 kV  
Transmission Line Rebuild Project,  
Monroe and Noble Counties, Ohio**

**Ecological Resources Inventory  
Report**

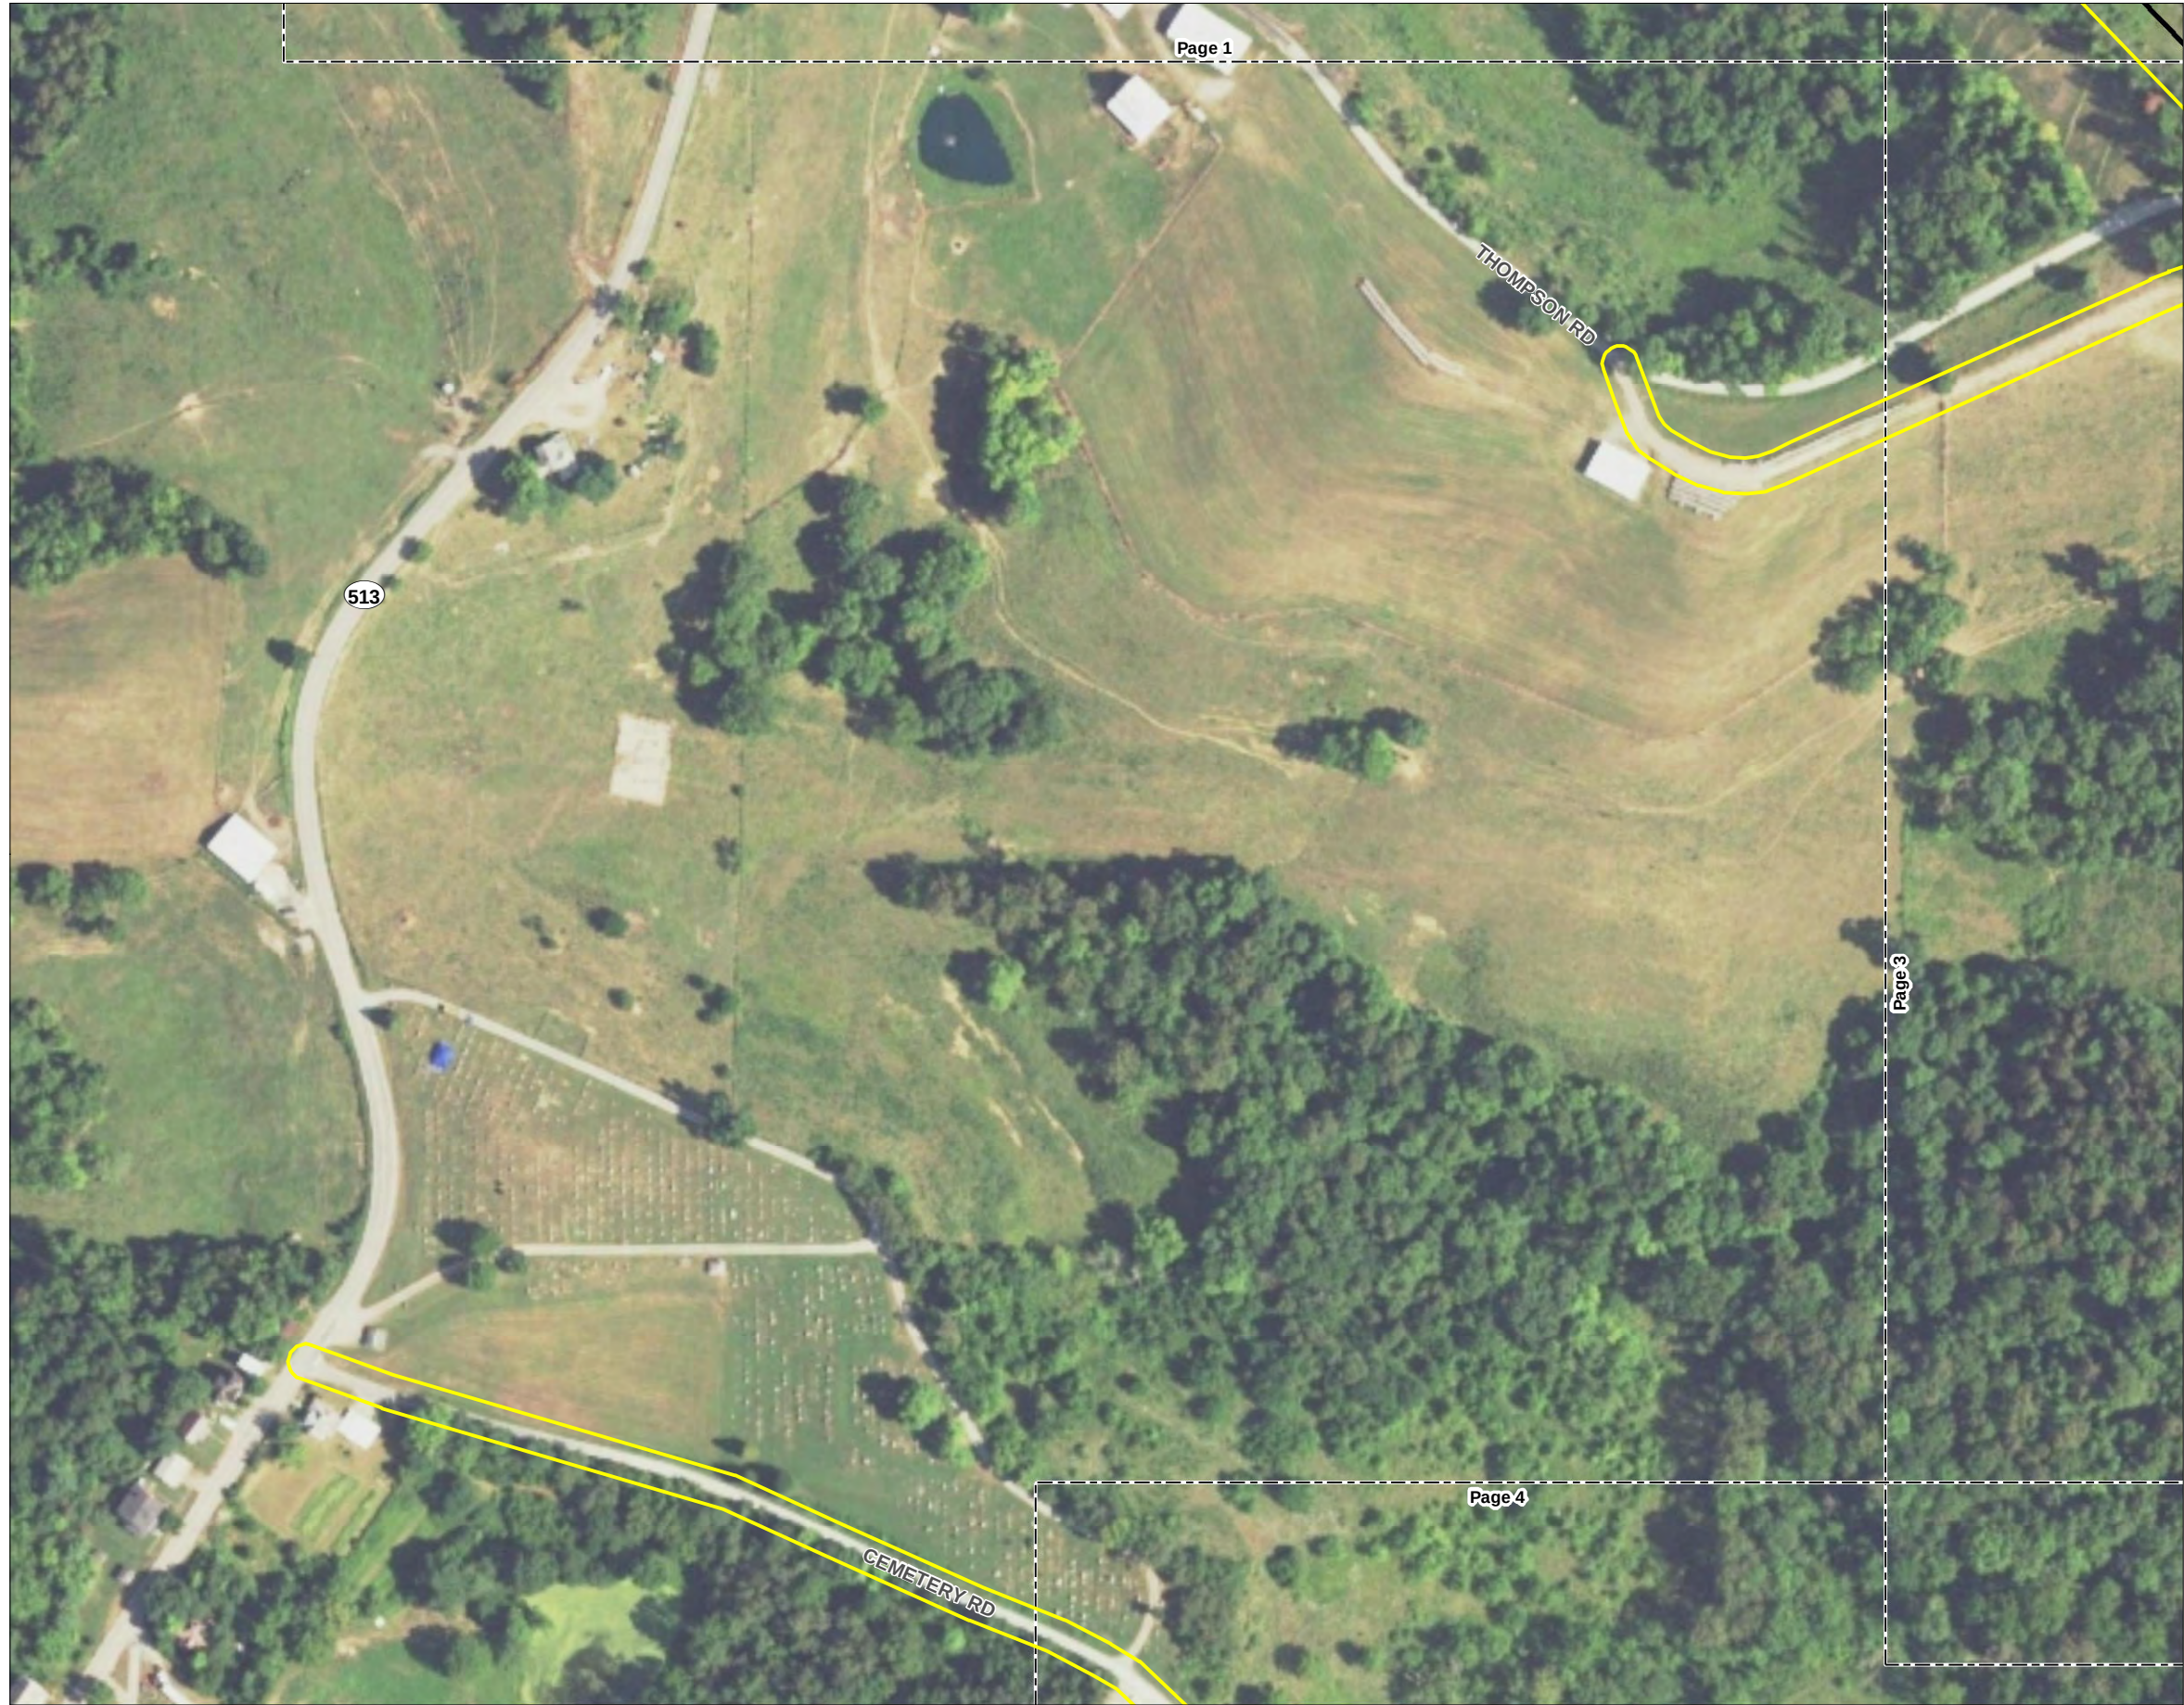
Figure No.  
**2**

Title  
**Wetland and Waterbody  
Delineation Map**

Stantec completed field surveys for wetlands within the Project area on June 15 through 16, 2017 and July 20 through 21, 2017. Figure 2 (Appendix A) shows the wetlands identified by Stantec within the Project area. Representative wetland photographs are included in Appendix C of this report (photo locations are shown on Figure 2, Appendix A). Completed wetland determination and ORAM data forms are included in Appendix D. Information regarding the Cowardin classification and ORAM categories of wetlands identified within the Project area is provided in Table 2.

Stantec completed field surveys for waterbodies within the Project area on June 15 through 16, 2017, and July 20 through 21, 2017. Figure 2 (Appendix A) shows the waterbodies (streams and open water features) identified by Stantec within the Project area, as well as the locations of non-jurisdictional upland drainage features identified within the Project area. Representative photographs of the streams, open waters, and upland drainage features are included in Appendix C of this report (photo locations are shown on Figure 2, Appendix A). Completed QHEI and HHEI data forms are included in Appendix D. Information regarding the streams identified within the Project area is provided in Table 3.

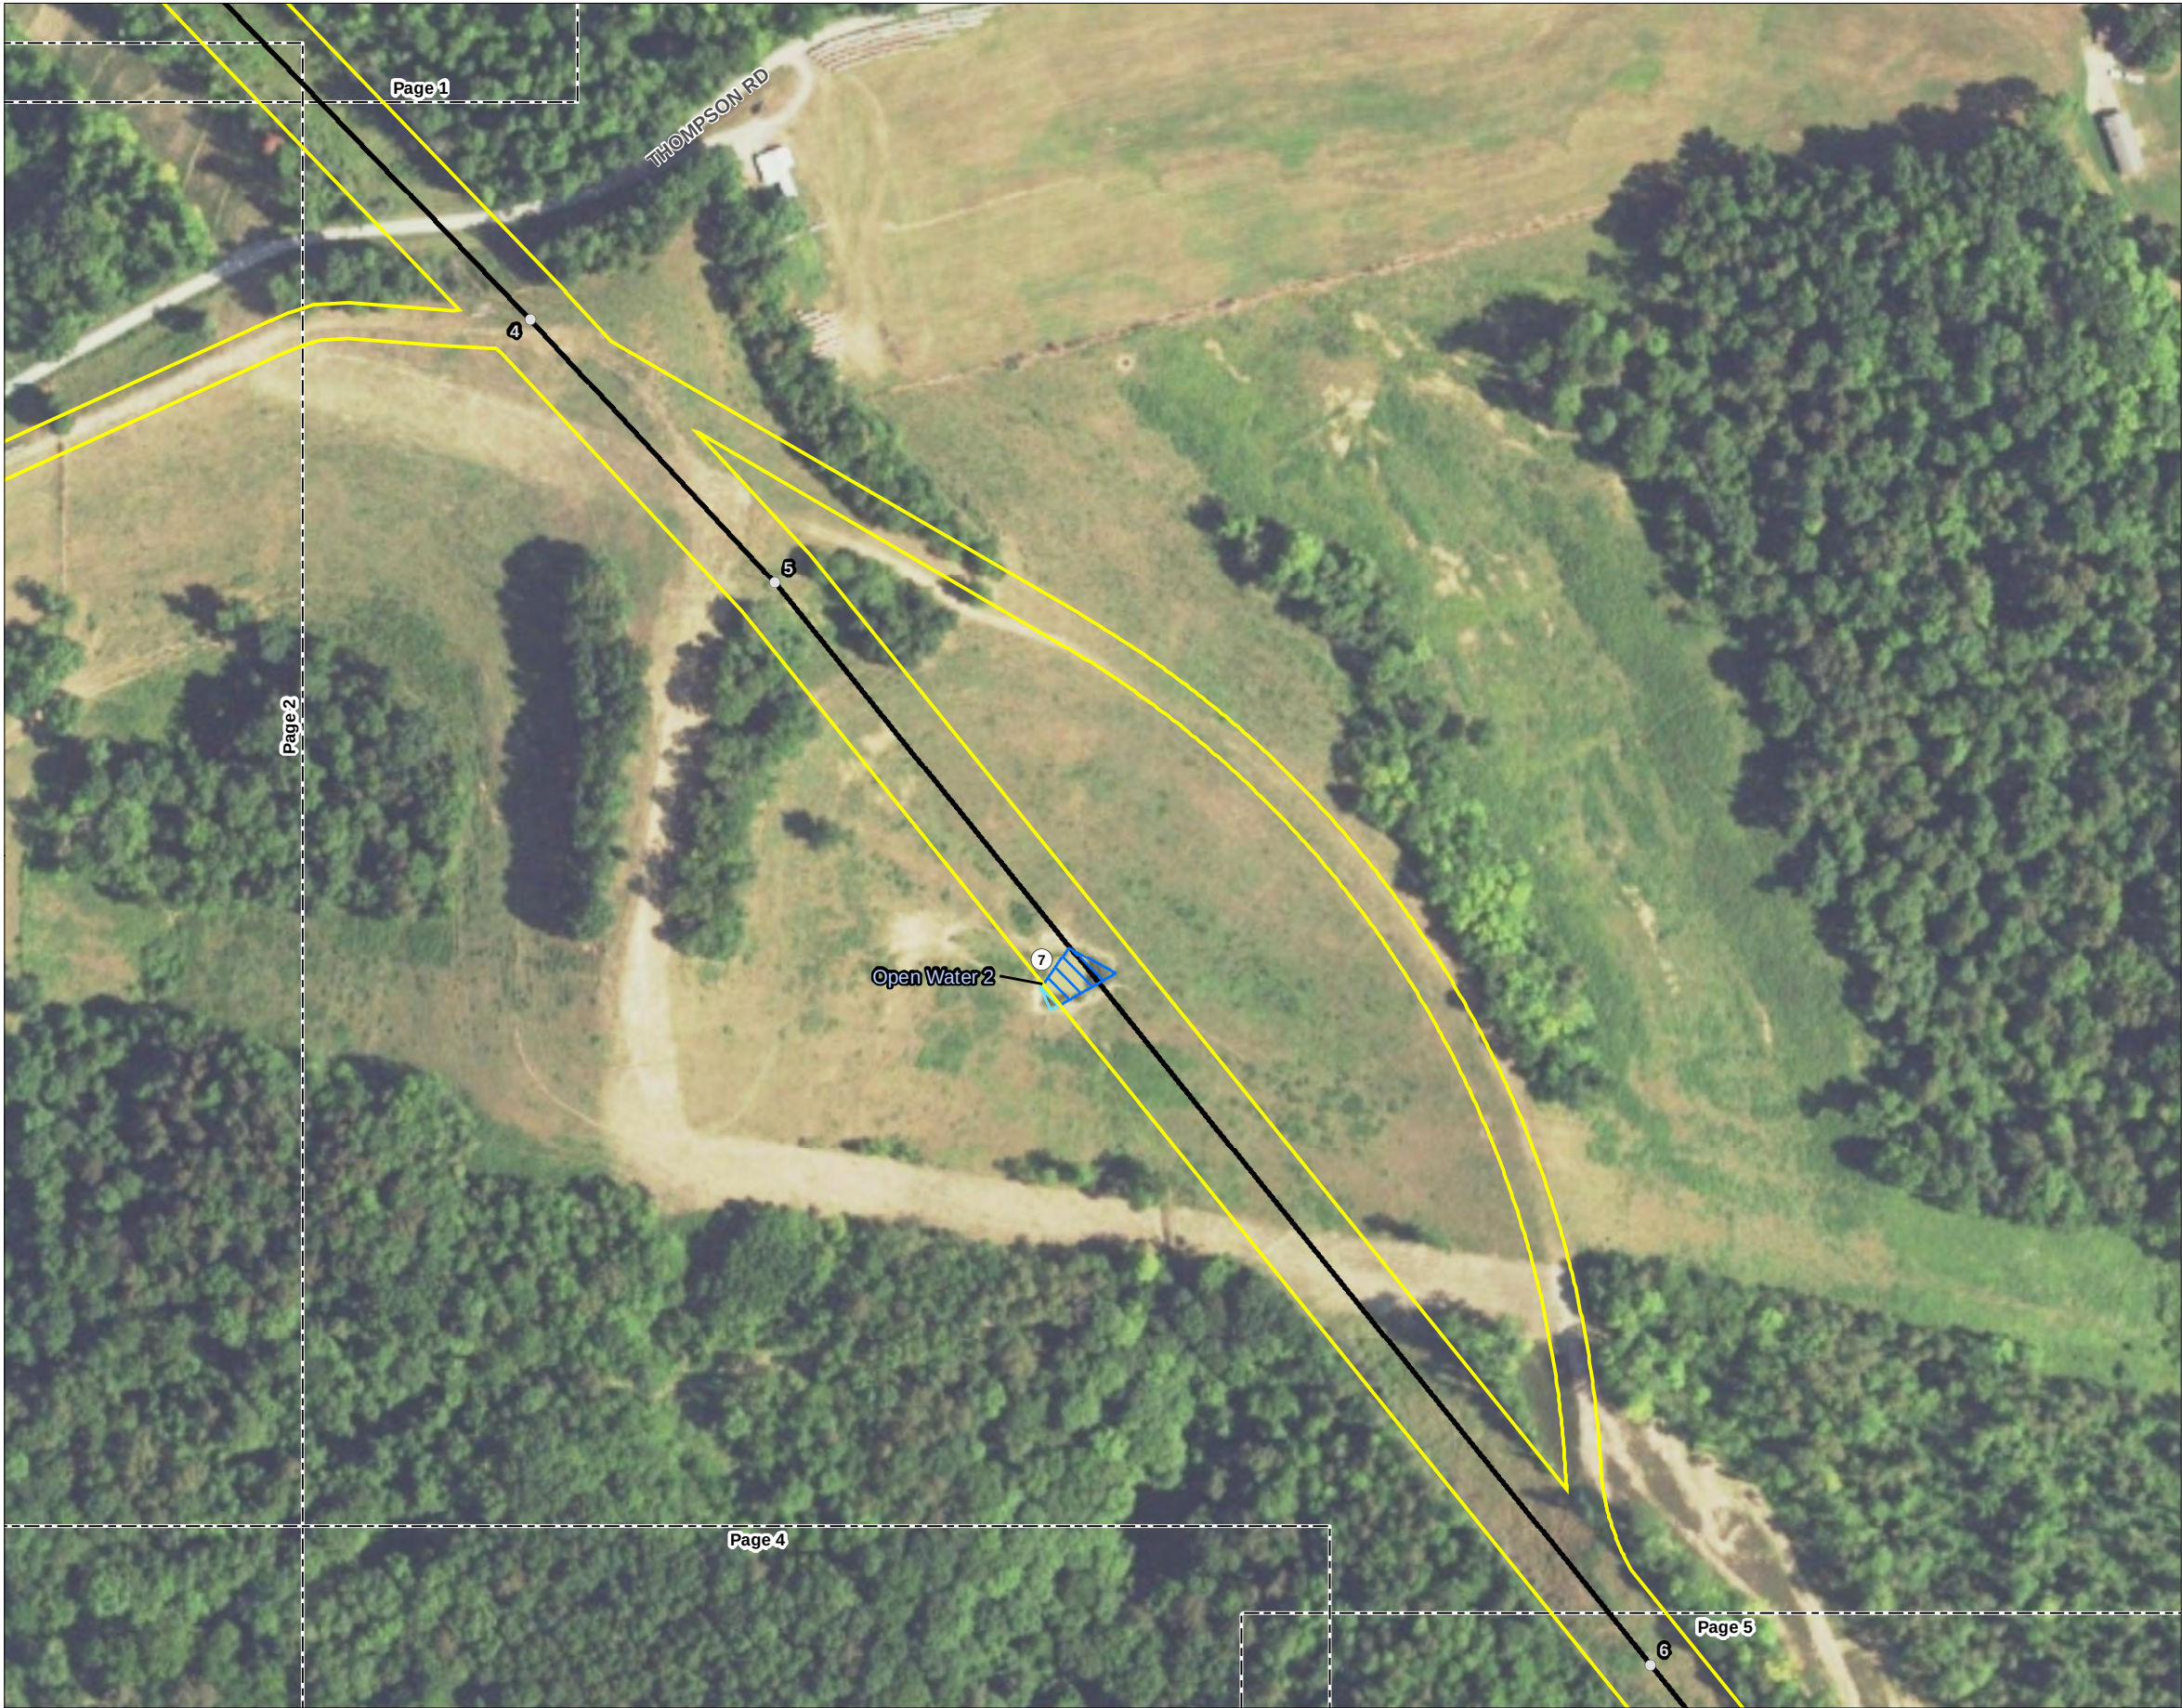
Figure No.  
2

Title  
Wetland and Waterbody  
Delineation Map

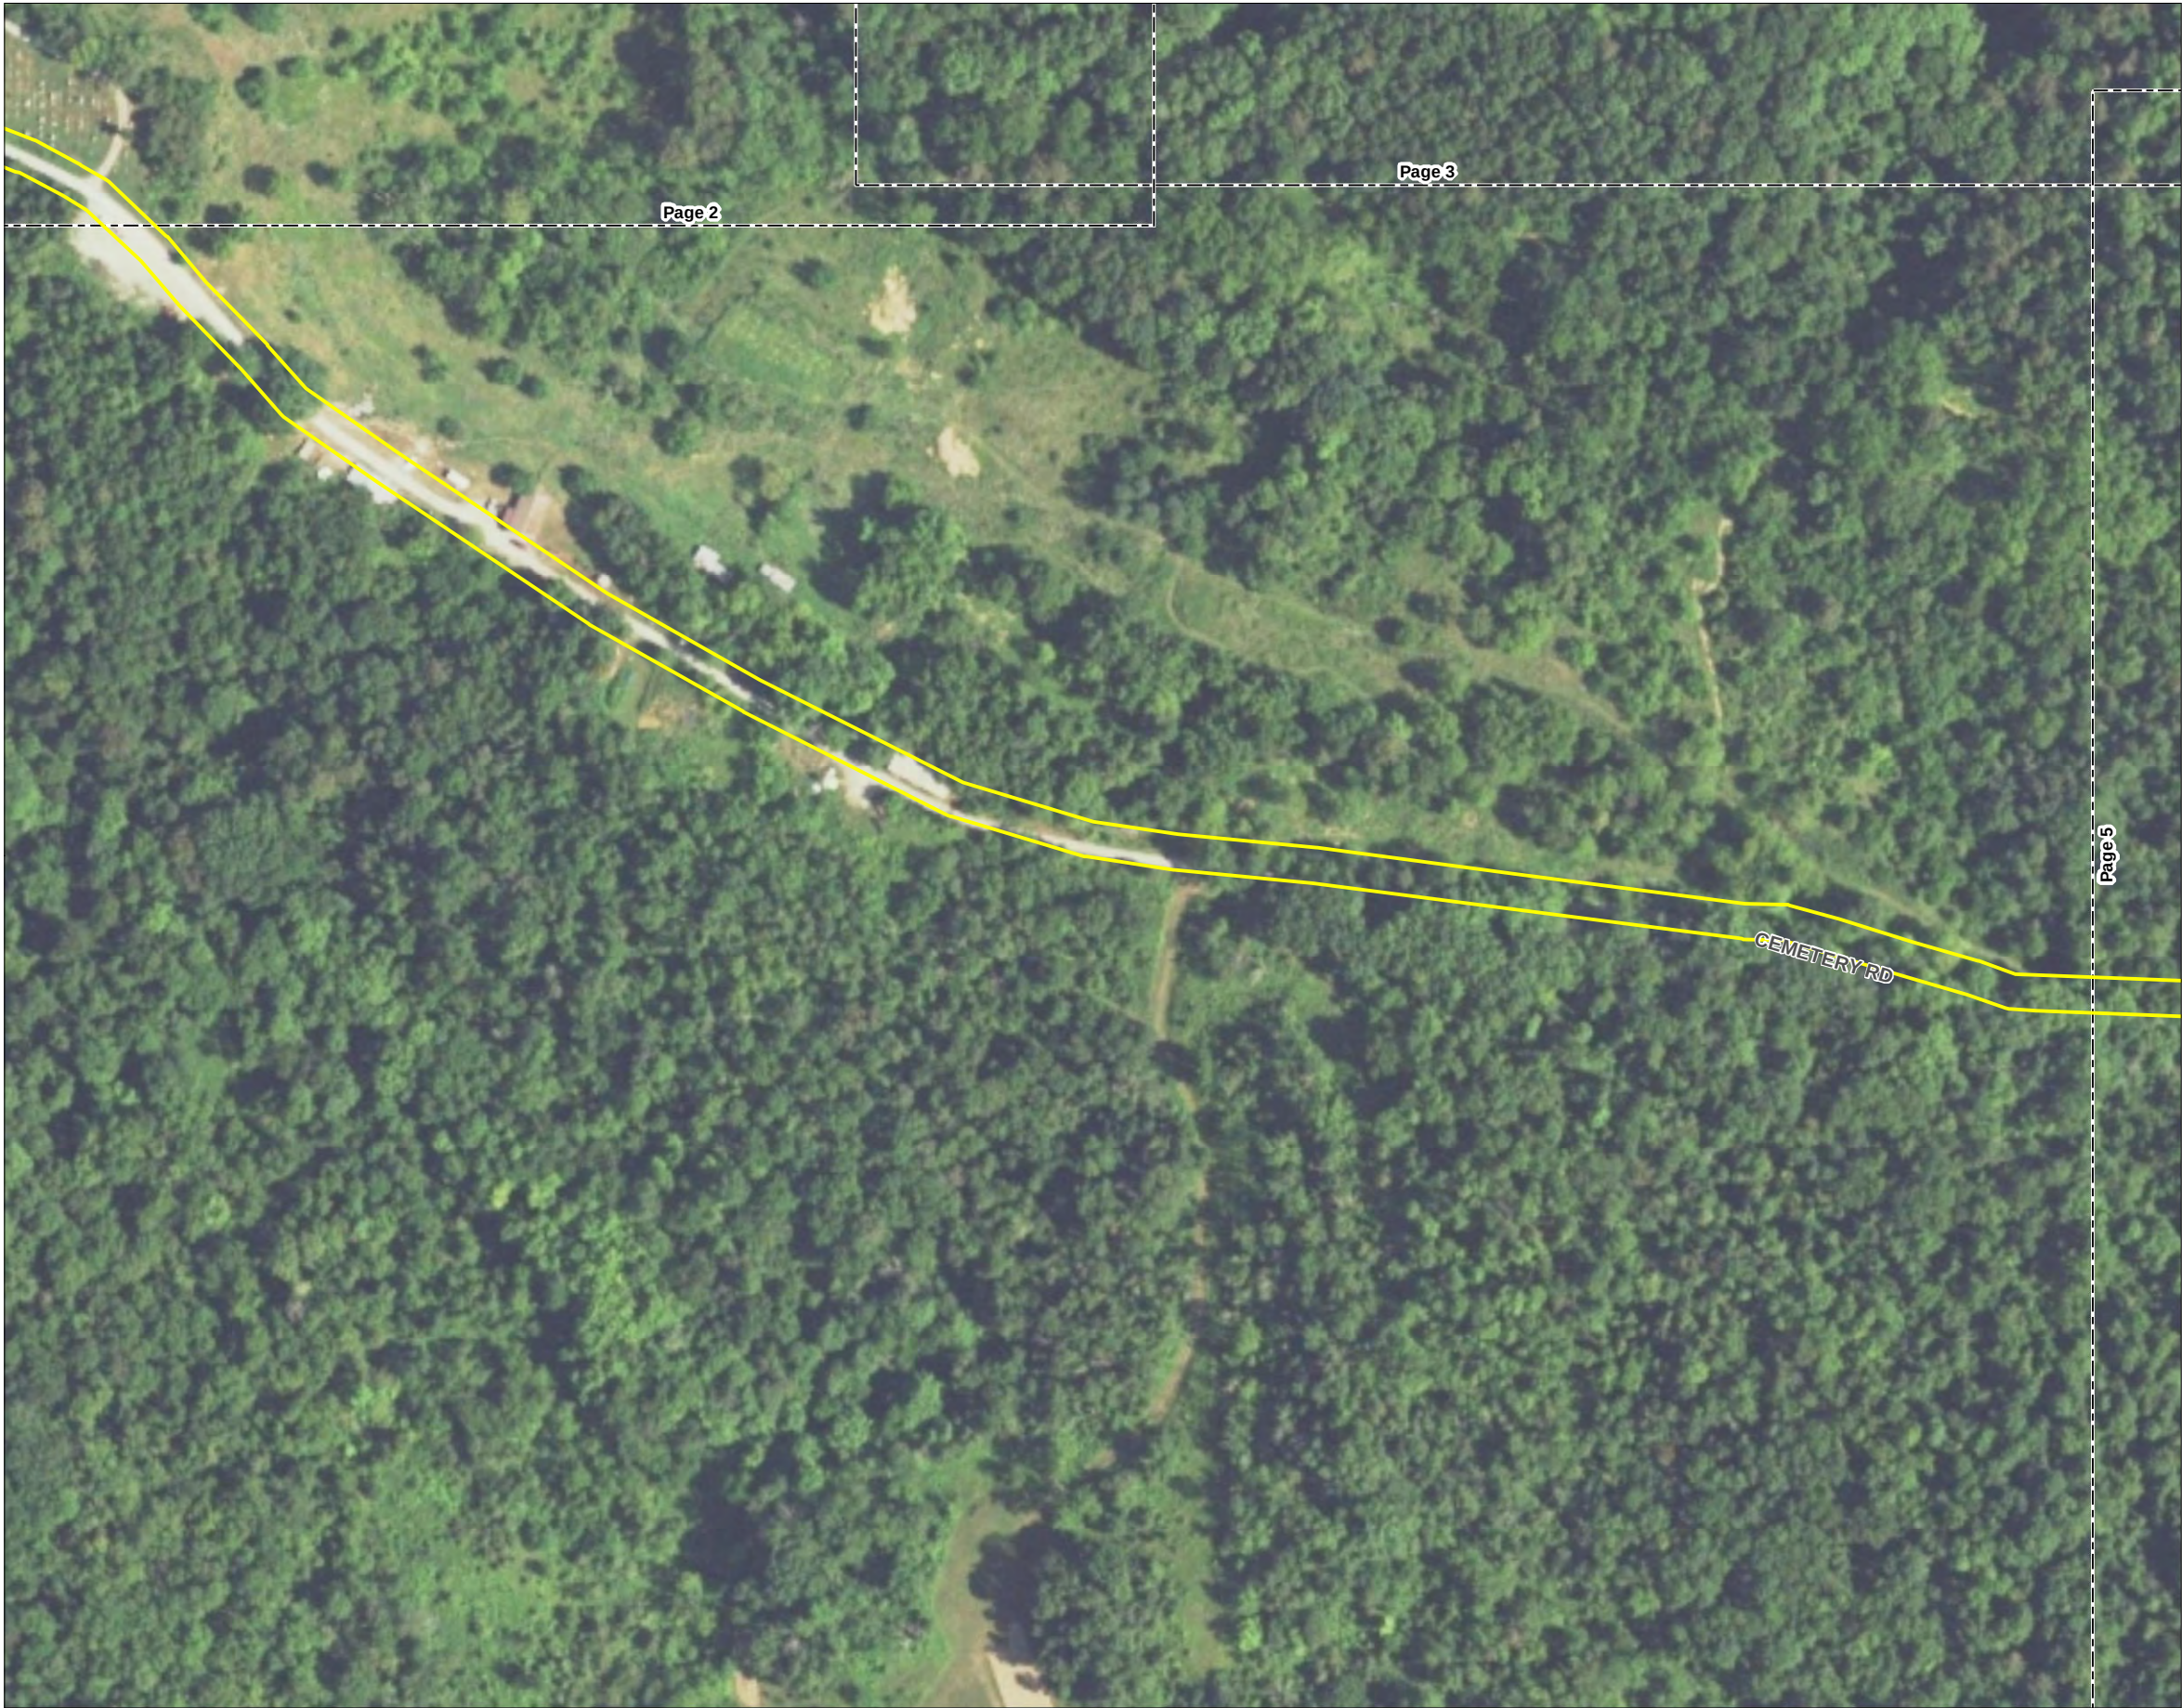
Figure No.  
2

Title  
Wetland and Waterbody  
Delineation Map
