Republic Wind Project

WETLAND AND STREAM
DELINEATION REPORT AND FORMS

Surface Water Delineation Report

Republic Wind Project
January 23, 2018

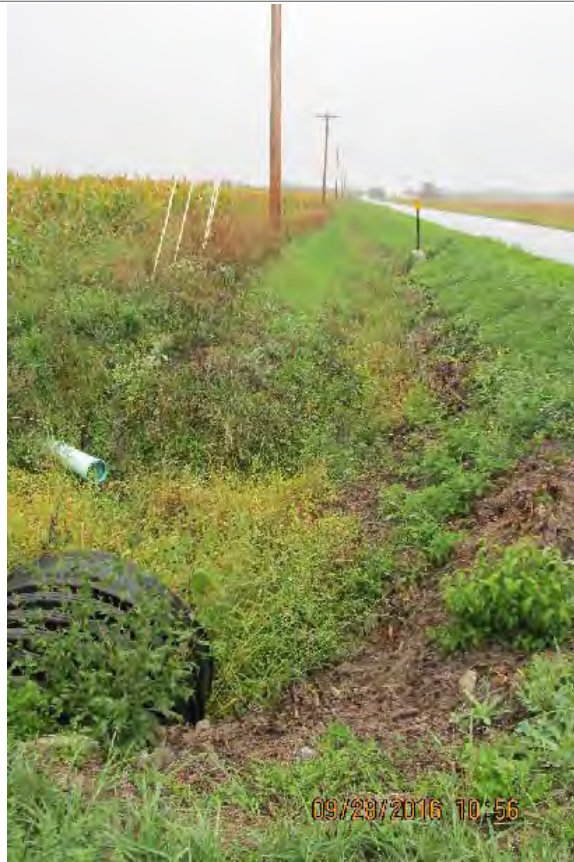
Description: Photo of ditch DOH-001 which was typical for most ephemeral ditches in the Delineation Area. The channel lacked any standing water which indicated it likely flowed during larger storm events. And due to the constant mowing of the banks and input from field tile, the waterbody was considered modified. The combination of lacking habitat and constant disturbance meant the waterbody was of low biological quality.

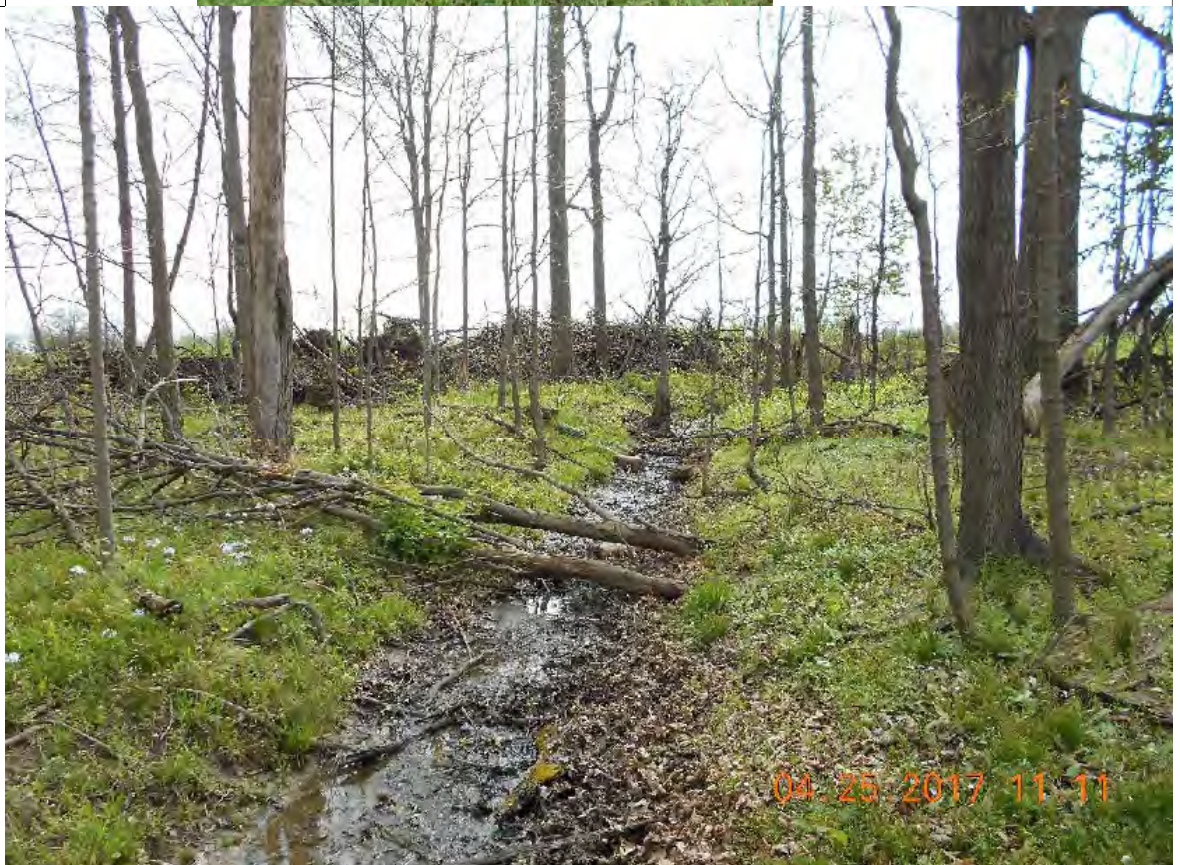
Photo: Typical Naturalized Ephemeral Waterbody

Description: Stream SOH-108 was identified as an ephemeral waterbody due to the presence of a defined bed and bank and indications of flow (as evidenced by sticks and snags). Unlike a modified waterbody, the naturalized ephemeral waterbodies lacked signs of recent man-made disturbance. Although the features lacked disturbance, the lack of consistent water meant biological utilization was likely low.

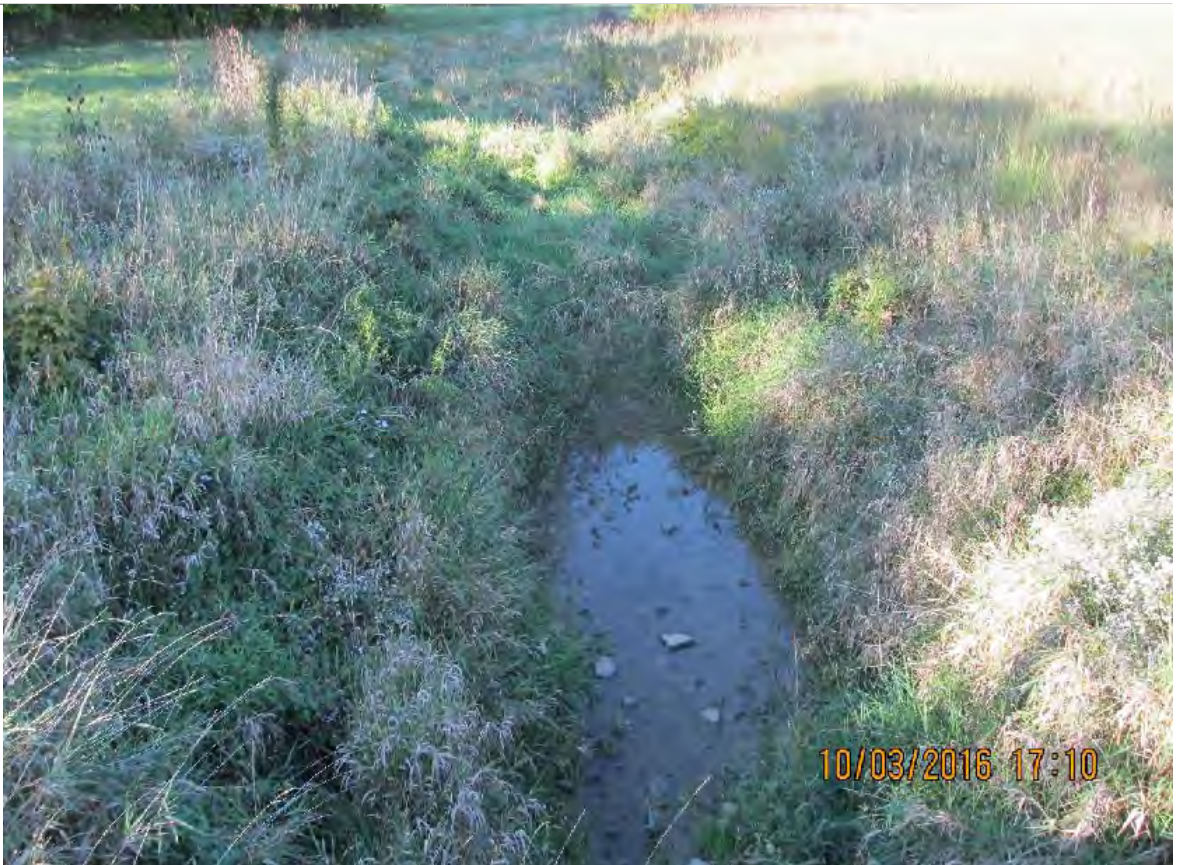
Photo: Typical Modified Intermittent Waterbody

Description: Photo of ditch DOH-038 which was typical for most intermittent ditches in the Delineation Area. The channel had pockets of standing water throughout its length. Due to the constant mowing of the banks and input from field tile, the waterbody was considered modified. Modified ditches such as this feature often had limited potential for significant biological utilization due to the constant disturbance of the banks.

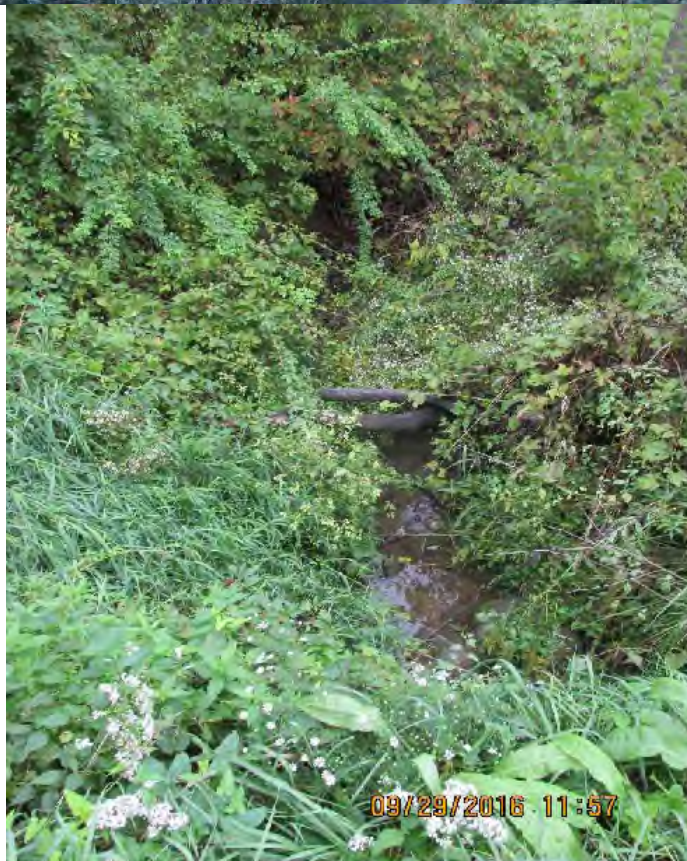
Photo: Typical Naturalized Intermittent Waterbody

Description: Stream SOH-004 was identified as an intermittent waterbody due to the presence of a defined bed and bank and pockets of standing water. This particular waterbody had signs of recovery from historic modification in the form of mature trees growing along straightened channels. Naturalized intermittent streams were considered to have a higher biological utilization than modified features due to the presence of habitat along the banks.

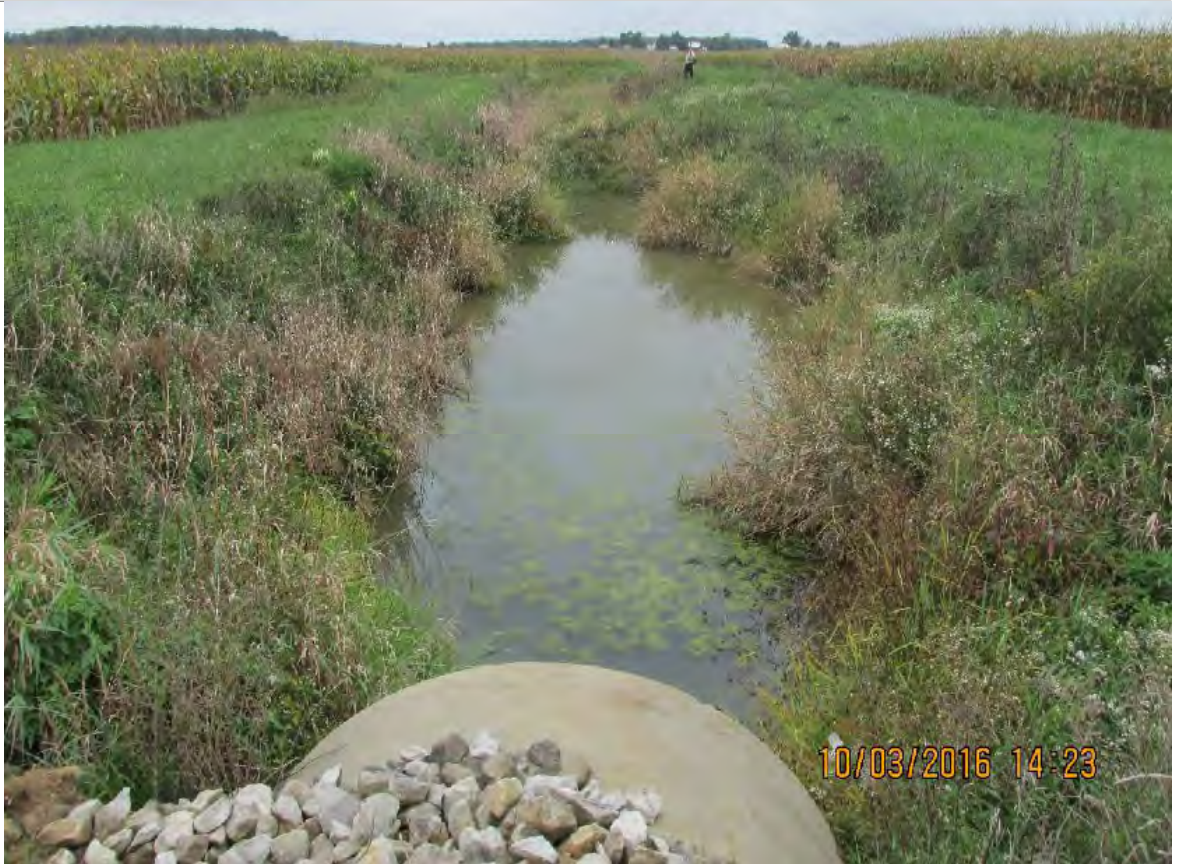
Photo: Typical Modified Perennial Waterbody

Description: Photo of ditch DOH-041 which was typical for most perennial ditches in the Delineation Area. The channel had flowing water throughout approximately 6 inches deep. Due to the constant mowing of the banks and input from field tile, the waterbody was considered modified. Modified ditches such as this feature often had limited potential for significant biological utilization due to the constant disturbance of the banks.

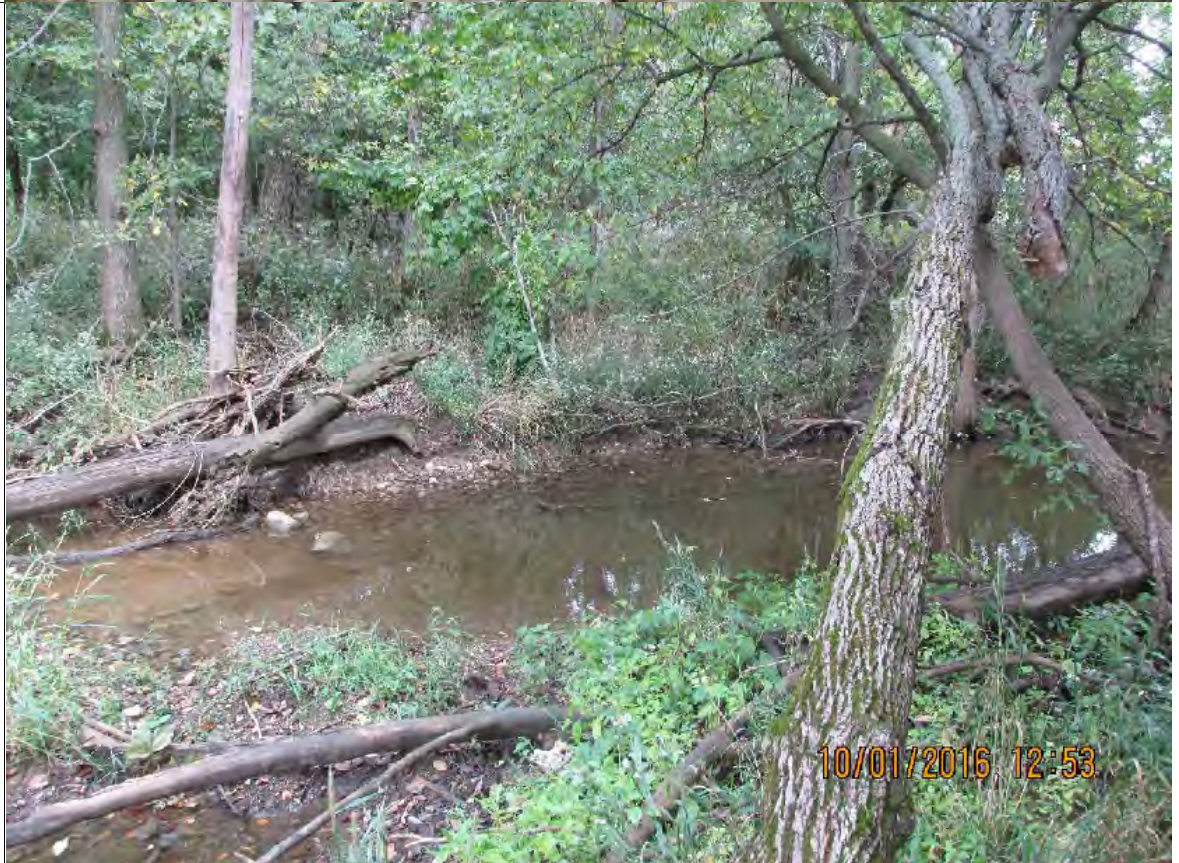
Photo: Typical Naturalized Perennial Waterbody

Description: Stream SOH-011 was typical of the perennial naturalized streams in the Delineation Area. Such waterbodies had significant flowing water, and often had pools over a foot deep. The naturalized waterbodies had mature trees along the banks which in turn deposited woody debris in the channel. The availability of habitat within the channel and lower levels of disturbance from surrounding landuse meant that the naturalized perennial waterbodies could potentially see high biological utilization.

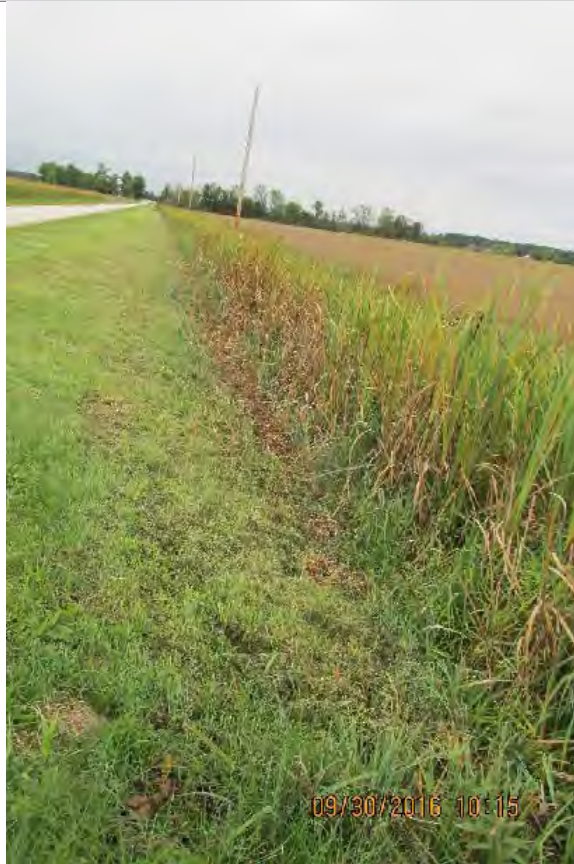
Photo: Typical Category 1 Wetland

Description: Typical low quality palustrine emergent wetland found in the Delineation Area. This wetland (WOH-002) was located in a small depressional area along a roadside. The presence of invasive narrow leaf cattail (*Typha angustifolia*), lack of buffers from surrounding landuse, and lack of standing water led to the wetland scoring as a Category 1 wetland on the ORAM forms.

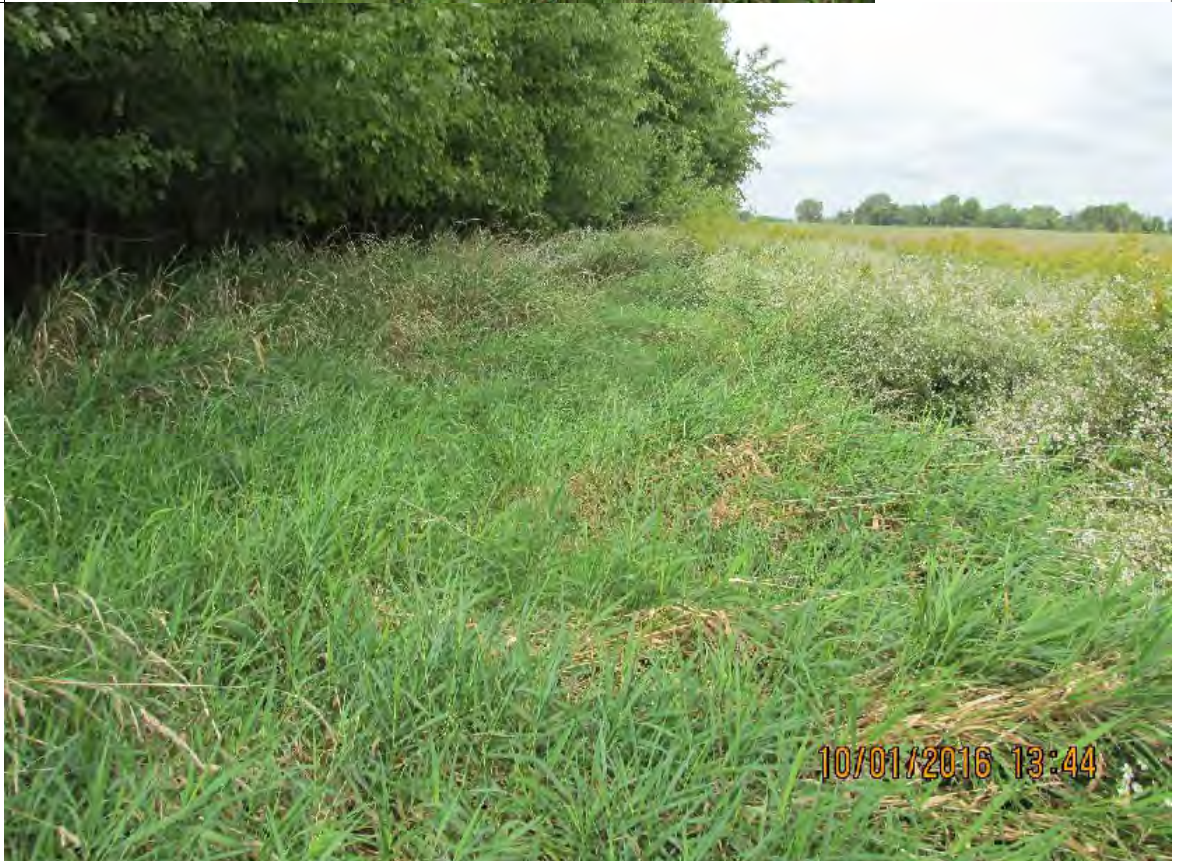
Photo: Typical Modified Category 2 Wetland

Description: Photo of wetland WOH-003, which was a mix of emergent and forested wetland. Due to the historic modification of the wetland area adjacent to the crop area, the wetland had lost some of its functions. However when scoring on the ORAM form, the forested portion (which extends to the left in the photo) indicated the wetland could increase its score and recover some of its lost functions; which led to it scoring as a Modified Category 2 on the ORAM forms.

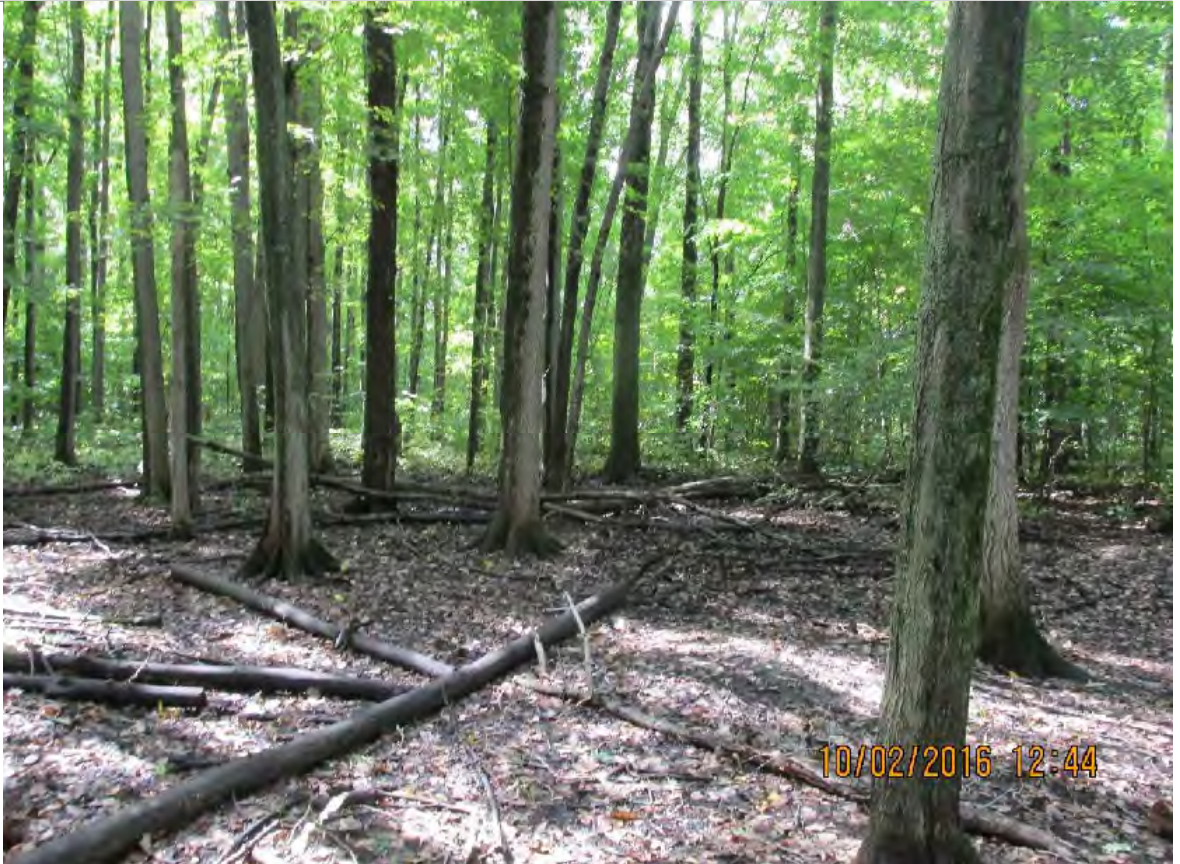
This wetland was typical of the forested wetlands, which often exhibited sparsely vegetated concave surfaces and root buttressing.

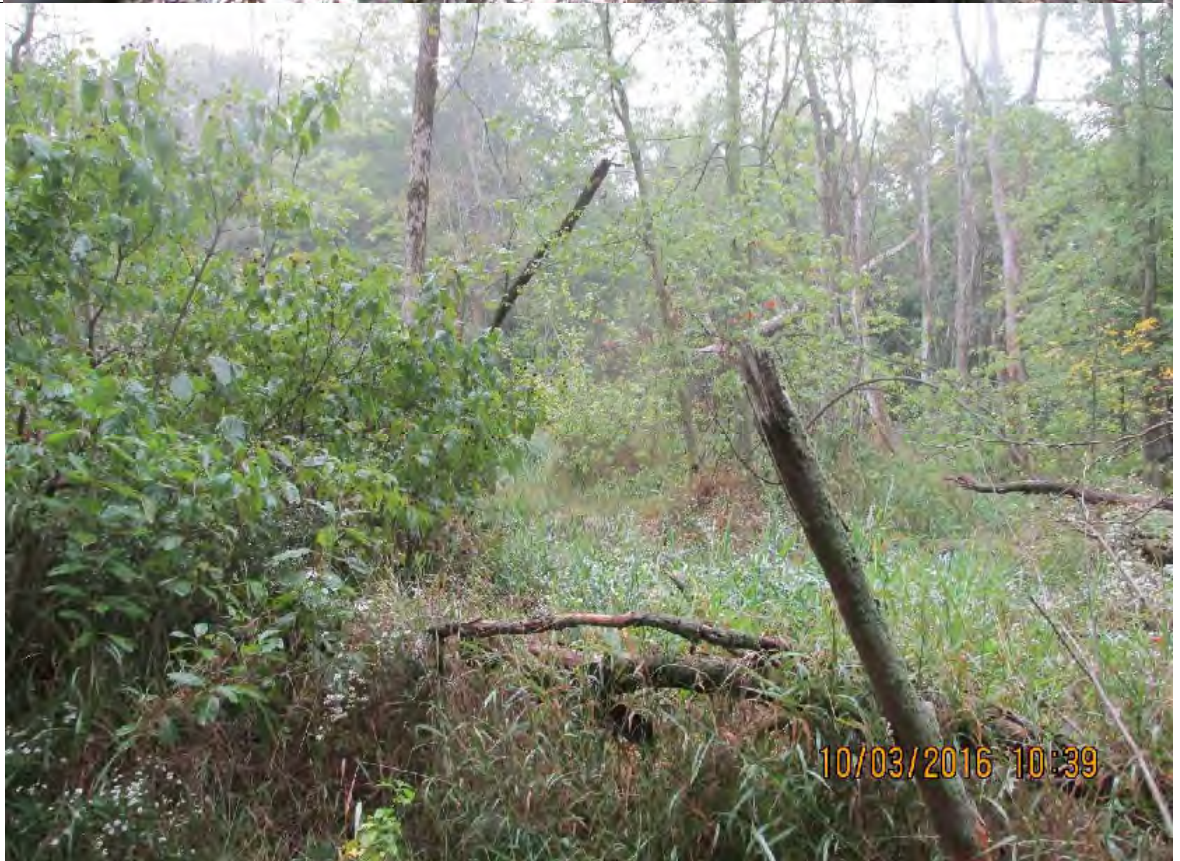
Photo: Typical Category 3 Wetland

Description: Photo of wetland WOH-008, which was a mix of emergent and forested wetland. The wetland was the largest wetland identified in the Delineation Area. The wetland had a high interspersed vegetation types, high amount of dead standing and woody debris, and was relatively large which led to it scoring highly on the ORAM.

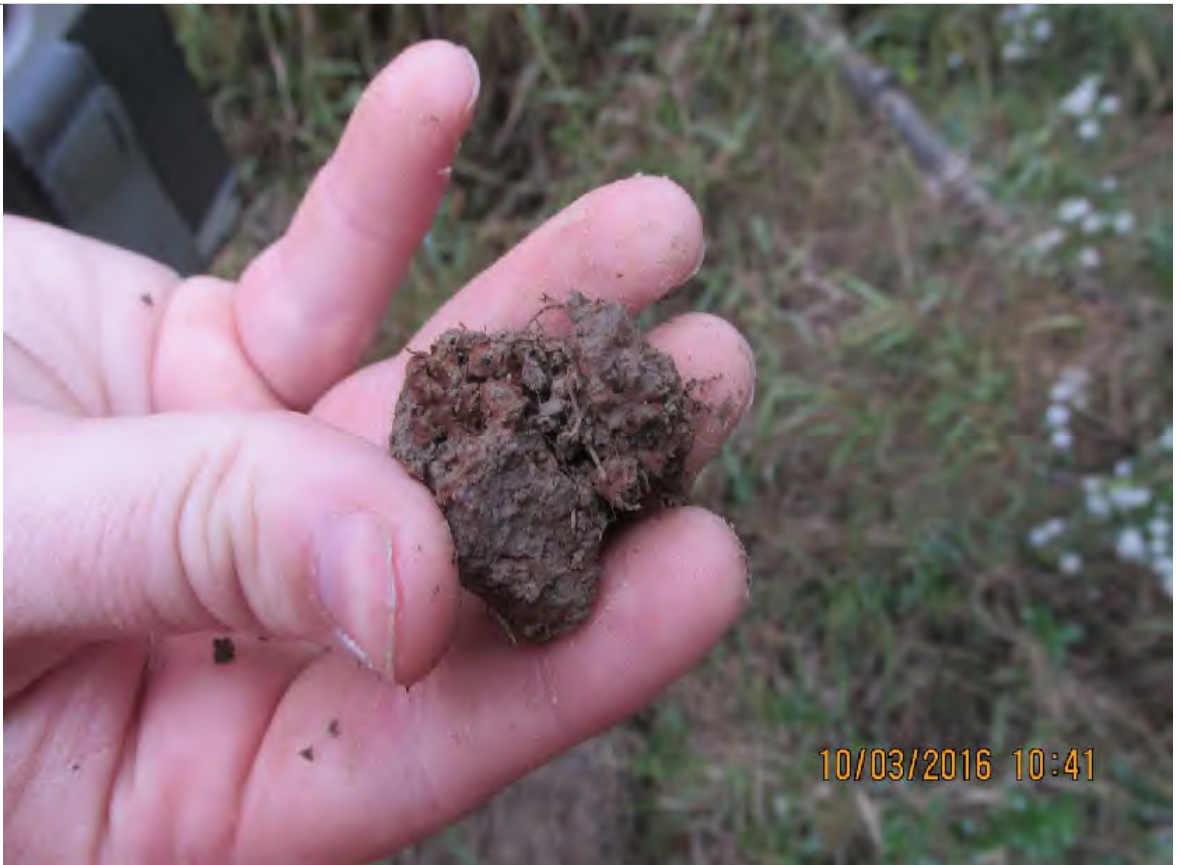
Wetland soils often had clay components as well which helped the soils retain water for longer periods.

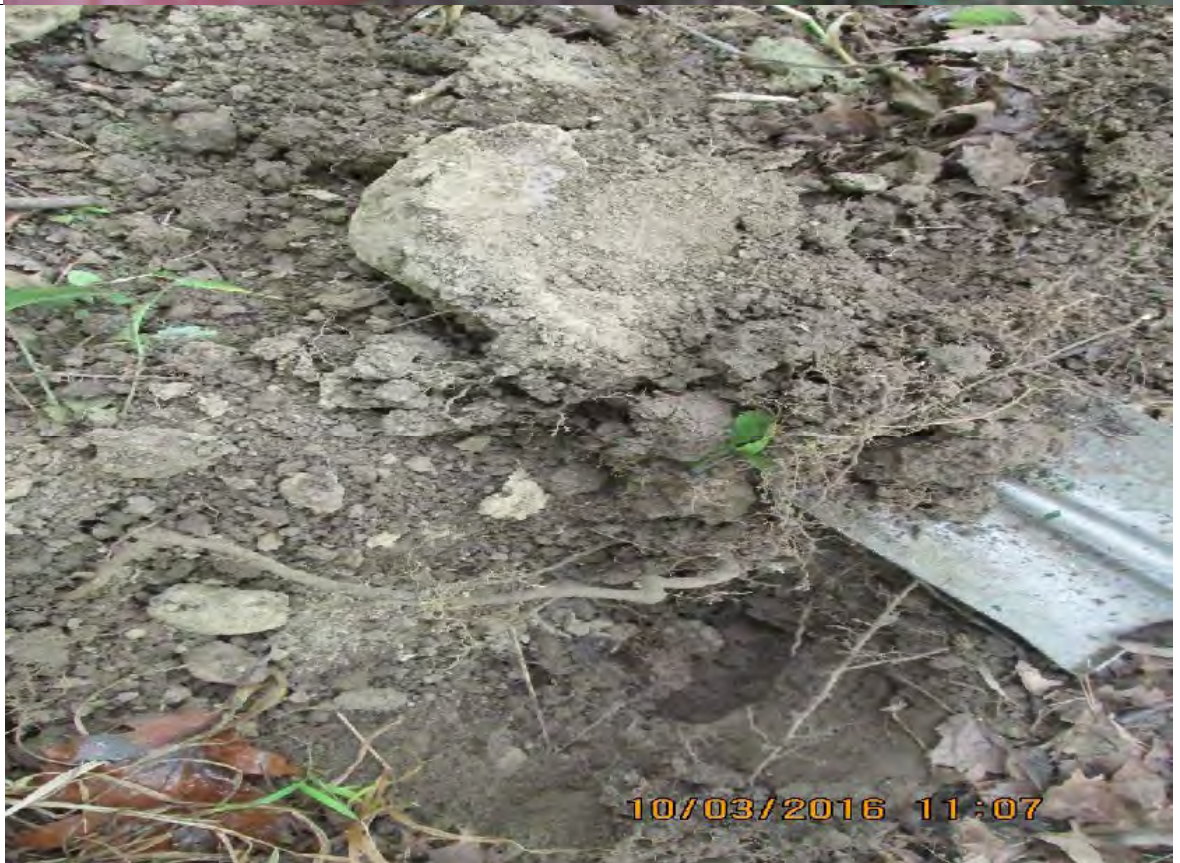
Photo: Typical Upland Soils

Description: Upland soils in the Delineation Area were often brightly colored dry loams, with minor amounts of clay in the matrix. This composition allowed for water to pass more easily to deeper depths.

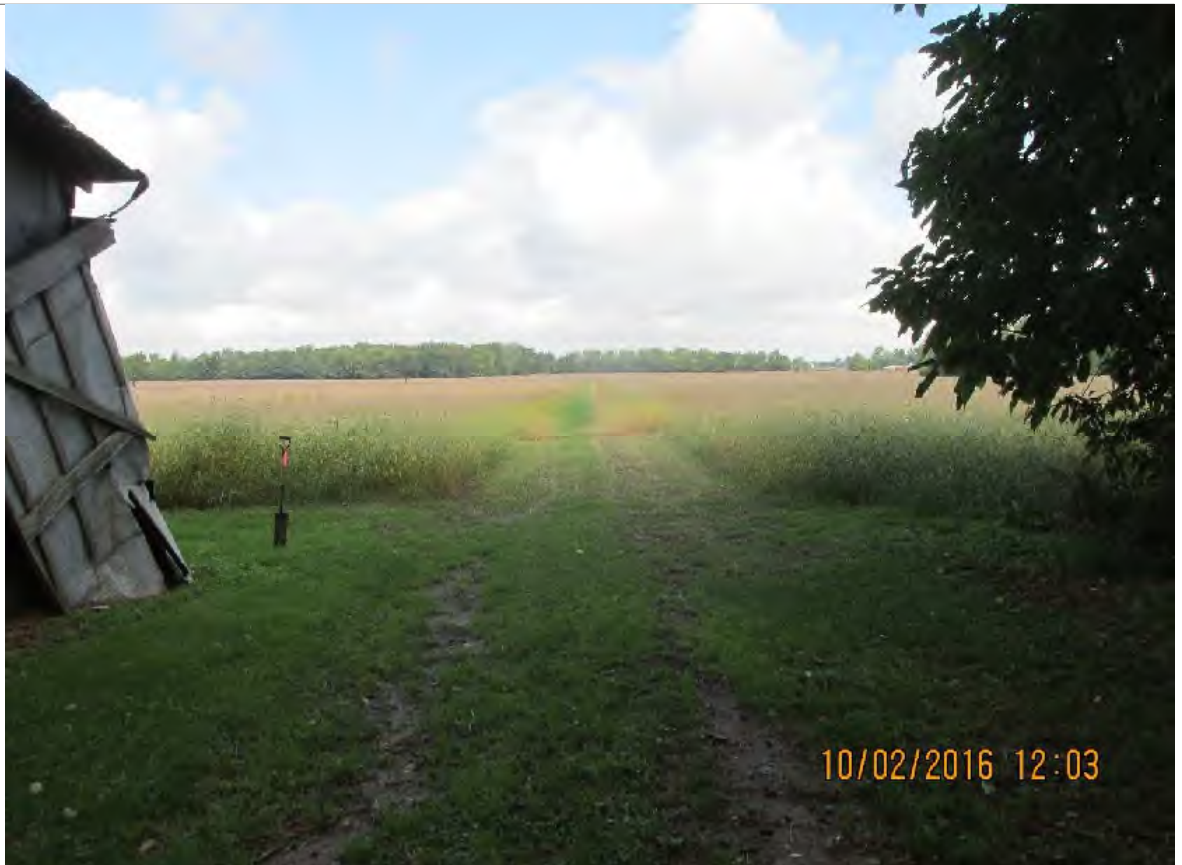
Date: 10/02/16

Description: The majority of the Delineation Area consisted of active crop areas. The crops encountered during the surveys included soybeans and corn. The crop areas often had small windrows of trees which served to denote property lines.

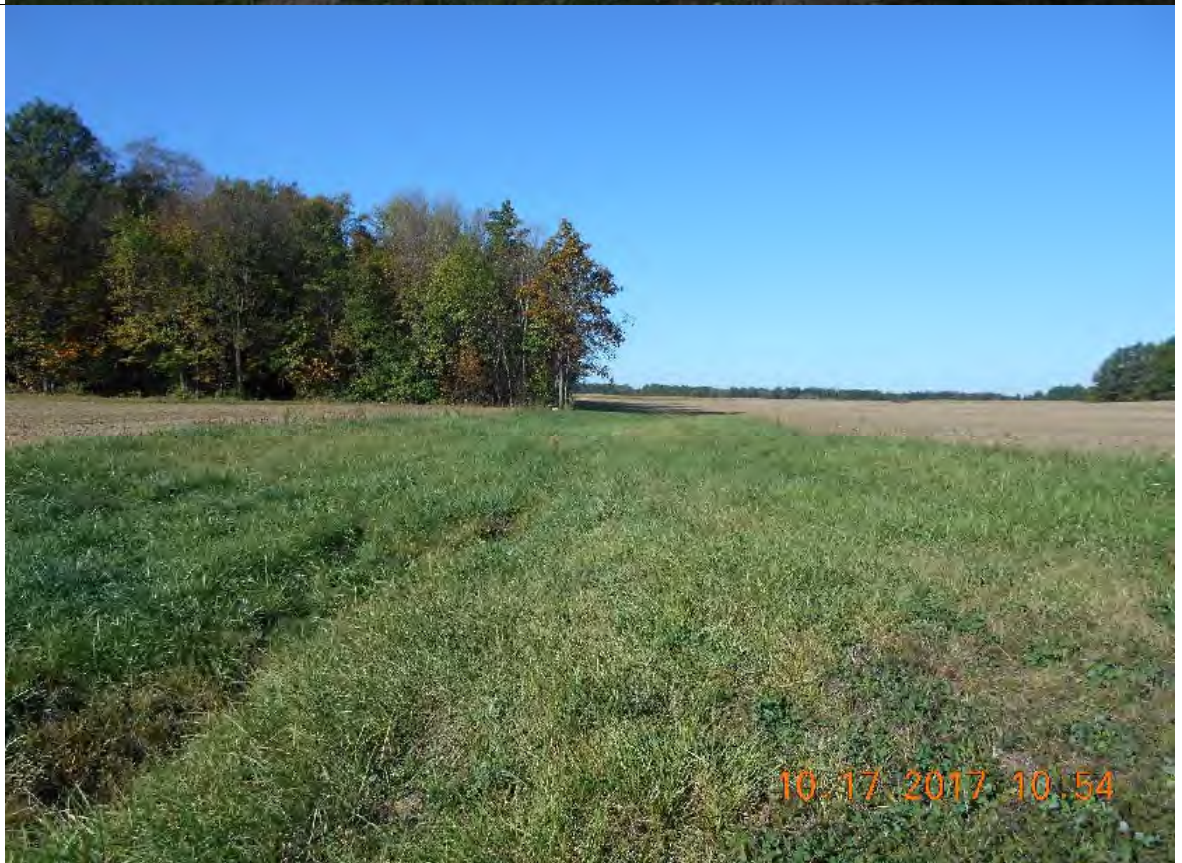
Photo: Typical Crop Area

Date: 10/17/17

Description: many of the crop areas also had grassy swales between fields. These swales were designed to convey stormwater runoff from the fields and into nearby ditches or streams. Due to a lack of identifiable ordinary high water mark and upland vegetation, swales are not considered wetlands or waterbodies.

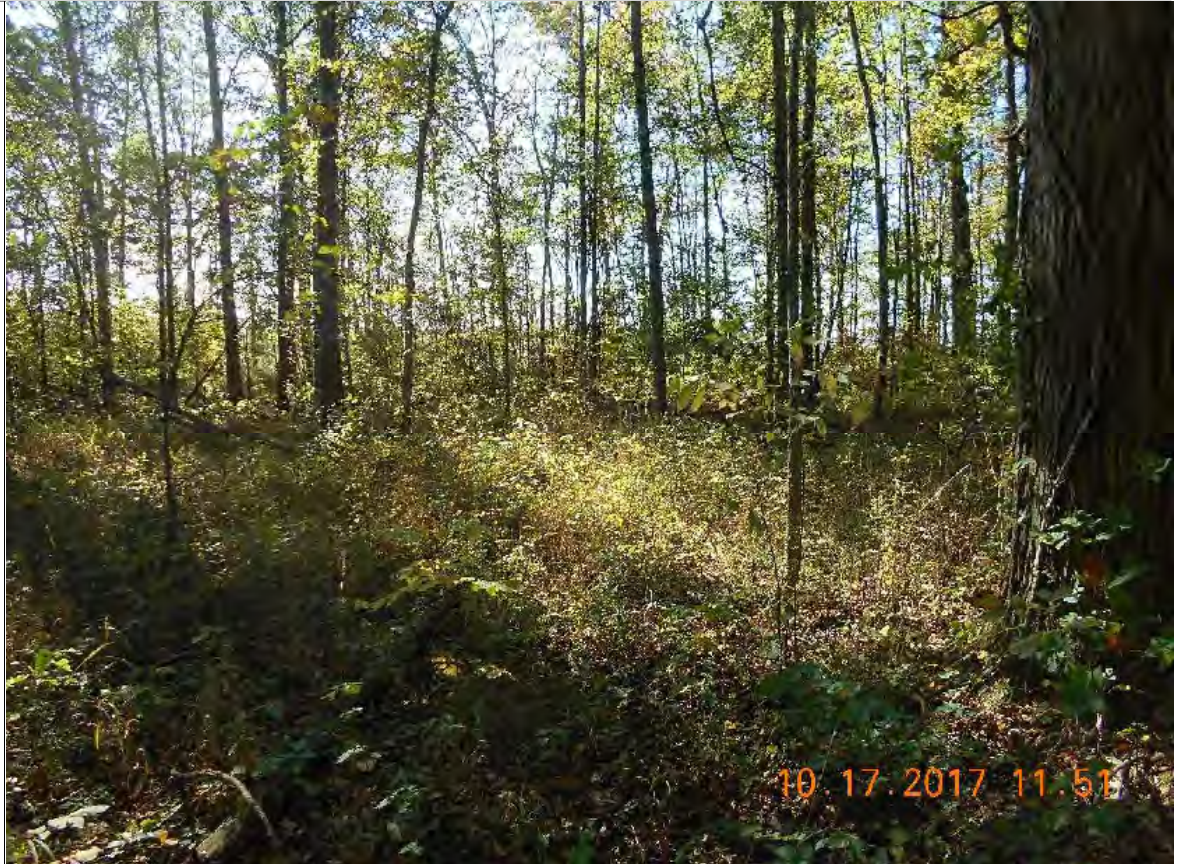
Photo: Typical Forested Woodlot

Date: 10/17/17

Description: Understory development in woodlots varied between parcel, and likely reflected historic disturbance and land use. Some woodlots had relatively dense understories dominated by blackberry (*Rubus* spp.) and grasses; while others might be relatively sparse and dominated by saplings.

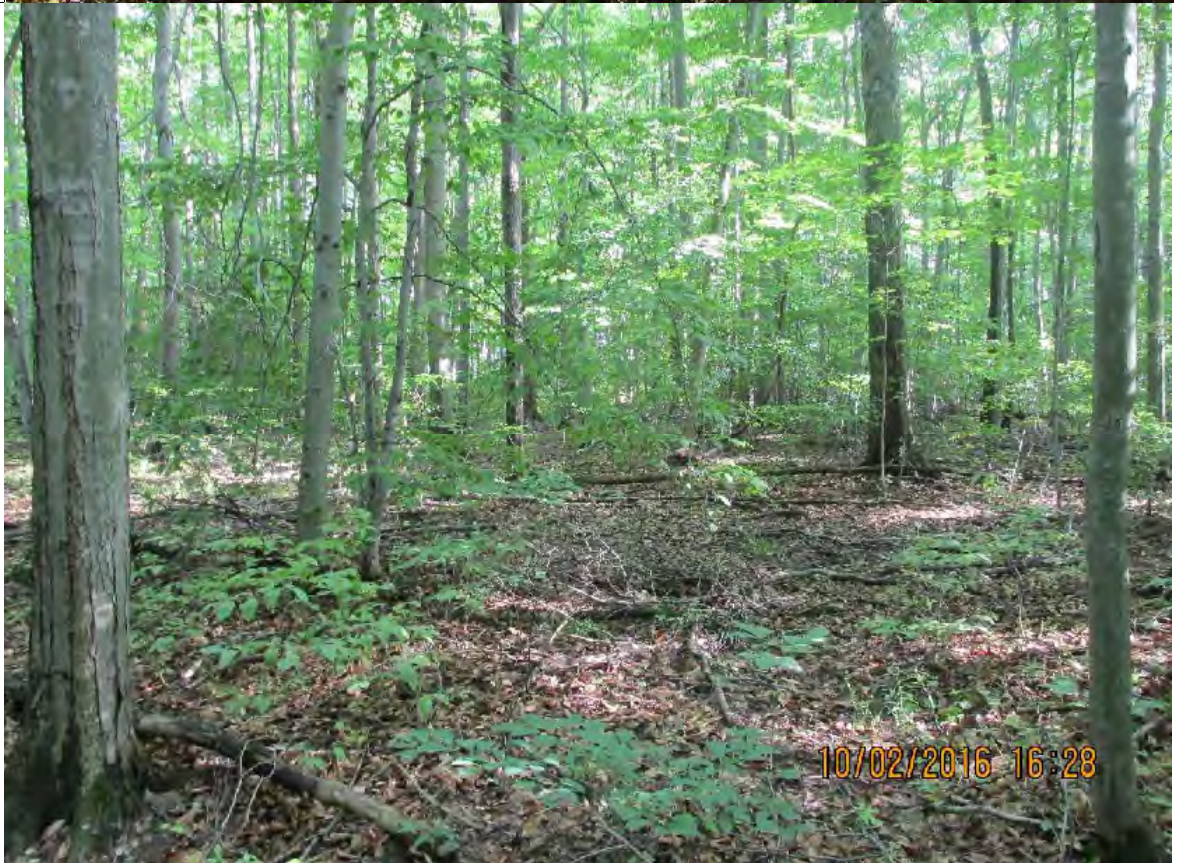
Photo: Typical Forested Woodlot

Date: 10/02/16

Description: The woodlots in the Delineation Area varied in species variety with some woodlots being dominated by American beech (*Fagus grandifolia*), and others a mix of multiple hickory (*Carya* sp.), maples (*Acer* sp.), and oaks (*Quercus* sp.).

Many of the woodlots had evidence of historic logging due to the presence of flat topped tree stumps and overgrown roads.
