A report by the staff of the **Public Utilities Commission of Ohio**

In the Matter of the Request by Ashland Railway to Downgrade Warning Devices at N. Main Street/SR 13 (DOT#152-160H) Grade Crossing in the City of Mansfield, Richland County, Ohio.

Case Number 17-2166-RR-RCP

April 5, 2018

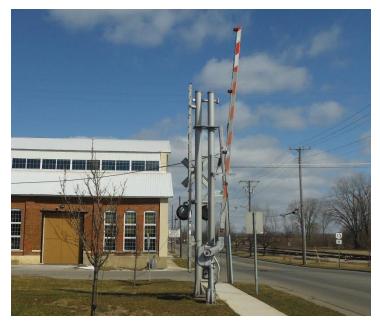
Back view of damaged cantilever.

Upon inspection I found the cantilever in the northwest quadrant had its bridge missing and no longer had lights out over the roadway. The only remaining lights were located on the lower half of the cantilever and the gate mechanism remained in place. The devices are located ten feet from the face of the curb behind the sidewalk.

It is recommended the railroad be granted the downgrade of the active highway rail grade crossing system and the cantilever be removed from the northwest quadrant as long as the railroad agrees to meet the following exceptions and stipulations.

The gates and flashing lights must be relocated to 4'-3" from the face of the curb in order for the cantilever to be removed.

- 1) Approve the ASRY request to downgrade the warning devices at the crossing with the following condition:
 - a. The flasher mast and gate is moved in the northwest quadrant to the required minimum of 4'-3" from the face of curb as outlined in OMUTCD Section 8C.01.
- 2) Require ASRY to notify Staff when the work is completed.
- 3) Require staff to conduct follow-up inspections to verify that the modifications have been made as approved.

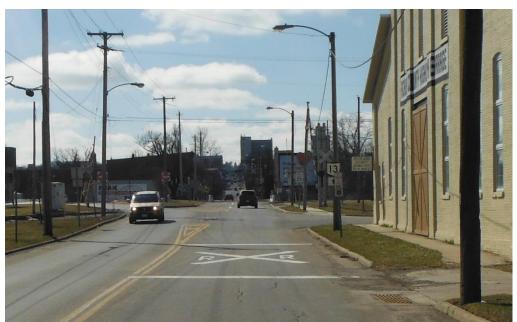
View of crossing when driving S. on N. Main Street/SR 13. Warning devices are hard to see due to utility poles and signage in the area.

When traveling southbound on Main Street it is difficult to see the lights or crossbuck due to the buildings and poles along the edge of the roadway. It is difficult to tell a set of tracks are even there. You can actually see the Norfolk Southern crossing just south of the Ashland Railway crossing before you see the ASRY Main Street crossing.

This will provide a better site view for the approaching southbound traffic and would eliminate the need for the cantilever.

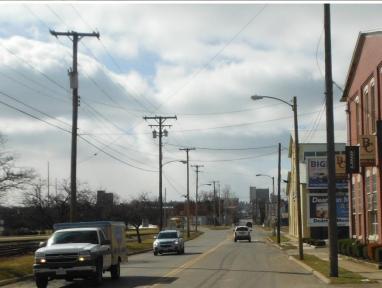
View of crossing when driving S. on N. Main Street/SR 13. Warning devices are hard to see due to utility poles and signage in the area.
