CONSTRUCTION NOTIFICATION FOR THE

LINE A000B NATURAL GAS PIPELINE REPLACEMENT PROJECT

PUCO Case Number 18-498-GA-BNR

Duke Energy Ohio, Inc.

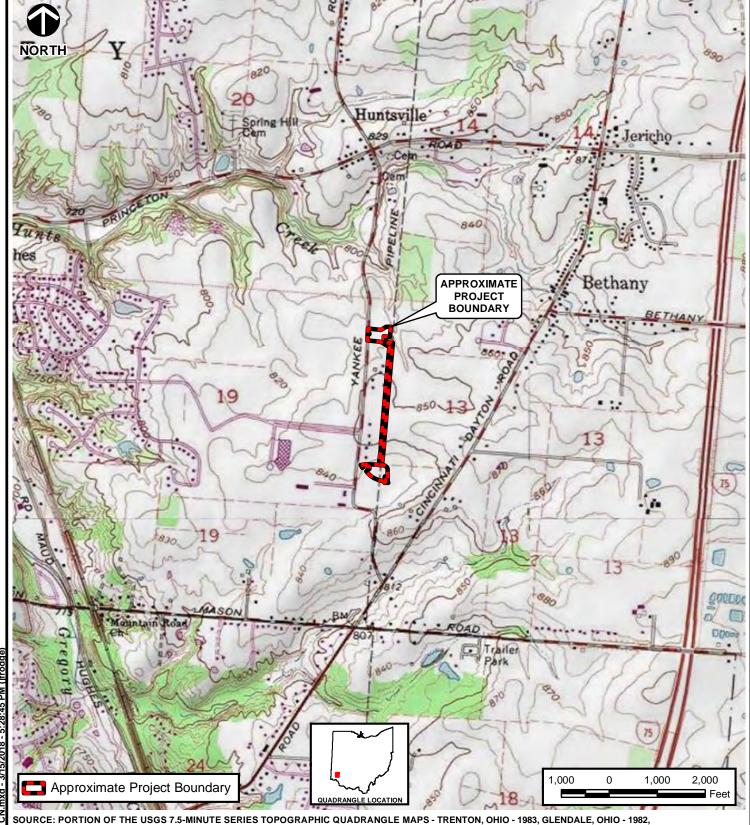
SOURCE: PORTION OF THE USGS 7.5-MINUTE SERIES TOPOGRAPHIC QUADRANGLE MAPS - TRENTON, OHIO - 1983, GLENDALE, OHIO - 1982, MASON, OHIO - 1982, & MONROE, OHIO - 1975

The location of this project is illustrated on Figures 1 and 2 in Attachment 1. Figure 1 shows the general project vicinity illustrated on a U.S. Geological Survey (USGS) quadrangle map. Figure 2 illustrates the proposed replacement pipeline project limits and the existing pipeline that is to be abandoned in place on an aerial base map.

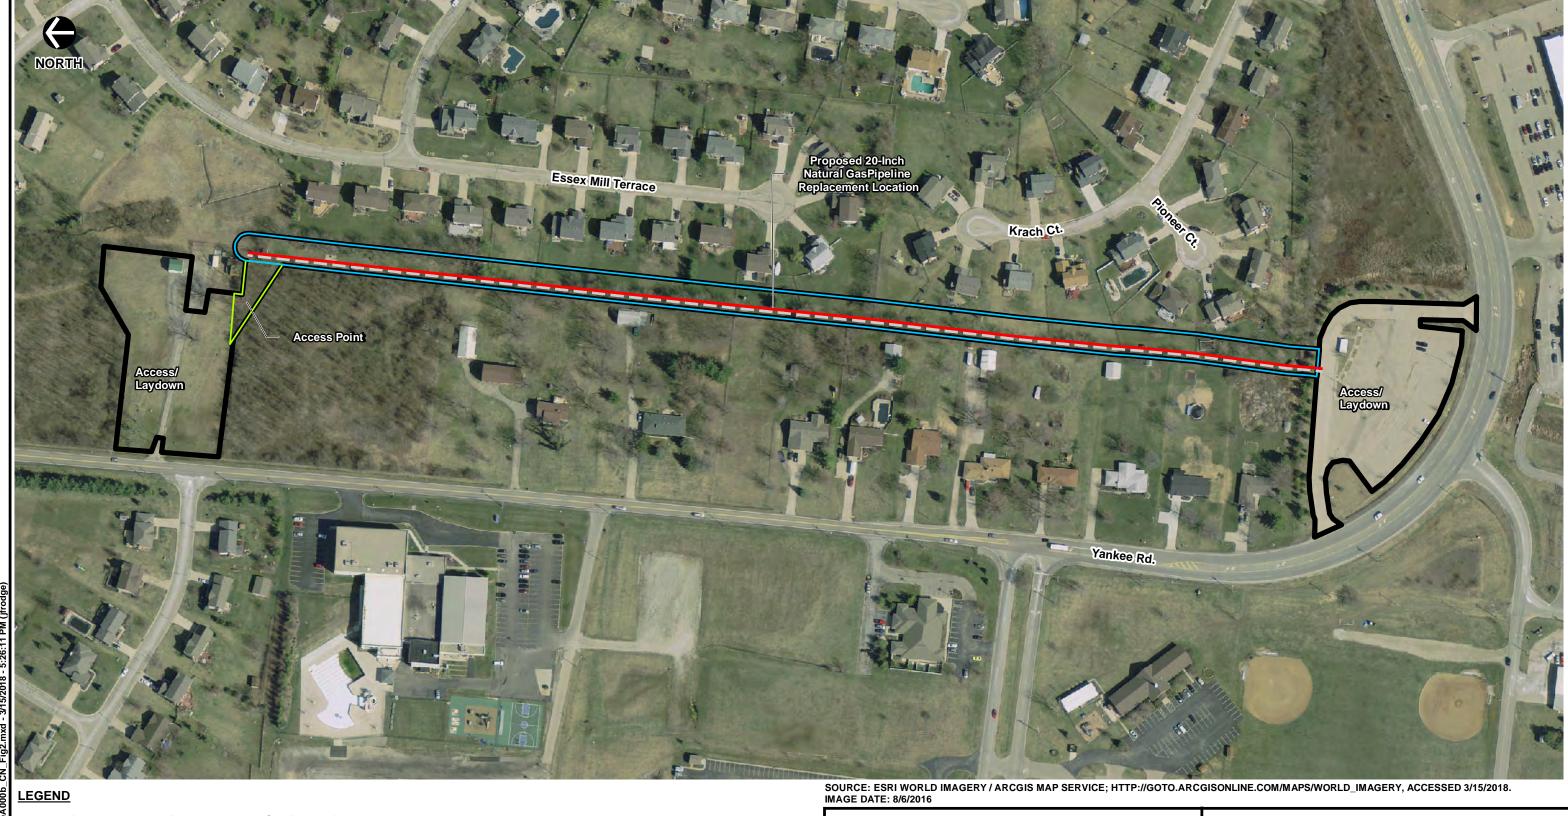
Proposed 20-Inch Diameter Natural Gas Pipeline Replacement

Existing 18-Inch Diameter Natural Gas Pipeline to be Abandoned In-Place

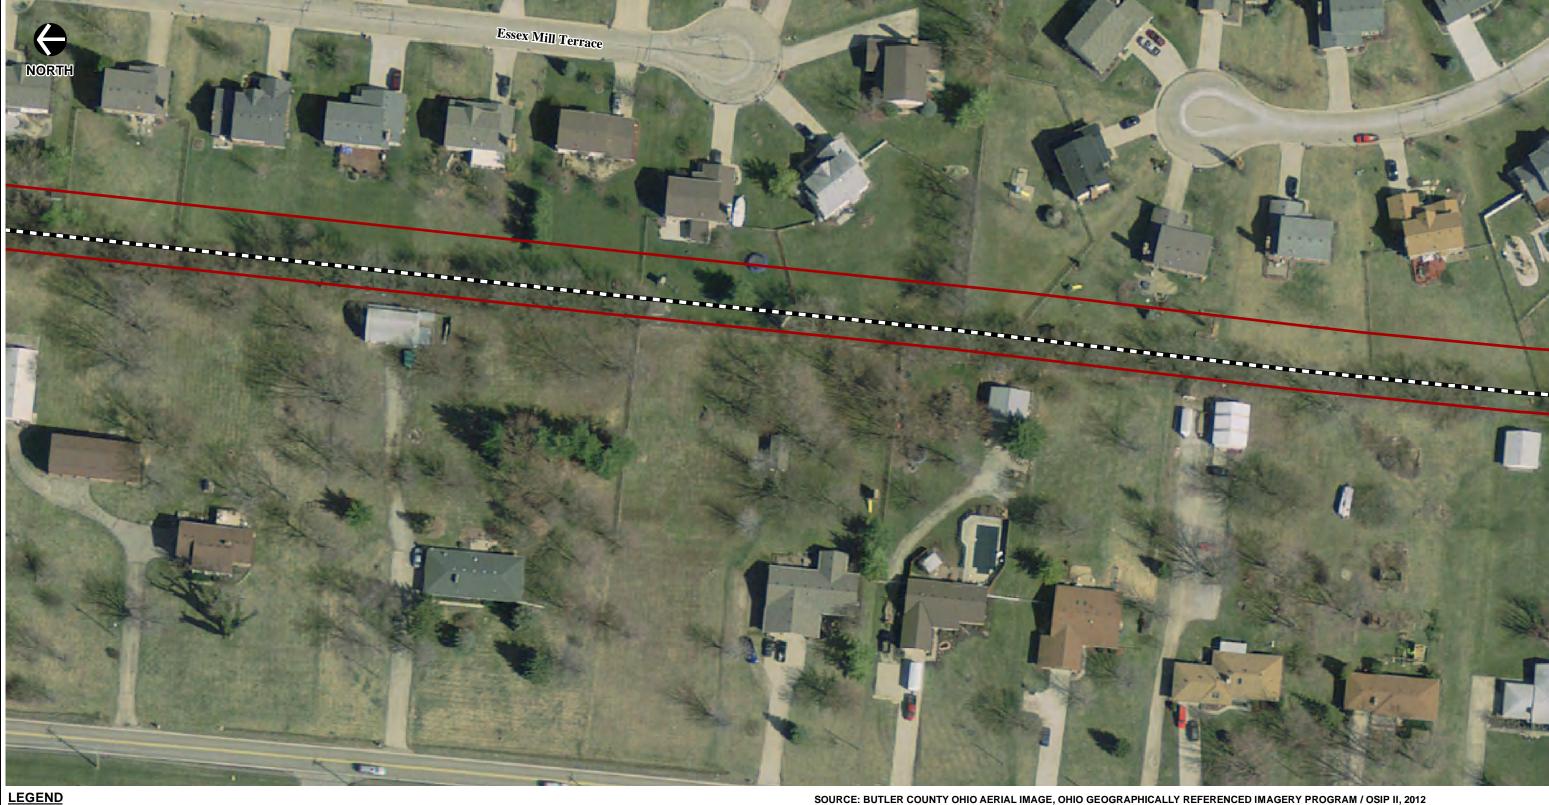
> WETLAND AND WATERBODY **DELINEATION MAP**

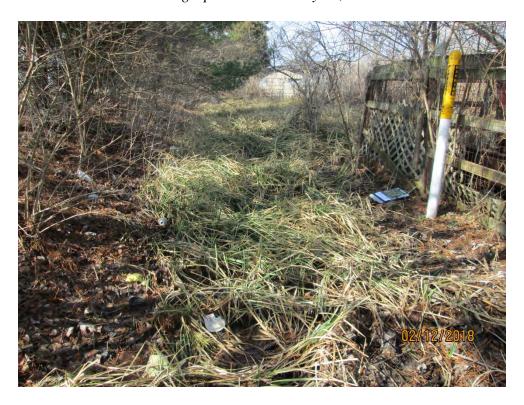
Photograph 1. Representative view of Wetland 1 (PEM). Photograph taken facing to the west.

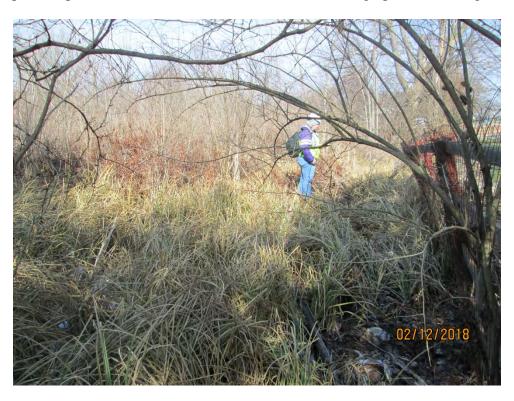
Photograph 2. Representative view of Wetland 1 (PEM). Photograph taken facing to the west.

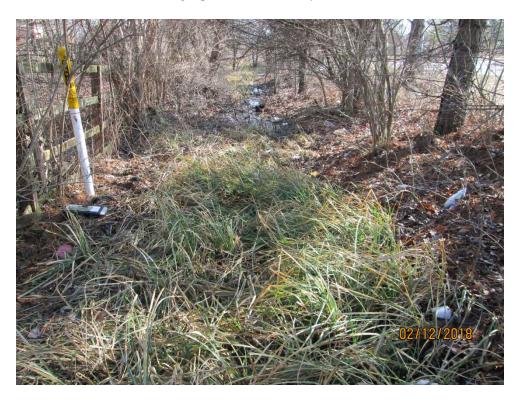
Photograph 3. Representative view of Wetland 1 (PEM). Photograph taken facing to the east.

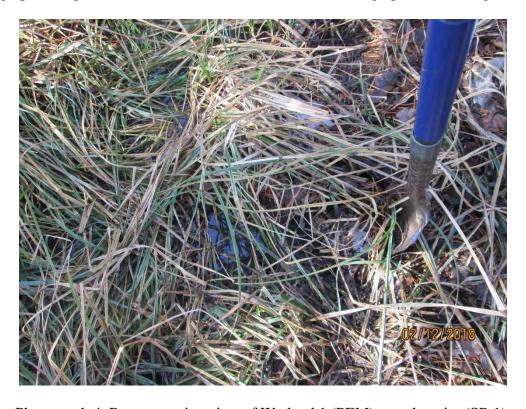
Photograph 4. Representative view of Wetland 1 (PEM) sample point (SP-1).

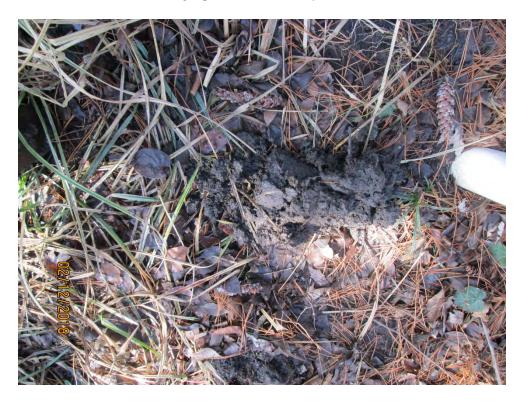
Photograph 5. Representative view of Wetland 1 (PEM) upland sample point (SP-2).

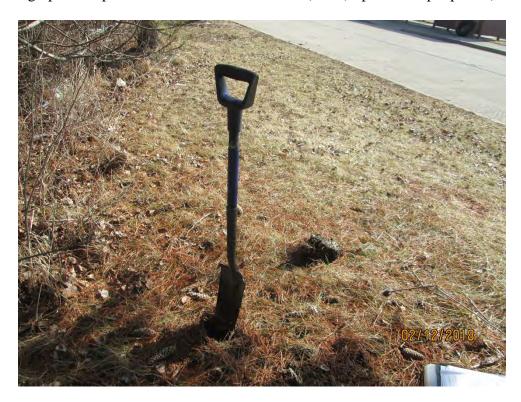
Photograph 6. Representative view of Wetland 1 upland sample point (SP-2) vicinity. Photograph taken facing to the southeast.

Photograph 6. Representative view of Wetland 1 upland sample point (SP-2) vicinity. Photograph taken facing to the southeast.

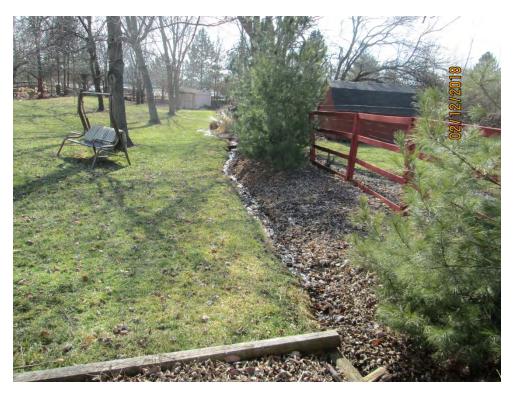
Photograph 7. Representative view of maintained lawn/existing ROW habitat in southern portion of replacement pipeline area of impact. Photograph taken facing to the south.

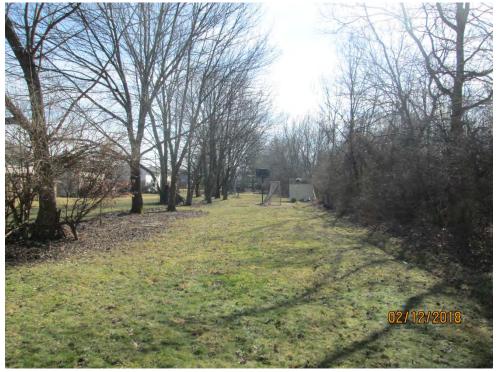
Photograph 8. Representative view of maintained lawn/existing ROW habitat in northern portion of replacement pipeline area of impact. Photograph taken facing to the south.

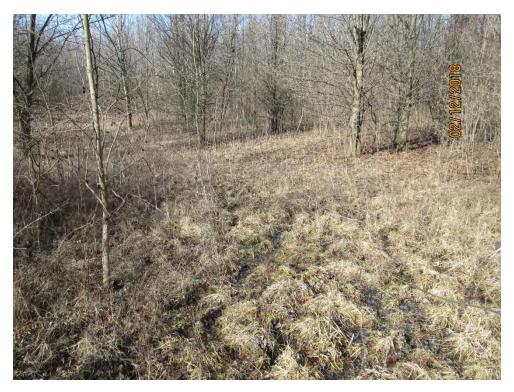
Photograph 9. Representative view of eastern side of Wetland 2 (PEM portion). Photograph taken facing to the west.

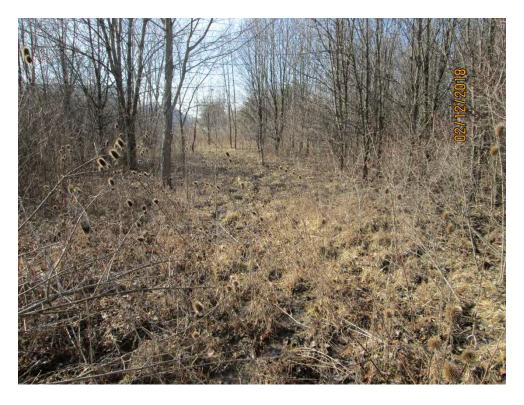
Photograph 10. Representative view of middle area Wetland 2 (PEM portion). Photograph taken facing to the west.

Photograph 10. Representative view of middle area Wetland 2 (PEM portion). Photograph taken facing to the west.

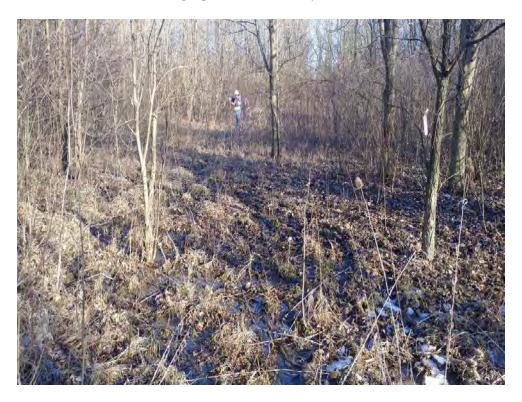
Photograph 11. Representative view of western side of Wetland 2 (PEM portion). Photograph taken facing to the east.

Photograph 11. Representative view of western side of Wetland 2 (PEM portion). Photograph taken facing to the east.

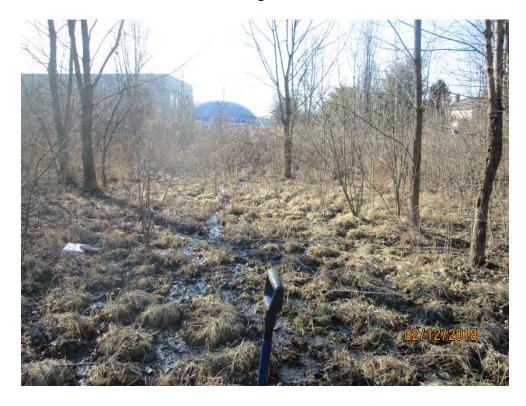
Photograph 12. Representative view of Wetland 2 (PEM portion) sample point (SP-3) vicinity. Photograph taken facing to the west.

Photograph 12. Representative view of Wetland 2 (PEM portion) sample point (SP-3) vicinity. Photograph taken facing to the west.

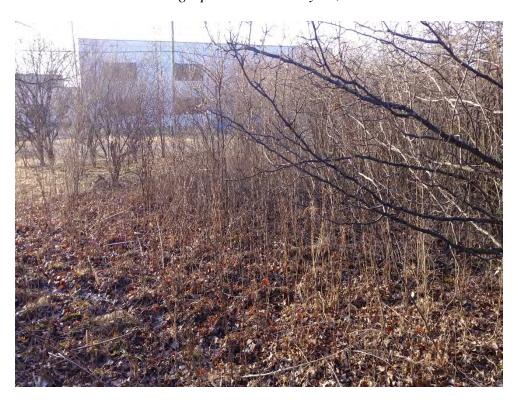
Photograph 13. Representative view of southeastern area of Wetland 2 (PSS portion). Photograph taken facing to the west.

Photograph 13. Representative view of southeastern area of Wetland 2 (PSS portion). Photograph taken facing to the west.

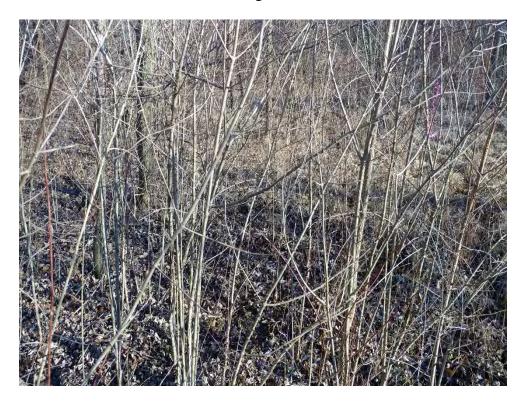
Photograph 14. Representative view of northern area of Wetland 2 (PSS portion). Photograph taken facing to the east.

Photograph 14. Representative view of northern area of Wetland 2 (PSS portion). Photograph taken facing to the east.

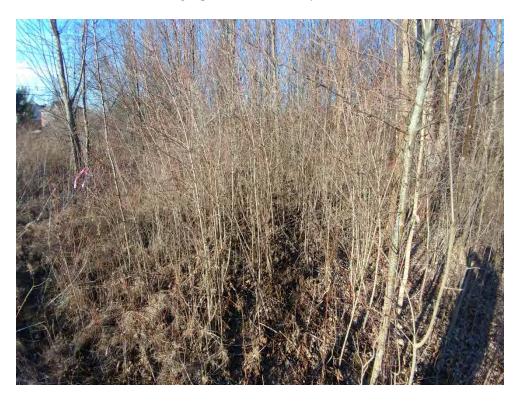
Photograph 15. Representative view of western area of Wetland 2 (PSS portion). Photograph taken facing to the south.

Photograph 15. Representative view of western area of Wetland 2 (PSS portion). Photograph taken facing to the south.

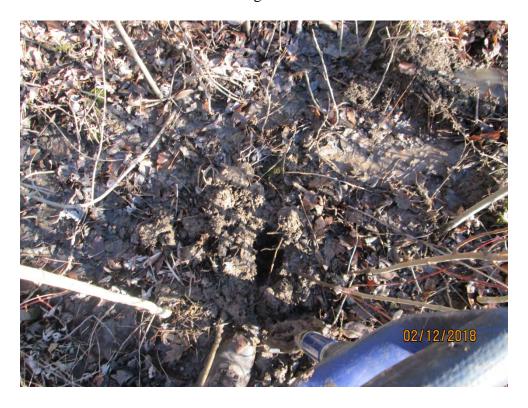
Photograph 16. Representative view of Wetland 2 (PSS portion) sample point (SP-4).

Photograph 16. Representative view of Wetland 2 (PSS portion) sample point (SP-4).

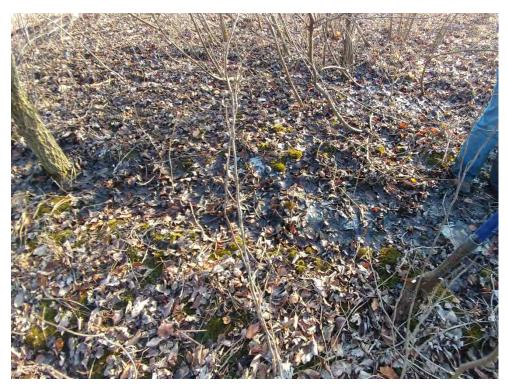
Photograph 17. Representative view of upland SP-5 habitat. Photograph taken facing south.

Photograph 17. Representative view of upland SP-5 habitat. Photograph taken facing south.

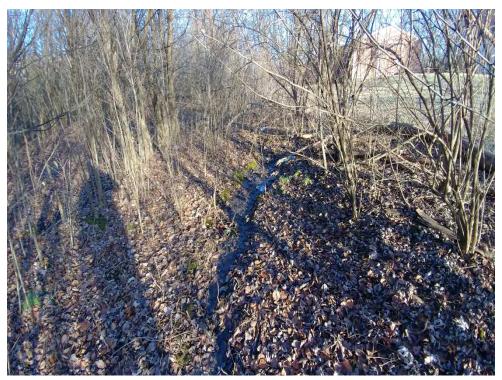
Photograph 18. Representative view of drainage ditch in southwest corner of young second growth forest habitat. Photograph taken facing to the east.

Photograph 18. Representative view of drainage ditch in southwest corner of young second growth forest habitat. Photograph taken facing to the east.

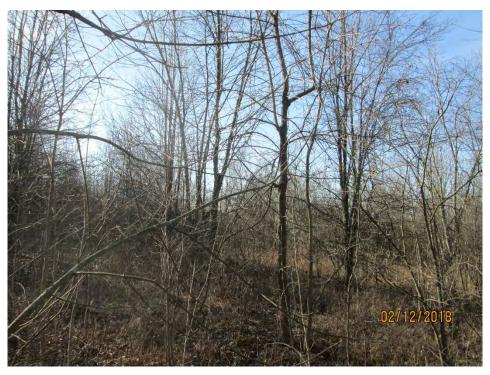
Photograph 19. Representative view of northeastern wooded portion of the woodlot that is intended for tree clearing. Photograph taken facing to the east.

Photograph 19. Representative view of northeastern wooded portion of the woodlot that is intended for tree clearing. Photograph taken facing to the east.

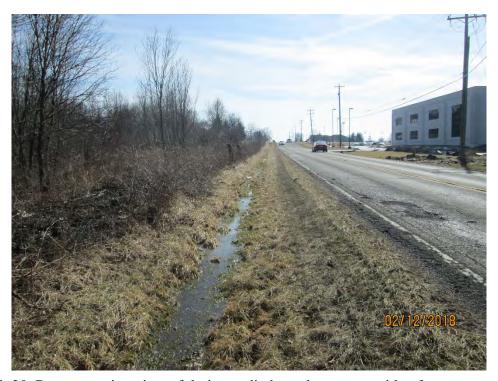
Photograph 20. Representative view of drainage ditch on the western side of young second growth forest habitat. Photograph taken facing to the south.

Photograph 20. Representative view of drainage ditch on the western side of young second growth forest habitat. Photograph taken facing to the south.

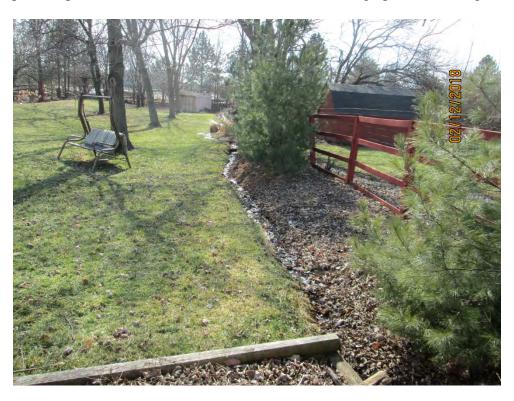
Photograph 2. Representative view of maintained lawn/existing ROW habitat in southern portion of replacement pipeline area of impact. Photograph taken facing to the south.

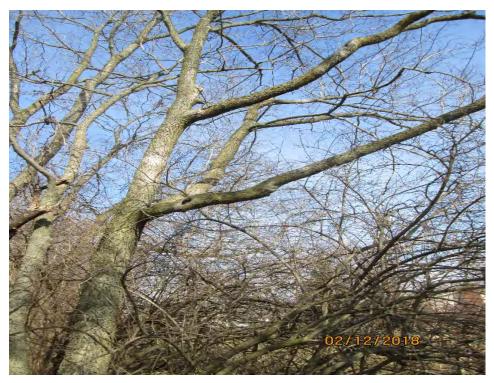
Photograph 3. View of potential roost tree (PRT) 1, a common hackberry (*Celtis occidentalis*). Photograph taken facing to the southwest.
