Letter of Notification For East Lima Station Expansion Project

PUCO Case No. 18-0906-EL-BLN

AEP Ohio Transmission Company, Inc.'s East Lima Station Expansion Project

EAST LIMA STATION EXPANSION PROJECT, ALLEN COUNTY, OHIO

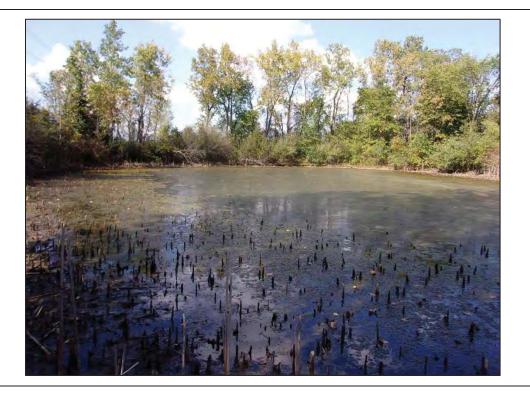
Pond 01

Facing north

One pond, totaling approximately 0.45 acre, was observed within the Project survey area. This pond was observed to be manmade for recreational or livestock purposes.

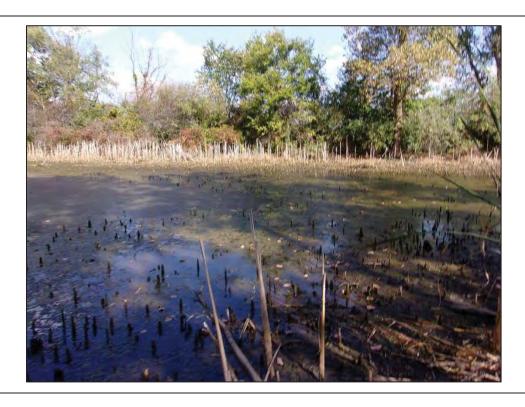
Photo No. 2

Pond 01

Facing east
