## Paulding Wind Farm IV LLC Case No. 18-91-EL-BGN

## Surface Water Delineation Report

EDP Renewables, LLC Timber Road IV Wind Project

# Timber Road IV Wind Project, Paulding County, Ohio Wetland and Waterbody Field Delineation Surveys Representative Photolog Winter 2017 & Spring 2018

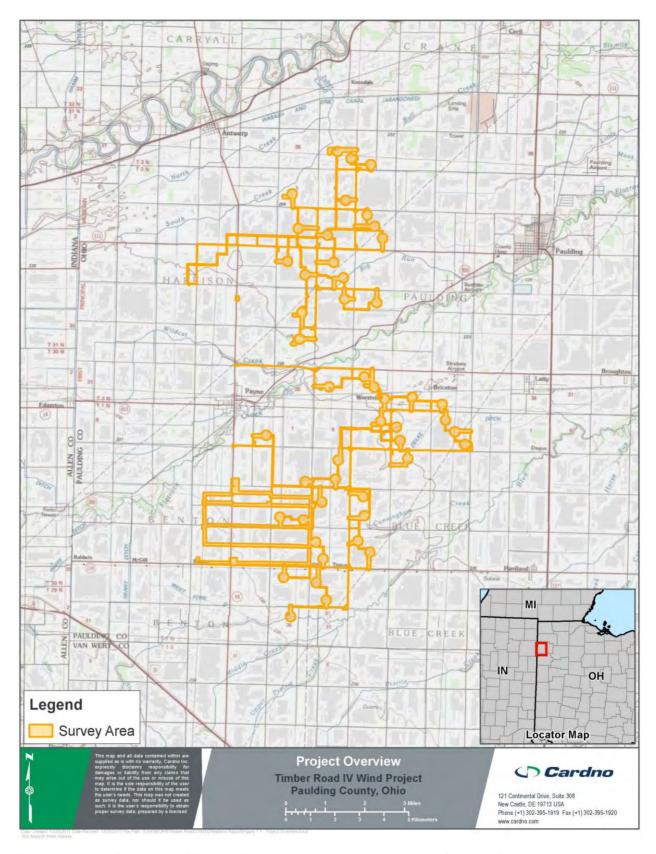
Figure 1.1 Overview of Timber Road IV Wind Farm in Paulding County, Ohio

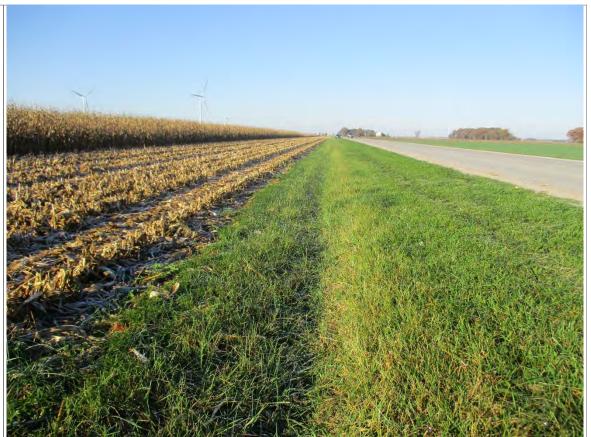
Date: 11/08/2017

Description: Photo of a typical grassy swale that was commonly found along roadsides and through agricultural fields. This swale is located adjacent to a partially harvested corn field, which was a common sight during field surveys. Most fields like this one within the Project Corridor are planted with corn or soybean during growing season.

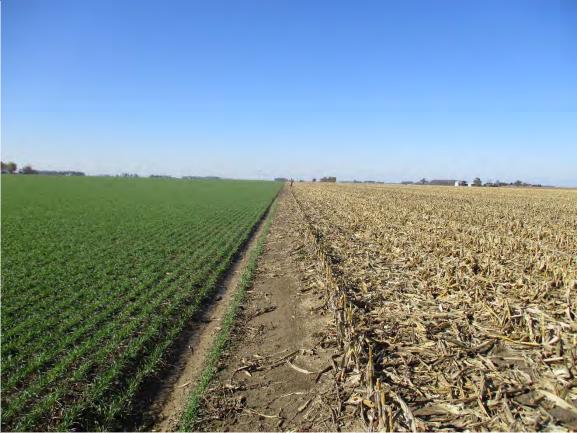
Date: 11/08/2017

**Description: Photo of** typical adjacent agricultural fields within the Project Corridor. On the left is a recently planted crop, and on the right is a recently harvested corn field. At the time of the survey, there was often still remnants of last year's harvested crops in the fields. Minimal buffer area was observed between agricultural fields and it was common that these areas were occupied by grassy swales or excavated ditches.

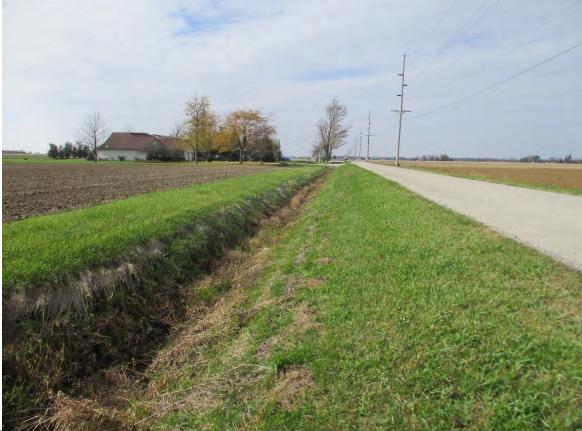
Date: 11/10/2017

Description: Photo of a typical intermittent, Class II ditch running between two crop fields. It was a common observation by field teams that many manmade ditches would be excavated between agricultural fields for the purpose of stormwater runoff. This waterbody had a very narrow channel and relatively shallow water depths.

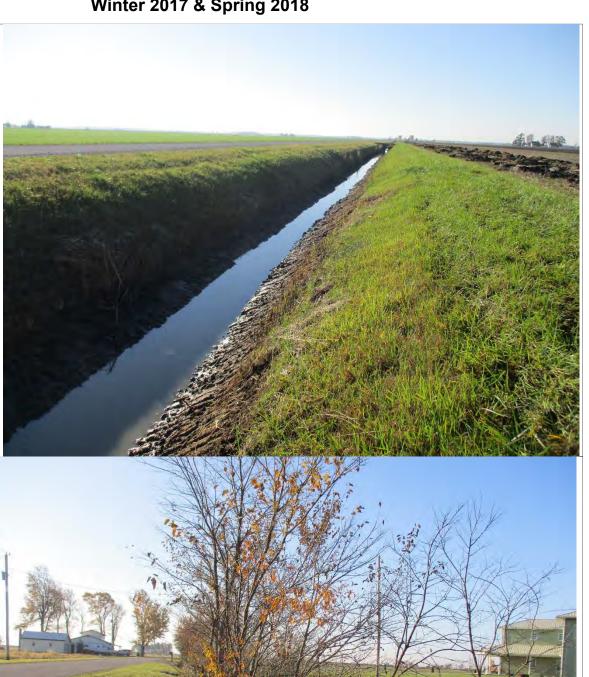
Date: 11/09/2017

Description: Photo of a typical intermittent, Class II, highly vegetated waterbody. This waterbody also acted as a roadside drainage feature and had relatively deep but turbid water. The banks of this ditch were vegetated with young saplings and other weedy species and received a high HHEI score due to it's wide channel, depth of water, and mix of substrate.

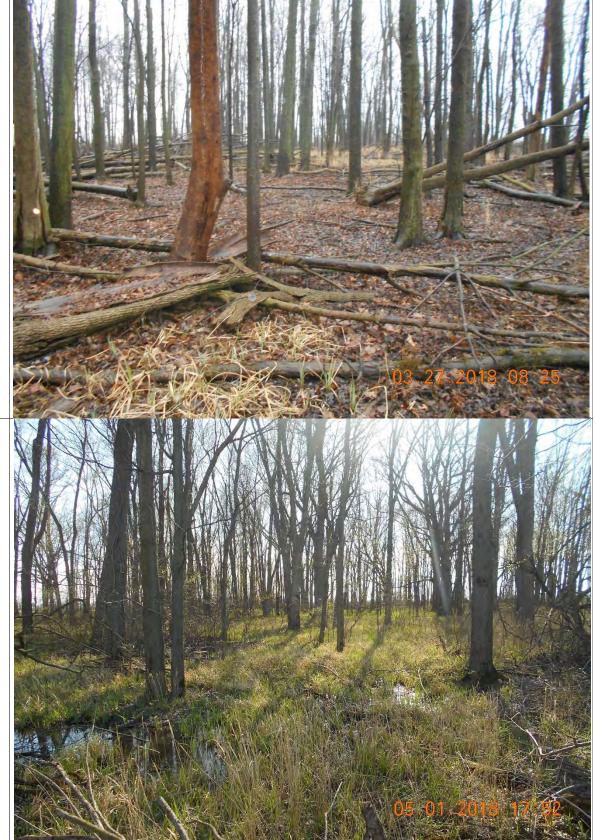
Date: 05/01/2018

Description: Photo of a forested wetland located to the east of an existing string of turbines in the northern half of the Project Corridor. This wetland is not anticipated to be jurisdictional due to a lack of connection to a WOTUS.
