**Re: PUCO Case No. 18-1170-EL-BLN**  
**In the Matter of the Letter of Notification for the**  
**Shannon-Astor 138 kV Transmission Line Extension Project**

# Letter of Notification for Shannon-Astor 138 kV Transmission Line Extension Project

### AEP Ohio Transmission Company, Inc. Shannon-Astor 138 kV Transmission Line Extension Project

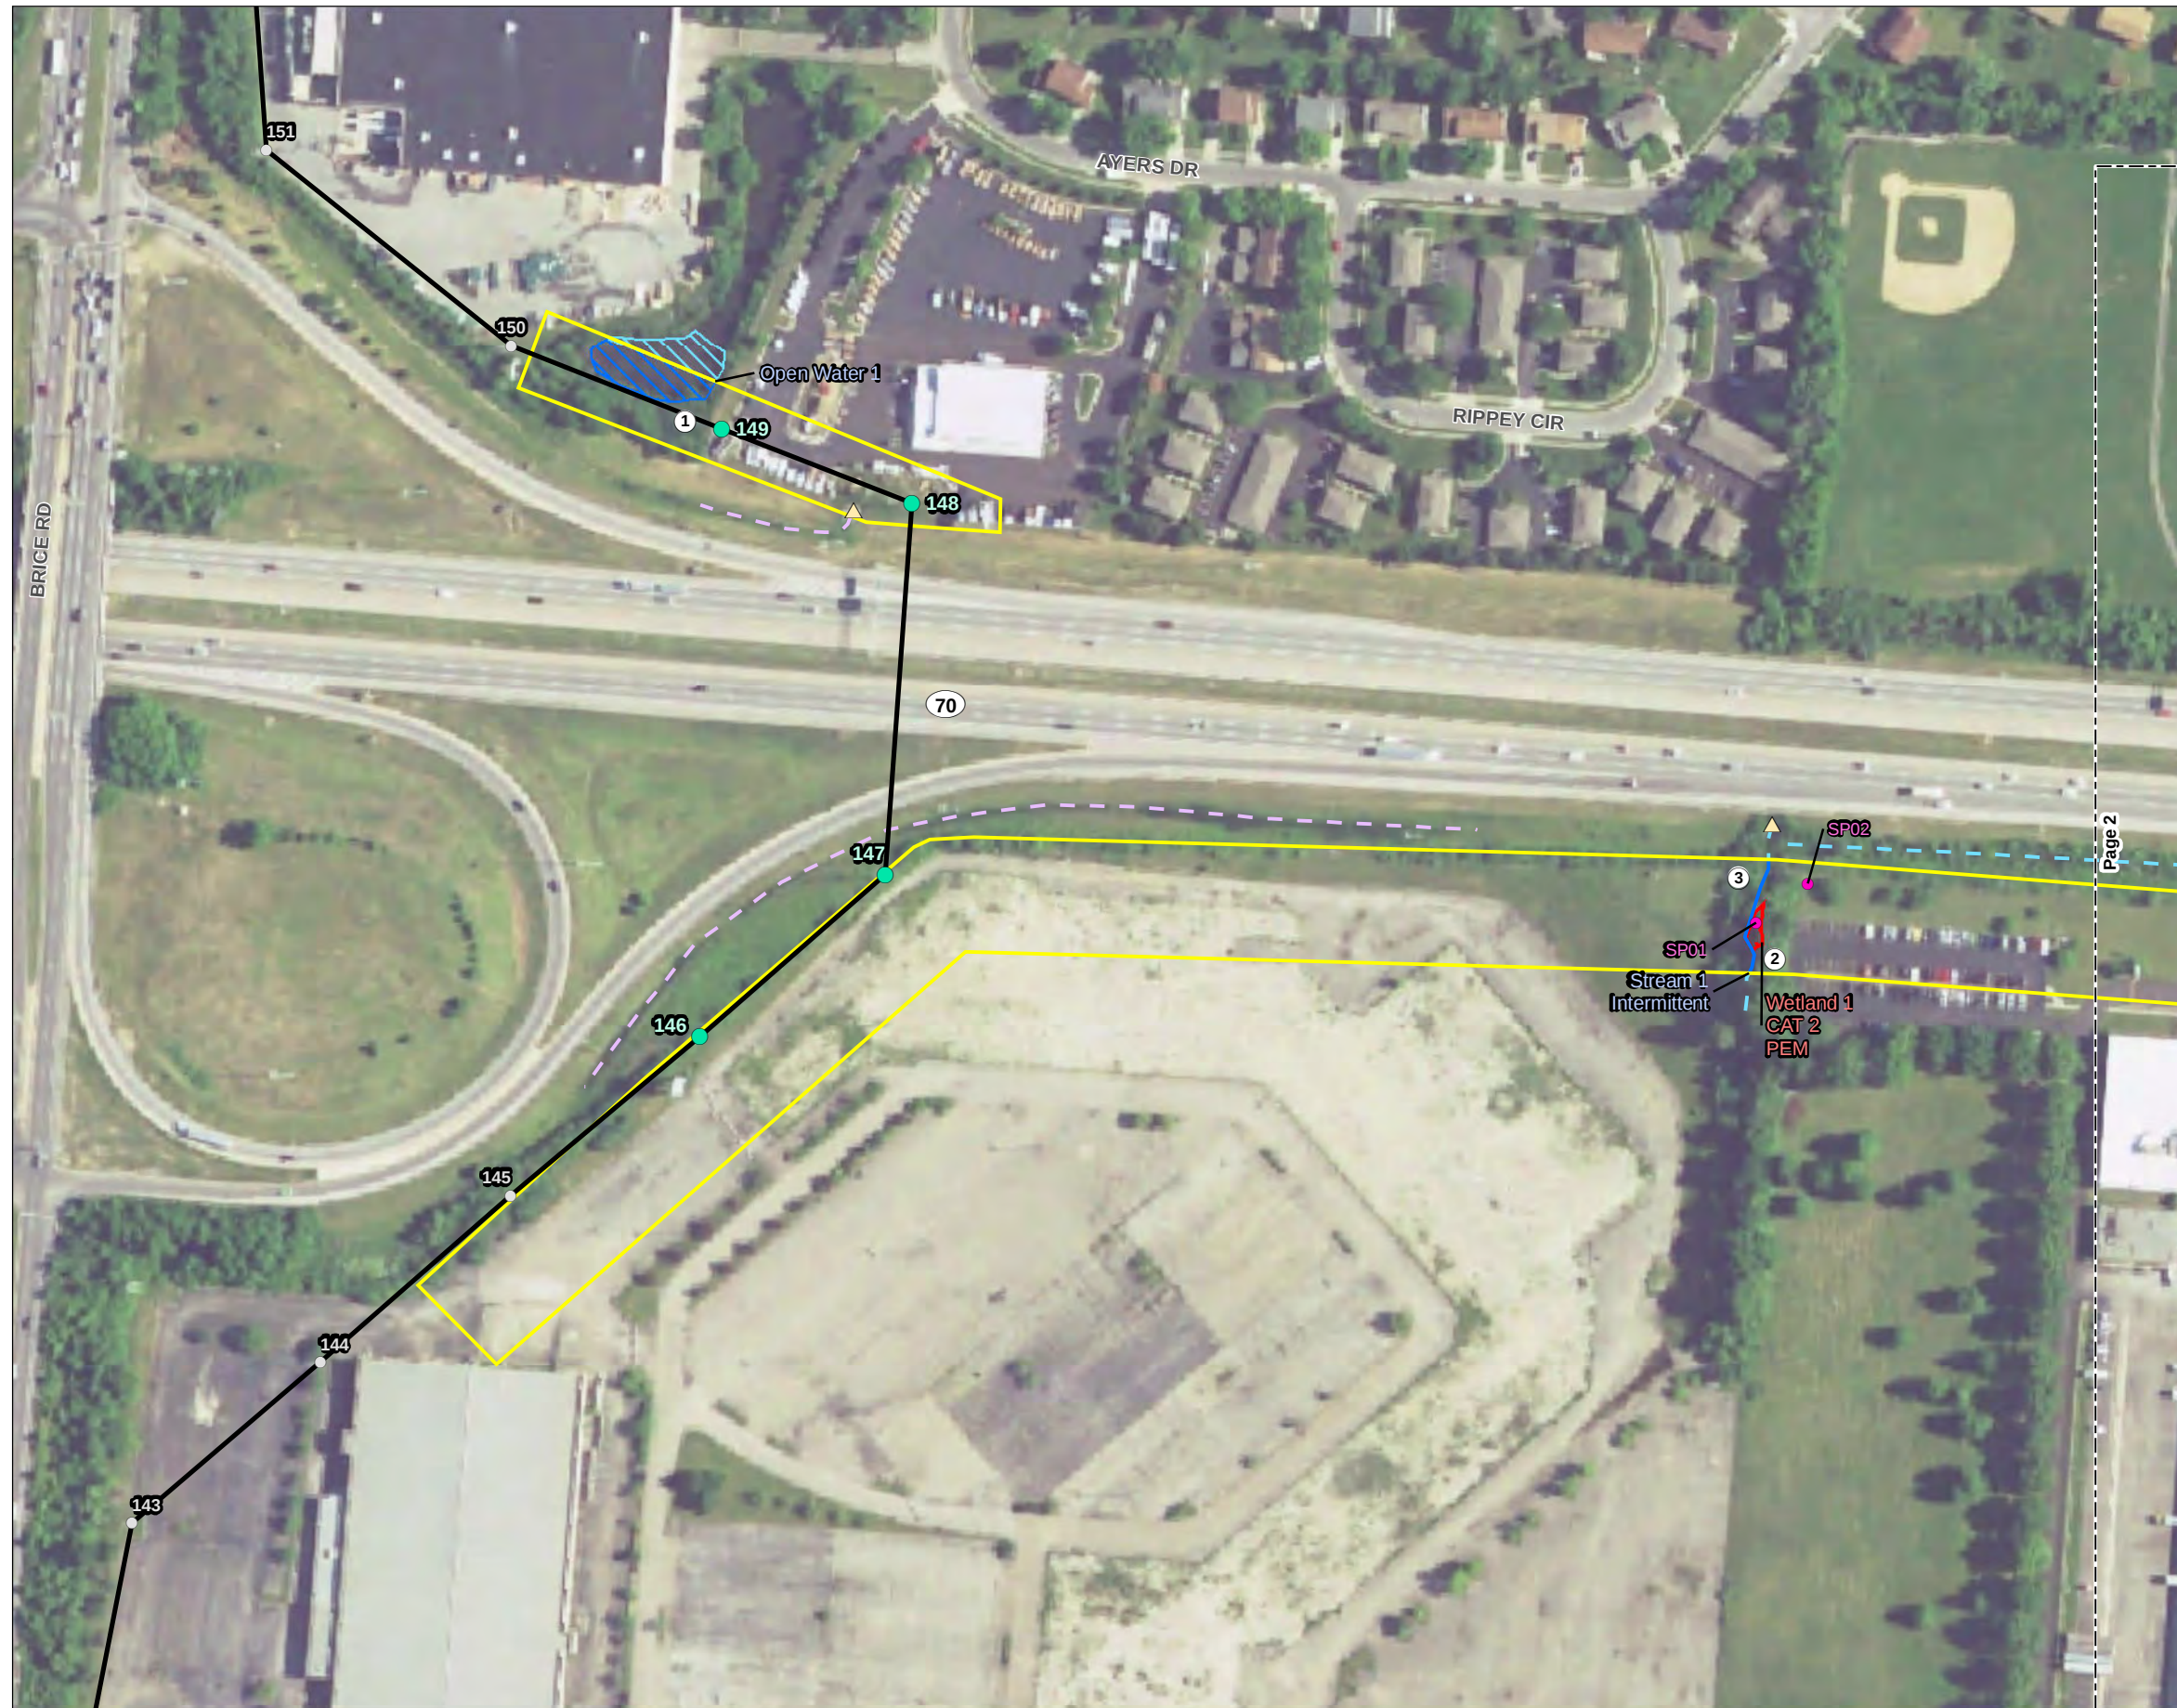
Figure No.  
2

Title  
Wetland and Waterbody  
Delineation Map

Stantec completed field surveys within the Project area on June 14, 2018 for wetlands, waterbodies, and threatened and endangered species or their habitats. Figure 2 (Appendix A) shows the wetlands and waterbodies identified by Stantec within the Project area, as well as the locations of open waters and upland drainage features identified within the Project area. Figure 3 (Appendix A) shows the habitats and locations of any identified rare, threatened or endangered species observed within the Project area. Representative photographs of the wetlands, streams, upland drainage features, and other habitats identified within the Project area are included in Appendix C of this report (photo locations are shown on Figures 2 and 3, Appendix A).

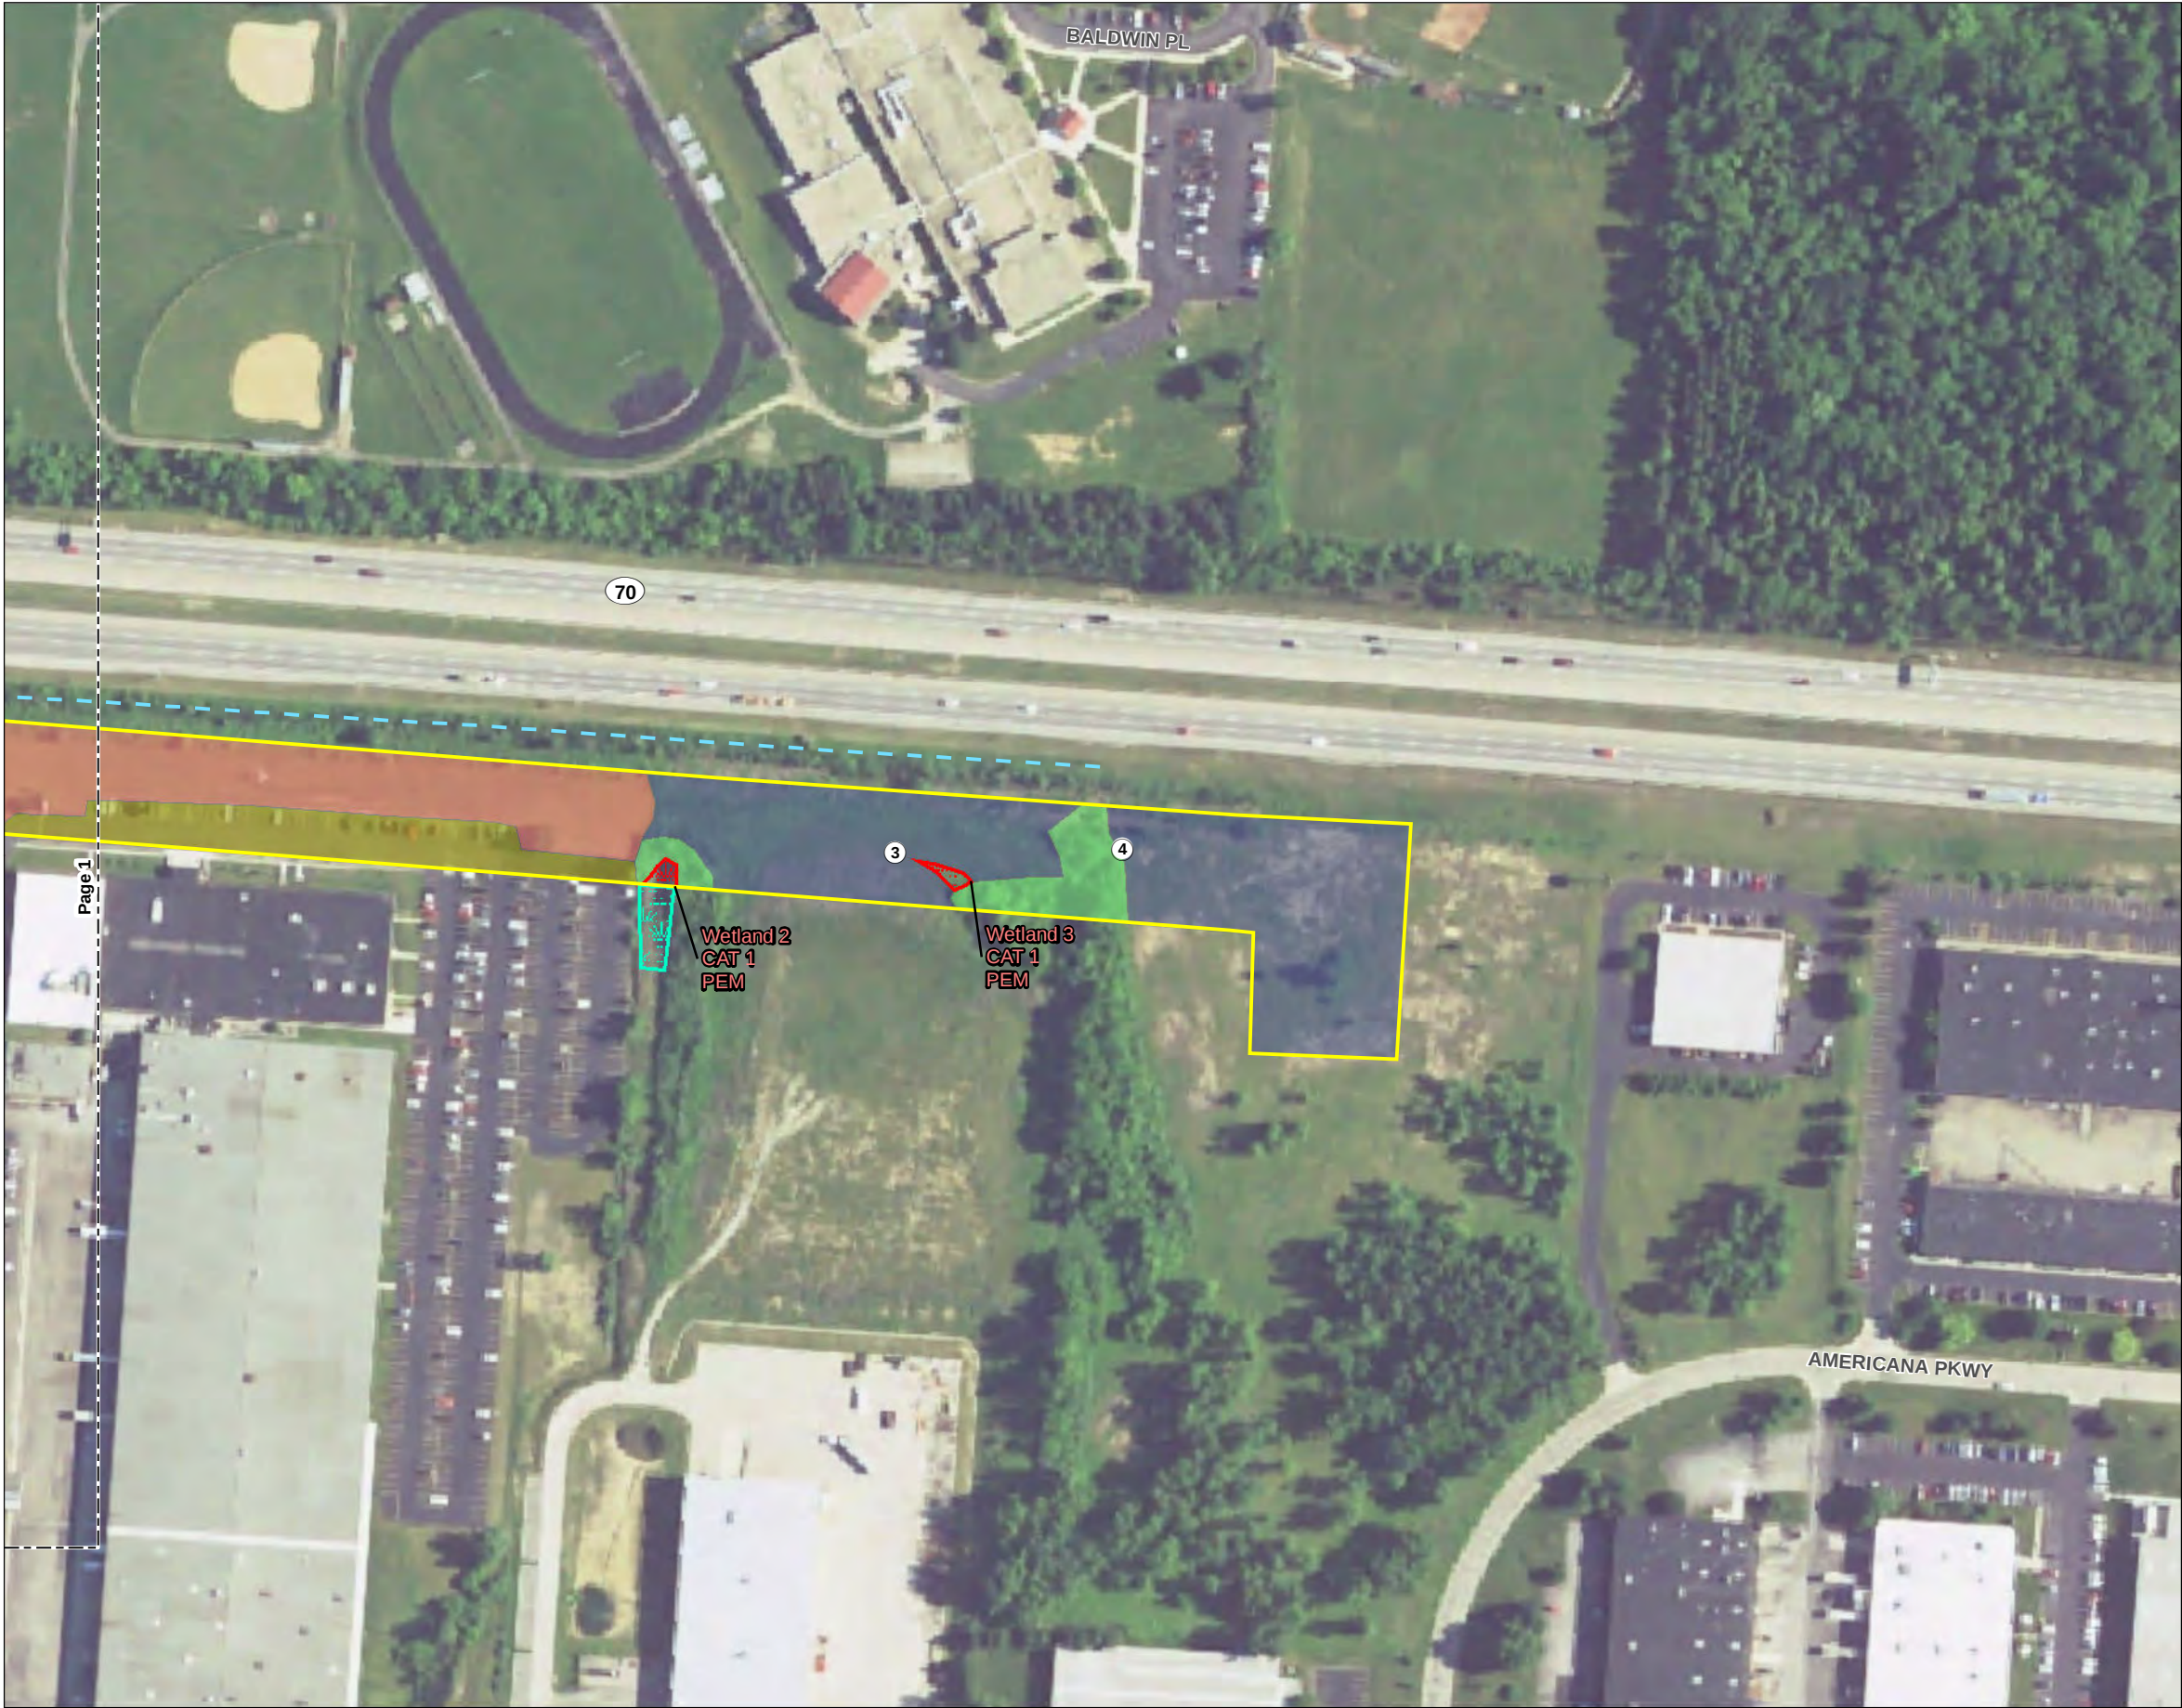
Figure No.  
**3**

Title  
**Habitat Assessment Map**

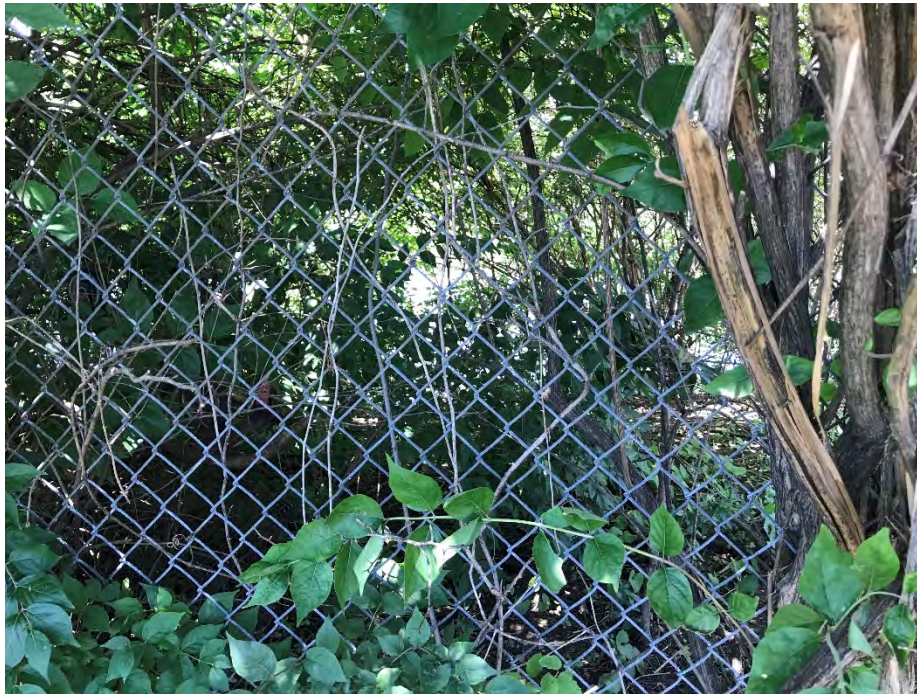
Photo Location 1. View of fence around Open Water 1. Photograph taken facing northwest.

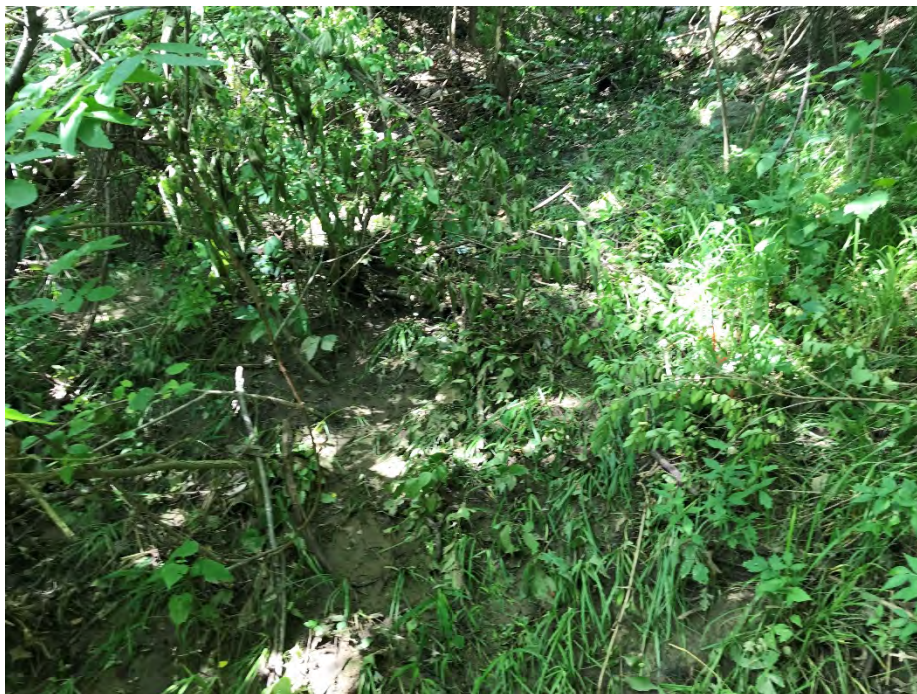
Photo Location 2. View of Wetland 1. Photograph taken facing north.

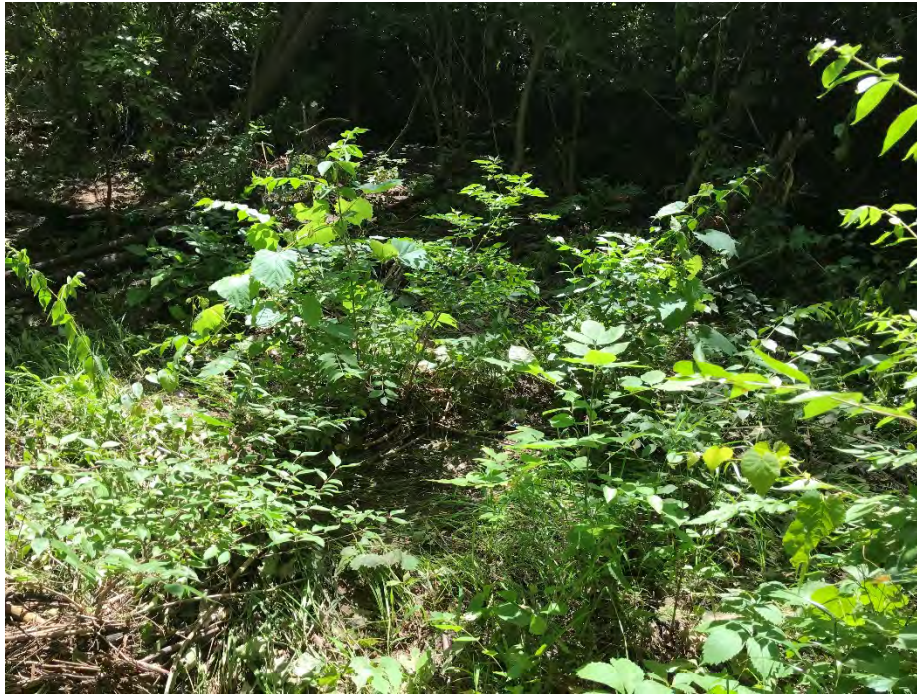
Photo Location 2. View of Wetland 1 and wetland determination sample point SP01.  
Photograph taken facing west.

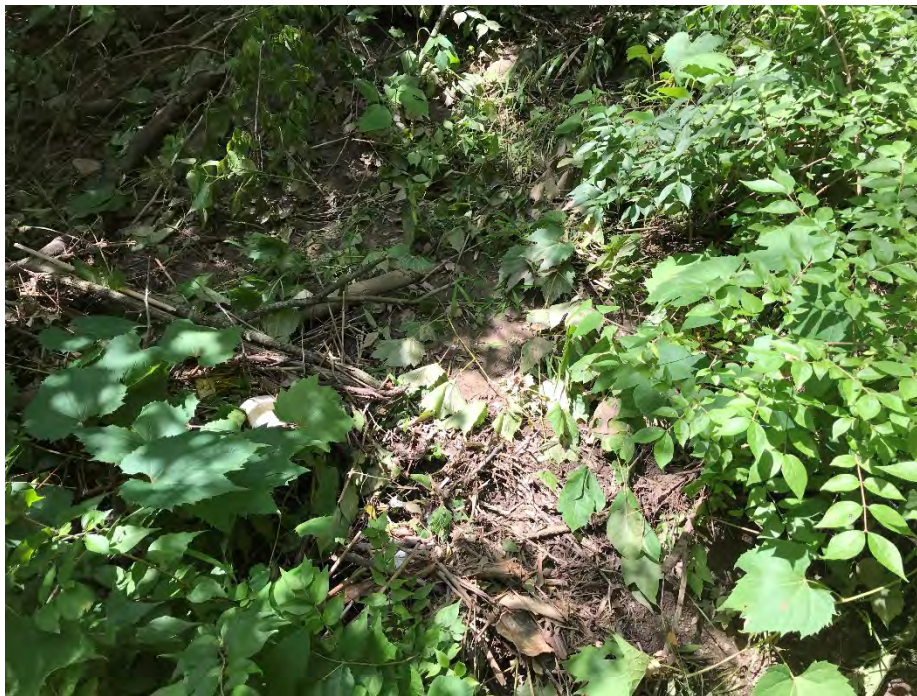
Photo Location 2. View of Wetland 1 and wetland determination sample point SP01.  
Photograph taken facing south.

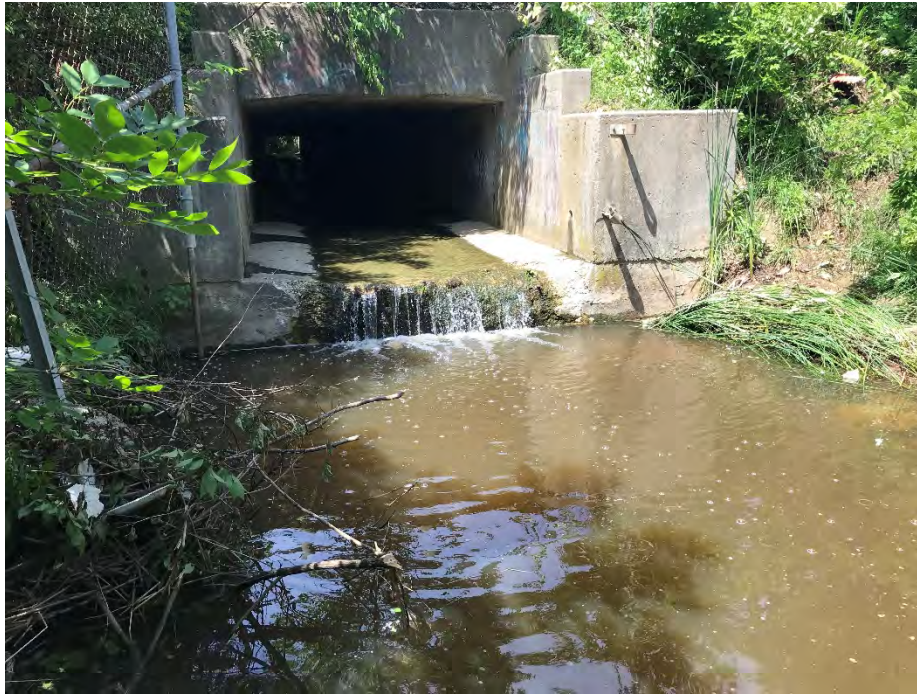
Photo Location 3. View of Stream 1. Photograph taken facing north (upstream).

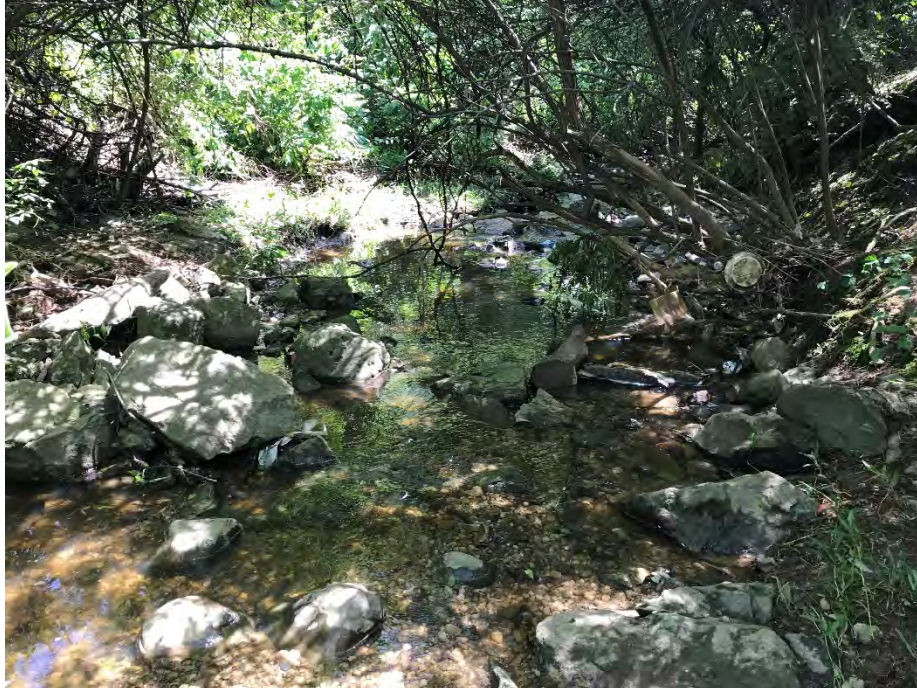
Photo Location 3. View of Stream 1. Photograph taken facing south (downstream).

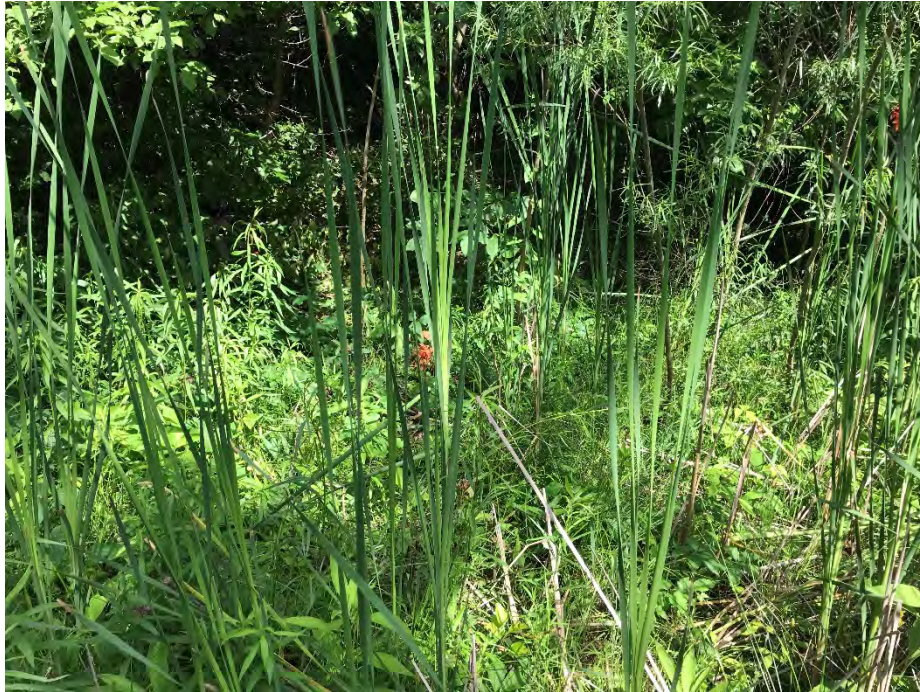
Photo Location 4. View of Wetland 2. Photograph taken facing east.

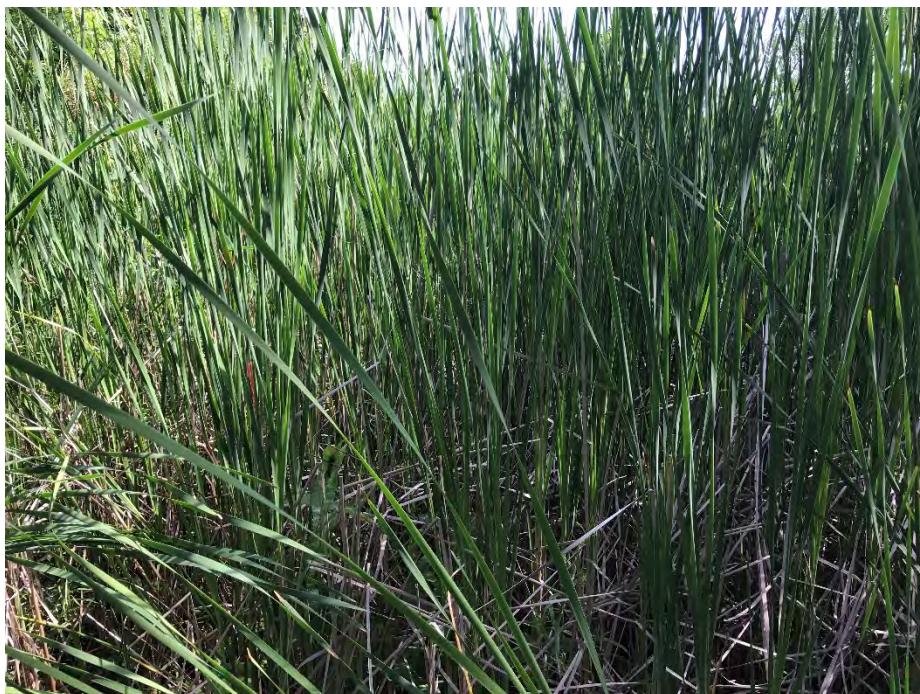
Photo Location 4. View of Wetland 2. Photograph taken facing south.

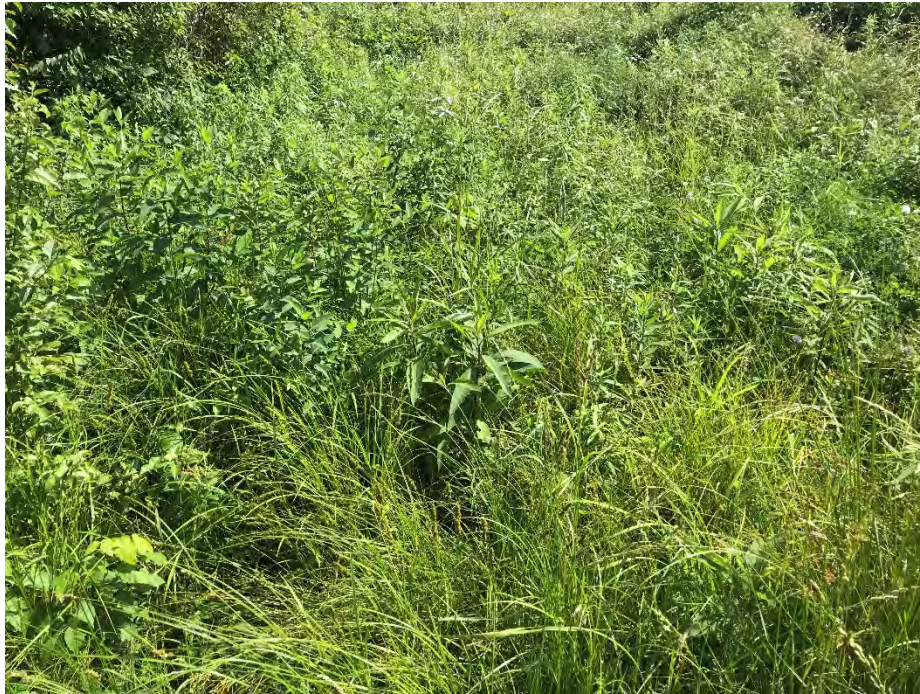
Photo Location 5. View of Wetland 3. Photograph taken facing east.

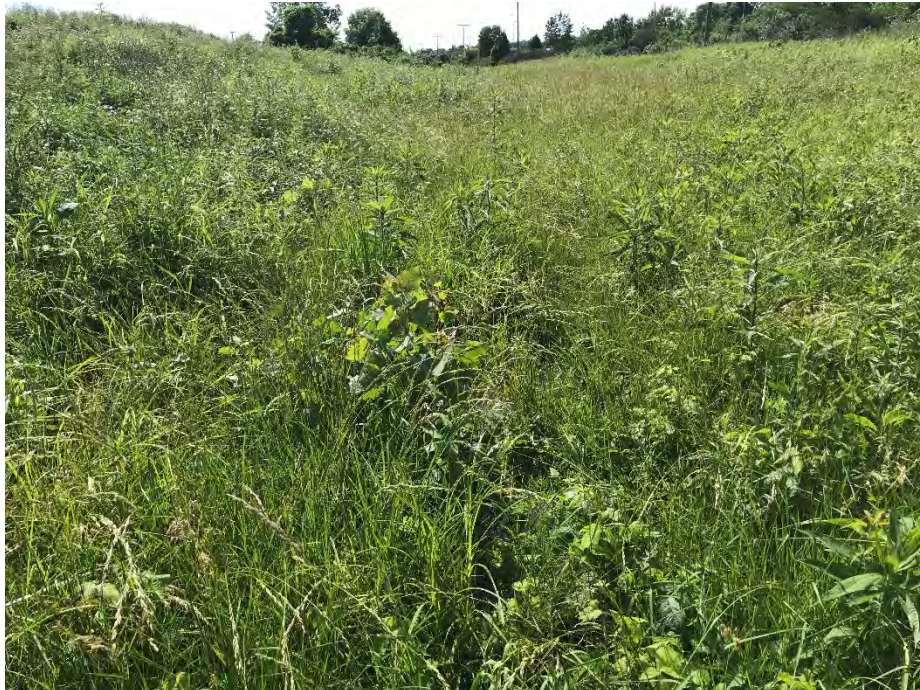
Photo Location 5. View of Wetland 3. Photograph taken facing west.
