RE: Case No. 18-1799-EL-BNR
In the Matter of the Construction Notice Application for
AEP Ohio Transmission Company, Inc. for a Certificate of
Environmental Compatibility and Public Need for the
Devola-Gorsuch 138kV Transmission Line Extension Project

Construction Notice for the Devola – Gorsuch 138 kV Transmission Line Project

AEP Ohio Transmission Company, Inc.'s Devola - Gorsuch 138 kV Transmission Line Project

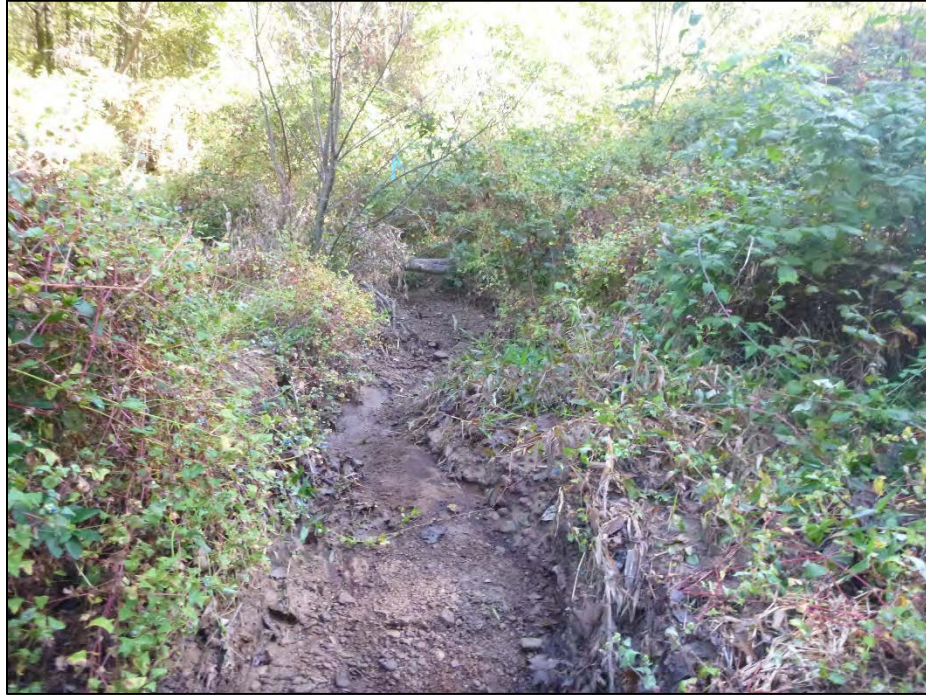
Site Name	Photo Direction
Stream SBR001 (Ephemeral)	Upstream

A total of five streams, were identified within the ESA. All streams are unnamed tributaries to the Muskingum River. All five streams were determined to have ephemeral flow based on the HHEI scores, field observations, and the USGS topographic maps (Figure 1). All streams appear to have significant nexus with a TNW (the Muskingum River) and are therefore likely to be considered jurisdictional by the USACE. It is noted that the USACE and OEPA make the final determination of significant nexus with a TNW. Completed HHEI forms are provided in Appendix A and representative photographs of the streams are provided in Appendix D.

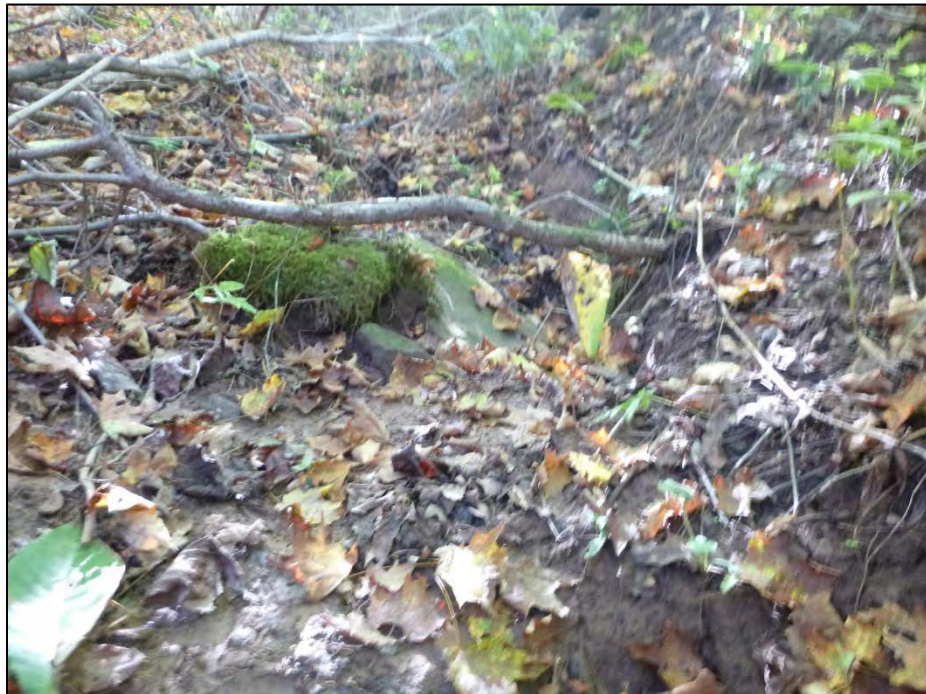
Site Name	Photo Direction
Stream SBR002 (Ephemeral)	Upstream

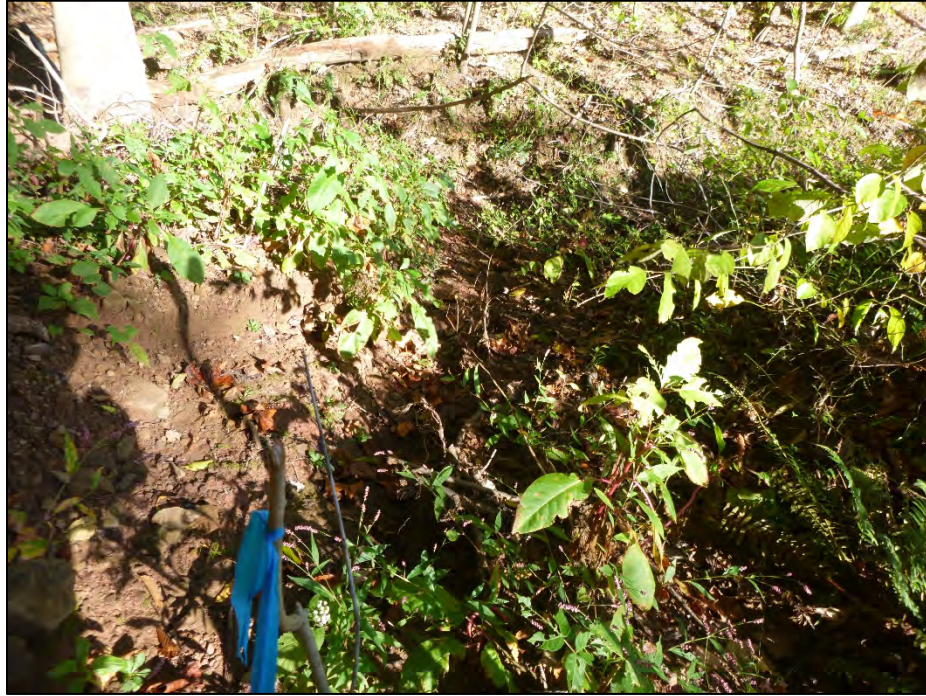
Site Name	Photo Direction
Stream SJF100 (Ephemeral)	Downstream

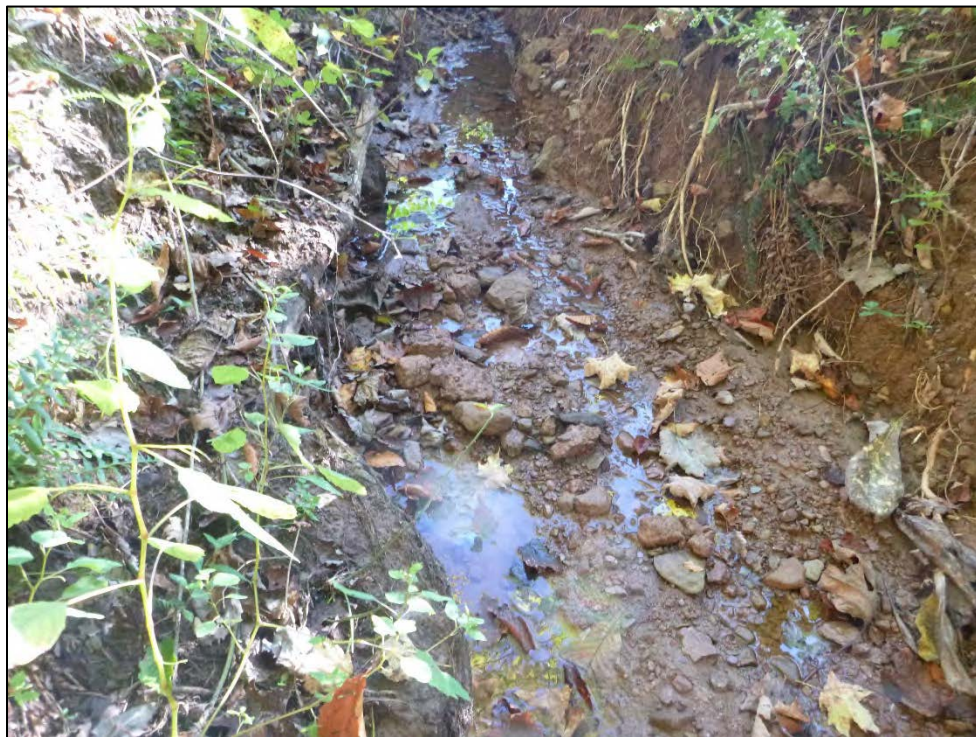
Site Name	Photo Direction
Stream SJF101 (Ephemeral)	Upstream

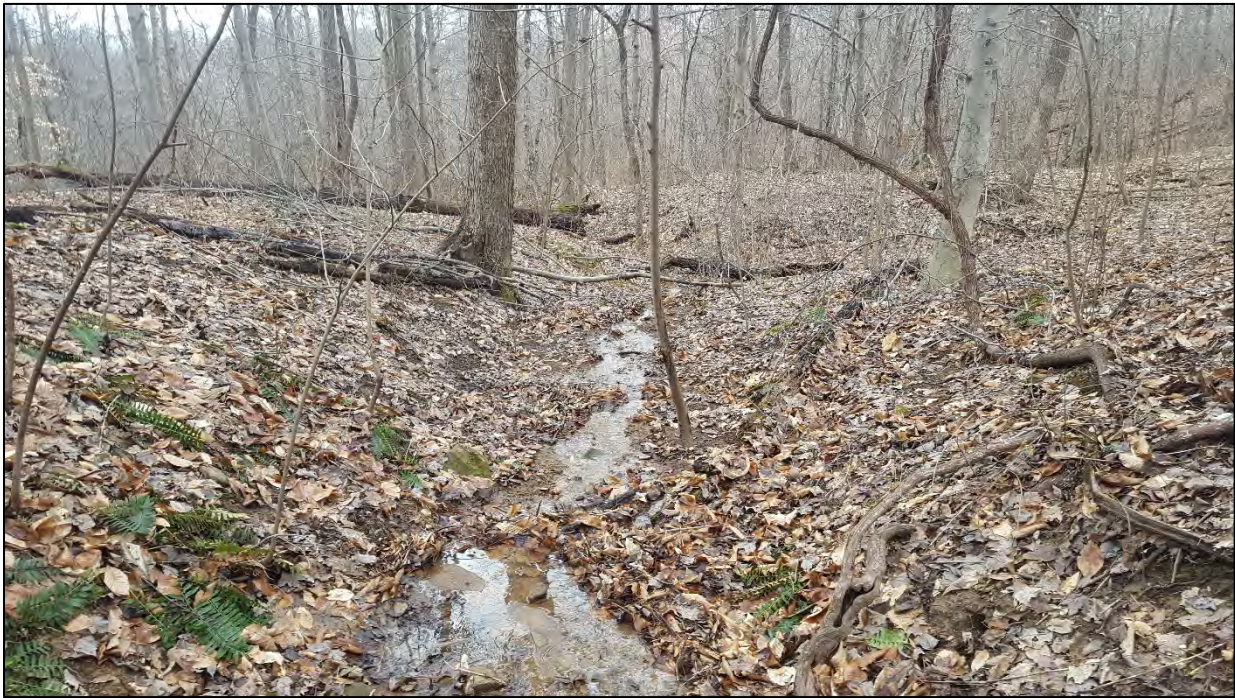
Site Name	Photo Direction
Stream SJF102 (Ephemeral)	Downstream
