The Republic Wind Project is proposed as a 200-MW wind farm with up to 50 turbines on private lands in northern Seneca County and southeast Sandusky County, Ohio. The Project is proposed in a predominantly agricultural area. The history of land conversion and landscape manipulation for farming has reduced the land available for wetlands to develop.

**Apex Republic Wind Project, Seneca and Sandusky County Ohio**  
**Wetland and Waterbody Field Delineation Surveys**  
**Photolog**  
**Fall 2016 Through Fall 2018**

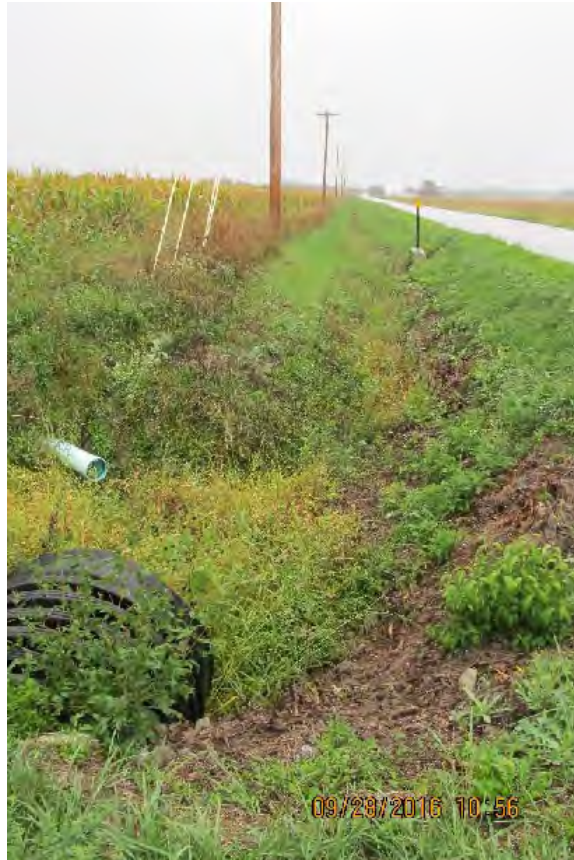
**Description:** Photo of ditch DOH-001 which was typical for most ephemeral ditches in the Delineation Area. The channel lacked any standing water which indicated it likely flowed during larger storm events. And due to the constant mowing of the banks and input from field tile, the waterbody was considered modified. The combination of lacking habitat and constant disturbance meant the waterbody was of low biological quality.

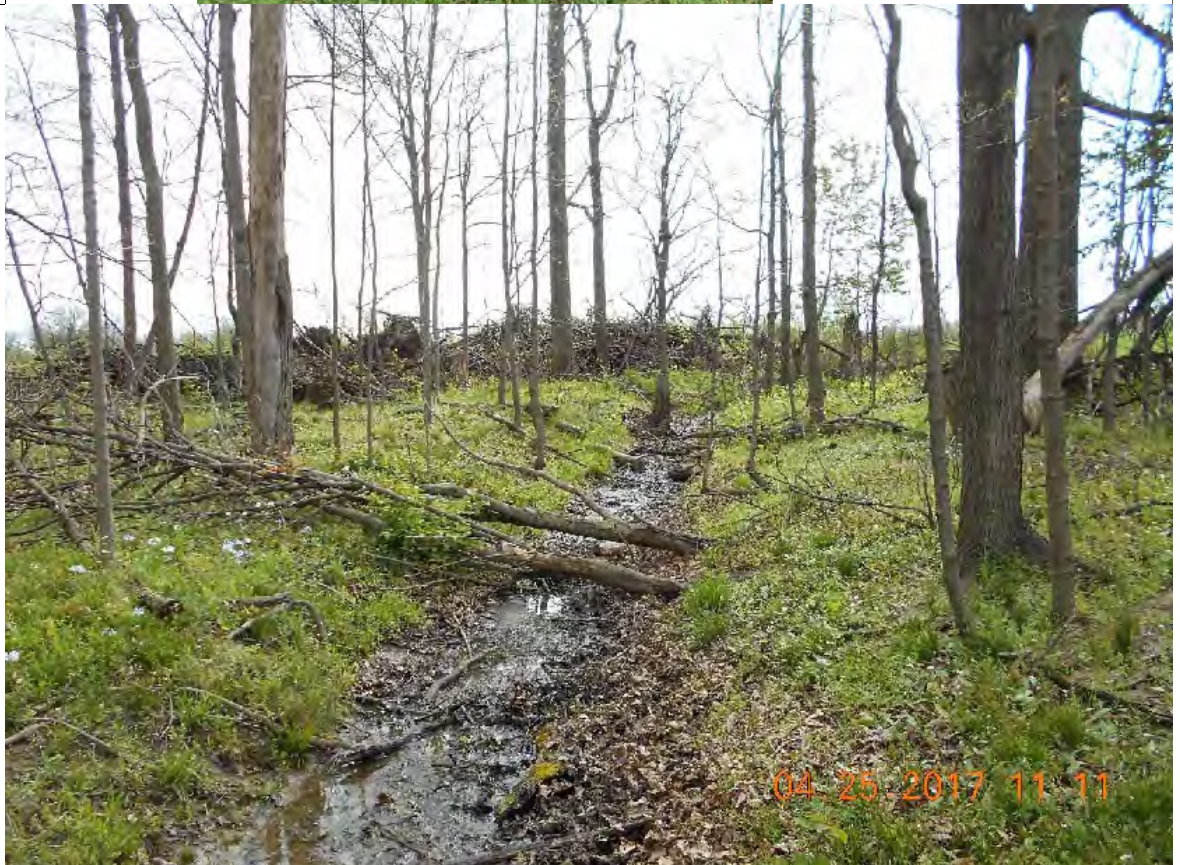
**Photo: Typical Naturalized Ephemeral Waterbody**

**Description:** Stream SOH-108 was identified as an ephemeral waterbody due to the presence of a defined bed and bank and indications of flow (as evidenced by sticks and snags). Unlike a modified waterbody, the naturalized ephemeral waterbodies lacked signs of recent man-made disturbance. Although the features lacked disturbance, the lack of consistent water meant biological utilization was likely low.

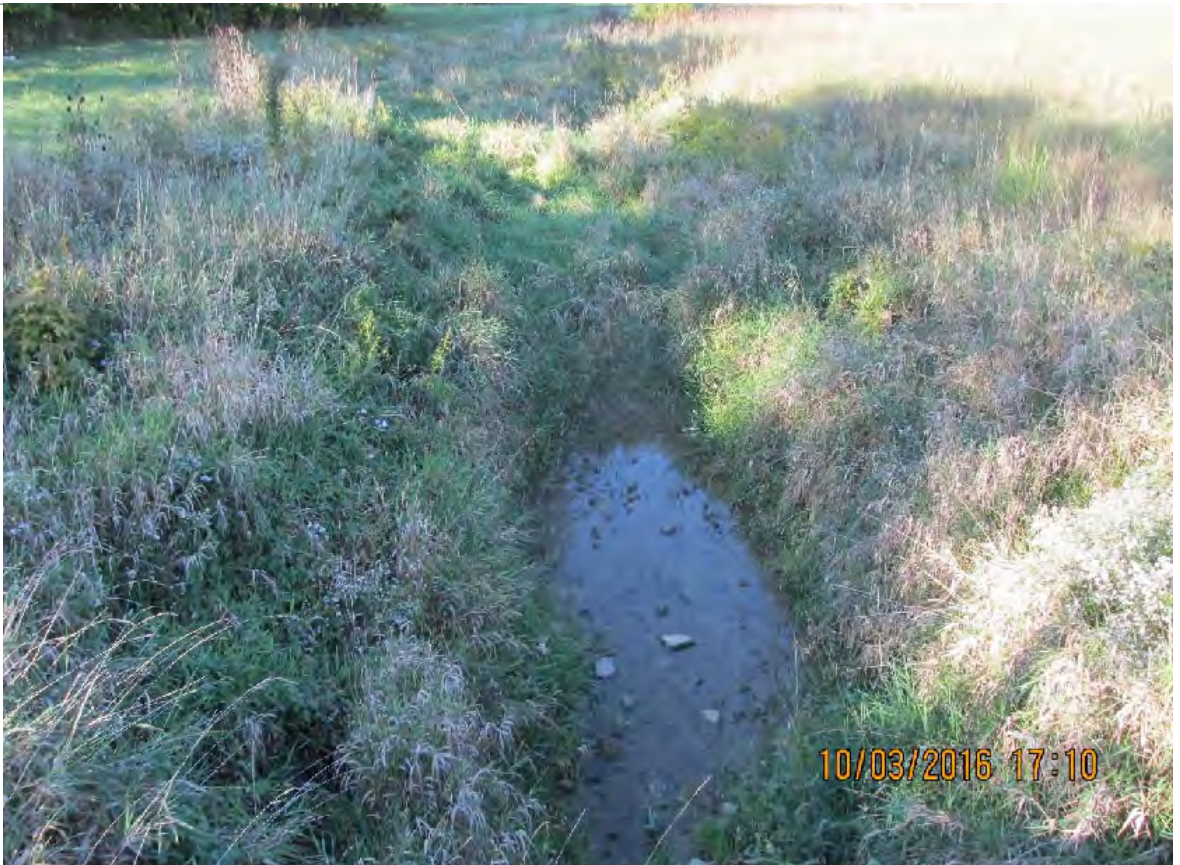
**Photo: Typical Modified Intermittent Waterbody**

**Description:** Photo of ditch DOH-038 which was typical for most intermittent ditches in the Delineation Area. The channel had pockets of standing water throughout its length. Due to the constant mowing of the banks and input from field tile, the waterbody was considered modified. Modified ditches such as this feature often had limited potential for significant biological utilization due to the constant disturbance of the banks.

**DOH-038** is a modified intermittent ditch that meanders through several active cultivated crop areas before crossing under CR 24. The ditch had moderate pooling along its course, but generally no deeper than 6 inches. The banks of the ditch had a narrow riparian buffer of shrubs and trees which provided shade along a portion of the ditch. The mix of substrates and wider bankfull width (approximately 11 feet wide) led to the ditch scoring well on the HHEI, however no QHEI was conducted since it lacks a predominance of pools at least 16 inches deep. Project related activities will likely rely on horizontal directional drilling (HDD) to install collection lines under the waterbody and thus avoid impacts. Due to DOH-038 being identified as a tributary to an identified WOTUS, the feature is considered jurisdictional.

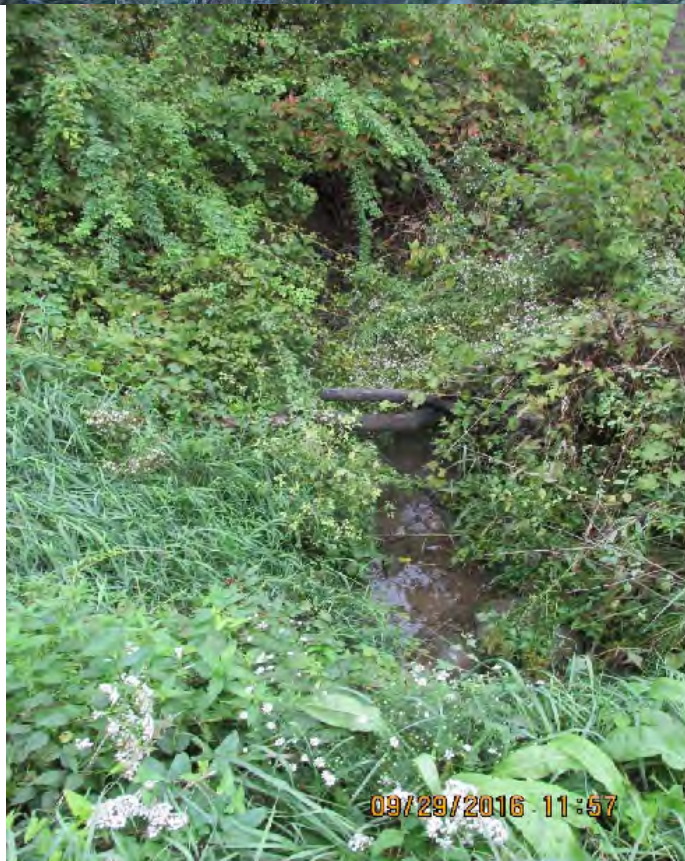
**Photo: Typical Naturalized Intermittent Waterbody**

**Description:** Stream SOH-004 was identified as an intermittent waterbody due to the presence of a defined bed and bank and pockets of standing water. This particular waterbody had signs of recovery from historic modification in the form of mature trees growing along straightened channels. Naturalized intermittent streams were considered to have a higher biological utilization than modified features due to the presence of habitat along the banks.

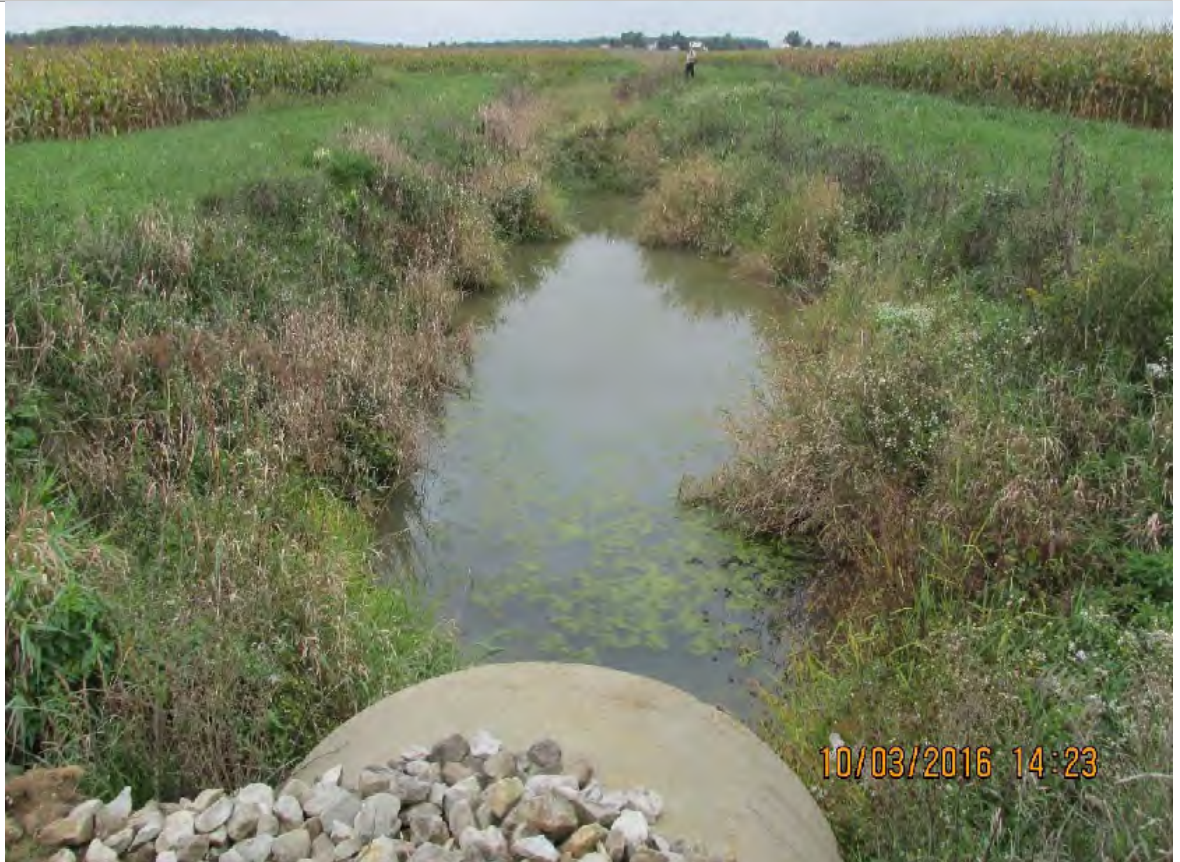
**Description:** Photo of ditch DOH-041 which was typical for most perennial ditches in the Delineation Area. The channel had flowing water throughout approximately 6 inches deep. Due to the constant mowing of the banks and input from field tile, the waterbody was considered modified. Modified ditches such as this feature often had limited potential for significant biological utilization due to the constant disturbance of the banks.

**DOH-041** is a modified perennial ditch located among cultivated crop areas, with a culverted crossing under TR 183. The channel was flowing at the time of the survey, with the deepest pools having approximately 8 inches of water in them. The banks of the channel were primarily grasses and weedy species which appeared to be seasonally mowed. Along the western edge of the ditch within the Survey Area, the buffer area includes a large woodlot that may have several wetlands inside. The depth of the pools and wider dimensions resulted in DOH-041 scoring higher than other agricultural ditches. The surrounding cultivated crop areas and ongoing manipulation of the banks would likely inhibit use by any significant wildlife along much of the waterbody. No QHEI evaluation was conducted since it lacks a predominance of pools at least 16 inches deep. Project related activities will likely rely on HDD to install collection lines under the waterbody and thus avoid impacts. Due to DOH-041 being identified as a tributary to an identified WOTUS, the feature is identified as jurisdictional.

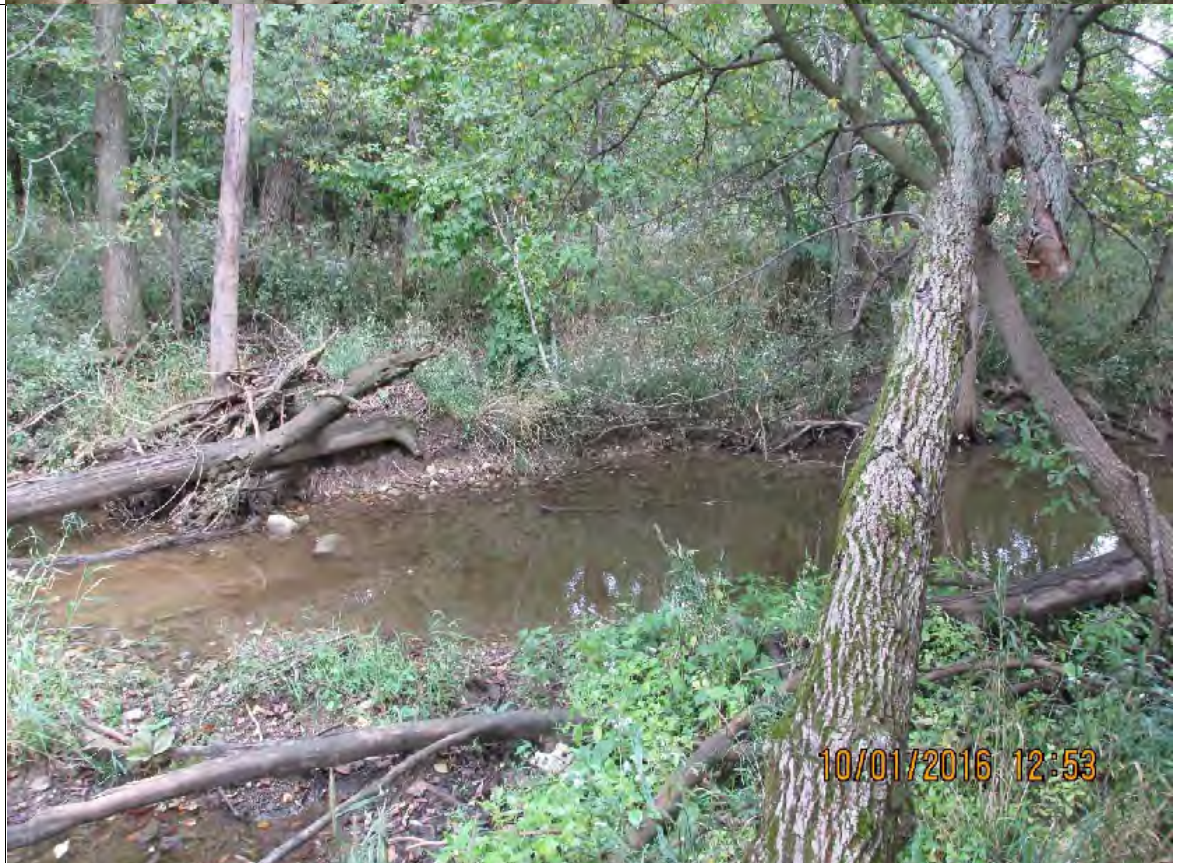
**Photo: Typical Naturalized Perennial Waterbody**

**Description:** Stream SOH-011 was typical of the perennial naturalized streams in the Delineation Area. Such waterbodies had significant flowing water, and often had pools over a foot deep. The naturalized waterbodies had mature trees along the banks which in turn deposited woody debris in the channel. The availability of habitat within the channel and lower levels of disturbance from surrounding landuse meant that the naturalized perennial waterbodies could potentially see high biological utilization.

**SOH-011** is a naturalized perennial stream that flows between two crop areas. The stream has a narrow riparian buffer on both sides with a mix of mature trees and weedy herbaceous species which have migrated in from the edge of the nearby crops. The channel was approximately 12 feet wide and had pools approximately 18 inches deep. The substrate in the channel was a well-balanced mix of cobble, gravel, sand, and silt. During the surveys, a handful of minnow-like fishes were observed in the deeper pools. The complexity of the substrate, wide bankfull width, and depth of pools led the stream to score highly on both the HHEI and QHEI forms. Due to SOH-011 being identified as a tributary to an identified WOTUS, the feature is considered to be jurisdictional.

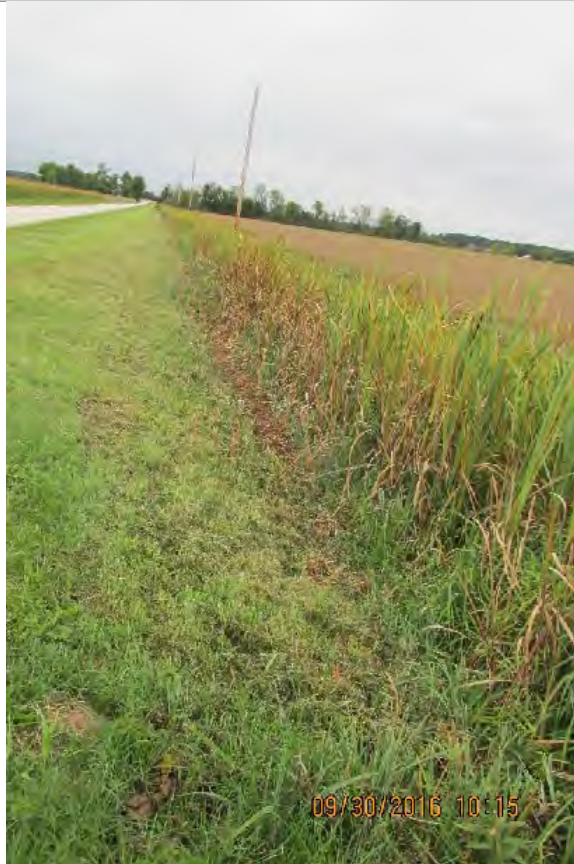
**Photo: Typical Category 1 Wetland**

**Description:** Typical low quality palustrine emergent wetland found in the Delineation Area. This wetland (WOH-002) was located in a small depressional area along a roadside. The presence of invasive narrow leaf cattail (*Typha angustifolia*), lack of buffers from surrounding landuse, and lack of standing water led to the wetland scoring as a Category 1 wetland on the ORAM forms.

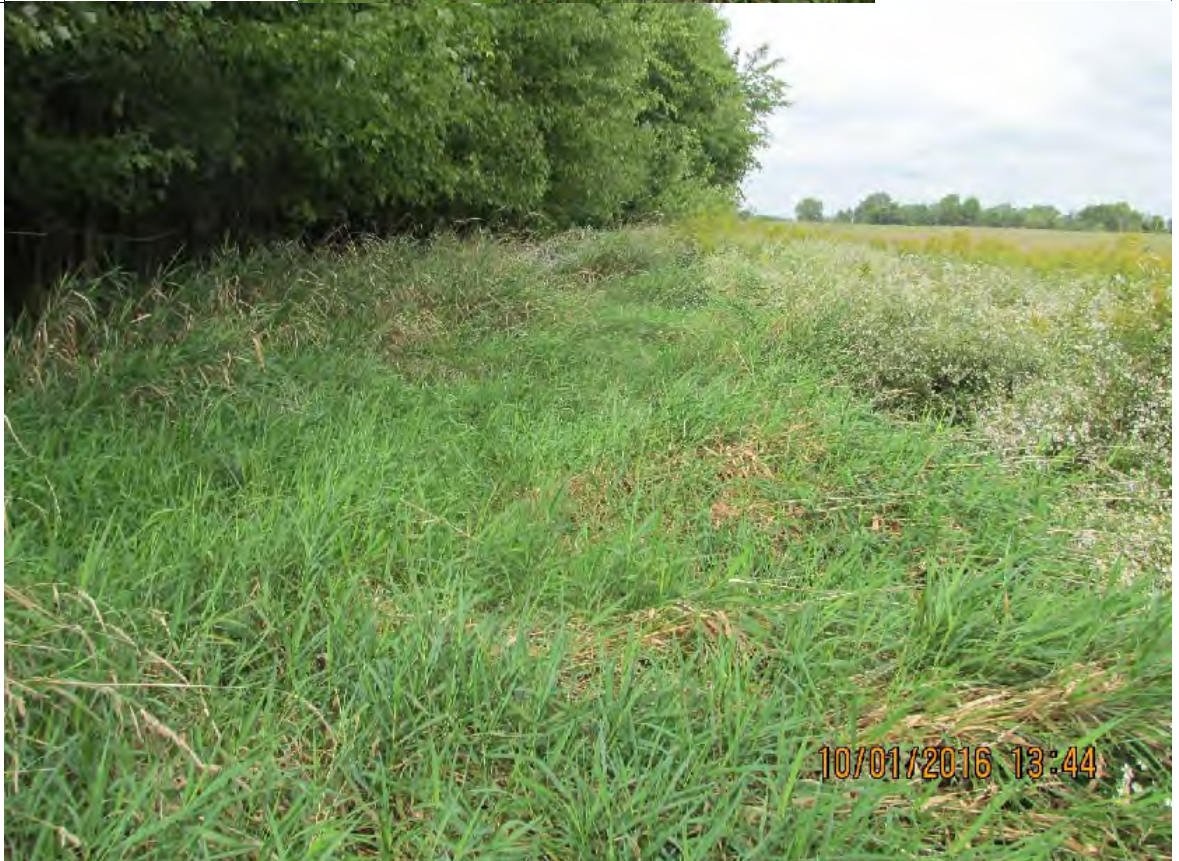
**Photo: Typical Modified Category 2 Wetland**

**Description:** Photo of wetland WOH-003, which was a mix of emergent and forested wetland. Due to the historic modification of the wetland area adjacent to the crop area, the wetland had lost some of its functions. However when scoring on the ORAM form, the forested portion (which extends to the left in the photo) indicated the wetland could increase its score and recover some of its lost functions; which led to it scoring as a Modified Category 2 on the ORAM forms.

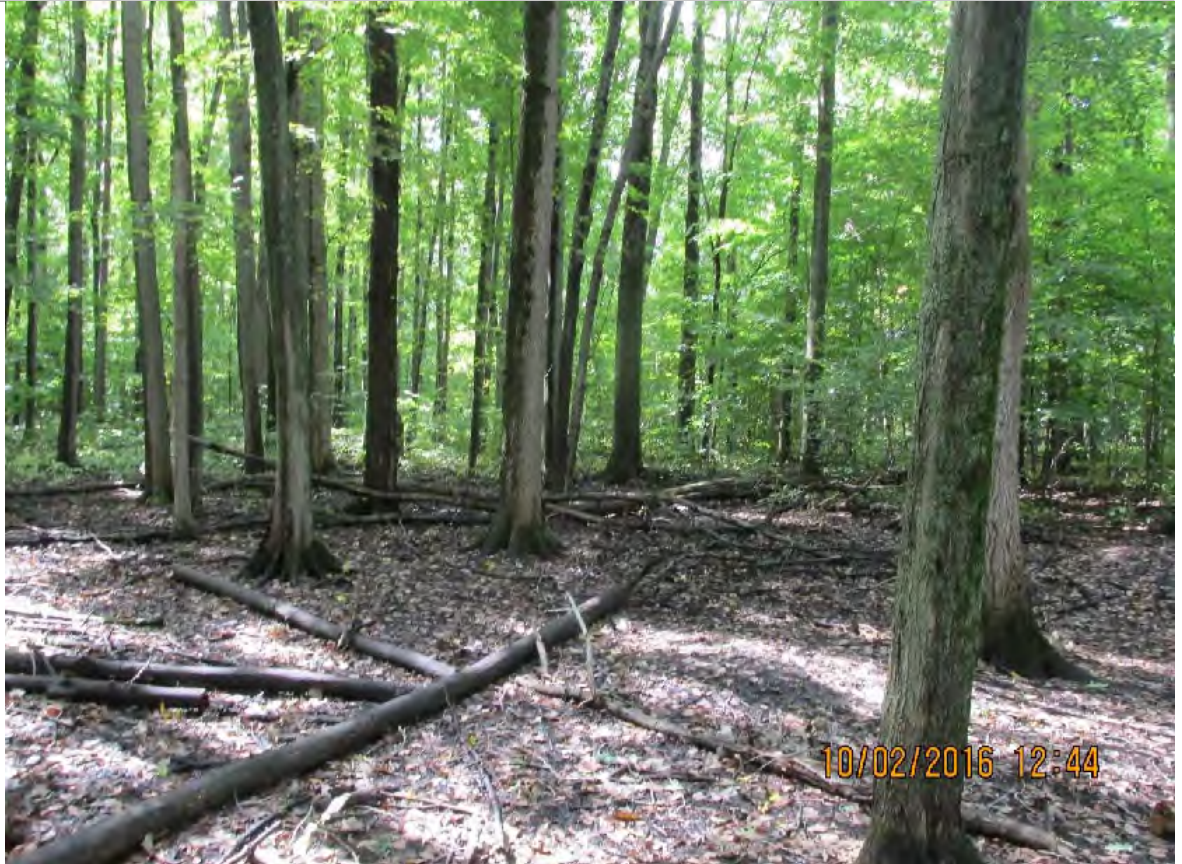
**Photo: Typical Category 2 Wetland**

This wetland was typical of the forested wetlands, which often exhibited sparsely vegetated concave surfaces and root buttressing.

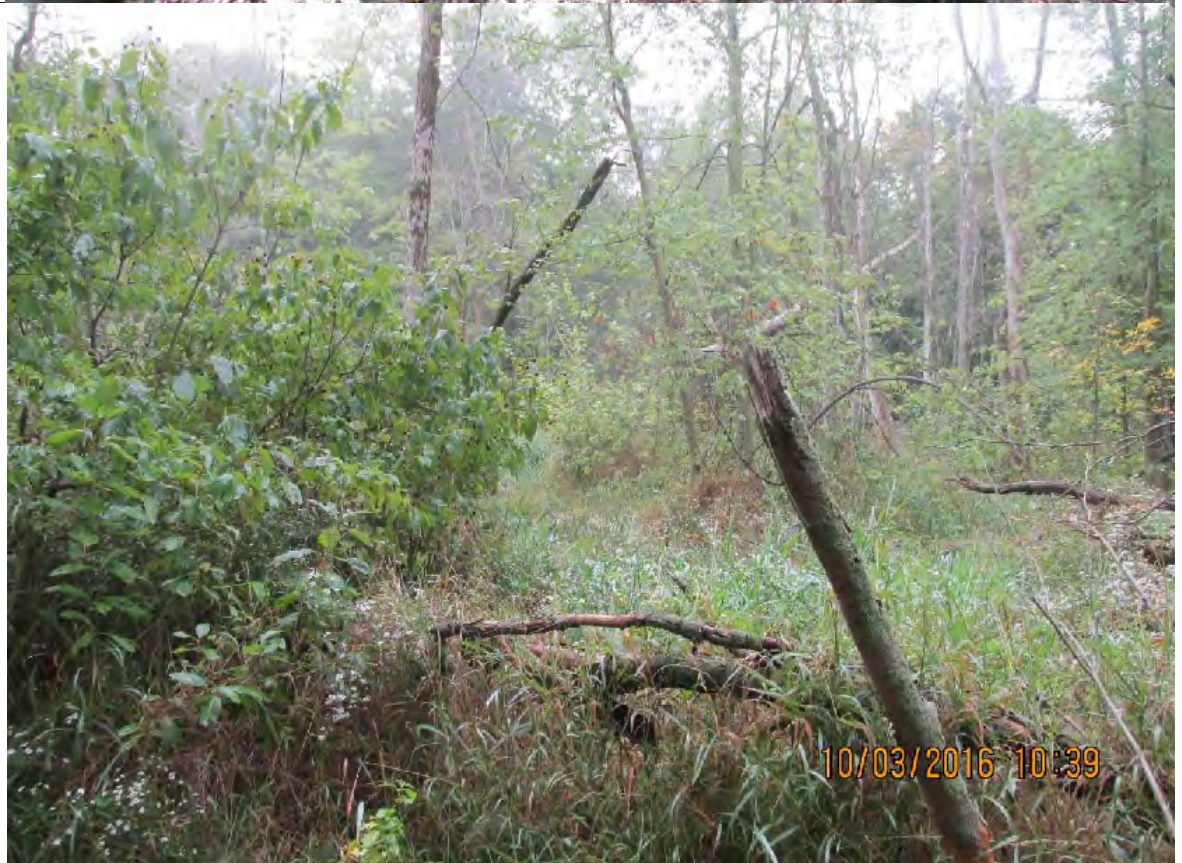
**Photo: Typical Category 3 Wetland**

**Description:** Photo of wetland WOH-008, which was a mix of emergent and forested wetland. The wetland was the largest wetland identified in the Delineation Area. The wetland had a high interspersed vegetation types, high amount of dead standing and woody debris, and was relatively large which led to it scoring highly on the ORAM.

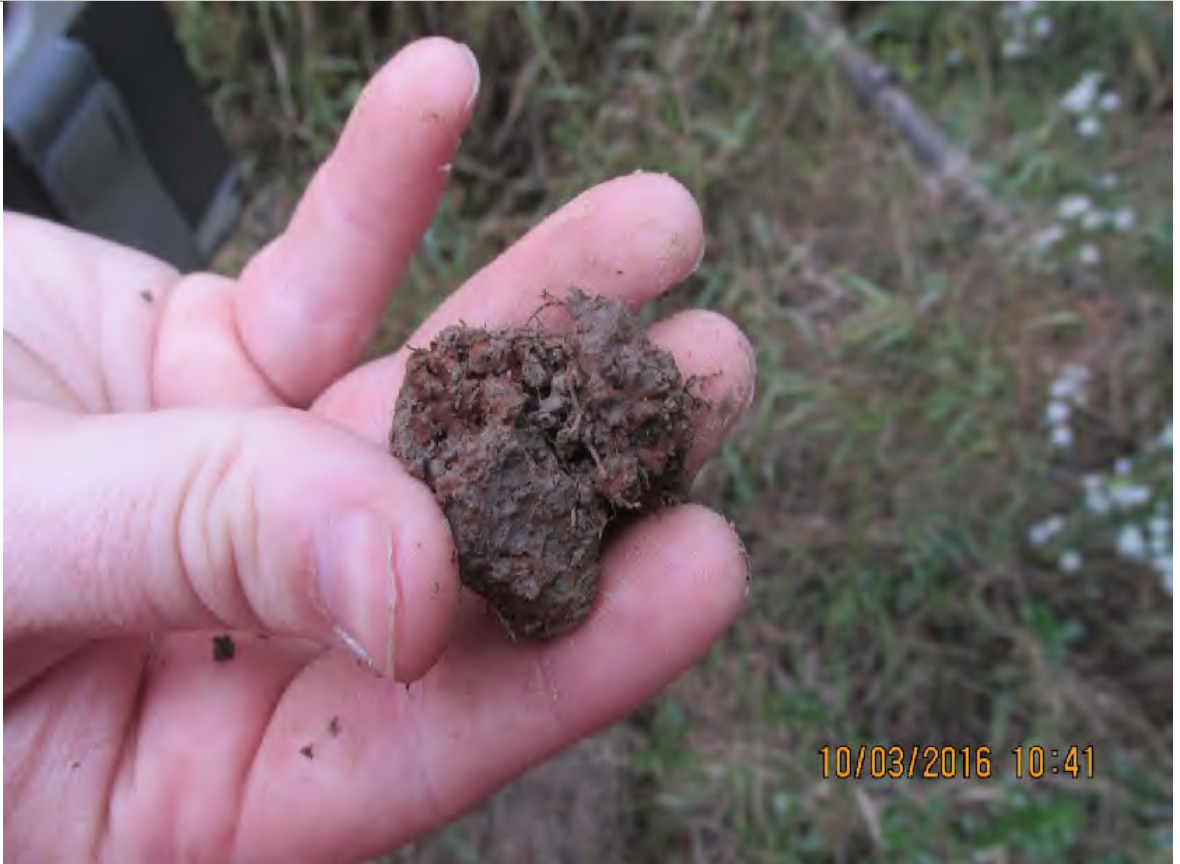
**Photo: Typical Wetland Soils**

Wetland soils often had clay components as well which helped the soils retain water for longer periods.

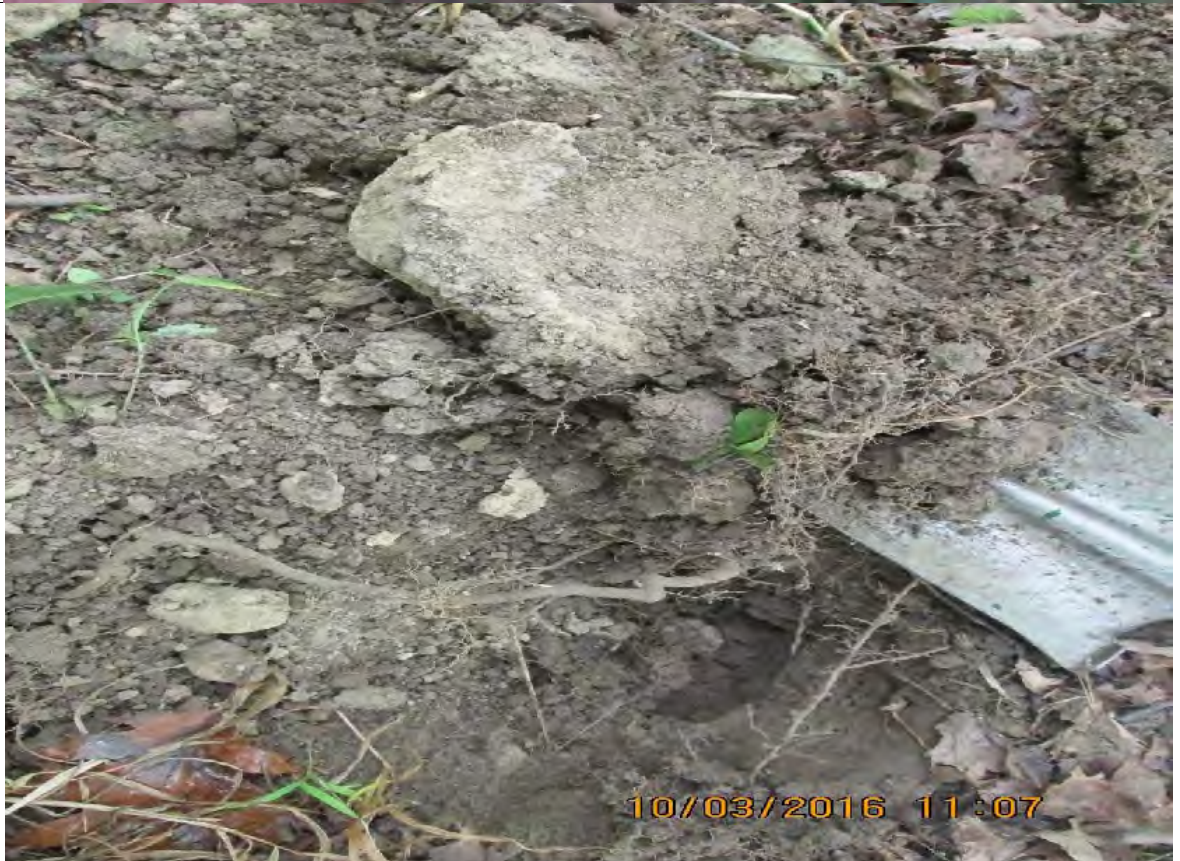
**Photo: Typical Upland Soils**

**Description:** Upland soils in the Delineation Area were often brightly colored dry loams, with minor amounts of clay in the matrix. This composition allowed for water to pass more easily to deeper depths.

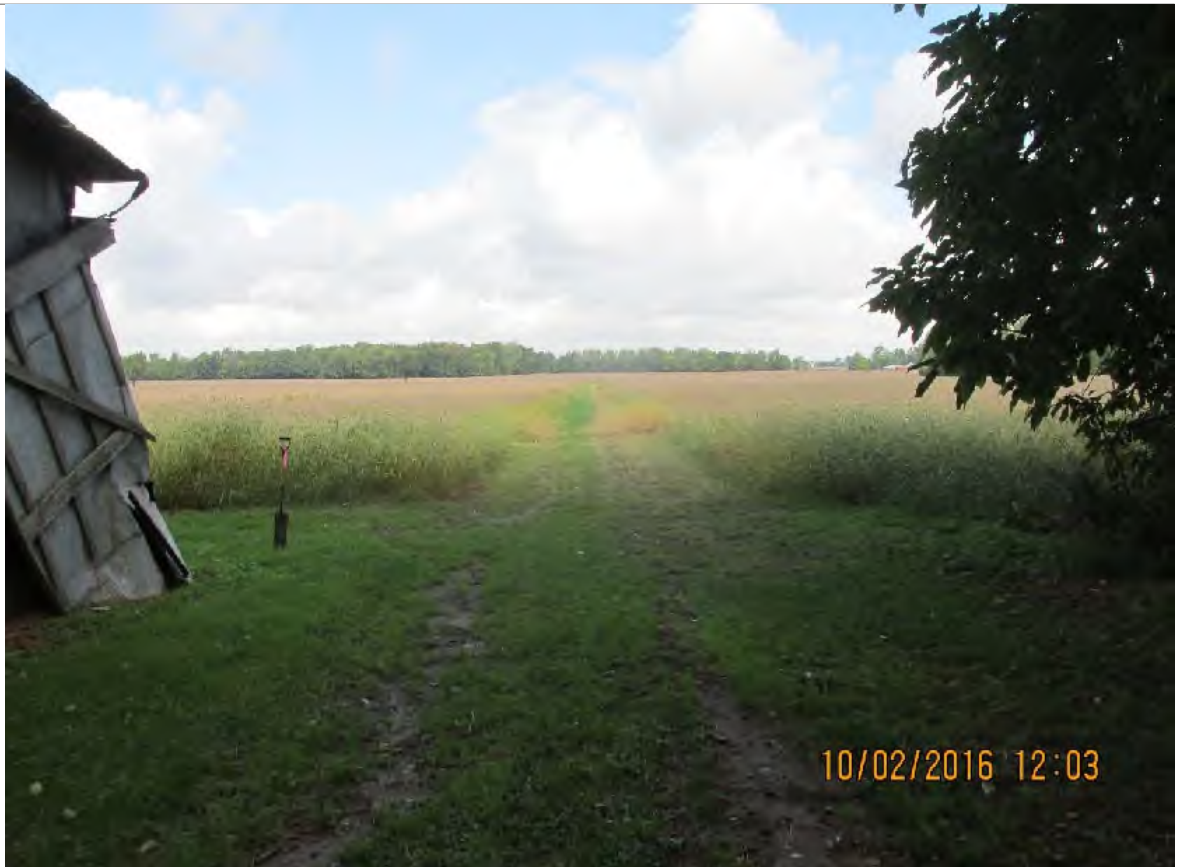
**Photo: Typical Crop Area**

**Description:** many of the crop areas also had grassy swales between fields. These swales were designed to convey stormwater runoff from the fields and into nearby ditches or streams. Due to a lack of identifiable ordinary high water mark and upland vegetation, swales are not considered wetlands or waterbodies.

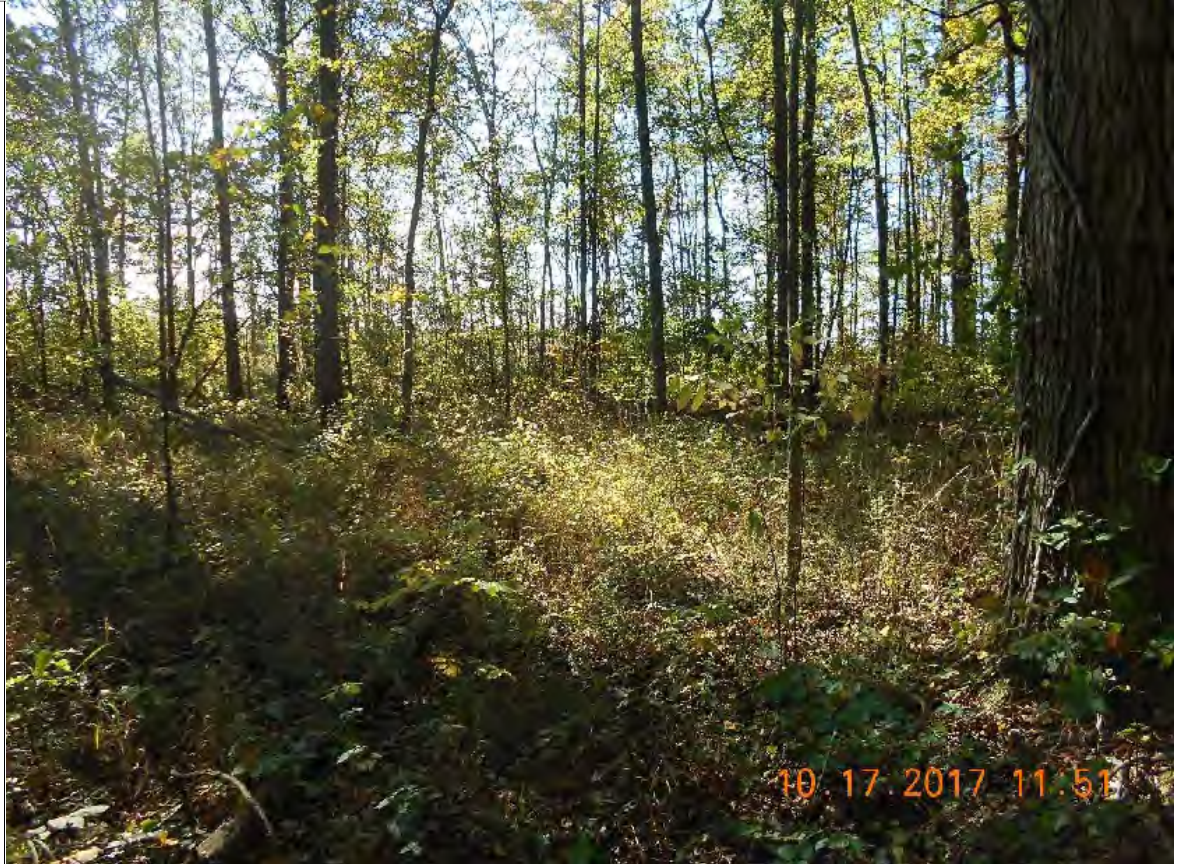
**Photo: Typical Forested Woodlot**

**Description:** The woodlots in the Delineation Area varied in species variety with some woodlots being dominated by American beech (*Fagus grandifolia*), and others a mix of multiple hickory (*Carya* sp.), maples (*Acer* sp.), and oaks (*Quercus* sp.).

Many of the woodlots had evidence of historic logging due to the presence of flat topped tree stumps and overgrown roads.
