Letter of Notification
Darrow Substation Expansion Project
Case No. 19-0585-EL-BLN

**Darrow Substation Expansion Project
Case Number 19-0585-EL-BLN**

WETLAND DELINEATION
AND SURFACE WATER STUDY

FirstEnergy's Darrow Substation Ring Bus Expansion

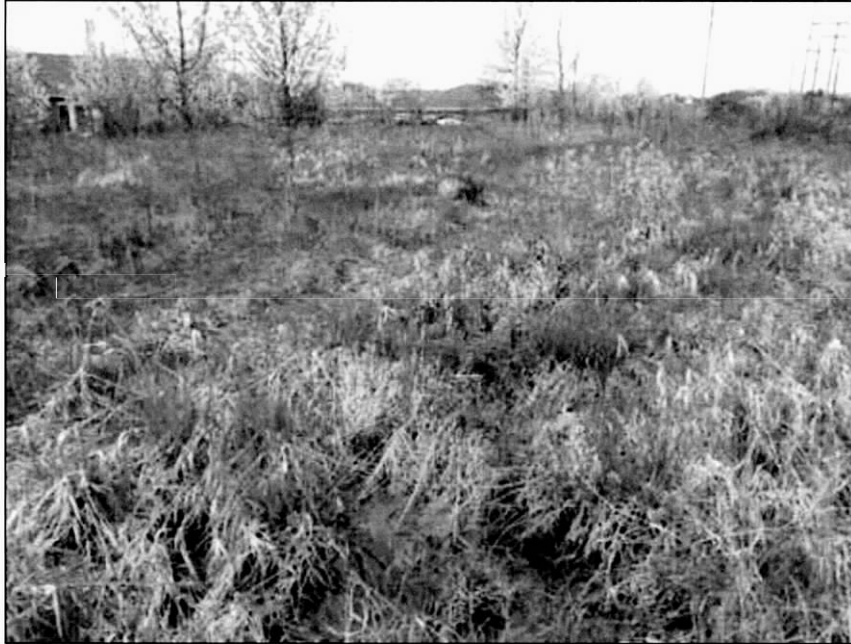
Photograph 1. View facing southwest towards Wetland 0423-01.

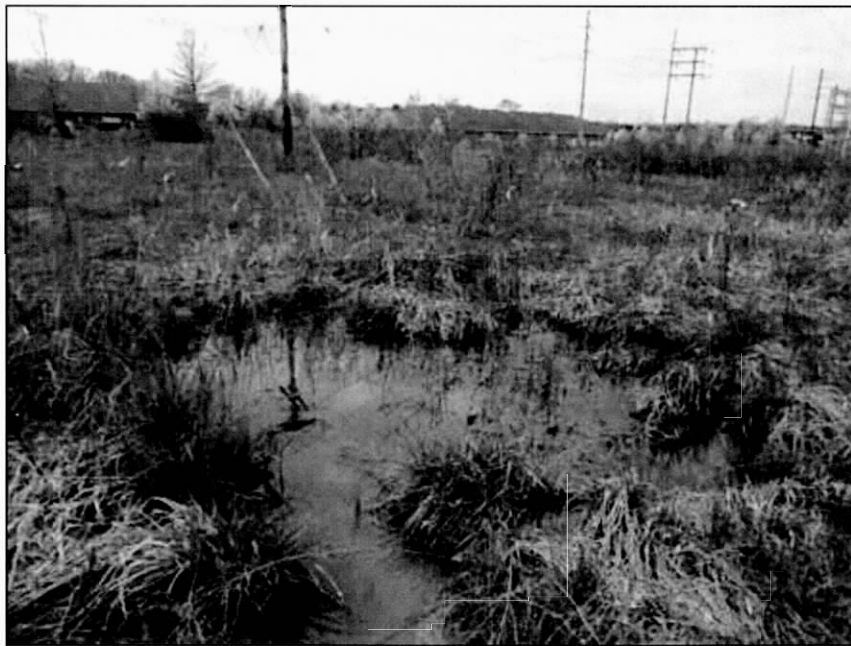
Photograph 2. View facing south towards Wetland 0423-03

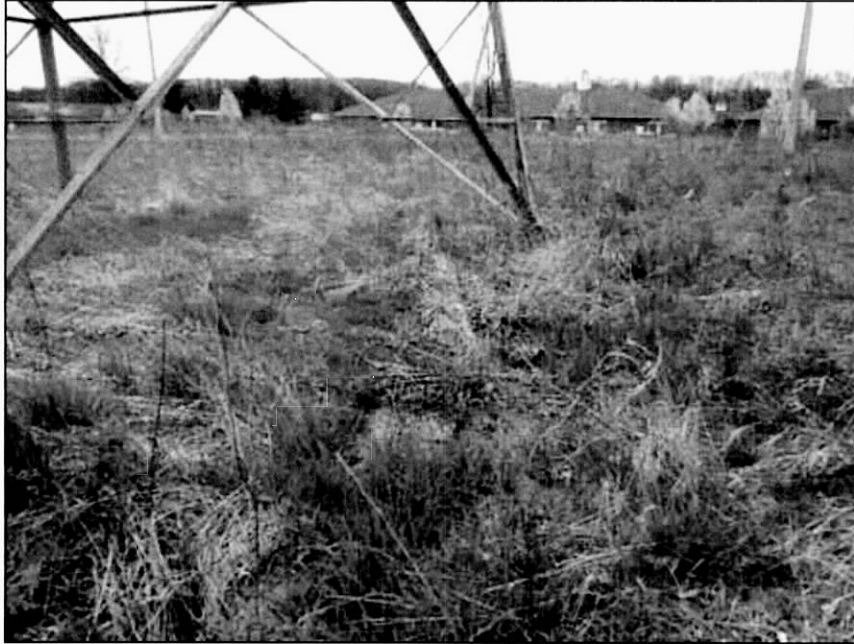
Photograph 3. View facing south towards Wetland 0423-03.

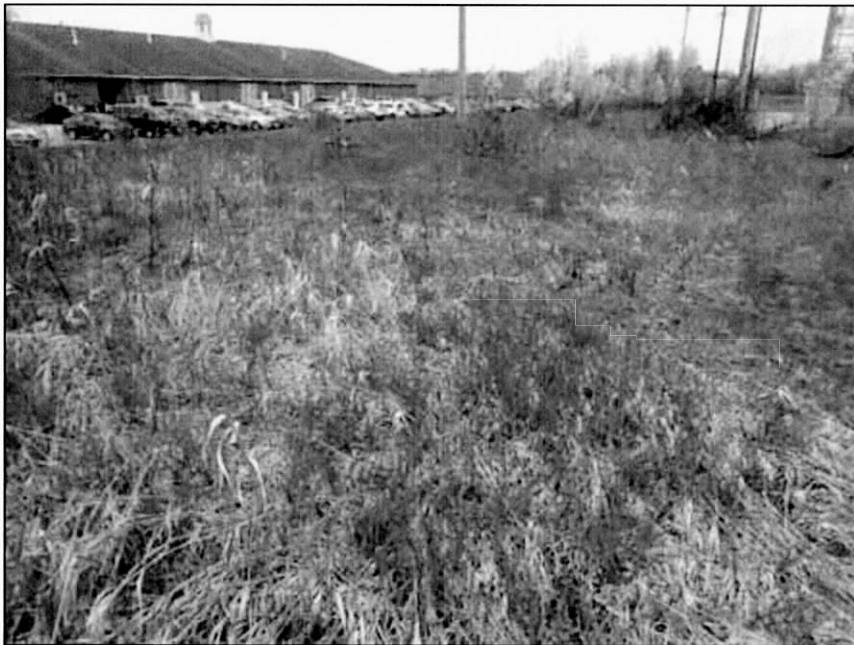
Photograph 4. View facing southwest towards Wetland 0423-05

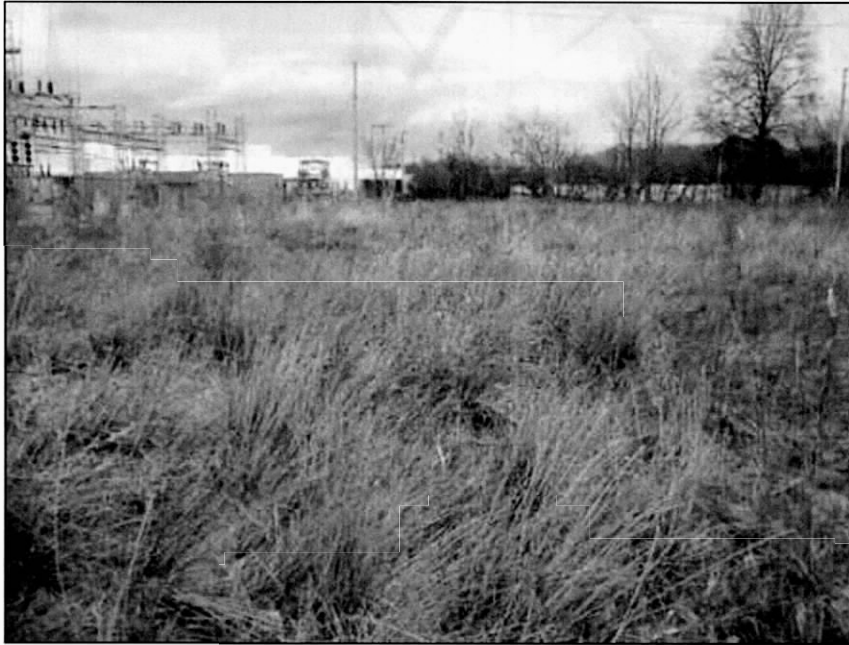
Photograph 5. View facing northwest towards Wetland 0423-07

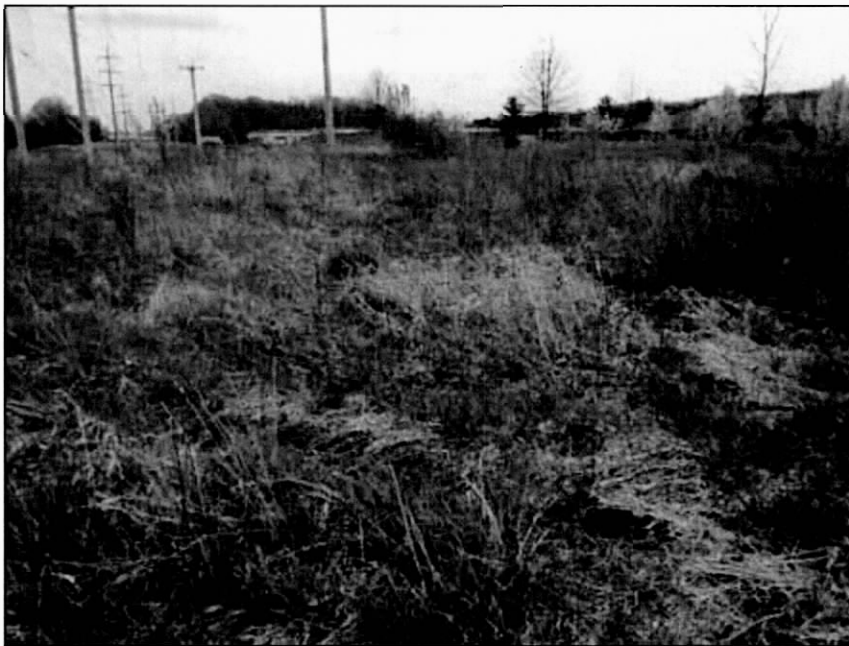
Photograph 6. View facing east towards Wetland 0423-07

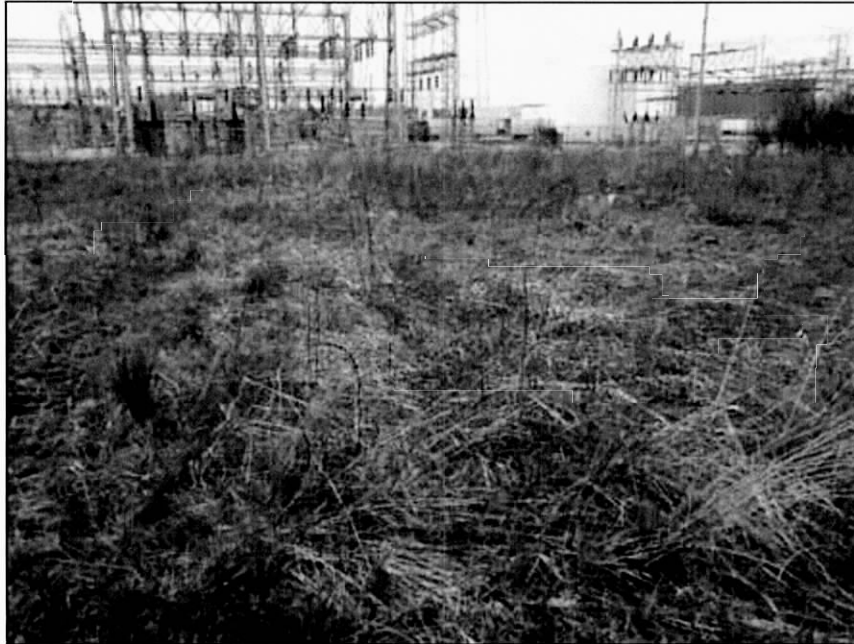
Photograph 7. View facing west towards Wetland 0423-09

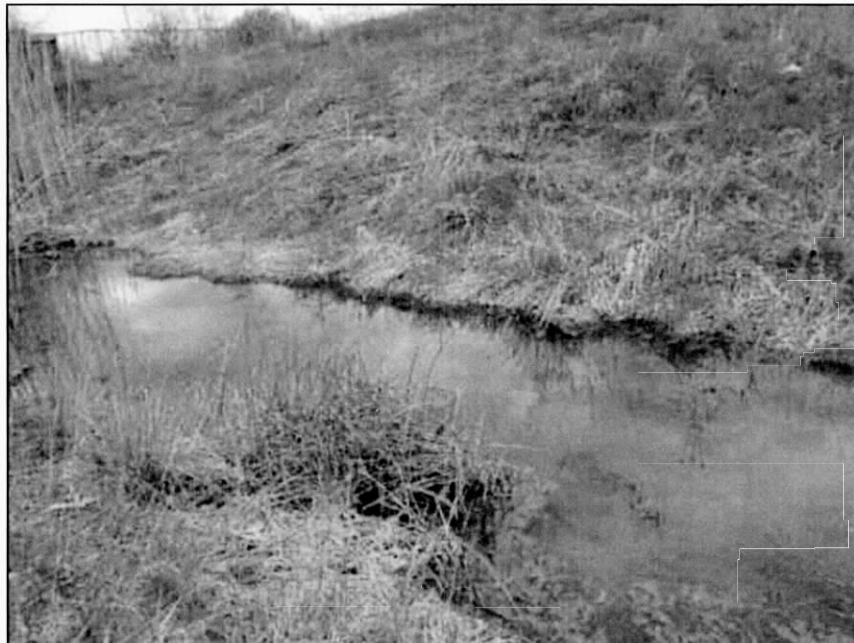
Photograph 8. View facing northwest facing upstream along Stream 0423-04

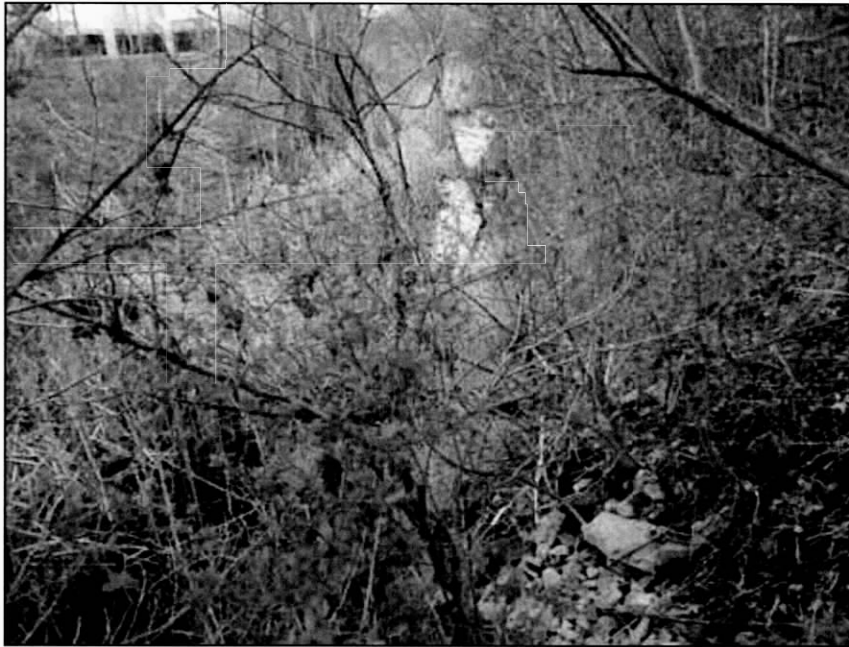
Photograph 9. View facing east facing downstream along Stream 0423-04
