In the Matter of the Application of Hardin Wind Energy LLC for a Certificate of
Environmental Compatibility and Public Need for the Hardin Wind Farm.

**Phase 3 – Compliance with Condition 24, Case No. 09-479-EL-BGN –
Delivery Route Plan**

Hardin County Wind Farm

Road Condition Report

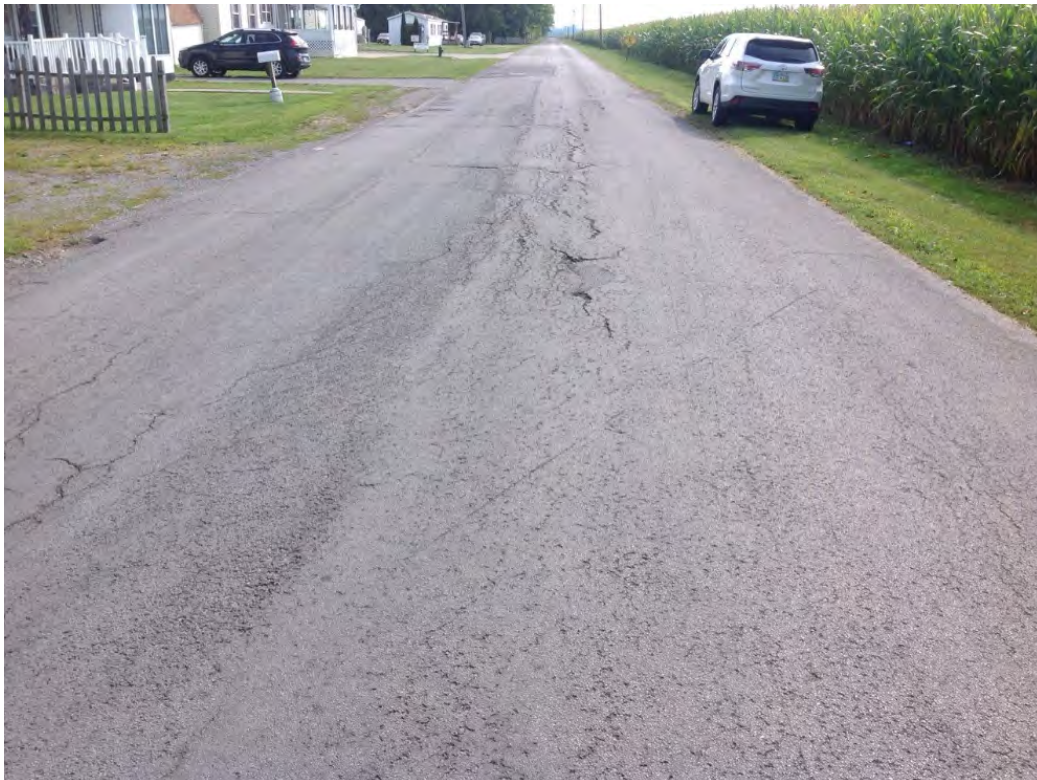
Figure 4-1 TR -92 Section 1

Section 1 was observed in poor condition. The inspected pavement presented several distresses throughout its length such as, alligator cracking, longitudinal and transverse cracking, patching, weathering and raveling, potholes, edge cracking, block cracking, slippage cracking, and bumps and sags. The severity of each distresses observed ranged from low to medium. Figure 4-1 shows examples of these distresses.

SAMPLE UNIT	PCI	RATING
1	11	SERIOUS
2	36	VERY POOR
3	36	VERY POOR
4	48	VERY POOR

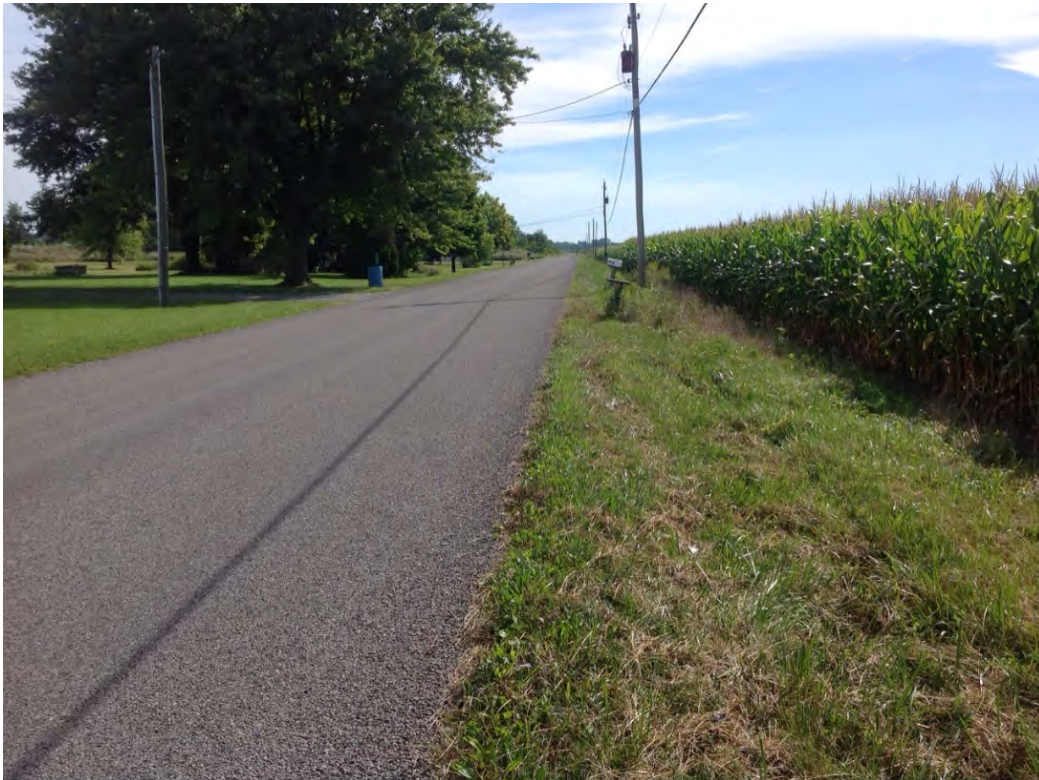
Figure 4-2 TR -92 Section 2

Section 2 was observed with different pavement that the previous sections, newer, homogenous and did not have significant distresses other than slight bleeding towards the center of the road.

SAMPLE UNIT	PCI	RATING
1	98	GOOD
2	92	GOOD
3	87	GOOD

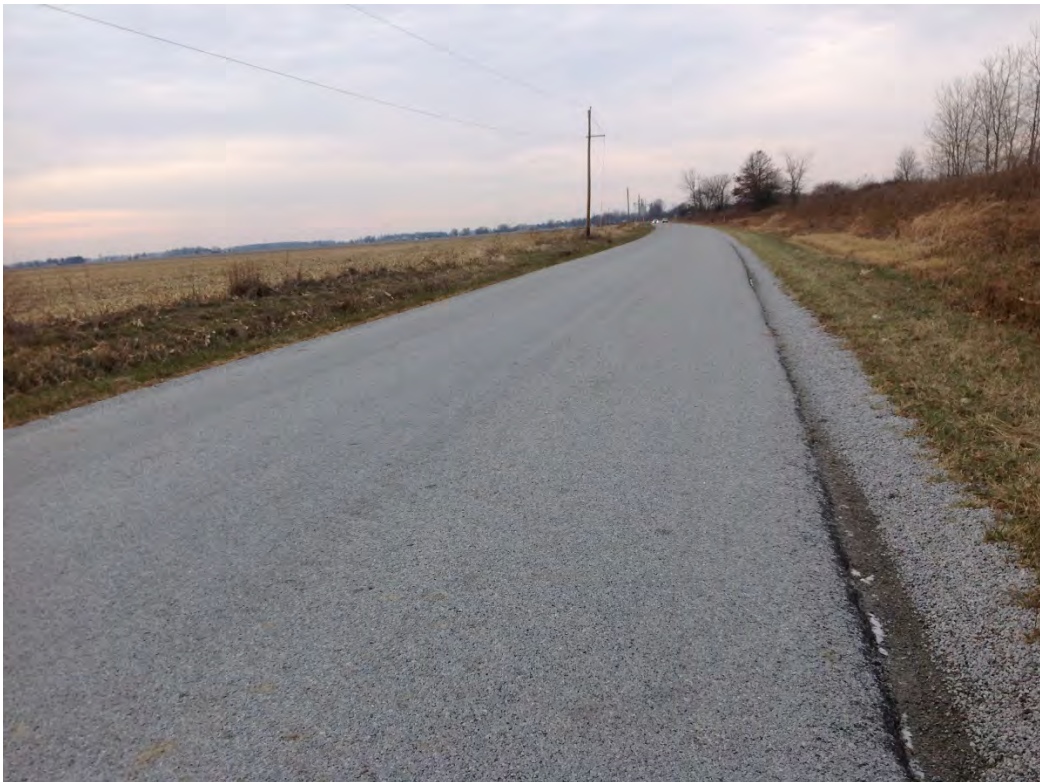
Figure 4-3 TR -92 Section 3

SAMPLE UNIT	PCI	RATING
1	87	GOOD
2	92	GOOD

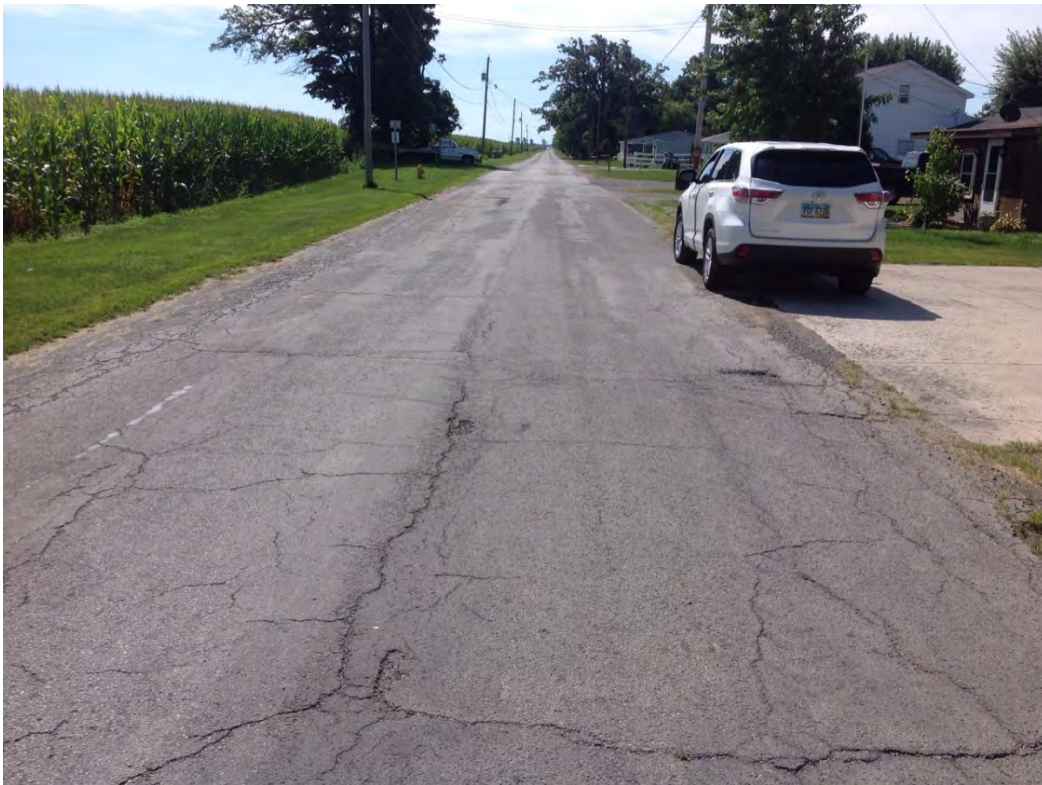
Figure 4-4 CR-35 Section 1

Section 1 was observed in poor condition. Several distresses such as alligator and edge cracking, potholes, longitudinal and transversal cracking, and weathering, were observed in this section. See Table 4-5 and Figure 4-4.

SAMPLE UNIT	PCI	RATING
1	19	SERIOUS
2	39	VERY POOR
3	36	VERY POOR

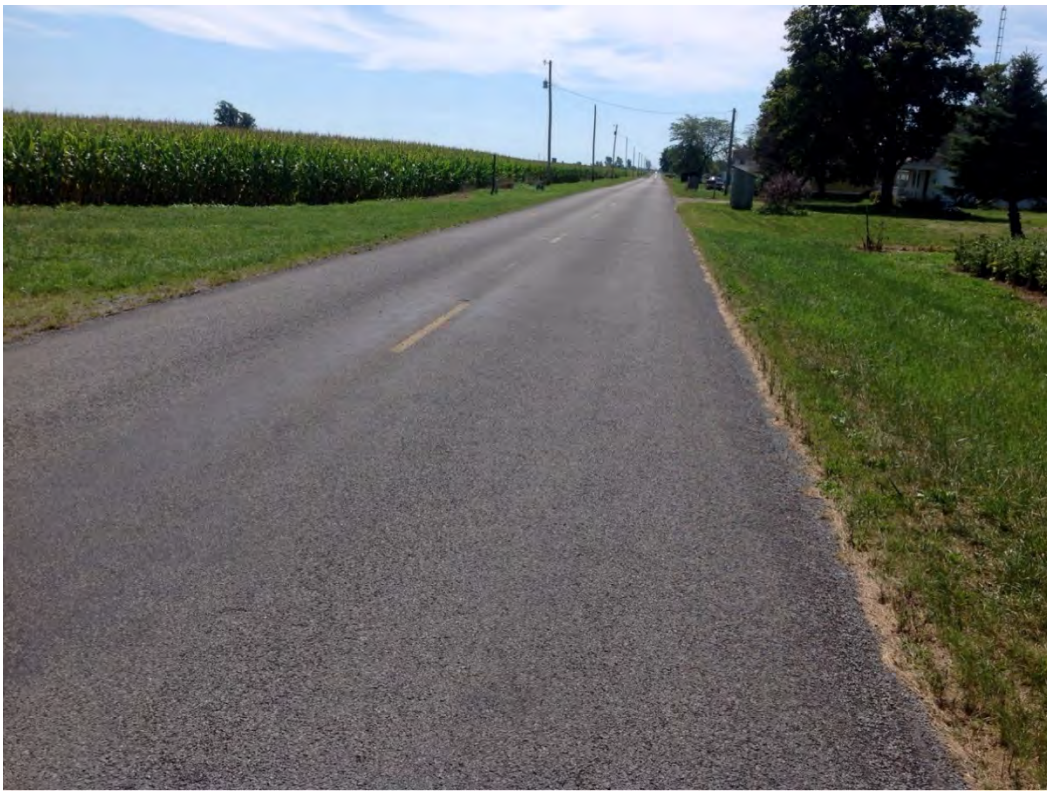
Figure 4-5 CR-35 Section 2

Section 2 was generally in good condition. Low severity bleeding was observed throughout its length with localized depressions.

SAMPLE UNIT	PCI	RATING
1	93	GOOD
2	93	GOOD
3	91	GOOD

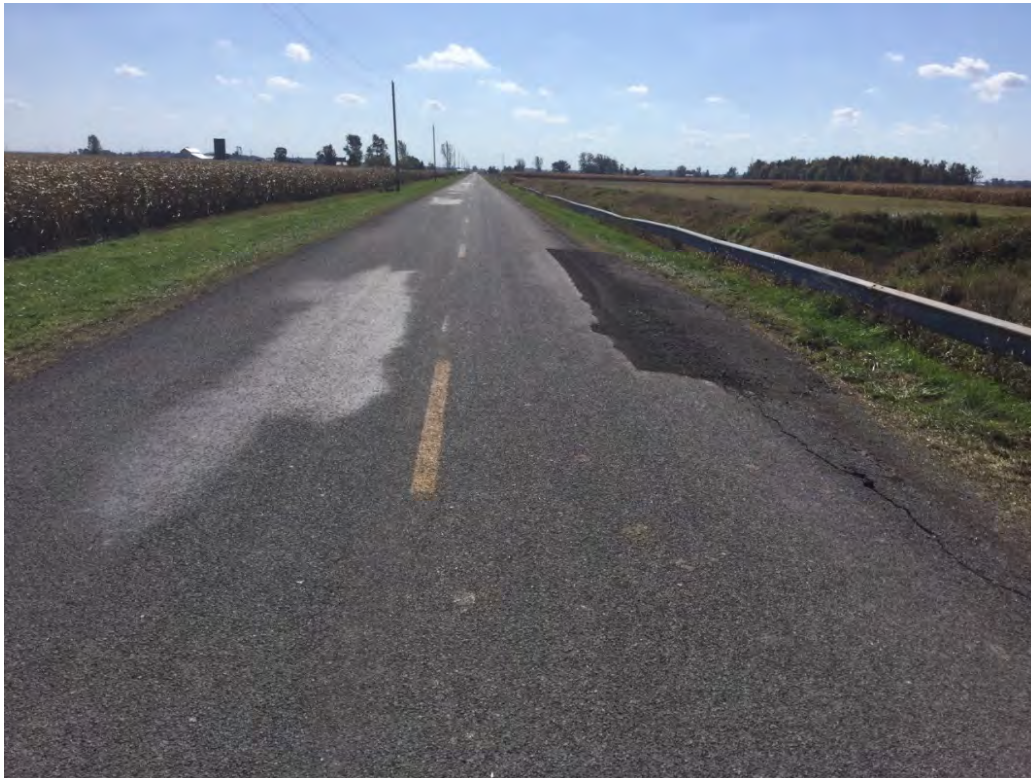
Figure 4-6 CR-35 Section 3

Section 3 was categorized in fair condition. Distresses like edge cracking, bleeding, shoulder drop-off and longitudinal cracking were observed with low to medium severity, however, two sections of the road presented significant loss of asphalt that were filled with aggregate. Weathering and raveling was also observed around these areas.

SAMPLE UNIT	PCI	RATING
1	97	GOOD
2	42	POOR
3	91	GOOD
4	22	SERIOUS
5	84	SATISFACTORY

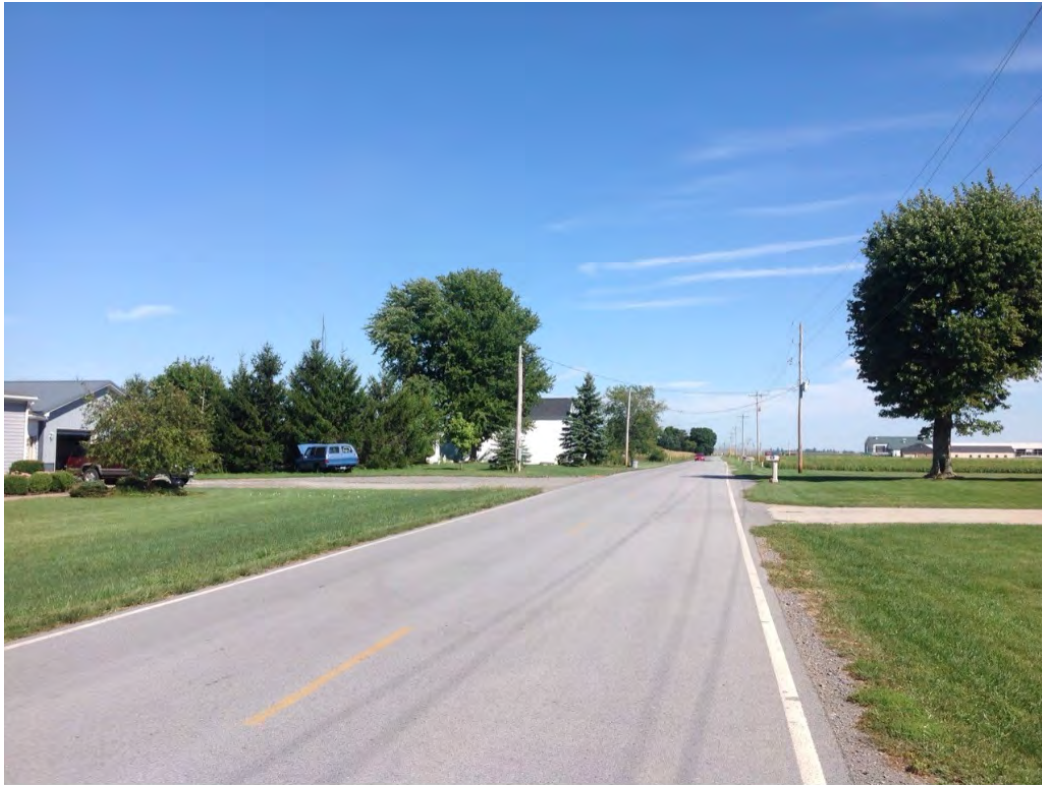
Figure 4-8 CR-110 (West)

CR-110 was inspected from OH-235 to the intersection with access road to turbine 23 and was generally in good condition. Minimal distresses such as shoulder drop-off, sags and bumps were observed, specifically on the bridge at the intersection with CR-35 and at the irrigation ditch crossings by the Van Deurzen Dairy site. Heavy traffic from harvesting activities was observed coming in and out of the Van Deurzen Dairy site, and travelling east on CR-110 to the adjacent fields. During the site visit no significant distresses were observed in this section of road product of the heavy traffic.

SAMPLE UNIT	PCI	RATING
1	97	GOOD
2	97	GOOD

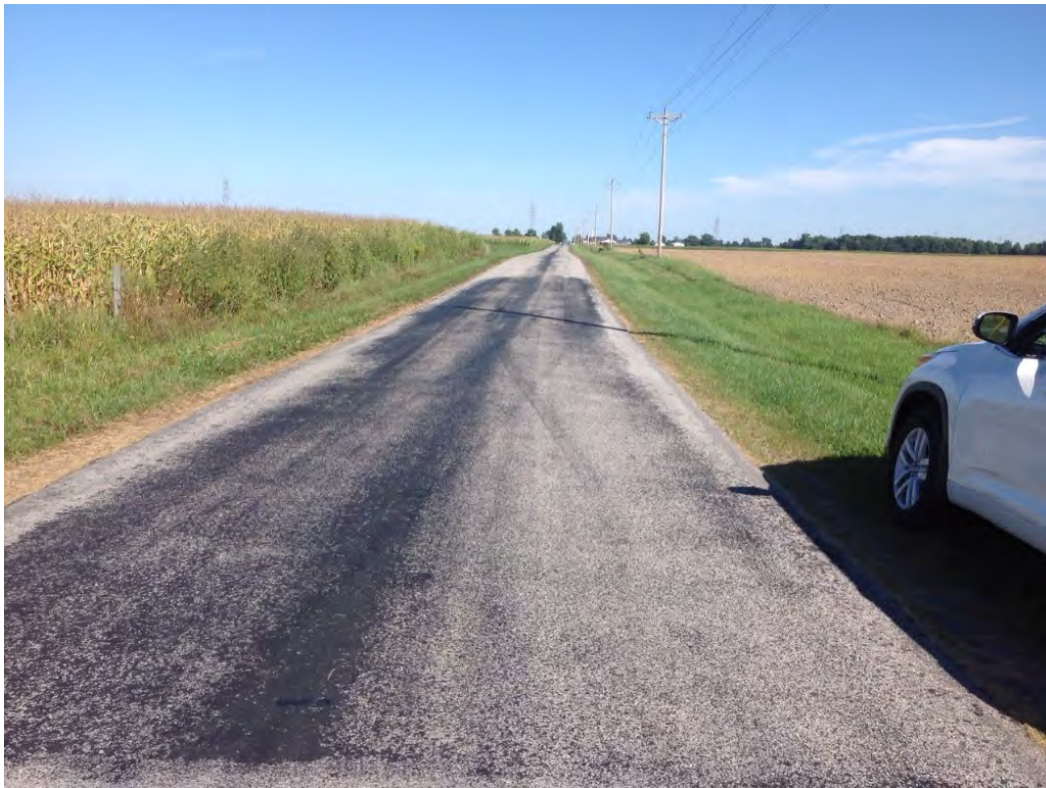
Figure 4-9 TR-120

TR-120 was inspected from the intersection with OH-235 to the intersection with access road to turbine 237 and was observed in good conditions with minimal distresses such as bleeding. Two sample units were selected that are summarized in Table 4-9.

SAMPLE UNIT	PCI	RATING
1	97	GOOD
2	97	GOOD

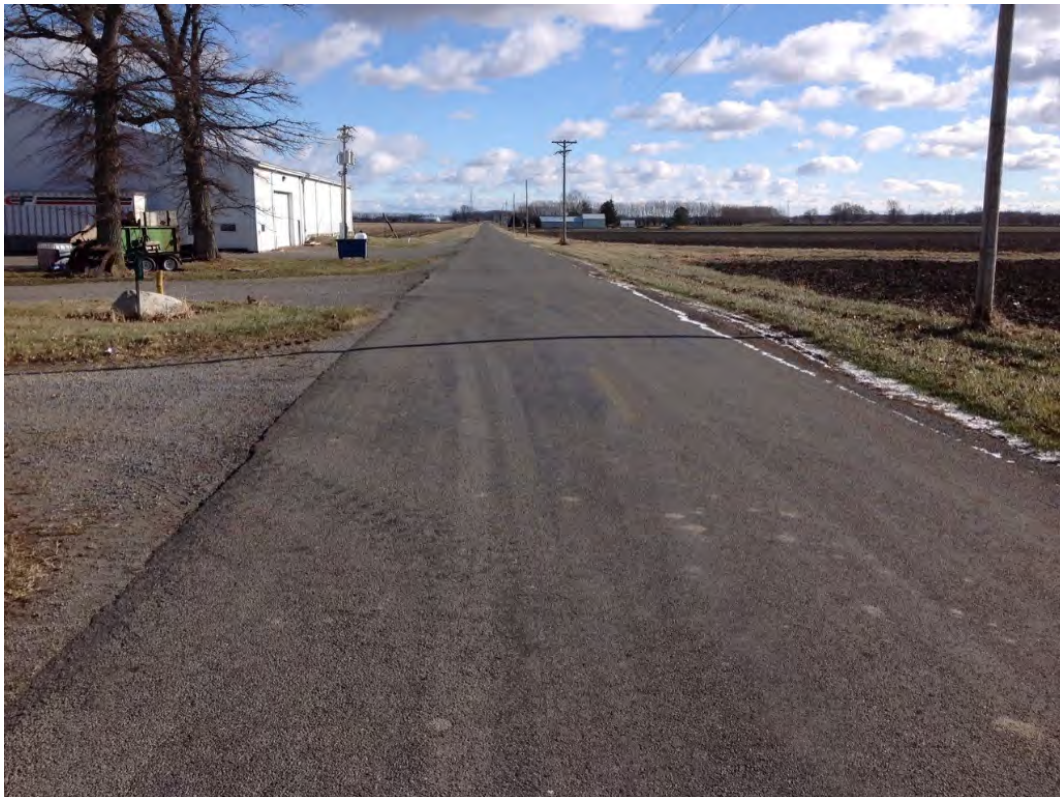
Figure 4-10 CR-130 Section 1

Section 1 conditions were generally good with one fair section due to potholes. Such distresses were mainly classified as low.

SAMPLE UNIT	PCI	RATING
1	86	GOOD
2	64	FAIR
3	88	GOOD
4	93	GOOD

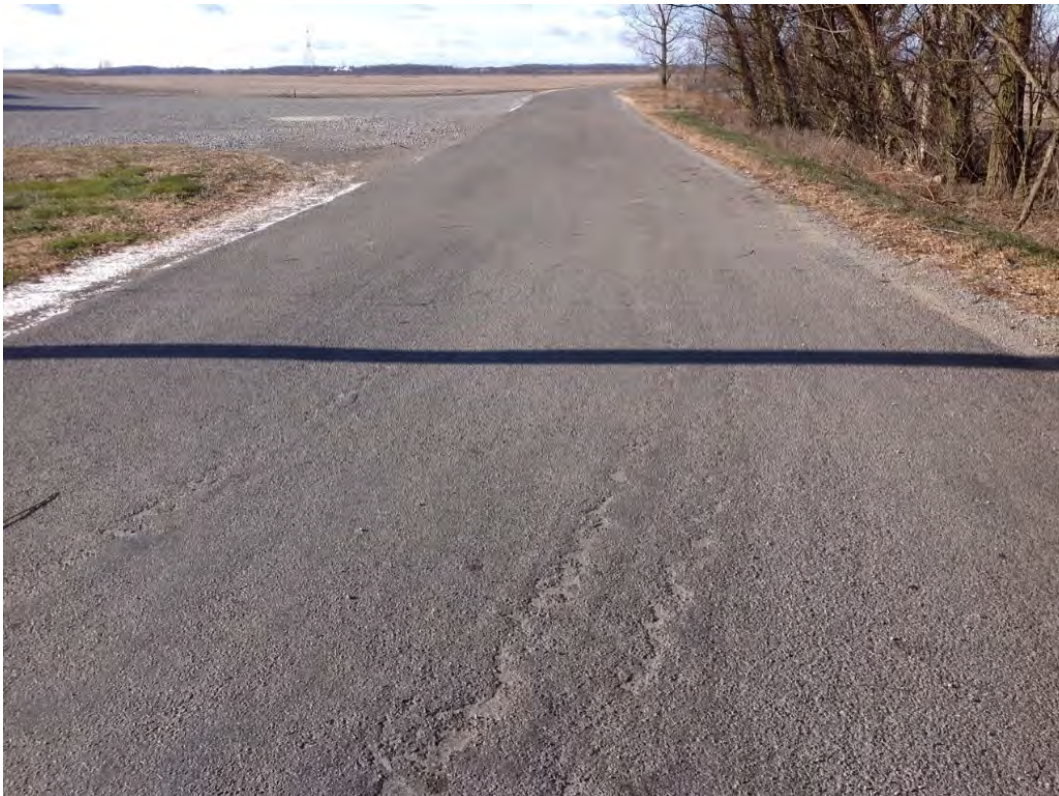
Figure 4-11 CR-130 Section 2

Section 2 road conditions varied along its length from fair to good with the majority of the distresses at the intersections with other roads, bridges or at farm entrances. Such distresses were mainly classified as low, with few areas where the severity was deemed as medium.

SAMPLE UNIT	PCI	RATING
1	76	SATISFACTORY
2	89	GOOD
3	87	GOOD
4	72	SATISFACTORY
5	67	FAIR
6	70	SATISFACTORY
7	64	FAIR
8	68	FAIR

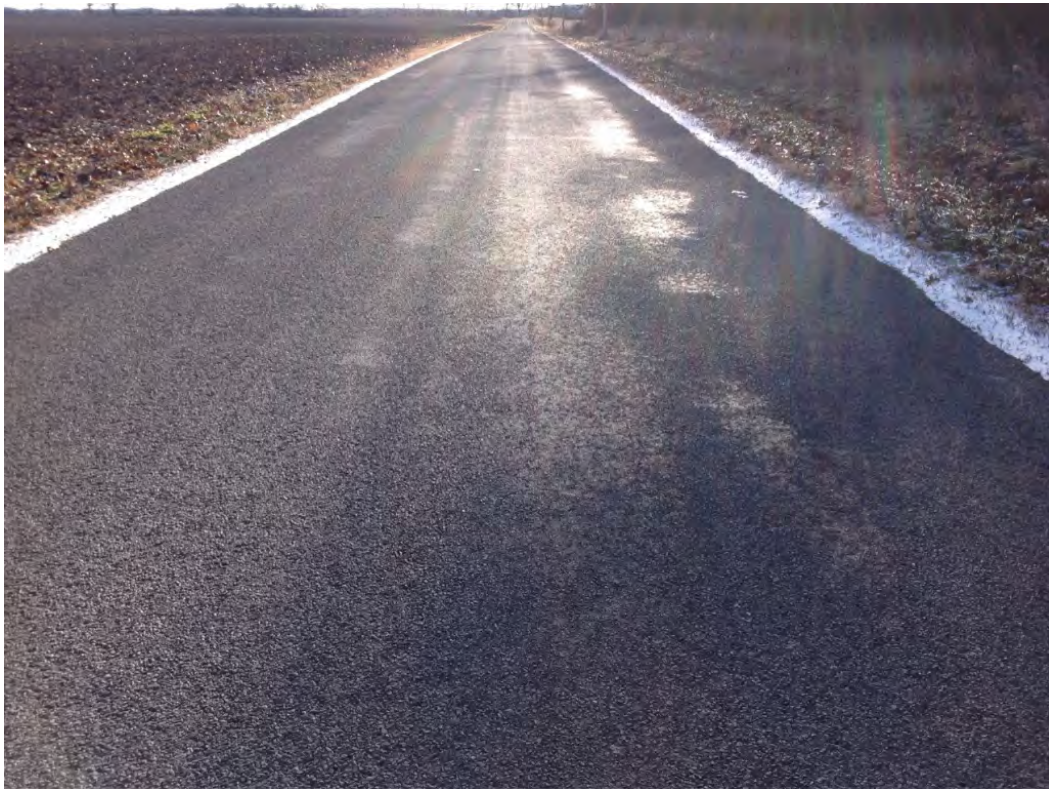
Figure 4-12 CR-130 Section 3

Section 3 road was observed generally in good condition. The pavement has minimal distresses such as bleeding. The road differs from previous sections with a width of 17 feet compared to 20 feet. Two sample units were selected within the section.

SAMPLE UNIT	PCI	RATING
1	90	GOOD
2	93	GOOD

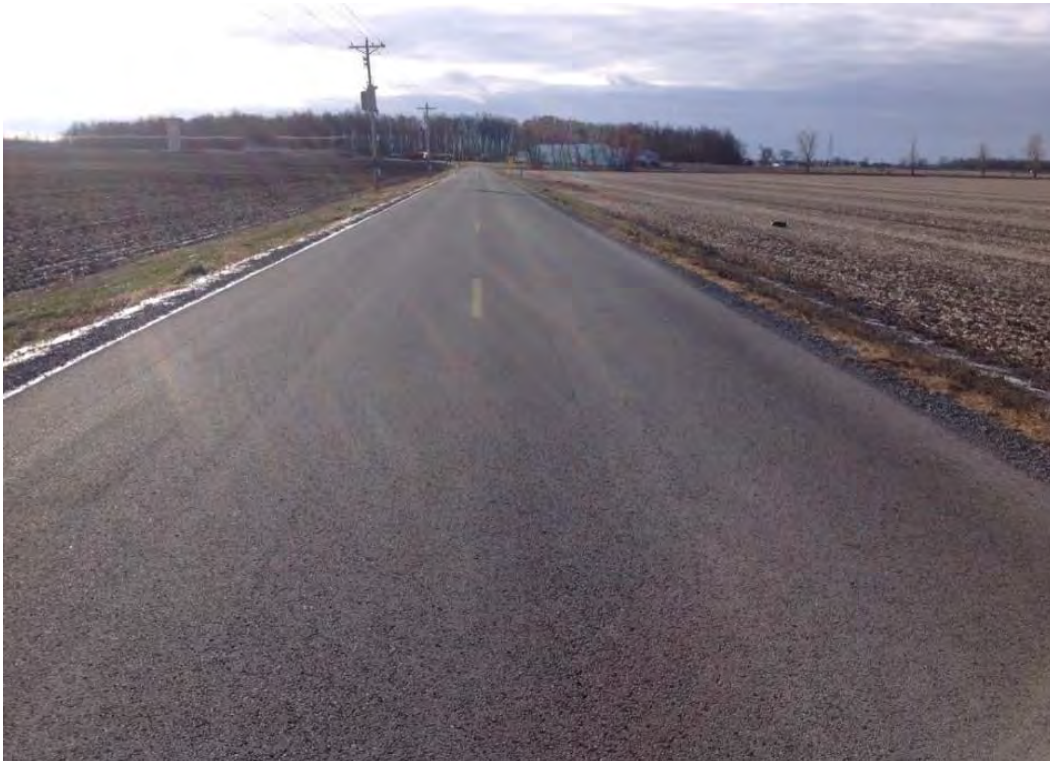
Figure 4-13 CR-65

Approximately 4,530 feet of road were inspected for CR-65, from the intersection with CR-130 to the intersection with the access road of turbine 52. CR-65 was measured at 20-foot wide and was observed in good condition. Low severity distresses such as shoulder drop-off and patching were observed, especially near the intersection with CR-130.

SAMPLE UNIT	PCI	RATING
1	87	GOOD
2	87	GOOD
3	86	GOOD

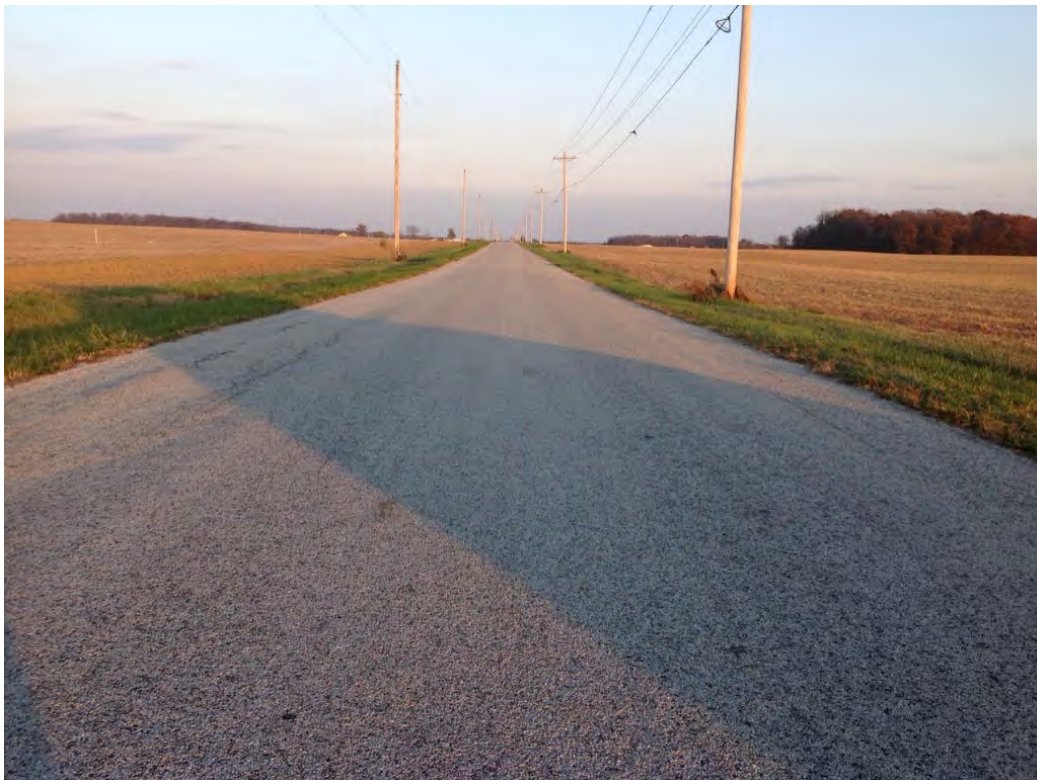
Figure 4-14 TR -90

TR-90 was inspected from TR-105 to the intersection with access road to turbine 114. It was observed in satisfactory condition with low severity distresses throughout its length. One of the sample units with a low PCI index due to shoving in the road.

SAMPLE UNIT	PCI	RATING
1	FAIR	57
2	SATISFACTORY	70
3	GOOD	87
4	SATISFACTORY	77

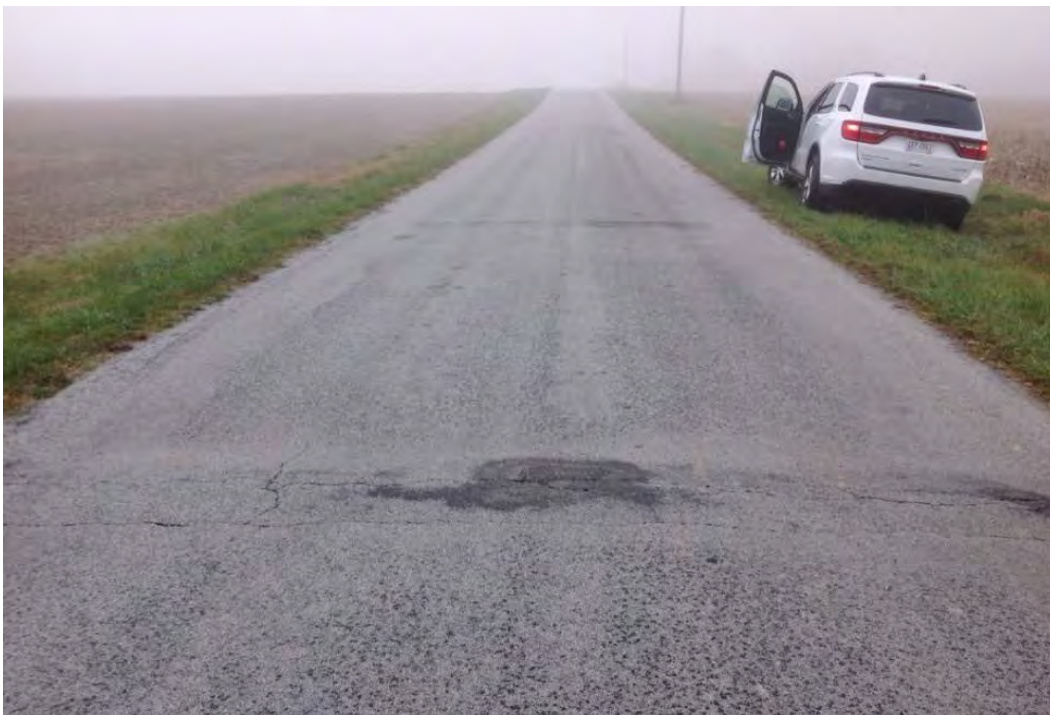
Figure 4-15 TR-105 Section 1 – Sample 2

The rating for Section 1 was found as fair. Even though the general condition of the road was observed to be satisfactory, the sample units analyzed presented several distresses that lowered the rating. Distresses such as utility patching, alligator cracking and longitudinal cracking were observed along culverts that crossed the road. The measurements taken at these areas contributed to the lower rating (See Figure 4-15 and Figure 4-16).

SAMPLE UNIT	PCI	RATING
1	97	GOOD
2	73	SATISFACTORY
3	52	POOR
4	35	VERY POOR
5	68	FAIR

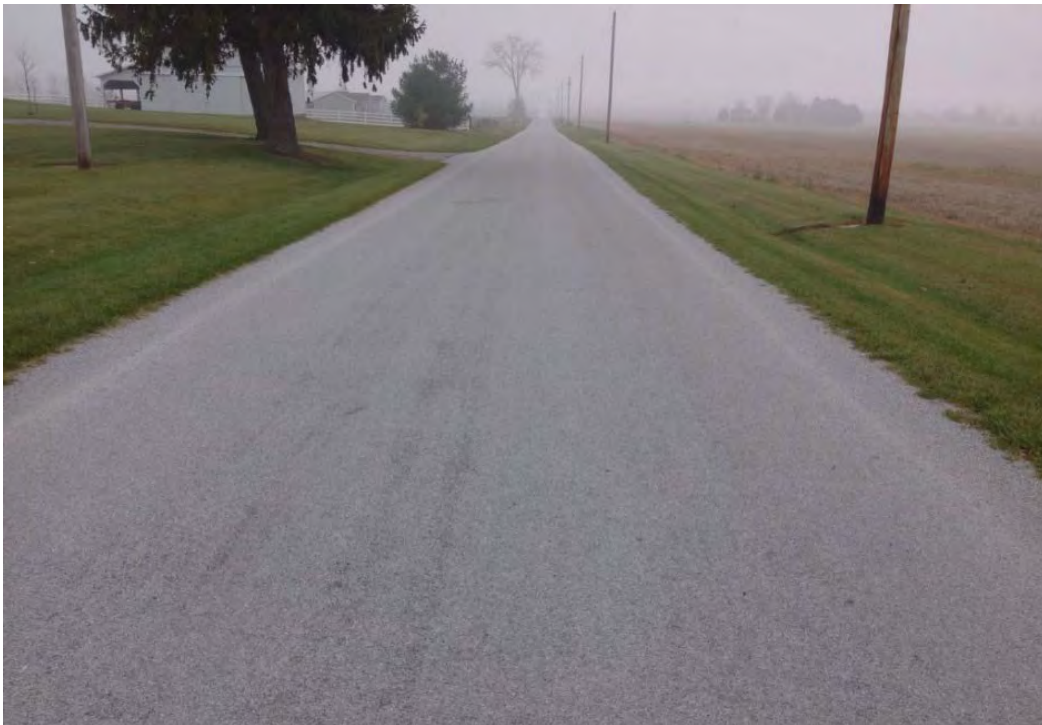
Figure 4-17 TR-105 Section 2

Section 2 had a bituminous surface treatment that appeared to be applied recently. No major distresses to note were observed during the site visit.

SAMPLE UNIT	PCI	RATING
1	99	GOOD
2	99	GOOD

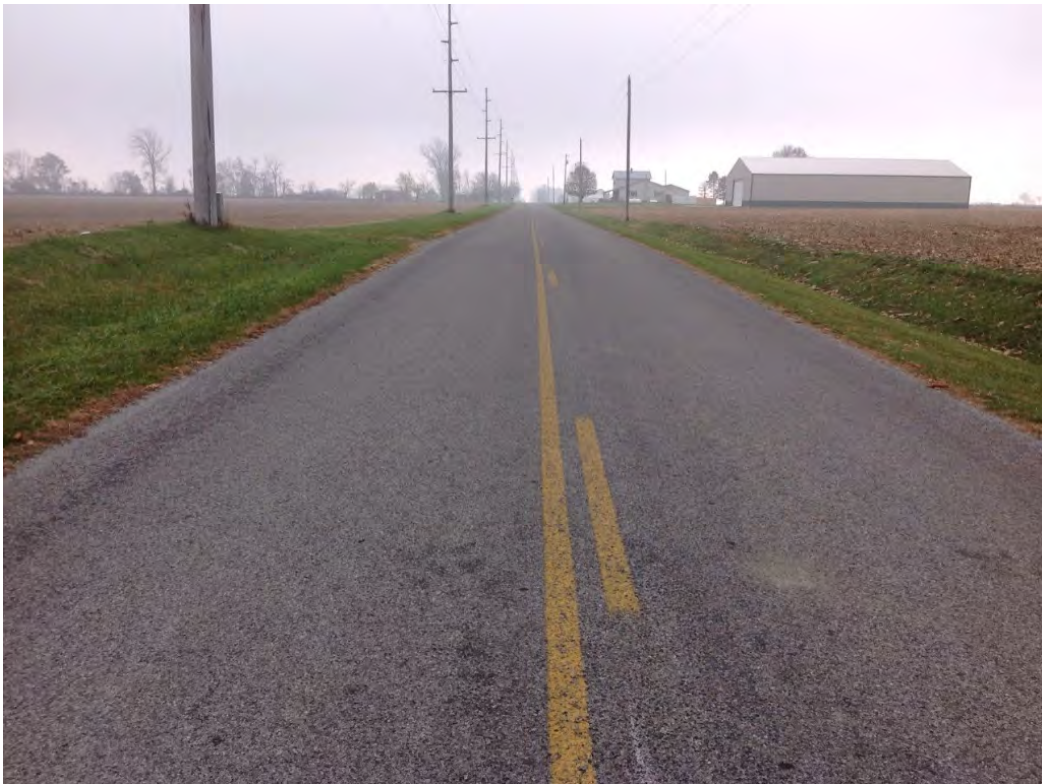
Figure 4-18 CR-115

CR-115 was inspected from the intersection with access road to turbine 116 to the intersection with OH-309. This road was rated in good conditions due to minimal distresses observed such as bleeding, edge cracking, longitudinal cracking and shoulder drop-off.

SAMPLE UNIT	PCI	RATING
1	99	GOOD
2	97	GOOD
3	92	GOOD

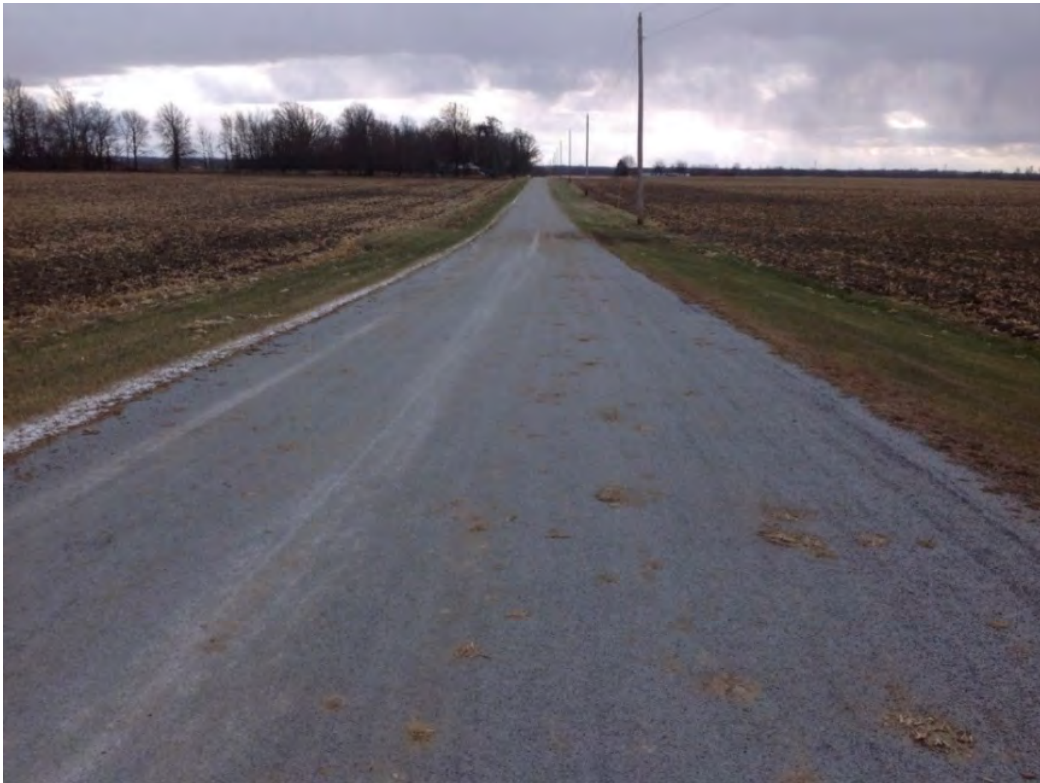
Figure 4-19 TR-85

TR-85 was inspected from OH-309 to CR-90. The road transitions from a 17 foot road to a 15 foot road approximately 100 feet south of the intersection with OH-309. The road appeared to have been rehabilitated recently and minor distresses were observed, especially near the entrance to the property on the east side of the road and towards the intersection with CR-90. This road was rated satisfactory.

SAMPLE UNIT	PCI	RATING
1	80	SATISFACTORY

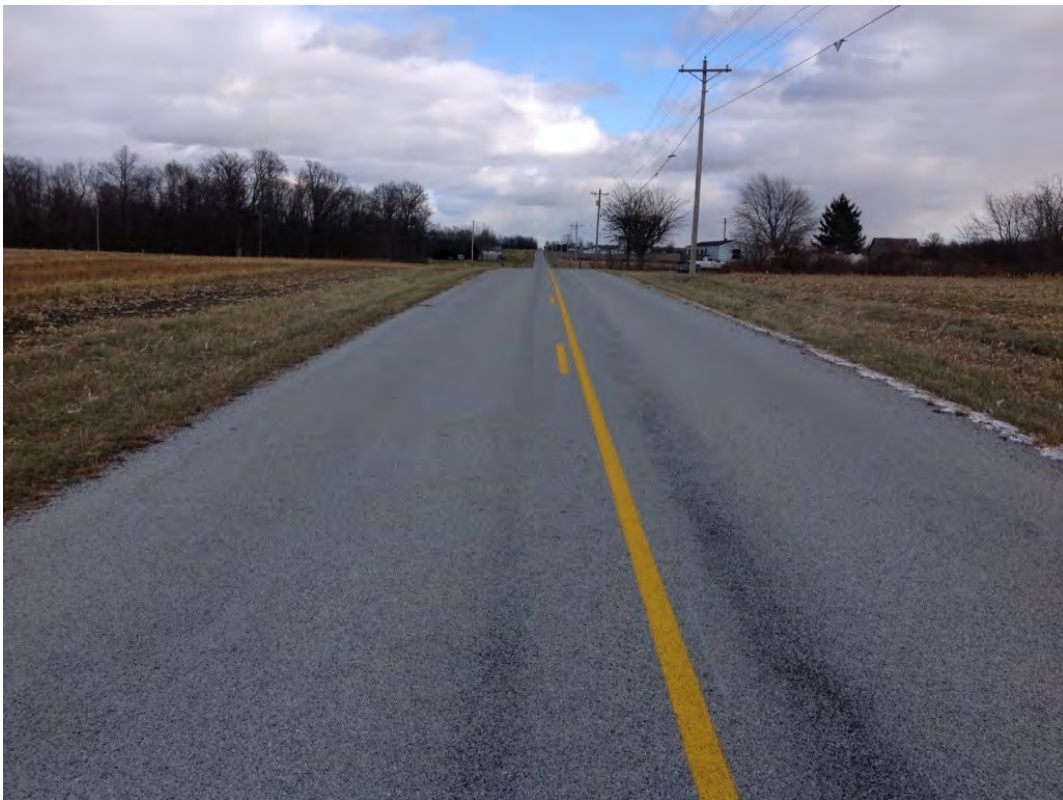
Figure 4-20 CR-90

CR-90 was inspected from the intersection with the access road to turbine 91, to the intersection with the access road to turbine 94. The road has a width of 20 feet and appeared to be recently rehabilitated with minor distresses observed.

SAMPLE UNIT	PCI	RATING
1	93	GOOD

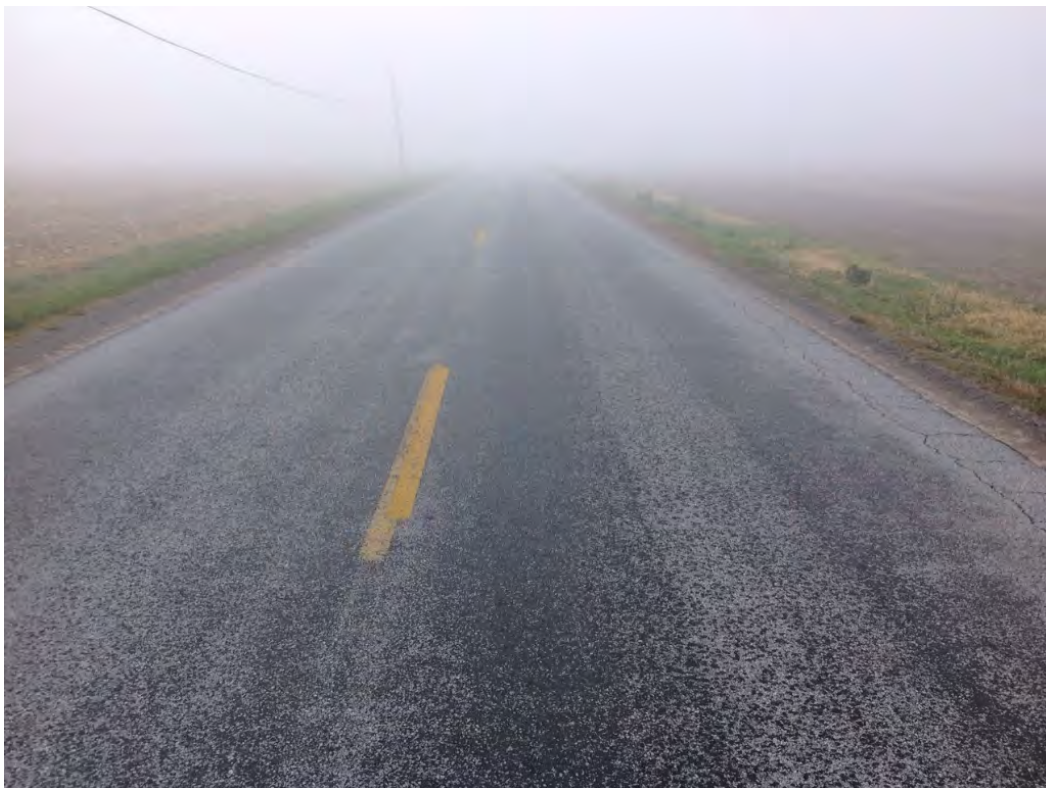
Figure 4-21 CR-95 Section 1

Sections 1 and 2 were found in satisfactory conditions. They presented low severity distresses throughout their length such as longitudinal and transverse cracking, edge cracking, block cracking, bleeding, polished aggregate, and shoulder drop-offs.

SAMPLE UNIT	PCI	RATING
1	79	SATISFACTORY
2	81	SATISFACTORY
3	78	SATISFACTORY
4	84	SATISFACTORY
5	85	GOOD

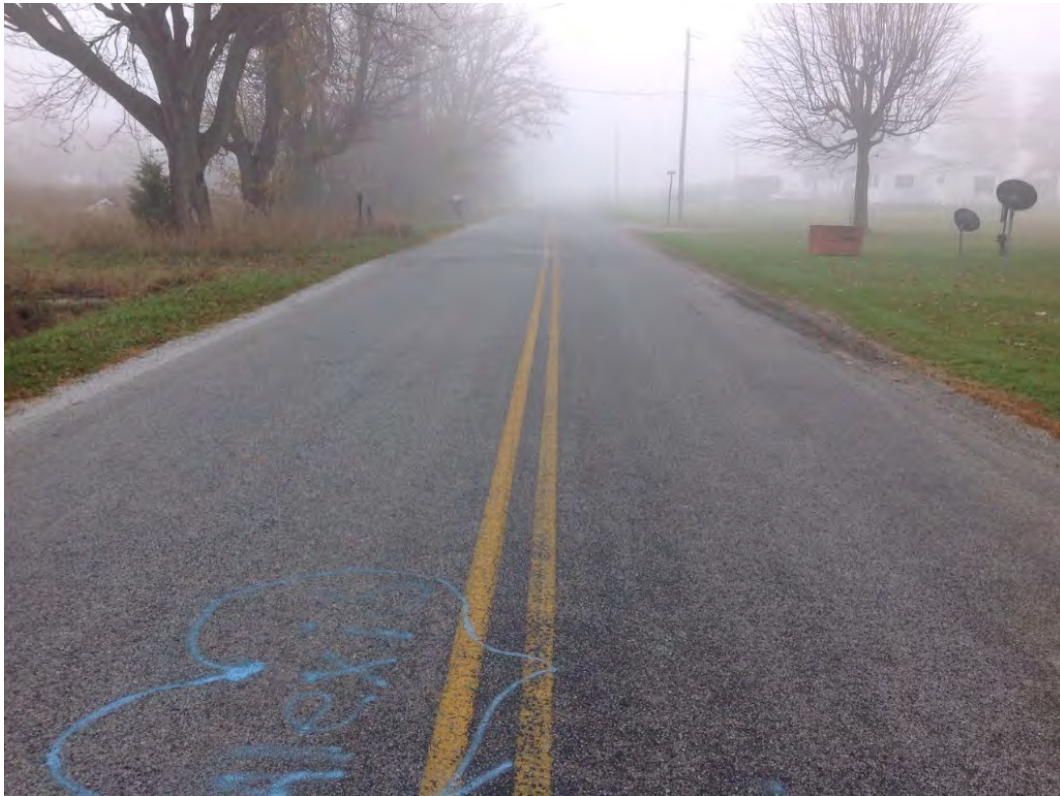
Figure 4-22 CR-95 Section 3

Section 3 presented similar conditions and distresses but the individual measurements were lower than Sections 1 and 2, thus the higher PCI values in sample units 1 and 3.

SAMPLE UNIT	PCI	RATING
1	84	GOOD
2	76	SATISFACTORY
3	99	GOOD

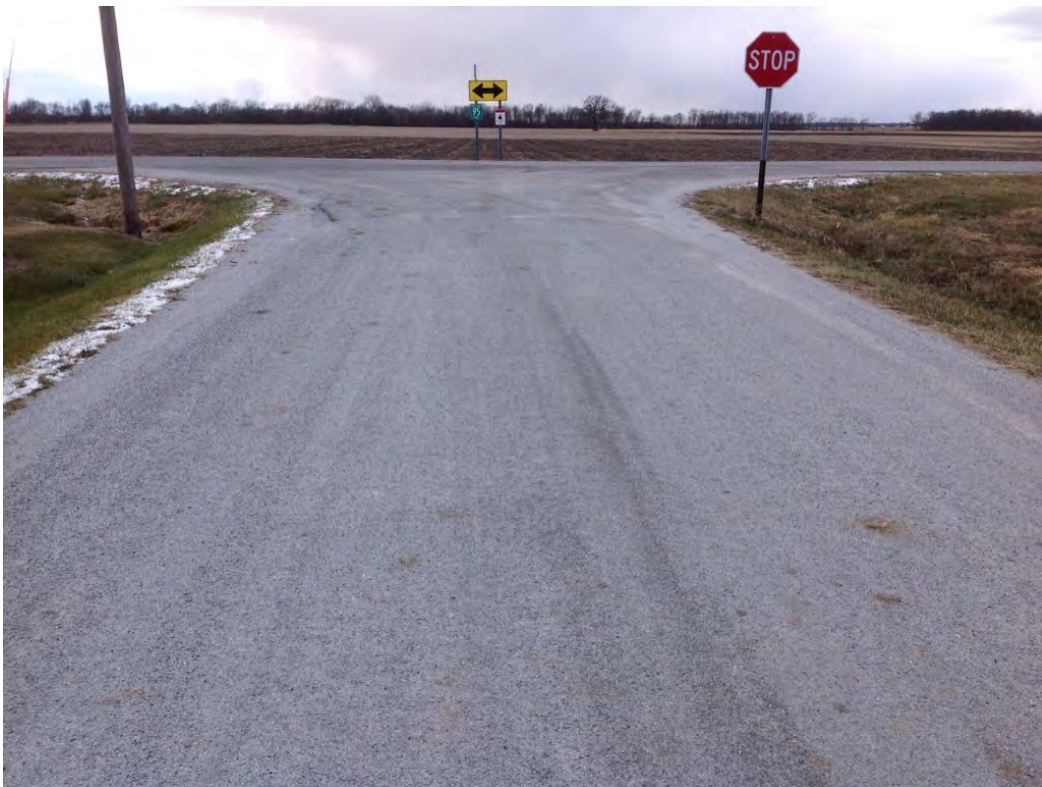
Figure 4-23 TR-100

TR-100 was inspected from CR-95 to the intersection with access road to turbine 118. The section was subject to recent rehabilitation and distresses were not observed at the time of the inspection.

SAMPLE UNIT	PCI	RATING
1	99	GOOD
2	99	GOOD

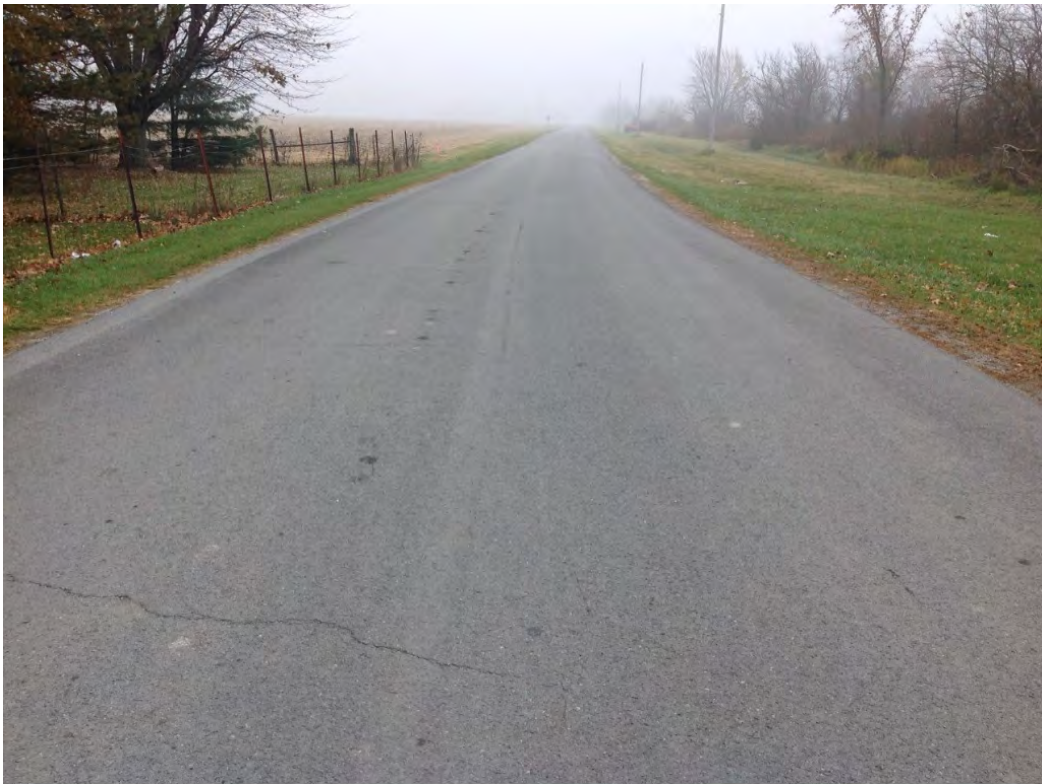
Figure 4-24 TR-106

TR-106 is located within the town of Foraker. The road receives heavy traffic from semitrailers coming in and out of the Foraker elevator, located at the corner of TR-106 and CR-89. Distresses with low severity such as shoulder drop-off, alligator cracking, block cracking, longitudinal and transverse cracking were observed.

SAMPLE UNIT	PCI	RATING
1	82	SATISFACTORY
2	76	SATISFACTORY
3	70	SATISFACTORY

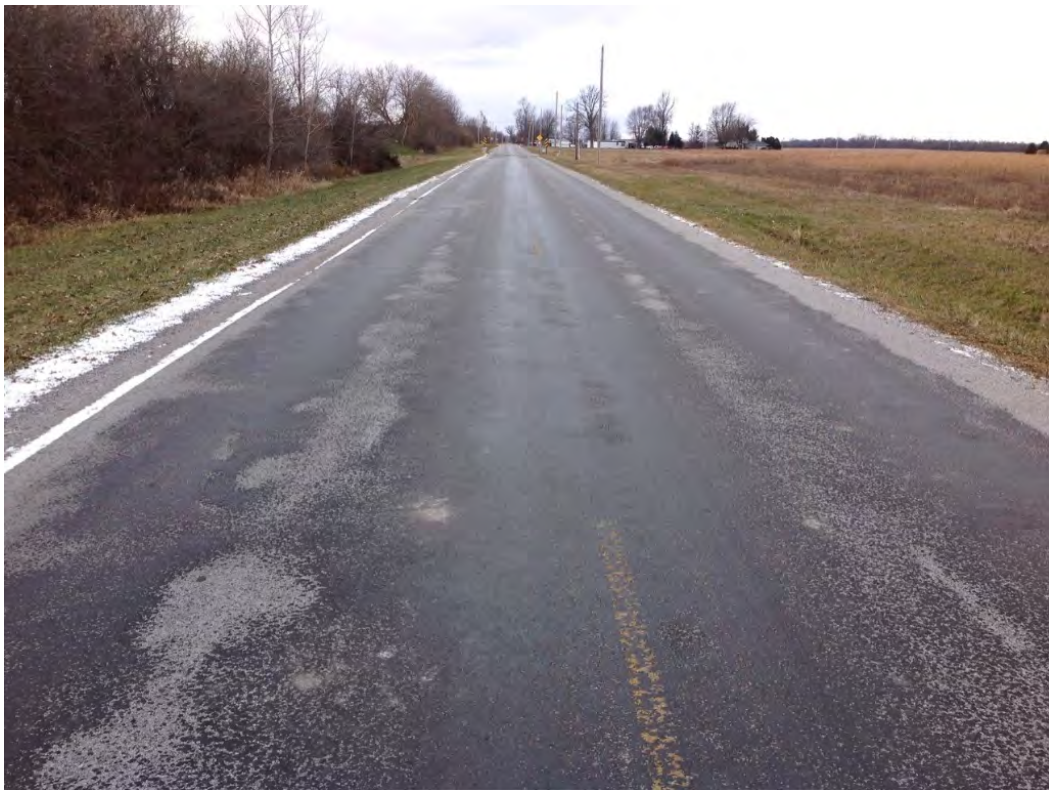
Figure 4-25 CR-106

CR-106 was inspected from CR-95 to the intersection with the access road to T-107. This section presented low severity distresses and was observed to be in satisfactory to good condition.

SAMPLE UNIT	PCI	RATING
1	77	SATISFACTORY
2	80	SATISFACTORY
3	92	GOOD

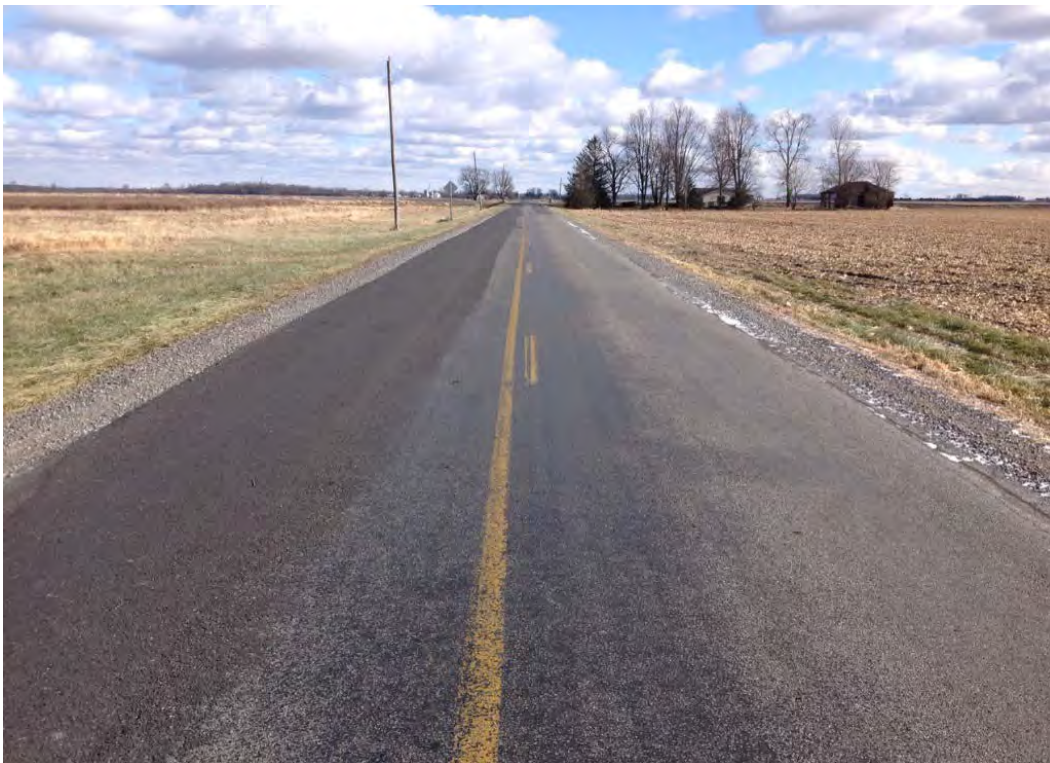
Figure 4-26 CR-110 (East) Section 1

Section 1 was observed generally in fair condition. Heavier traffic was observed in this section of the road, thus, more distresses were present such as bumps, patching, alligator cracking, bleeding, transversal cracking, edge cracking, etc., however these distresses were low severity.

SAMPLE UNIT	PCI	RATING
1	67	FAIR
2	58	FAIR
3	77	SATISFACTORY
4	69	FAIR

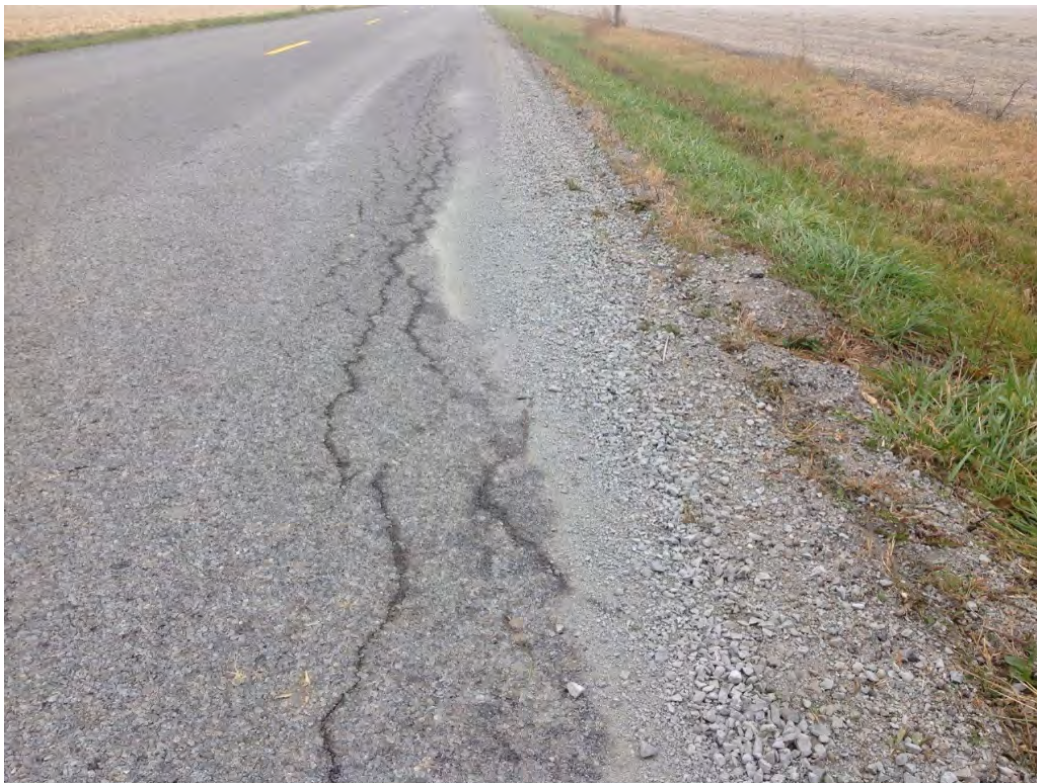
Figure 4-27 CR-110 – (East) Section 2

Section 2 is a portion of the road in an urban area within the town of Foraker and was observed in satisfactory conditions. The distresses observed were shoulder drop-off and edge cracking, as well as a localized depression towards the intersection of CR-95.

SAMPLE UNIT	PCI	RATING
1	82	SATISFACTORY
2	97	GOOD
3	66	FAIR
4	82	SATISFACTORY
