In the Matter of the Application of Hardin Wind Energy LLC for a Certificate of
Environmental Compatibility and Public Need for the Hardin Wind Farm.

**Phase 3 – Compliance with Condition 24, Case No. 09-479-EL-BGN –
Delivery Route Plan**

Hardin County Wind Farm

Road Condition Report

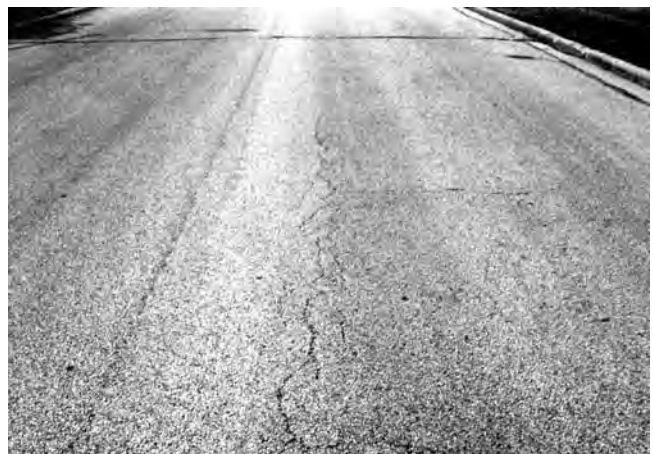
X1.5.1.1 **L**—Fine, longitudinal hairline cracks running parallel to each other with no, or only a few interconnecting cracks. The cracks are not spalled ([Fig. X1.1](#)).

FIG. X1.1 Low-Severity Alligator Cracking

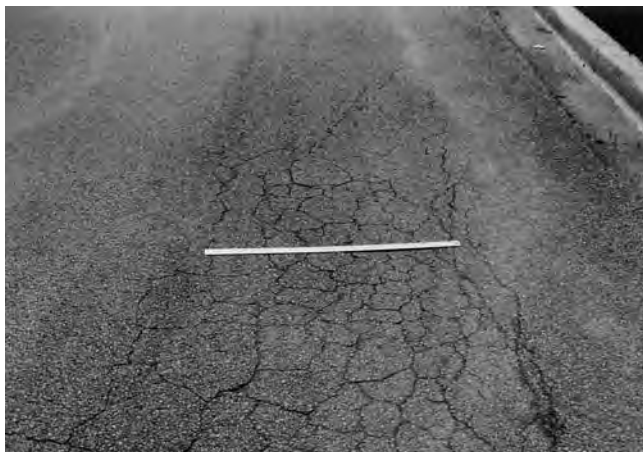
X1.5.1.2 **M**—Further development of light alligator cracks into a pattern or network of cracks that may be lightly spalled (Fig. X1.2).

FIG. X1.2 Medium-Severity Alligator Cracking

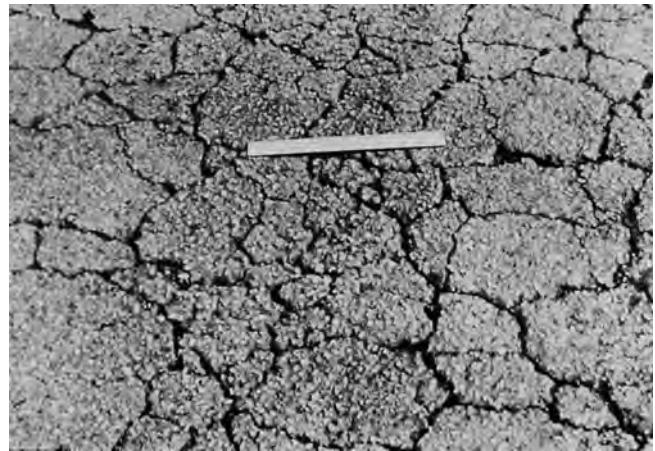
FIG. X1.3 High-Severity Alligator Cracking

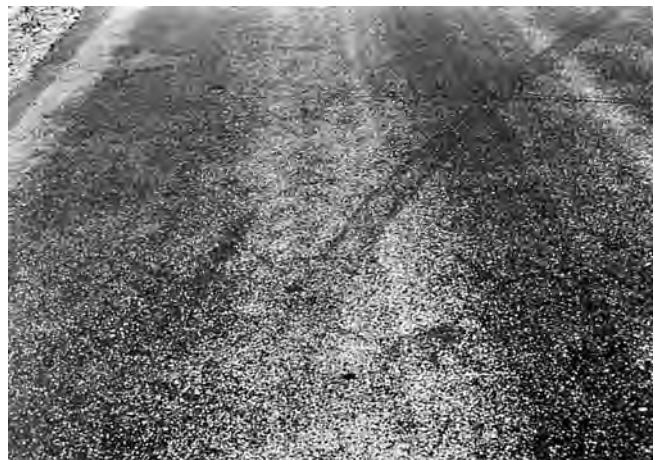
FIG. X1.4 Low-Severity Bleeding

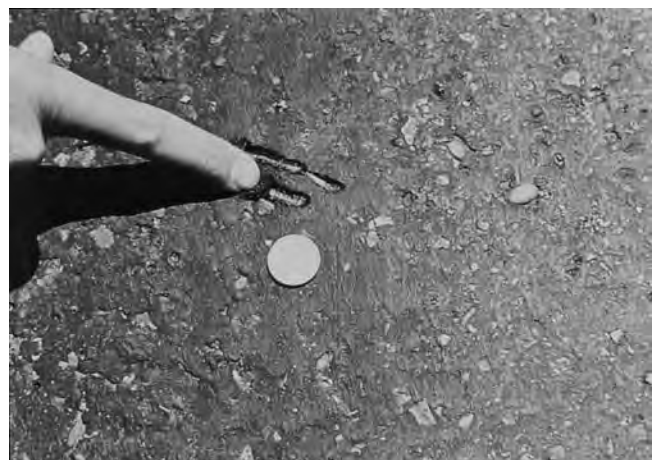
FIG. X1.5 Medium-Severity Bleeding

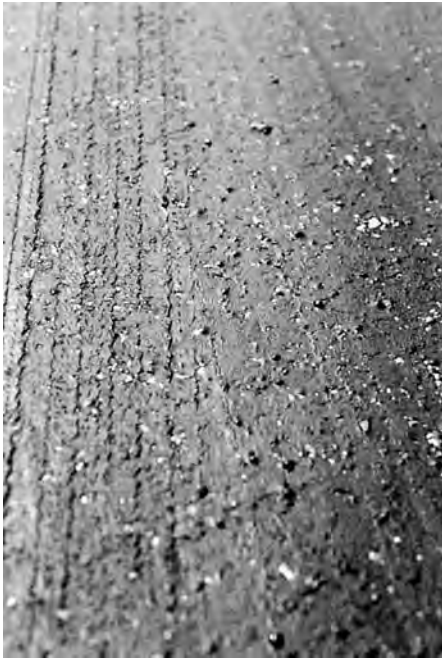
X1.6.1.3 **H**—Bleeding has occurred extensively and considerable asphalt sticks to shoes and vehicles during at least several weeks of the year (Fig. X1.6).

FIG. X1.6 High-Severity Bleeding

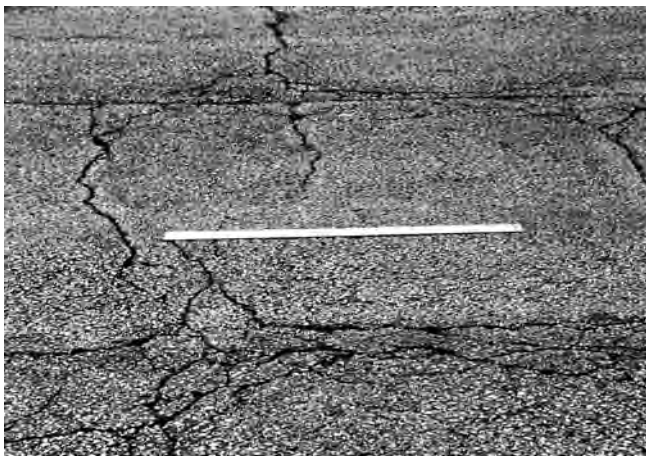
X1.7.1.1 **L**—Blocks are defined by low-severity³ cracks (Fig. X1.7).

FIG. X1.7 Low-Severity Block Cracking

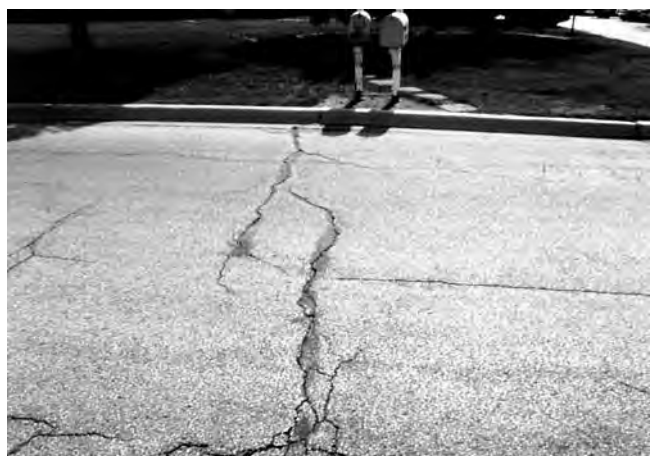
X1.7.1.2 **M**—Blocks are defined by medium-severity³ cracks (Fig. X1.8).

FIG. X1.8 Medium-Severity Block Cracking

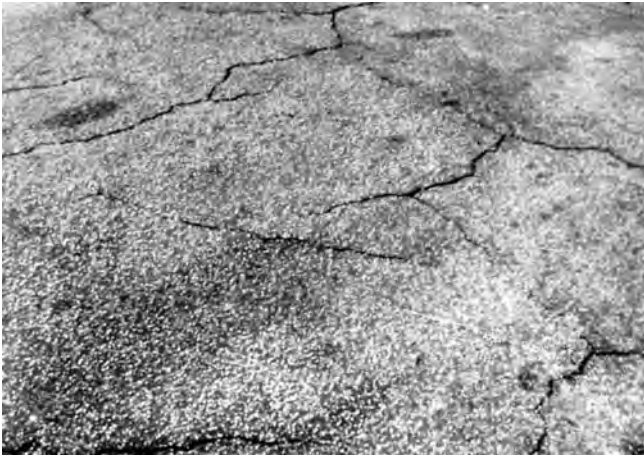
FIG. X1.9 High-Severity Block Cracking

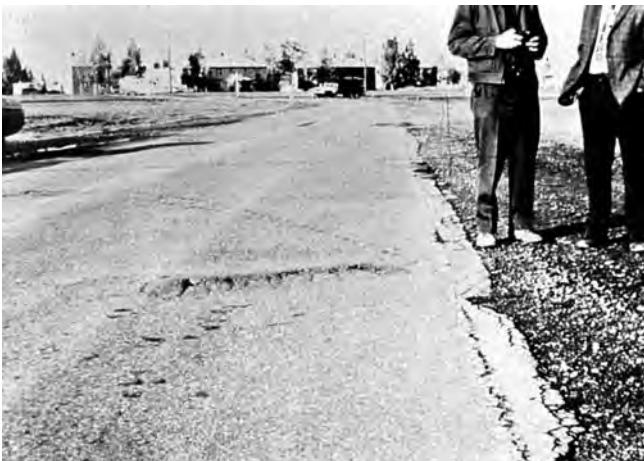
FIG. X1.11 Medium-Severity Bumps and Sags

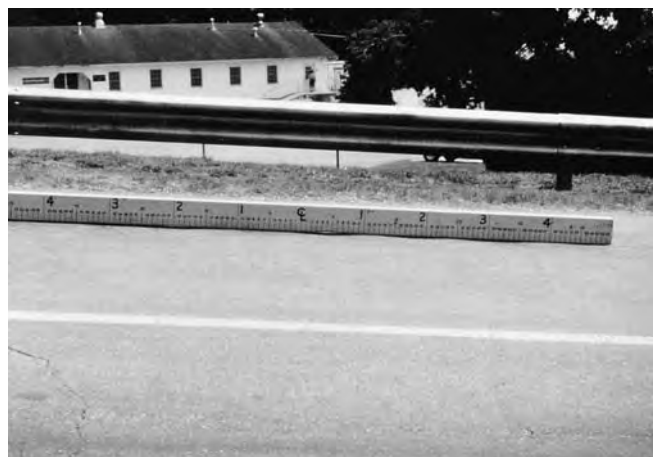
FIG. X1.13 Low-Severity Corrugation

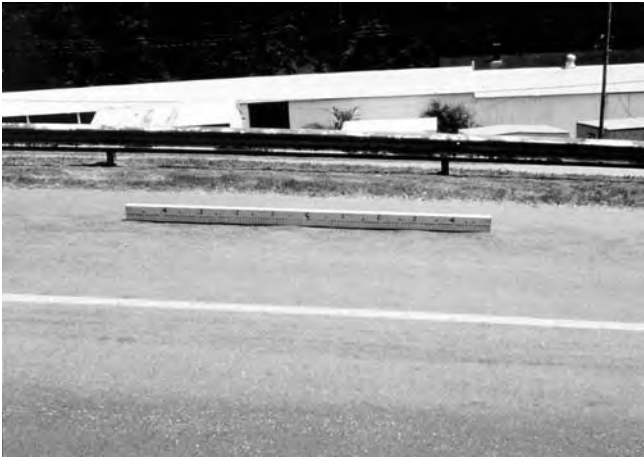
FIG. X1.14 Medium-Severity Corrugation

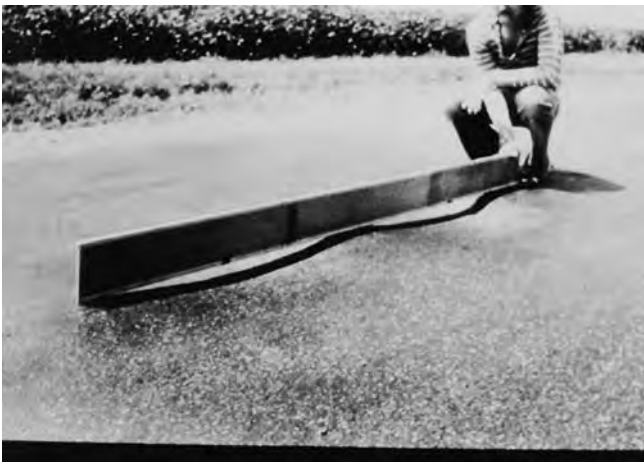
FIG. X1.15 High-Severity Corrugation

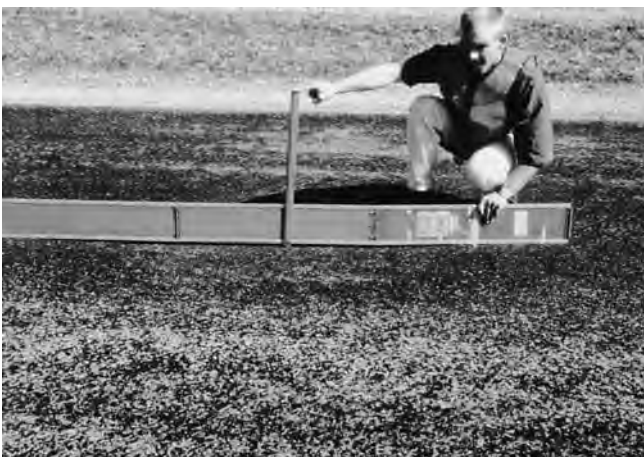
FIG. X1.16 Low-Severity Depression

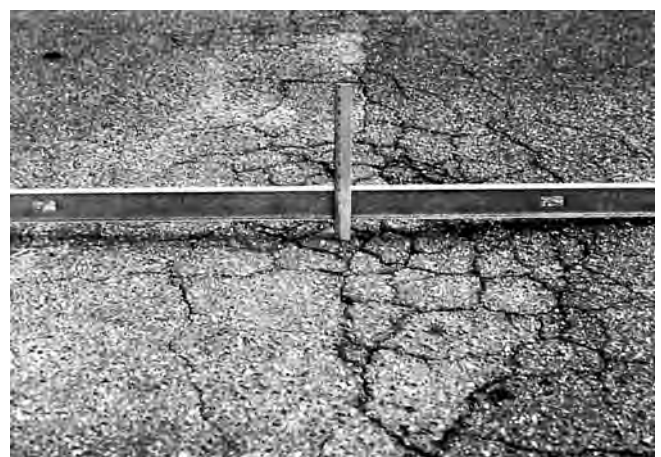
FIG. X1.18 High-Severity Depression

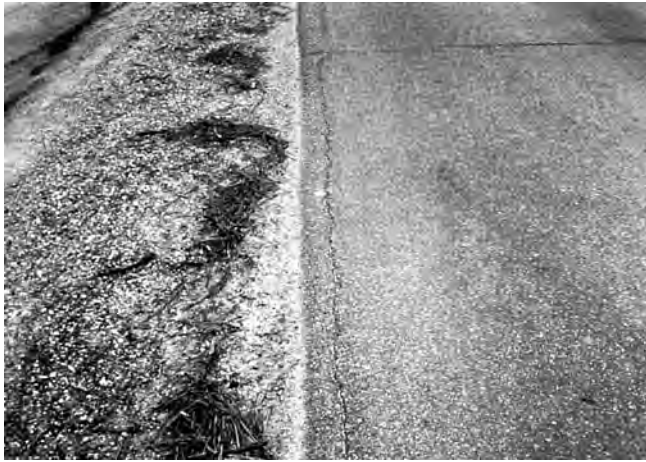
FIG. X1.19 Low-Severity Edge Cracking

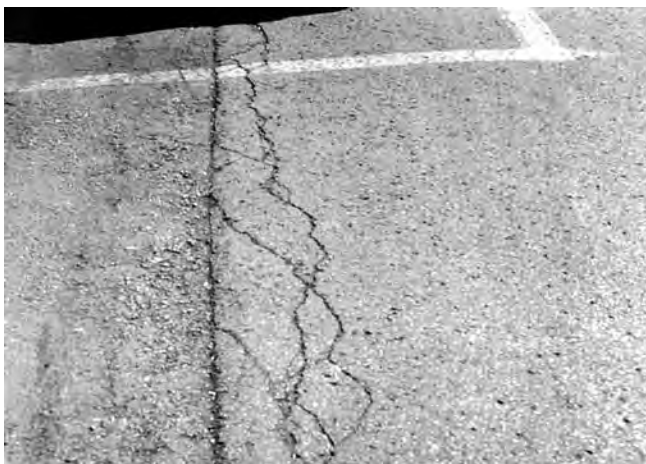
FIG. X1.20 Medium-Severity Edge Cracking

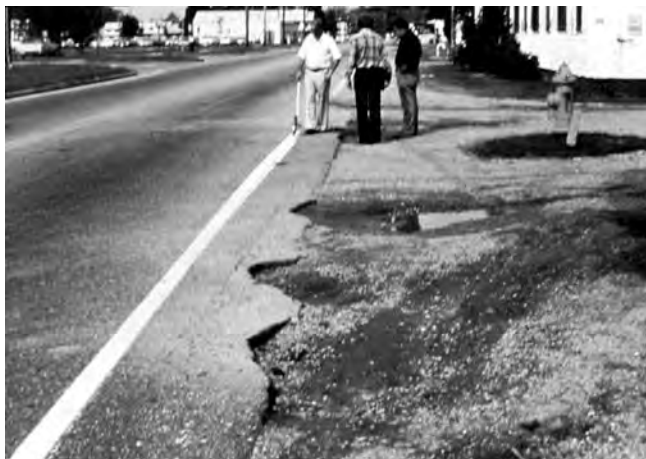
X1.11.1.3 **H**—Considerable breakup or raveling along the edge (Fig. X1.21).

FIG. X1.21 High-Severity Edge Cracking

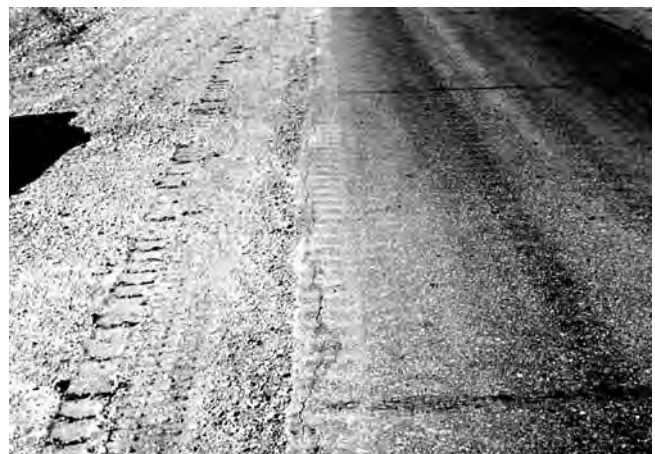
FIG. X1.22 Low-Severity Joint Reflection Cracking

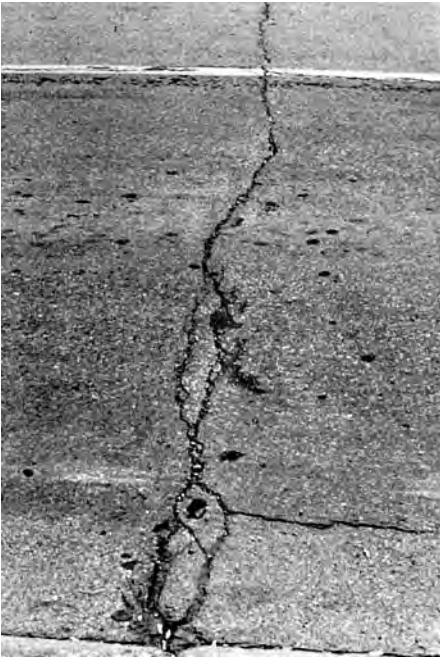
FIG. X1.23 Medium-Severity Joint Reflection Cracking

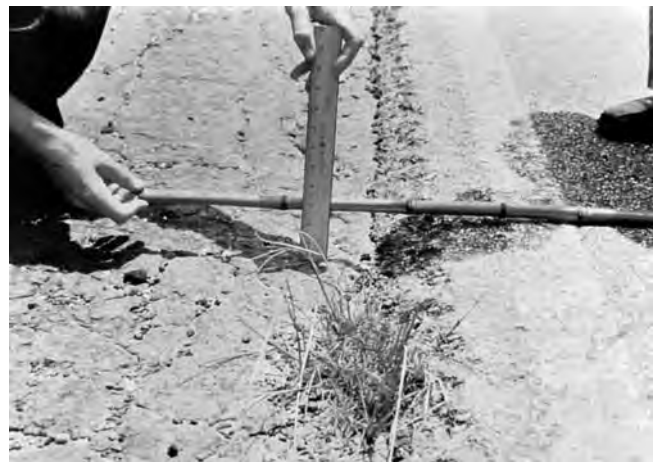
FIG. X1.26 Medium-Severity Lane/Shoulder Drop-Off

X1.13.1.2 **M**—The difference in elevation is > 50 mm (2 in.) and < 100 mm (4 in.) (Fig. X1.26).

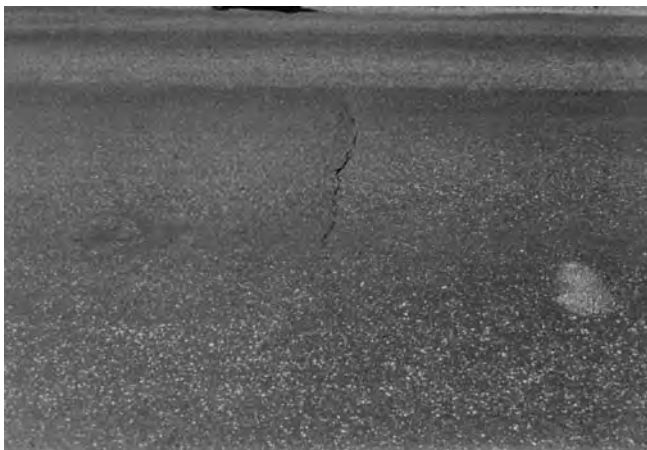
FIG. X1.28 Low-Severity Longitudinal and Transverse Cracking

X1.14.2.1 **L**—One of the following conditions exists (Fig. X1.28): nonfilled crack width is less than 10 mm ($\frac{3}{8}$ in.), or filled crack of any width (filler in satisfactory condition).

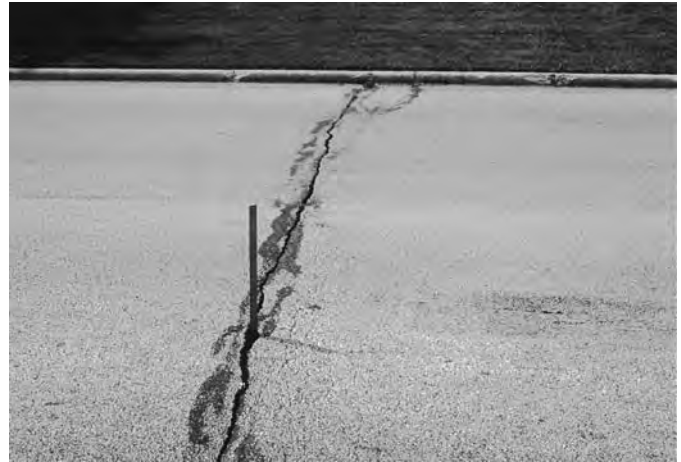
FIG. X1.29 Medium-Severity Longitudinal and Transverse Cracking

X1.14.2.2 **M**—One of the following conditions exists (Fig. X1.29): nonfilled crack width is greater than or equal to 10 mm and less than 75 mm ($\frac{3}{8}$ to 3 in.); nonfilled crack is less than or equal to 75 mm (3 in.) surrounded by light and random cracking; or, filled crack is of any width surrounded by light random cracking.

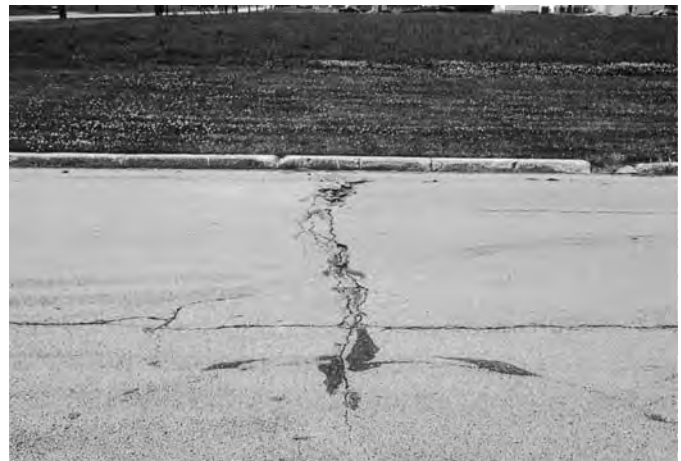
FIG. X1.30 High-Severity Longitudinal and Transverse Cracking

X1.14.2.3 **H**—One of the following conditions exists (Fig. X1.30): any crack filled or nonfilled surrounded by medium- or high-severity random cracking; nonfilled crack greater than 75 mm (3 in.); or, a crack of any width where approximately 100 mm (4 in.) of pavement around the crack is severely broken.

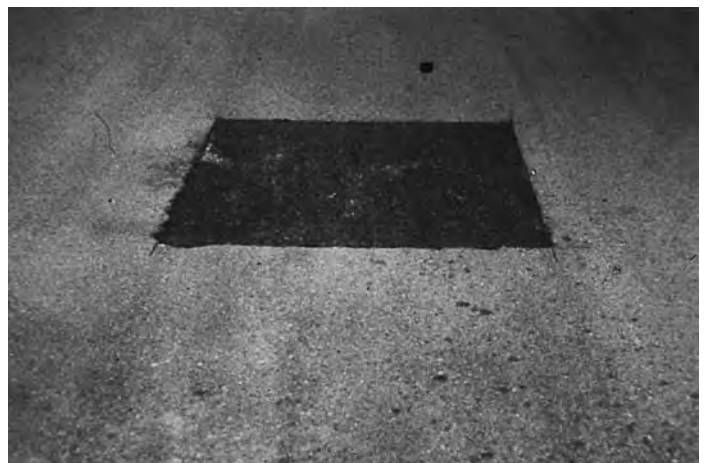
FIG. X1.31 Low-Severity Patching and Utility Cut Patching

X1.15.1.1 **L**—Patch is in good condition and satisfactory. Ride quality is rated as low severity or better (Fig. X1.31).

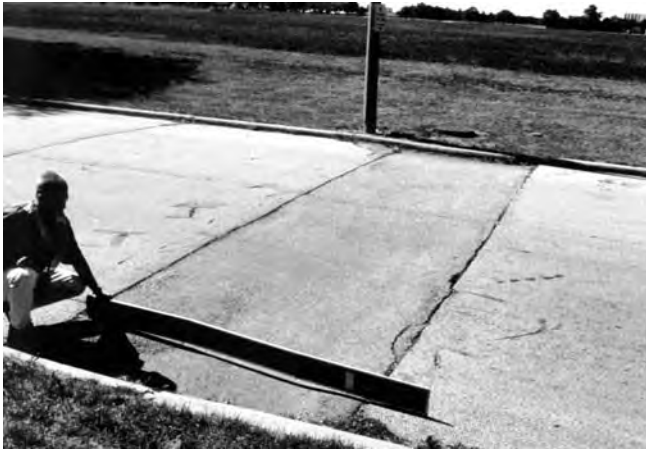
FIG. X1.32 Medium-Severity Patching and Utility Cut Patching

X1.15.1.2 **M**—Patch is moderately deteriorated, or ride quality is rated as medium severity, or both (Fig. X1.32).

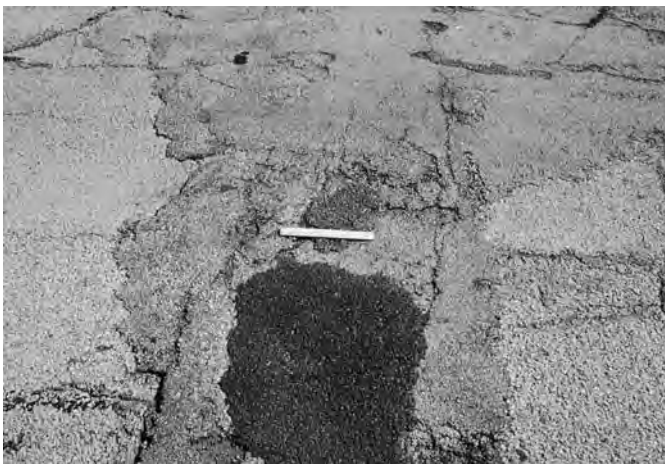
FIG. X1.33 High-Severity Patching and Utility Cut Patching

X1.15.1.3 **H**—Patch is badly deteriorated, or ride quality is rated as high severity, or both; needs replacement soon (Fig. X1.33).

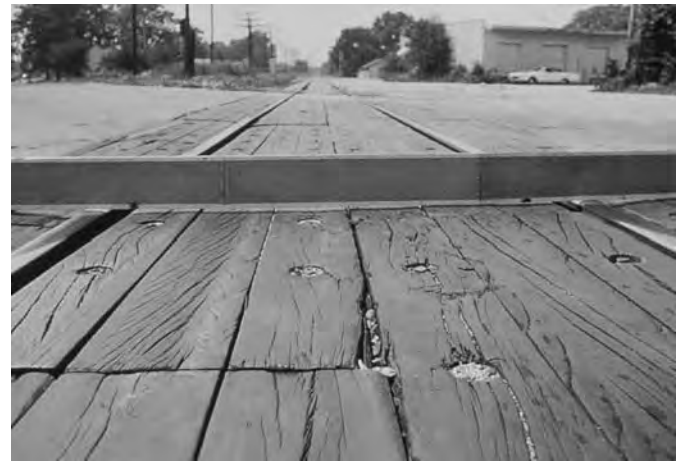
FIG. X1.38 Low-Severity Railroad Crossing

X1.18.1.1 **L**—Railroad crossing causes low-severity ride quality (Fig. X1.38).

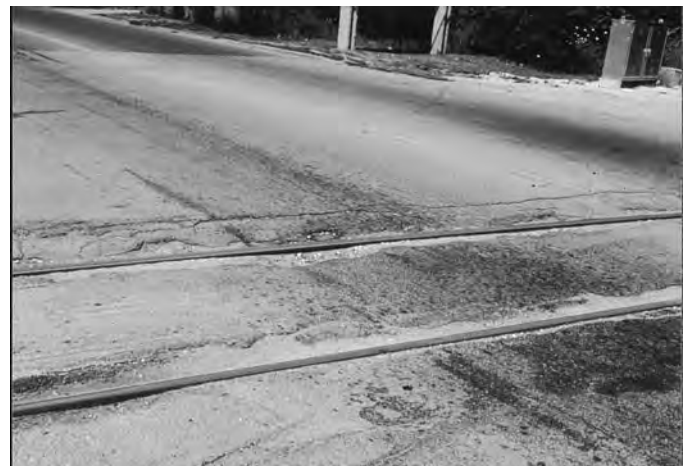
FIG. X1.39 Medium-Severity Railroad Crossing

X1.18.1.2 **M**—Railroad crossing causes medium-severity ride quality (Fig. X1.39).

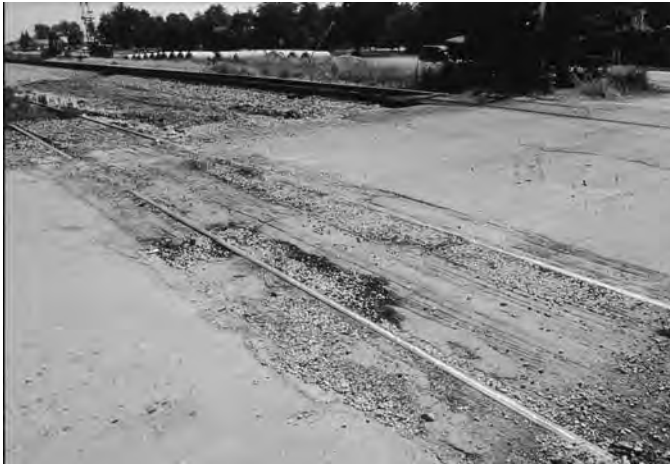
FIG. X1.40 High-Severity Railroad Crossing

X1.18.1.3 **H**—Railroad crossing causes high-severity ride quality (Fig. X1.40).

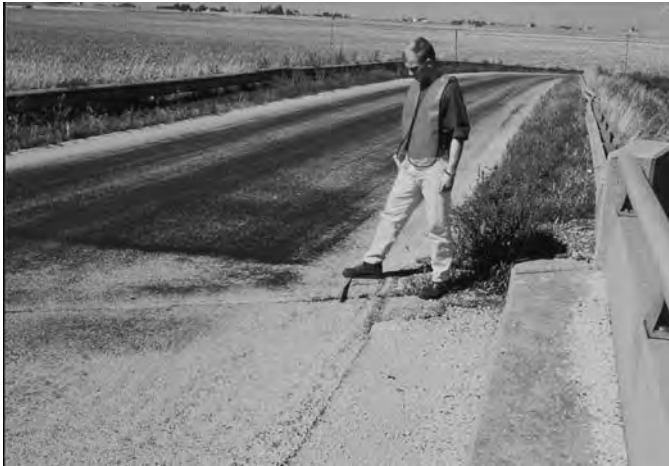
FIG. X1.44 Low-Severity Shoving

X1.20.3.1 **L**—Shove causes low-severity ride quality (Fig. X1.44).

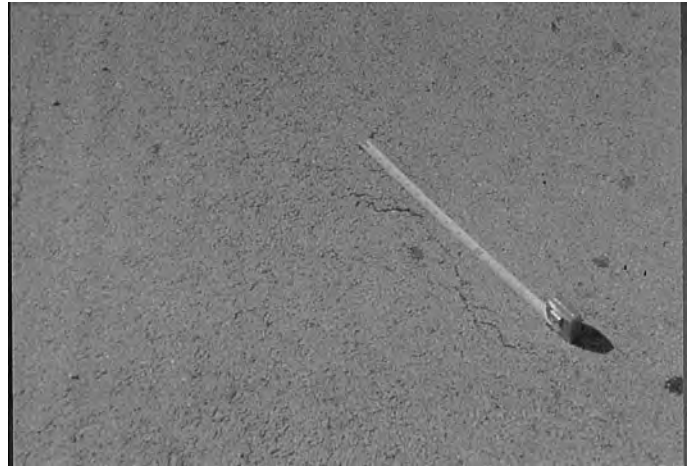
FIG. X1.47 Low-Severity Slippage Cracking

X1.21.1.1 **L**—Average crack width is < 10 mm ($\frac{3}{8}$ in.) (Fig. X1.47).

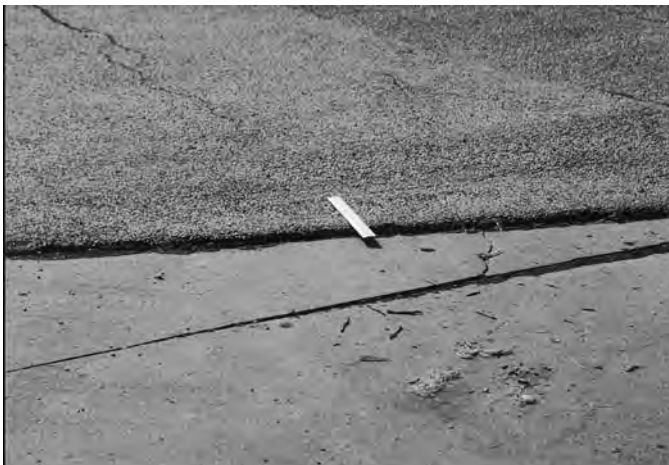
FIG. X1.45 Medium-Severity Shoving

X1.20.3.2 **M**—Shove causes medium-severity ride quality (Fig. X1.45).

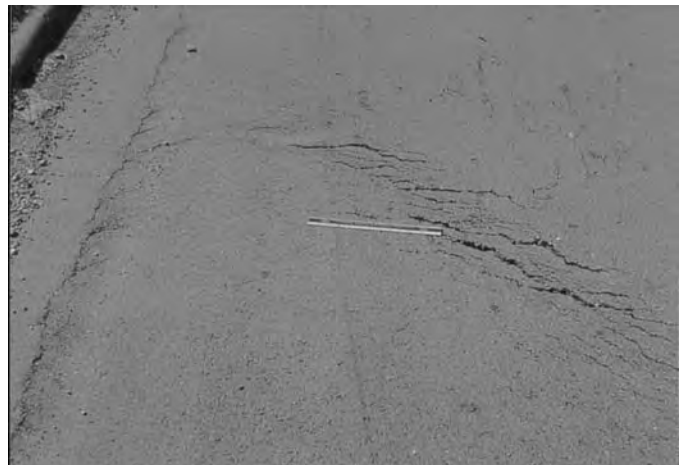
FIG. X1.48 Medium-Severity Slippage Cracking

1-1/2 in.); or the area around the crack is moderately spalled, or surrounded with secondary cracks.

X1.21.1.2 **M**—One of the following conditions exists (Fig. X1.48): average crack width is ≥ 10 and < 40 mm ($\geq \frac{3}{8}$ and $<$

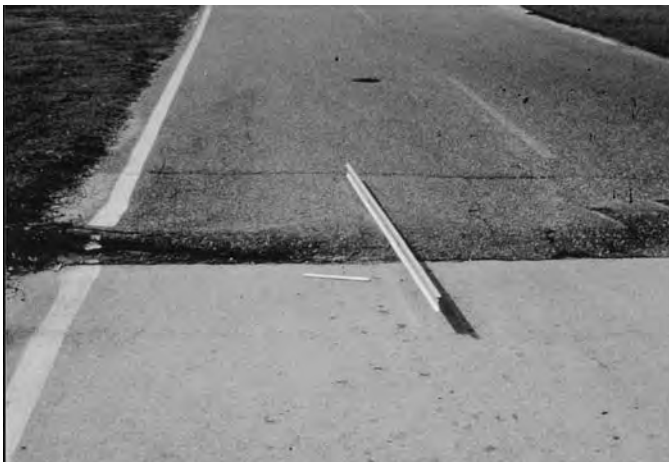
FIG. X1.46 High-Severity Shoving

X1.20.3.3 **H**—Shove causes high-severity ride quality (Fig. X1.46).

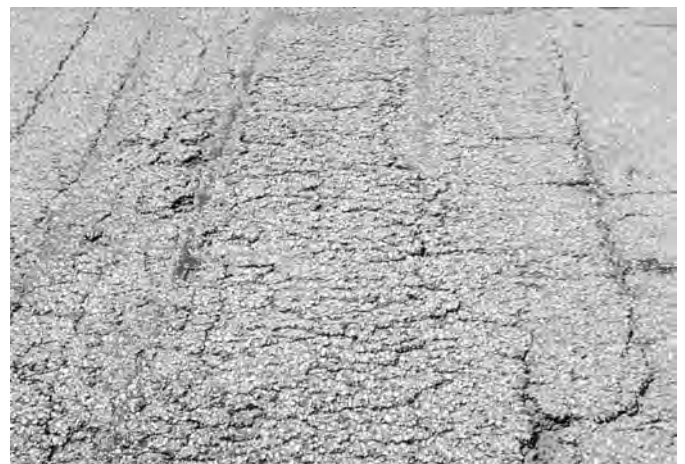
FIG. X1.52 Medium-Severity Weathering and Raveling

X1.23.1.2 M—Aggregate or binder has worn away. The surface texture is moderately rough and pitted (Fig. X1.52). In the case of oil spillage, the surface is soft and can be penetrated with a coin.

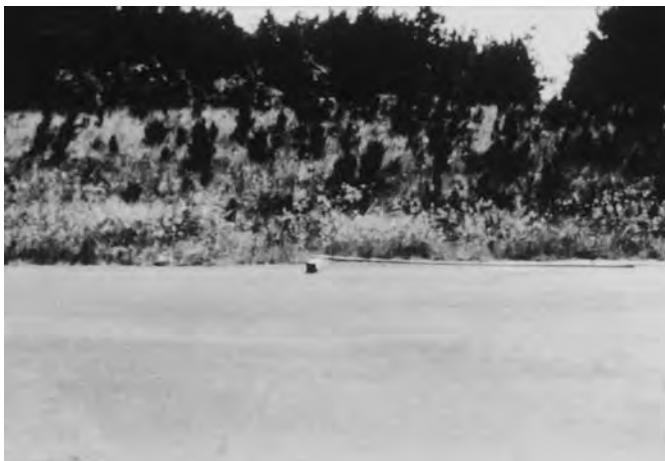
FIG. X1.50 Example Swell. Severity level is based on ride quality criteria.

X1.22 Description—Swell is characterized by an upward bulge in the pavement's surface, a long, gradual wave more than 3 m (10 ft) long (Fig. X1.50). Swelling can be accompanied by surface cracking. This distress usually is caused by frost action in the subgrade or by swelling soil.

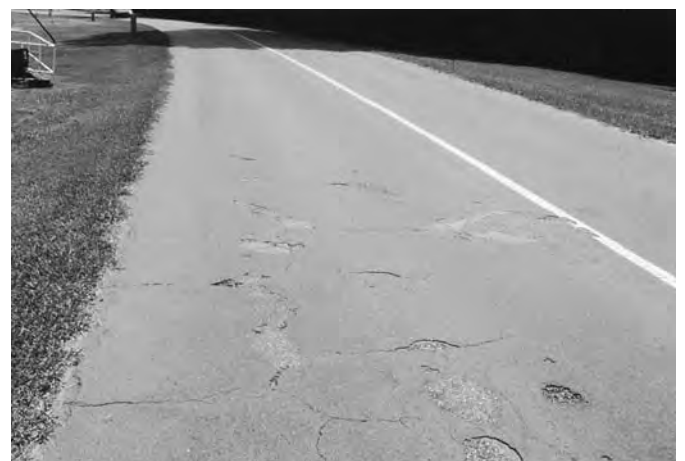
FIG. X1.53 High-Severity Weathering and Raveling

X1.23.1.3 H—Aggregate or binder has been worn away considerably. The surface texture is very rough and severely pitted. The pitted areas are less than 10 mm (4 in.) in diameter and less than 13 mm (½ in.) deep (Fig. X1.53); pitted areas larger than this are counted as potholes. In the case of oil

spillage, the asphalt binder has lost its binding effect and the aggregate has become loose.

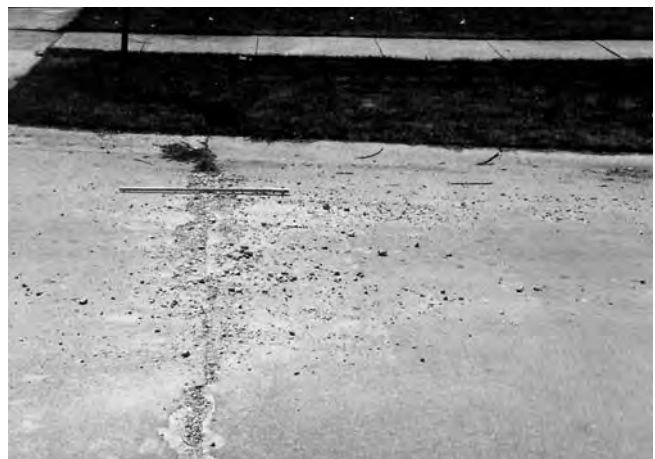
FIG. X2.1 Low Severity Blowup/Buckling

X2.3.1.1 **L**—Buckling or shattering causes low-severity ride quality (Fig. X2.1).

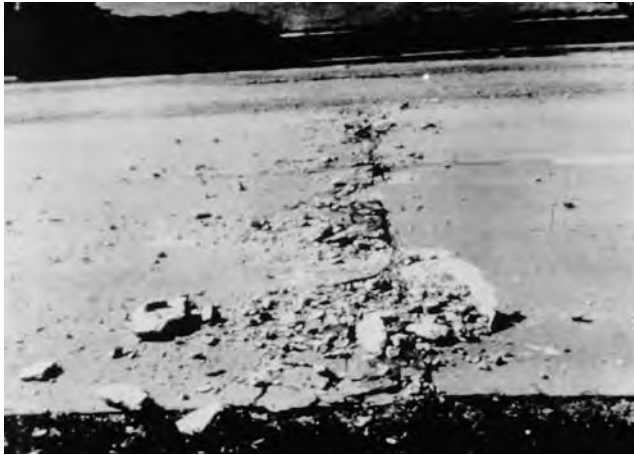
FIG. X2.2 Medium Severity Blowup/Buckling

X2.3.1.2 **M**—Buckling or shattering causes medium-severity ride quality (Fig. X2.2).

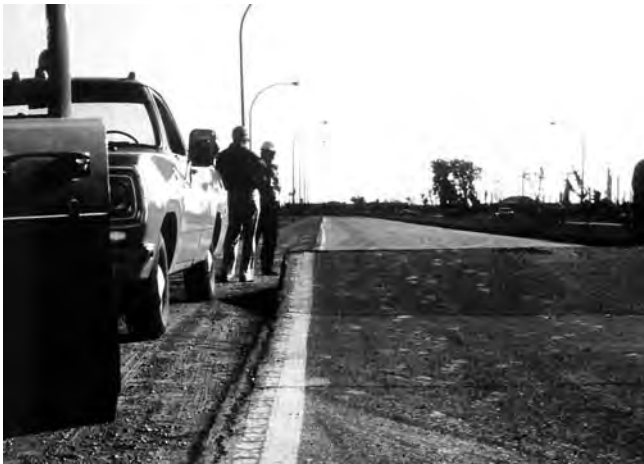
FIG. X2.3 High-Severity Blowup/Buckling

X2.3.1.3 **H**—Buckling or shattering causes high-severity ride quality (Fig. X2.3).

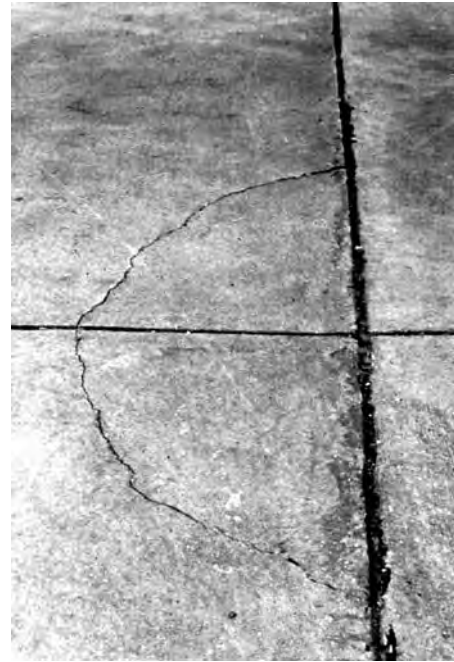
FIG. X2.4 Low-Severity Corner Break

X2.4.1.1 **L**—Break is defined by a low-severity⁴ crack. A low severity crack is < 13 mm ($\frac{1}{2}$ in.), cracks of any width with satisfactory filler; no faulting. The area between the break and the joints is not cracked or may be lightly cracked (Fig. X2.4).

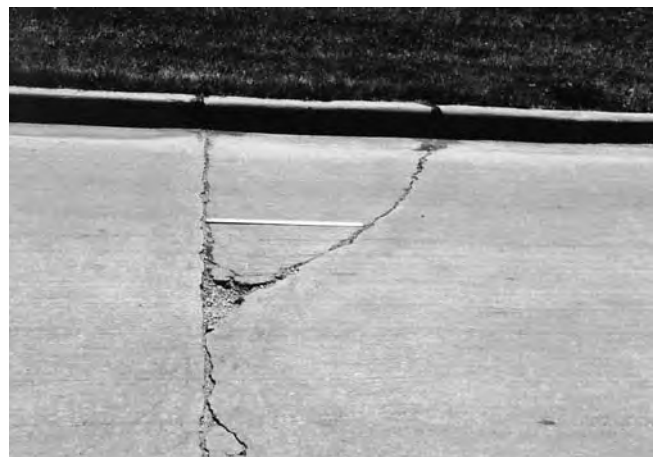
FIG. X2.5 Medium-Severity Corner Break

X2.4.1.2 **M**—Break is defined by a medium-severity⁴ crack, or the area between the break and the joints, or both, has a medium crack. A medium severity crack is a nonfilled crack > 13 mm and < 50 mm ($>\frac{1}{2}$ in. and < 2 in.), a nonfilled crack <

50 mm (2 in.) with faulting < 10 mm ($\frac{3}{8}$ in.), or a any filled crack with faulting < 10 mm ($\frac{3}{8}$ in.) (Fig. X2.5).

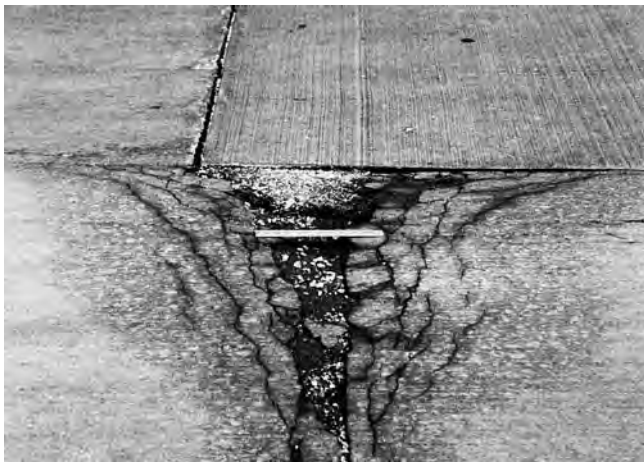
FIG. X2.11 Medium-Severity Durability Cracking

X2.6.1.2 M—One of the following conditions exists (Fig. X2.11): “D” cracks cover less than 15 % of the area and most of the pieces are loose and or missing, or “D” cracks cover more than 15 % of the area. Most of the cracks are tight, but a few pieces may be loose and or missing.

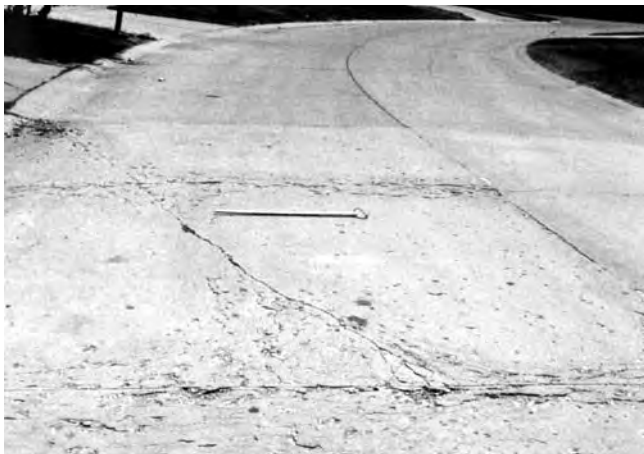
FIG. X2.12 High-Severity Durability Cracking

X2.6.1.3 H—“D” cracks cover more than 15 % of the area and most of the pieces have come out or could be removed easily (Fig. X2.12).

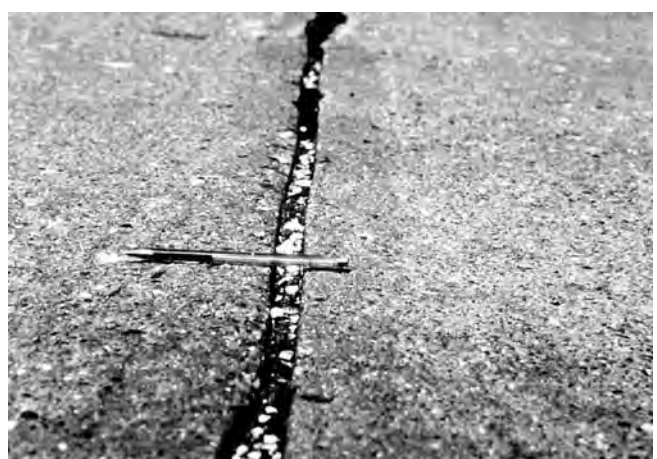
FIG. X2.18 High-Severity Joint Seal Damage

X2.8.2.3 **H**—Joint sealant is in generally poor condition over the entire section, with one or more of the above types of damage occurring to a severe degree. Sealant needs immediate replacement (Fig. X2.18). Joint seal damage is at high severity if 10 % or more of the joint sealer exceeds limiting criteria listed above or if 10 % or more of sealer is missing.

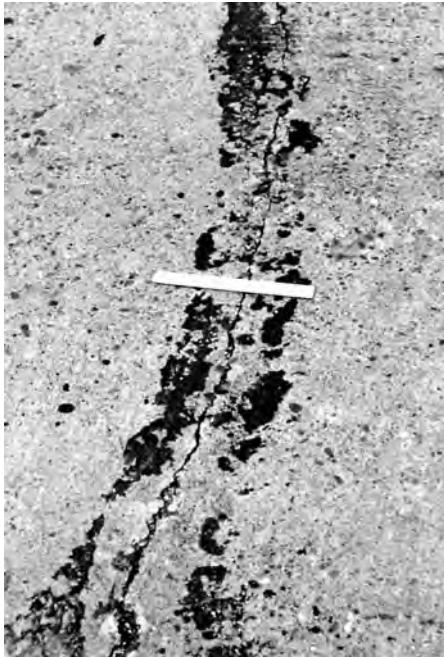
FIG. X2.22 Low-Severity Linear Cracking

X2.10.1.1 **L**—Nonfilled⁴ cracks ≤ 13 mm ($\leq \frac{1}{2}$ in.) or filled cracks of any width with the filler in satisfactory condition. No faulting exists (Fig. X2.22).

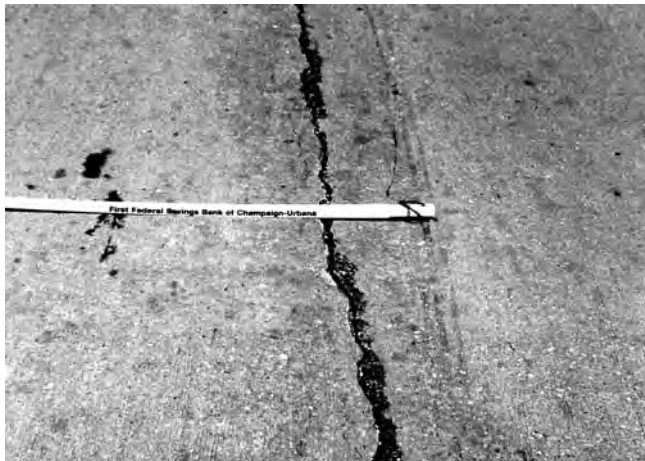
FIG. X2.23 Medium-Severity Linear Cracking

X2.10.1.2 **M**—One of the following conditions exists: non-filled crack with a width >13 and ≤ 50 mm ($>\frac{1}{2}$ and ≤ 2 in.); nonfilled crack of any width ≤ 50 mm (2 in.) with faulting of <10 mm ($\frac{3}{8}$ in.), or filled crack of any width with faulting <10 mm ($\frac{3}{8}$ in.) (Fig. X2.23).

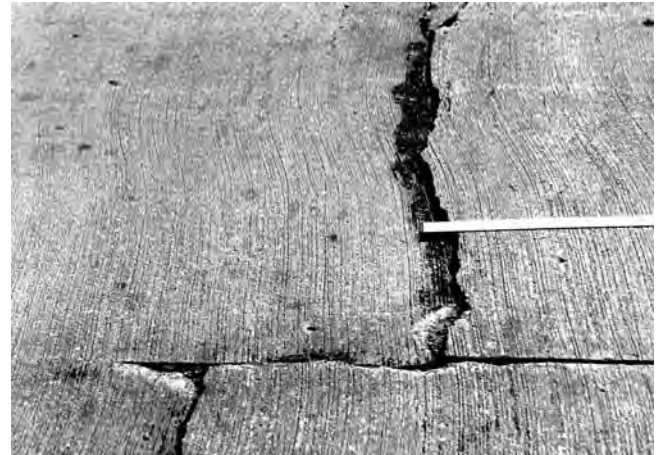
FIG. X2.24 High-Severity Linear Cracking

X2.10.1.3 **H**—One of the following conditions exists: non-filled crack with a width >50 mm (2 in.), or filled or nonfilled crack of any width with faulting >10 mm ($\frac{3}{8}$ in.) (Fig. X2.24).

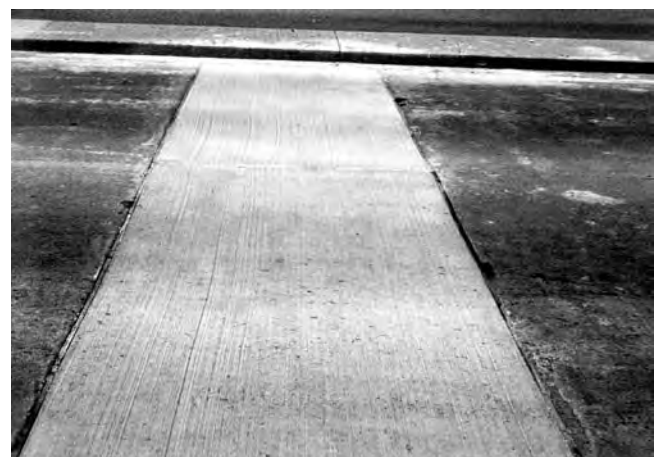
FIG. X2.25 Low-Severity Patching, Large and Utility Cuts

X2.11.1.1 L—Patch is functioning well, with little or no deterioration (Fig. X2.25).

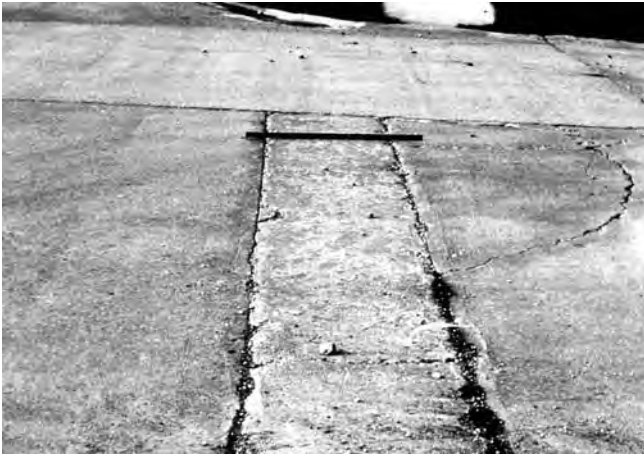
FIG. X2.26 Medium-Severity Patching, Large and Utility Cuts

X2.11.1.2 M—Patch is moderately deteriorated, or moderate spalling can be seen around the edges, or both. Patch material can be dislodged with considerable effort (Fig. X2.26).

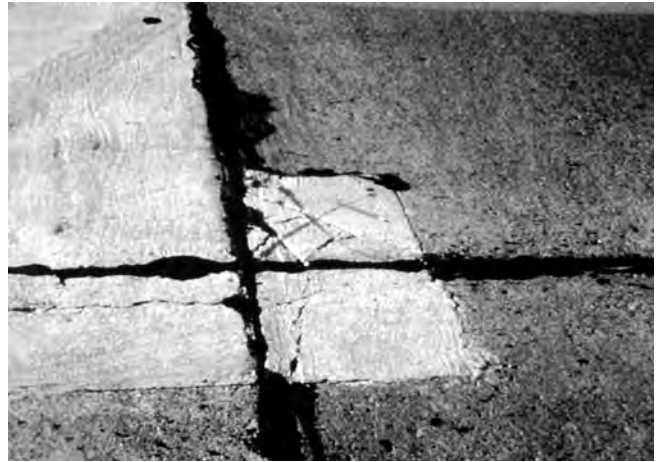
FIG. X2.29 Medium-Severity Patching, Small

X2.12.1.2 M—Patch is moderately deteriorated. Patch material can be dislodged with considerable effort (Fig. X2.29).

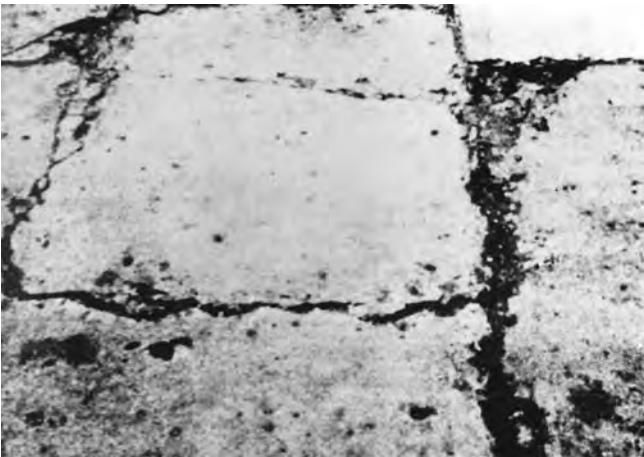
FIG. X2.27 High-Severity Patching, Large and Utility Cuts

X2.11.1.3 H—Patch is badly deteriorated. The extent of the deterioration warrants replacement (Fig. X2.27).

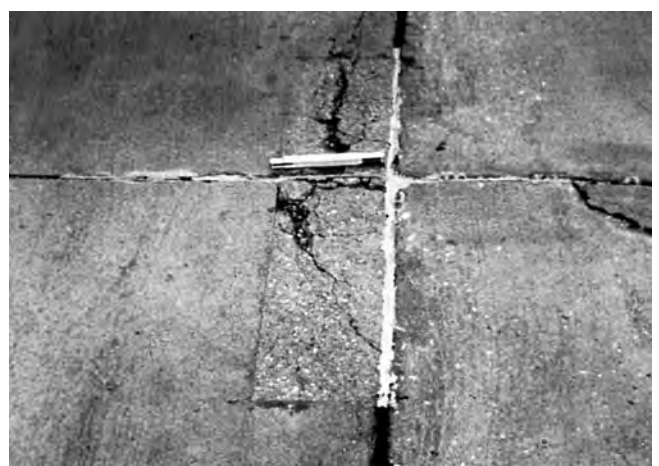
FIG. X2.30 High-Severity Patching, Small

X2.12.1.3 H—Patch is badly deteriorated. The extent of deterioration warrants replacement (Fig. X2.30).

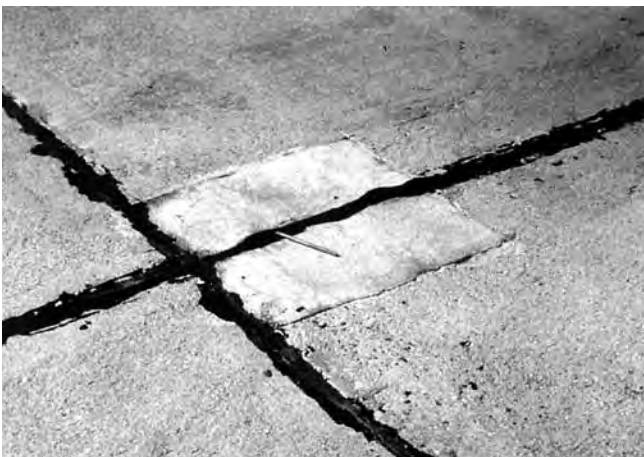
FIG. X2.28 Low-Severity Patching, Small

X2.12.1.1 L—Patch is functioning well with little or no deterioration (Fig. X2.28).

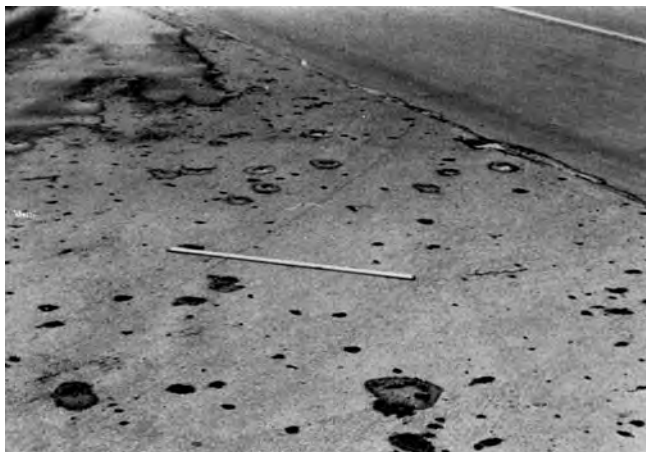
FIG. X2.32 Popouts

X2.14 Description—A popout is a small piece of pavement that breaks loose from the surface due to freeze-thaw action, combined with expansive aggregates. Popouts usually range in diameter from approximately 25 to 100 mm (1 to 4 in.) and in depth from 13 to 50 mm (½ to 2 in.).

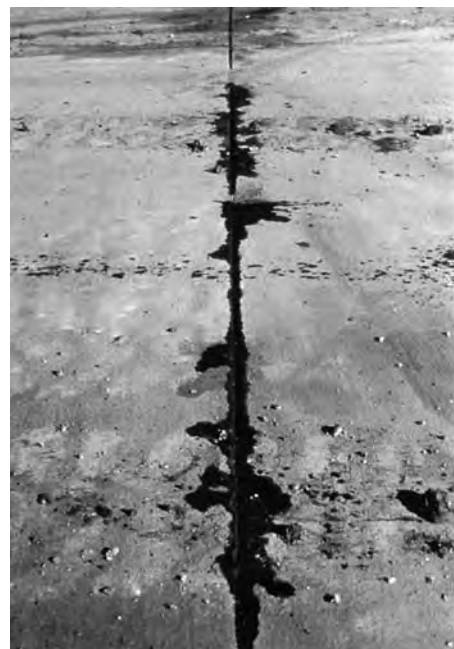
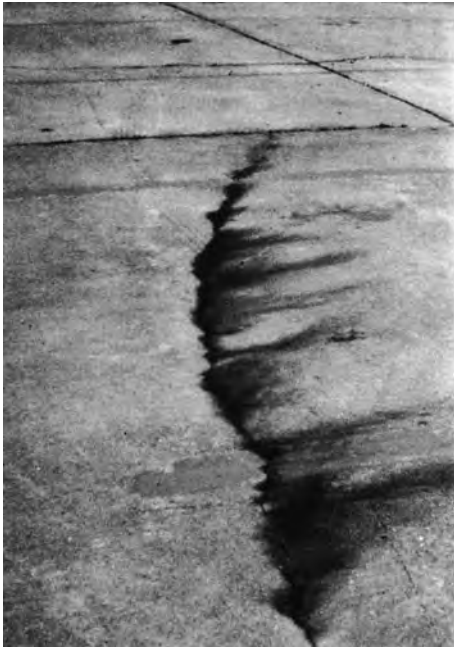
X2.15 *Description*—Pumping is the ejection of material from the slab foundation through joints or cracks. This is caused by deflection of the slab with passing loads. As a load moves across the joint between the slabs, water is first forced under the leading slab, and then forced back under the trailing slab. This action erodes and eventually removes soil particles resulting in progressive loss of pavement support. Pumping can be identified by surface stains and evidence of base or subgrade material on the pavement close to joints or cracks. Pumping near joints is caused by poor joint sealer and indicates loss of support; repeated loading eventually will produce cracks. Pumping also can occur along the slab edge causing loss of support.

X2.15.1 *Severity Levels*—No degrees of severity are defined. It is enough to indicate that pumping exists (Fig. X2.33 and Fig. X2.34).

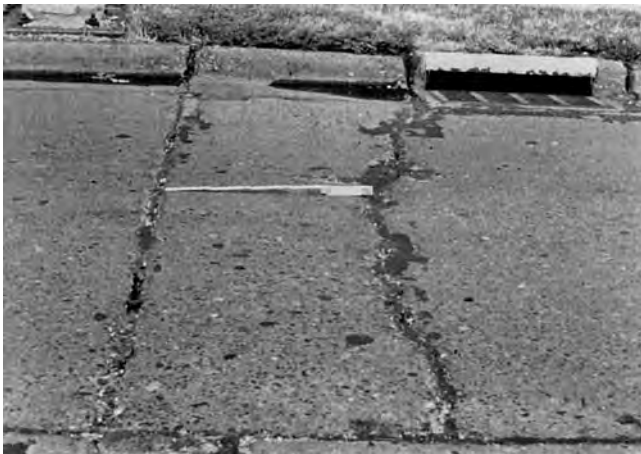
FIG. X2.35 Low-Severity Punchout

X2.16 *Description*—This distress is a localized area of the slab that is broken into pieces. The punchout can take many different shapes and forms, but it is usually defined by a crack and a joint. The distance between the joint and the crack or two closely spaced cracks is ≤ 1.5 m (5 ft) wide. This distress is caused by heavy repeated loads, inadequate slab thickness, loss of foundation support, or a localized concrete construction deficiency, for example, honeycombing.

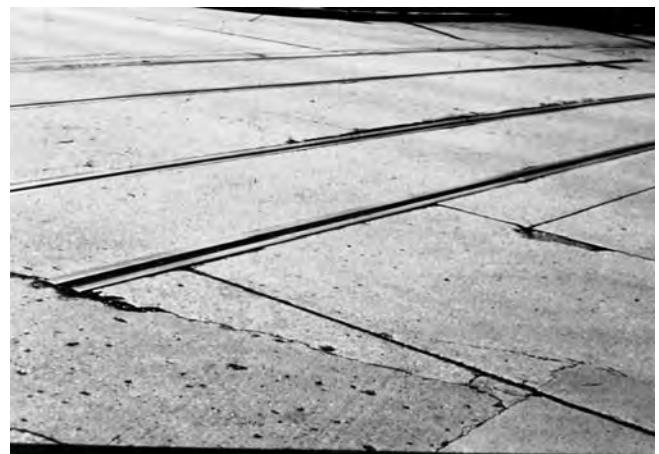
FIG. X2.38 Low-Severity Railroad Crossing

X2.17.1.1 **L**—Railroad crossing causes low-severity ride quality (Fig. X2.38).

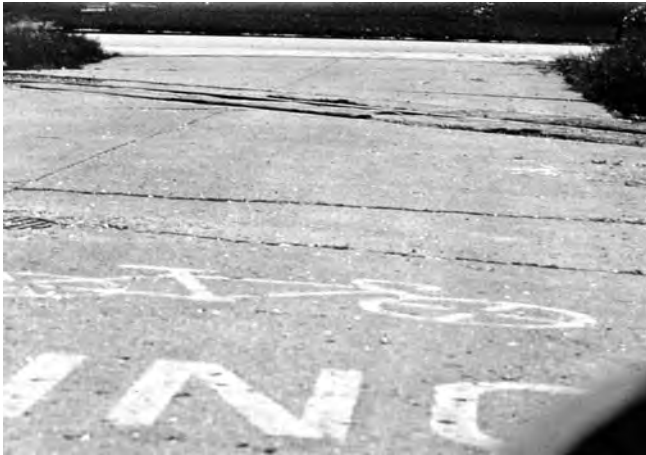
FIG. X2.39 Medium-Severity Railroad Crossing

X2.17.1.2 **M**—Railroad crossing causes medium-severity ride quality (Fig. X2.39).

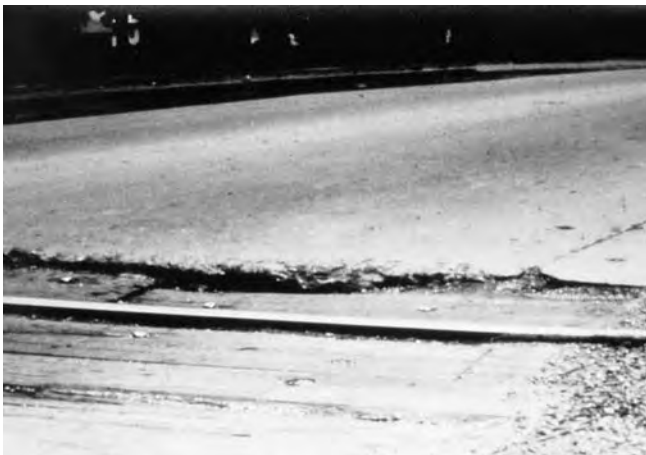
FIG. X2.40 High-Severity Railroad Crossing

X2.17.1.3 **H**—Railroad crossing causes high-severity ride quality (Fig. X2.40).

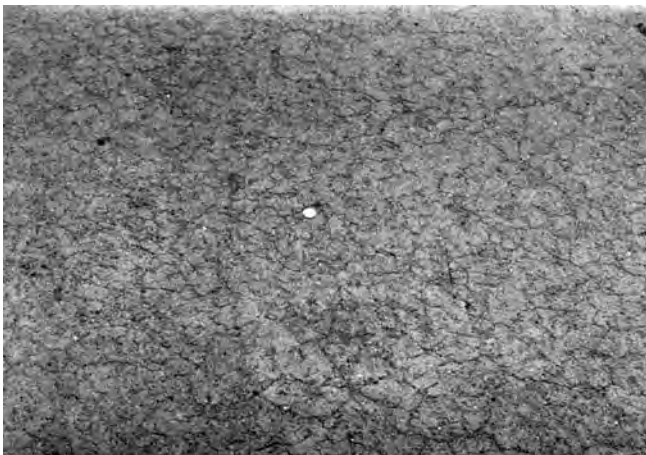
FIG. X2.41 Low-Severity Scaling, Map Cracking, and Craze

X2.18.1.1 **L**—Crazing or map cracking exists over most of the slab area; the surface is in good condition, with only minor scaling present (Fig. X2.41).

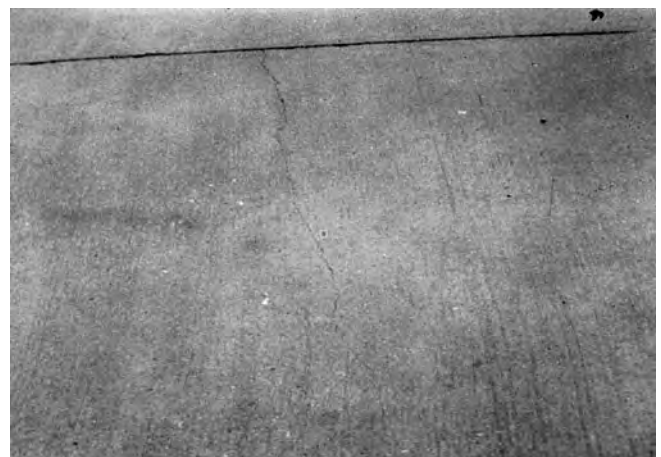
FIG. X2.44 Shrinkage Cracks

X2.19 *Description*—Shrinkage cracks are hairline cracks

that usually are less than 2-m long and do not extend across the entire slab. They are formed during the setting and curing of the concrete and usually do not extend through the depth of the slab.

X2.19.1 *Severity Levels*—No degrees of severity are defined. It is enough to indicate that shrinkage cracks are present (Fig. X2.44).

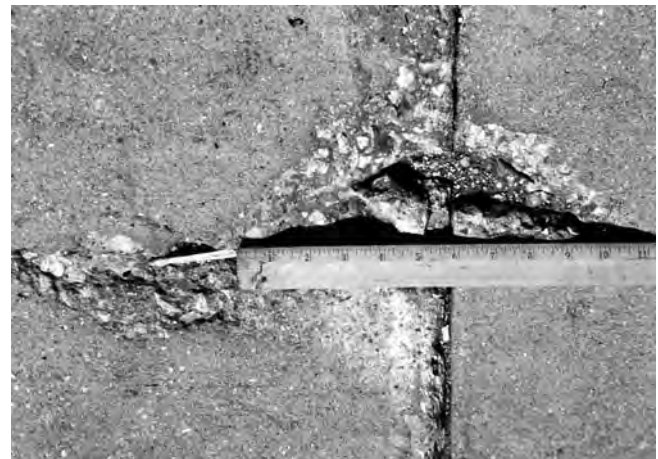
FIG. X2.46 Medium-Severity Spalling, Corner

X2.20.1 *Severity Levels*—Table X2.3 lists the levels of severity for corner spalling. Figs. X2.45-X2.47 show examples. Corner spalling with an area of less than 650 cm (10 in.²) from the crack to the corner on both sides should not be counted.
