In the Matter of the Application of Hardin Wind Energy LLC for a Certificate of
Environmental Compatibility and Public Need for the Hardin Wind Farm.

**Phase 3 – Compliance with Condition 24, Case No. 09-479-EL-BGN –
Delivery Route Plan**

Hardin County Wind Farm

Road Condition Report

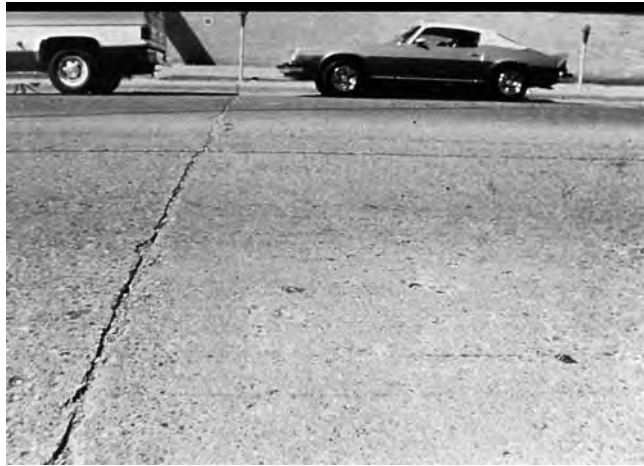
FIG. X2.48 Low-Severity Spalling, Joint

X2.21.2 *Severity Levels*—Table X2.4 and Figs. X2.48-X2.50 show the severity levels of joint spalling. A frayed joint where the concrete has been worn away along the entire joint is rated as low severity.

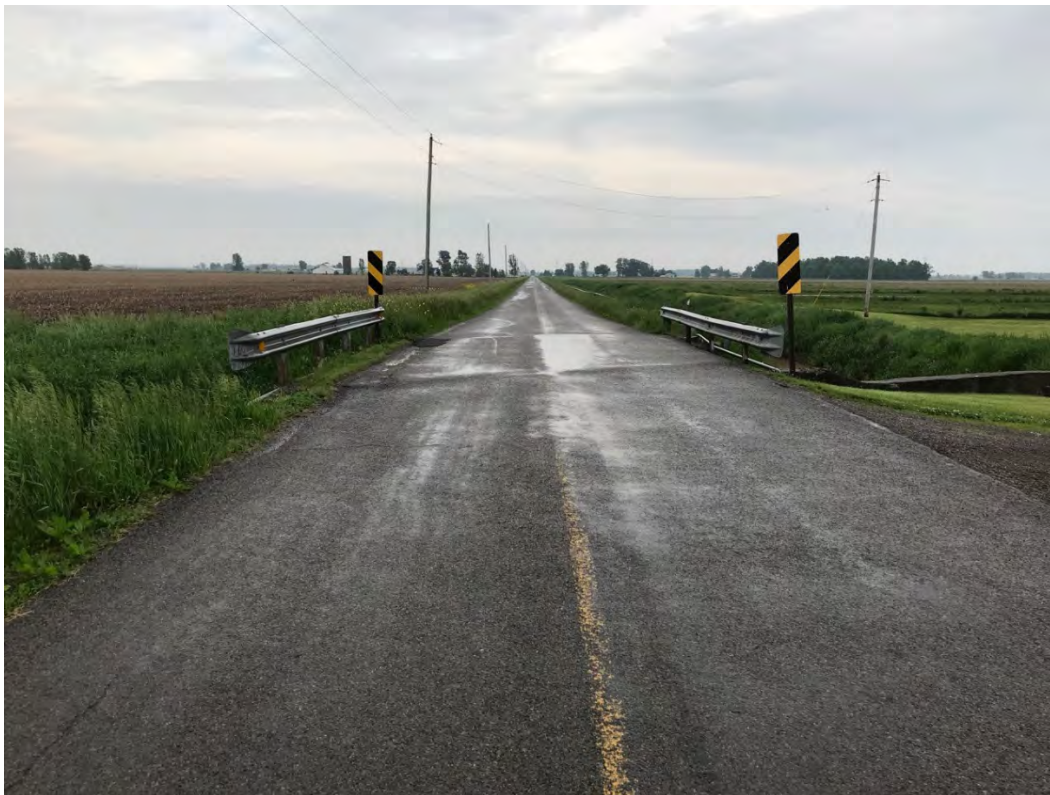
Figure 3-1 CR-35 STA 52+00

While investigating the potential dip and bump locations in the field, they were determined to be inconsequential. The majority of the potential dips and bumps were found to be either nonexistent or locations where the road was flat but passed over ditches, streams, or rivers. Figure 3-1 shows the locations identified in the profile from Figure 2-2.

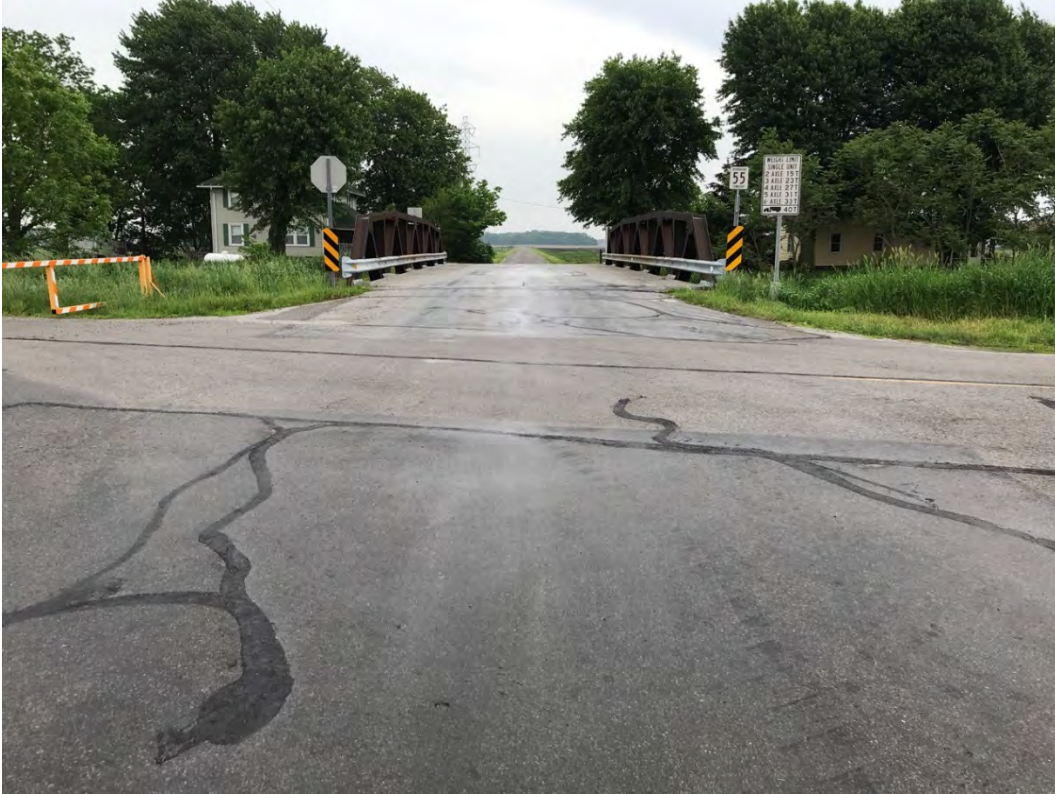
Figure 3-2 CR-130 Bridge from west

One of the dips and bumps identified prior to the field investigation was determined to require further investigation by the Invenergy transportation coordinator. This location was along County Road 130, just east of the intersection with Township Highway 195. At this location, there is an approximately 90-foot long bridge, with a 20 foot ramp on either end, each with an estimated 6-12 inch increase in elevation. Figures 3-2 and 3-3 show the bridge approaches.

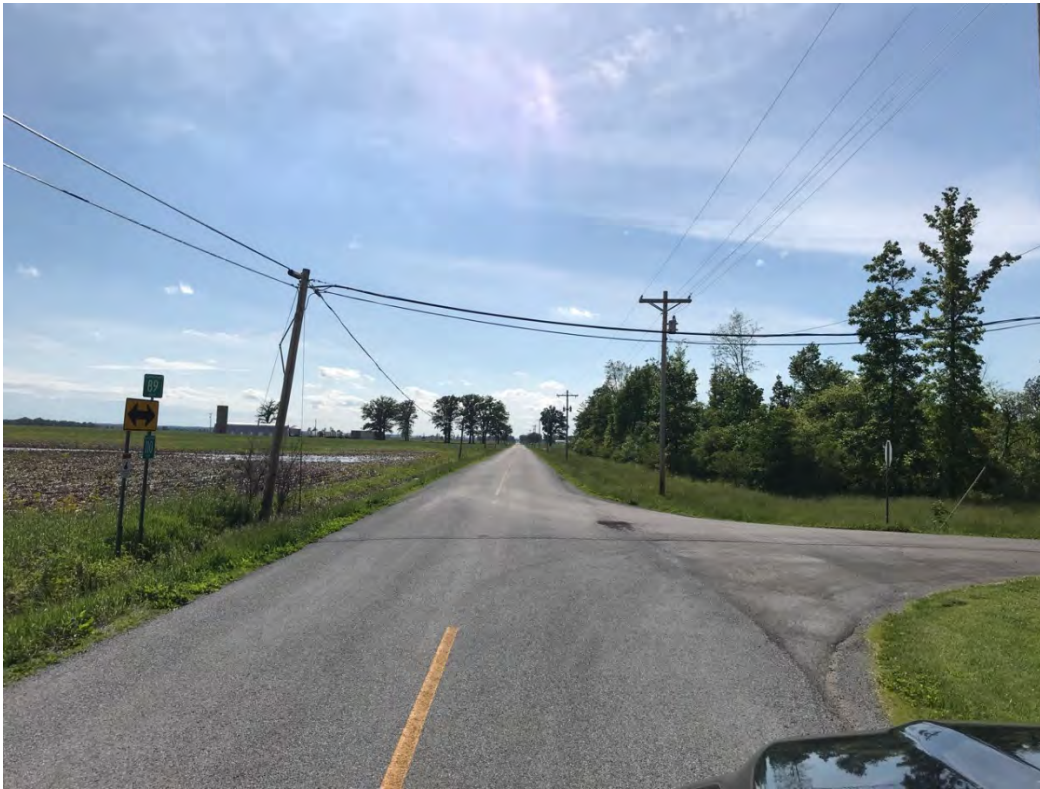
Figure 4-1 Low utility crossing

The majority of these have an estimated minimum height of 20 feet or more above the road, but 14 will require further investigation by the Invenenergy transportation coordinator. Figure 2 shows all the crossing and identifies those requiring further investigation as “Low Crossing Location” (See Appendix A). An example of low utility crossing is shown in Figure 4-1.

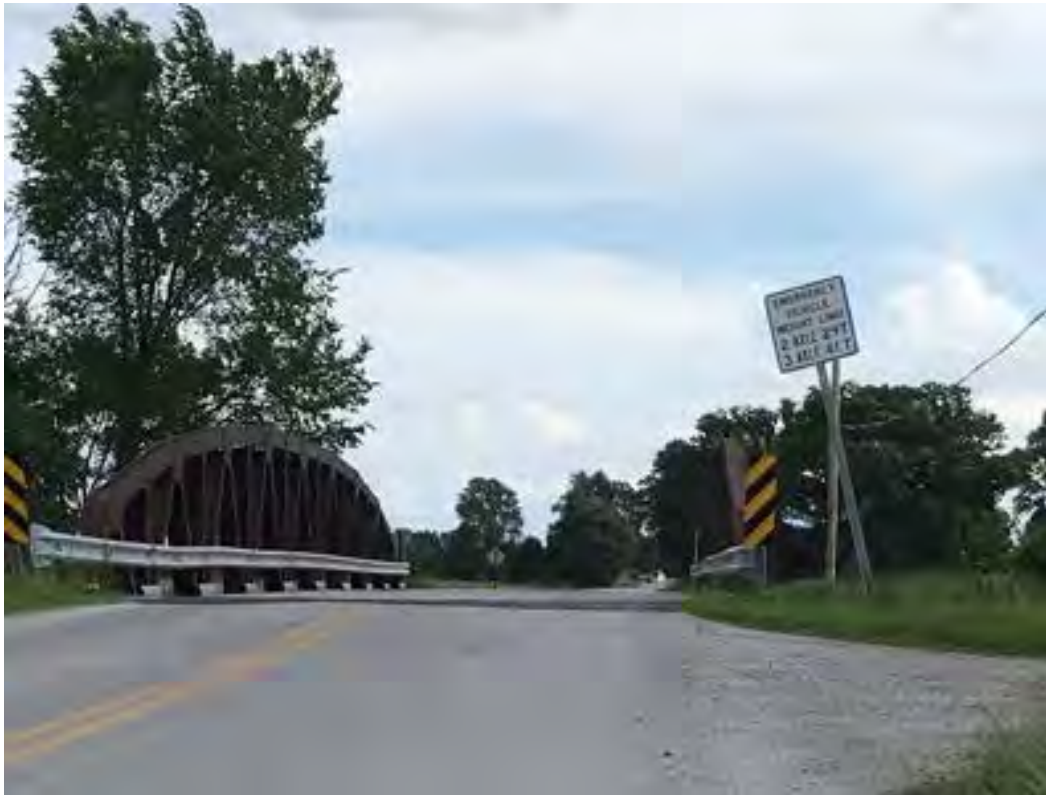
Figure 5-1 CR-95 bridge posting

WHKS performed a preliminary bridge condition assessment prior to bridge rating (See Appendix B). Initial assessment show all bridges to be satisfactory. The bridges can be used by construction vehicles adhering to Ohio legal loads with the exception of bridge 3334406 (CR-95 over Scioto River) and bridge 3346935 (CR-130 over Scioto River) which are posted. Posted limits must be followed for these locations. Figures 5-1 and 5-2 show the postings.
