**Phase 3 – Compliance with Condition 57(a), Case No. 09-479-EL-BGN –  
2018 and 2019 Wetlands Delineation Reports (Turbine Foundations and Access  
Roads)**

**WETLANDS AND OTHER WATERS OF THE U.S.  
DELINEATION REPORT**

**Hardin Wind Energy Project**

**Hardin County, Ohio**

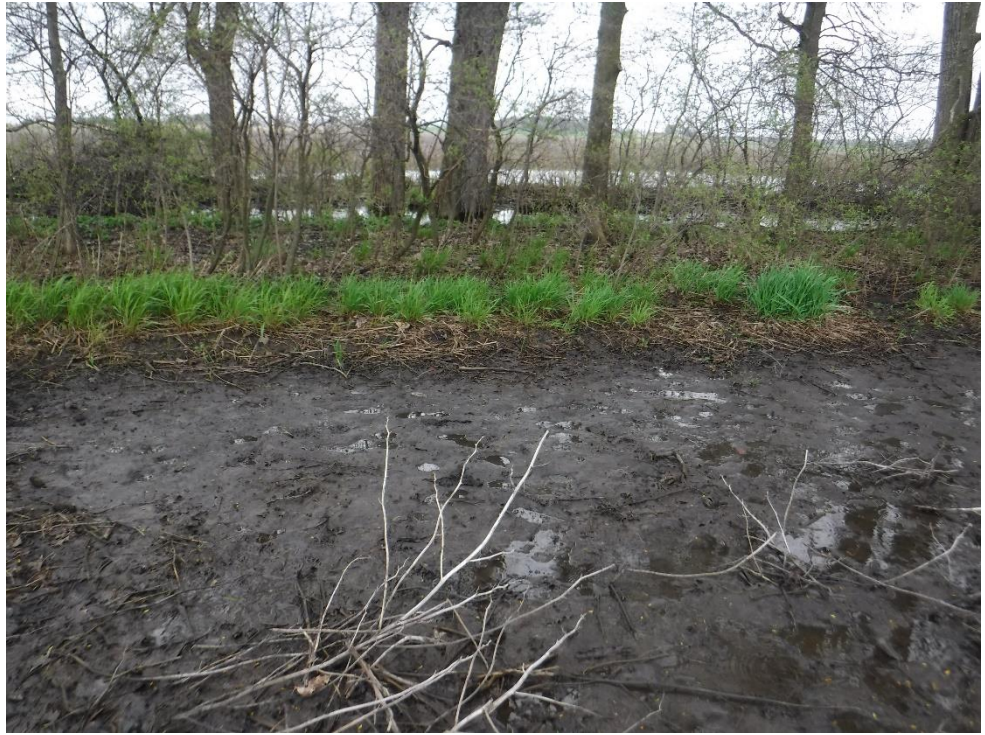
**Description:**  
Photo of Wetland W-SKB-01 facing north.

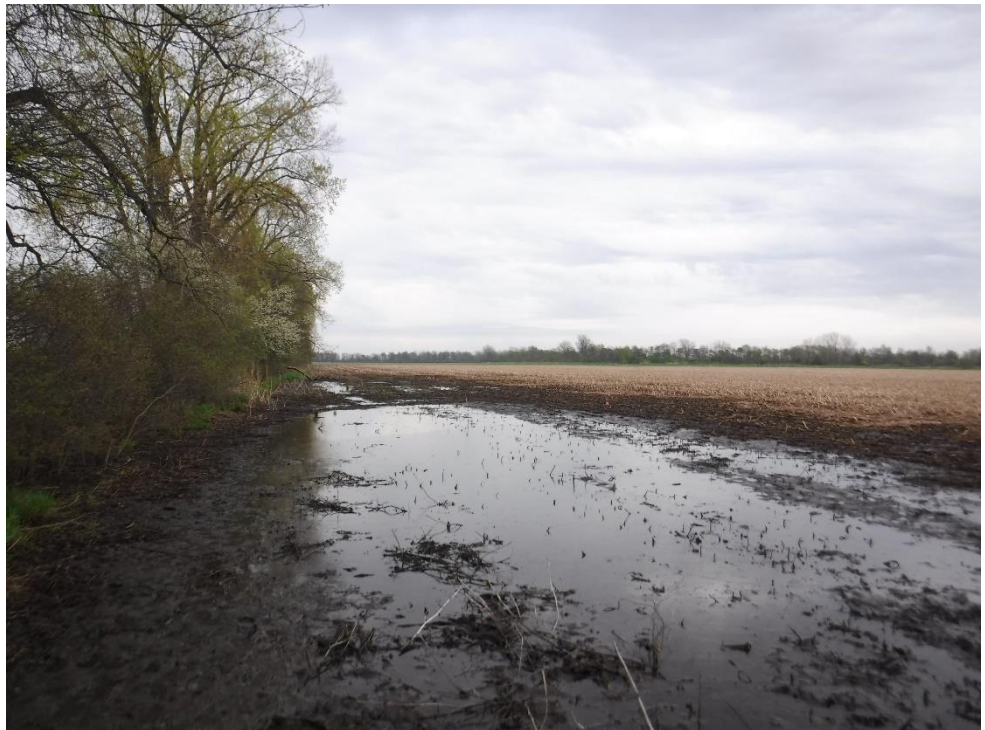
**Photo No. 2.**

**Description:**  
Photo of Wetland W-SKB-01 facing east.

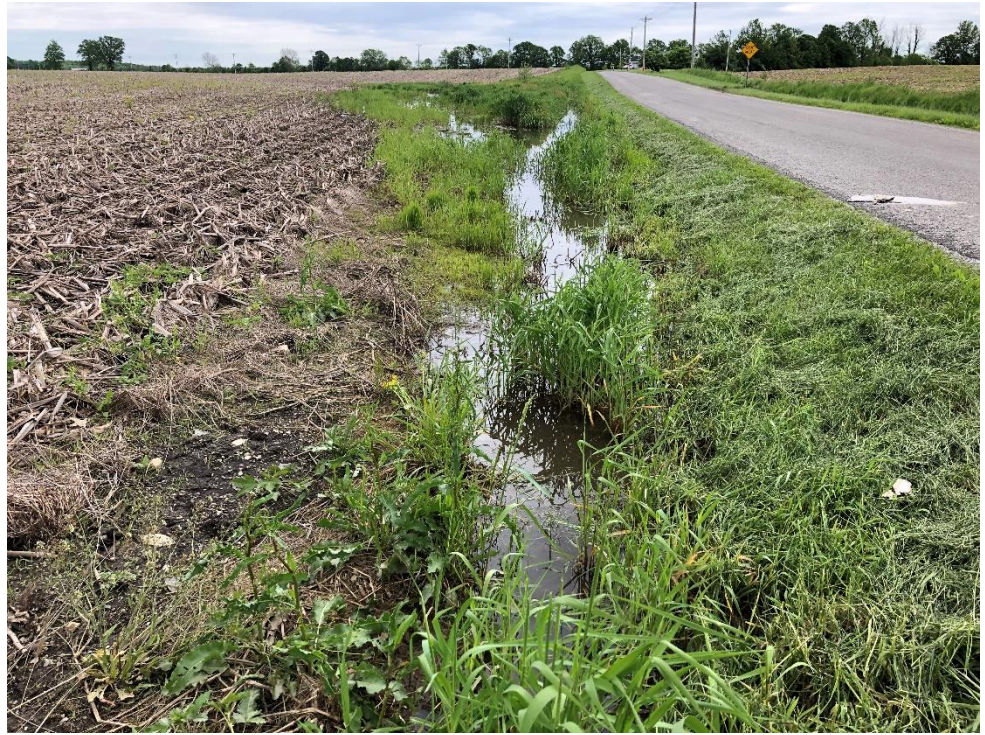
Photo of Wetland HW-MM. The wetland was extended as part of the May 2019 Hardin Wind field investigations.

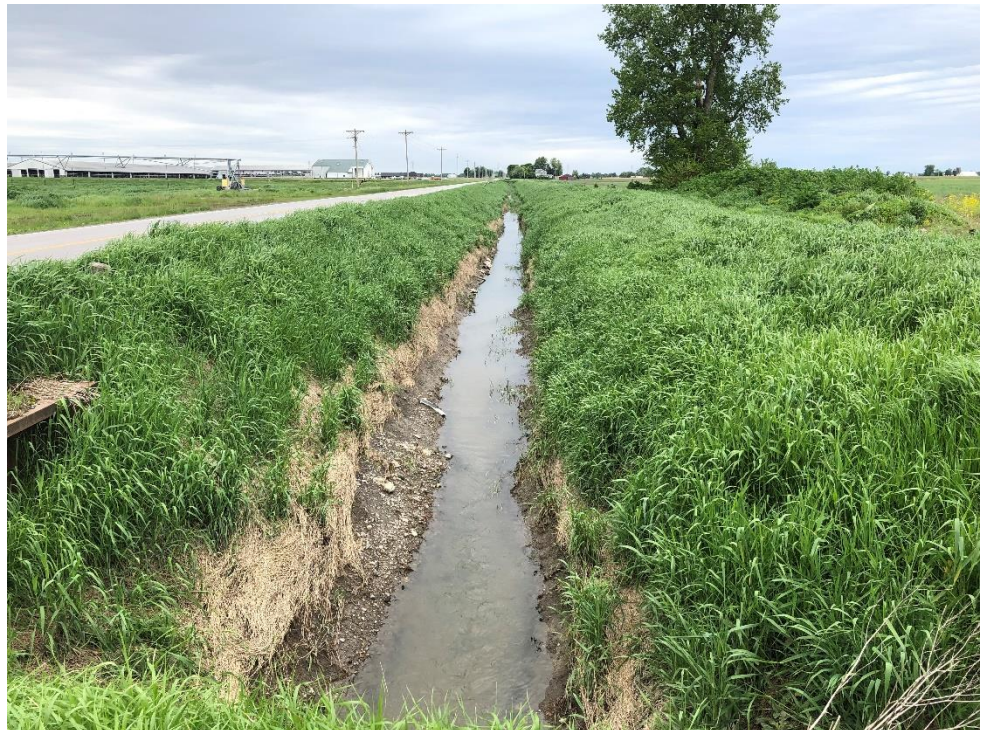
**Photo No. 6.**

Photo of Stream HW-M9. The stream was extended as part of the May 2019 field investigations.
