MEMORANDUM

TO: Equitrans Midstream, LLC
FROM: Samantha Zelenka
DATE: September 13, 2019
PROJECT NAME: EHP418_000 Pipeline **PROJECT NO.** 102502114
SUBJECT: Aquatic Resources Investigation

INTRODUCTION

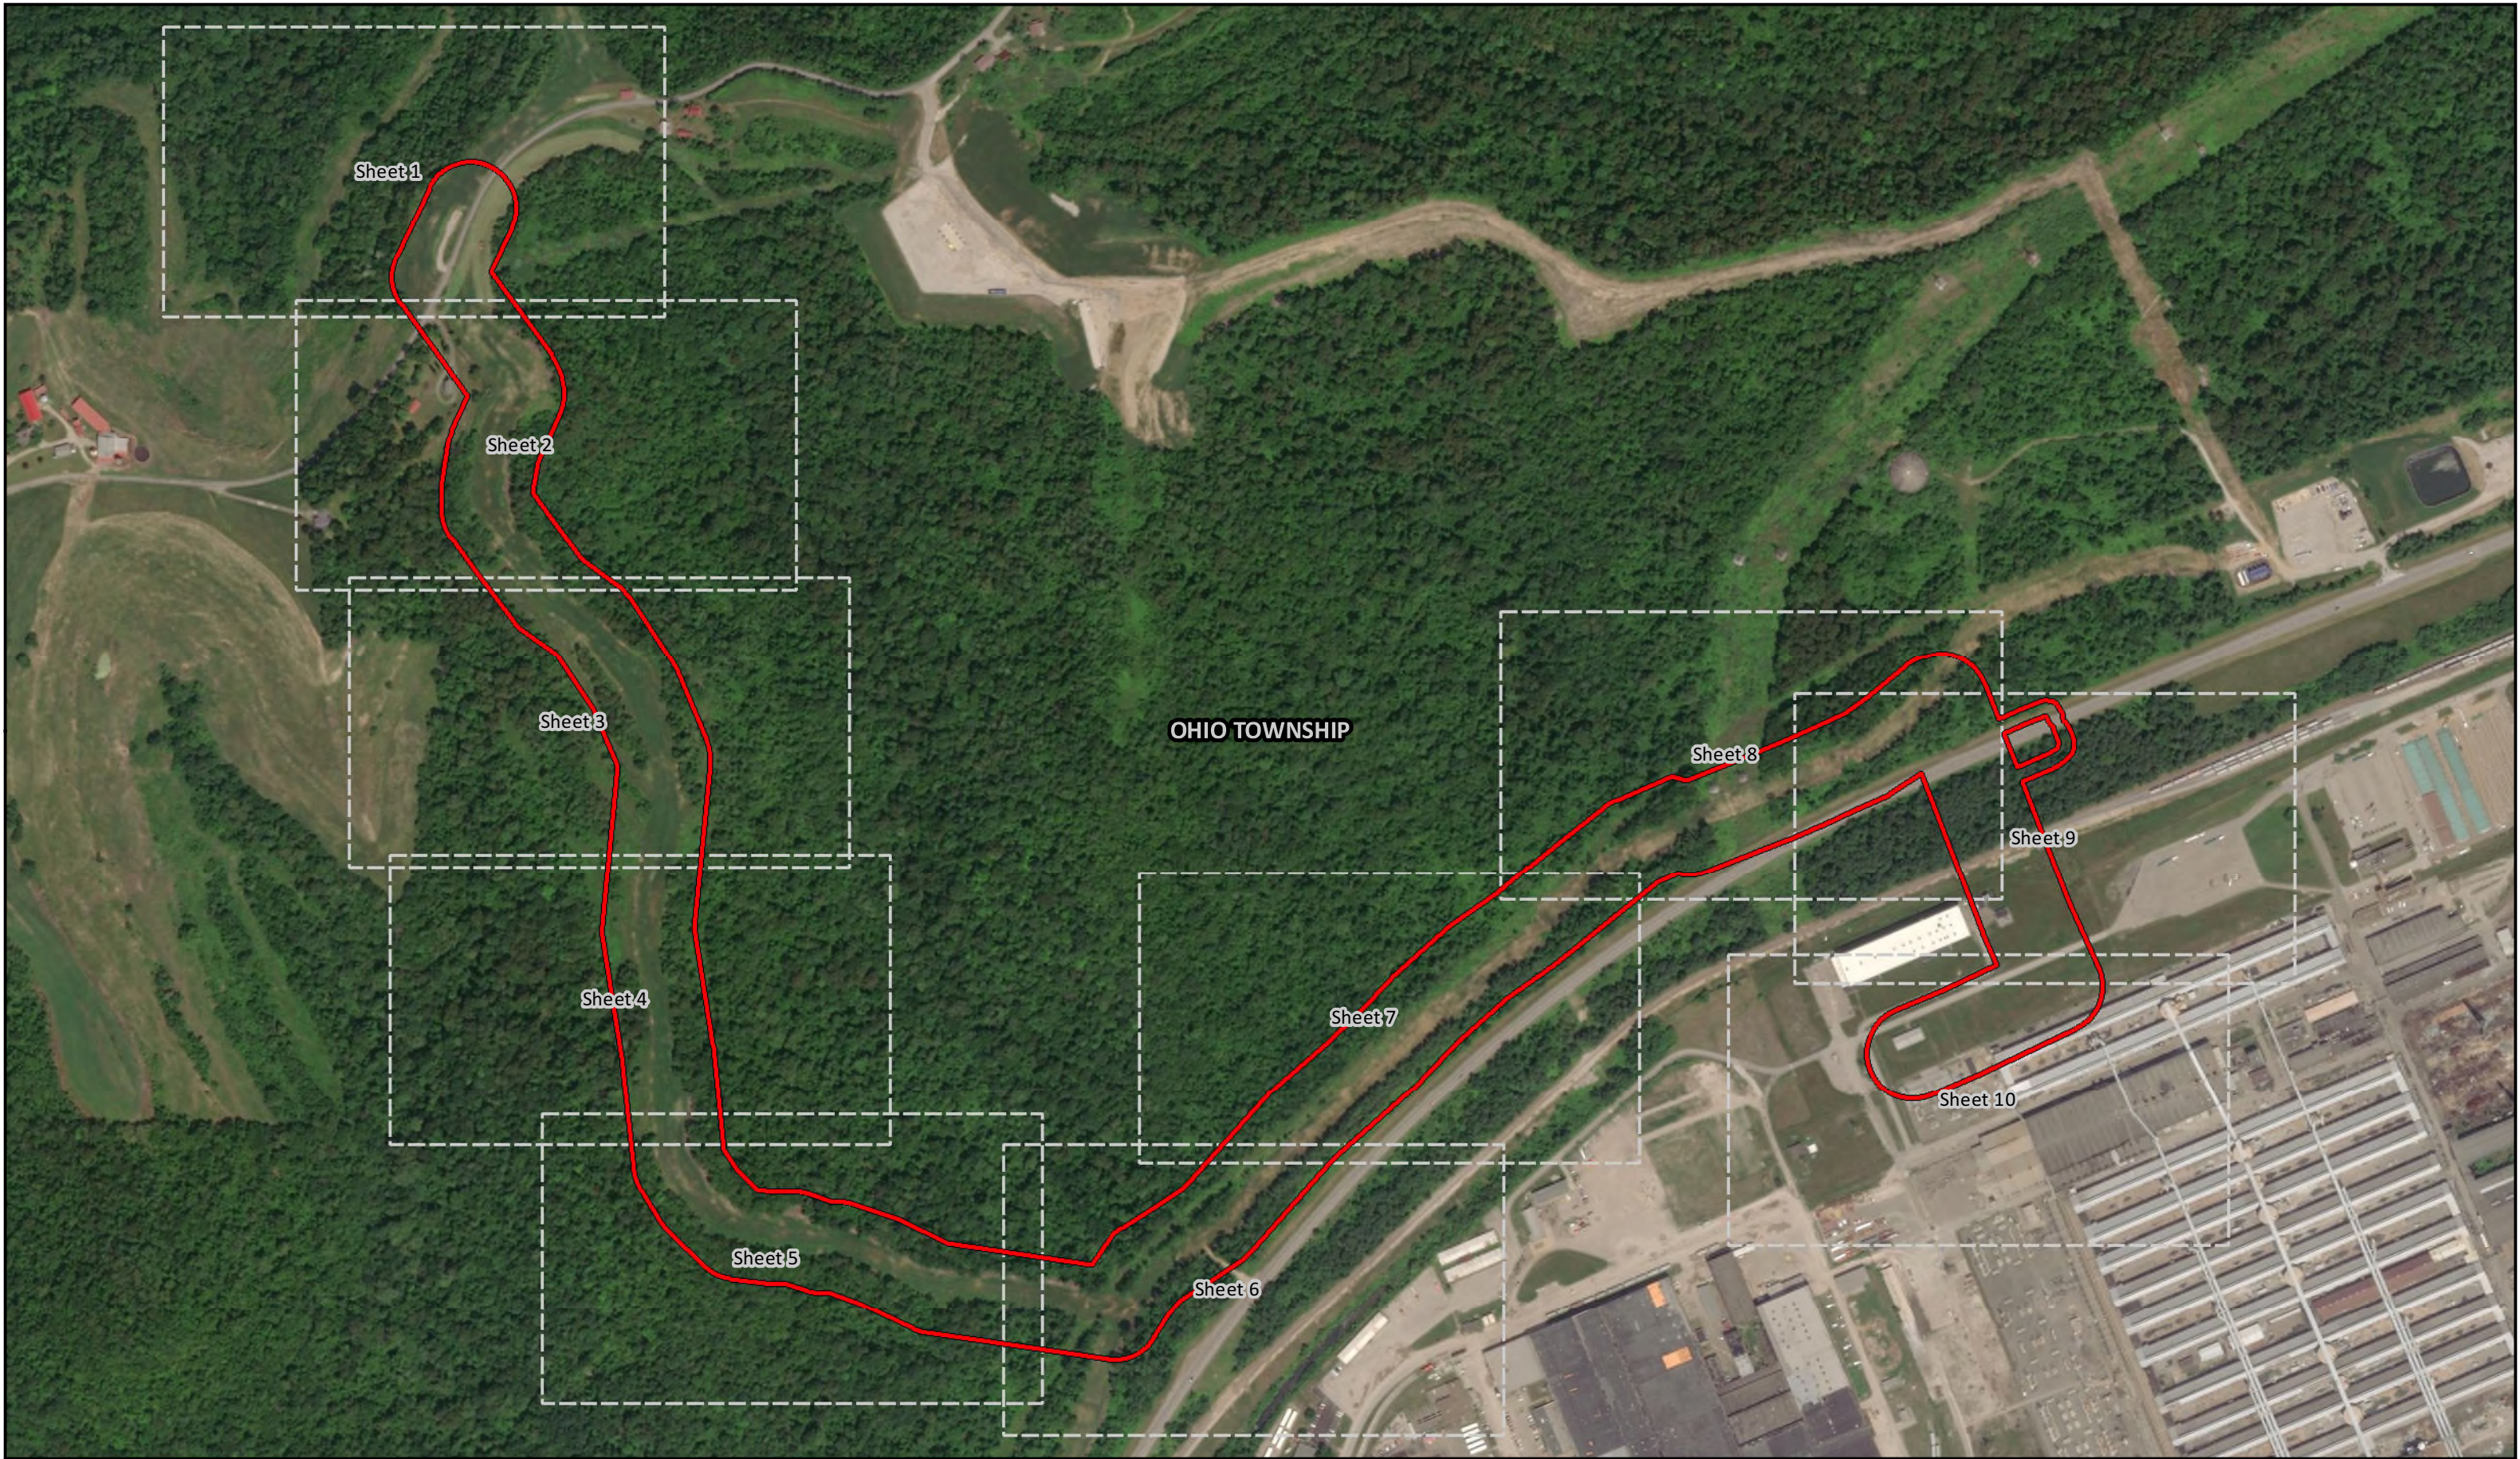
Equitrans Midstream, LLC
EHP418_000
Figure 2 - Aerial Basemap
Ohio Township, Monroe County, OH
Project No. 102502114

The AOI consists of young deciduous forests and existing utility rights-of-way (ROW). Twelve streams and three wetlands were identified within the AOI. The following descriptions provide summaries of the uplands, wetlands, and streams. Please refer to **Attachment A, Figure 2** for an aerial overview of all features referenced in this report.
