# Letter of Notification Highland-GM 138 kV Transmission Line Loop to Magellan Substation Project Case No. 20-1176-EL-BLN

In this Project, ATSI is proposing to construct the new 138 kV 11-breaker breaker-and-a-half (future 12 breaker) Magellan Substation, which will be approximately 106,250 square feet in size. The Project also proposes an approximately 0.5-mile long 138 kV transmission line loop connecting the new Magellan Substation to the Highland-GM 138 kV Transmission Line. The Magellan Substation will serve a new ATSI customer, Ultium Cells LLC, and improve reliability in the area of the Project.

### Highland-GM 138 kV Transmission Line Loop to Magellan Substation Project Case Number 20-1176-EL-BLN

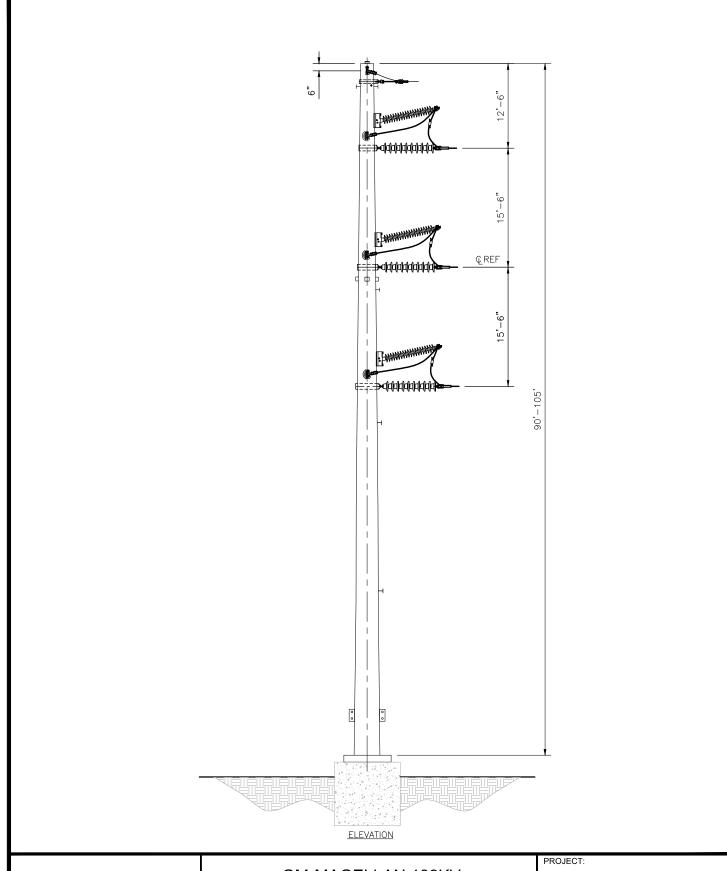
GM-MAGELLAN 138KV & HIGHLAND-MAGELLAN NO. 1 138KV SINGLE CIRCUIT TUBULAR STEEL POLE DEADEND 40-70 DEGREES

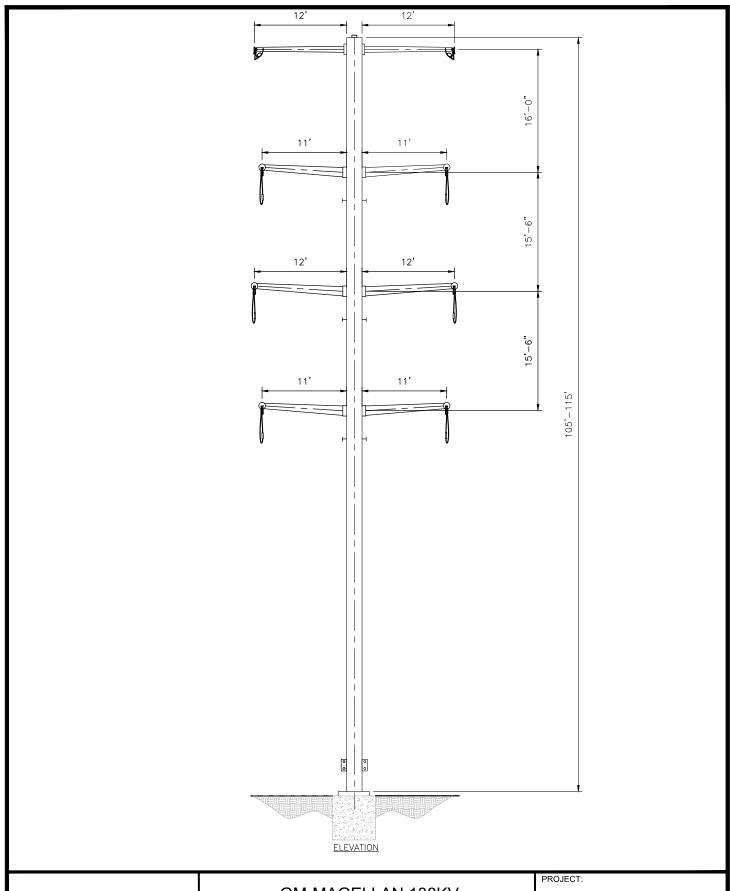
**GM-MAGELLAN 138KV** & HIGHLAND-MAGELLAN NO. 1 138KV DOUBLE CIRCUIT TUBULAR STEEL POLE **DEADEND 0-5 DEGREES**

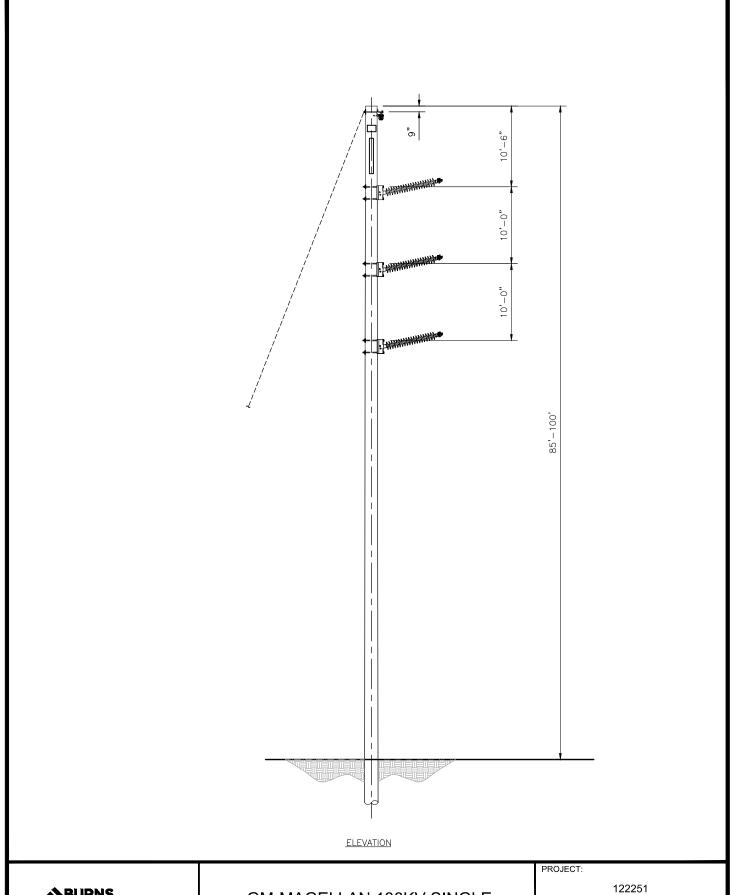
GM-MAGELLAN 138KV SINGLE CIRCUIT WOOD POLE TANGENT 0-15 DEGREES

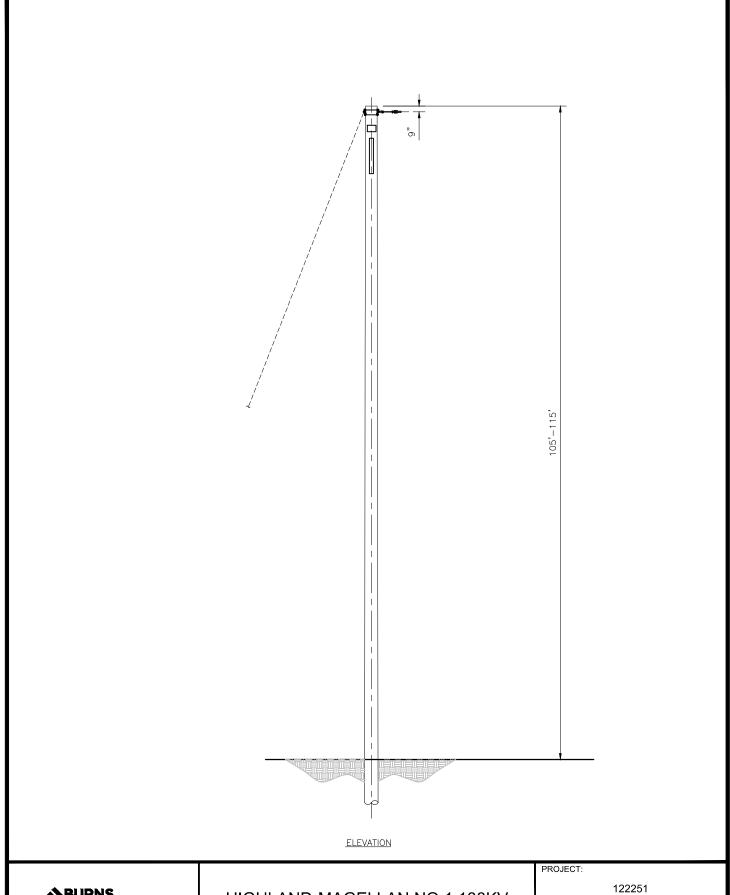
HIGHLAND-MAGELLAN NO.1 138KV SHIELD WIRE ONLY STEEL POLE ONE SIDED DEADEND

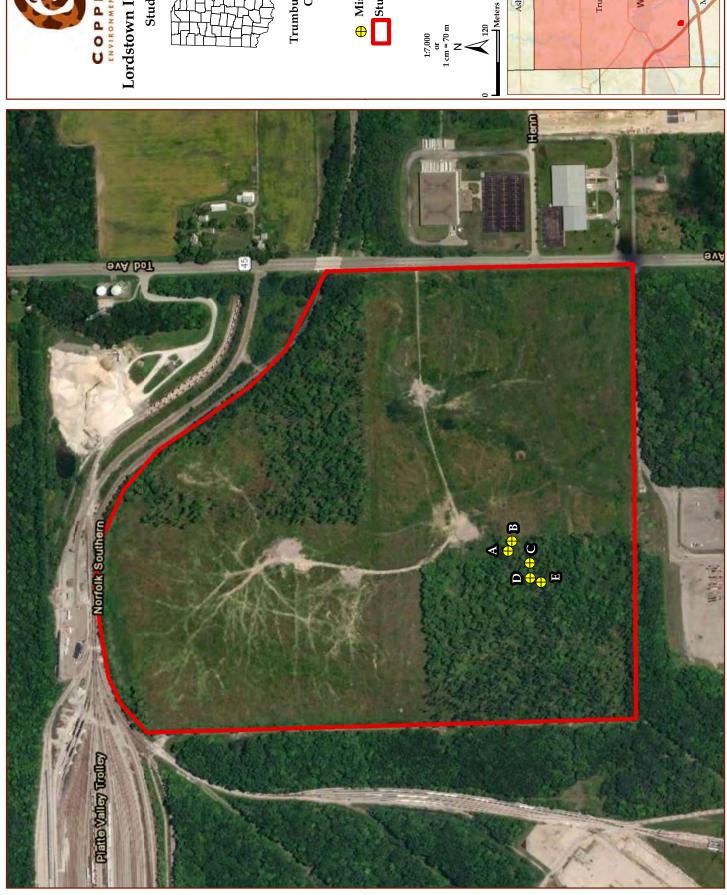
Figure 1. Mist-net locations for the proposed NorthPoint Development of the Lordstown Industrial Park, Trumbull County, Ohio. Summer 2018.

Mist-Net	Dates Surveyed (2018)*	No. of Net Nights	Latitude	Longitude
A	6 June	1	41.15054	-80.86351
В	6-7 June	2	41.15047	-80.86329
С	6-7 June	2	41.15018	-80.86378
D	6-7 June	2	41.15018	-80.86411
Е	6-7 June	2	41.15000	-80.86421

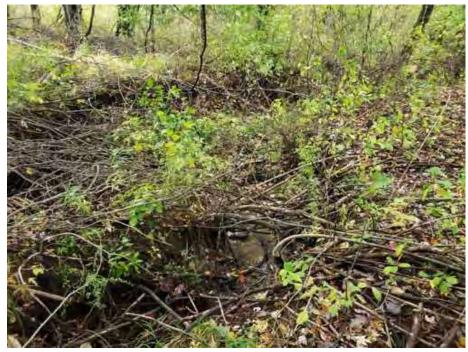
Photo 7: View of incised banks of Stream 1. (Photo taken 10/16/2019)

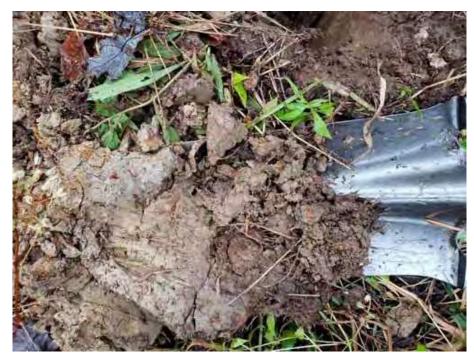
Photo 9: Depleted matrix (F3) soil profile at DP17 which is typical for wetland areas throughout the Site. (Photo taken 10/17/2019)

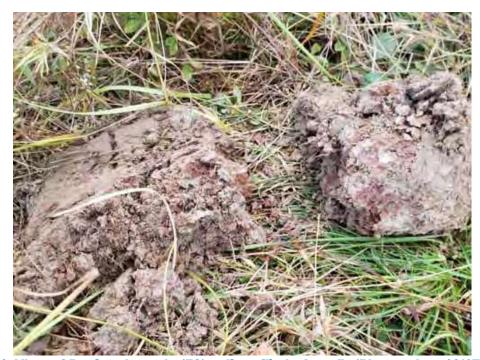
Photo 14: View of Depleted matrix (F3) soil profile in Area B. (Photo taken 10/17/2019)
