# CONSTRUCTION NOTICE FOR Licking Co-Op Extension – Bladensburg 138kV Transmission Line Project

PUCO Case No. 20-1474-EL-BNR

Submitted to:  
The Ohio Power Siting Board  
Pursuant to Ohio Administrative Code  
Section 4906-6-05

Submitted by:  
Ohio Power Company

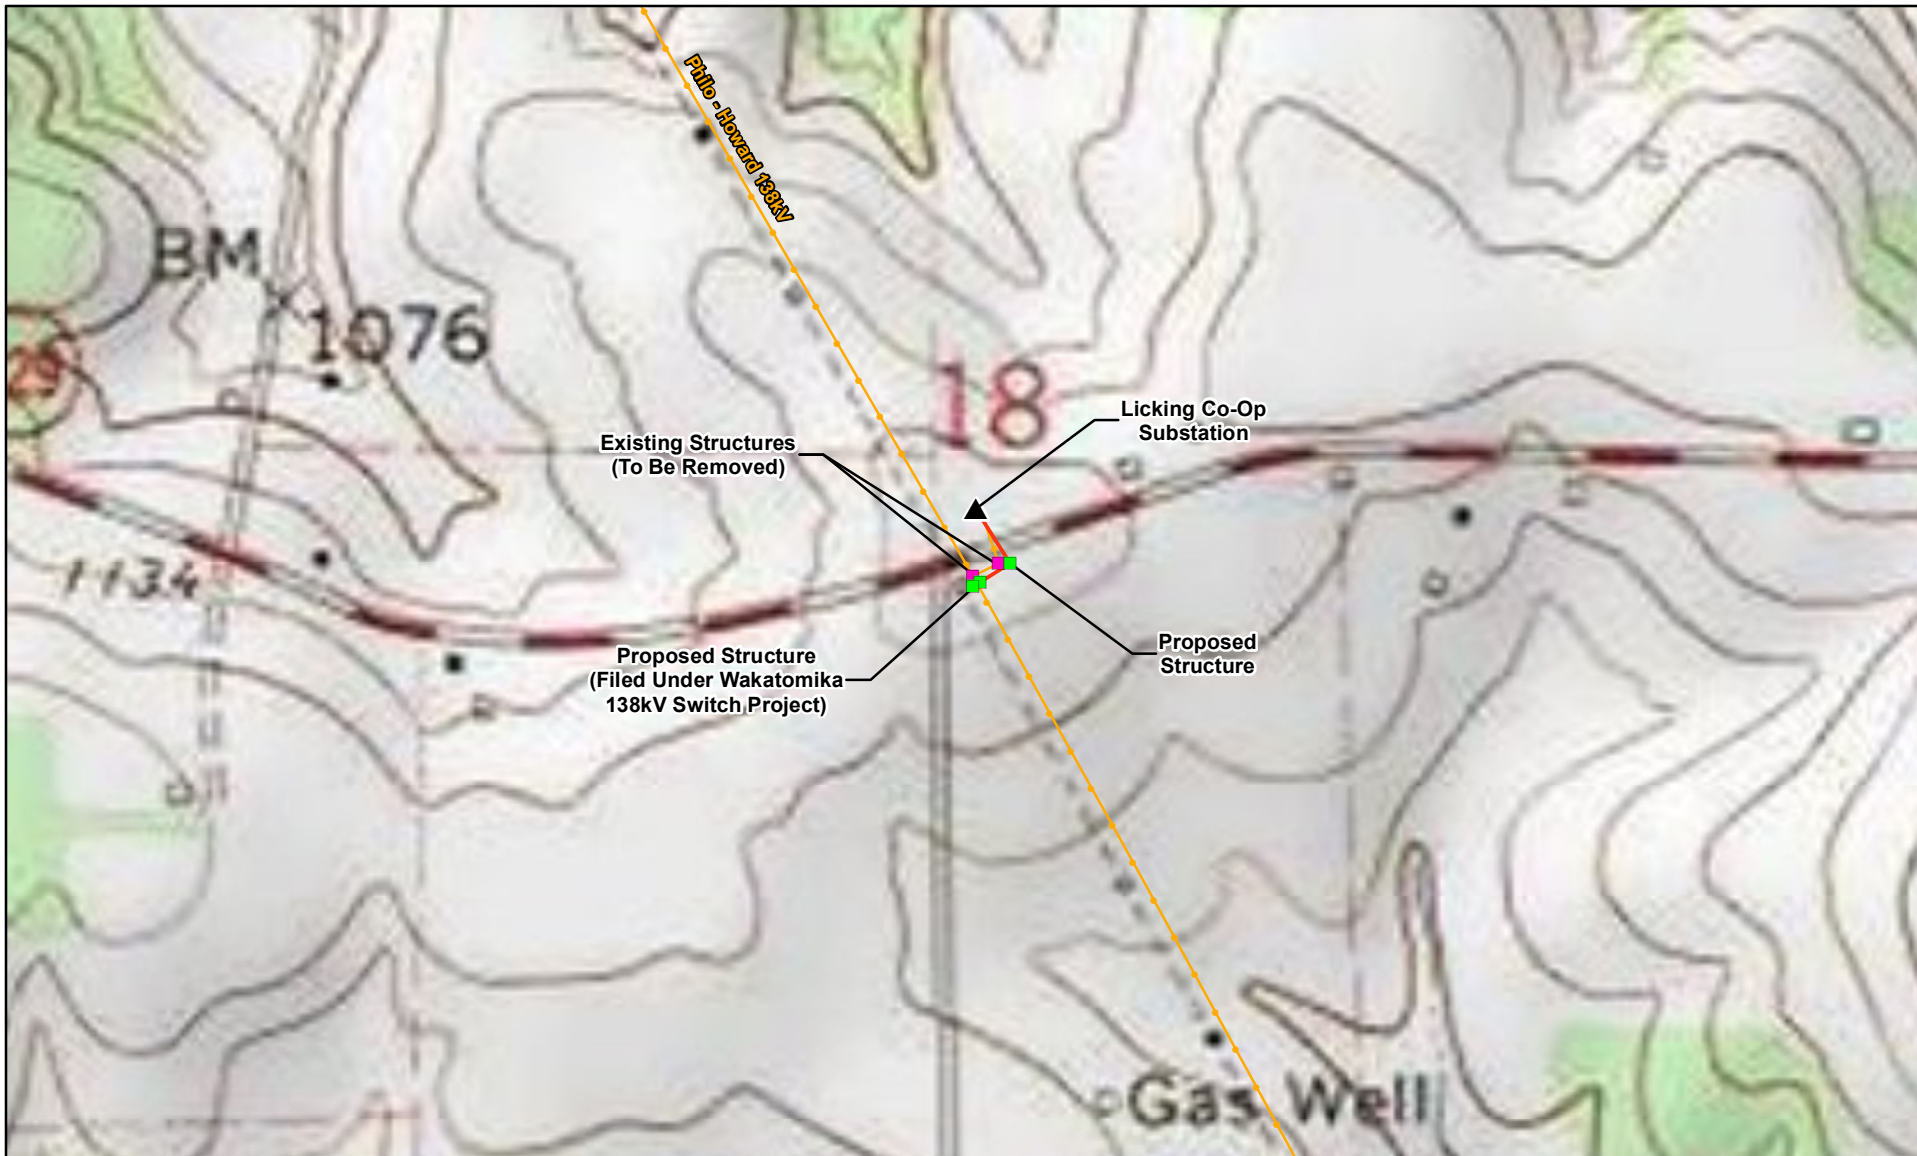
#### Map 1 Project Location Map

Map 1 included in Appendix A identifies the location of the Project area on a United States Geological Survey 1:24,000 quadrangle map. Map 2 in Appendix A is an aerial map of the Project area.

The location of the Project in relation to existing transmission lines and substations is shown on Map 1 in Appendix A.

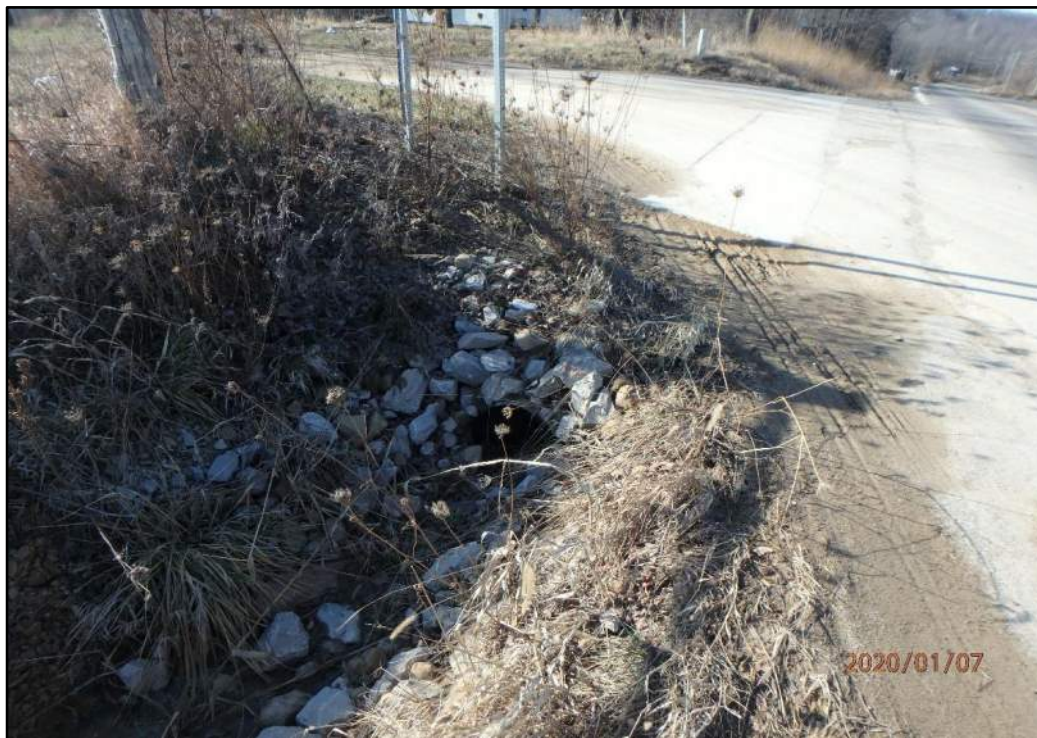
**Photograph 1. Culvert at road crossing, Facing West**

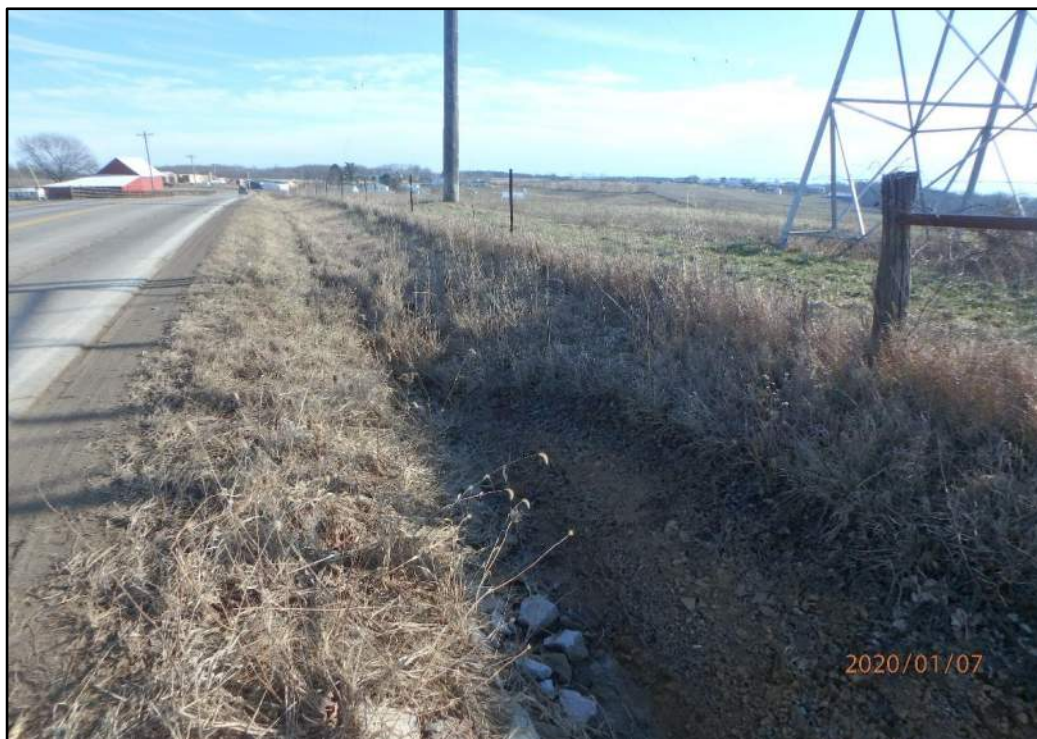
**Photograph 2. Ditch 001, Facing East**

One non-jurisdictional ditch and no stream segments were identified within the Project study area. Information on the delineated waterbodies and their classifications can be found in Table 1, and photographs of the identified resources are included in Appendix A.
