**Case ID - Case Name:** 19-1823-EL-BGN - Big Plain Solar  
**Company Name:** Big Plain Solar, LLC  
**Amendment(s):** 21-1196-EL-BGA  
**Related Case(s):** 21-1174-EL-BLN  
**Case Status:** Under Construction  
**Certificate Approved Date:** March 18, 2021  
**Construction Start Date:** March 10, 2022  
**Case Type:** Solar Generation  
**Capacity, Acreage:** 196.0 MW, 2438 acres  
**County(s):** Madison  
**Township(s):** Fairfield, Oak Run  
**Report Number:** CI23-19-1823-001R4

Summary: Report containing Staff's fourth interim report filed in regard to Big Plain Solar compliance inquiry CI23-19-1823-001 electronically filed by Eric R. Morrison on behalf of OPSB Staff.

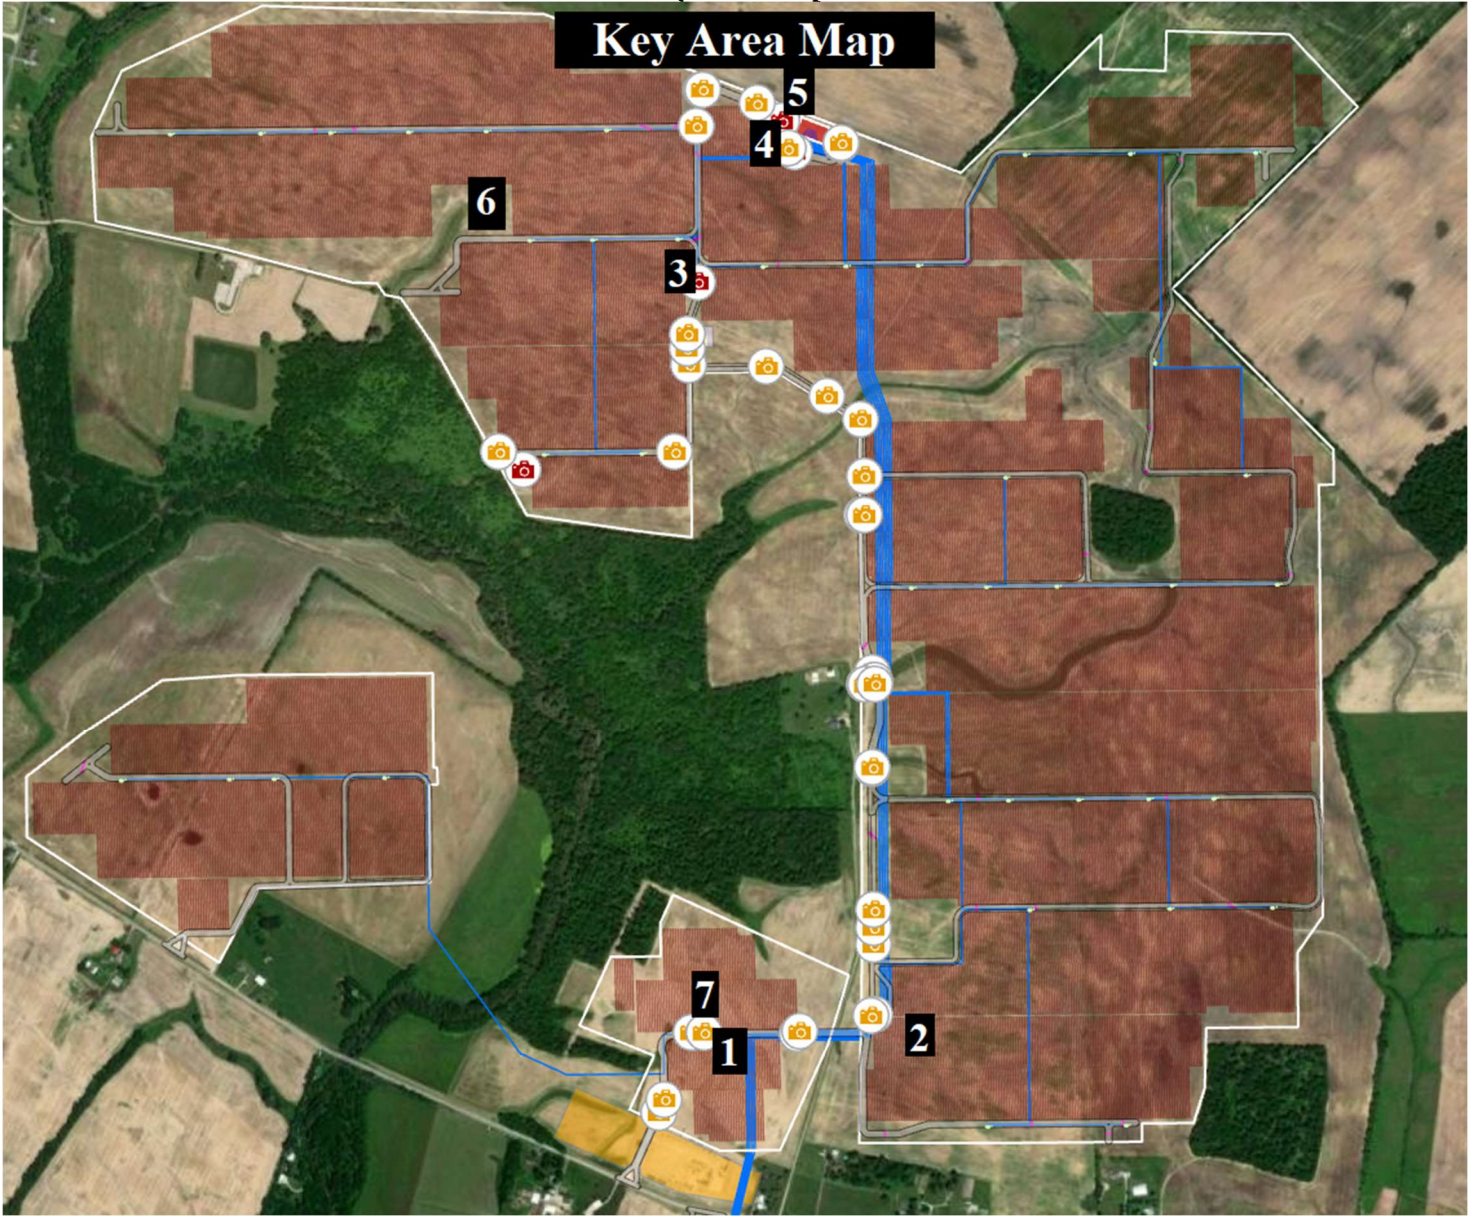
Key Area Map

On November 29, 2023, weather and ground conditions were sufficient to evaluate progress on impounded water remediation. Key areas 1, 4, 5, and 7 were dry. Key area 3 showed some inundation due mostly to a lack of gradient. However, maintenance crews were able to mow it. Key area 2 was mostly drained due to the installation of a hickenbottom.<sup>2</sup> The recent grading in key area 4 had been seeded but not mulched. Grading was still being attempted in key area 2 at the time of inspection.

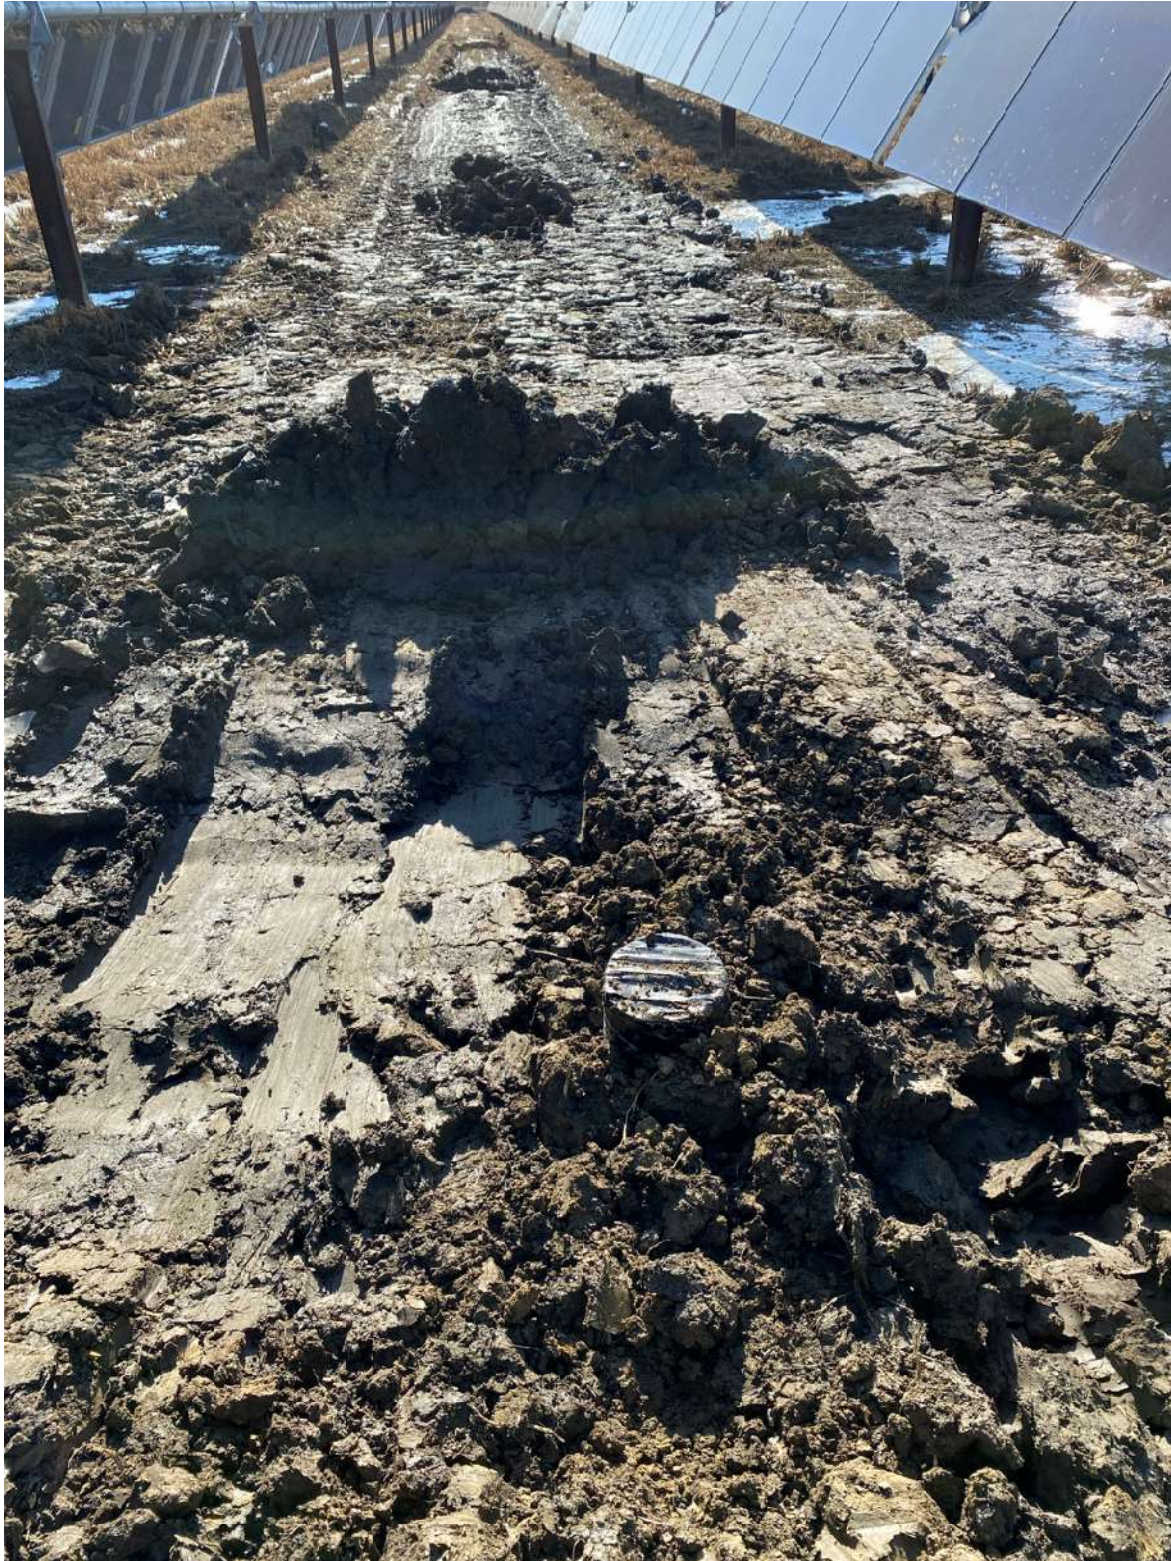
**Key Area 2 Hickenbottom**

Big Plain has not performed any kind of technical analysis of the drain tile system prior to introducing surface water control via the installation of hickenbottoms. Although the hickenbottoms appear to be functional, this is not a best management practice.

<sup>2</sup> A hickenbottom intake is a drainage pipe that allows surface water runoff to directly drain to the underground drain tile network.

- Staff requests Big Plain produce a map indicating the locations of hickenbottoms which are tied into the field tile system.
- Staff recommends monitoring neighboring properties for signs of irregular drainage patterns that may be caused by connecting hickenbottoms to the drain tile system.

- Staff is not supportive of installing future hickenbottoms at this or any other project without advance consultation with Staff as to the engineering rationale to support the need for this equipment.

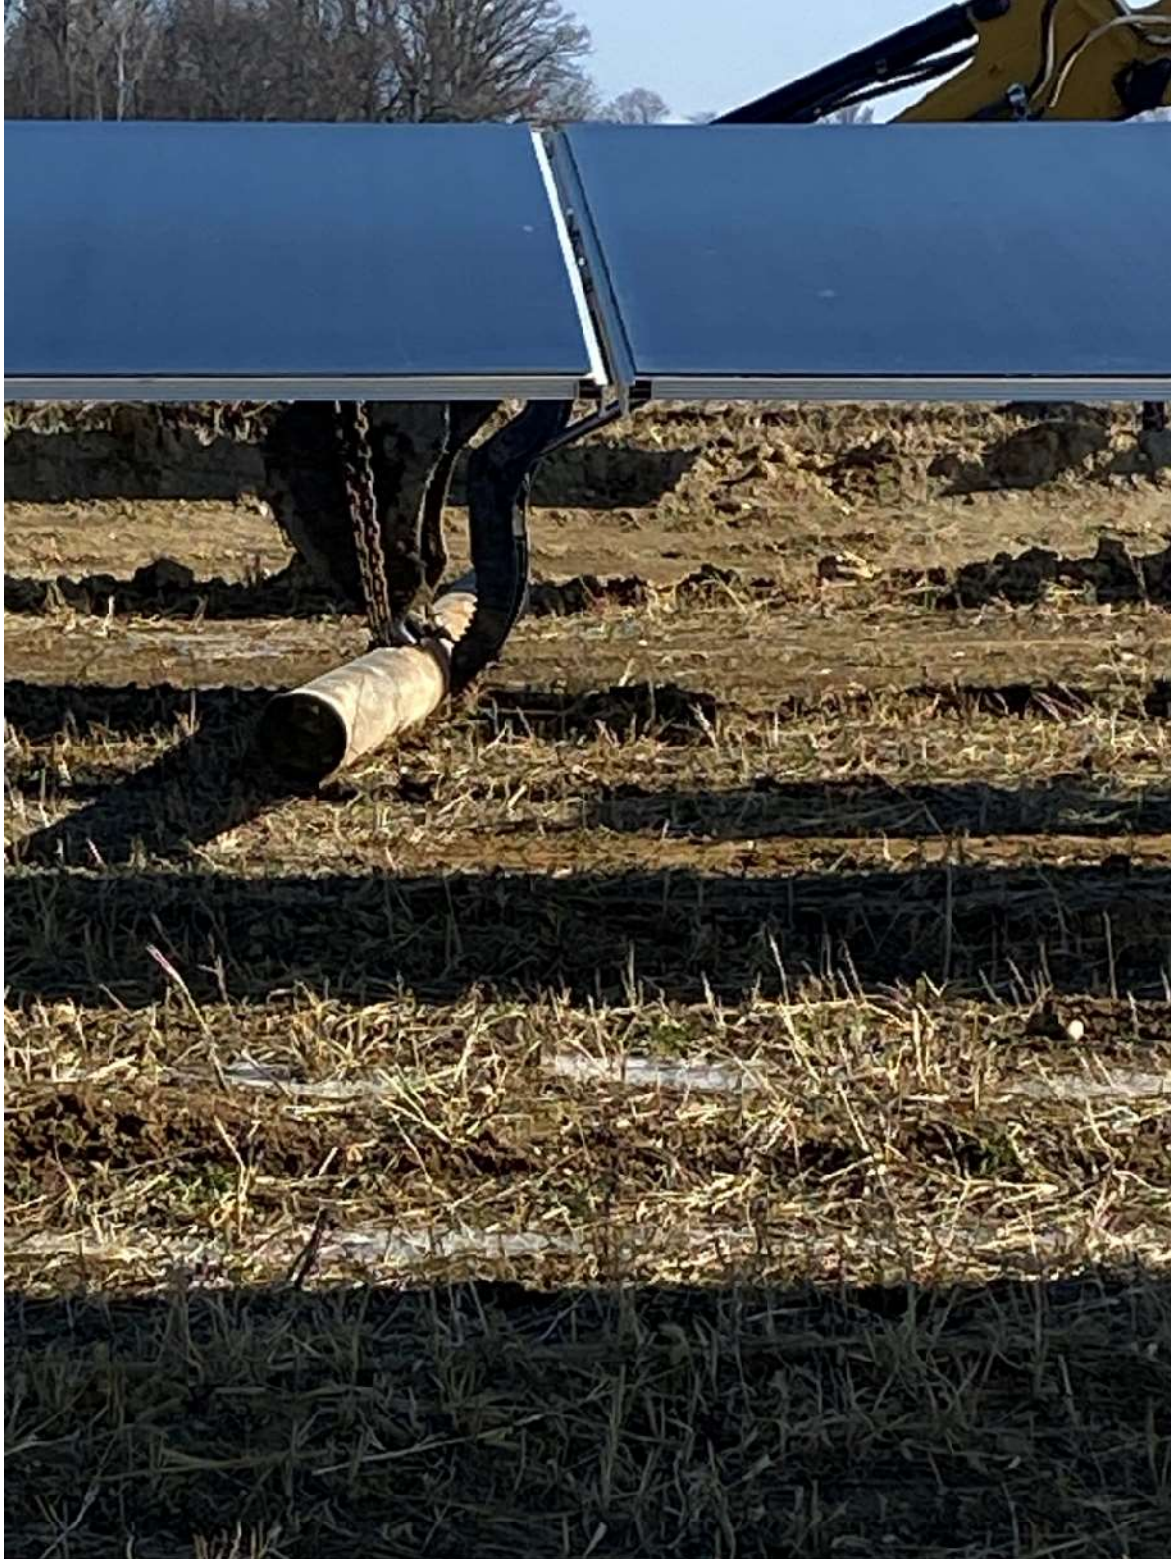
**Improvised grading tool and soil ridge rows**

Improperly graded ground still exists onsite. Though much progress has been made, the unfinished (rutted and ridged) areas will likely have to wait until the ground dries out. Recent restoration efforts have created more problems than they have fixed. Flattening ruts in the array rows has caused obstructive ridges of soil to form under the panels. An improvised grading mechanism utilizing a pipe chained to the bucket of an excavator was witnessed unsuccessfully attempting to mitigate the ridges.

- Staff recommends restoration activities involving grading be postponed until soil conditions allow for an appropriate finish. When that time comes, Staff also recommends acquiring equipment designed to perform the restoration work efficiently.
