Case ID - Case Name: 18-1334-EL-BGN - Hecate Energy Highland Solar Farm
Company Name: Hecate Energy Highland LLC
Case Status: Under Construction
Certificate Approved Date: May 16, 2019
Construction Start Date: January 14, 2022
Case Type: Solar Generation
Capacity, Acreage: 300.0 MW, 2,800 acres
County(s): Highland
Township(s): Clay, Whiteoak
Report Number: CI24-18-1334-001

Summary

Summary: Report detailing Compliance Inquiry CI24-18-1334-001 with regard to Hecate Energy Highland LLC solar project. electronically filed by Eric R. Morrison on behalf of OPSB Staff.

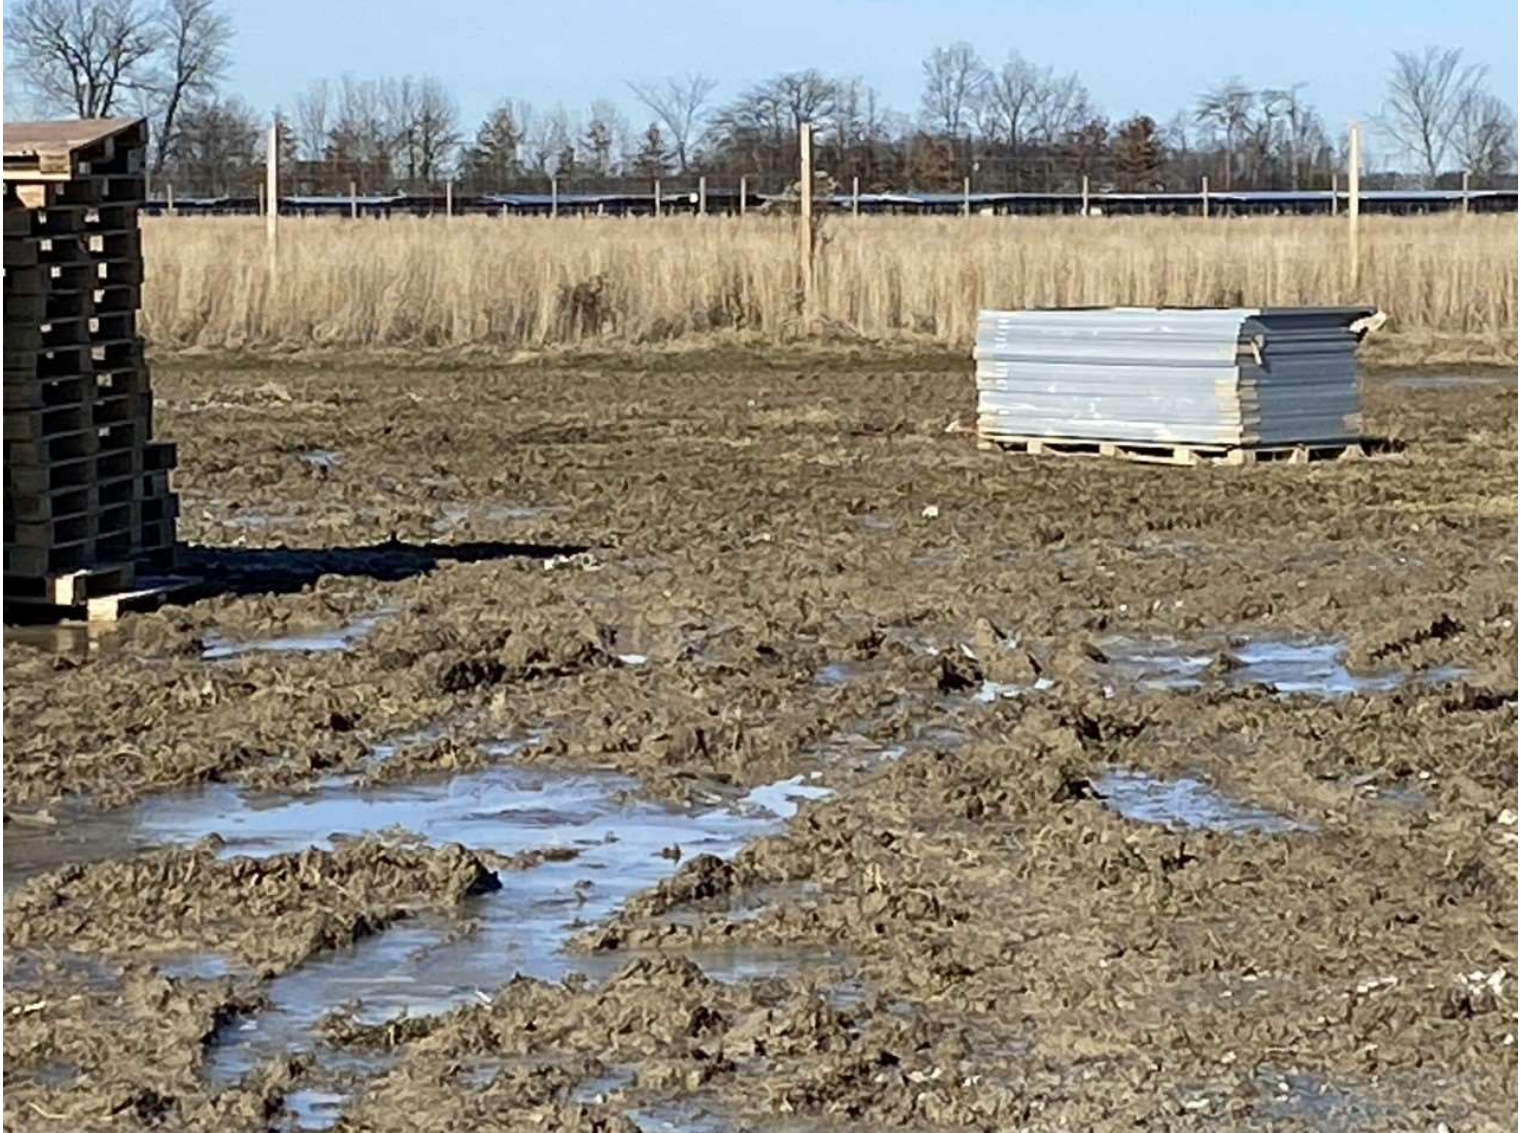
Photo 1: Example of material improperly stored in the middle of an un-stabilized area.

- Highland did not respond to Staff’s request to relocate construction materials stored⁴ on un-stabilized ground as well as vegetated ground. Construction materials stored in this manner for extended periods prevent vegetative growth, obstruct soil stabilization efforts, and encourage off-road travel. All dumpsters identified as being located on un-stabilized surfaces must be relocated to stabilized areas that include a stable route leading to and from the dumpsters. Staff expects these materials and dumpsters to be relocated to stabilized storage areas within 4 weeks of receiving this notification. This request does not include skids containing modules positioned for installation or materials about to be installed that are staged at the end of rows.

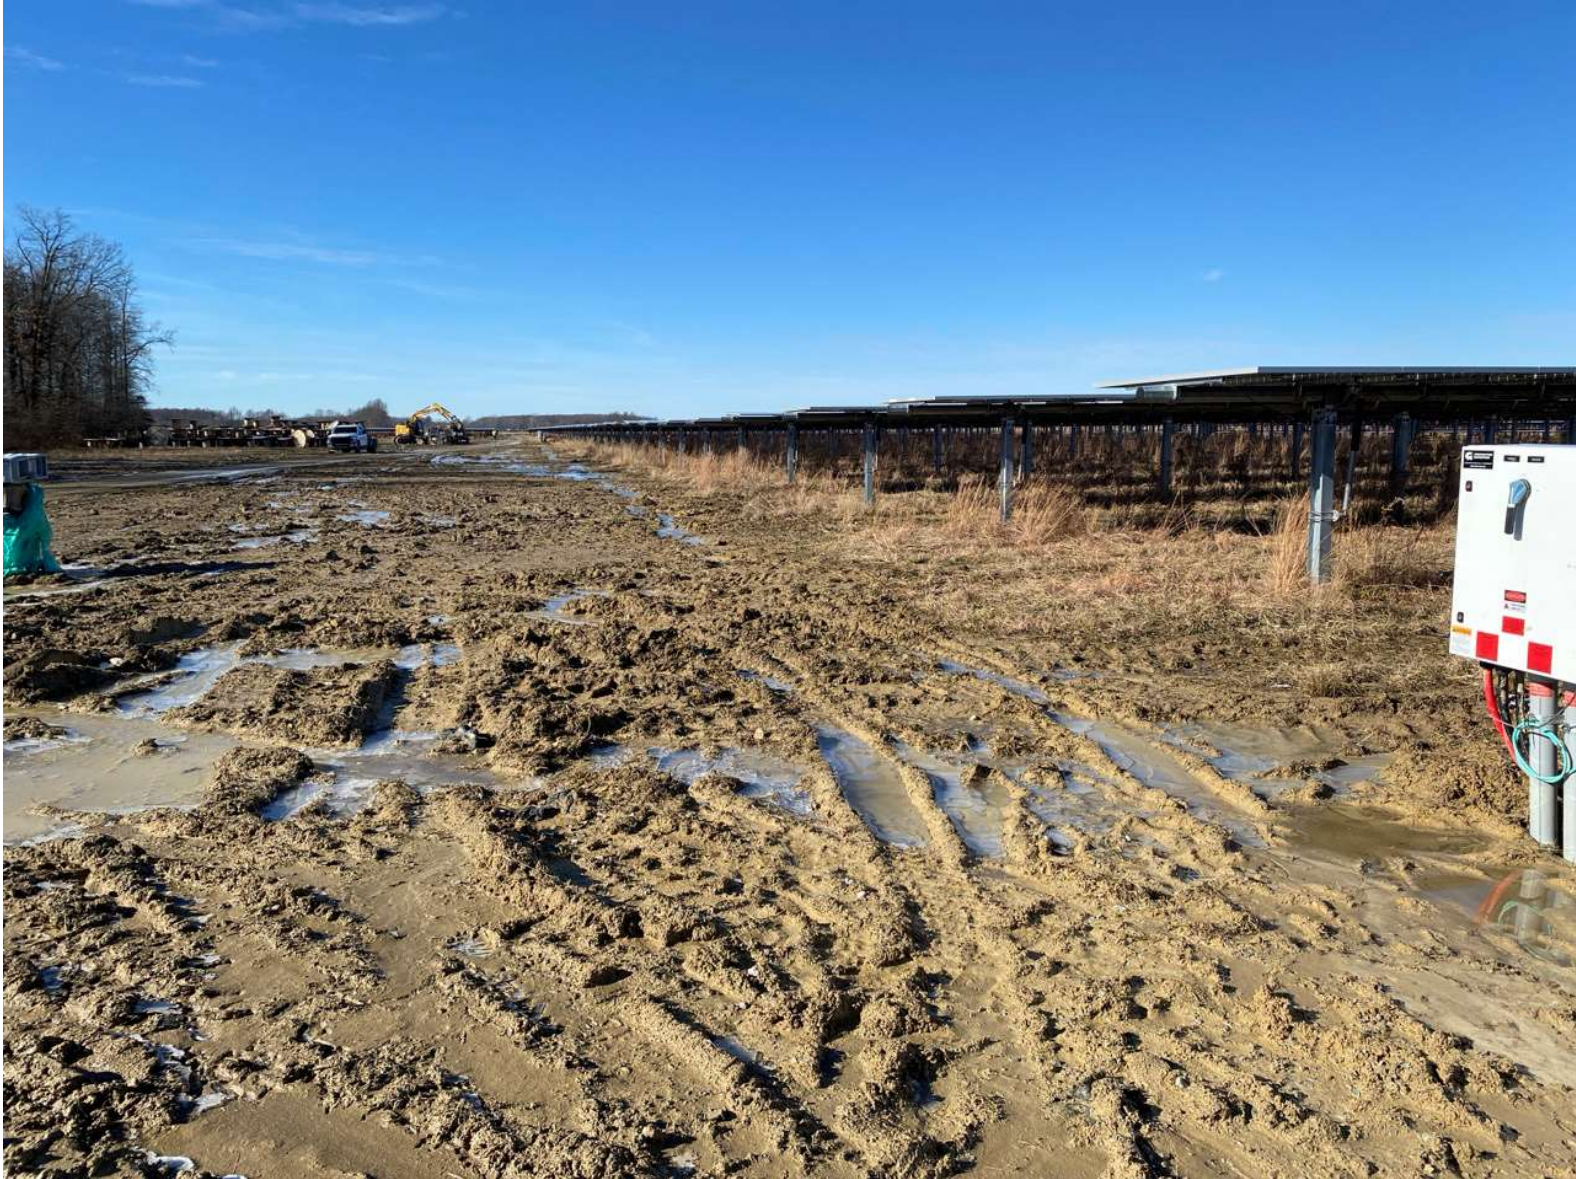
Photo 2: An example of an un-stabilized, inactive area. Improperly stored material visible on the left. Stored material and dumpster located on un-stabilized ground in the background.

Photo 2: An example of an un-stabilized, inactive area. Improperly stored material visible on the left. Improperly stored material and dumpster located on un-stabilized ground in the background.

- Highland submitted evidence to Staff of mulching applied to two bare, inactive areas. In comparing this evidence to the dozens of acres of bare areas onsite which were not stabilized, a substantial increase in resources devoted to mulching bare areas is needed to achieve compliance with the Storm Water Pollution Prevention Plan in an acceptable timeframe. According to the RLD Manual, mulch should be used liberally throughout construction to limit the areas that are bare and susceptible to erosion. Further, where straw mulch is applied, crimping the straw is suggested on gentle slopes that are less than 2:1 and in areas of higher flow rates but less than 3.5 feet/second. Straw mulch should not be used on steep slopes or higher flow rate areas as it will just wash away. On flat areas straw can be “punched” into the soil. This can be accomplished by track walking or rollers. It is not necessary to crimp all areas where straw is applied. Moisture will also assist with keeping straw in place. Staff expects to see near 100% coverage of bare areas with mulch in accordance with these standards within 4 weeks of Highland receiving this notification. The expectation is that this mulching activity will take place when site conditions are conducive for doing so, and that no construction activities occur in these bare areas until stabilization is achieved. Staff also requests evidence that all areas utilized as off-road shortcuts have been restricted from further through traffic, and detail what is being communicated to the labor staff to achieve this.

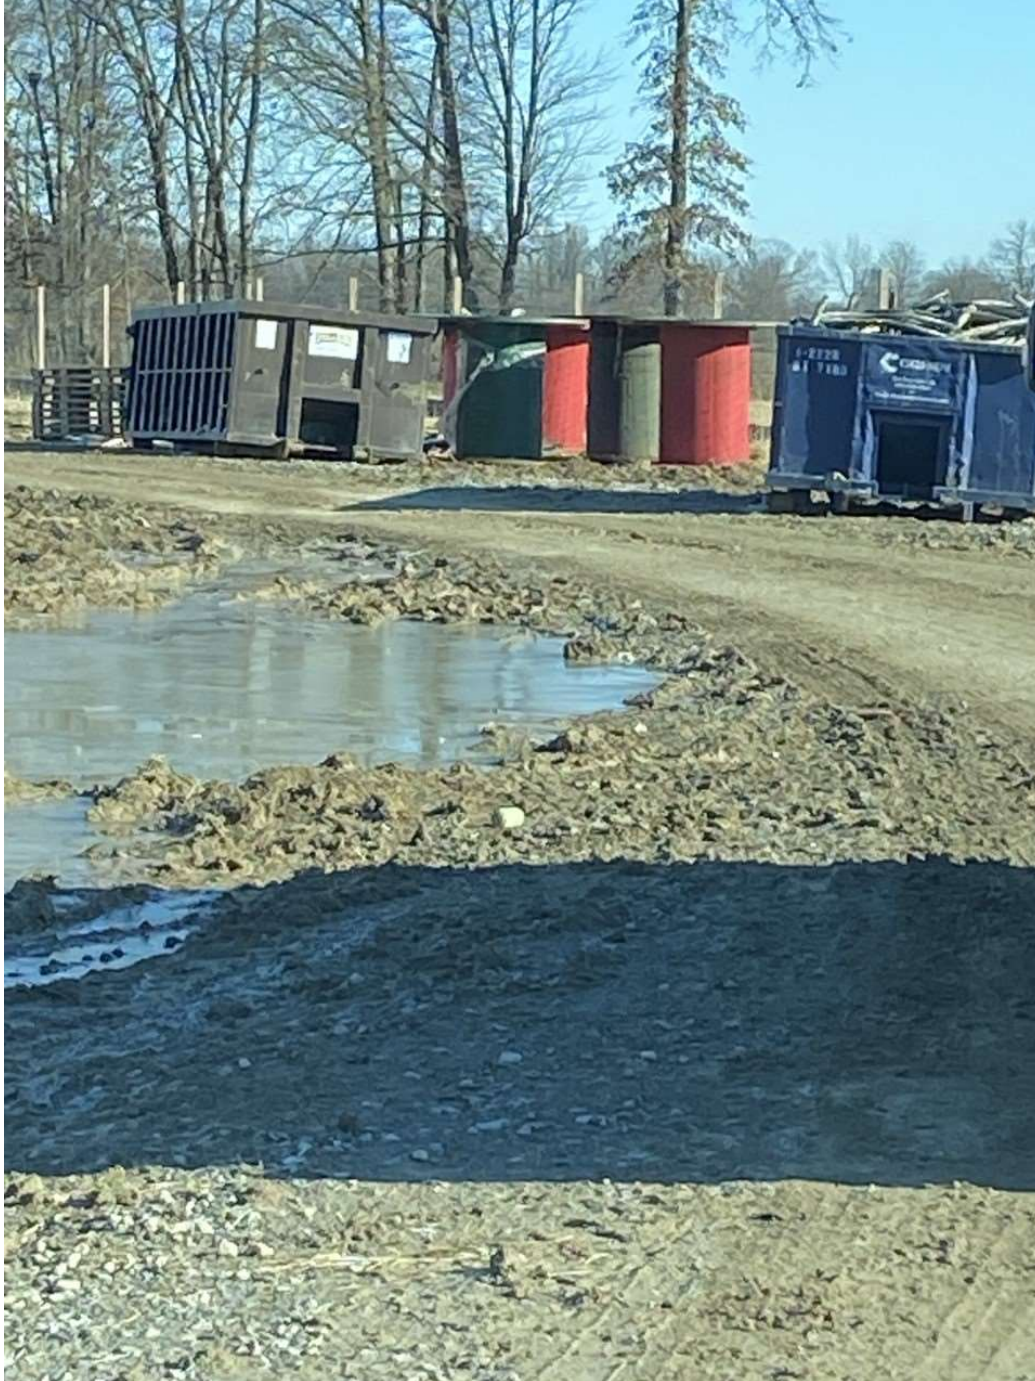
Photo3: Dumpsters and material stored on un-stabilized ground.

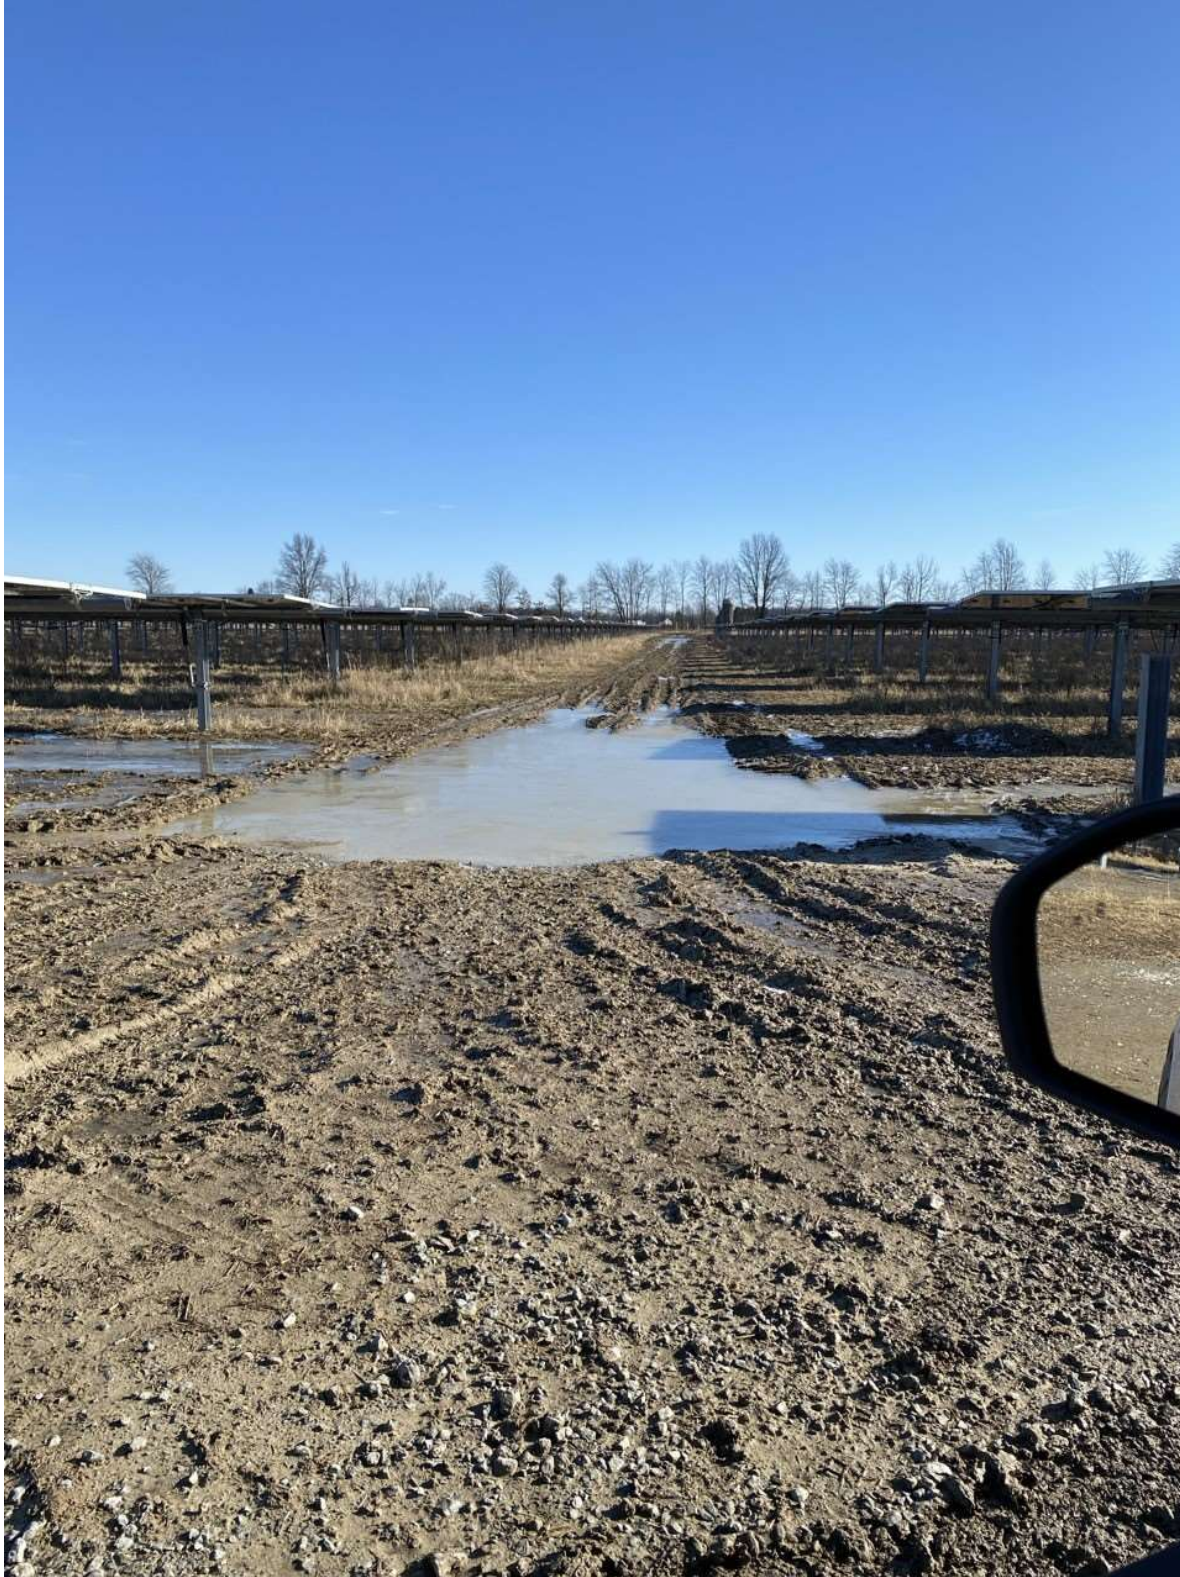
Photo 4: Example of a heavily traveled off-road shortcut.

- Restricting off-road travel in accordance with the RLD Manual, maintaining access roads in accordance with the Civil Plans, regularly rehabilitating egress rip rap zones in accordance with the SWPPP and Civil Plans, stabilizing bare soil areas in accordance with the SWPPP and RLD Manual, and sweeping entrances when needed in accordance with the SWPPP are all necessary to prevent hazardous conditions for the traveling public in the vicinity of the project. Staff expects all these requirements to be in place and in good working order within 4 weeks of receiving this notification.
