**Case ID - Case Name:** 18-1334-EL-BGN - Hecate Energy Highland Solar Farm  
**Company Name:** Hecate Energy Highland LLC  
**Case Status:** Under Construction  
**Certificate Approved Date:** May 16, 2019  
**Construction Start Date:** January 14, 2022  
**Case Type:** Solar Generation  
**Capacity, Acreage:** 300.0 MW, 3400 acres  
**County(s):** Highland  
**Township(s):** Clay, Whiteoak  
**Report Number:** CI24-18-1334-001R1

Summary: Report detailing the first response by OPSB Staff to the Certificate holder's reply to Compliance Inquiry CI24-18-1334-001 electronically filed by Eric R. Morrison on behalf of OPSB Staff.

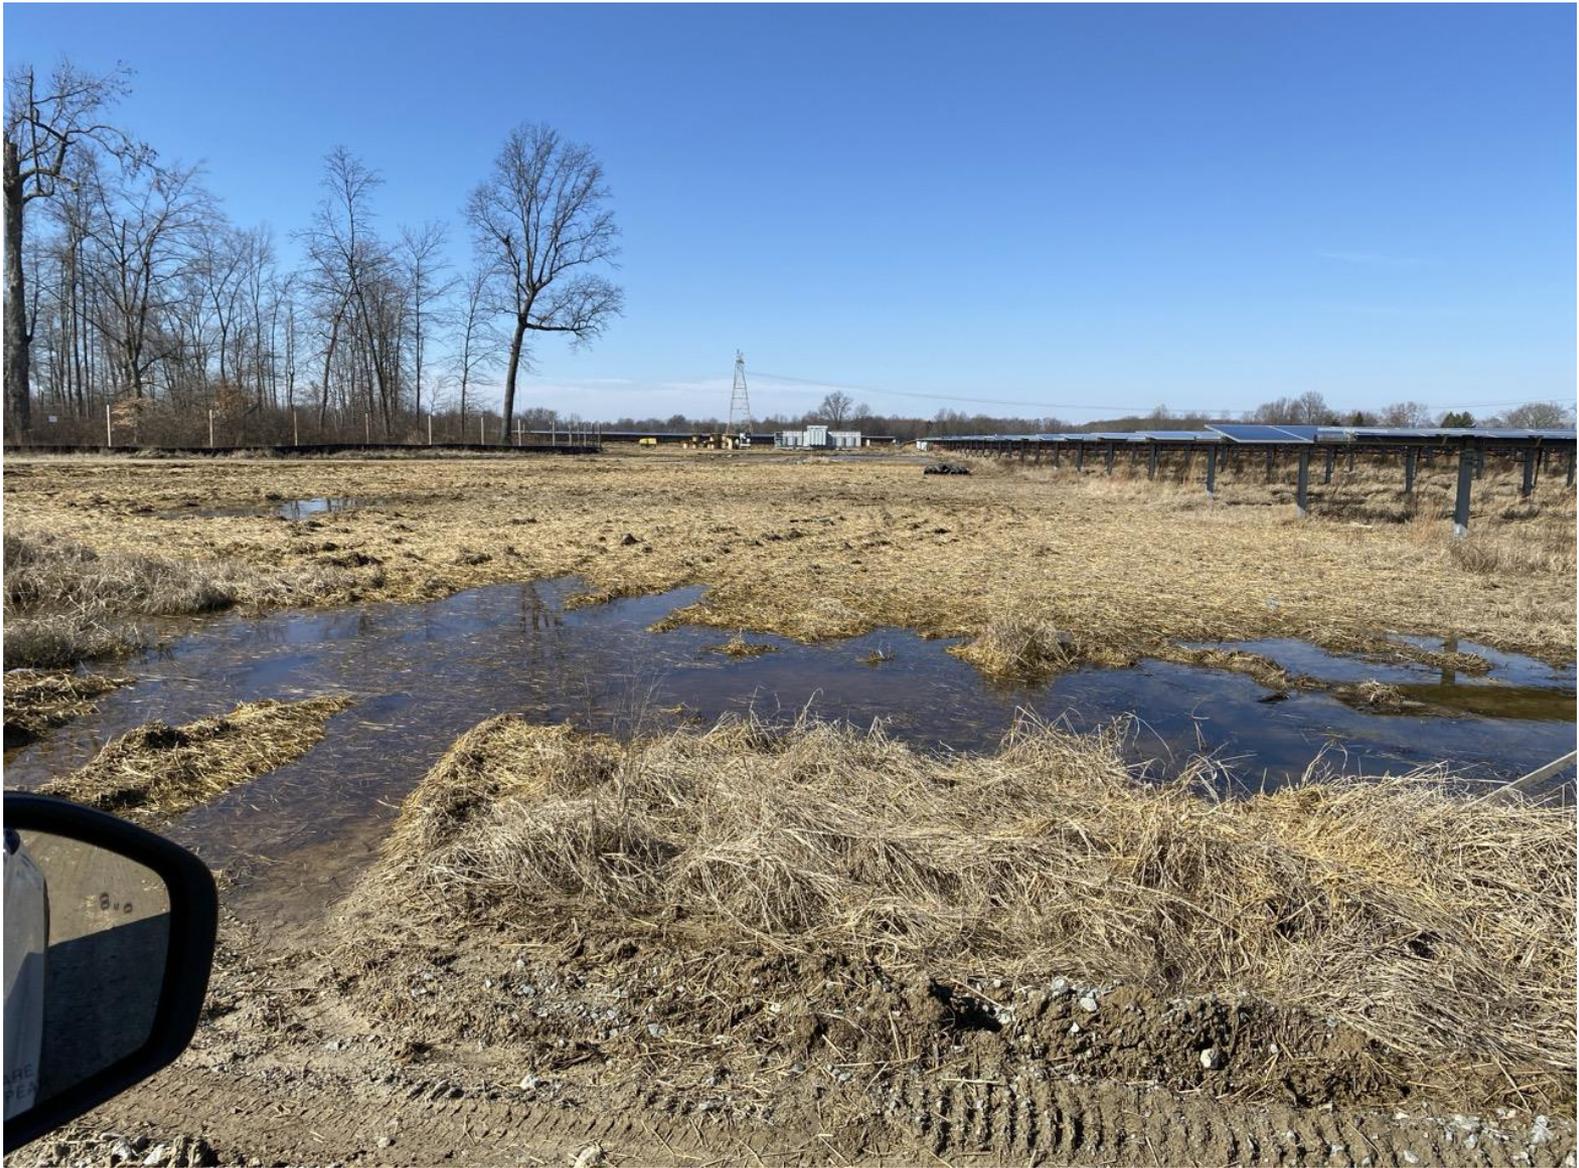
- Highland has covered a significant area with mulch material in an effort to temporarily stabilize bare soil areas, though there are still significant areas that remain to be stabilized in accordance with the SWPPP.

Photo 1: Straw mulch stabilization

- Staff recommends Highland continue to monitor off-road traffic and apply the same BMPs as work progresses across the site.
- For guidance regarding ongoing soil stabilization efforts, please refer to OEPA's February 29, 2024, Construction Stormwater Inspection Summary Letter. Staff recommends materials and dumpsters continue to be handled in a manner that minimizes site soil disruption.
- Staff requests that the location data watermark on all future photos be in degree decimal format.
- As requested in the Previous Report and until further notice, Staff recommends that Highland submit a weekly monitoring report containing a record of temporary and permanent stabilization work, including the Weekly Straw Mulch Log.

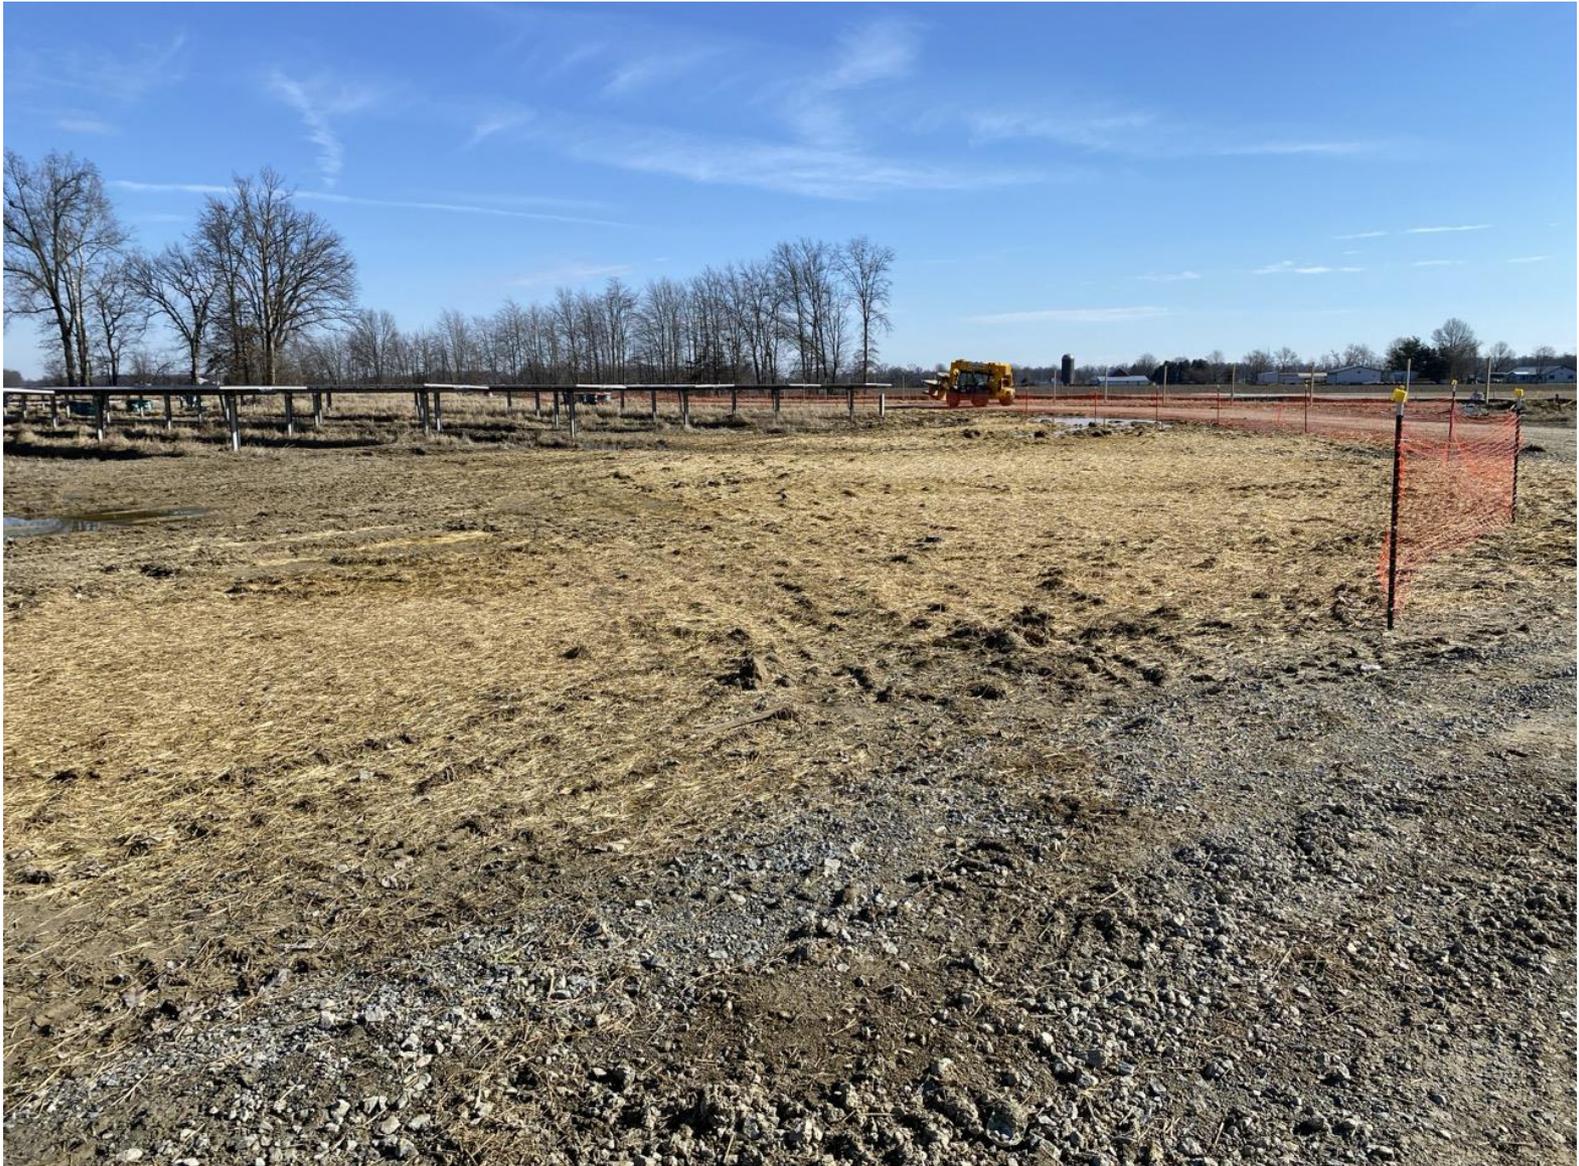
- Highland has shown a significant effort to reduce unnecessary off-road traffic by use of snow fence and roping. Staff witnessed these best management practices (BMPs) applied to particularly troublesome areas where workers were either taking shortcuts or running off the shoulder of the access roads.

Photo 2: Access road shoulder protection, Straw mulch stabilization

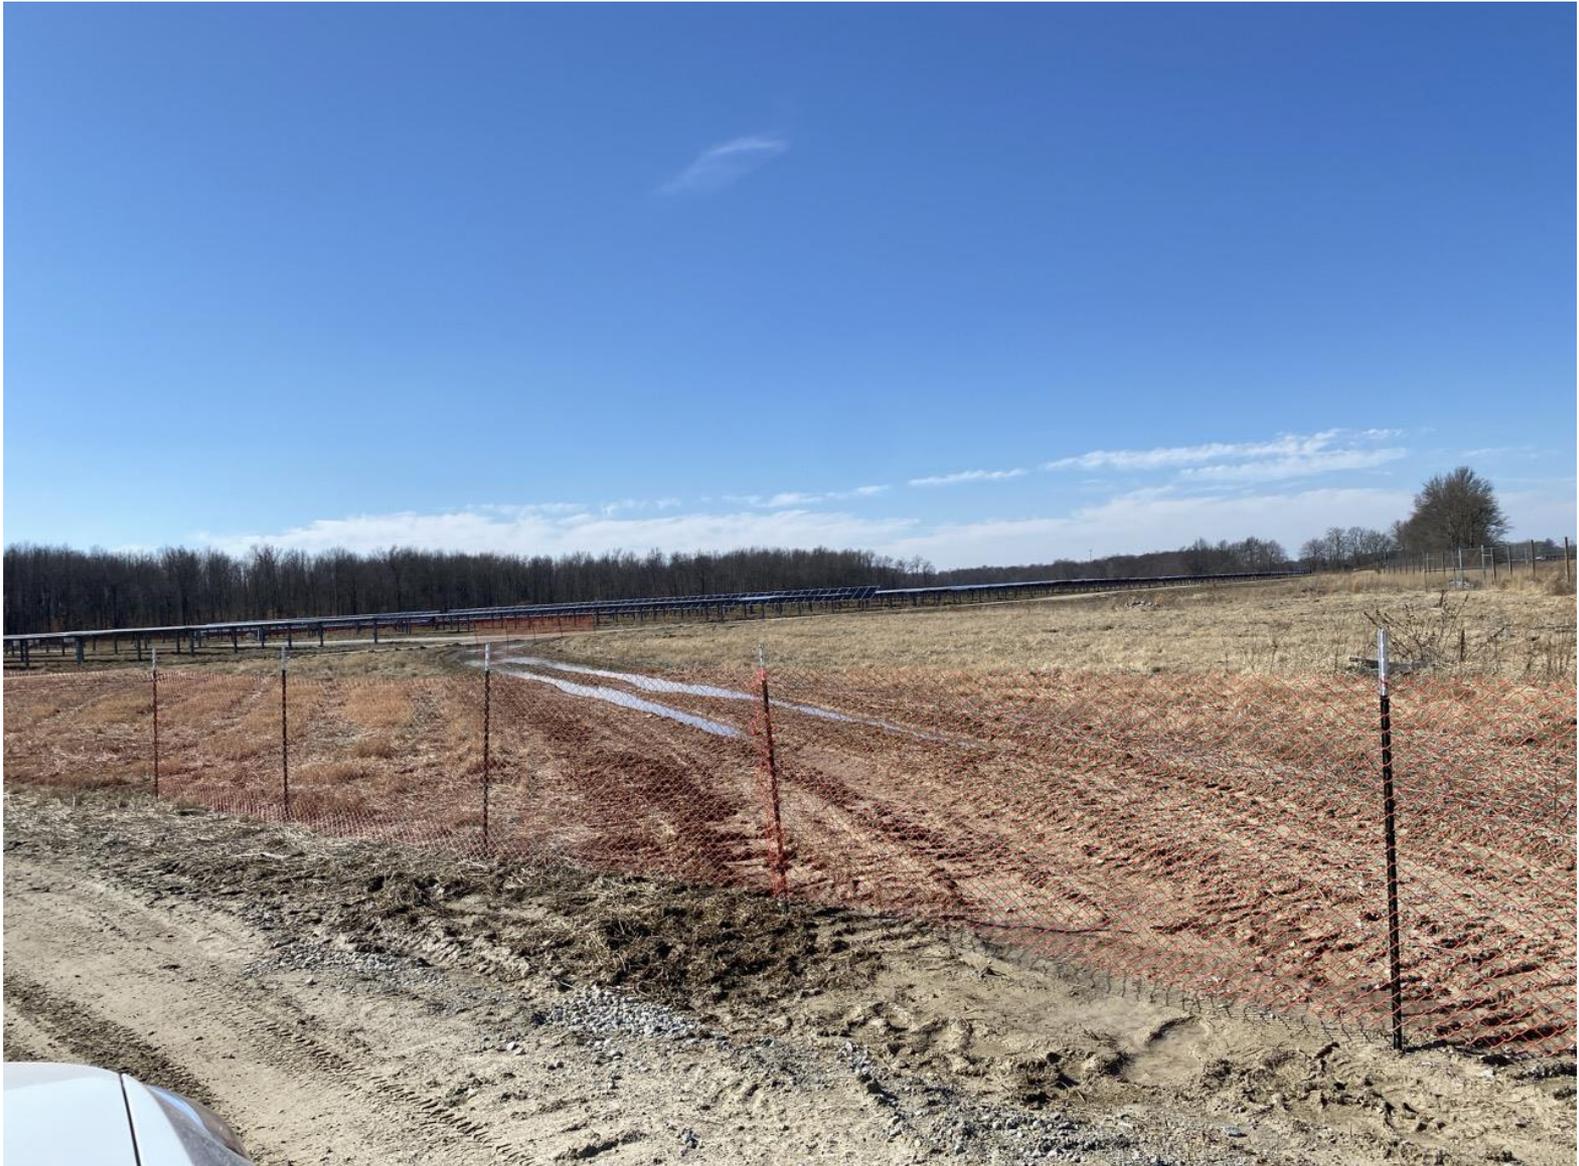
Photo 3: Shortcut elimination
