Case Number : 05-360-EL-BSB  
05-361-EL-BTX

Description of Document :  
TRANSCRIPT

## Hillcrest - Eastwood Transmission Line Substation and Power Line Construction Project

Hillcrest-Eastwood 138kV  
Electric Transmission Line

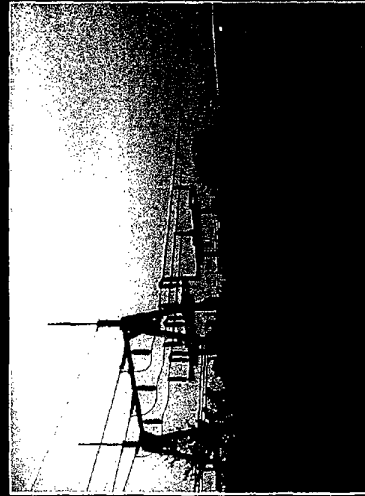
CG&E's Eastwood Substation.

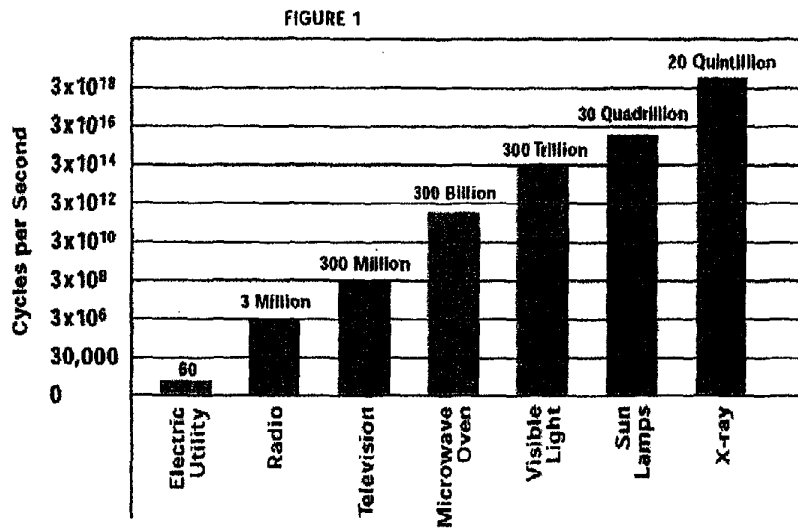
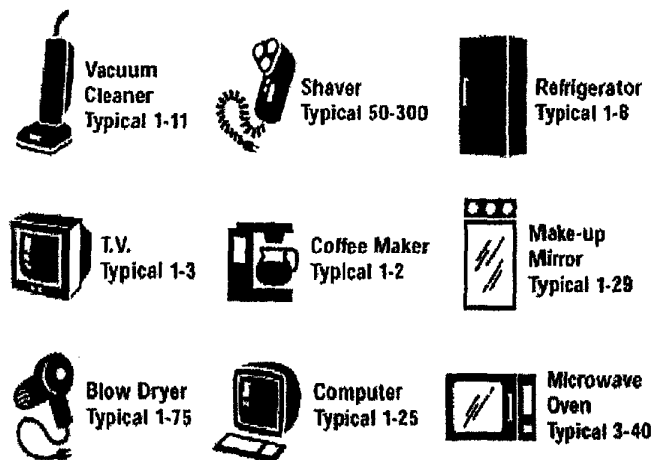
**Magnetic Field Strengths**  
**FIGURE 2** Measurements in milligauss, taken at normal user distances

Magnetic fields are found around any type of electrical wire or device that is turned on. This includes household appliances, light bulbs, motors, and of course, electric wires whether on a tower, a pole, or the wiring in your home. The magnetic field stops when the device is turned off. Figure 2 shows the magnetic field caused by several common appliances at distances where people would normally use the appliance.

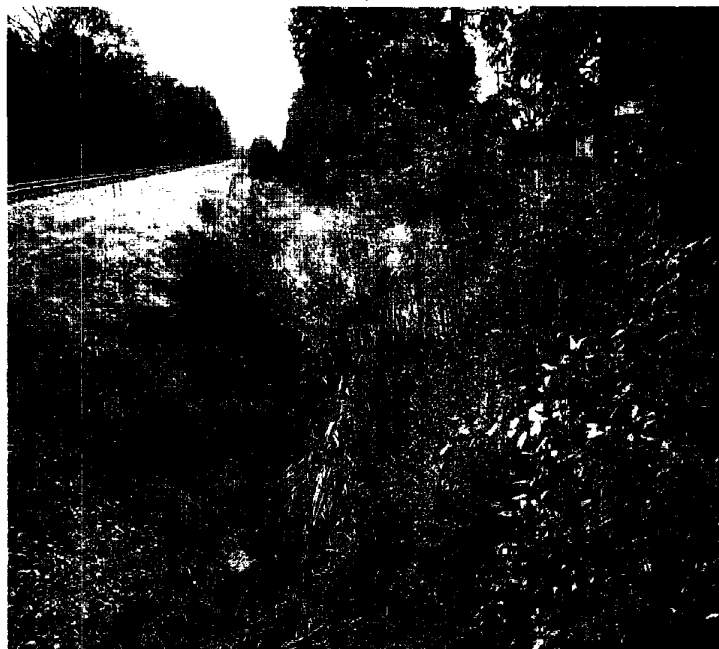
Photograph 2: View of Wetland 2 facing east-southeast.

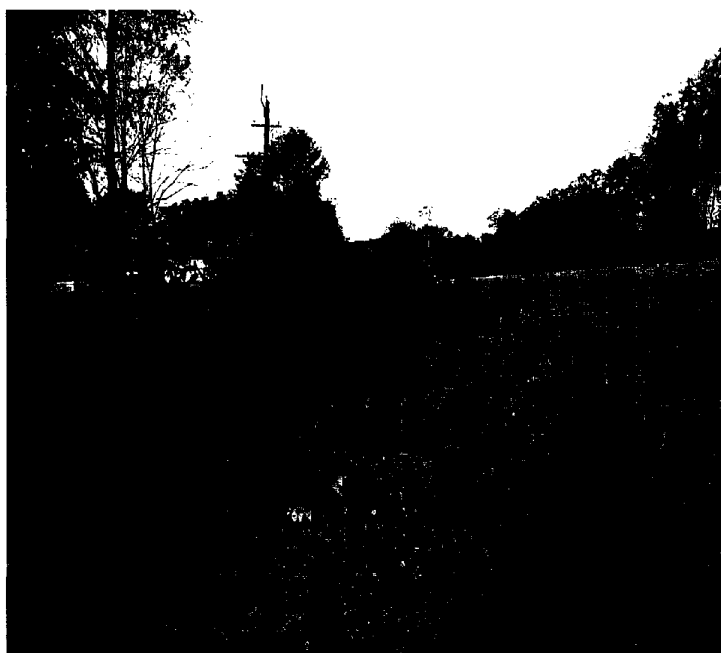
Photograph 3: View of Wetland 2 from the east. This location is immediately south of the Norfolk and Western Railroad.

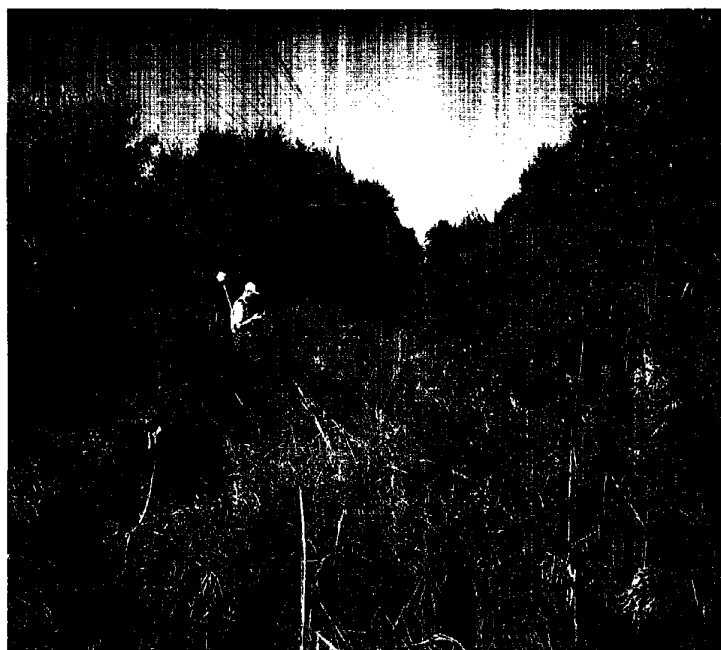
Photograph 4: Another view of Wetland 2 facing west. This photograph was taken from a location east of Photograph 3.

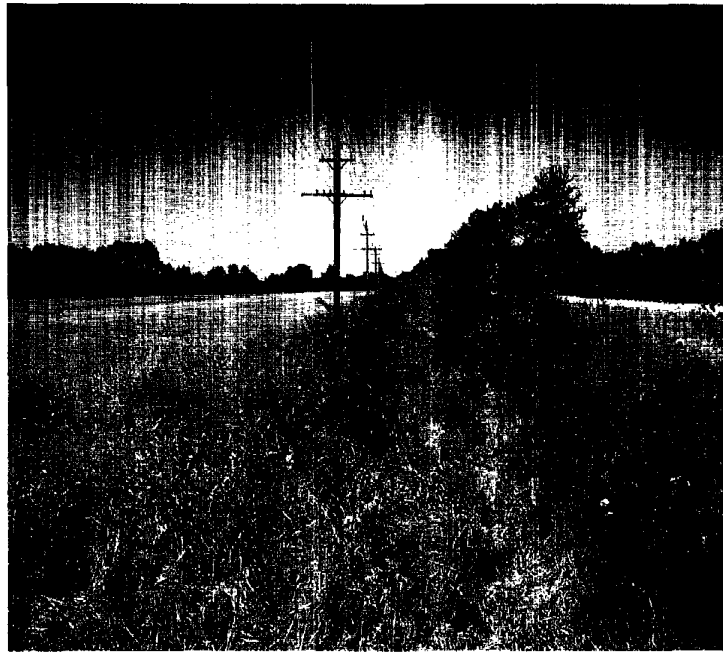
Photograph 5: View of Wetland 3A facing west-northwest.

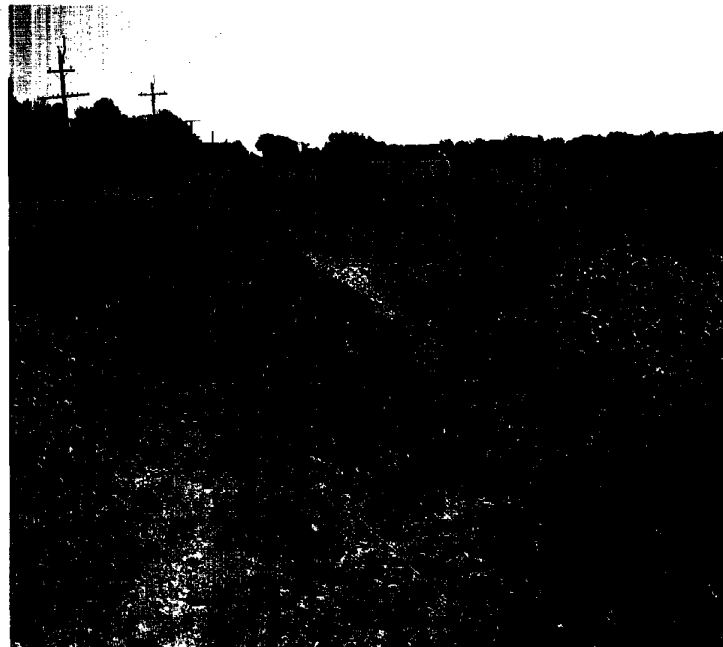
Photograph 6: View of Wetland 3B facing east.

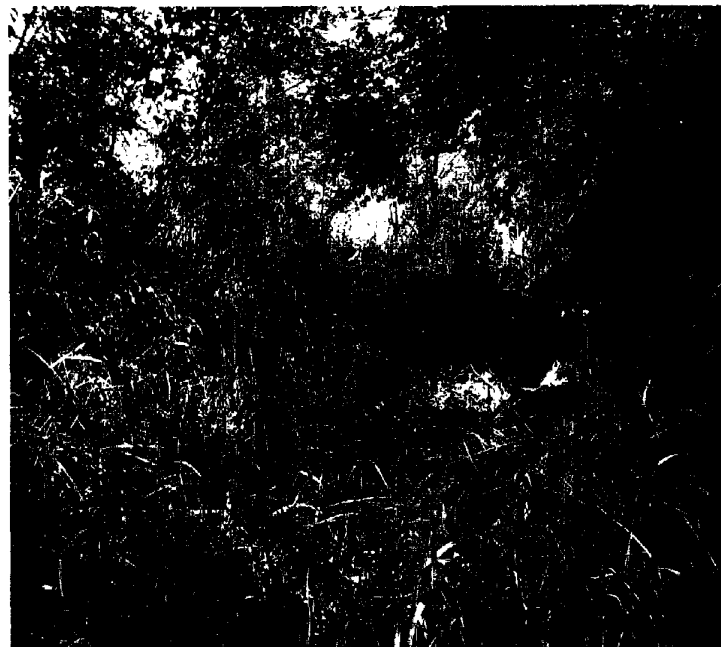
Photograph 8: View of Wetland 4B facing east.

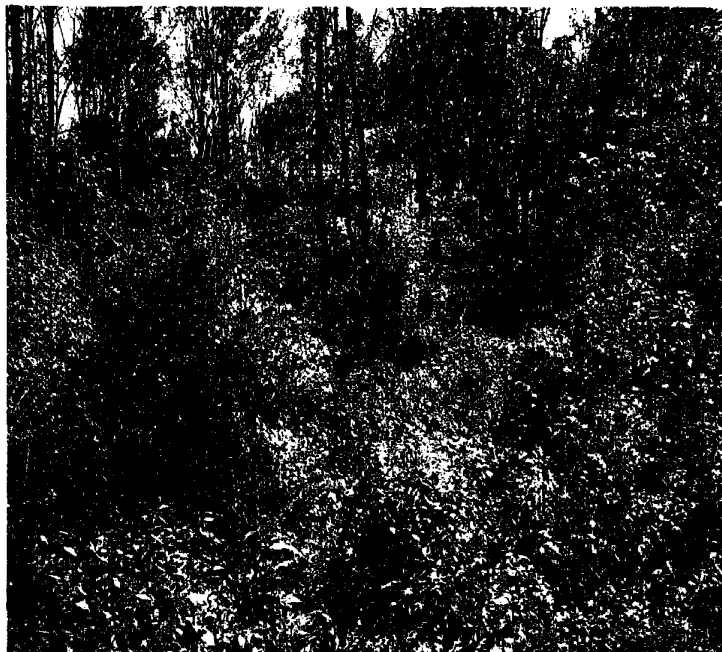
Photograph 9: View of Wetland 4C from the Norfolk and Western Railroad, facing south.

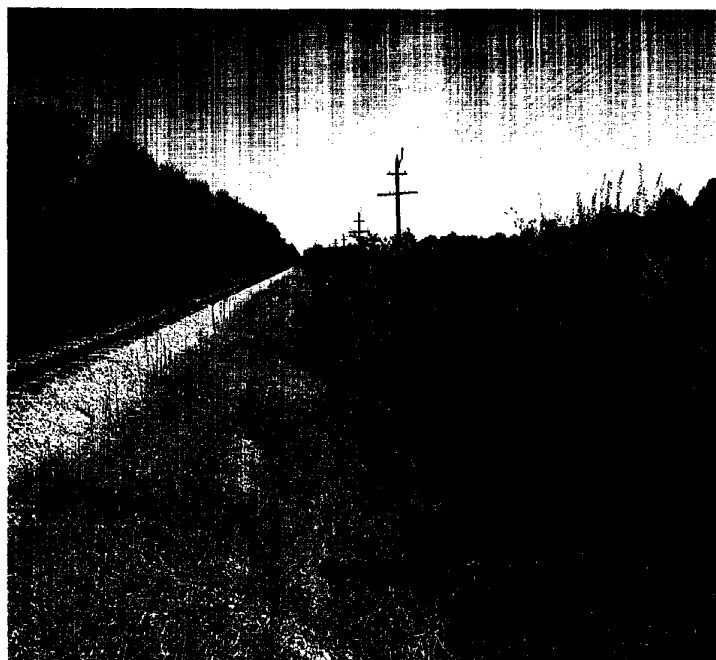
Photograph 10: View of Wetland 5 facing east.

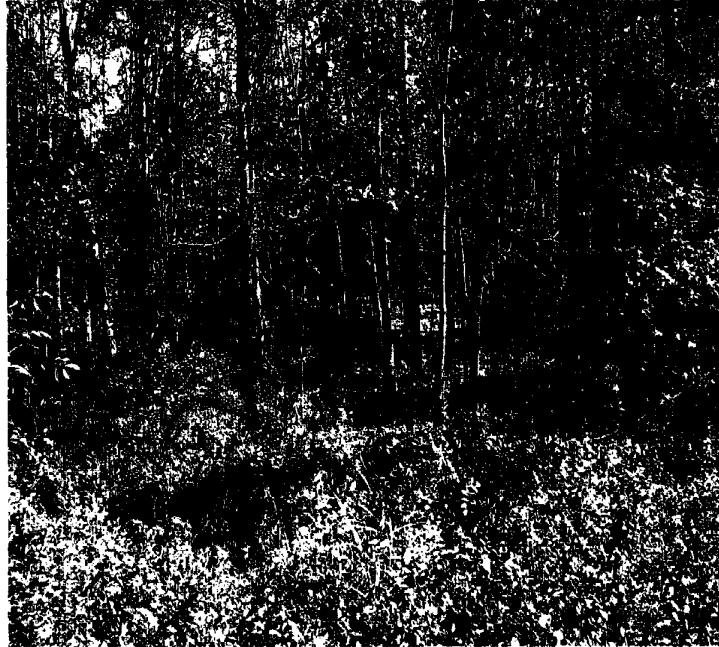
Photograph 11: View of Wetland 5 from the north.

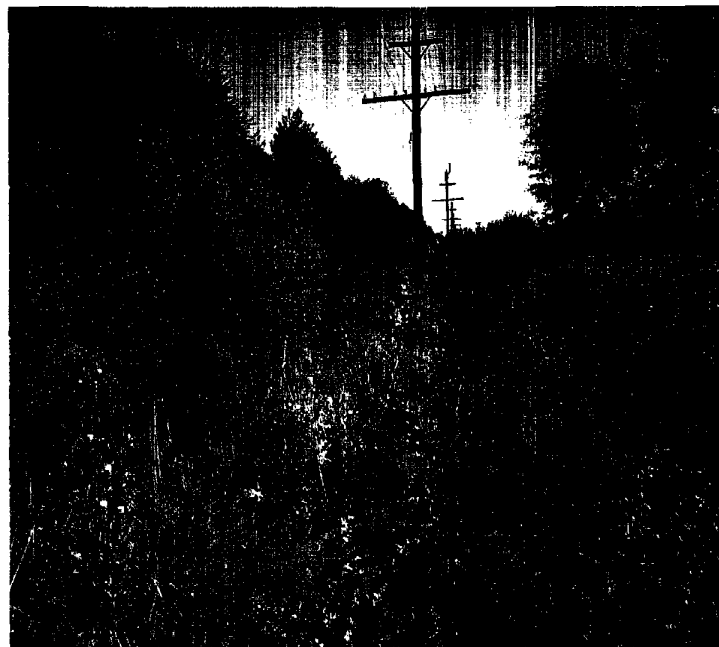
Photograph 12: View of Wetland 6 from a generally west direction.

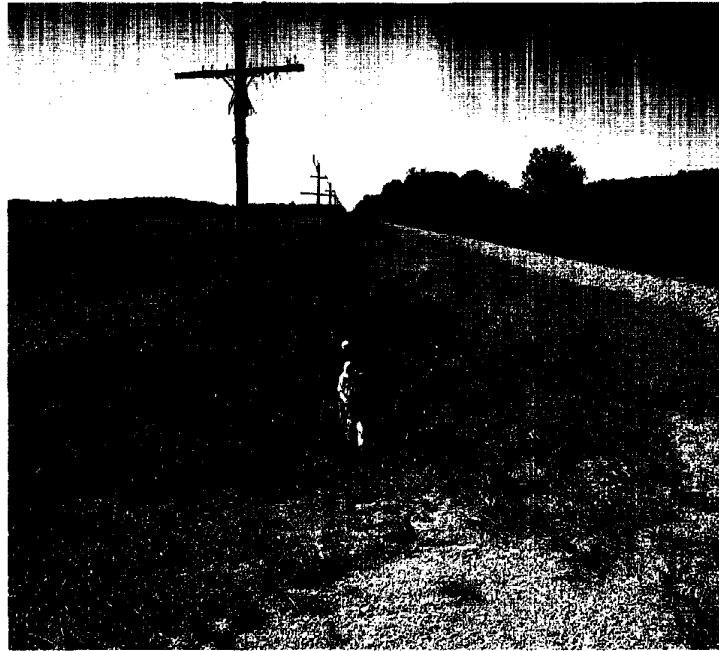
Photograph 13: View of Wetland 7 from a generally east direction.

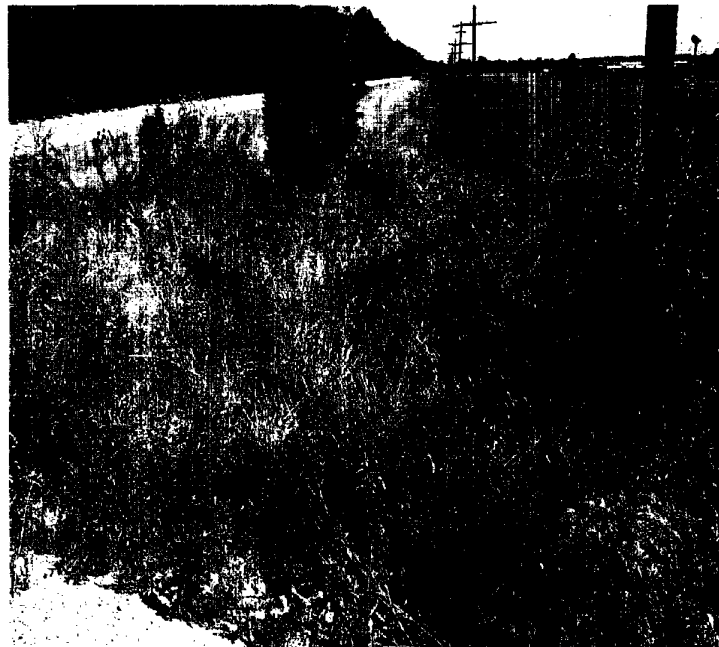
Photograph 14: View of Wetland 8 facing south-southeast.

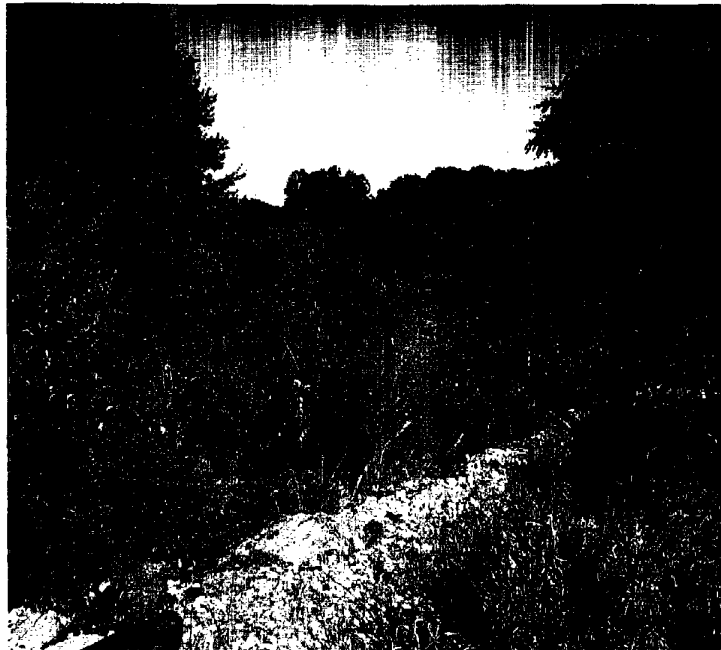
Photograph 15: View of Wetland 9A from the southwest.

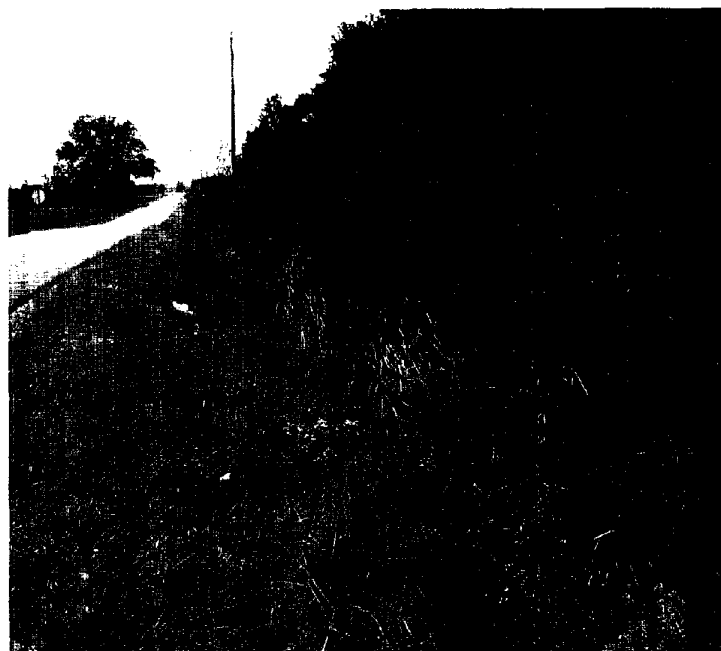
Photograph 16: View of Wetland 9B facing north-northeast.

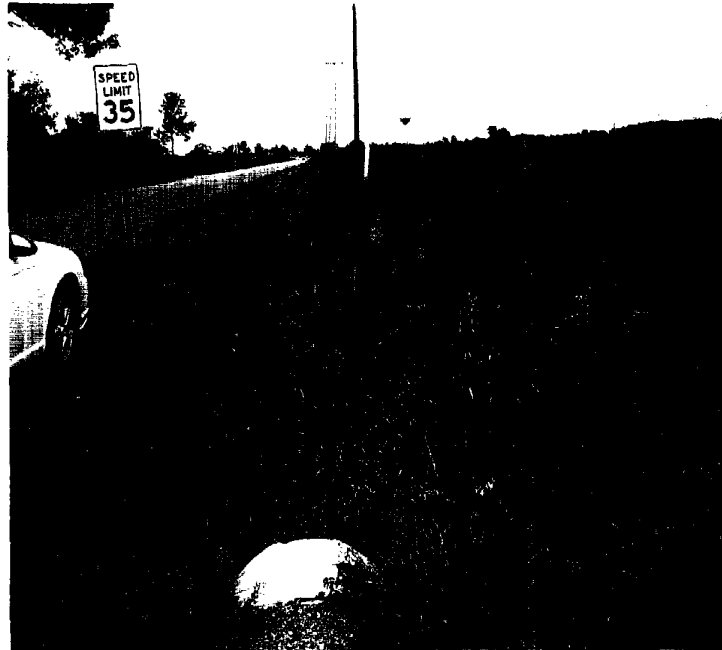
Photograph 17: View of Wetland 9C from the south-southwest.

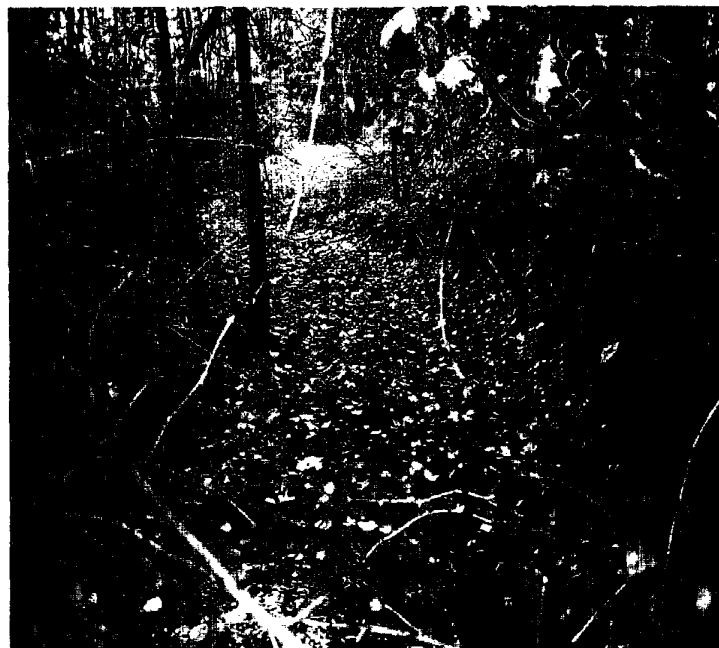
Photograph 18: View of Stream 3 (UT to Sterling Run) from the southeast.

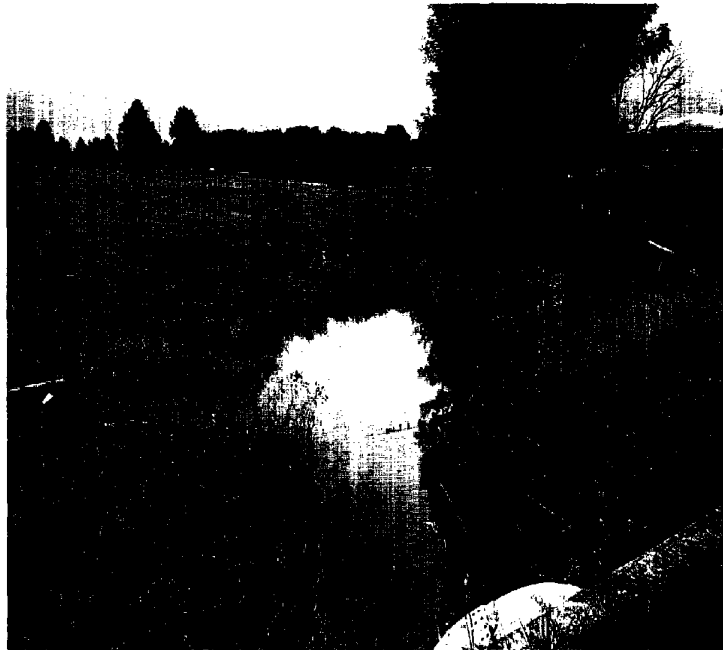
Photograph 19: View of Wetland 10 from the southeast.

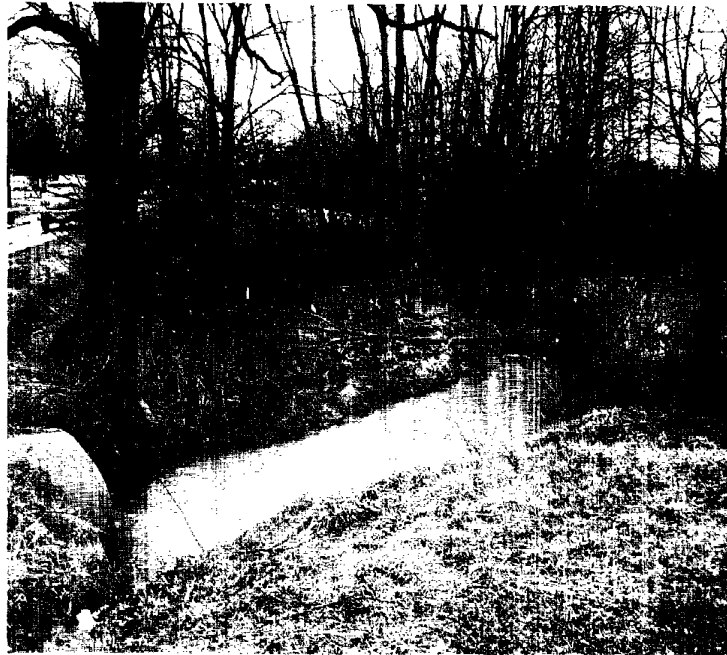
Photograph 21: View of Stream 4A (UT to Sterling Run) facing east-northeast, along the south side of Waits Road.

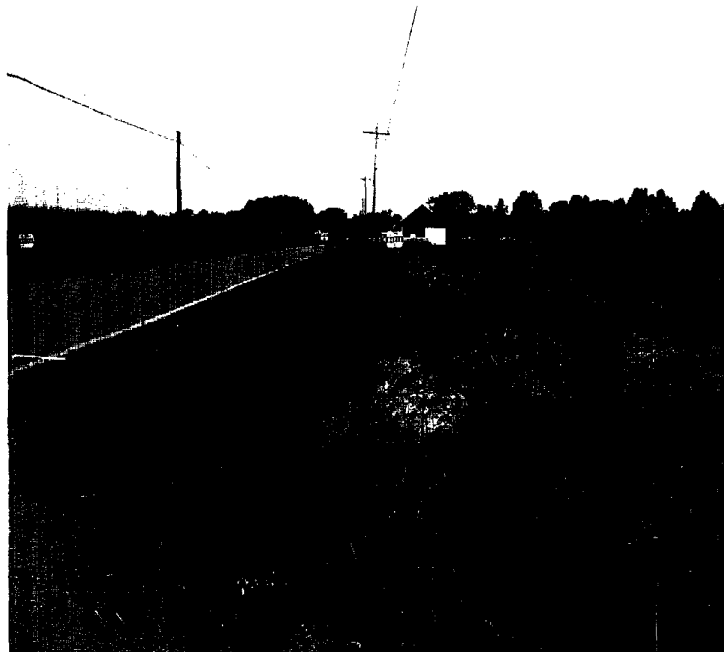
Photograph 23: View of Wetland 12A from a generally east direction.

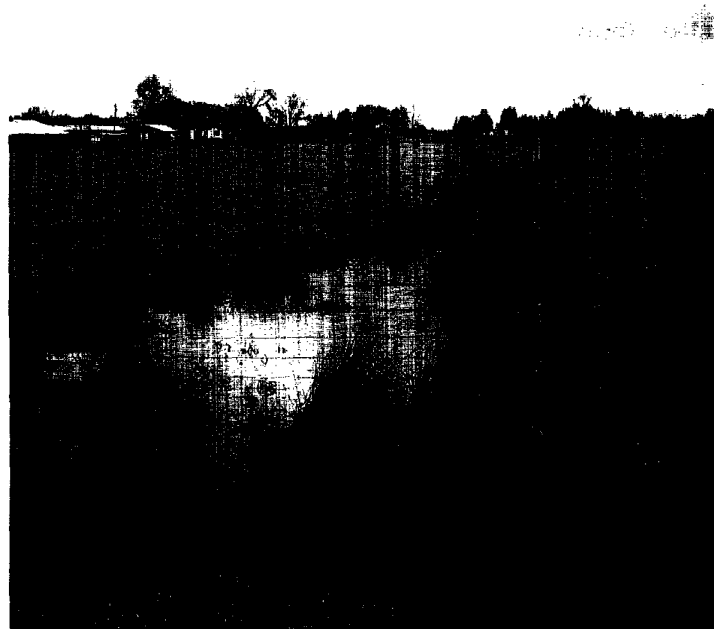
Photograph 24: View of Wetland 12B facing north.
