CONSTRUCTION NOTICE

Hillcrest Solar Interconnect PUCO Case No. 20-938-EL-BNR

Submitted to:
The Ohio Power Siting Board

Submitted by: Duke Energy Ohio, Inc.

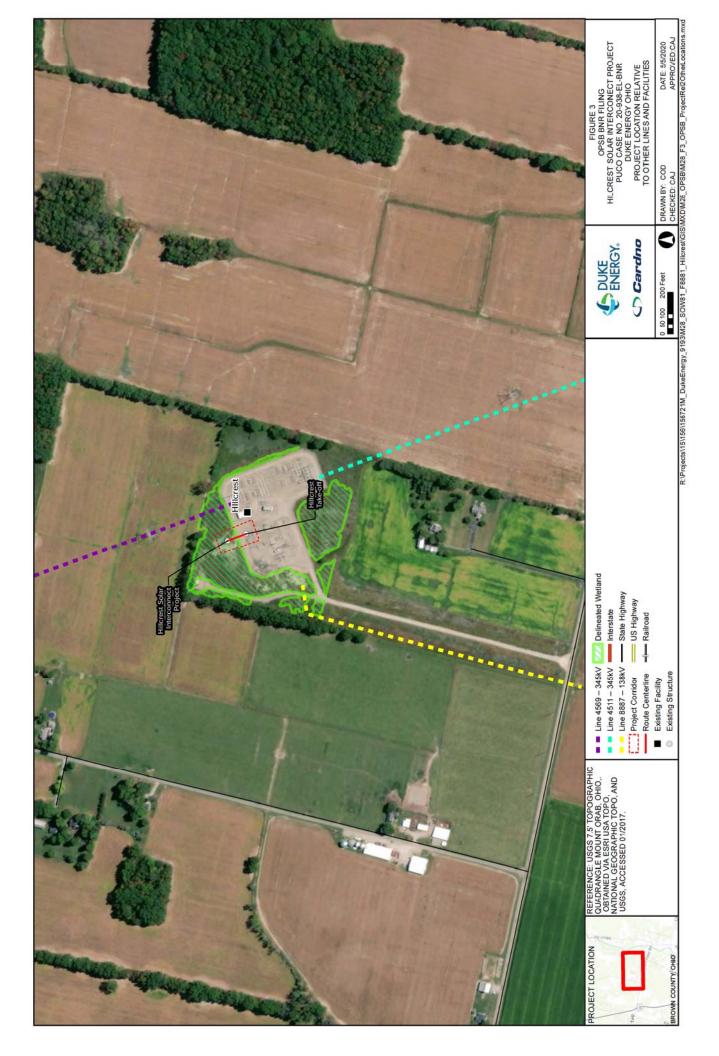
The location of the Project in relationship to existing transmission lines and substations is shown on Figure 3. Three existing transmission circuits (4569 – 345 kV, 4511 – 345 kV and 8887 – 138 kV) and electric distribution circuits are connected to Hillcrest Substation.
