DUKE ENERGY
LINE D000B PIPELINE REPLACEMENT PROJECT
CINCINNATI, HAMILTON COUNTY, OHIO

RUNNING BUFFALO CLOVER SURVEY MAP

APPENDIX A-1

SITE PHOTOGRAPHS

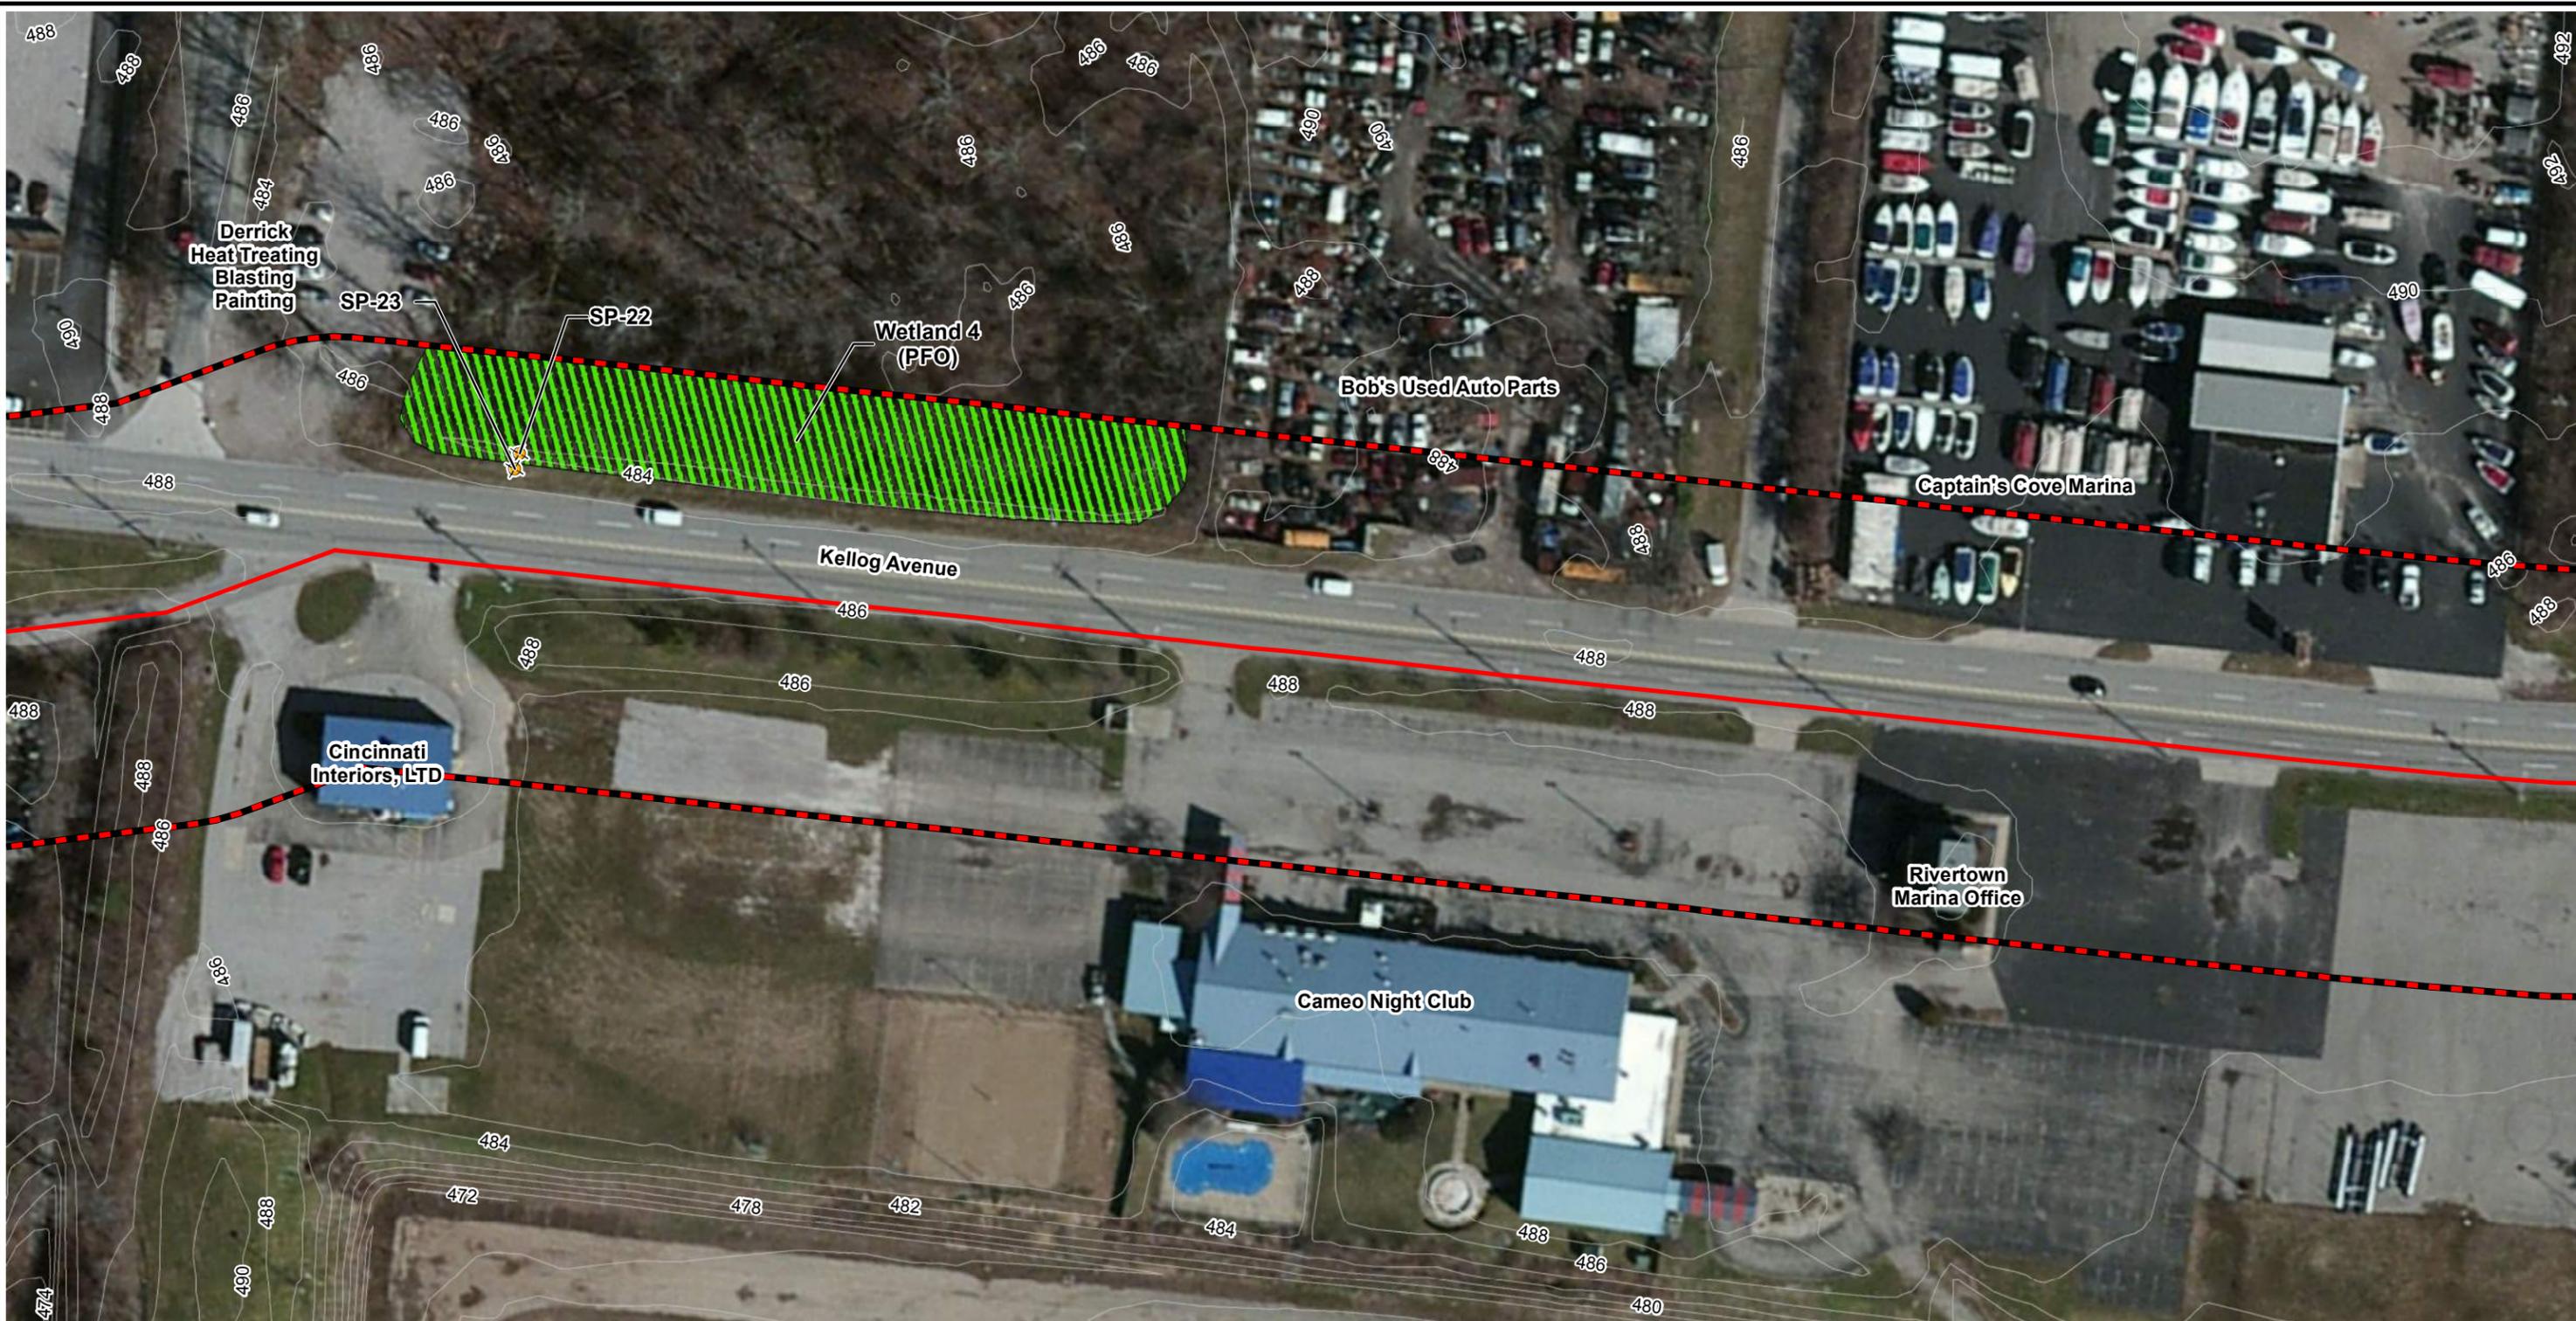
DRAWN BY: DMG	CHECKED BY: JAV	APPROVED BY: JAV*	FIGURE NO: 14
DATE: SEPTEMBER 23, 2016	DWG SCALE: 1" = 75'	PROJECT NO: 153-230

NOTES: FULL EXTENT OF STUDY CORRIDOR IS WITHIN 100-YEAR FLOODPLAIN.
NO STREAMS OR WATERBODIES WERE IDENTIFIED WITHIN THE STUDY CORRIDOR.

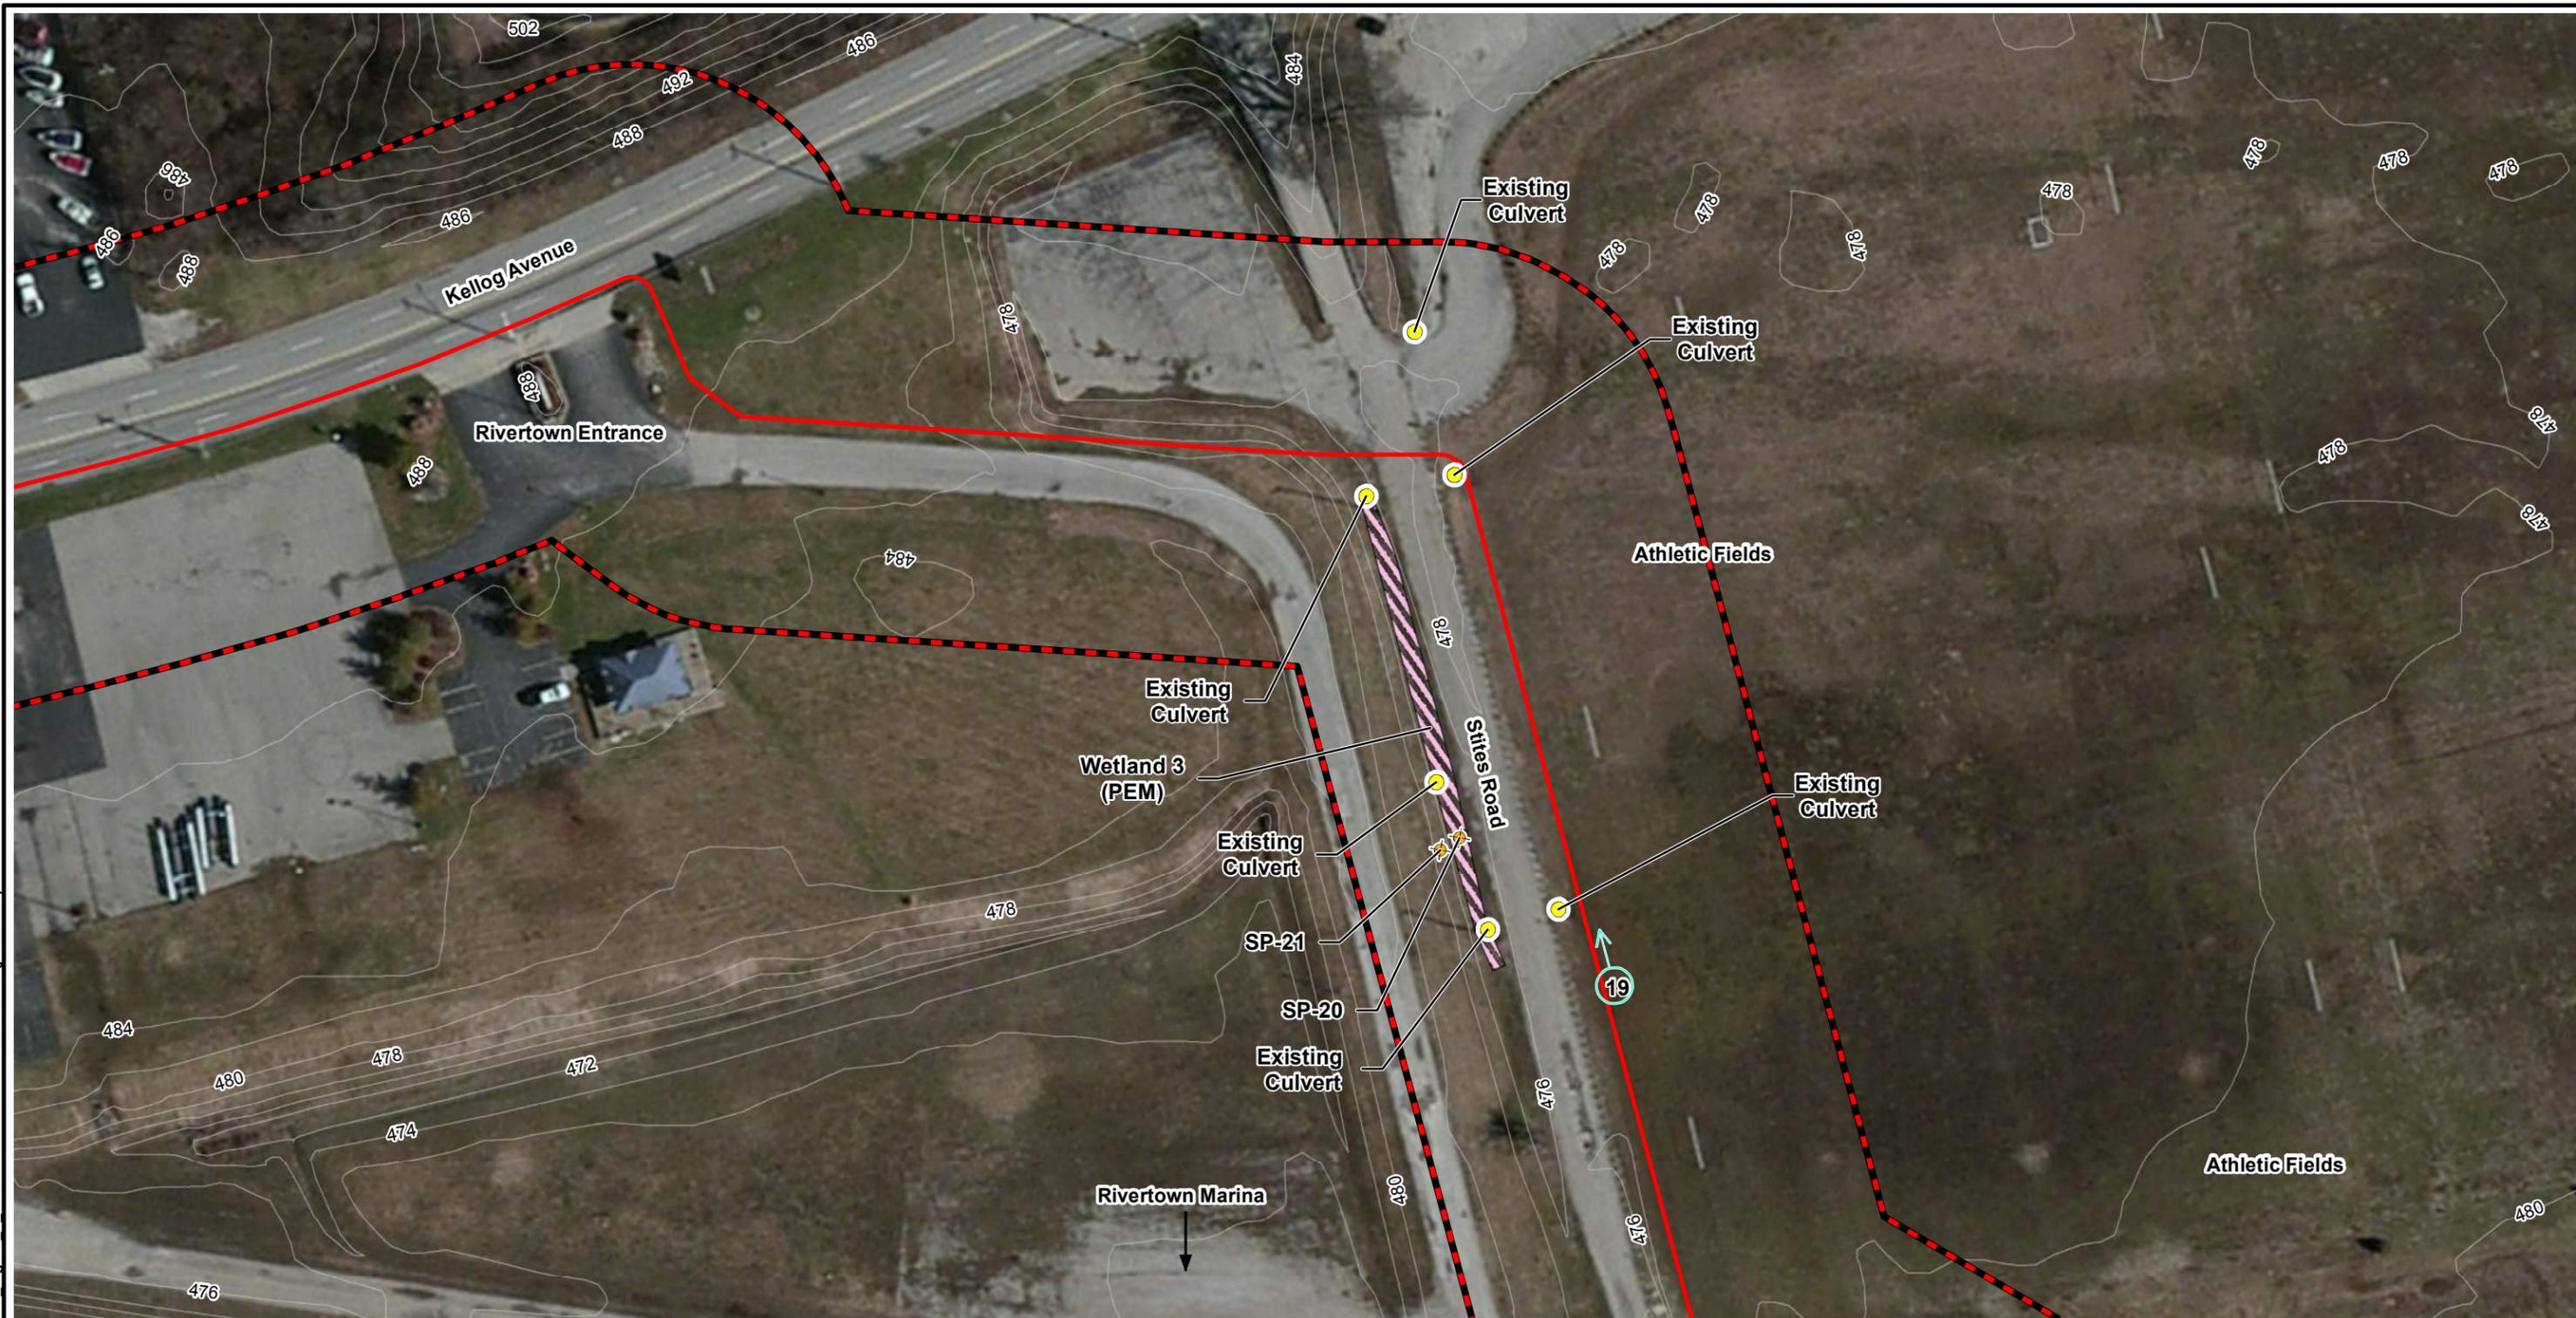
NOTES: FULL EXTENT OF STUDY CORRIDOR IS WITHIN 100-YEAR FLOODPLAIN.
NO STREAMS OR WATERBODIES WERE IDENTIFIED WITHIN THE STUDY CORRIDOR.

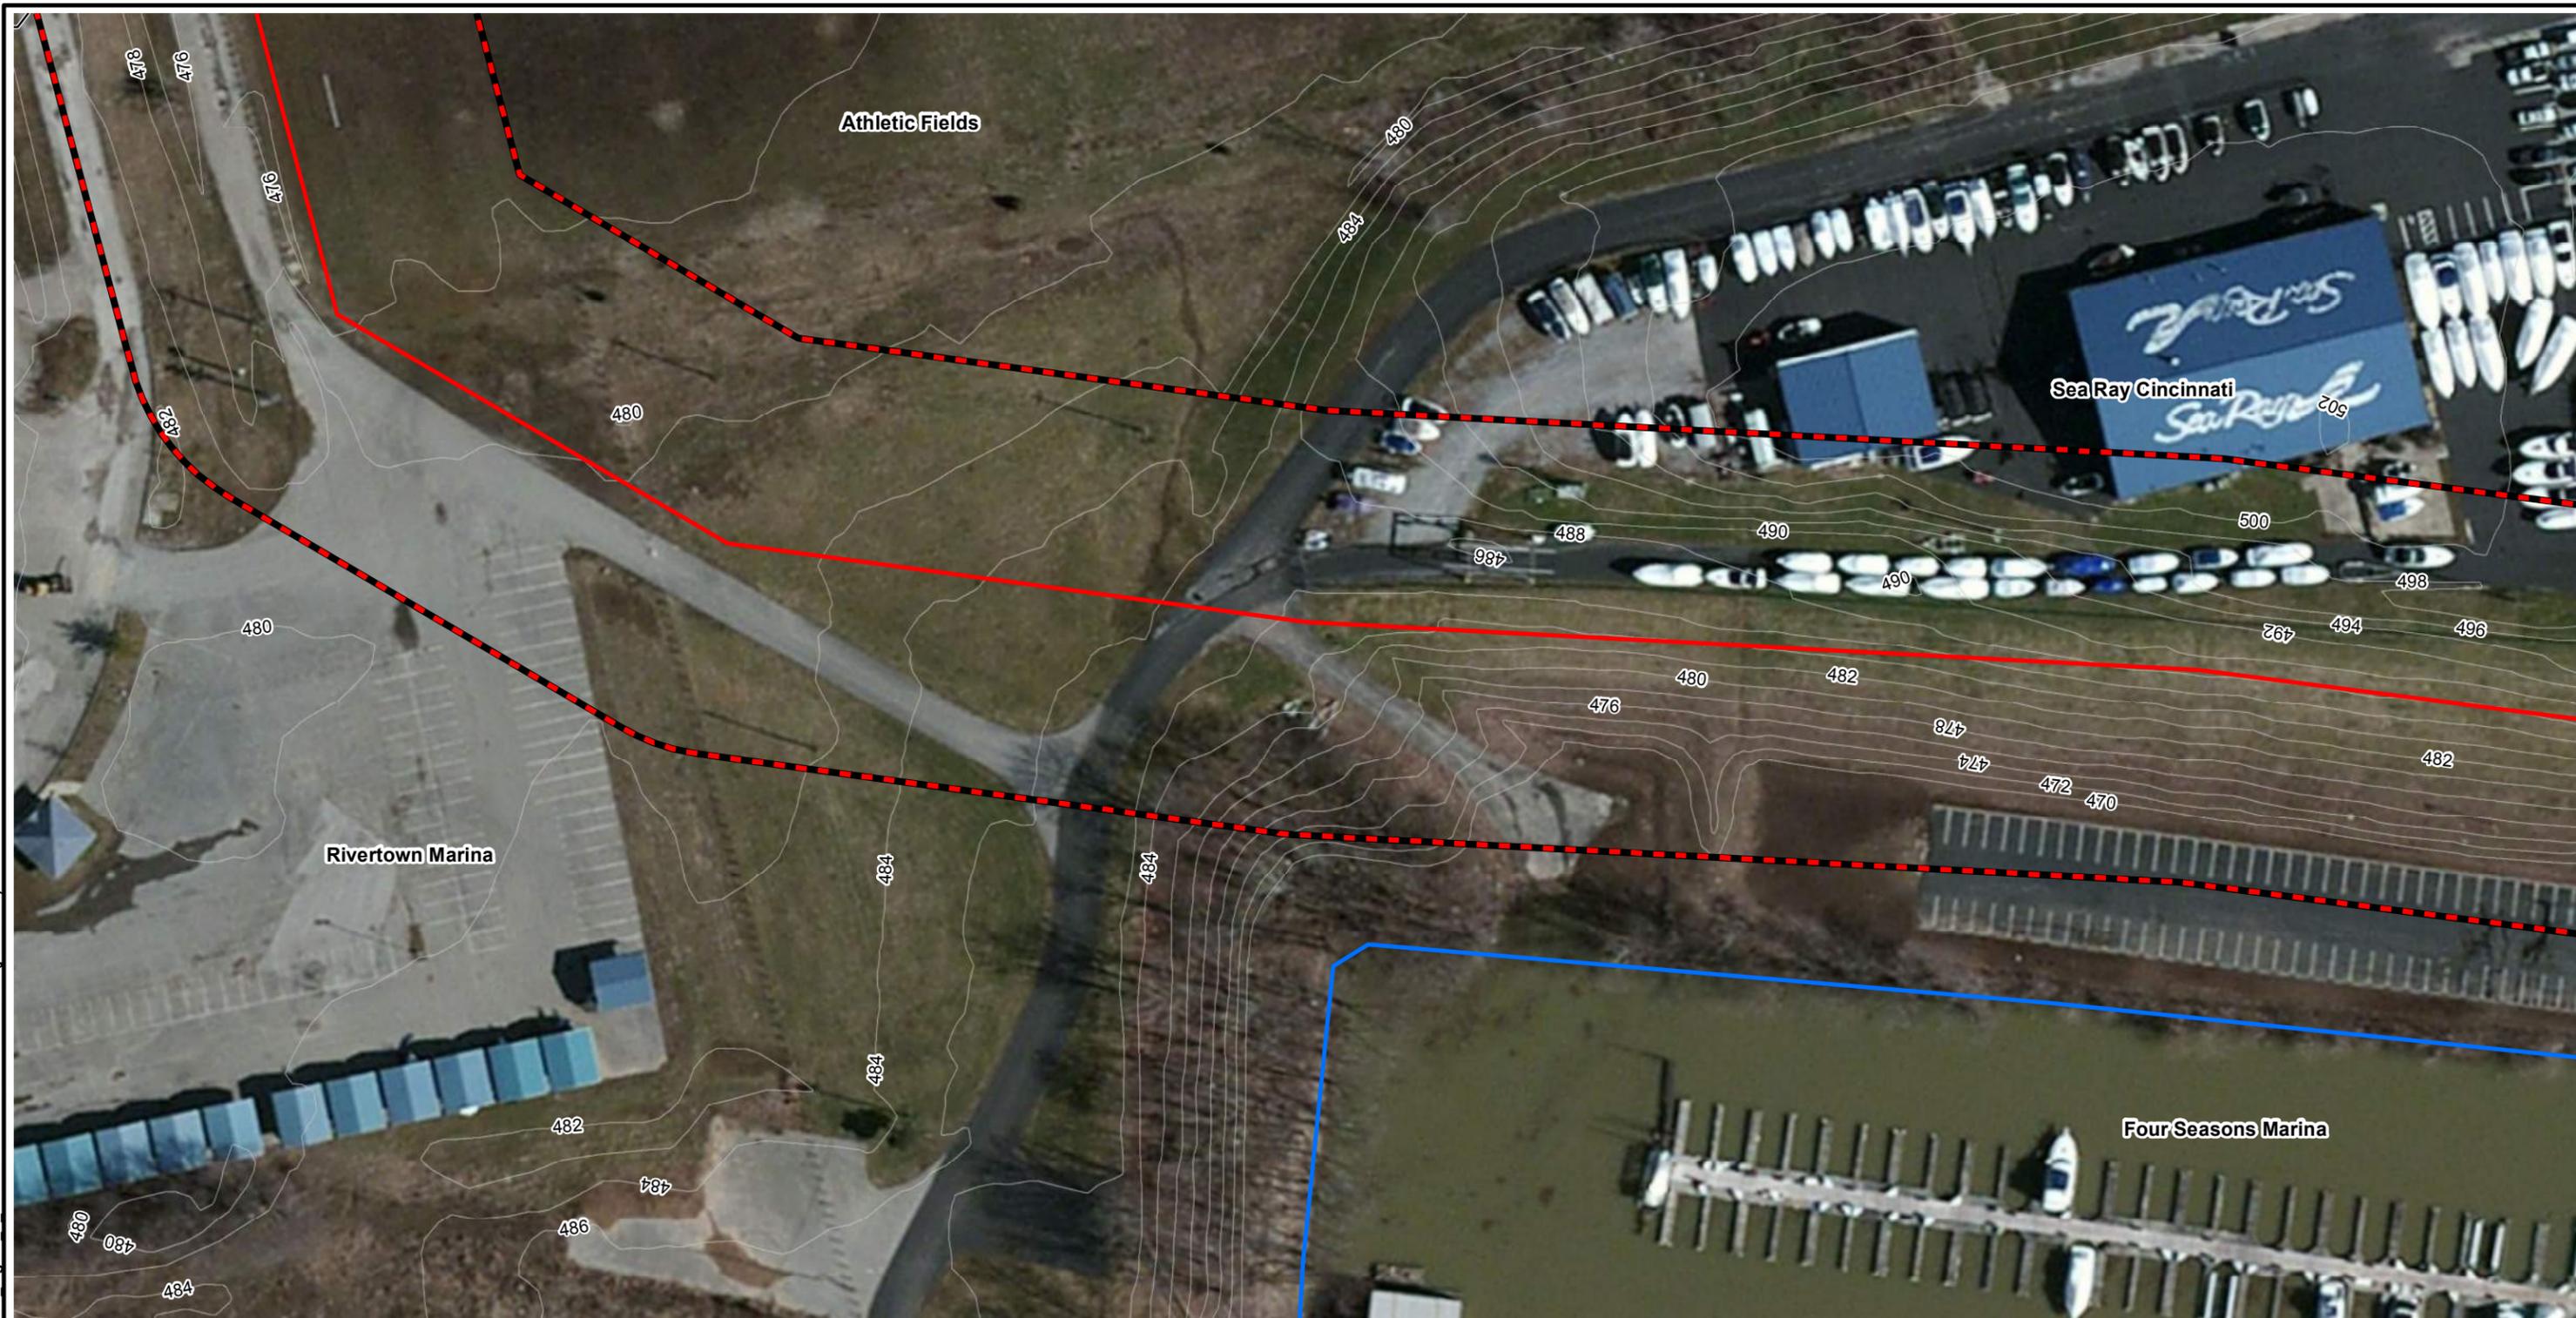
NOTES: FULL EXTENT OF STUDY CORRIDOR IS WITHIN 100-YEAR FLOODPLAIN.
NO STREAMS OR WATERBODIES WERE IDENTIFIED WITHIN THE STUDY CORRIDOR.

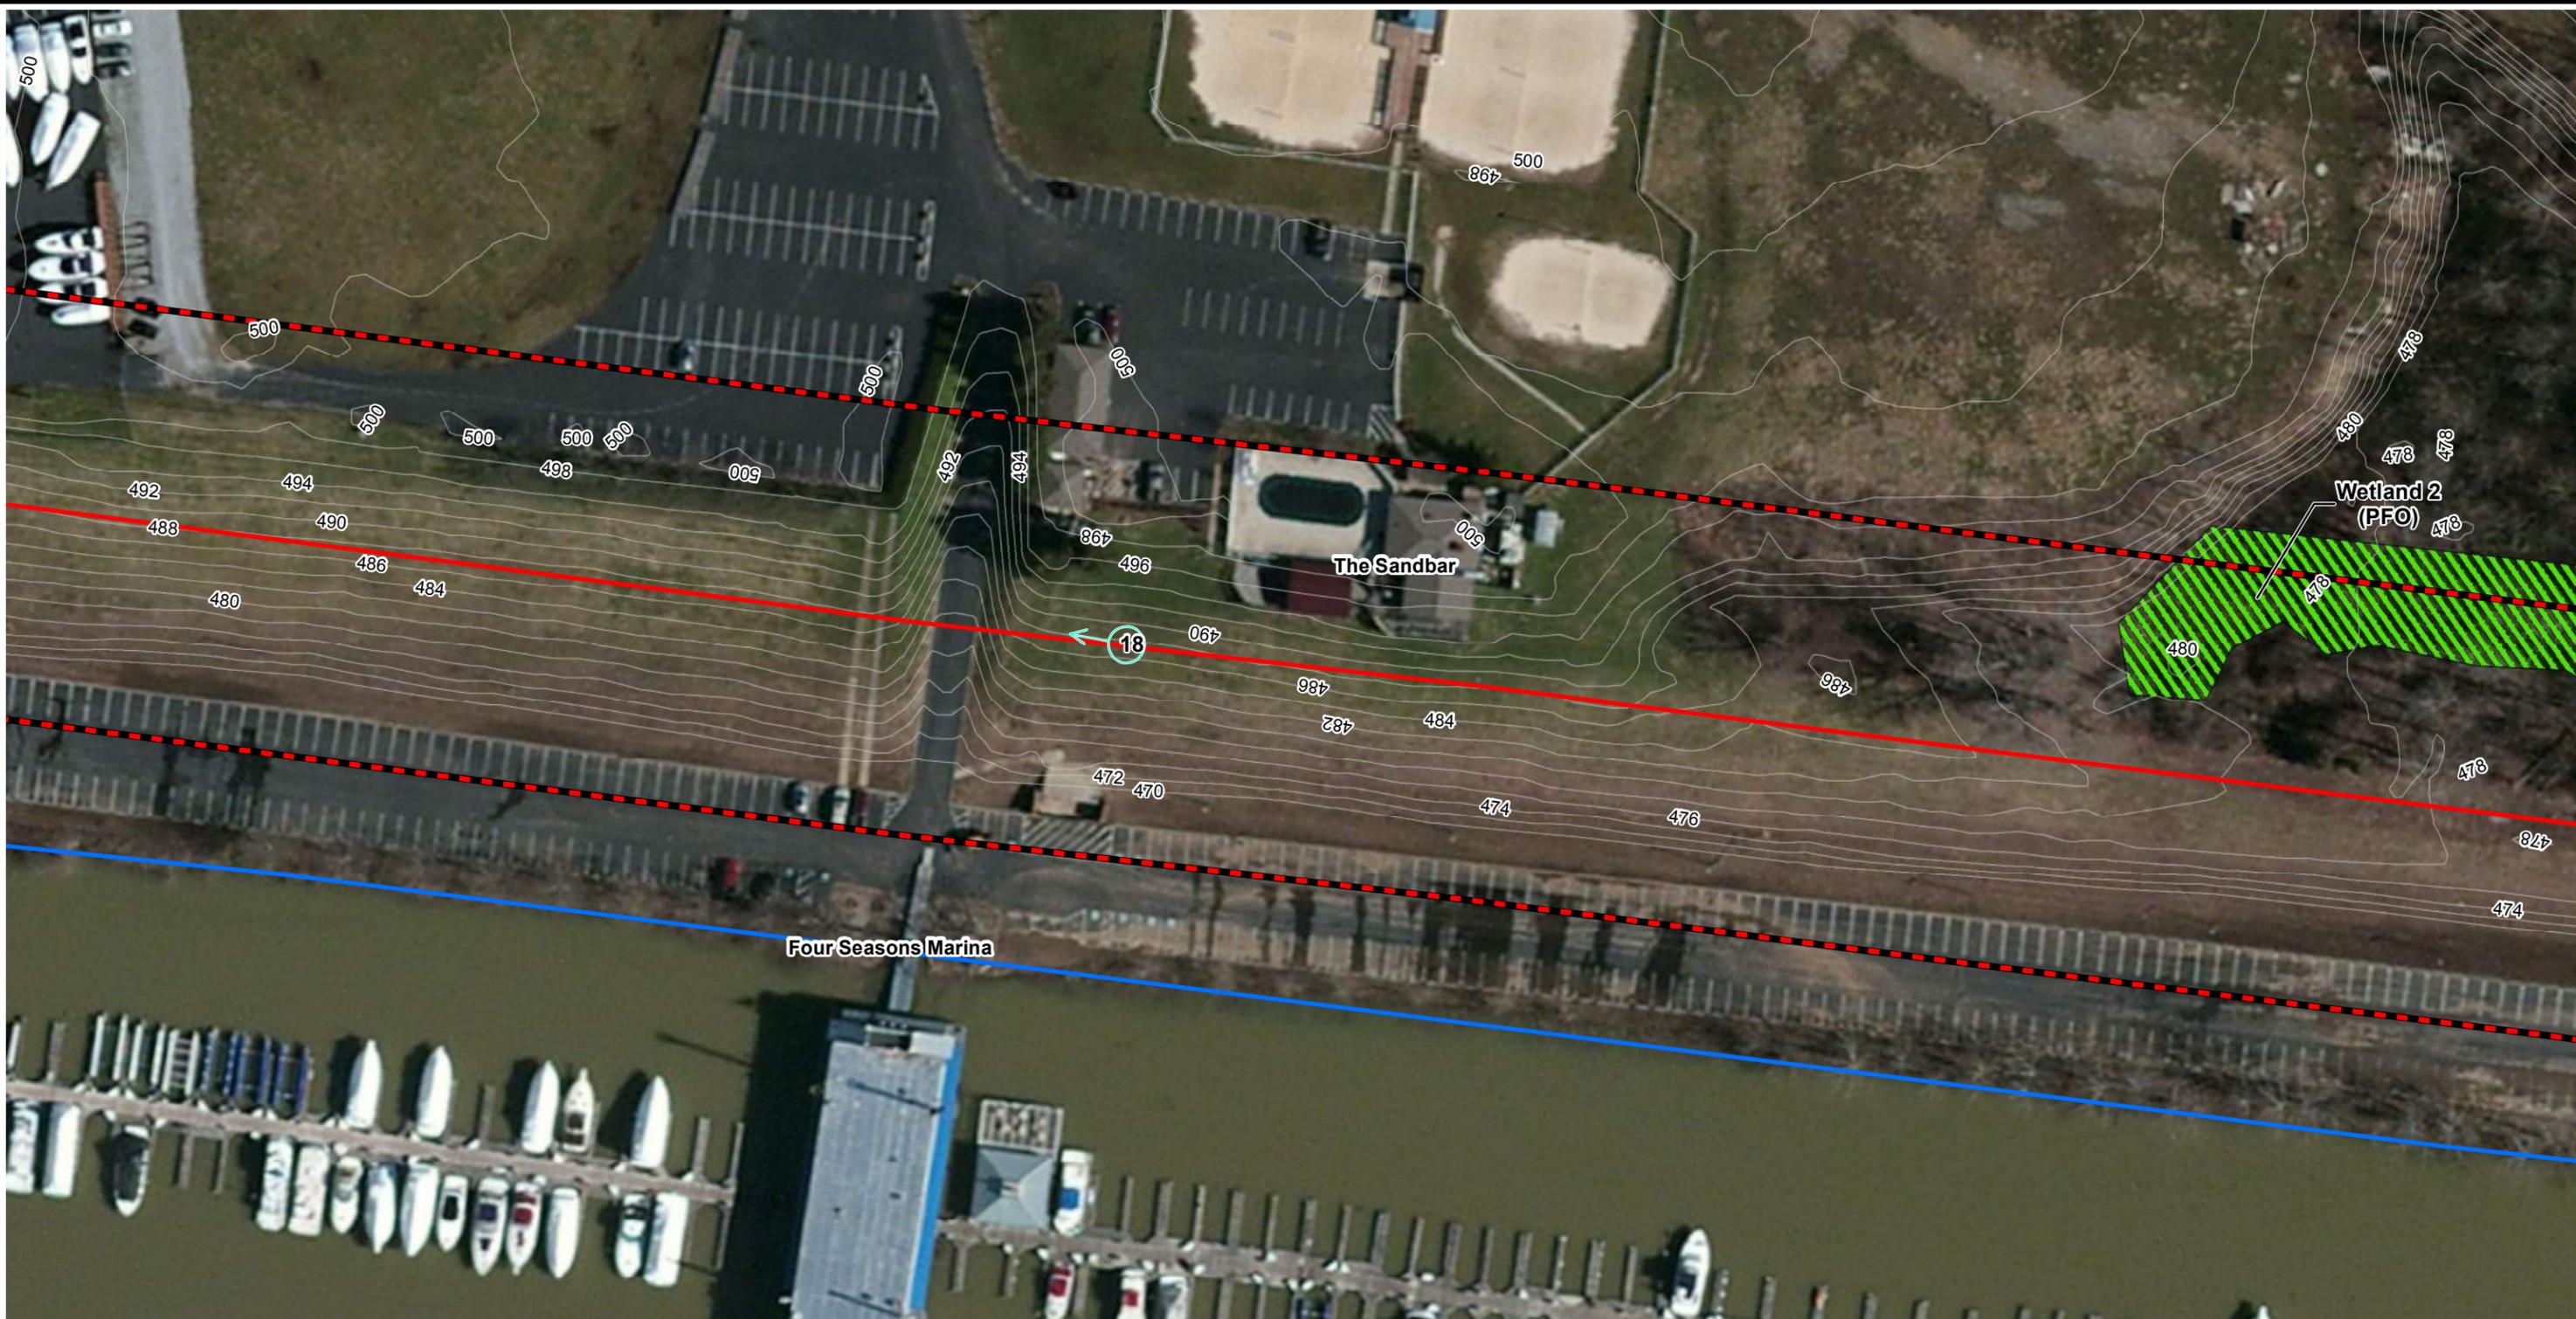
DRAWN BY: DMG	CHECKED BY: JAV	APPROVED BY: JAV*	FIGURE NO: 17
DATE: SEPTEMBER 23, 2016	DWG SCALE: 1" = 75'	PROJECT NO: 153-230

NOTES: FULL EXTENT OF STUDY CORRIDOR IS WITHIN 100-YEAR FLOODPLAIN.
NO STREAMS OR WATERBODIES WERE IDENTIFIED WITHIN THE STUDY CORRIDOR.

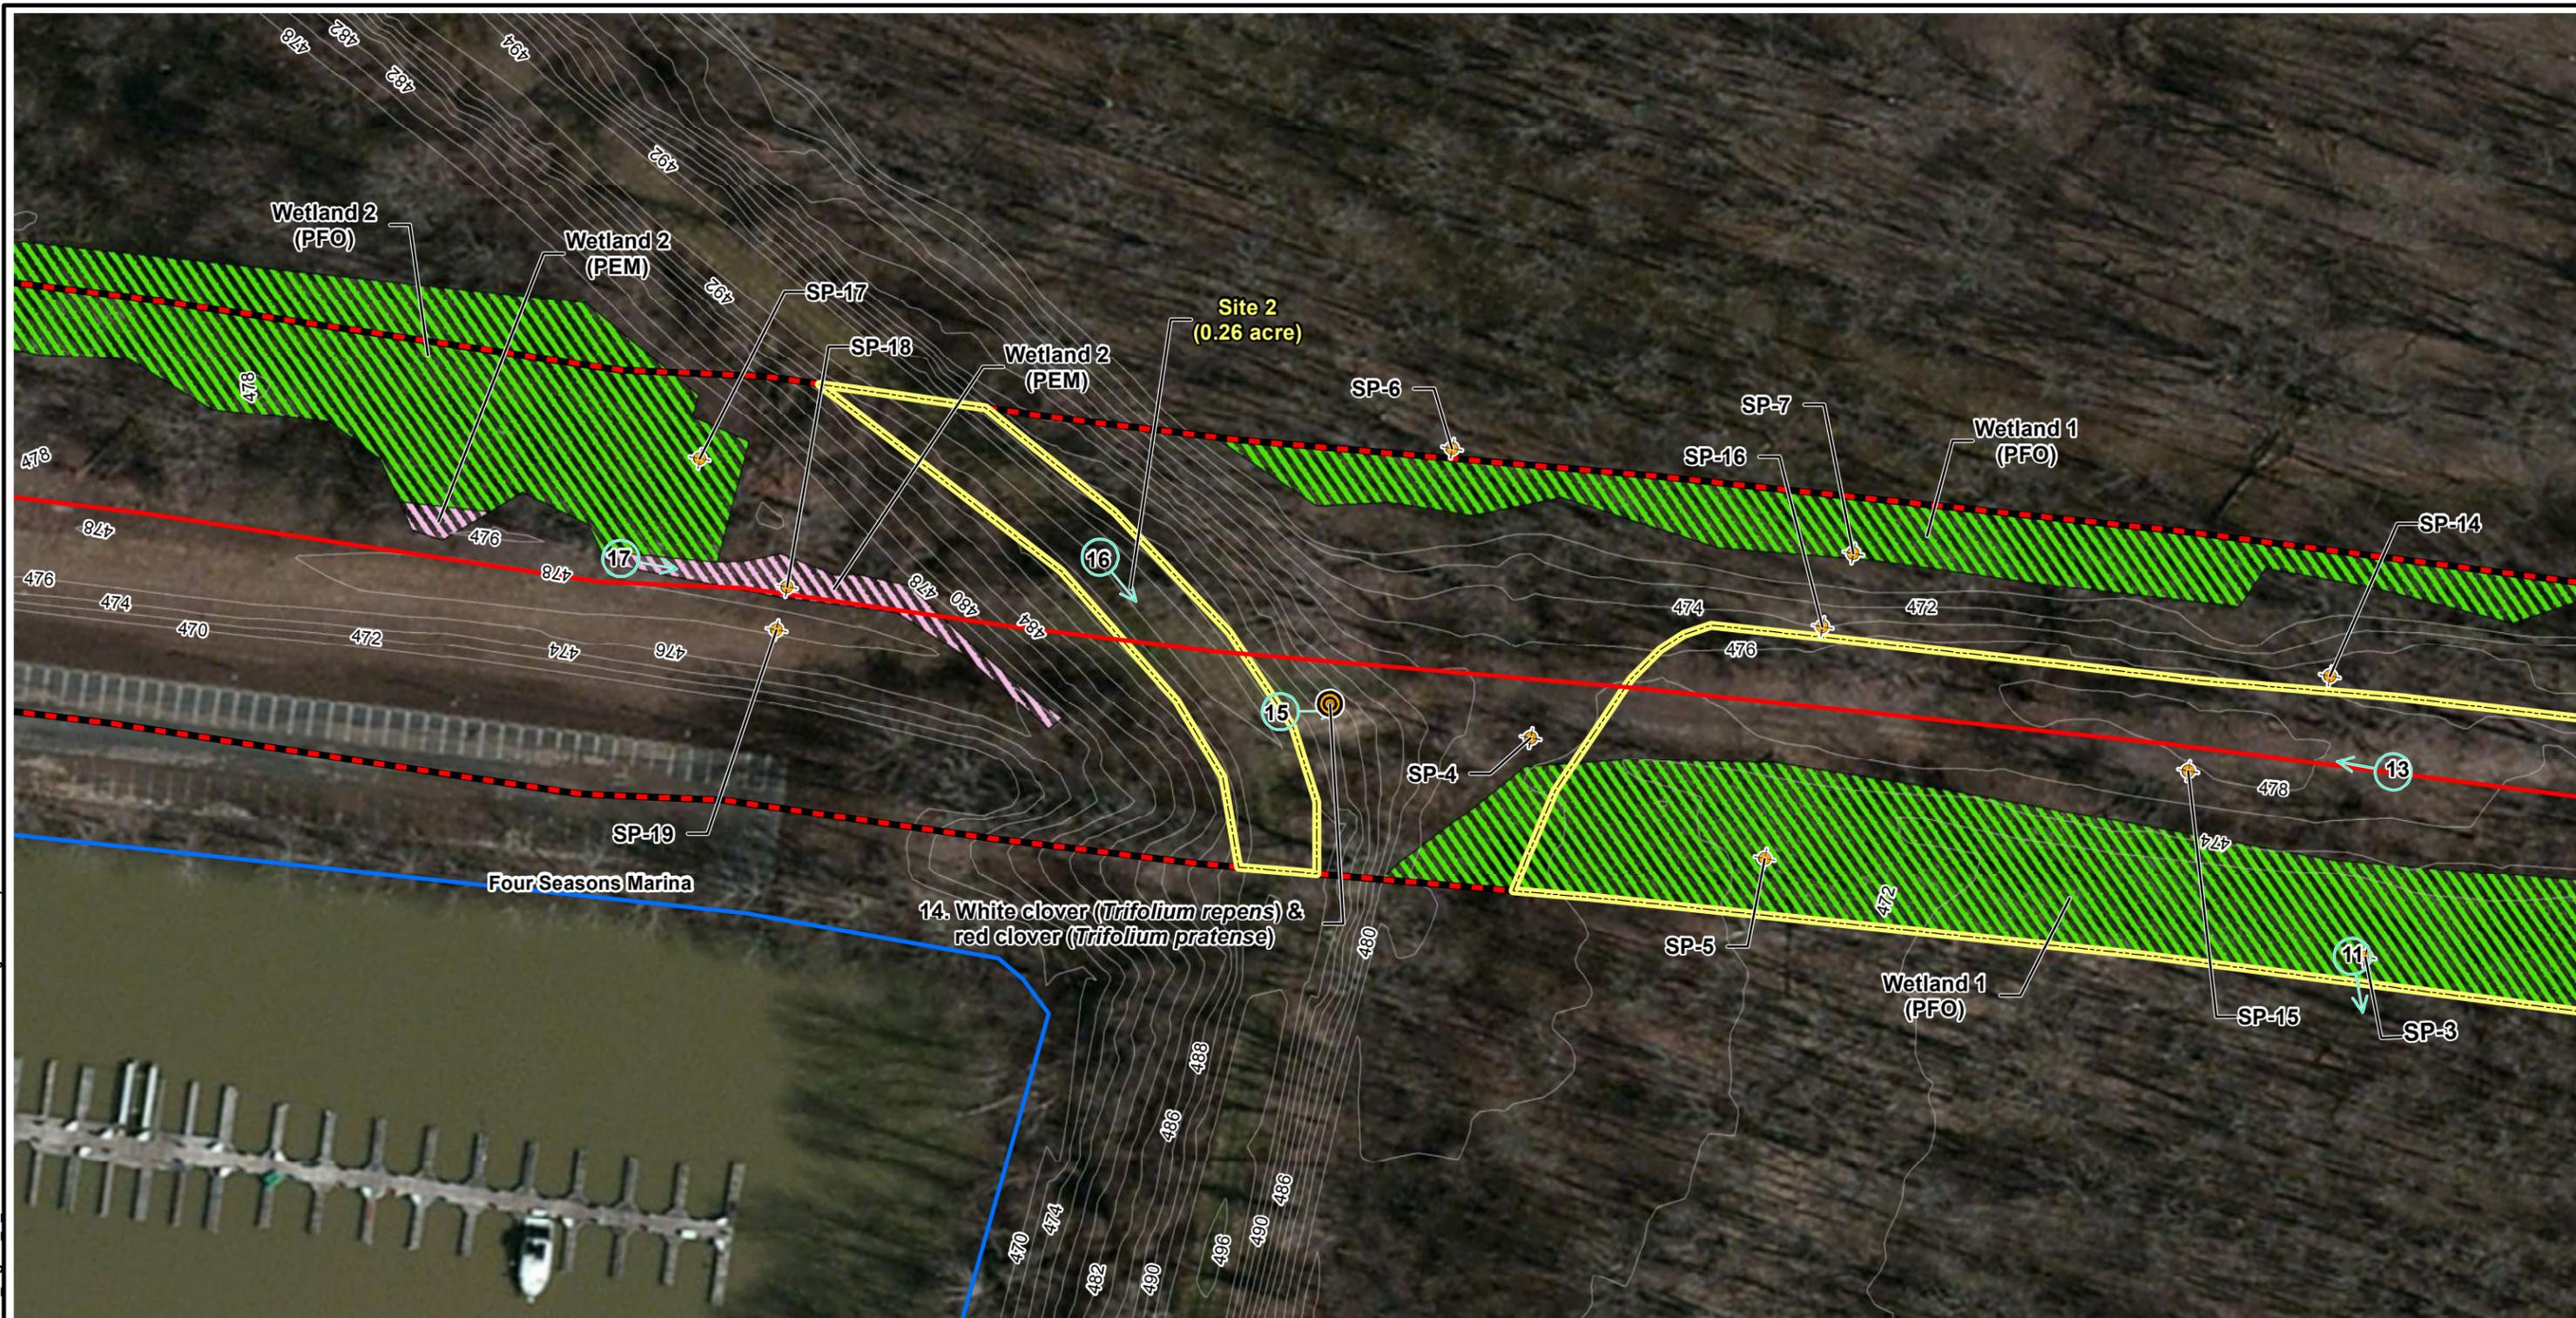
NOTES: FULL EXTENT OF STUDY CORRIDOR IS WITHIN 100-YEAR FLOODPLAIN.
NO STREAMS OR WATERBODIES WERE IDENTIFIED WITHIN THE STUDY CORRIDOR.

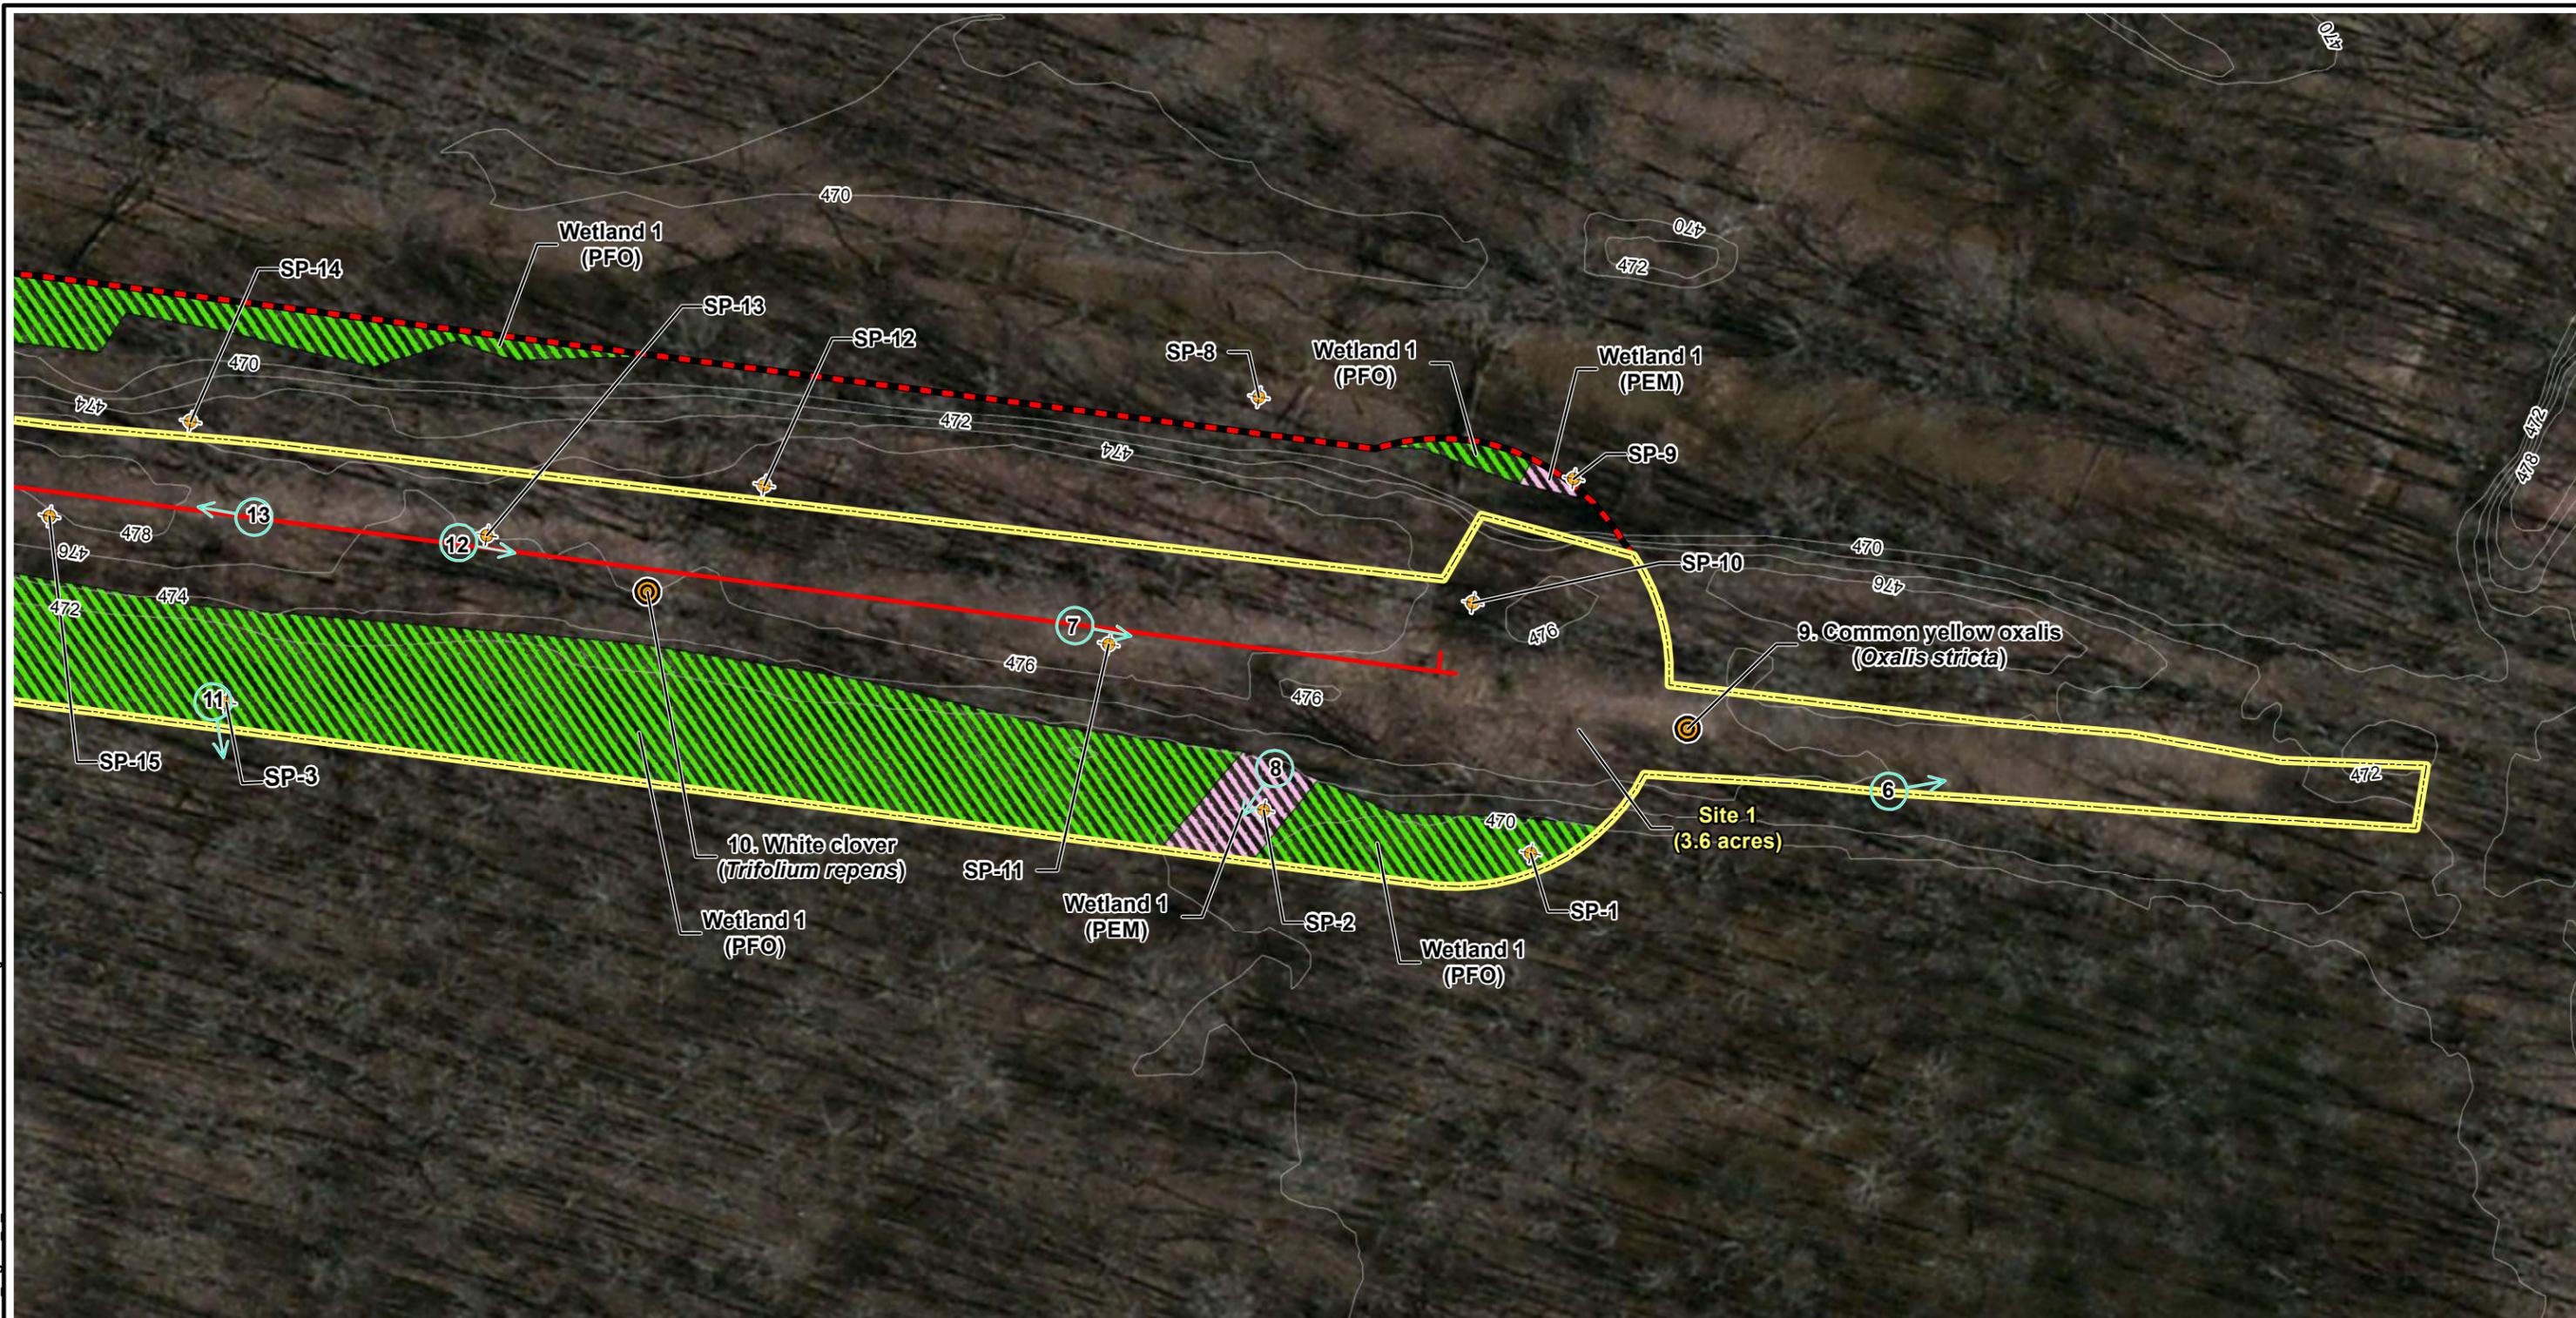
NOTES: FULL EXTENT OF STUDY CORRIDOR IS WITHIN 100-YEAR FLOODPLAIN.
NO STREAMS OR WATERBODIES WERE IDENTIFIED WITHIN THE STUDY CORRIDOR.

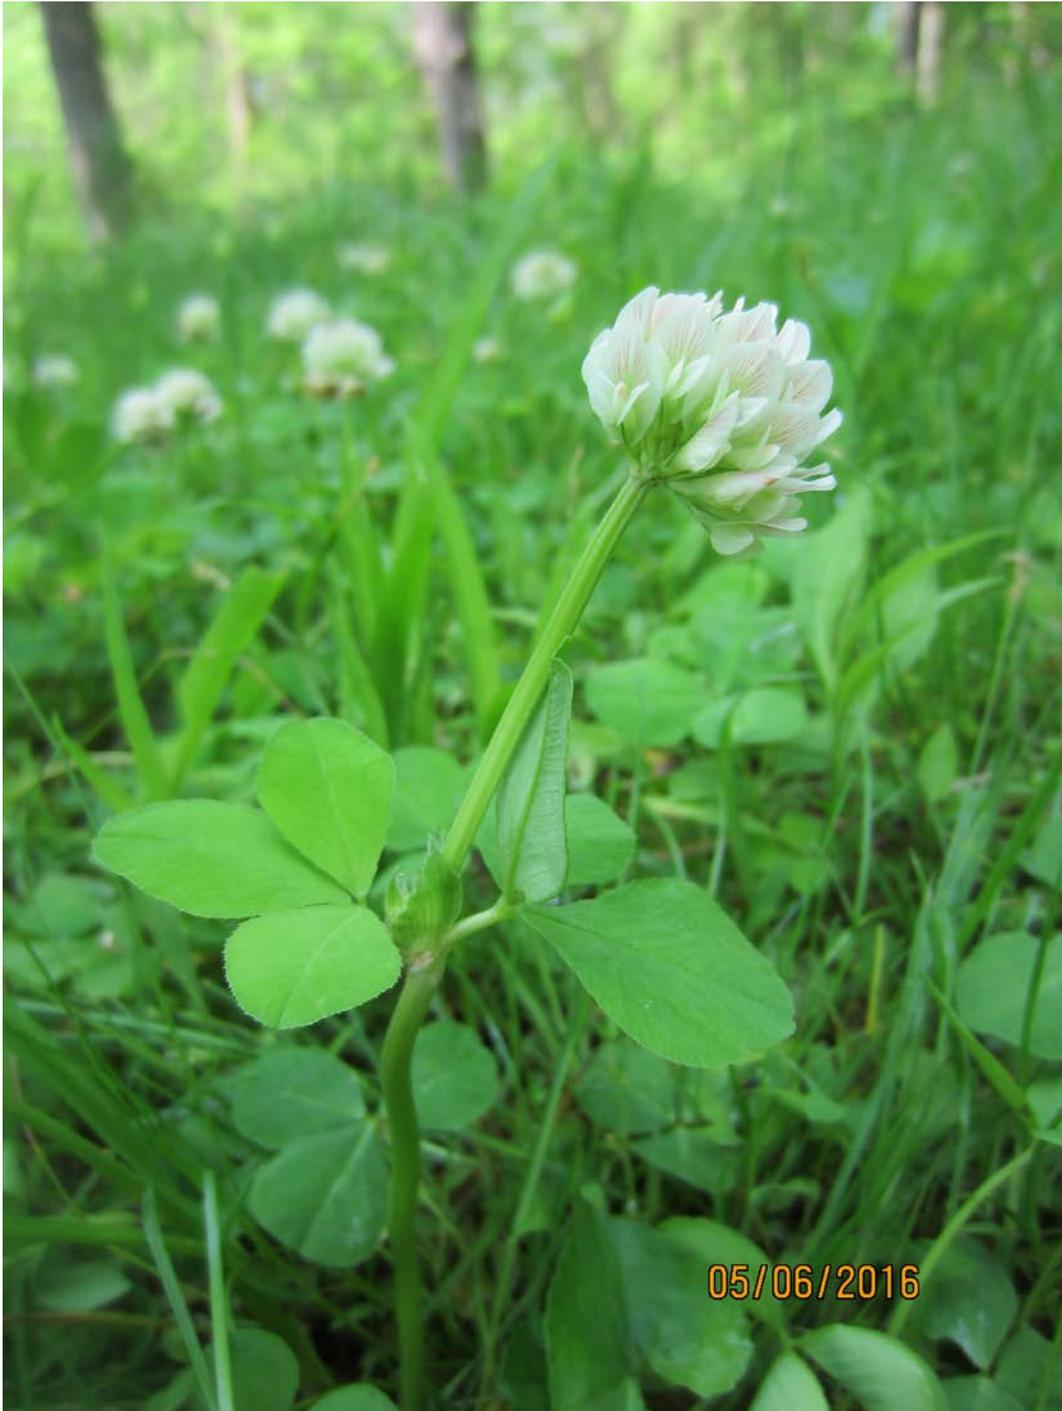
Photograph 1. RBC reference specimen from the Dinsmore Woods State Nature Preserve in Boone County, Kentucky. Note the opposite leaflets on the flowering stem.
