DUKE ENERGY
LINE D000B PIPELINE REPLACEMENT PROJECT
CINCINNATI, HAMILTON COUNTY, OHIO

RUNNING BUFFALO CLOVER SURVEY MAP

APPENDIX A-1

SITE PHOTOGRAPHS

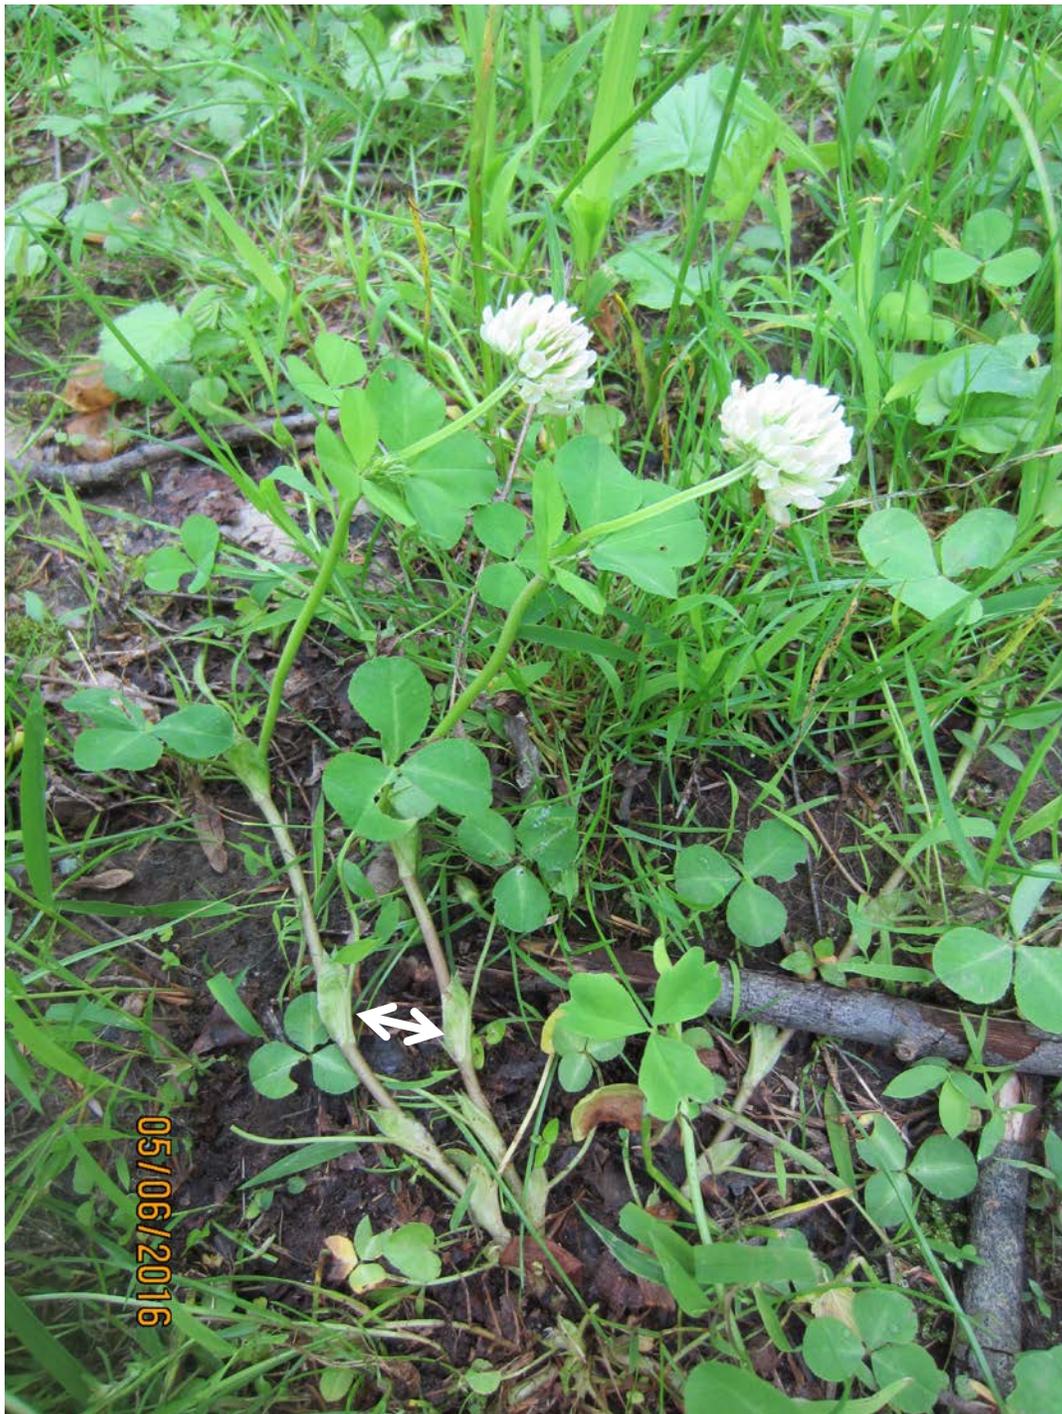
Photograph 2. Another view of RBC reference specimens from the Dinsmore Woods State Nature Preserve. Note the presence of stipules, an identifying characteristic.

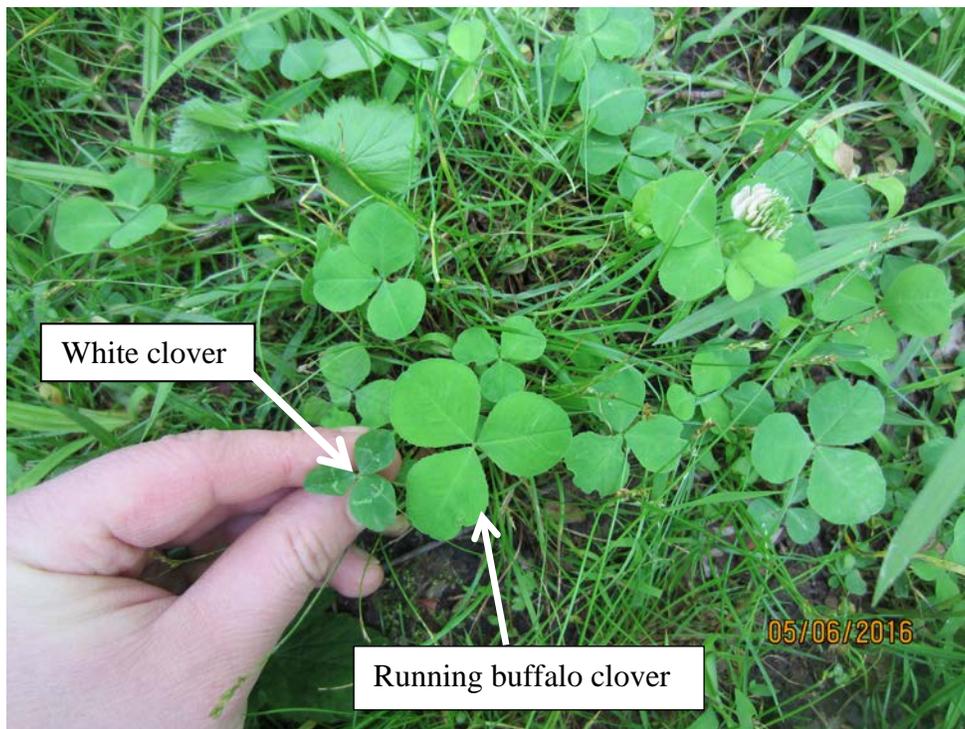
Photograph 3. Comparison of RBC look-alike white clover to running buffalo clover at the Dinsmore Woods State Nature Preserve.

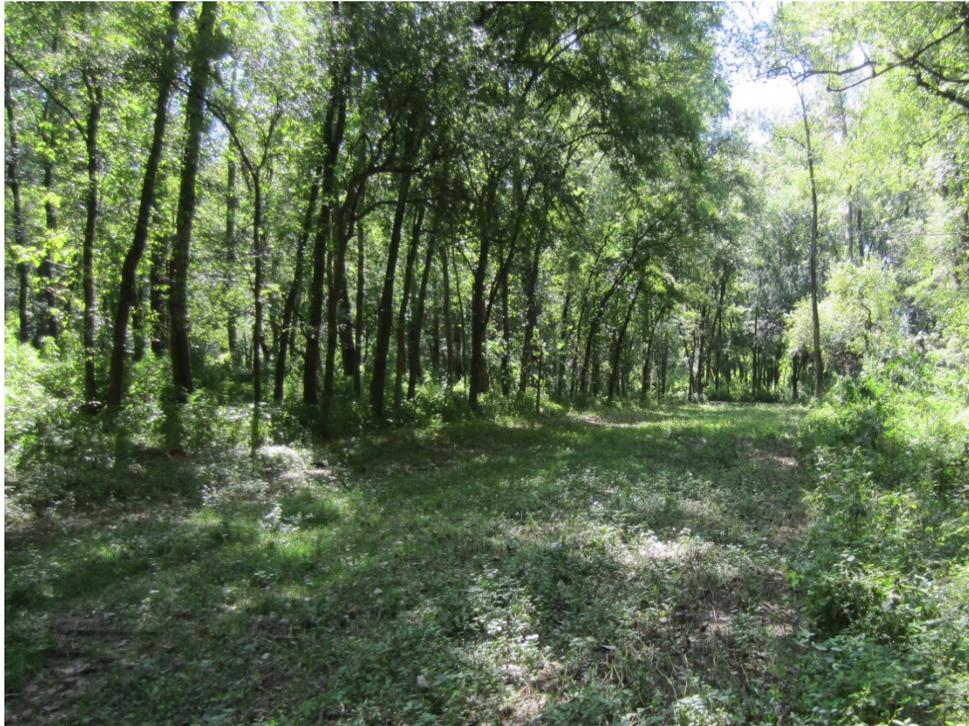
Photograph 6. View of maintained Line D000B ROW, south of proposed southern terminus of Project. Photograph taken facing south-southeast.

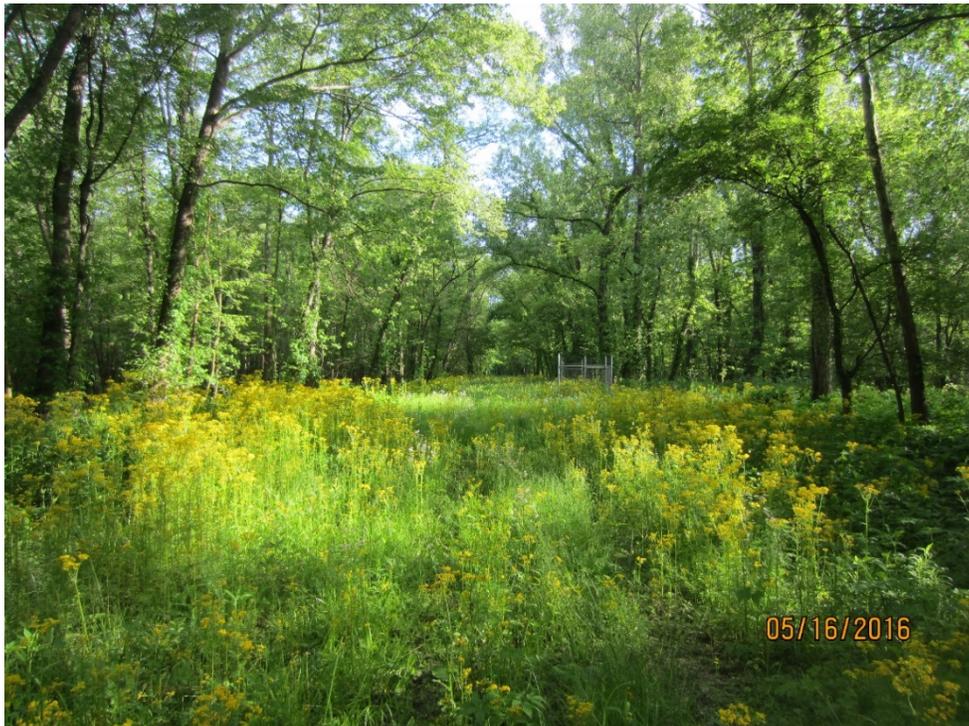
Photograph 7. View of existing Line D000B ROW at the southern terminus of study corridor. Photograph taken facing south.

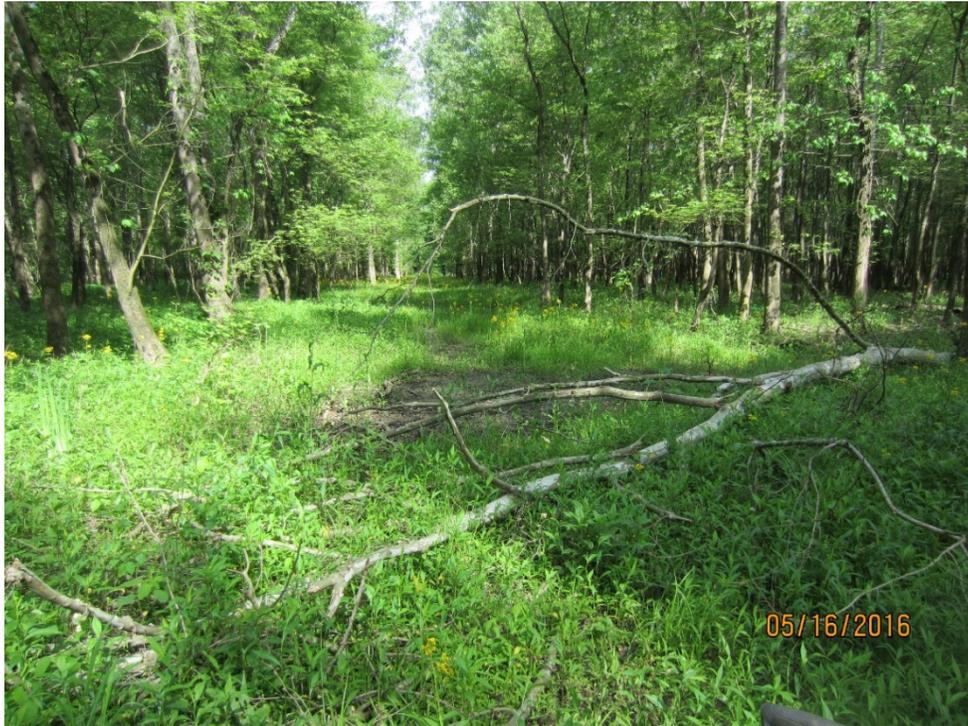
Photograph 8. Representative view of the PEM portion of Wetland 1. Photograph taken facing north-northwest along existing, maintained utility ROW.

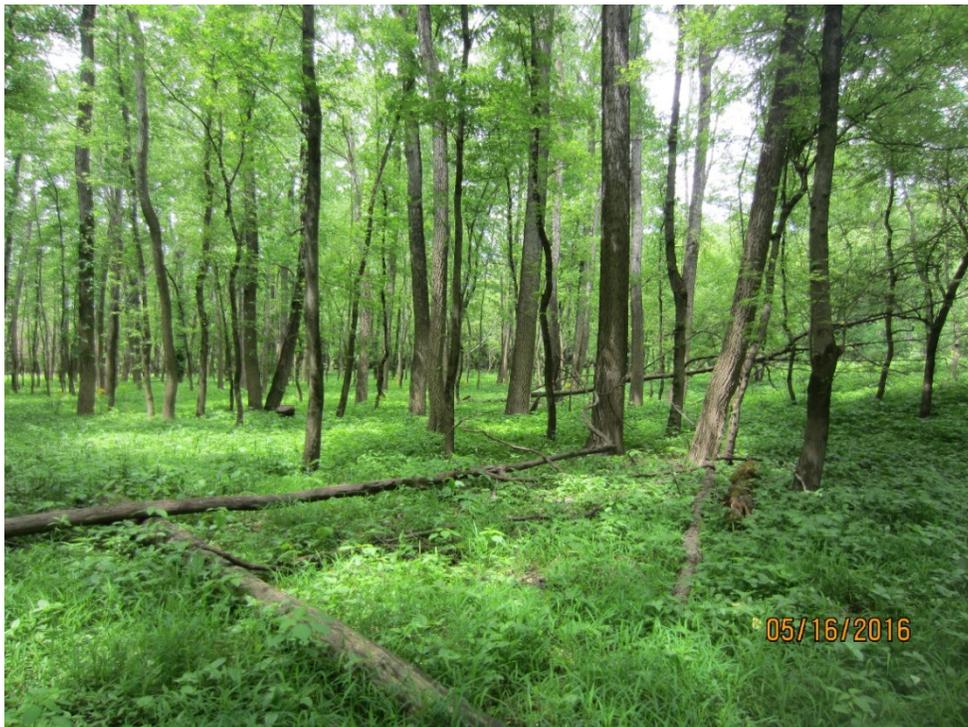
Photograph 11. View of the PFO portion of Wetland 1 along the west side of the Line D000B ROW near the southern terminus of the Project.
Photograph taken facing west.

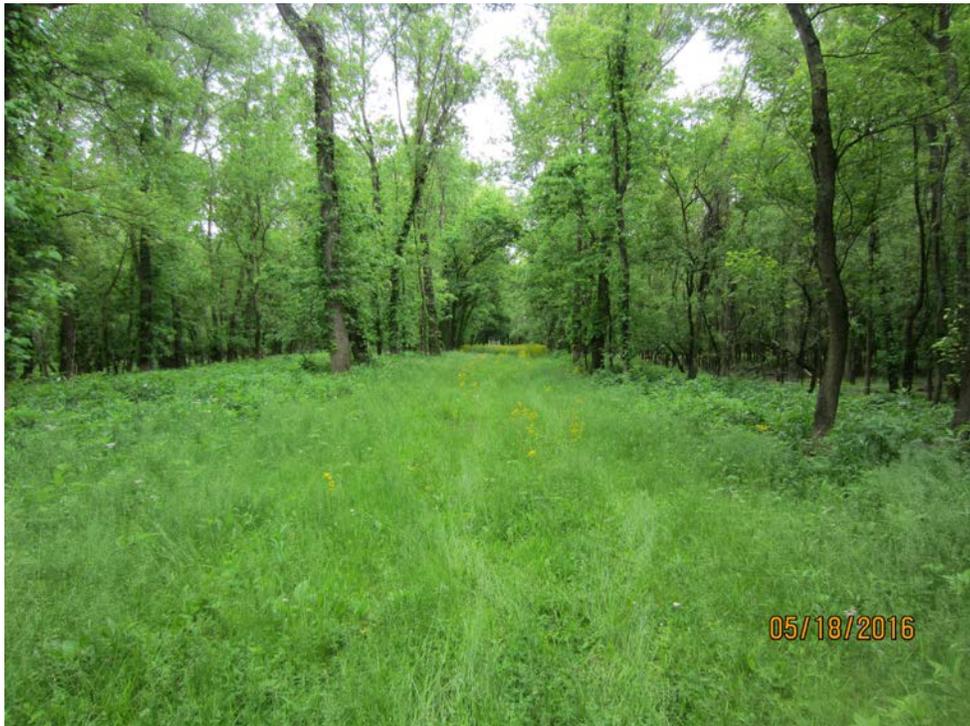
Photograph 12. Representative view of elevated and maintained ROW, bisecting Wetland 1 at wetland determination SP-6. Photograph taken facing south.

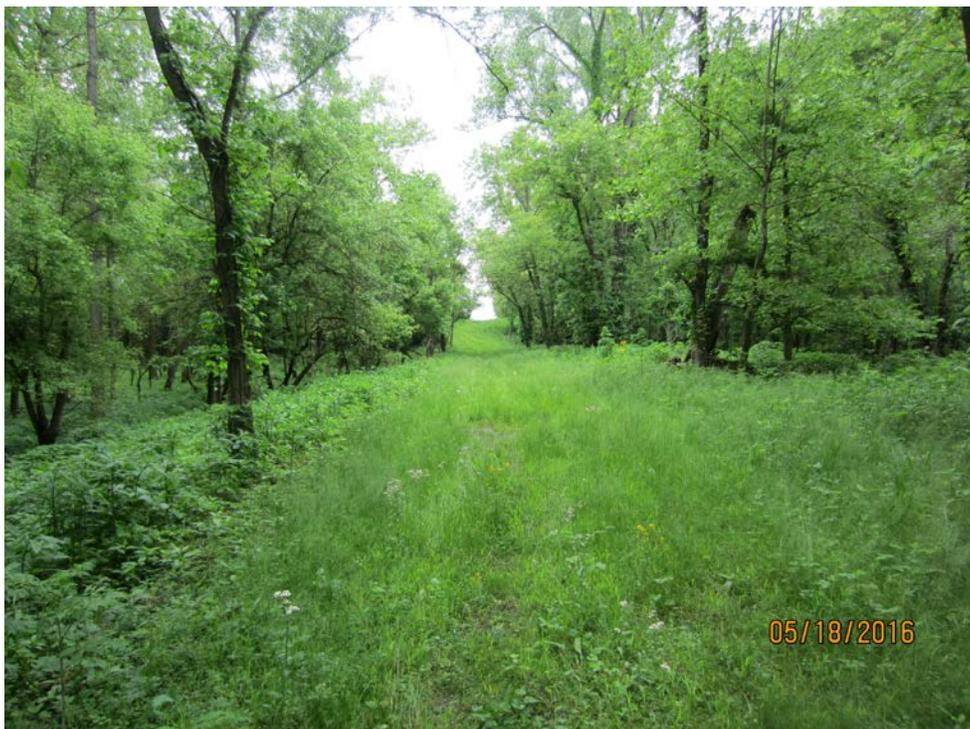
Photograph 13. Representative view of elevated and maintained Line D000B ROW, bisecting Wetland 1. Photograph taken facing north.

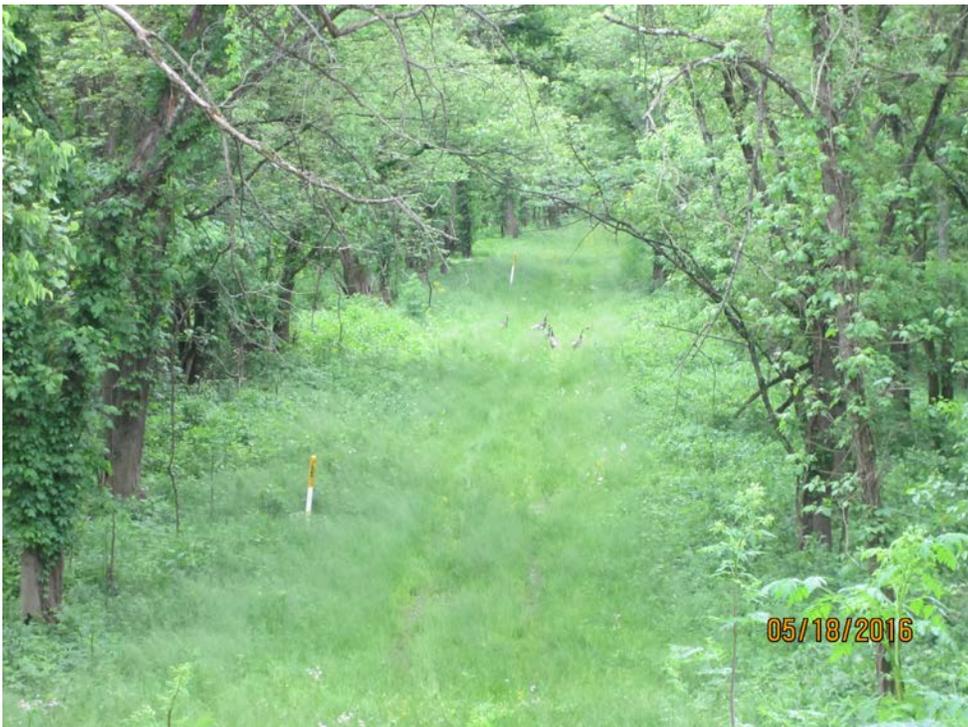
Photograph 15. Elevated view of existing bermed, maintained Line D000B ROW, bisecting Wetland 1. Photograph taken facing south.

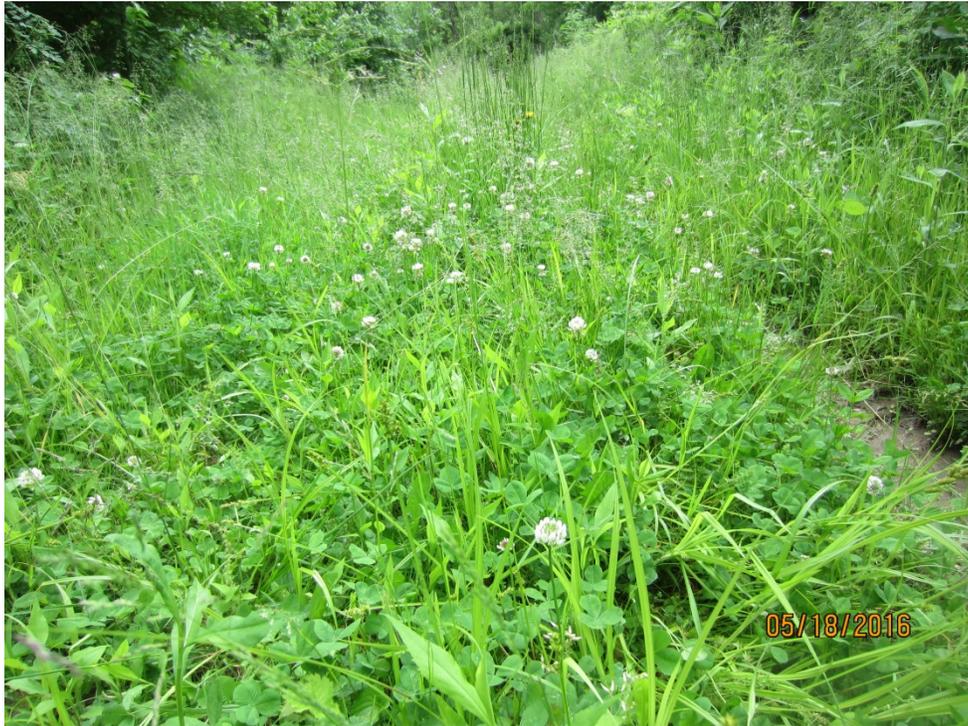
Photograph 16. View of white clover and other herbaceous vegetation growing along trail or two track that is located on an embankment that formerly functioned as railroad corridor, facing southwest.

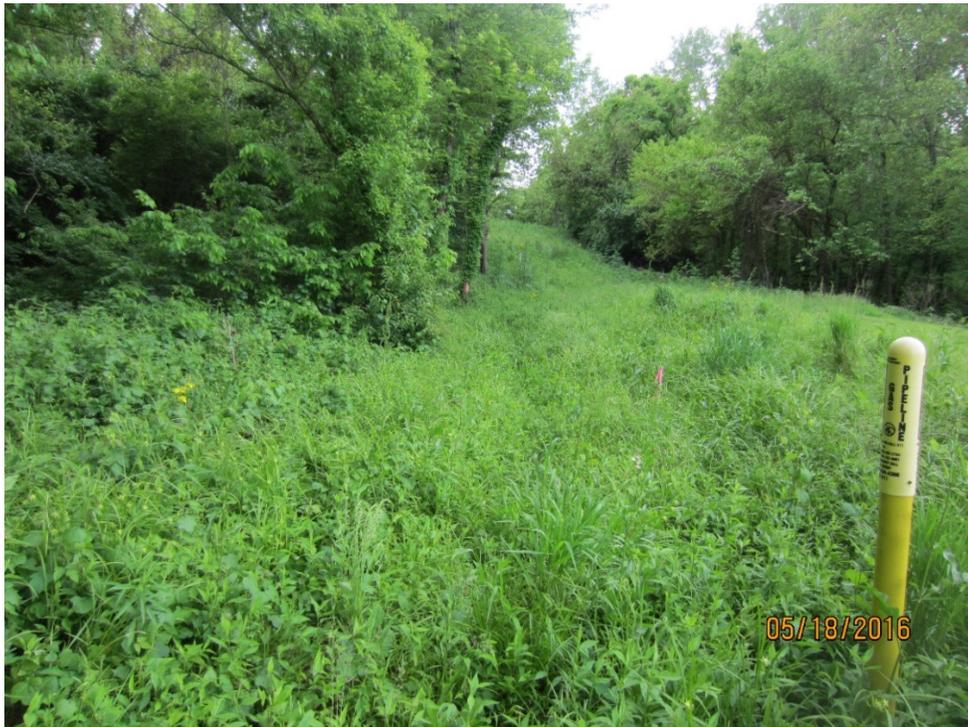
Photograph 17. View of the PEM portion of Wetland 2, facing south.
