Rehabilitation of a salt water disposal line in West Virginia USA

RTP-Rehab™ Case Study

Replacing a Corroded Steel line with RTP piping System

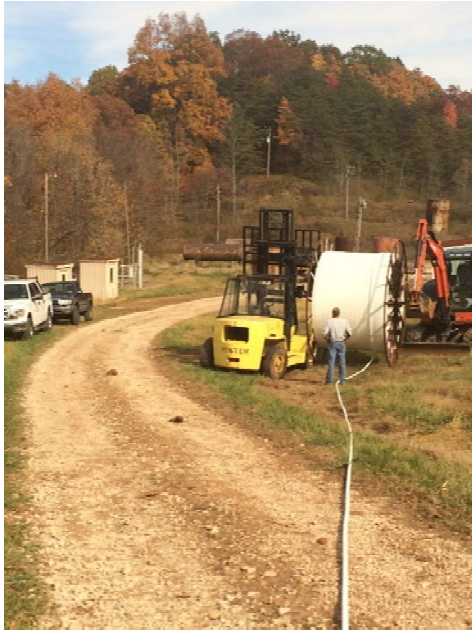
No Special Equipment for Unspooling

RTP Pipe was pulled out with an ATV and with a total crew size of three persons

7,500ft run with one length of pipe on a spool.

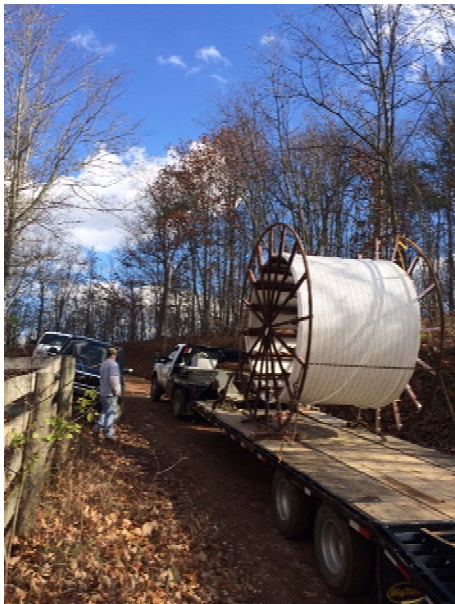
Light Weight for Easy Transport
