OTC-24721-MS

A Case Study Detailing the Design, Planning, Installation and Cost and Environmental Benefit Analysis of a Reinforced Thermoplastic Pipe Pulled Through the Inside of an Existing Offshore Steel Flow Line in the East Malaysia Samarang Field

John R Wright Jr, Polyflow LLC, Khairul Anuar Karim, PETRONAS Carigali and Steve Kennedy, SCG Oil and Gas

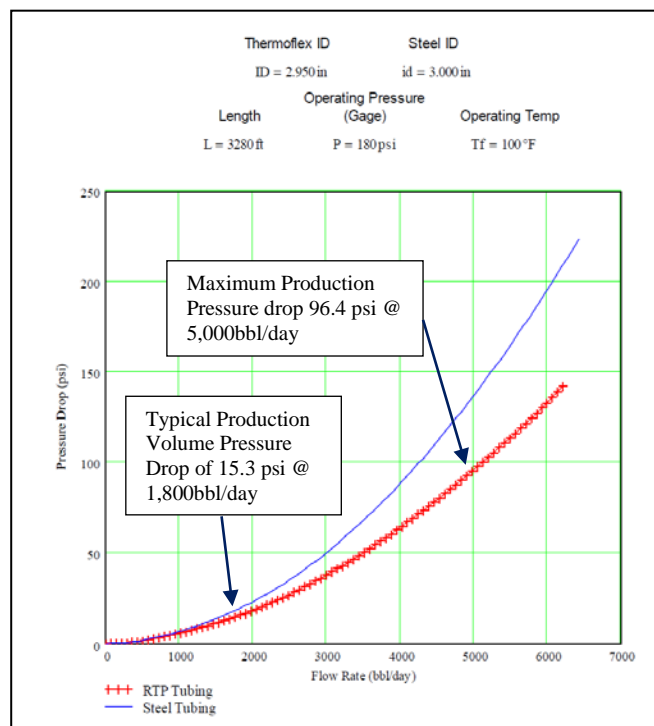
Figure 1: Impact of Flow Rate and Pressure Drop on RTP Pipe and Carbon Steel Pipeline

In the case of PL-112, the average fluid production was comprised of oil and water and a typical flow rate was 1,800bbl/day. The line was used as a bypass line for other flow lines and the production volume could spike to 5,000bbl/day. The maximum inlet pressure is 180 psi to minimize any backpressure against the wells and the ideal pipeline exit pressure flowing into the separator is set at 100 psi. Figure 1 and Figure 2 below shows the impact of flow rate on of a 3.5" RTP Pipe (2.95" ID) compared with a 3.0" ID steel pipe.

Refer to Figure 1, at 1,800bbl/day the pressure drop was modeled at 15.3 psi which is within the design parameters requested. However when flow is bypassed into the PL-112 line and reaches 5,000bbl/day of production the pressure drop increases to 96.4 psi which is slightly higher than the design parameters of 80 psi pressure drop. Before moving to a larger size pipe the product velocity was analyzed.

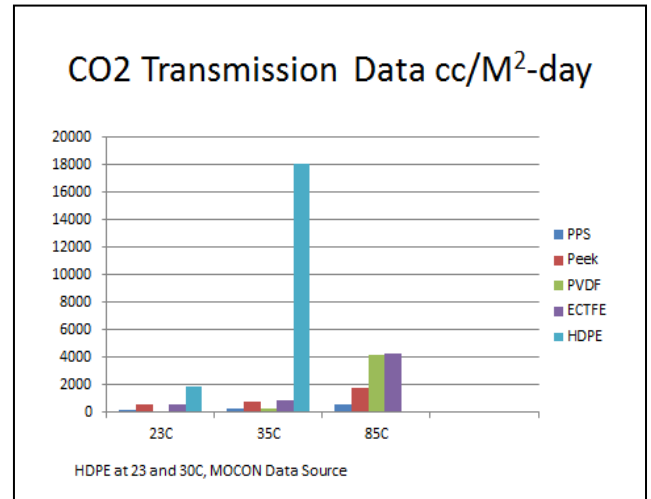
Figure 5: Comparison of CO₂ Permeation Rate for Polymer

Permeation through the liner does not necessarily damage the liner but rather can create operational issues such as build up gas pressure in the reinforcement layer creating issues with the outer jacket. In the case of the rehabilitation of a carbon steel pipeline, a build up of gas in the annulus between the RTP and the steel pipe can create non desirable issues. The Figure 5 is comparing various polymers permeation rates in CO₂ at various temperature to show a side by side comparisons. From the chart, it shows that polyethylene, a common polymer used in the oilfield has significant permeation rate compared to the other engineering plastics and Fortron (PPS) showed significantly lower levels of permeation.

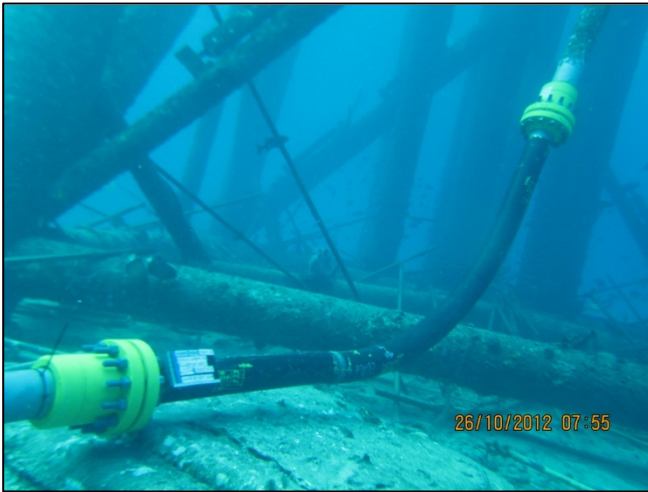
Figure 6: Replacement of 20D Riser Bottom Bend to allow for smooth RTP Pull-thru

It was first verified that the current bends at the base of the risers were having a 6” 5D bend radius. This was not deemed acceptable for pulling through a 3.5” RTP pipe inside the existing 6” carbon steel pipeline. A 6” 12D bend radius is required to provide sufficient size of bend radius for the pull through (Refer to Figure 6). Even though a tighter radius could be implemented for the project, the generous 12D radius cost no more to fabricate and assured an easy pull through the existing pipeline.

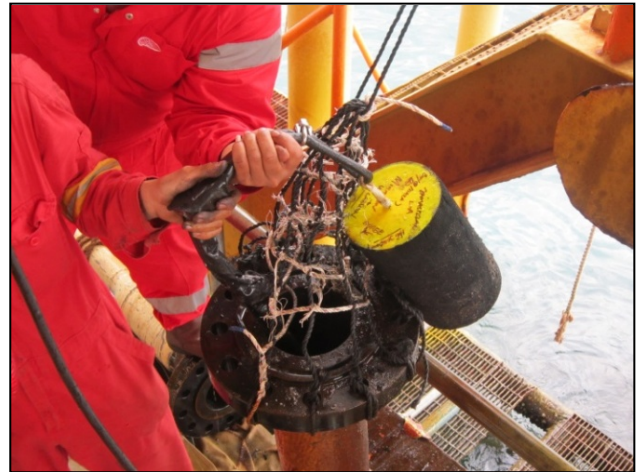
Figure 7: Retrieval of Foam Pig Attached with Pulling Rope

The next step was to insert the pulling rope through the line. A synthetic rope constructed from Technora aramid fiber and jacketed with a nylon cover was deployed because of its high strength, low weight and excellent

creep resistance. The rated tensile load was 9,090kg to meet a minimum five (5) times safety factor over the maximum pull force required to pull the 3.5" RTP through the existing steel line. The lightweight rope required only 60 psi of pigging pressure to be pulled with a foam pig through the line, thus minimizing any potential damage to the existing carbon steel pipeline. The process of pulling the rope through the existing steel line requires a foam pig with an eyehook on the back end attached to a clevis which is attached to the eye of the rope. The pig is inserted into the pipeline. The rope is passed through a lubricator which is attached to the pig launcher to allow for a seal around the rope as water pressure moves the pig along the pipeline.

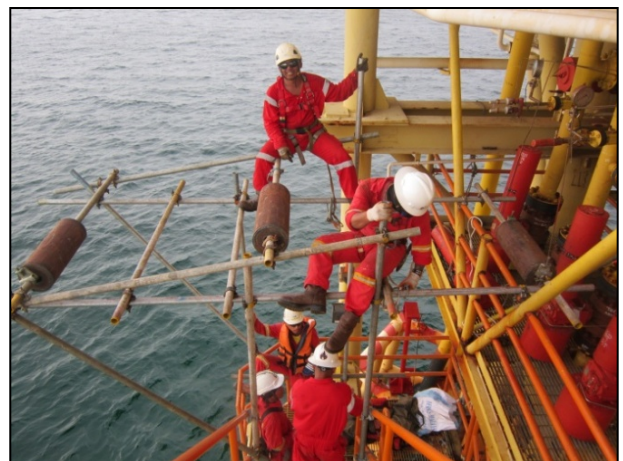
Figure 8: Erecting Scaffolding and Sheave prior to Pull Thru

The largest change to the original work plan occurred because the crane on the pipe deployment platform was inoperable. The pipe was required to be pulled from a DP2 vessel over a temporary gooseneck constructed on the platform directly over the pipe. Figure 8 shows the temporary sheave scaffolding, and Figure 9 visualizes the pulling of pipe from the boat. A standard winch is used to pull the rope through the pipeline and designed to match with the tensile strength of the rope. A load cell to monitor the tensile load during pulling is set between the entry point into the riser and the winch.

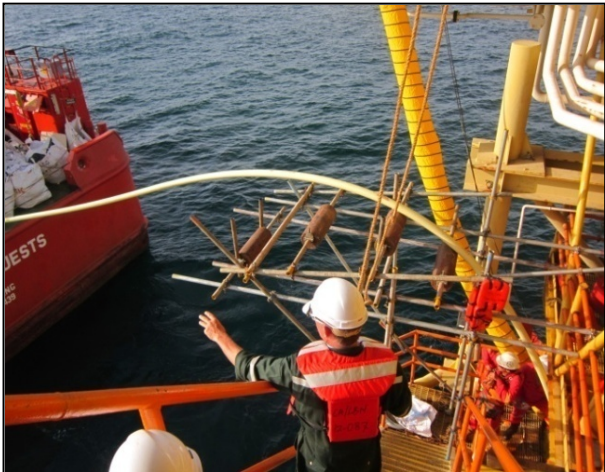
Figure 9: Pulling Process off the Vessel

Care must be taken during the pulling process to keep back tension against the reels of RTP pipe being unspooled and to avoid the pipe from creating an excessive loop between the riser pipe opening and the boat. This did occur once and kinked the RTP pipe creating the need to repair the kinked portion using splice coupling.

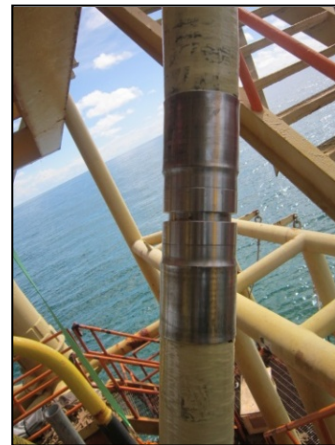
Figure 10: Duplex Splice Coupling

Each individual length of RTP pipe was approximately 300 meter in length requiring duplex 2205 jointless splice coupling to join pipes together. The splice couplings are comprised of a continuous length of stainless steel for an inner liner or insert with two outer ferrules that are swaged onto the pipe located between the insert and the ferrule. The result is a compression union of the two pipe ends together. When the end of a pipe on a reel is almost completed, the winch is stopped. The remaining pipe is removed from the spool and aligned into the coupling machine to swage one side of the splice coupling onto the pipe (See Figure 11). The starter end of the next length of pipe is pulled from the reel and put in line with the coupling machine and swaged onto the splice coupling already attached to the end of the previous length of pipe (See Figure 12). The winch is then activated to slowly pull the pipe into place (aligned with the gooseneck over the riser opening) and the pulling process continues. The winch pulling speed averaged 20 meters per minute.

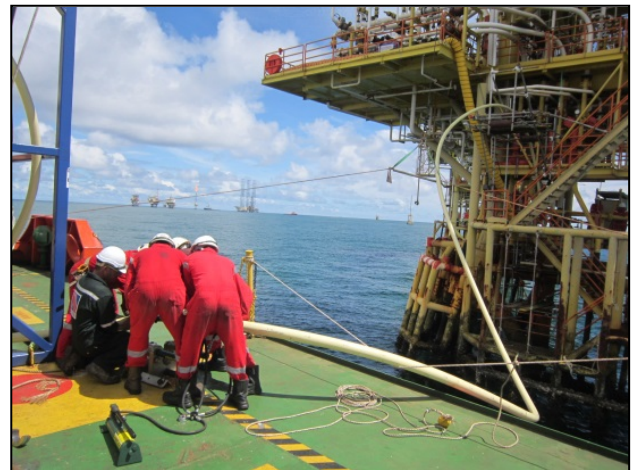
Figure 11: Splice Coupling Tail of Pipe

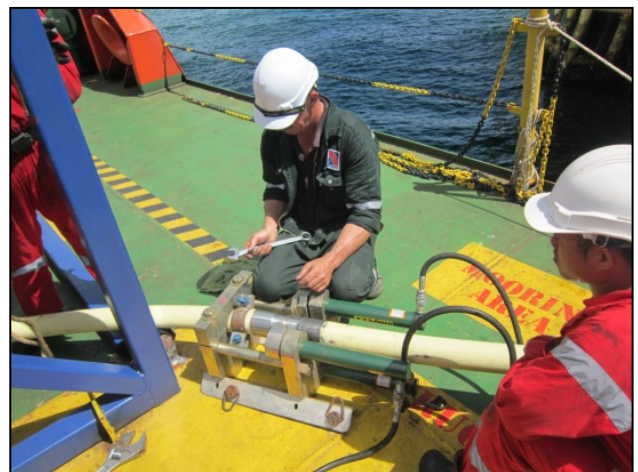
Figure 12: Splicing Lead End on Coupling

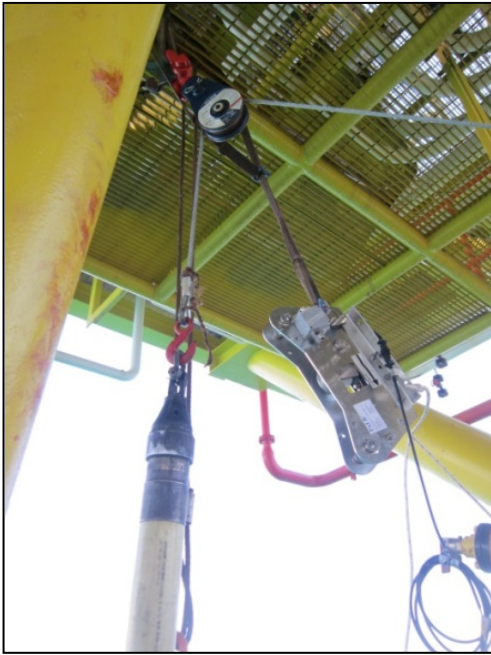
During the pulling process, the nylon jacket on the pulling rope was peeling off. It was assumed that the downhole flanges installed during the riser bottom bend modification had a sharp edge that “grabbed” the jacket and ripped it. The pulling process continued but the load cell was removed because the torn jacket was preventing the rope from passing through the load cell. The tension of the rope was then visually monitored to inspect for excess tension indicating a hang up. The exposed fiber in the

synthetic rope were being damaged during the pull and eventually snapped approximately 1 meter from the end of the pull. The pulling cone was grabbed with a cable via fishing techniques and the pull was finally completed.

Figure 13: Final Pull Out of the Existing Pipeline

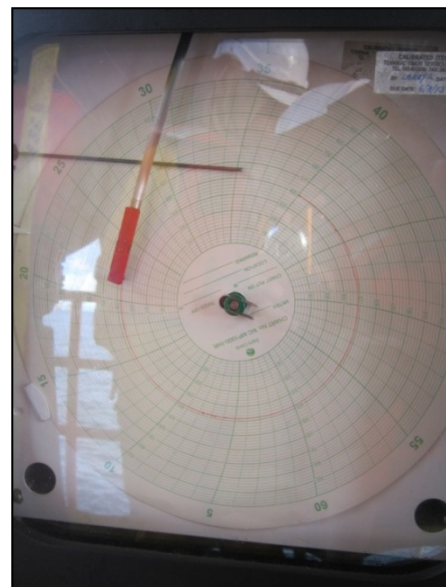
Once the topside connections were installed, the new RTP line was hydro-tested for 24 hours at 360 psi. The current MAOP of the line is 180 psi. The pipe RTP needed approximately two (2) hours to stabilize before being

hydro-tested for 24 hours.

Figure 16: Hydrotest Pressure Chart

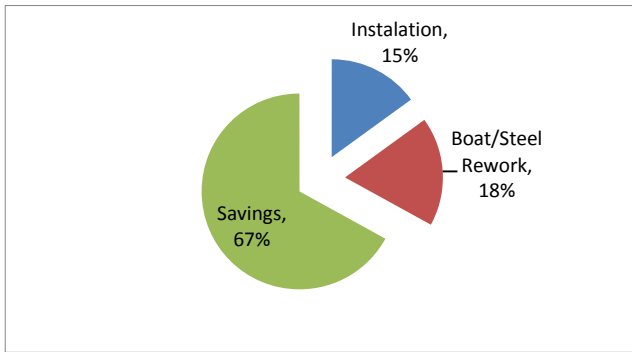
The total cost of installation, including riser modifications, vessel costs and installation, was 67% lower than the projected costs for a conventional installation of a carbon steel pipeline. The Figure 17 shows the percentage of installation and materials, the rework of the steel pipeline and vessel costs incurred, and the cost savings versus a new steel line.

Figure 17: Distribution of Cost Savings (%)

If rework to the damaged pipeline from the anchor were not necessary, the risers had a suitable bend radius not requiring replacement, and both the pulling winch and pipe can be staged and installed from the platforms, then installation would be 15% of the cost of laying a new conventional steel line.

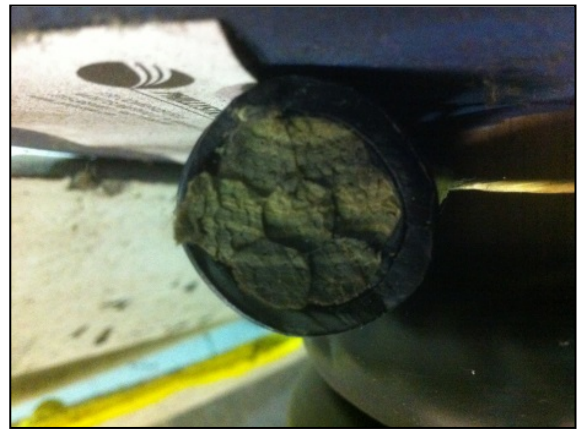
Figure 18: Thicker Polymer Jacket Pulling Rope

The existing rope protective jacket was too thin resulting in a stripping of the rope jacket during the pulling operation. For an improvement, after the completion of the project testing was performed on three (3) alternative jackets to protect the internal synthetic fibers. The first was a heavier polymer jacket that resists wrinkling at the minimum bend radius the rope will experience. The second option was an exterior fiber braid woven over the inner synthetic rope to provide abrasion resistance. The last option was a combination of a thicker polymer jacket with a braided fiber over the polymer jacket. (See Figures 18, 19 & 20)

In all cases the rope was spooled on an 8” diameter spool with no wrinkling. Drag tests are still being conducted but initial results show excellent resistance to abrasion.

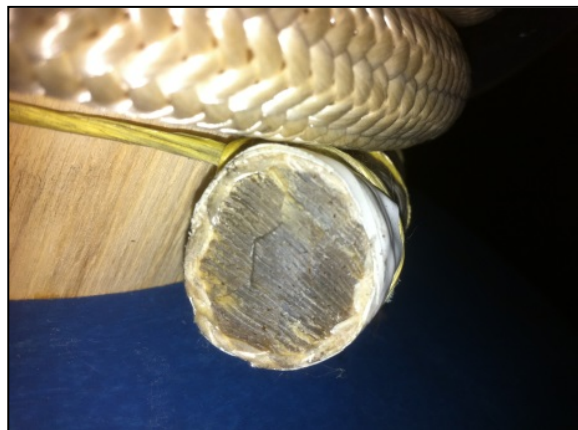
Figure 19: Braided Jacket Pulling Rope

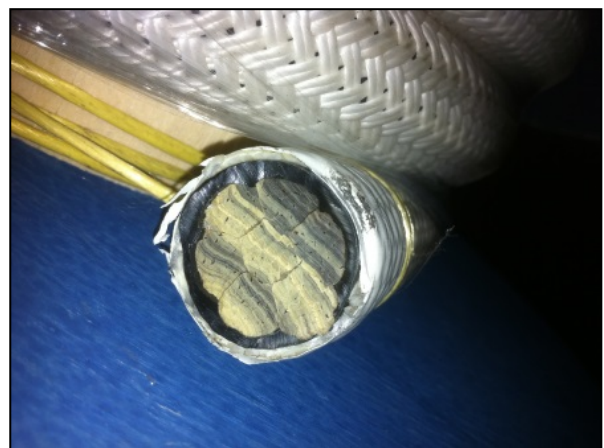
Figure 20: Polymer & Braided Jacket Pulling Rope
