RTP-Rehab™ Case Study

Installation of 3" RTP Pipelines Inside Corroded Steel Flow Lines Under a Ship Channel in the Gulf of Mexico

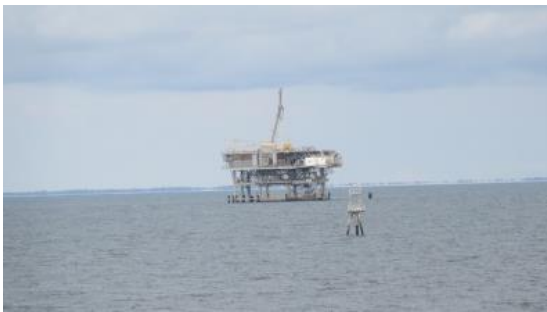
Figure 1. View of Platform Across Ship Channel

An operator in the Gulf of Mexico had several gas wells shut in due to multiple corroded pipelines. The two lines to be rehabilitated were approximately 1.7 miles (~ 9,300 ft) in length and between two platforms (Figure 1. shows view of one platform across ship channel). One line will flow gas the other line is for flow of produced liquids containing H₂S levels as high as 4,000 PPM. The gas line was DOT jurisdictional. The company selected Specialty RTP's reinforced thermoplastic pipe (RTP) as the best option to take advantage of rapid low cost installation and to minimize ongoing maintenance costs.

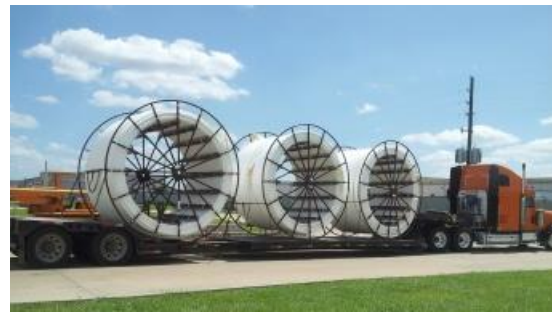
Figure 2. RTP on 12 ft OD Spools

The 3" RTP for each line was supplied on three 12 ft OD spools (see Figure 2), with one spool placed in an A-frame positioned on the mezzanine deck and the remaining two spools were staged on the platform's helideck (Figure 3 shows lifting RTP spool onto mezzanine deck).

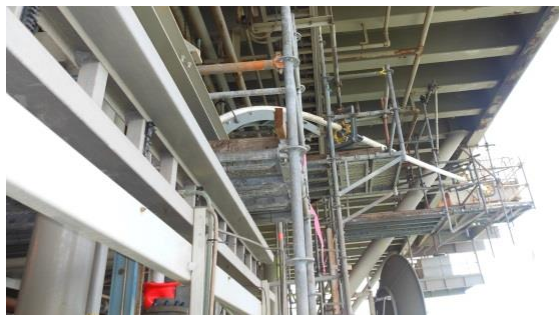
Figure 4. RTP Being Pulled from Platform

A synthetic rope was utilized to pull the 3" RTP between platforms, through 6" steel pipelines from riser flange to riser flange (Figure 4 shows RTP being pulled from spool on mezzanine deck to riser flange). All work was performed from the decks of the platforms.
