DUKE ENERGY OHIO  
F3886 PORT UNION TO MUHLHAUSER  
REBUILD PROJECT  
WETLAND DELINEATION REPORT

**ENVIRONMENTAL ACCESS PLAN KEY MAP**  
 F3886 PORT UNION TO MULHAUSER  
 REBUILD PROJECT  
 REGULATED WATERS DELINEATION REPORT  
 DUKE ENERGY OHIO

Regulated Waters Delineation Report  
F3886 Port Union to Muhlhauser Rebuild Project  
Duke Energy Ohio  
City of Fairfield and West Chester Township, Butler County, Ohio

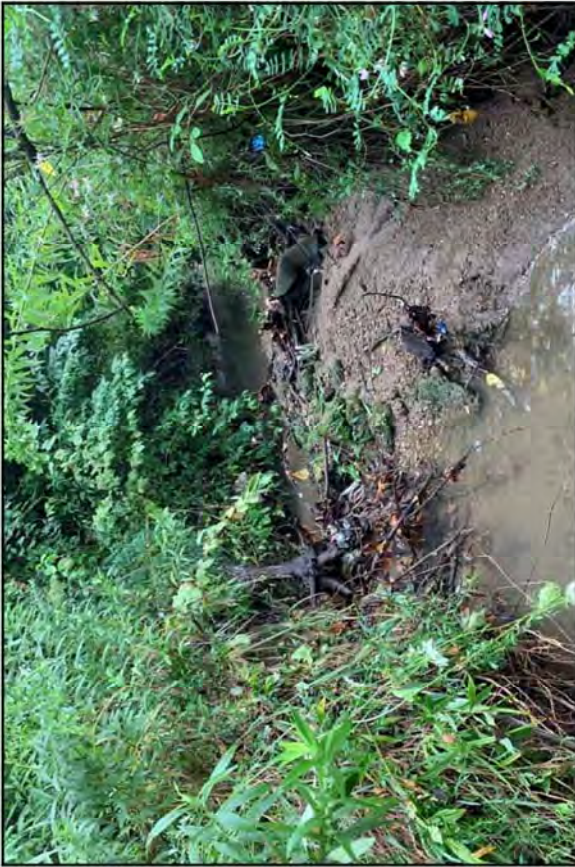
Photo 1: Stream 1, View Facing Upstream, 08/13/2019.

Stream 1 (S01) was a perennial stream that flowed east through the Study Area. The dominant substrates were sand and silt. Ordinary High Water Mark (OHWM) width of S01 was approximately six feet and depth was 2.5 feet. The maximum pool depth observed was approximately twelve inches. S01 flows into Mill Creek which is a tributary to the Ohio River, a TNW. Due to this connection, this stream should be considered a jurisdictional "water of the United States." The HHEI score was 53 for S01. Complete HHEI field data sheets are located in Appendix D.

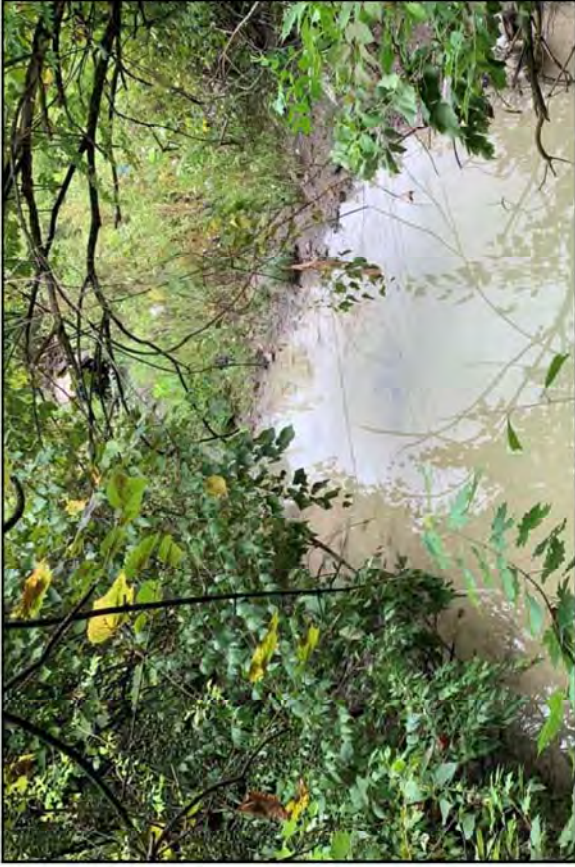
Photo 2: Stream 2, View Facing Upstream, 08/13/2019.

Stream 2 (S02) was an intermittent stream that flowed south through the Study Area. The dominant substrates were gravel and silt. OHWM width of S02 was approximately ten feet and depth was 1.5 feet. The maximum pool depth observed was approximately four inches. S02 flows into Mill Creek which is a tributary to the Ohio River, a TNW. Due to this connection, this stream

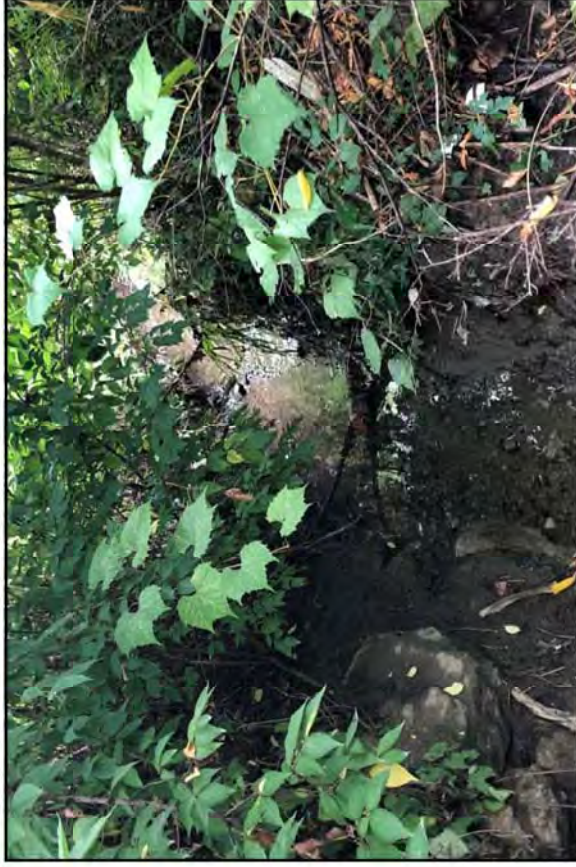
Photo 3: Stream 3, View Facing Upstream, 08/13/2019.

Stream 3 (S03) was an intermittent stream that flowed south through the Study Area. The dominant substrates were sand and silt. OHWM width of S03 was approximately five feet and depth was one-foot. The maximum pool depth observed was approximately four inches. S03 flows into Mill Creek which is a tributary to the Ohio River, a TNW. Due to this connection, this stream should be considered a jurisdictional “water of the United States.” The HHEI score was 58 for S03. Complete HHEI field data sheets are located in Appendix D.

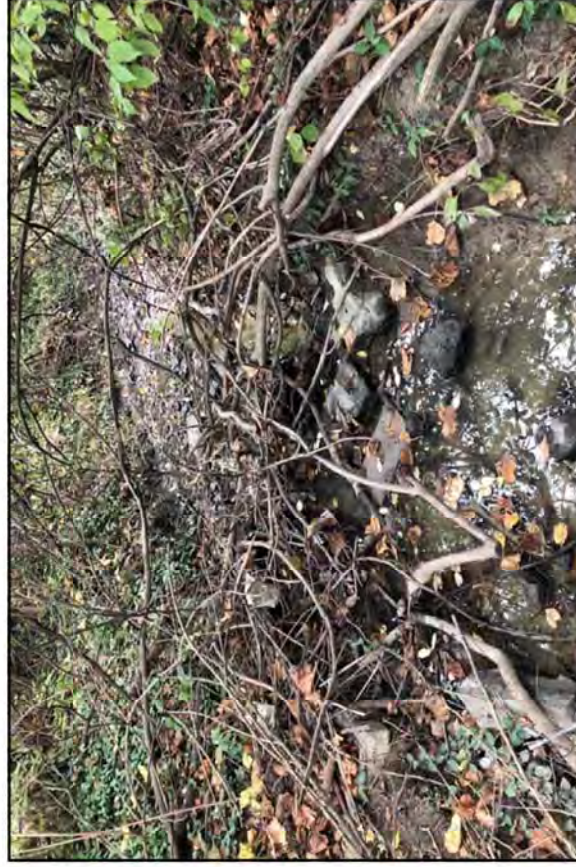
Photo 4: Stream 4, View Facing Upstream, 08/13/2019.

Stream 4 (S04) was an intermittent stream that flowed east through the Study Area. The dominant substrates were sand and clay/hardpan. OHWM width of S04 was approximately seven feet and depth was 1.5 feet. The maximum pool depth observed was approximately three inches. S04 flows into Mill Creek which is a tributary to the Ohio River, a TNW. Due to this connection, this stream should be considered a jurisdictional “water of the United States.” The HHEI score was 51 for S04. Complete HHEI field data sheets are located in Appendix D.

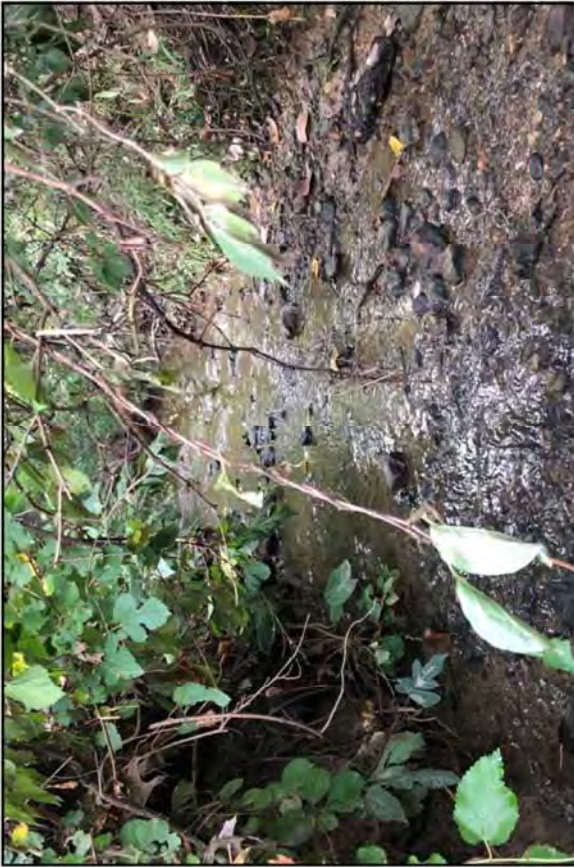
Photo 5: Stream 5, View Facing Upstream, 08/14/2019.

Stream 5 (S05) was an intermittent stream that flowed south through the Study Area. The dominant substrates were gravel and silt. OHWM width of S05 was approximately nine feet and depth was two feet. The maximum pool depth observed was approximately two to three inches. S05 flows into Mill Creek which is a tributary to the Ohio River, a TNW. Due to this connection, this stream should be considered a jurisdictional “water of the United States.” The HHEI score was 61 for S05. Complete HHEI field data sheets are located in Appendix D.

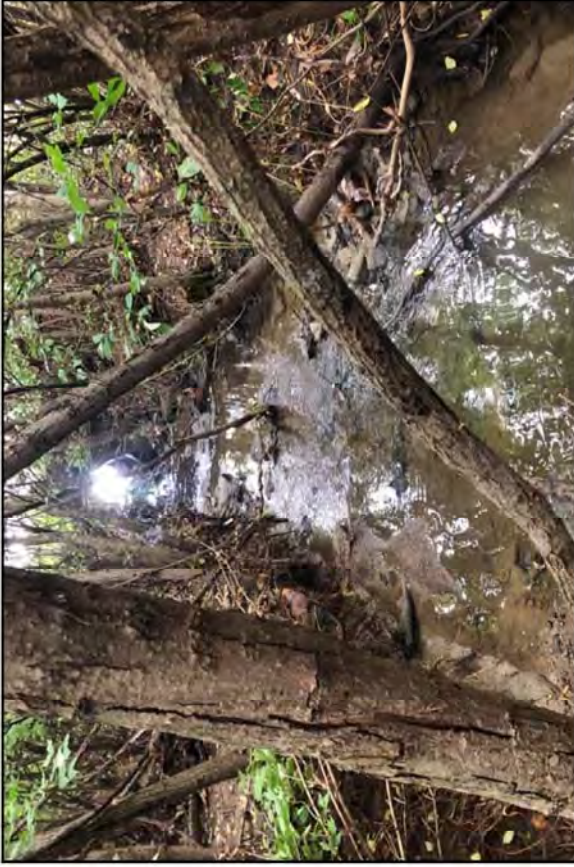
Photo 6: Stream 6, View Facing Upstream, 08/14/2019.

Stream 6 (S06) was an intermittent stream that flowed east through the Study Area. The dominant substrates were gravel and sand. OHWM width of S06 was approximately eleven feet and depth was two feet. The maximum pool depth observed was approximately four inches. S06 flows into Mill Creek which is a tributary to the Ohio River, a TNW. Due to this connection, this stream should be considered a jurisdictional “water of the United States.” The HHEI score was 69 for S06. Complete HHEI field data sheets are located in Appendix D.

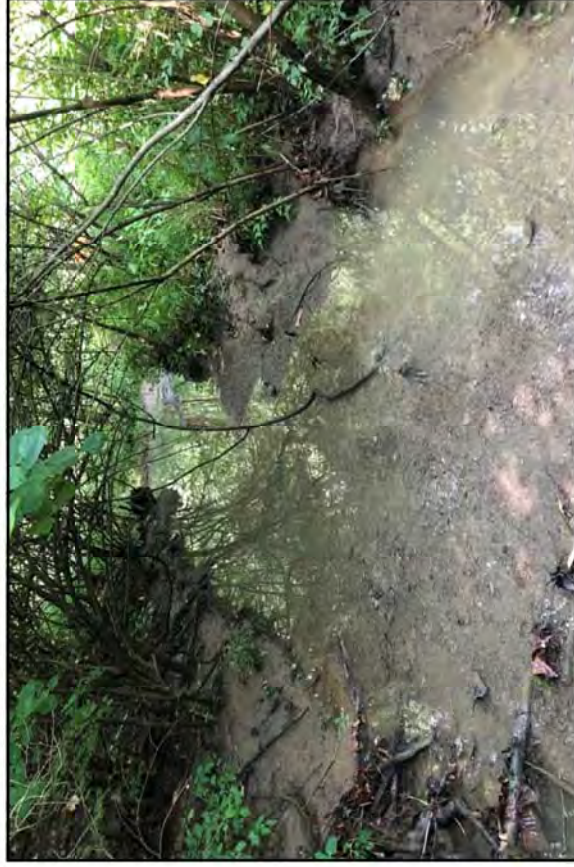
Photo 7: Stream 7, View Facing Upstream, 08/13/2019.

Stream 7 (S07) was an intermittent stream that flowed east through the Study Area. The dominant substrates were sand and clay/hardpan. OHWM width of S07 was approximately five feet and depth was 1.5 feet. The maximum pool depth observed was approximately four inches. S07 flows into Mill Creek which is a tributary to the Ohio River, a TNW. Due to this connection, this stream should be considered a jurisdictional “water of the United States.” The HHEI score was 54 for S07. Complete HHEI field data sheets are located in Appendix D.

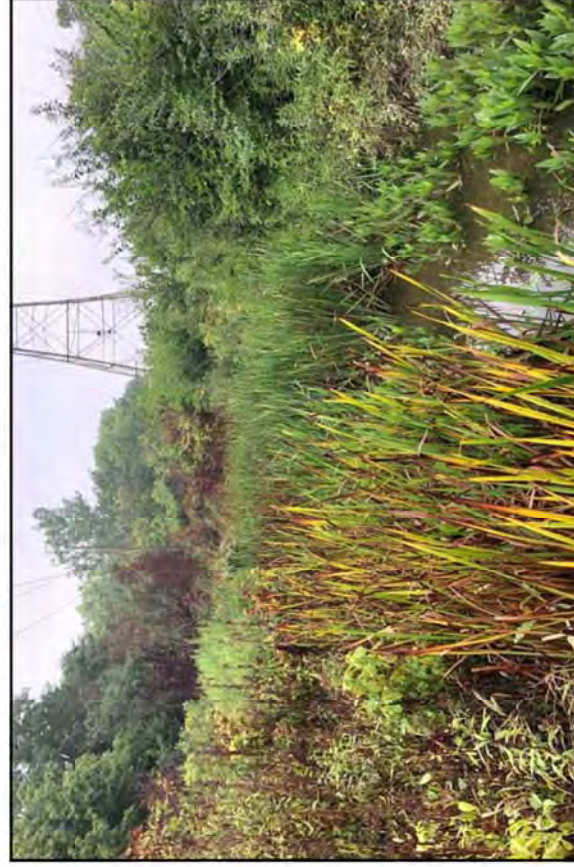
Photo 8: Stream 8, View Facing Upstream, 08/13/2019.

Stream 8 (S08) was an intermittent stream that flowed northeast through the Study Area. The dominant substrates were silt. OHWM width of S08 was approximately fifteen feet and depth was 2.5 feet. The maximum pool depth observed was approximately ten inches. S08 flows into Mill Creek which is a tributary to the Ohio River, a TNW. Due to this connection, this stream should

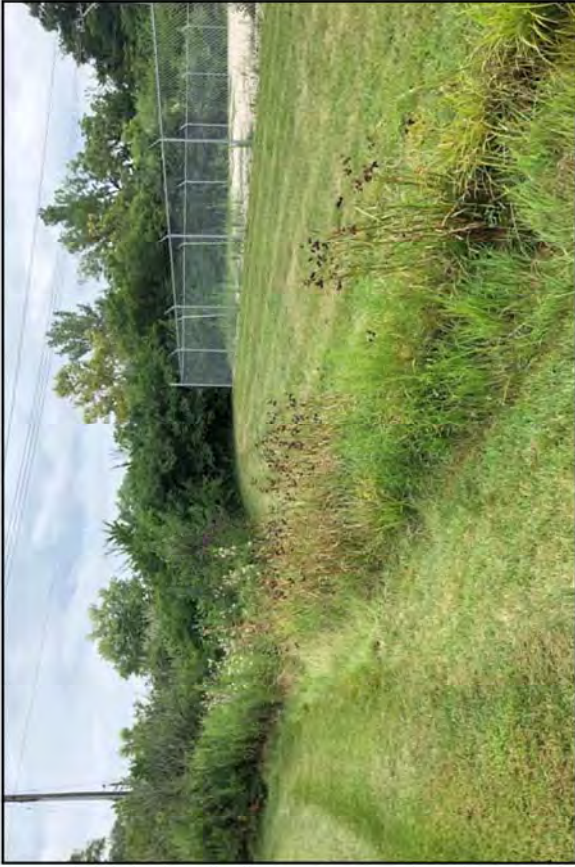
Photo 9: Overview of Wetland 1, View Facing South, 08/13/2019.

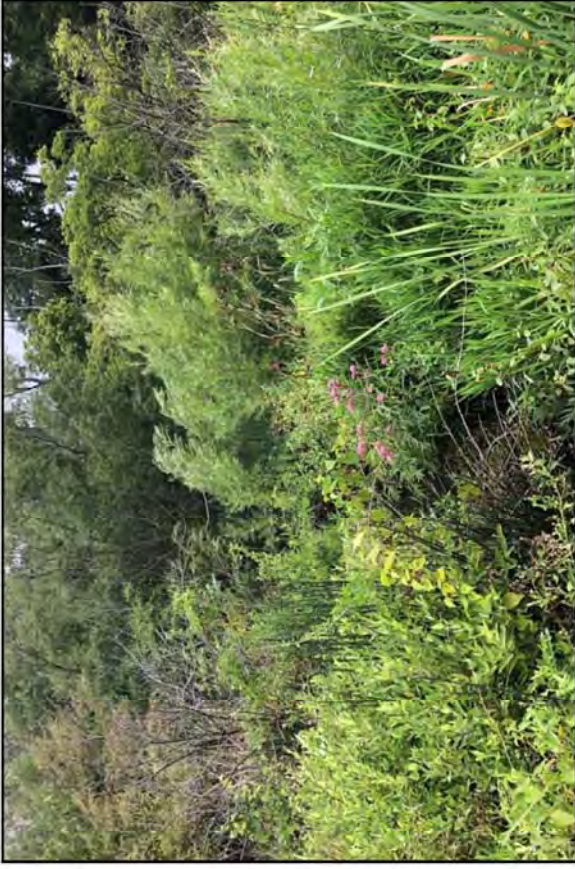
Photo 10: Overview of Wetland 2, View Facing North, 08/13/2019.

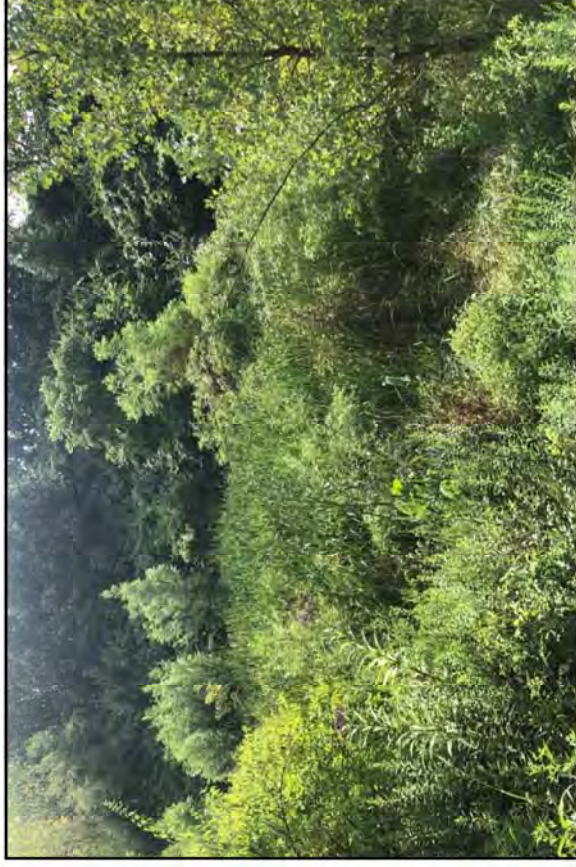
Photo 11: Overview of Wetland 3, View Facing South, 08/14/2019.

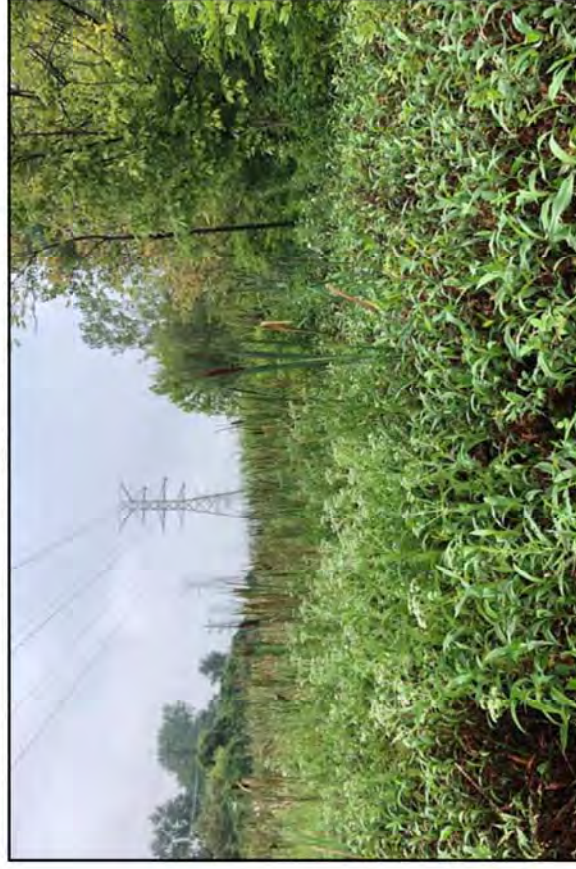
Photo 12: Overview of Wetland 4, View Facing South, 08/14/2019.
