DUKE ENERGY
F7581/F7582/F5689 – 138kV
GARVER SUBSTATION TLOOP

**RE: Duke Energy F7581/F7582/F5689—138kV Garver Substation
Rare, Threatened, and Endangered Species Consultation
Middletown, Butler County, Ohio**

LINE ENVIRONMENTAL ASSESSMENT
 F7581-F7582-F5689 Garver Substation
 DUKE ENERGY
 PROJECT VICINITY

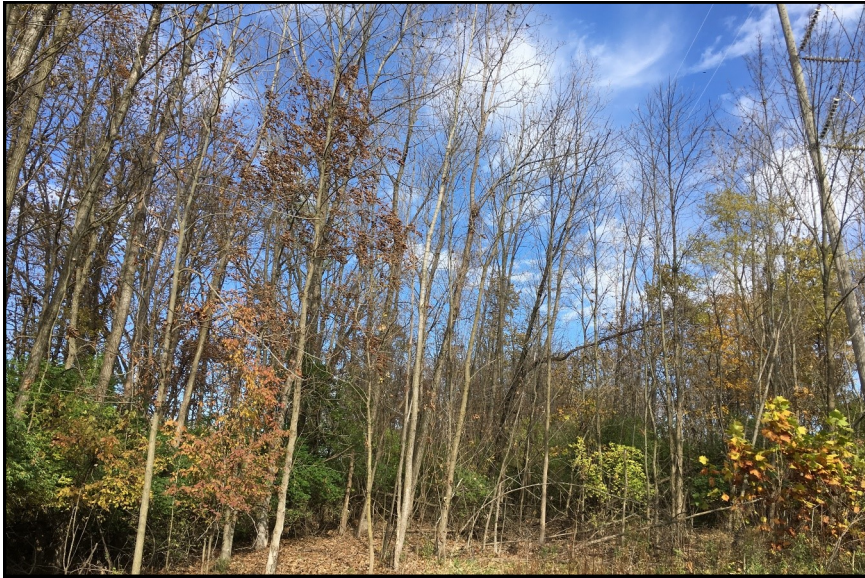
Photo 1. ROW Corridor, Secondary Growth Forest, facing Northwest

The secondary growth forest vegetation assemblage was located within the proposed study area. Dominant canopy species in this habitat type consisted of quaking aspen (*Populus tremuloides*), shellbark hickory (*Carya laciniosa*), and bur oak (*Quercus macrocarpa*). Understory vegetation was dominated by Amur honeysuckle (*Lonicera maackii*) and saplings of the canopy species. Although a formal study was not part of this scope, there was potential habitat for listed species identified within this habitat.

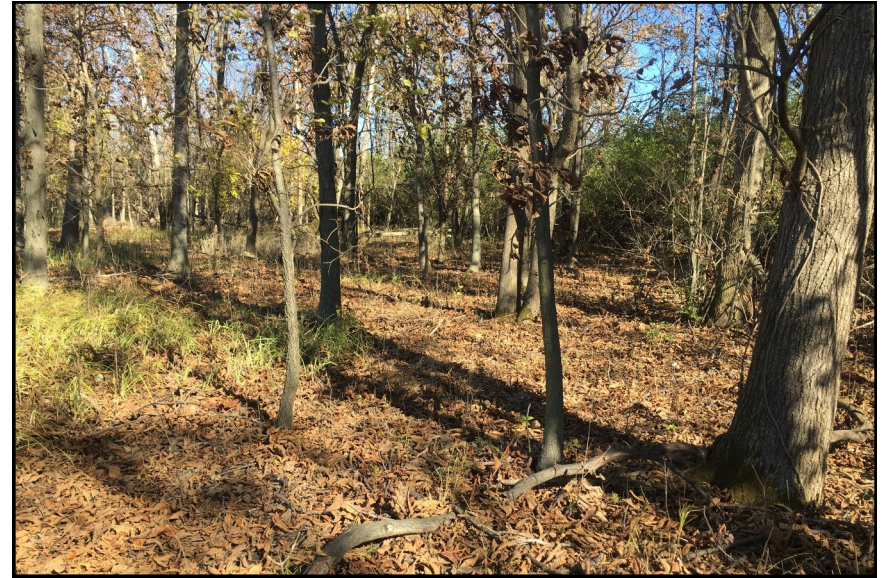
Photo 2. ROW Corridor, Forested Wetland, facing North.

The forested wetland vegetation assemblage was located within the proposed study area. Dominant canopy species in this habitat type consisted of shellbark hickory and hackberry (*Celtis occidentalis*). Understory vegetation was dominated by green ash (*Fraxinus pennsylvanica*) saplings, white grass (*Leersia virginica*), sedge species (*Carex* spp.), and saplings of the canopy species. Although a formal study was not part of this scope, there was potential habitat for listed species identified within this habitat.

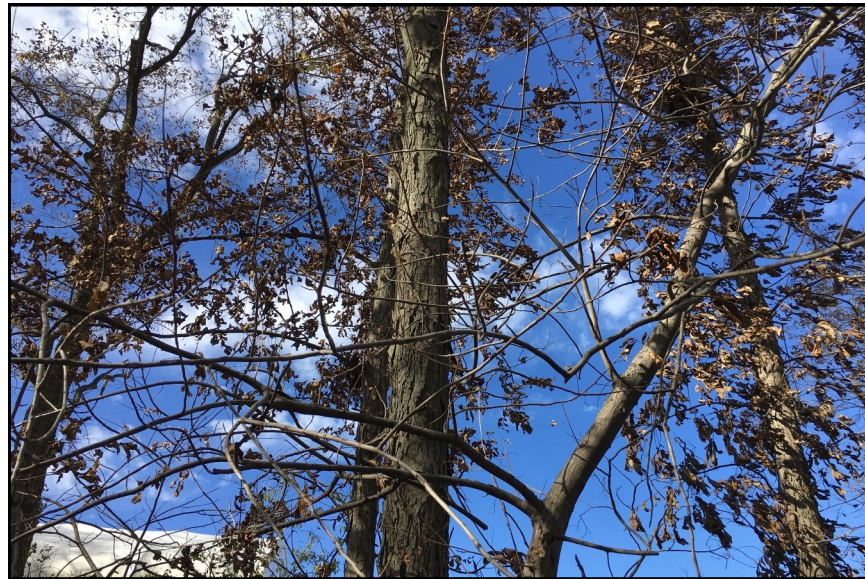
Photo 3. ROW Corridor, Secondary Growth Forest, Potential Roost Tree.

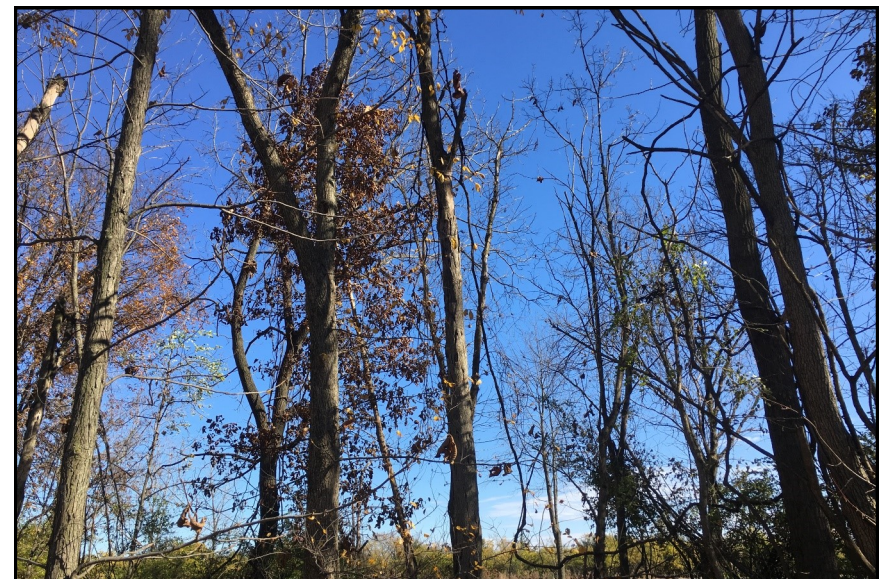
Photo 4. ROW Corridor, Secondary Growth Forest, Dead Standing.

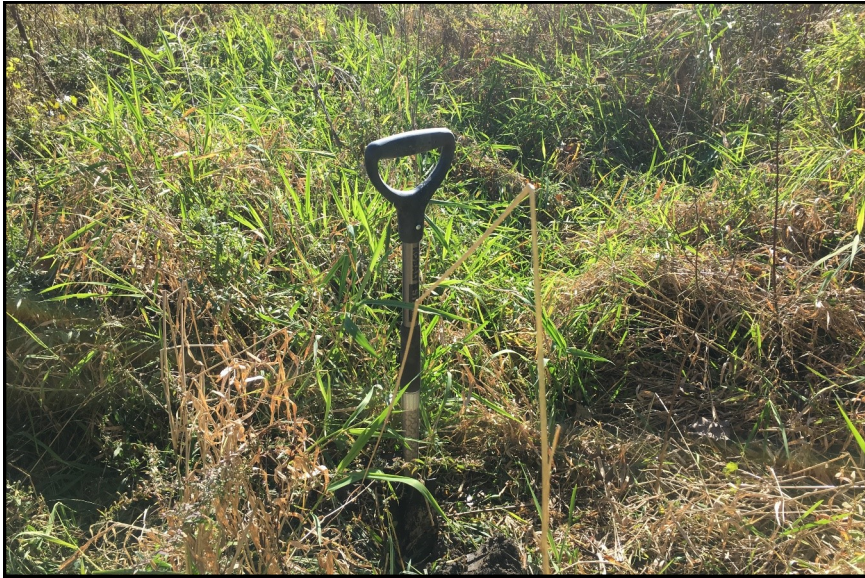
Photo 5. ROW Corridor, Emergent Wetland Vegetation, facing North.

The emergent wetland vegetation assemblage was located within the proposed study area. Understory vegetation was dominated by reed canary grass (*Phalaris arundinacea*), and dogbane (*Apocynum cannabinum*). Although a formal study was not part of this scope, there was potential habitat for listed species identified within this habitat.

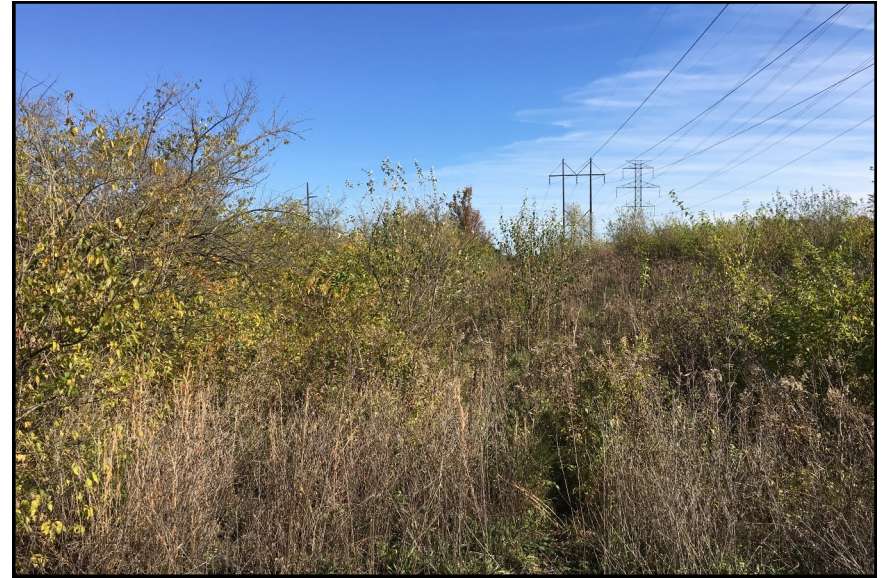
Photo 6. ROW Corridor, Scrub Shrub Vegetation, facing East.

The scrub shrub vegetation assemblage was located within the proposed study area. Dominant shrub species in this habitat type consisted of Amur honeysuckle, Callery pear (*Pyrus calleryana*), and Autumn olive (*Elaeagnus umbellata*). Understory vegetation was dominated by teasel (*Dipsacus fullonum*), Johnson grass (*Sorghum halapense*), and Canada goldenrod (*Solidago canadensis*). Although a formal study was not part of this scope, there was no potential habitat for listed species identified within this habitat.

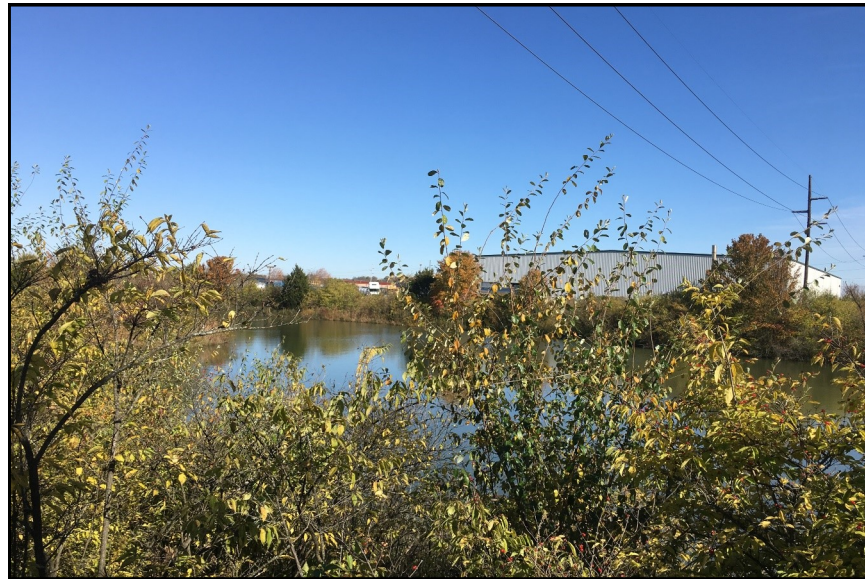
Photo 7. ROW Corridor, Pond, facing Northeast.

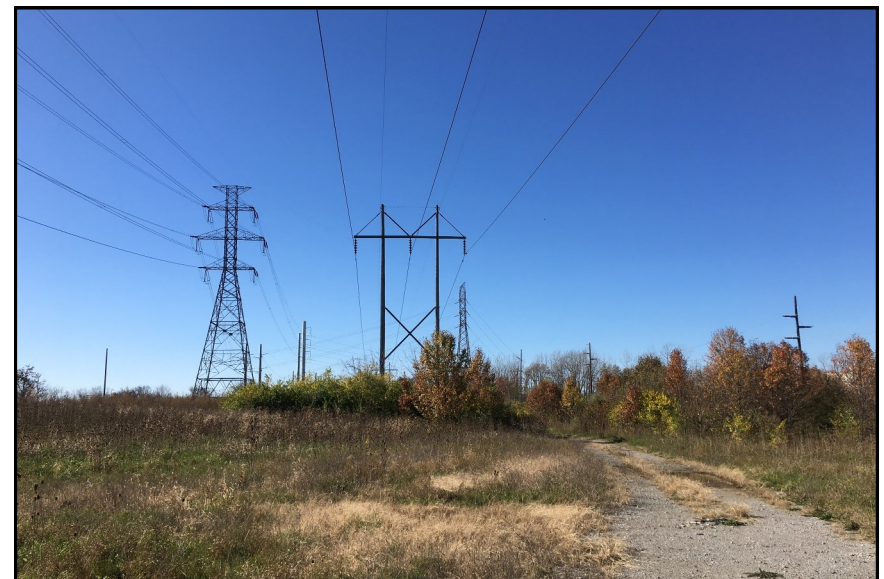
Photo 8. ROW Corridor, Fallow Field Vegetation, facing West.

The fallow field vegetation assemblage was located within the proposed study area. Dominant species in this habitat type consisted of teasel, tall fescue (*Schedonorus arundinaceus*), hairy aster (*Symphotrichum pilosum*), yellow foxtail (*Setaria pumila*), and fall panic grass (*Panicum dichotomiflorum*). Although a formal study was not part of this scope, there was no potential habitat for listed species identified within this habitat.
