**Wetland and Surface Water
Delineation Report**

Oregon Clean Energy Center
816 N. Lallendorf Road
Oregon, Ohio

Prepared for:
Oregon Clean Energy, LLC

Prepared by:
ARCADIS U.S., Inc.
100 E Campus View Blvd
Suite 200
Columbus
Ohio 43235-1447
Tel 614 985 9100
Fax 614 985 9170

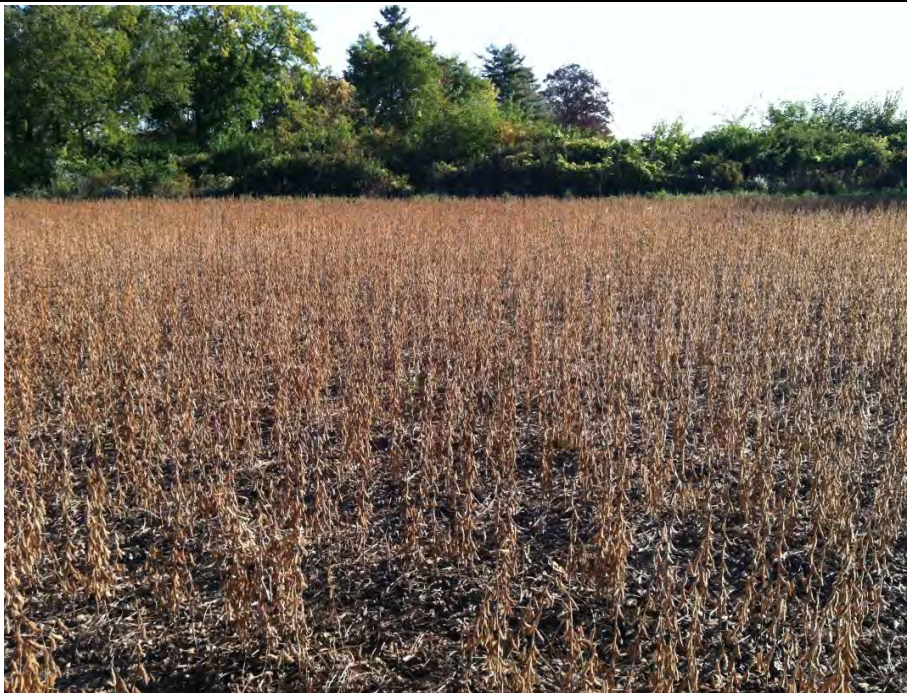
Property Name: Oregon Clean Energy		Location: Oregon, Ohio	Project No. MA001187.0001
Photo No. 1	Date: 10/11/12

Direction Photo Taken: East			
Description: View of Data Point 1 in an actively managed agricultural field.			
Property Name: Oregon Clean Energy		Location: Oregon, Ohio	Project No. MA001187.0001
Photo No. 2	Date: 10/11/12

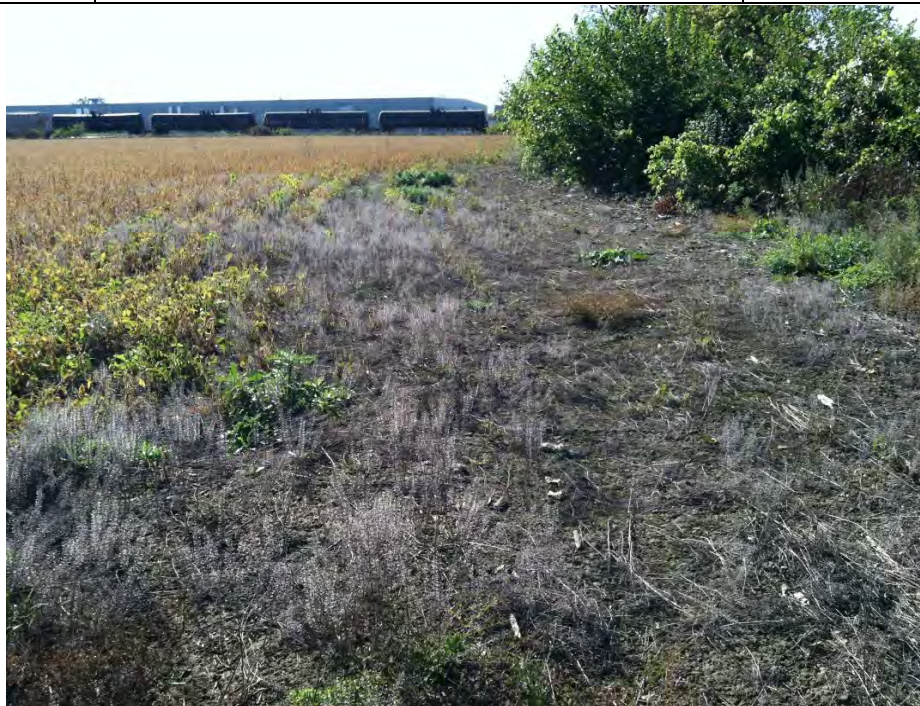
Direction Photo Taken: South			
Description: View of Data Point 2 and adjacent Driftmeyer Ditch. Typical row crop decline in areas with adjacent woody vegetation.

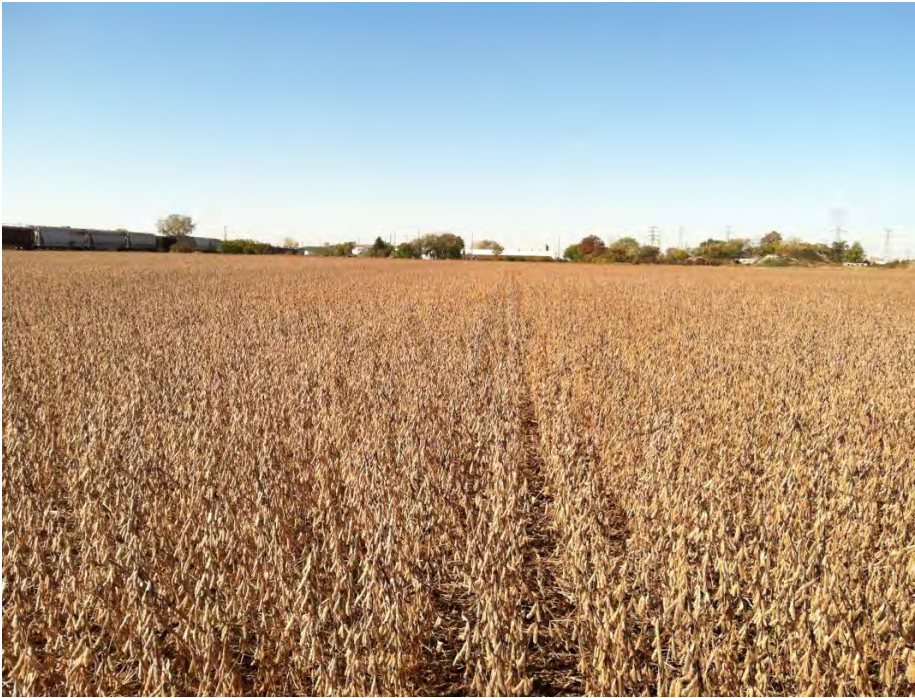
Property Name: Oregon Clean Energy		Location: Oregon, Ohio	Project No. MA001187.0001
Photo No. 7	Date: 10/11/12

Direction Photo Taken: West			
Description: View of Data Point 7 in an actively managed agricultural field.			
Property Name: Oregon Clean Energy		Location: Oregon, Ohio	Project No. MA001187.0001
Photo No. 8	Date: 10/11/12

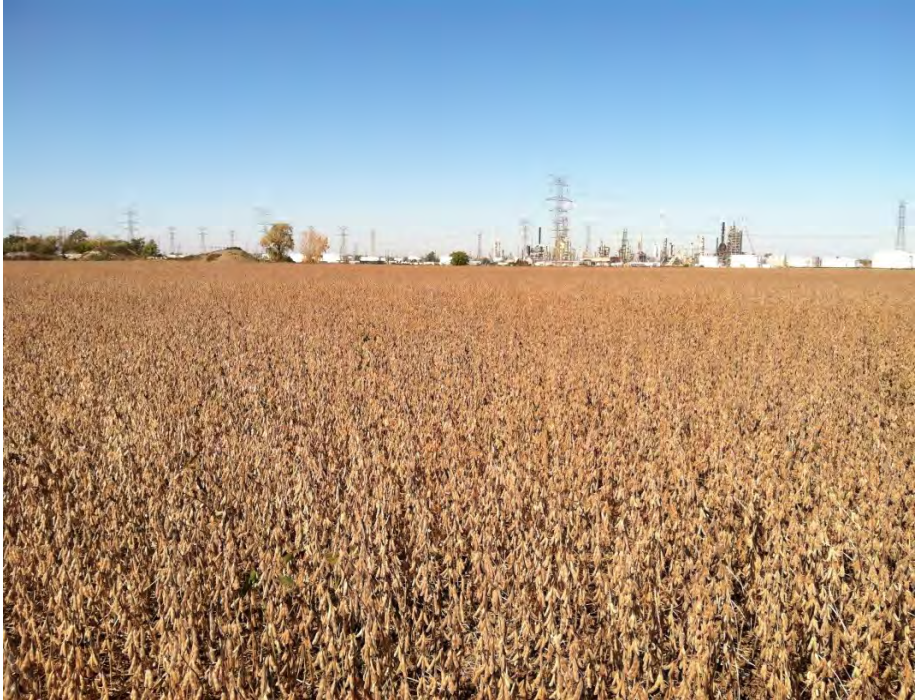
Direction Photo Taken: Northwest			
Description: View of Data Point 8 in an actively managed agricultural field.

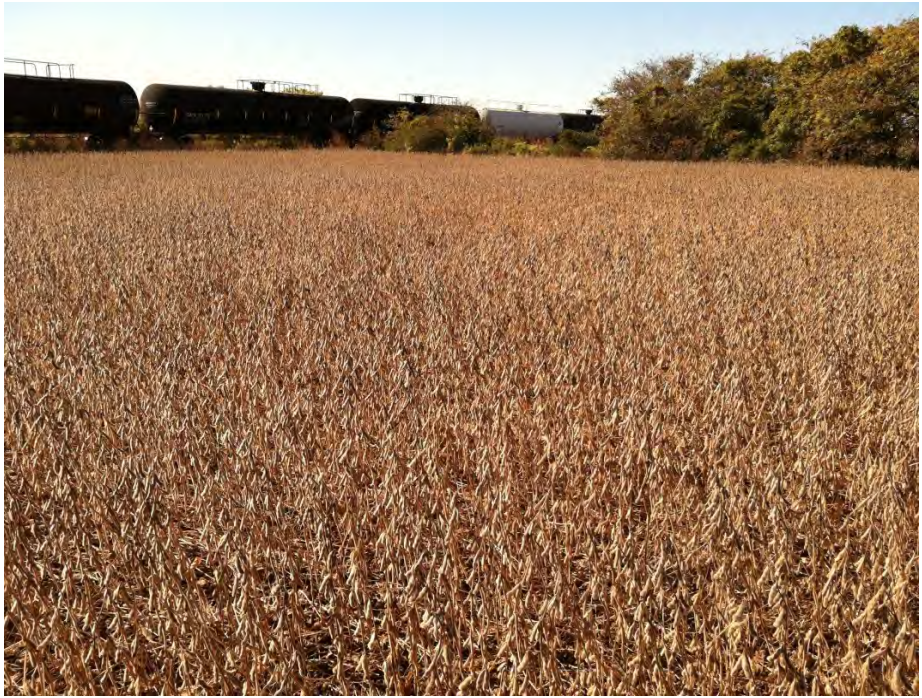
Property Name: Oregon Clean Energy		Location: Oregon, Ohio	Project No. MA001187.0001
Photo No. 9	Date: 10/11/12

Direction Photo Taken: Southwest			
Description: View of Data Point 9 in an actively managed agricultural field.			
Property Name: Oregon Clean Energy		Location: Oregon, Ohio	Project No. MA001187.0001
Photo No. 10	Date: 10/11/12

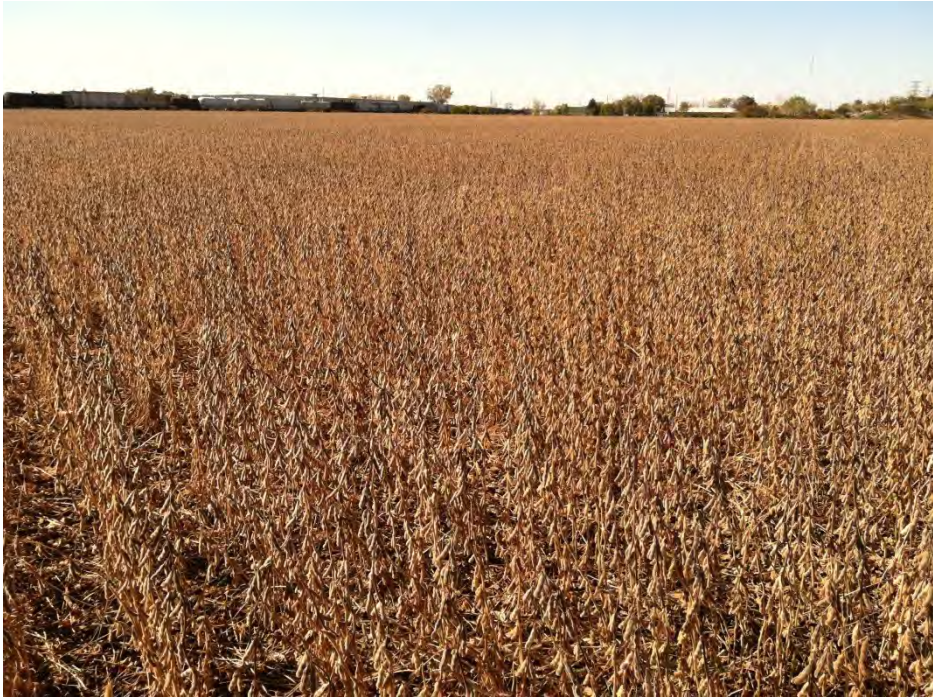
Direction Photo Taken: Southwest			
Description: View of Data Point 10 in an actively managed agricultural field.

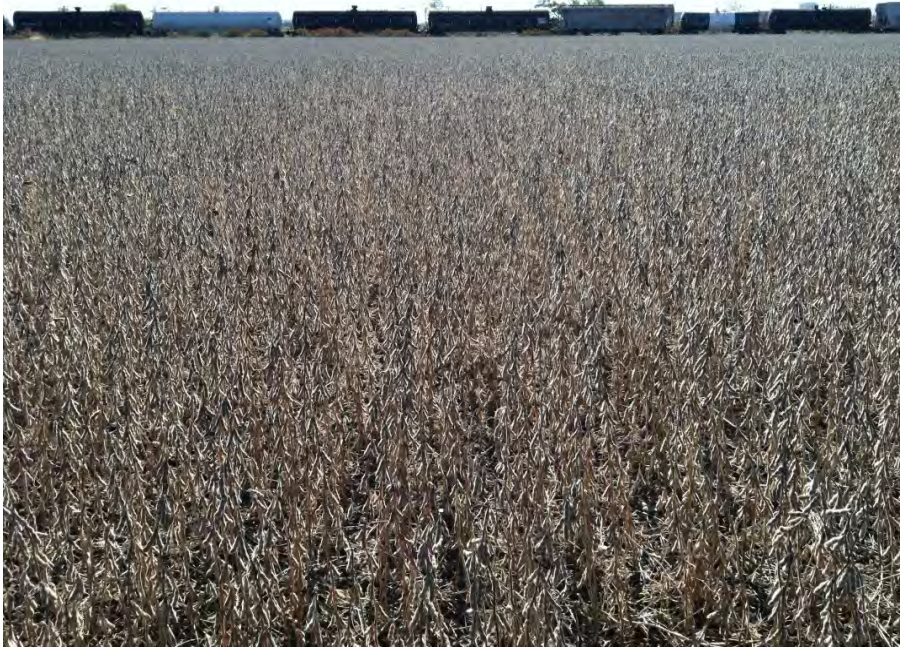
Property Name: Oregon Clean Energy		Location: Oregon, Ohio	Project No. MA001187.0001
Photo No. 11	Date: 10/11/12

Direction Photo Taken: South			
Description: View of Data Point 11 in an actively managed agricultural field.			
Property Name: Oregon Clean Energy		Location: Oregon, Ohio	Project No. MA001187.0001
Photo No. 12	Date: 10/11/12

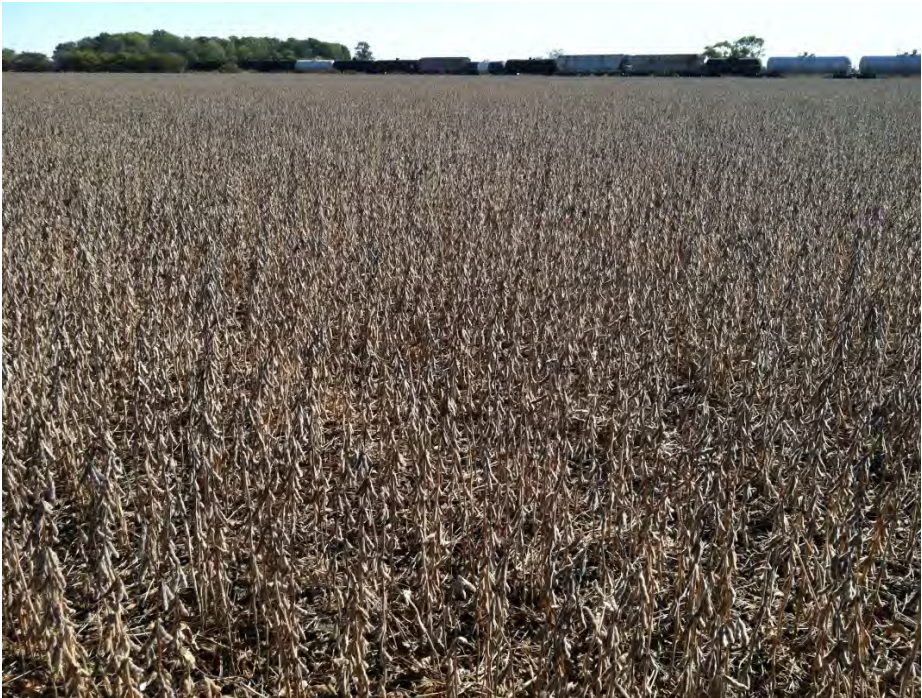
Direction Photo Taken: Southeast			
Description: View of Data Point 12 in an actively managed agricultural field.

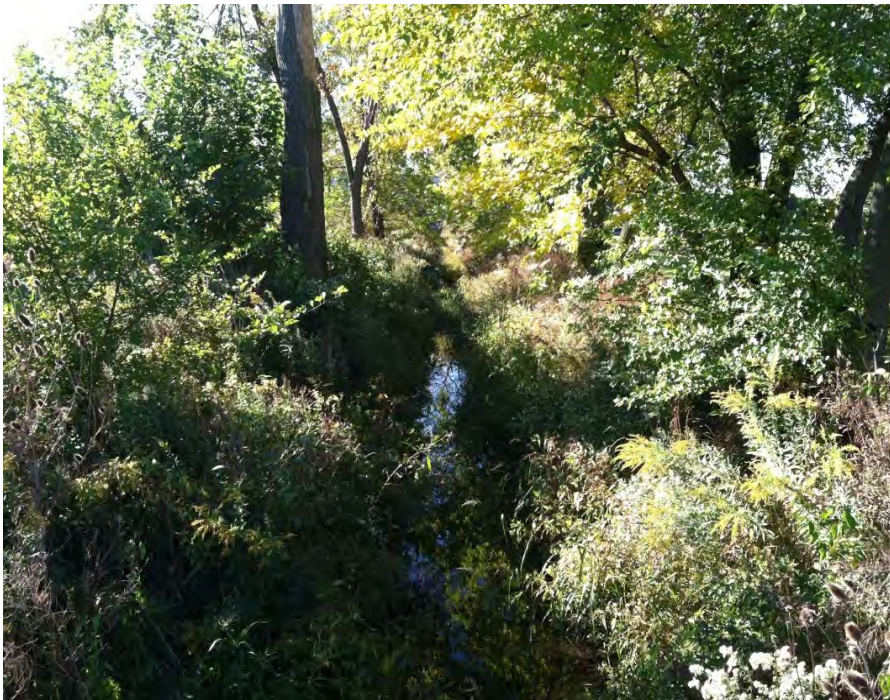
Property Name: Oregon Clean Energy		Location: Oregon, Ohio	Project No. MA001187.0001
Photo No. 13	Date: 10/12/12

Direction Photo Taken: South			
Description: Driftmeyer Ditch at upstream end of 84" concrete culvert; looking upstream.			
Property Name: Oregon Clean Energy		Location: Oregon, Ohio	Project No. MA001187.0001
Photo No. 14	Date: 10/12/12

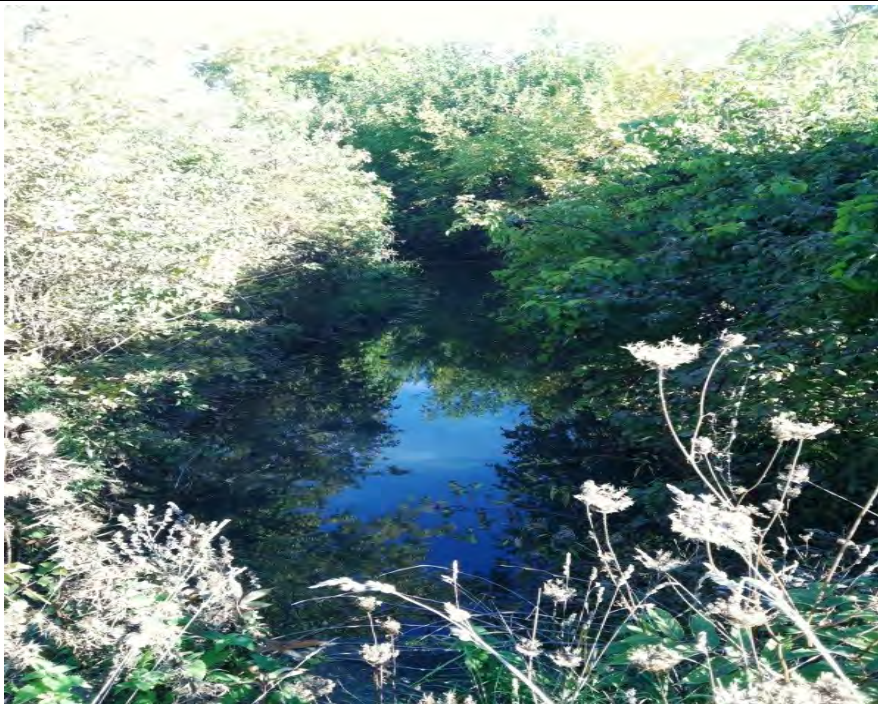
Direction Photo Taken: North			
Description: Driftmeyer Ditch at downstream end of 84" concrete culvert; looking downstream.

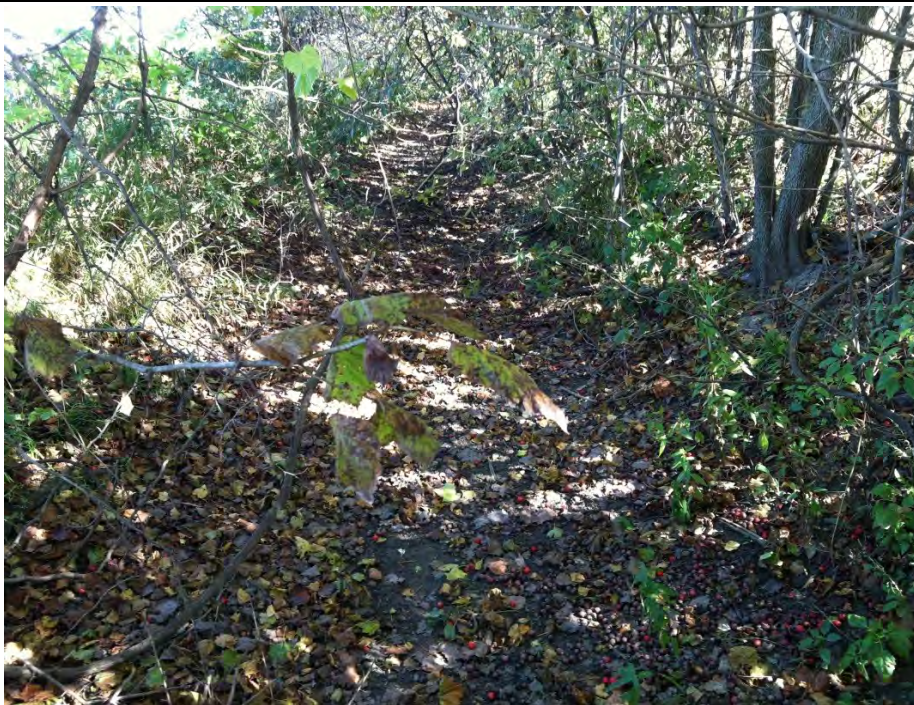
Property Name: Oregon Clean Energy		Location: Oregon, Ohio	Project No. MA001187.0001
Photo No. 15	Date: 10/12/12

Direction Photo Taken: Northwest			
Description: Johlin Ditch, looking downstream of the 18" HDPE culvert.			
Property Name: Oregon Clean Energy		Location: Oregon, Ohio	Project No. MA001187.0001
Photo No. 16	Date: 10/12/12

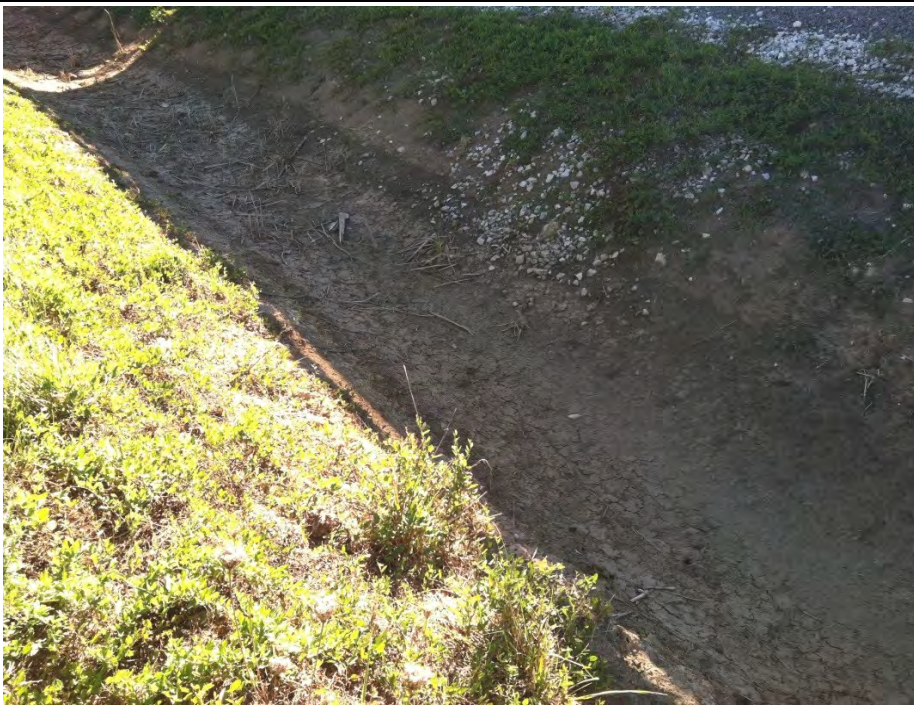
Direction Photo Taken: East			
Description: Dredged railroad drainage ditch east of Driftmeyer Ditch. Not included in study area. 41.666333 N -83.447666 W

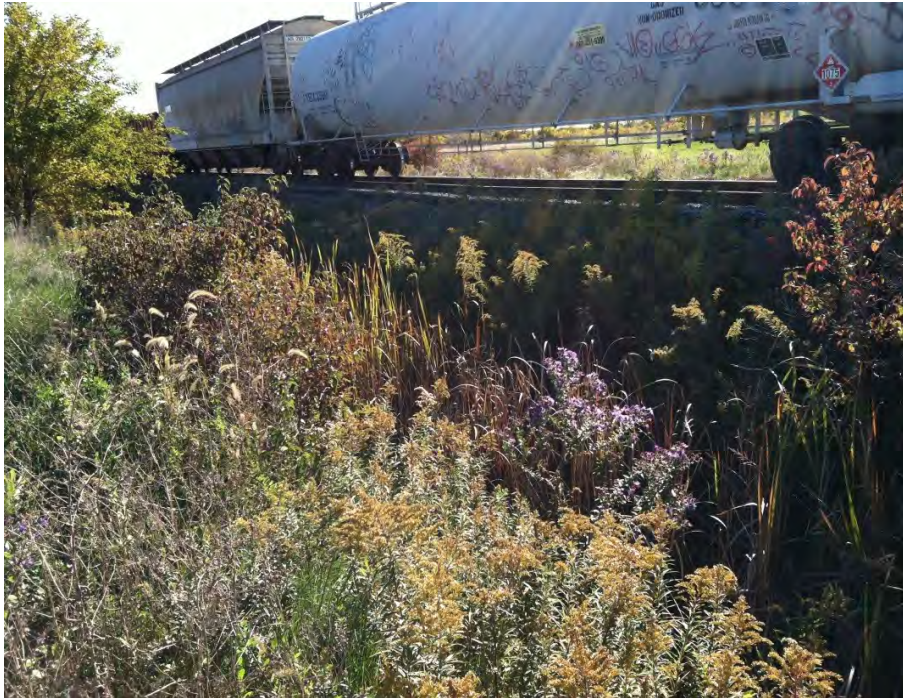
Property Name: Oregon Clean Energy		Location: Oregon, Ohio	Project No. MA001187.0001
Photo No. 17	Date: 10/12/12

Direction Photo Taken: East			
Description: Unmanaged section of RR drainage ditch in between Driftmeyer ditch and Johlin Ditch. Not included in study area. 41.66655 N -83.445833 W

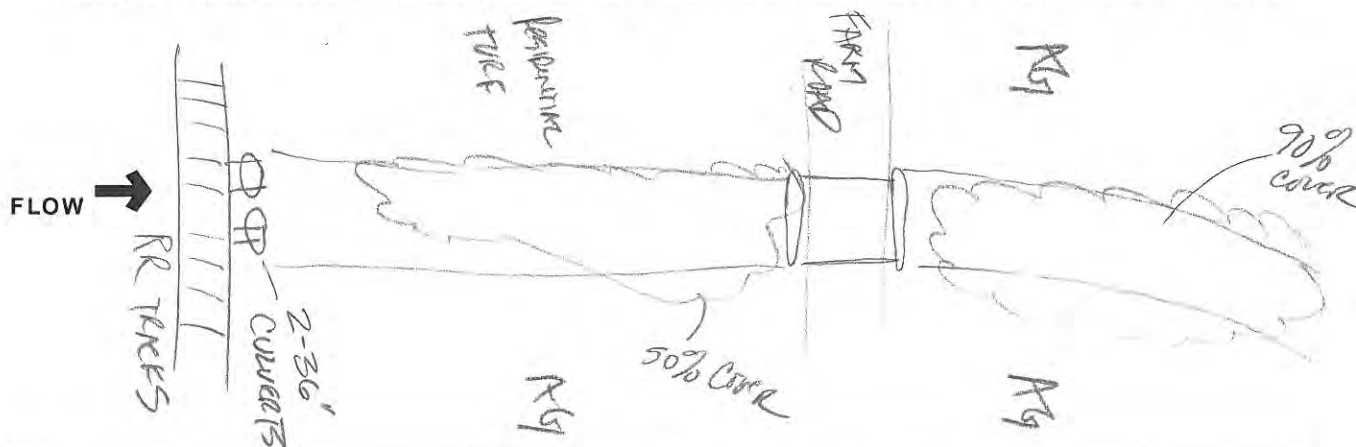
DRAWING AND NARRATIVE DESCRIPTION OF STREAM REACH (This must be completed):

Include important landmarks and other features of interest for site evaluation and a narrative description of the stream's location

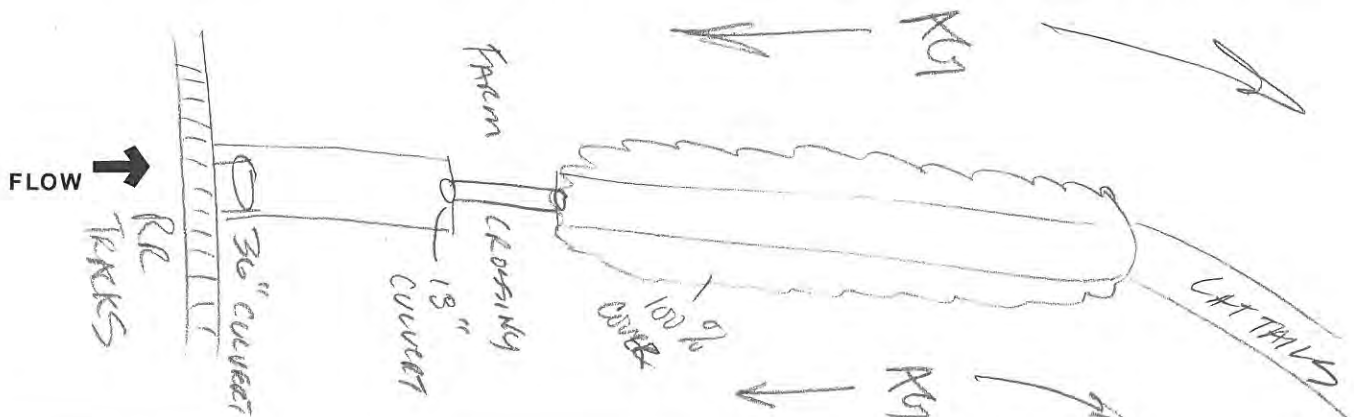
DRAWING AND NARRATIVE DESCRIPTION OF STREAM REACH (This must be completed):

Include important landmarks and other features of interest for site evaluation and a narrative description of the stream's location
