RE: **Letter of Notification**
Case No. 13-1330-EL-BLN Groves—Bexley 138 kV Transmission Line Rebuild Project

**LETTER OF NOTIFICATION FOR THE
GROVES - BEXLEY 138 KV TRANSMISSION LINE REBUILD
PROJECT**

PUCO Case No. 13-1330-EL-BLN

**AEP Ohio Transmission Company
(AEP Ohio Transco)**

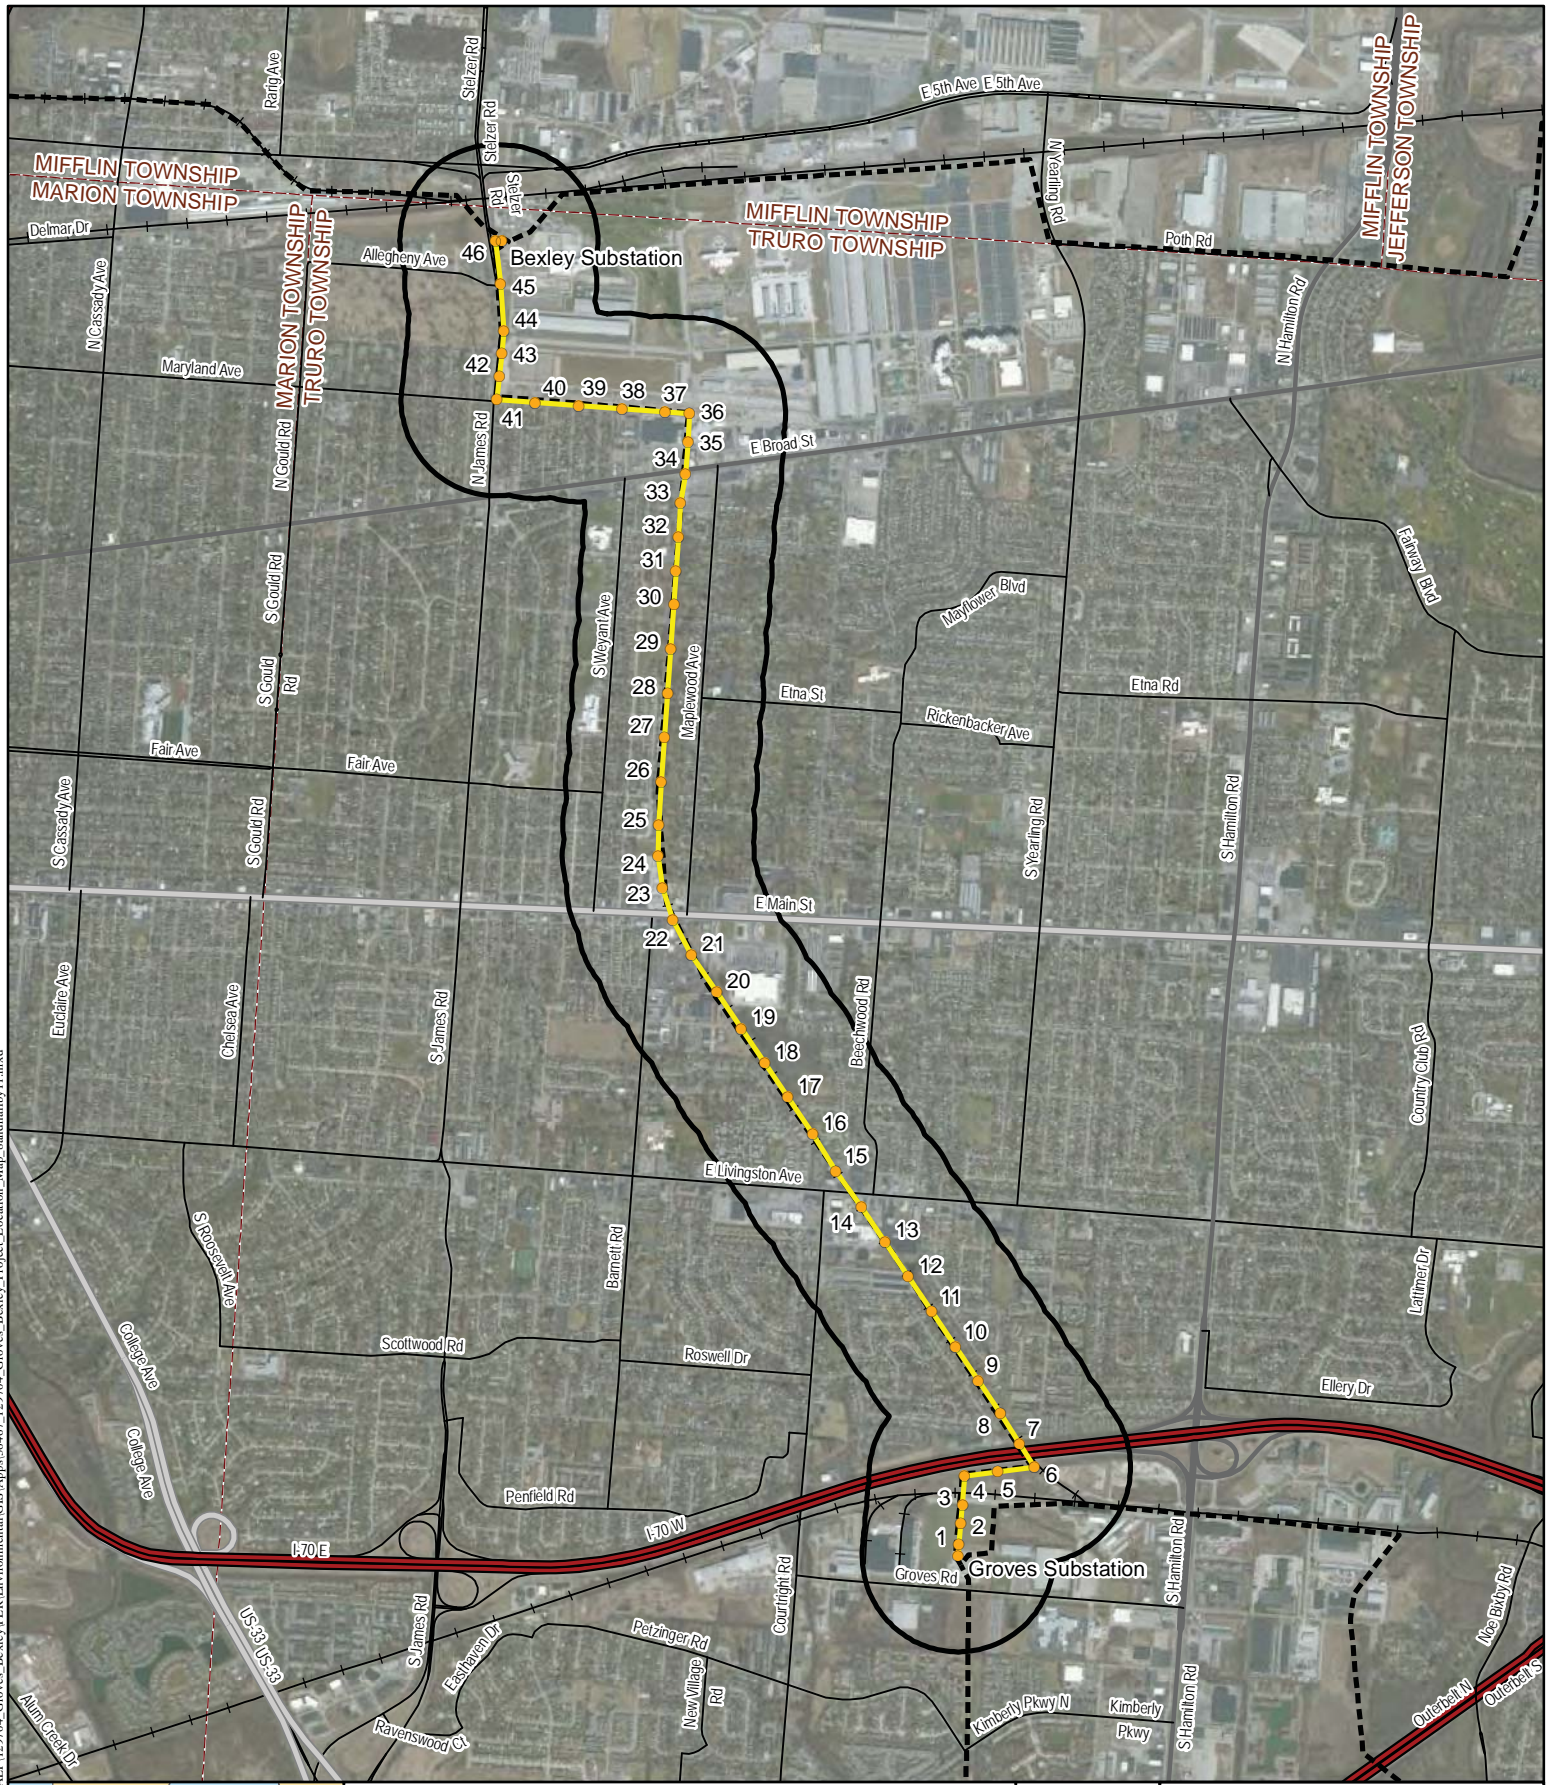
Figure 1 Project Location

An existing 138 kilovolt (kV) single circuit line will be rebuilt in an existing right-of-way (ROW) corridor (30 feet in width) between Groves Substation and Bexley Substation (Figure 1). The line will be built on AEP Ohio Transco standard single circuit 138 kV structures with provisions for underbuild on four structures. It is anticipated that self-supporting, custom, steel structures with direct embed foundations for tangents, and pier foundations for running angle and deadend structures will be utilized. The total length of the 138 kV line is approximately 4.4 miles replacing 46 existing structures with 47 new structures.

The location of this project in relation to existing transmission lines is shown on Figure 1. The proposed project, essentially a pole for pole replacement project along the same centerline, is located entirely within the incorporated areas of the City of Columbus and the City of Whitehall in Truro Township, Franklin County, Ohio.

Desktop analysis identified that no NWI wetlands were found within the Groves-Bexley 138 kV T-line survey corridor. OWI wetland mapping did identify small wetlands on the eastern side of Stream 1. These were not investigated as they were outside of the proposed area of impact (Figure 1).

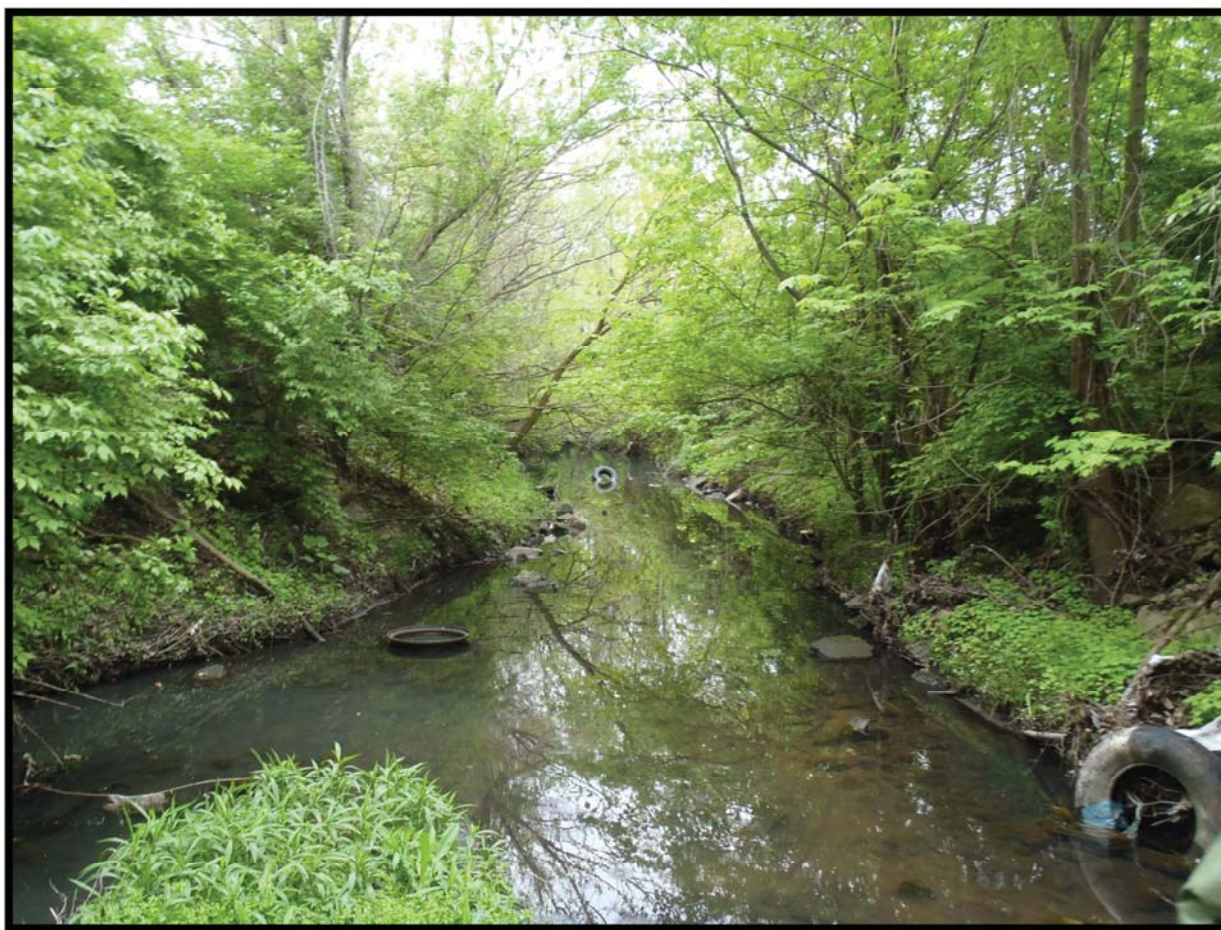
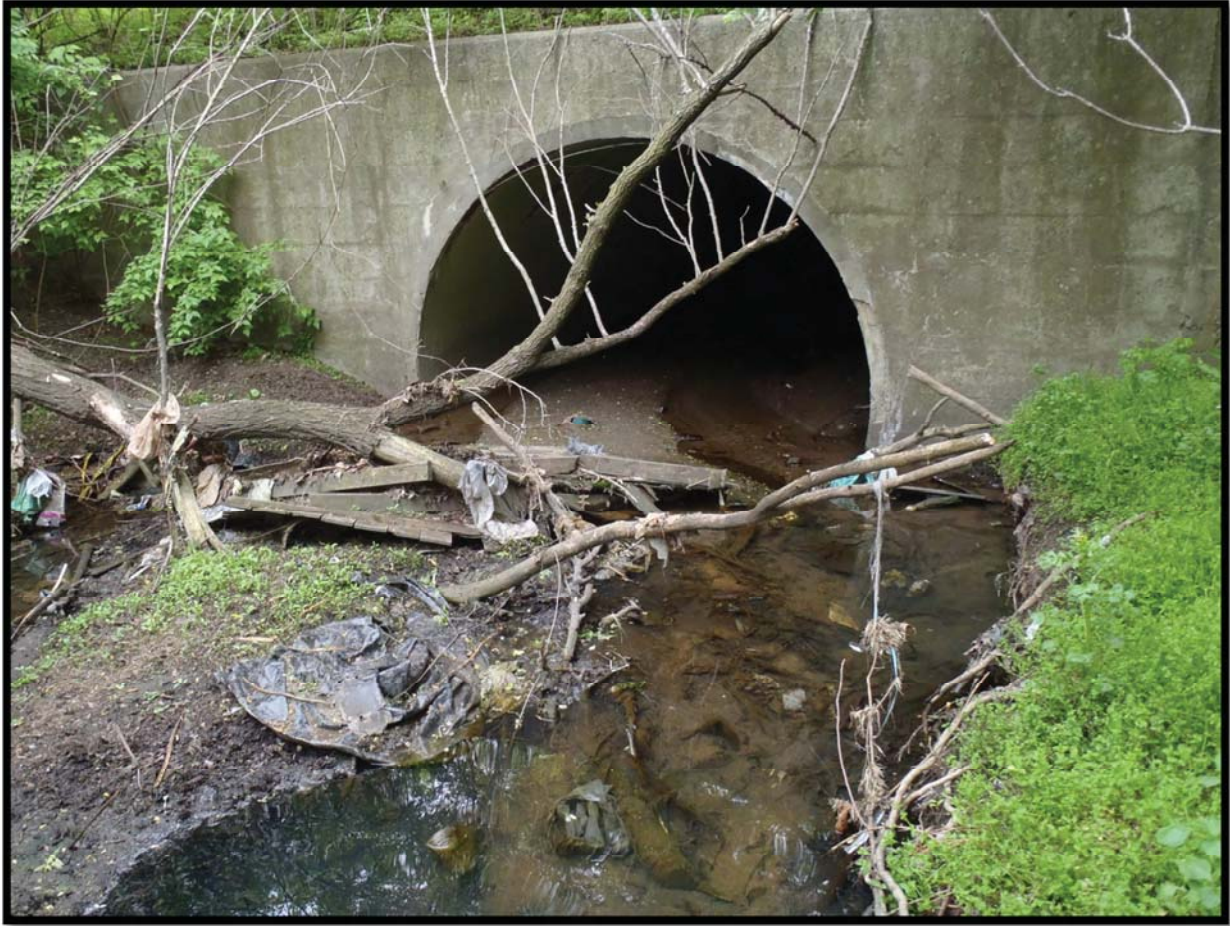
Stream 1

Stream Name	Unnamed tributary to Big Walnut Creek (Modified Warm Water Habitat)
Evaluation Score/System	37/OEPA QHEI
Watershed HUC (14-Digit)	Big Walnut Creek (05060001160030).
Flow Regime/Water Level	Perennial
Dominant Substrate(s)	Silt, gravel
Other Substrates	Silt, bedrock, leaf pack/woody debris, fine detritus, muck
Natural/Channelized	Modified and Channelized
Stream Order	2
Date Surveyed	May 6, 2013 and May 7, 2013

Stream 1, an unnamed tributary to Big Walnut Creek is a perennial stream mapped by both the USGS and the NHD. This stream has a drainage area of 1.47 square miles. The stream crosses the survey corridor between Structures 5 and 6. Land use adjacent to the stream varies from forested, maintained ROW, shrub/scrub, and urbanized and residential developments. Current land use appears to be impacting the stream negatively. There are multiple culverts, disturbances to riparian vegetation, and the bank is very unstable in some locations, causing accelerated erosion. Runoff from roads and residential areas is flowing into the stream as well, causing negative impacts to water quality. Accumulation of trash/debris was also documented throughout the stream stretch.

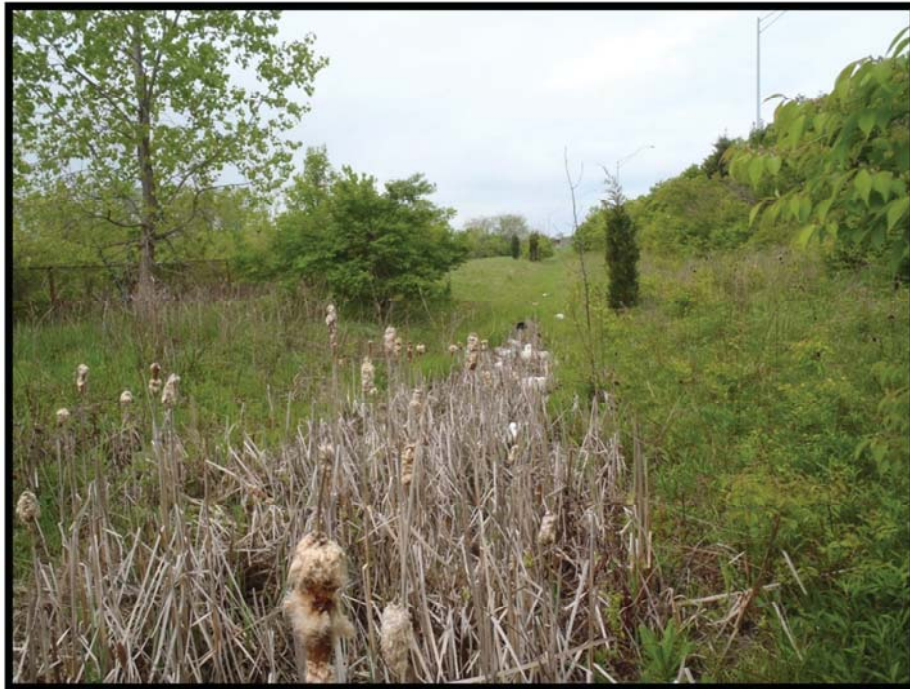
Location/ORAM Score	39.935294, -82.889663/9.0
Cowardin Classification	PEM
Dominant Plant Species	Narrowleaf cattail (<i>Typha angustifolia</i>), Twinsisters (<i>Lonicera tatarica</i>)
Other Species Observed	Poison ivy (<i>Toxicodendron radicans</i>), Crab apple (<i>Malus</i> spp.), Bull thistle (<i>Cirsium vulgare</i>), Redtop (<i>Agrostis gigantea</i>), Red cedar (<i>Juniperus virginiana</i>), Virginia creeper (<i>Parthenocissus quinquefolia</i>), giant goldenrod (<i>Solidago gigantea</i>)
Soil Map Unit	Udorthents-Urban land complex, gently rolling
Hydrology Indicators	Standing water, saturation
Connected or Isolated*	Connected
Date Surveyed	May 6, 2013

Wetland 1 is located adjacent to Structure 4. This wetland is a small (approximately 0.05 acre), wetland, located in an opening within a disturbed forest, adjacent to a highway. A drainage swale flows down the hillside from the highway and appears to be charging this wetland from the southwest. This nexus makes it subject to USACE jurisdiction. This wetland is a monoculture, low-quality feature, consisting mostly of Narrowleaf cattail. Because of its proximity to a major interstate highway, the water quality is most likely negatively impacted due to highway runoff.

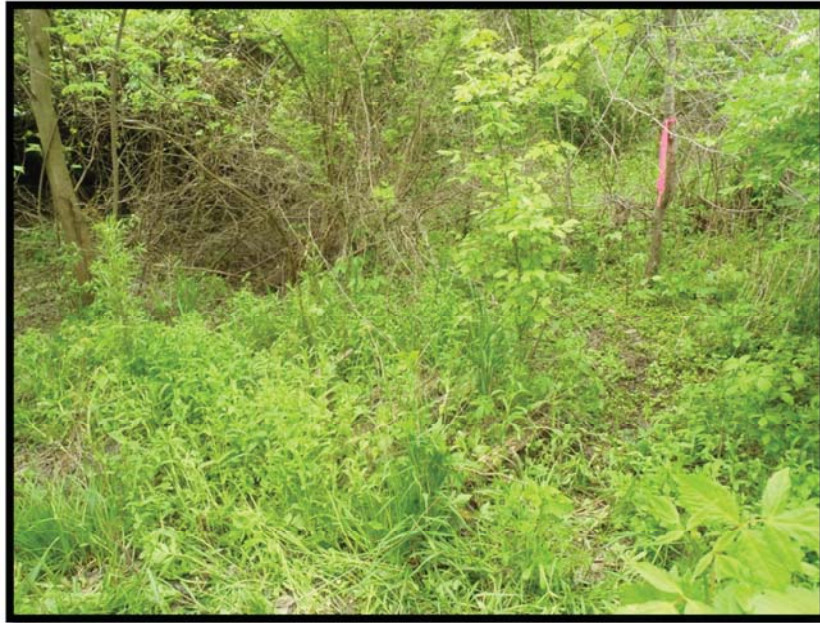
Location/ORAM Score	40.428993, -81.64927/20.0
Cowardin Classification	PSS
Dominant Plant Species	Water speedwell (<i>Veronica anagallis-aquatica</i>), Yellow avens (<i>Geum aleppicum</i>), Silver maple (<i>Acer saccharinum</i>),
Other Species Observed	American Elm (<i>Ulmus americana</i>), River grape (<i>Vitis riparia</i>), Twinsisters, giant goldenrod, Allegheny blackberry (<i>Rubus allegheniensis</i>), Box elder (<i>Acer negundo</i>), Sallow sedge (<i>Carex lurida</i>), Black willow (<i>Salix nigra</i>), Cottonwood (<i>Populus deltoides</i>)
Soil Map Unit	Bennington-Urban land complex, 0 to 2 percent slopes
Hydrology Indicators	Water-stained leaves,
Connected or Isolated*	isolated
Date Surveyed	May 6, 2013

Wetland 2 is a small (approximately 0.009 acre) wetland, located partially within a ROW area. This wetland appears to be spring fed. It is located between Structures 19 and 20. Adjacent land use is commercial and urban development along with disturbed forest. This wetland is significantly disturbed. This wetland is located in a manmade swale that was lined with a gravel base layer that impedes current hydrologic flow and that does not effectively drain surface waters to nearby water features due to adjacent land use and microtopography. The wetland is bordered by an industrial facility which can be a source of pollutants via runoff and leaching, as well.

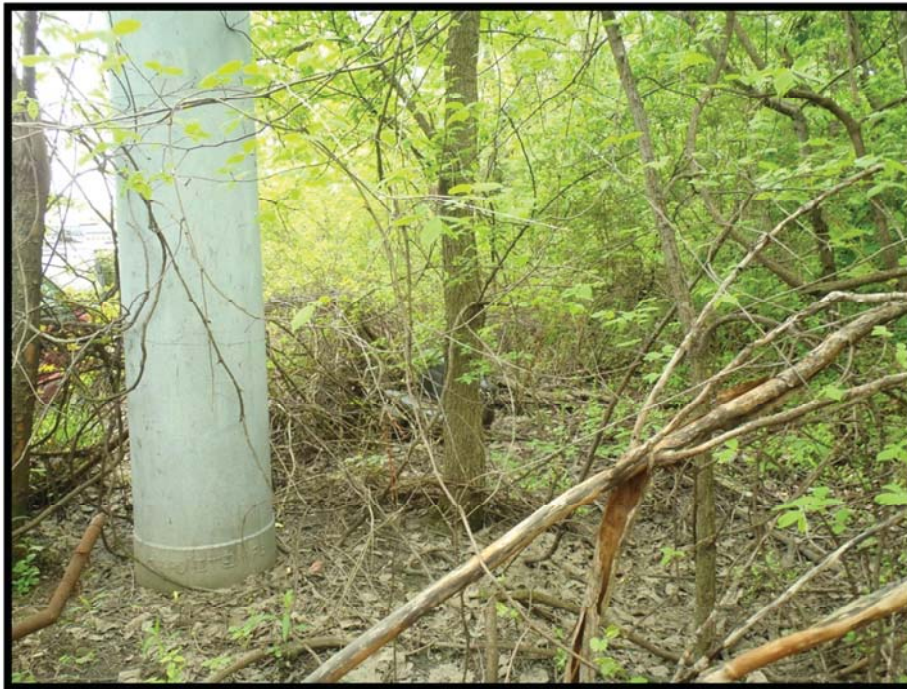
Location/ORAM Score	39.954690, -82.903487/16.0
Cowardin Classification	PSS/PFO
Dominant Plant Species	Jewelweed (<i>Impatiens capensis</i>), Silver maple, Poison ivy, American elm, Twinsisters
Other Species Observed	River grape, Dogwood (<i>Cornus</i> spp.), Glossy buckthorn (<i>Rhamnus frangula</i>), Sallow sedge
Soil Map Unit	Bennington-Urban land complex, 0 to 2 percent slopes
Hydrology Indicators	Water-stained leaves, saturation, high water table
Connected or Isolated*	isolated
Date Surveyed	May 7, 2013

Wetland 3 is a small (approximately 0.055 acre) depressional wetland containing woody vegetation. This wetland is within an excavated swale that does not drain, therefore retaining hydrology for long periods of time. It is located adjacent to Structure 21. This wetland is not connected to Stream 1. Adjacent land use is commercial and urban development along with disturbed forest. This wetland is located in a manmade swale that was lined with a gravel base layer that impedes current hydrologic flow and that does not effectively drain surface waters to nearby water features due to adjacent land use and microtopography. The wetland is bordered by an auto scrap yard which can be a source of pollutants via runoff and leaching, as well.

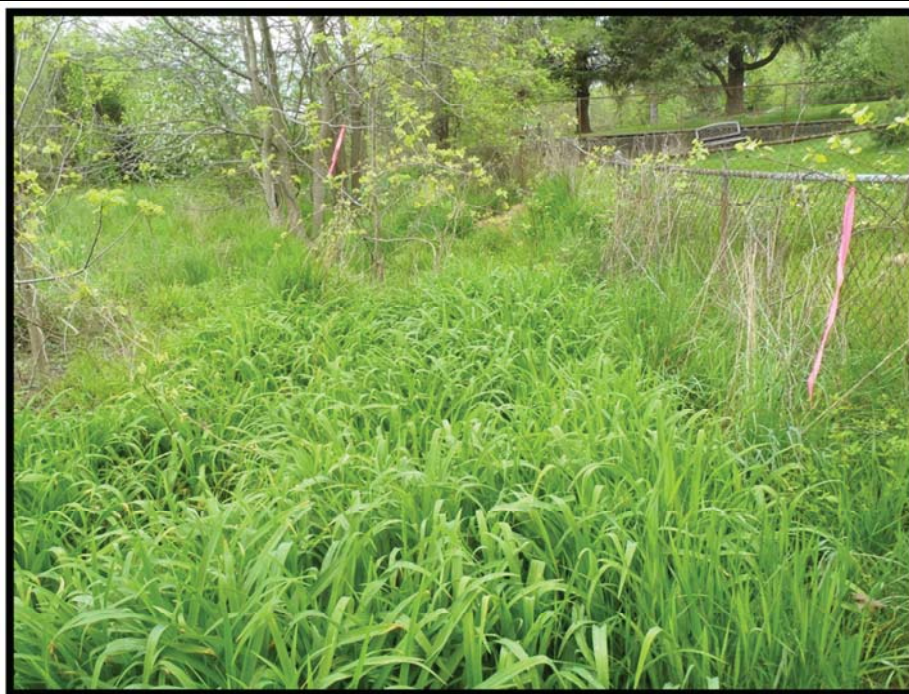
Location/ORAM Score	39.958175, -82.904966/9.0
Cowardin Classification	PEM
Dominant Plant Species	Daylily (<i>Hemerocallis fulva</i>), Reed canary grass (<i>Phalaris arundinacea</i>), Canada goldenrod (<i>Solidago canadensis</i>), Green ash (<i>Fraxinus pennsylvanica</i>), Twinsisters
Other Species Observed	Poison ivy, Burdock (<i>Arctium minus</i>), Common blue violet (<i>Viola sororia</i>), Common woodland sedge (<i>Carex blanda</i>), Wild carrot (<i>Daucus carota</i>), Dogwood, Summer grape (<i>Vitis aestivalis</i>)
Soil Map Unit	Bennington-Urban land complex, 0 to 2 percent slopes
Hydrology Indicators	Saturation, geomorphic position, water-stained leaves, water in soil pit
Connected or Isolated*	isolated
Date Surveyed	May 7, 2013

Wetland 4 is a small (approximately 0.005 acre), depressional wetland, surrounded by maintained ROW and residential neighborhoods. This wetland is within an excavated swale that does not drain, therefore retaining hydrology for long periods of time. It is located between Structures 23 and 24. This wetland is not connected to Stream 1. This wetland is located in a manmade swale that was lined with a gravel base layer that impedes current hydrologic flow and that does not effectively drain surface waters to nearby water features due to adjacent land use and microtopography.

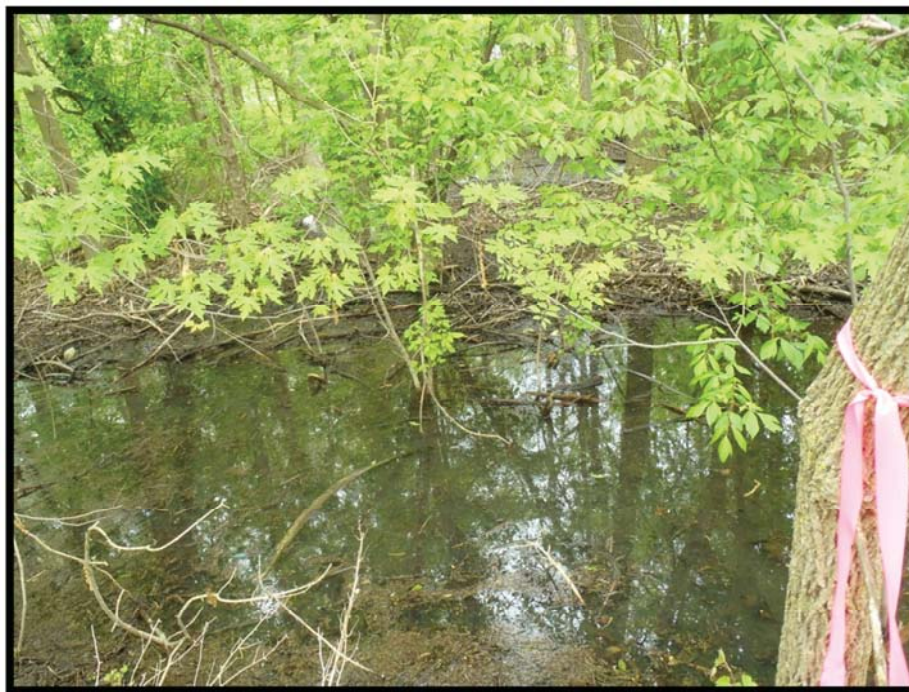
Location/ORAM Score	39.96962, -82.90409/25.0
Cowardin Classification	PSS/PFO
Dominant Plant Species	Sallow sedge, Green Ash, Poison ivy, Red maple (<i>Acer rubrum</i>), Box elder (<i>Acer negundo</i>)
Other Species Observed	Multiflora rose (<i>Rosa multiflora</i>), Yellow avens, Giant goldenrod
Soil Map Unit	Bennington-Urban land complex, 0 to 2 percent slopes
Hydrology Indicators	Standing water, saturation, high water table, water marks on trees, drift deposits
Connected or Isolated*	isolated
Date Surveyed	May 7, 2013

Wetland 5 is a larger (approximately 0.12 acre), forested/shrub-scrub wetland, located within the maintained ROW and adjacent residential properties. This wetland is primarily fed through precipitation. Due to its location within a depression there is no outlet, this wetland retains hydrology for long periods of time. It is located adjacent to Structure 31. This wetland appears somewhat disturbed, but provides some suitable habitat as sightings of waterfowl were reported. In addition, there was some evidence of soil disturbance based on the finding of a man-made hardpan at 14 inches.

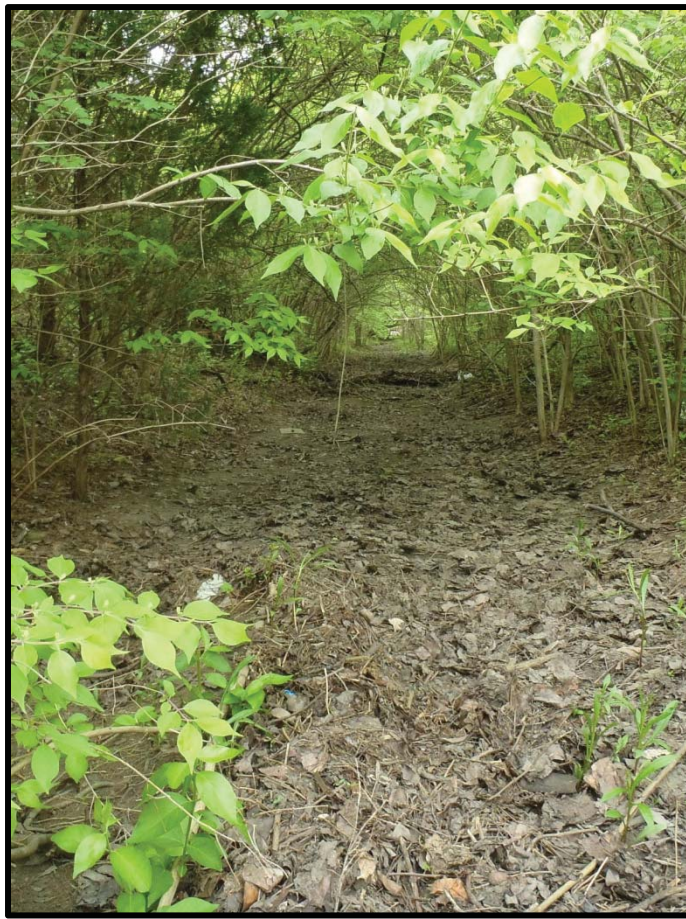
Photo 1. Swale connecting Wetland 1 and Stream 1 (unnamed tributary to Big Walnut Creek). This portion of the line is bordered on the east by interstate 70. Image taken looking west on May 6, 2013.

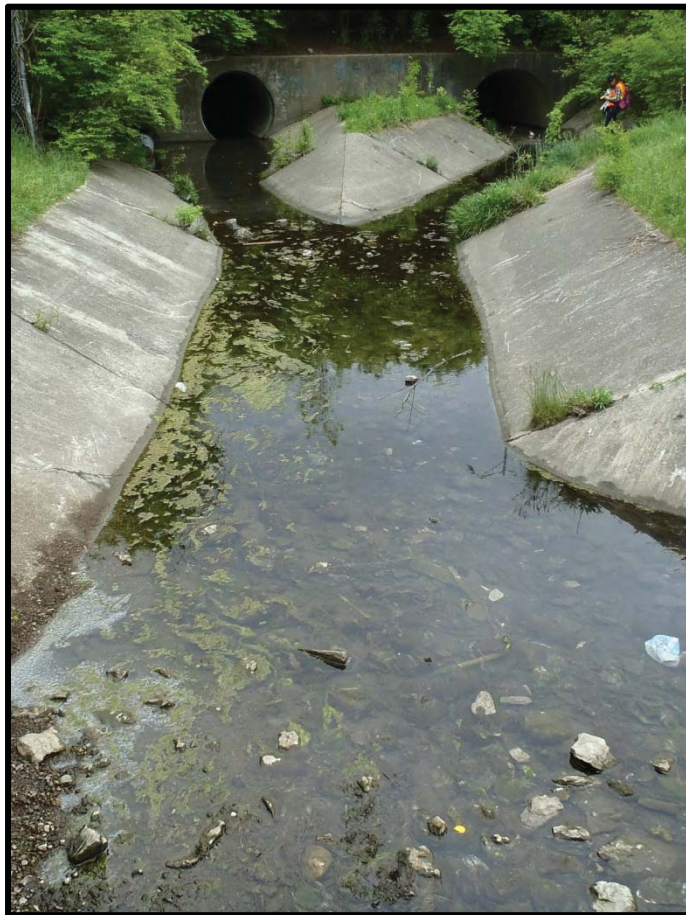
Photo 2. Stream 1 on a section where it has been channelized within the transmission line corridor near Structure 7. Image taken looking north on May 6, 2013.

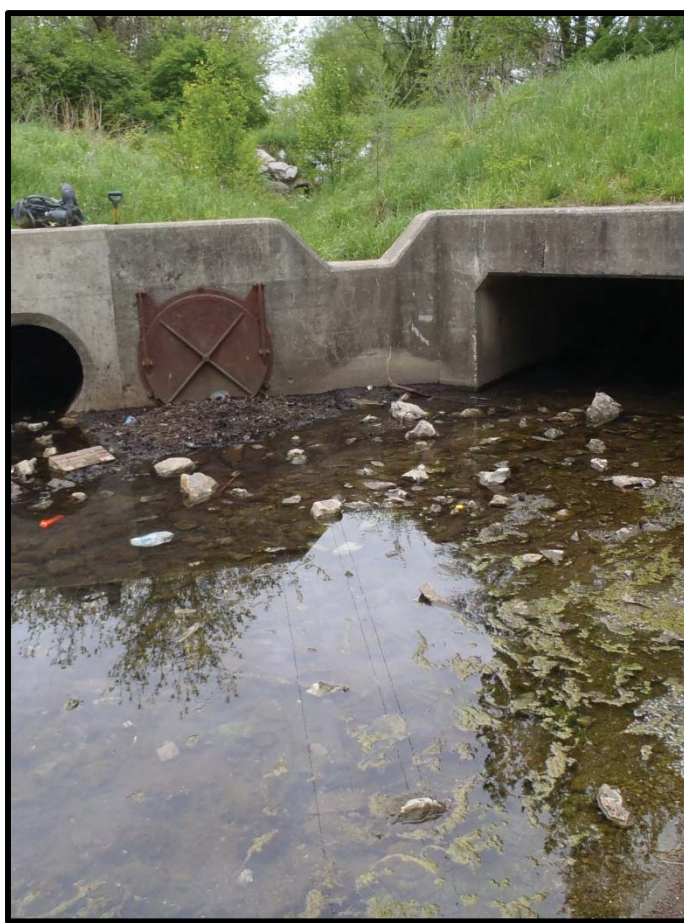
Photo 3. Portion of Stream 1 within transmission line corridor where stream has been channelized (culverts are also shown), near Structure 7. Image taken looking south on May 6, 2013.

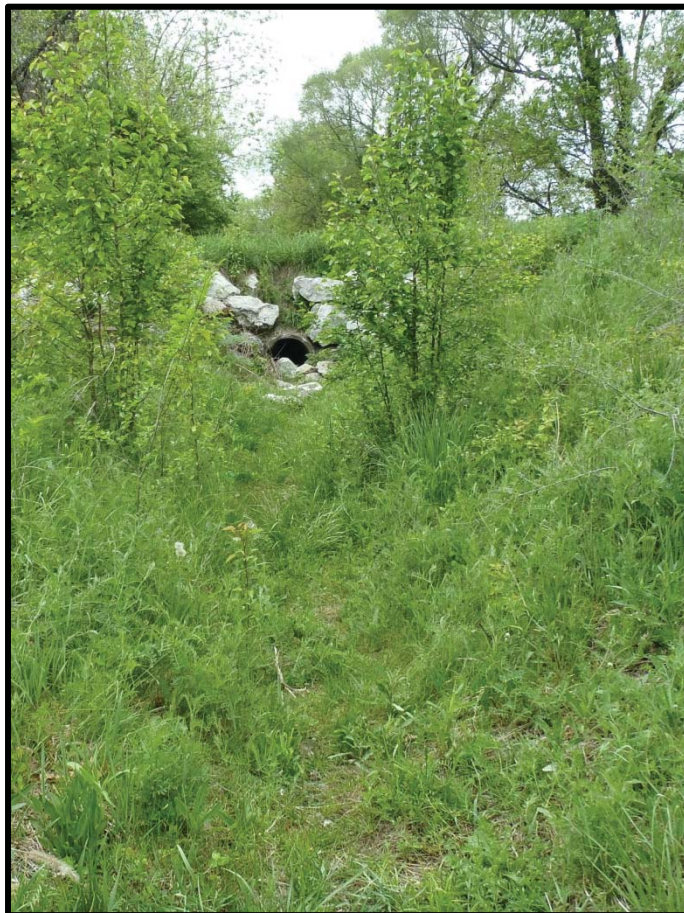
Photo 4. Portion of a drainage swale within the transmission line corridor with a culvert. Image taken looking north on May 6, 2013.

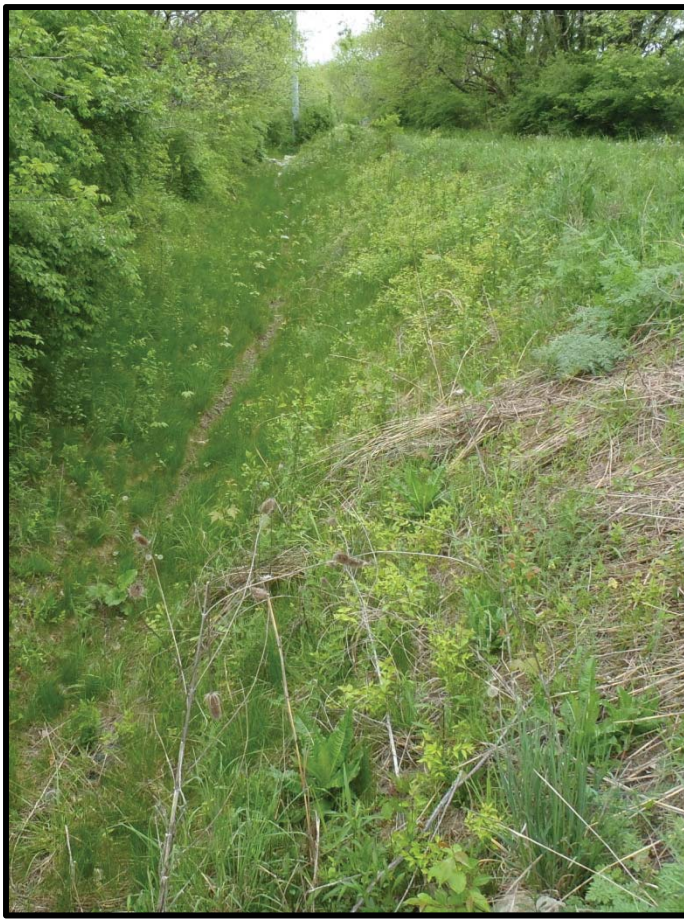
Photo 5. Drainage swale flowing to Stream 1 near Structure 7. Image taken looking north on May 6, 2013.

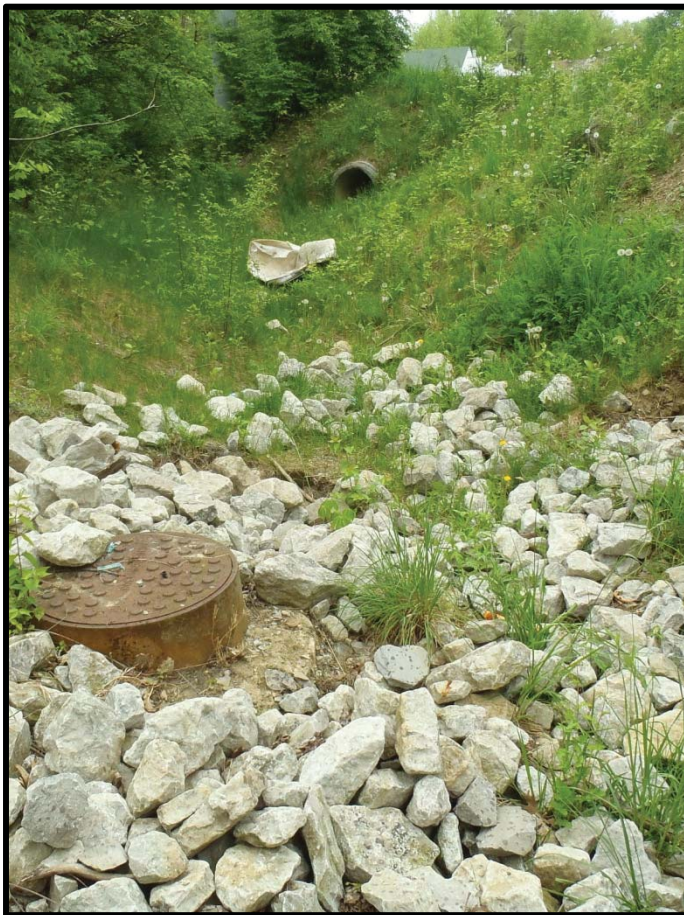
Photo 6. Drainage swale within the transmission line corridor with a culvert and drain near Structure 9. Image taken looking south on May 6, 2013.

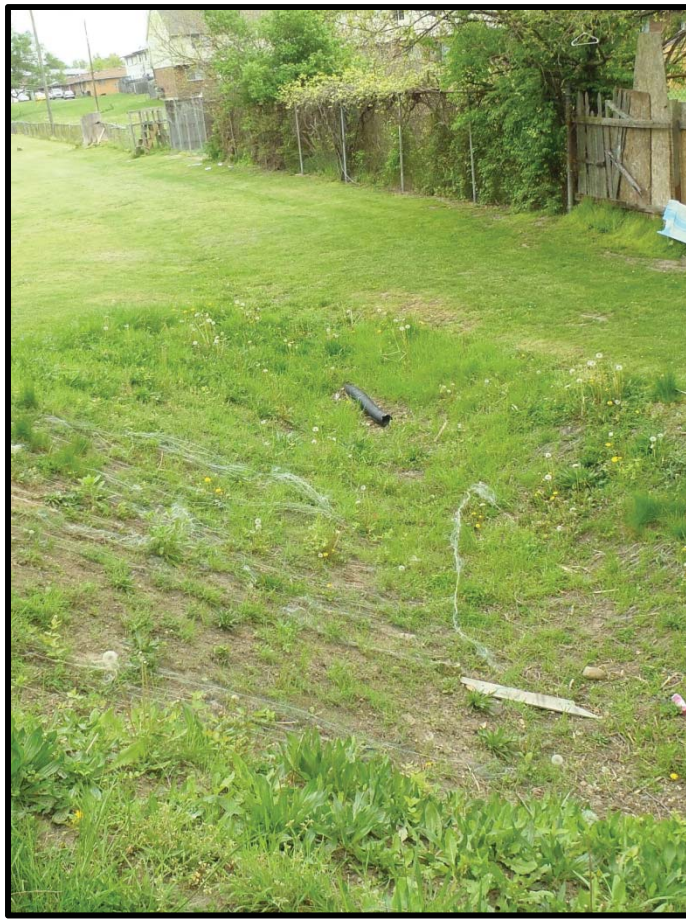
Photo 7. Drainage swale with discharge pipe within the transmission line corridor. Image taken looking north on May 6, 2013.

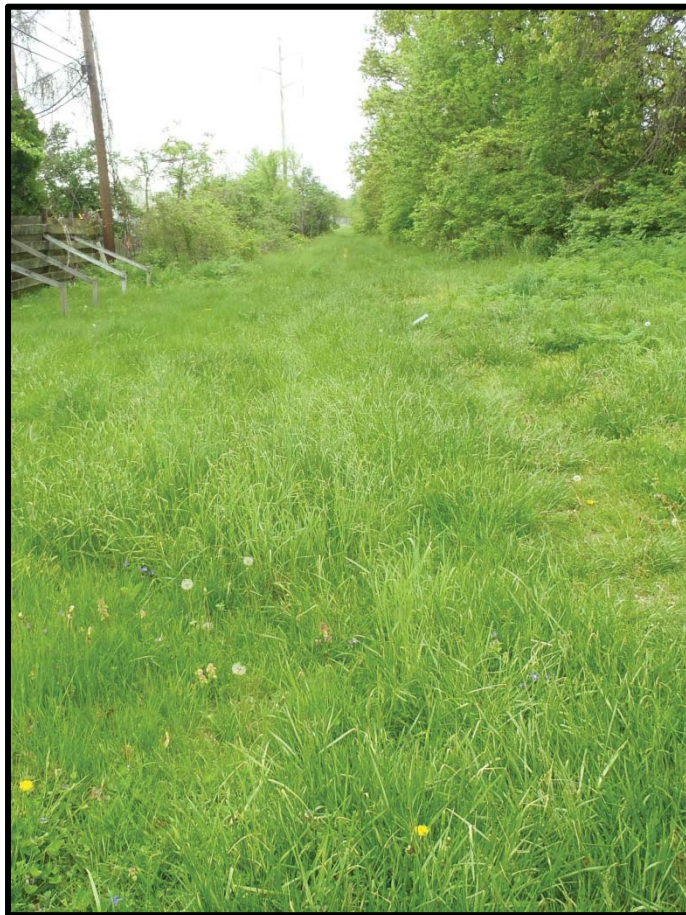
Photo 8. Open grassy maintained ROW within the transmission line corridor with commercial/residential properties and disturbed forest bordering to the east and west. Image taken looking south on May 6, 2013

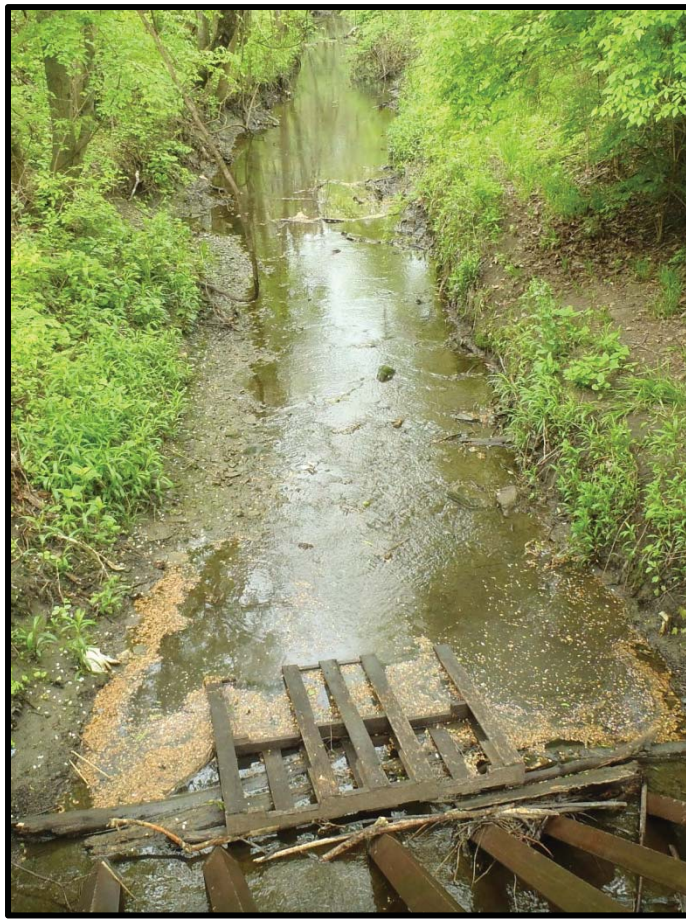
Photo 11. Stream 1 culvert inlet near Structure 16. This stream has been culverted and buried along the line until Structure 6. Image taken looking northwest on May 7, 2013.

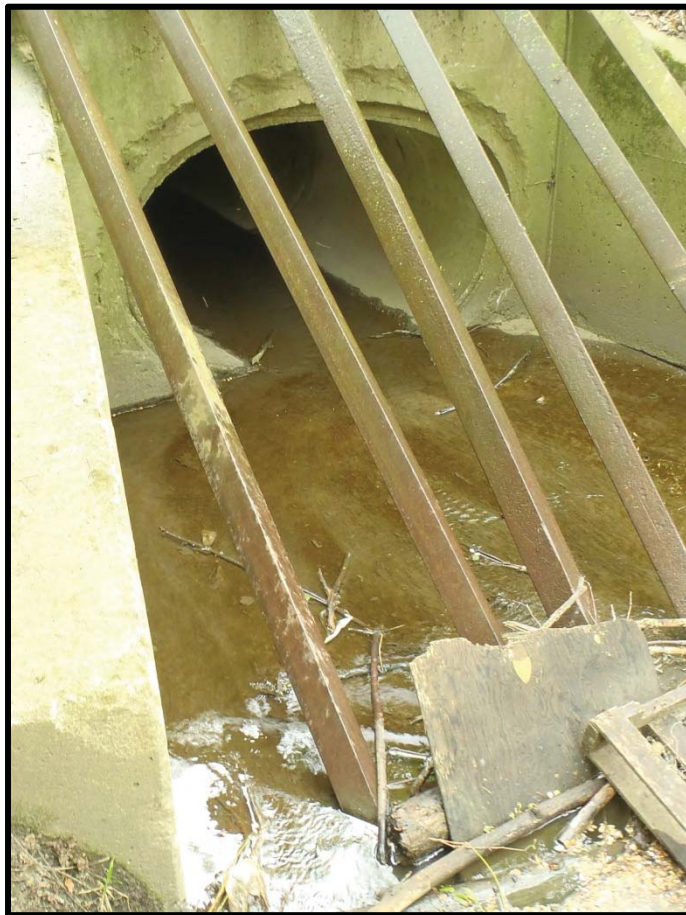
Photo 12. Stream 1 culvert inlet near Structure 16. This stream has been culverted and buried along the line until Structure 6. Image taken looking east on May 7, 2013.

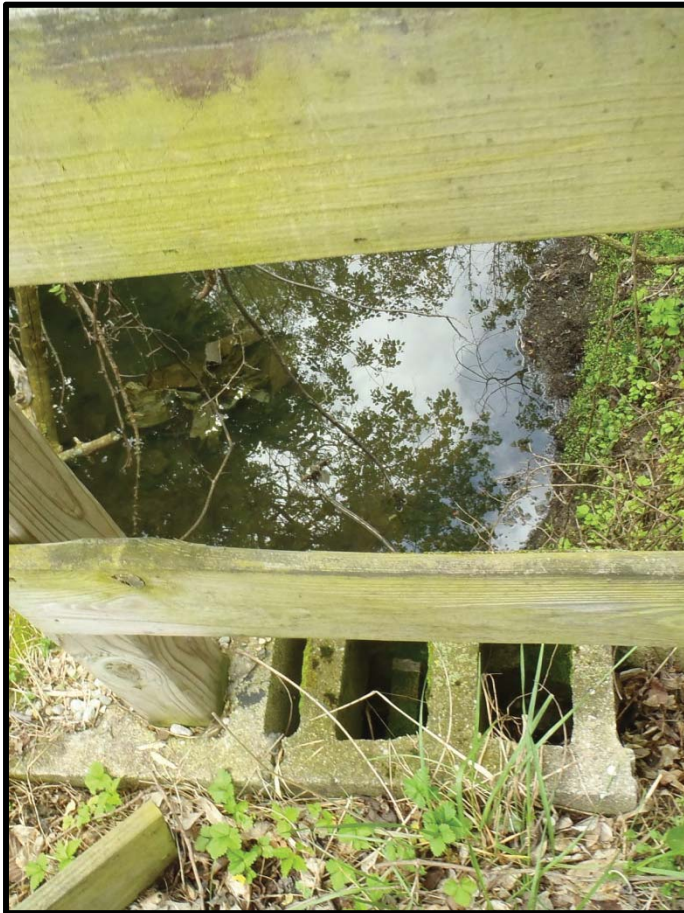
Photo 14. Ending of surface water flow of Stream 1 within the transmission line corridor. Stream is diverted through a culvert and flows underground via pipe system. Image is taken looking south. Taken May 7, 2013.

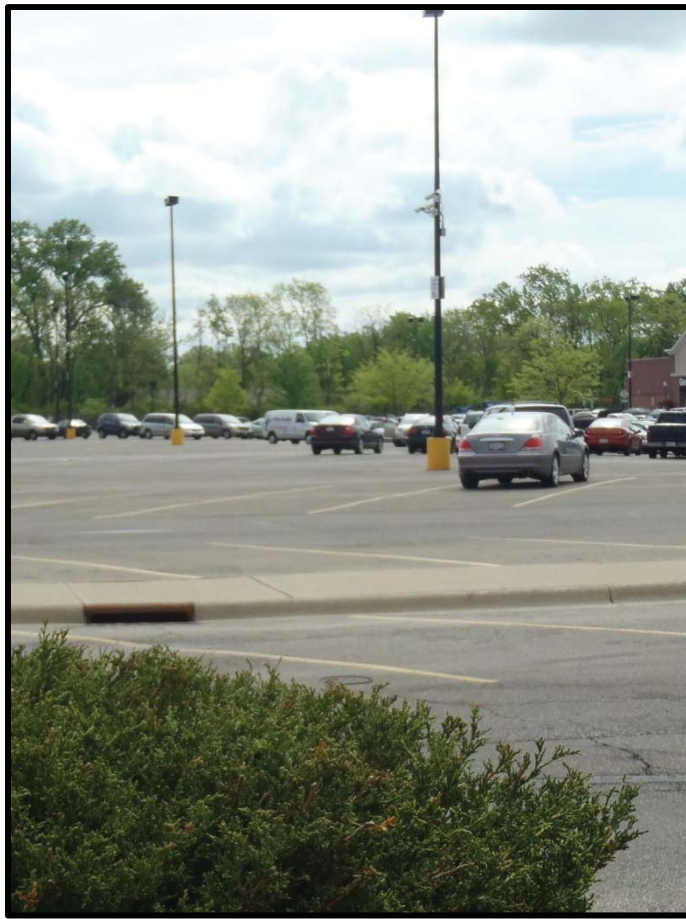
Photo 15. Urbanized and commercial development in transmission line corridor near Structure 22, looking northwest. Taken May 7, 2013.

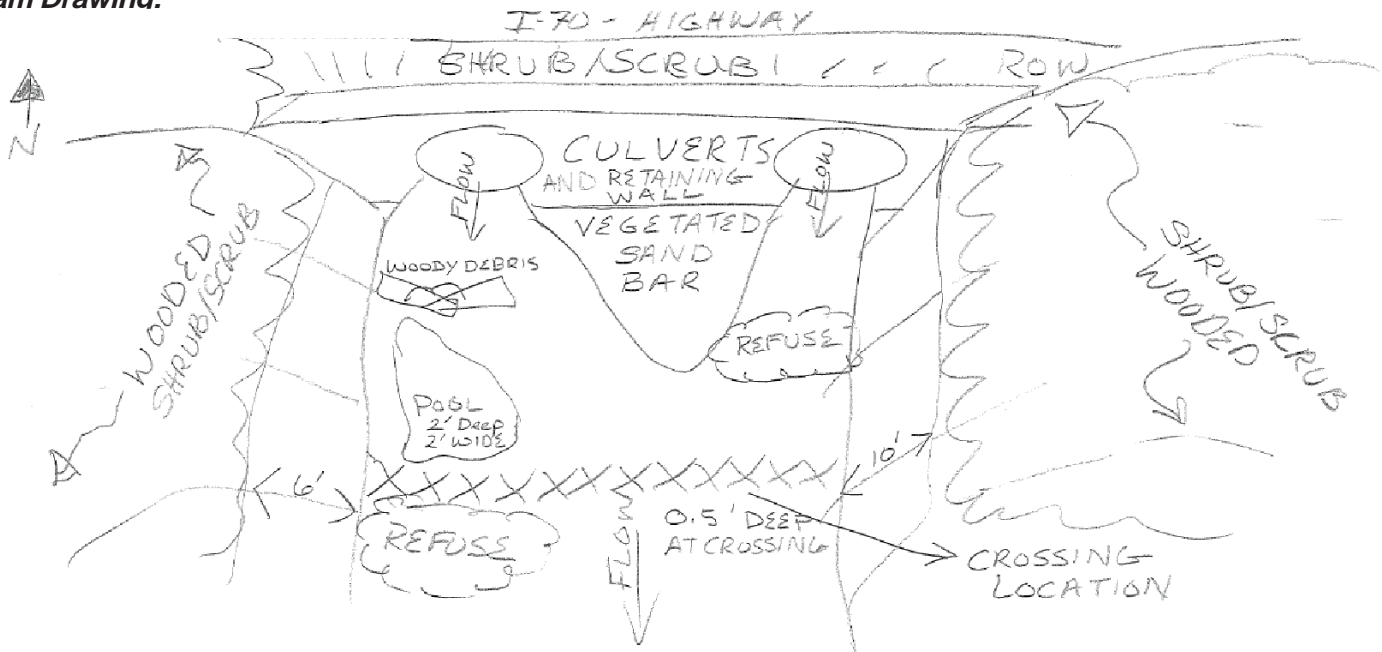
Stream Drawing:

Existing transmission lines cross this location of the UT to Big Walnut Creek. These lines are proposed for replacement/repair.

Algae growth dense. Extremely low habitat availability for all flora and fauna. Many invasives and not native species present.

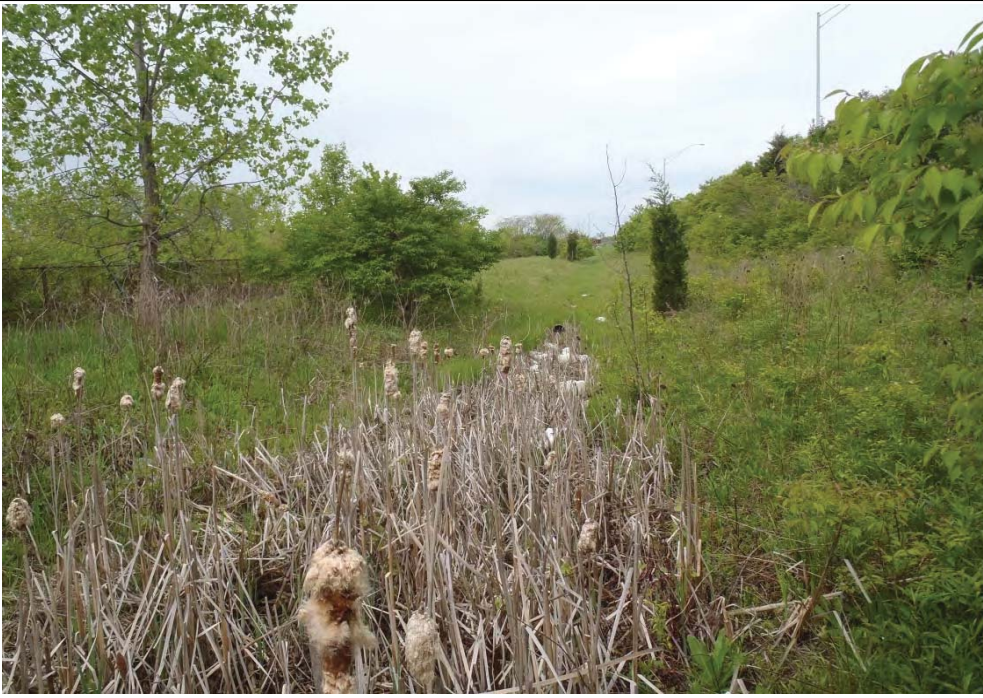
Name:	CMS	Date:	May 7, 2013
Affiliation:	BHE Environmental, Inc.		
User Address:	1 South Main Street, Akron, Ohio 44308		
Phone:	234-678-8889		
e-mail address	cstallone@bheenvironmental.com		
Wetlands Name	Wetland 1		
Location of Wetlands including address if available	39.935294°, -82.889663°		
	Sources of information used (check all that apply)		
UTM	Site Visit	<input checked="" type="checkbox"/>	
USGS Quad	USGS Topo	<input checked="" type="checkbox"/>	
Hydrologic Unit Code 5060001	NWI Map	<input checked="" type="checkbox"/>	
Wetland Size (acres) 0.051	OWI Map	<input checked="" type="checkbox"/>	
How was size estimated? Wetlands Delineation	Aerial Photo	<input checked="" type="checkbox"/>	
	Soil Survey	<input checked="" type="checkbox"/>	
	ODNR - DNAP	<input checked="" type="checkbox"/>	
	Delineation Report/Map	<input checked="" type="checkbox"/>	
Photograph

final score:	9	Provisional Wetland Category:	Category 1

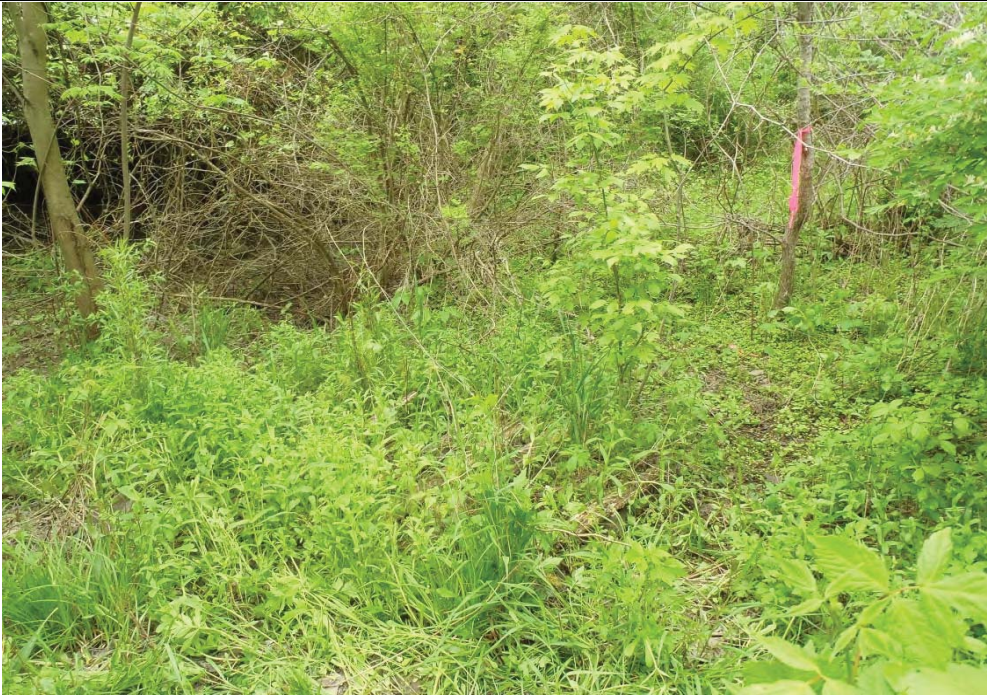
Name:	CMS	Date:	May 7, 2013
Affiliation:	BHE Environmental, Inc.		
User Address:	1 South Main Street, Akron, Ohio 44308		
Phone:	234-678-8889		
e-mail address	cstallone@bheenvironmental.com		
Wetlands Name	Wetland 2		
Location of Wetlands including address if available	39.952603°, -82.901627°		
		Sources of information used (check all that apply)	
UTM		Site Visit	<input checked="" type="checkbox"/>
USGS Quad		USGS Topo	<input checked="" type="checkbox"/>
Hydrologic Unit Code	5060001	NWI Map	<input checked="" type="checkbox"/>
Wetland Size (acres)	0.009	OWI Map	<input checked="" type="checkbox"/>
How was size estimated? Wetlands Delineation		Aerial Photo	<input checked="" type="checkbox"/>
		Soil Survey	<input checked="" type="checkbox"/>
		ODNR - DNAP	<input checked="" type="checkbox"/>
		Delineation Report/Map	<input checked="" type="checkbox"/>
Photograph

final score:	20	Provisional Wetland Category:	Category 1

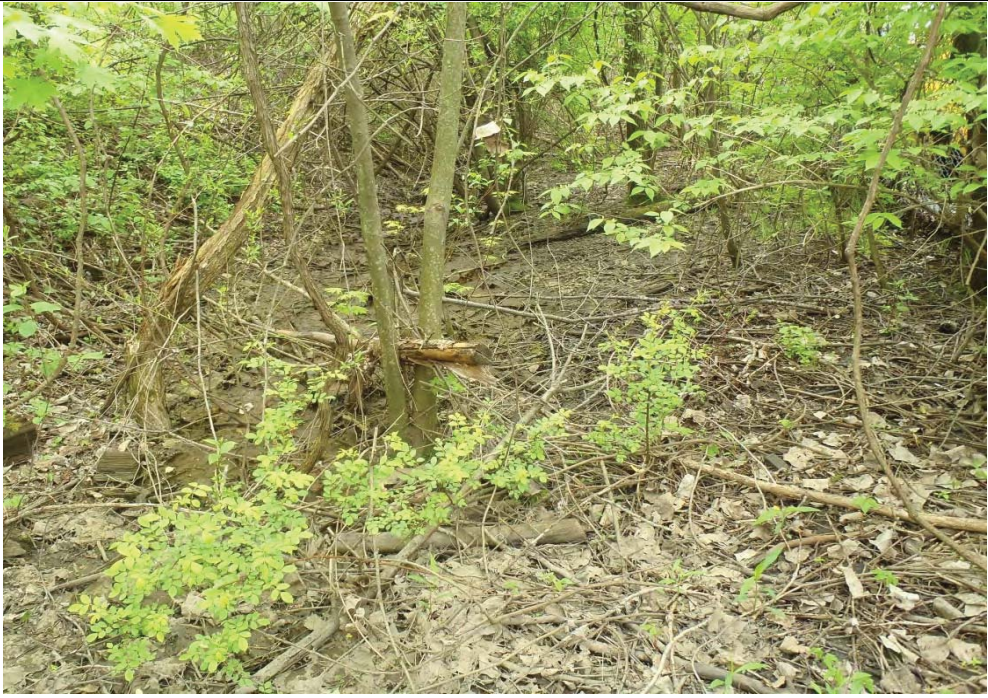
Name:	CMS	Date:	May 7, 2013
Affiliation:	BHE Environmental, Inc.		
User Address:	1 South Main Street, Akron, Ohio 44308		
Phone:	234-678-8889		
e-mail address	cstallone@bheenvironmental.com		
Wetlands Name	Wetland 3		
Location of Wetlands including address if available	39.952603°, -82.901627°		
		Sources of information used (check all that apply)	
UTM		Site Visit	<input checked="" type="checkbox"/>
USGS Quad		USGS Topo	<input checked="" type="checkbox"/>
Hydrologic Unit Code	5060001	NWI Map	<input checked="" type="checkbox"/>
Wetland Size (acres)	0.055	OWI Map	<input checked="" type="checkbox"/>
How was size estimated? Wetlands Delineation		Aerial Photo	<input checked="" type="checkbox"/>
		Soil Survey	<input checked="" type="checkbox"/>
		ODNR - DNAP	<input checked="" type="checkbox"/>
		Delineation Report/Map	<input checked="" type="checkbox"/>
Photograph

final score:	16	Provisional Wetland Category:	Category 1
