RE: **Letter of Notification**
Case No. 13-1330-EL-BLN Groves—Bexley 138 kV Transmission Line Rebuild Project

**LETTER OF NOTIFICATION FOR THE
GROVES - BEXLEY 138 KV TRANSMISSION LINE REBUILD
PROJECT**

PUCO Case No. 13-1330-EL-BLN

**AEP Ohio Transmission Company
(AEP Ohio Transco)**

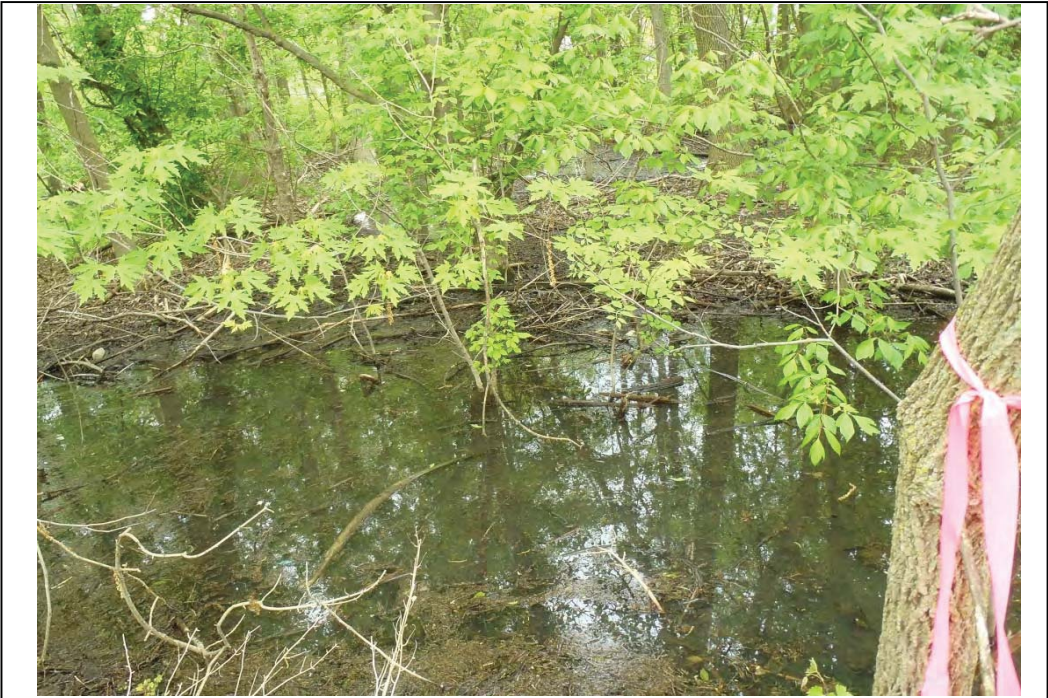
Name:	CMS	Date:	May 7, 2013
Affiliation:	BHE Environmental, Inc.		
User Address:	1 South Main Street, Akron, Ohio 44308		
Phone:	234-678-8889		
e-mail address	cstallone@bheenvironmental.com		
Wetlands Name	Wetland 5		
Location of Wetlands including address if available	39.969702°, -82.904150°		
		Sources of information used (check all that apply)	
UTM		Site Visit	<input checked="" type="checkbox"/>
USGS Quad		USGS Topo	<input checked="" type="checkbox"/>
Hydrologic Unit Code	5060001	NWI Map	<input checked="" type="checkbox"/>
Wetland Size (acres)	0.117727	OWI Map	<input checked="" type="checkbox"/>
How was size estimated? Wetlands Delineation		Aerial Photo	<input checked="" type="checkbox"/>
		Soil Survey	<input checked="" type="checkbox"/>
		ODNR - DNAP	<input checked="" type="checkbox"/>
		Delineation Report/Map	<input checked="" type="checkbox"/>
Photograph

final score:	25	Provisional Wetland Category:	Category 1
