Primary Headwater Habitat Evaluation Form

SITE NAME/LOCATION Stream 9SITE NUMBER Stream 9RIVER BASIN ELRO1DRAINAGE AREA (mi²) 0.00LENGTH OF STREAM REACH (ft) 200 LAT. 41.30165 LONG. -82.07833 RIVER CODE RIVER MILE DATE 05/09/14 SCORER TK/AG/LZ COMMENTS

| Project Name: Avon Lake Gas Addition Project | | Site Location: Lorain County, Ohio | |

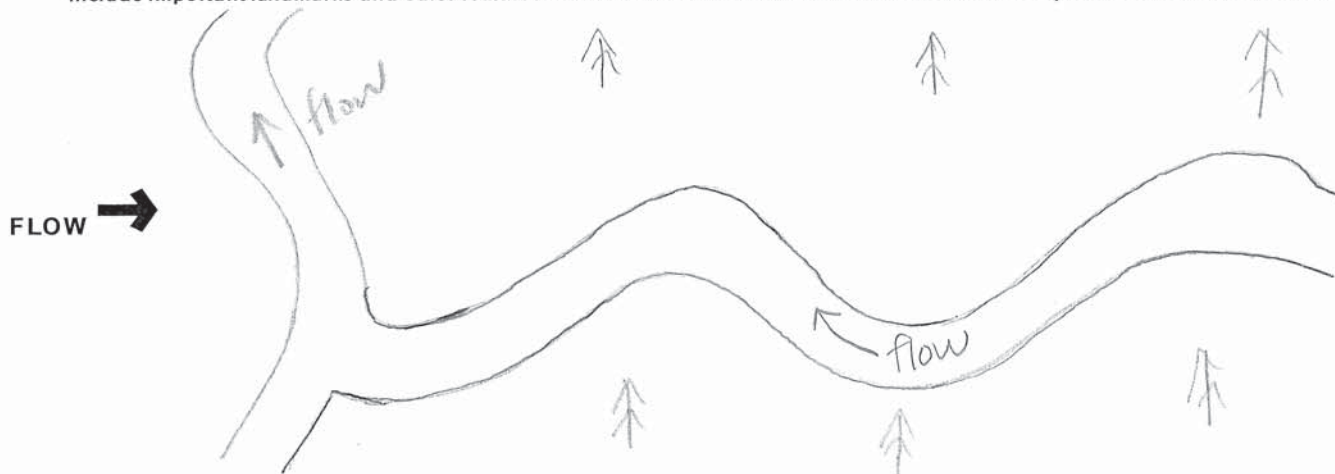
DRAWING AND NARRATIVE DESCRIPTION OF STREAM REACH (This must be completed):

Include important landmarks and other features of interest for site evaluation and a narrative description of the stream's location

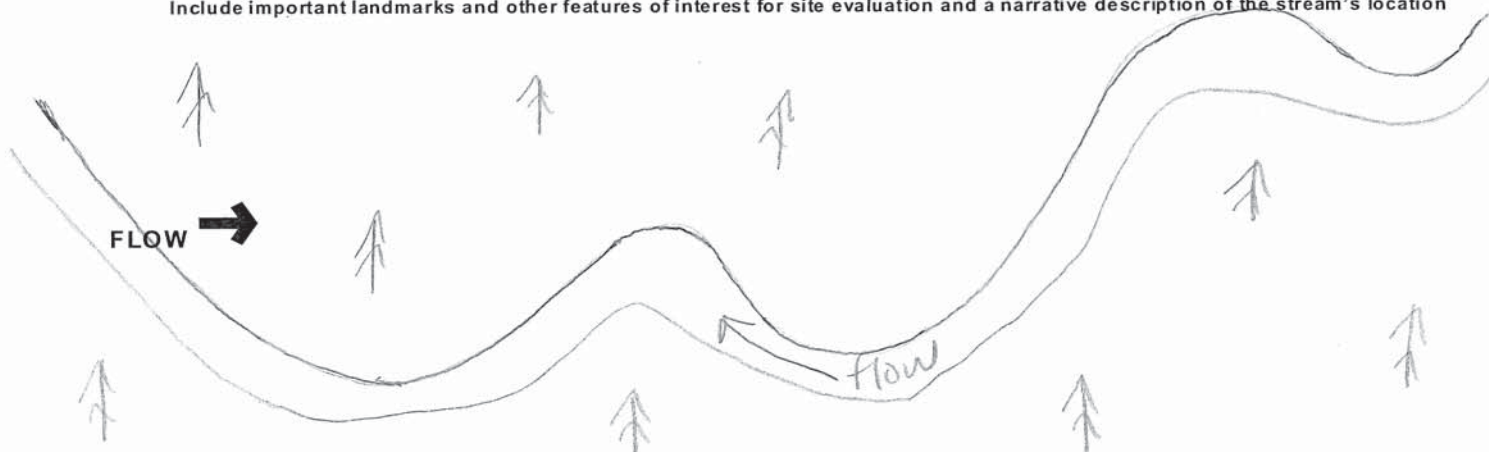
DRAWING AND NARRATIVE DESCRIPTION OF STREAM REACH (This must be completed):

Include important landmarks and other features of interest for site evaluation and a narrative description of the stream's location

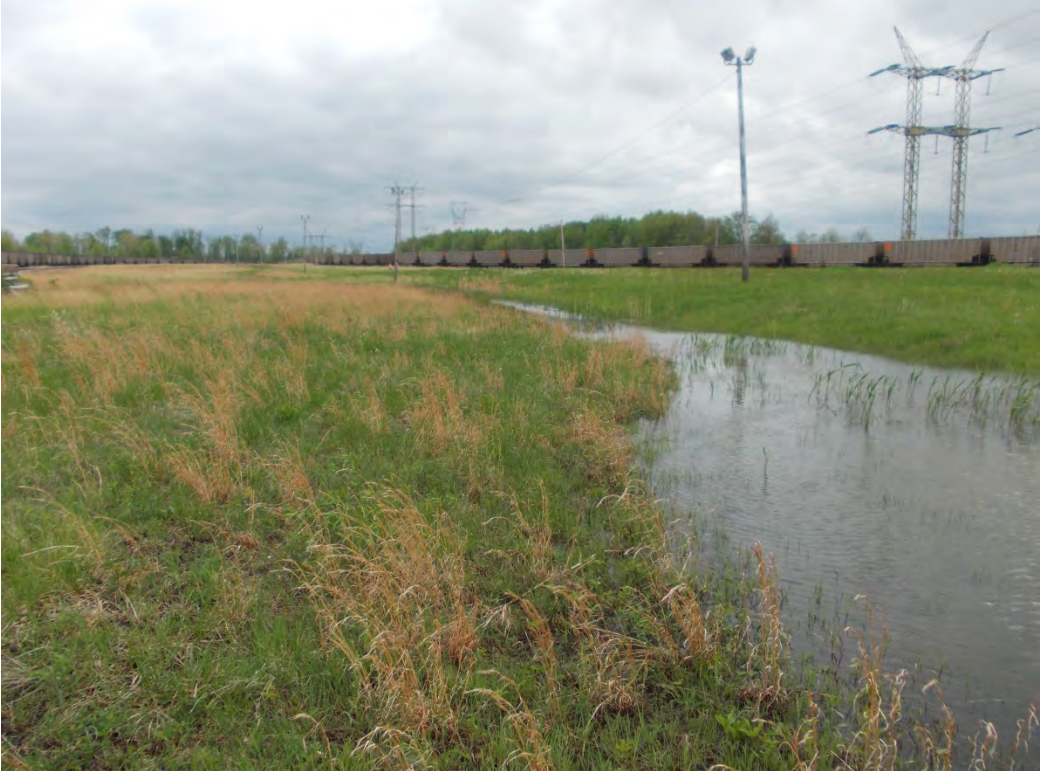
| Photo No. 8 | Date: 05/15/14 | |

| Direction Photo Taken: South | | |
| Description: Wetland 5 emergent wetland. | | |

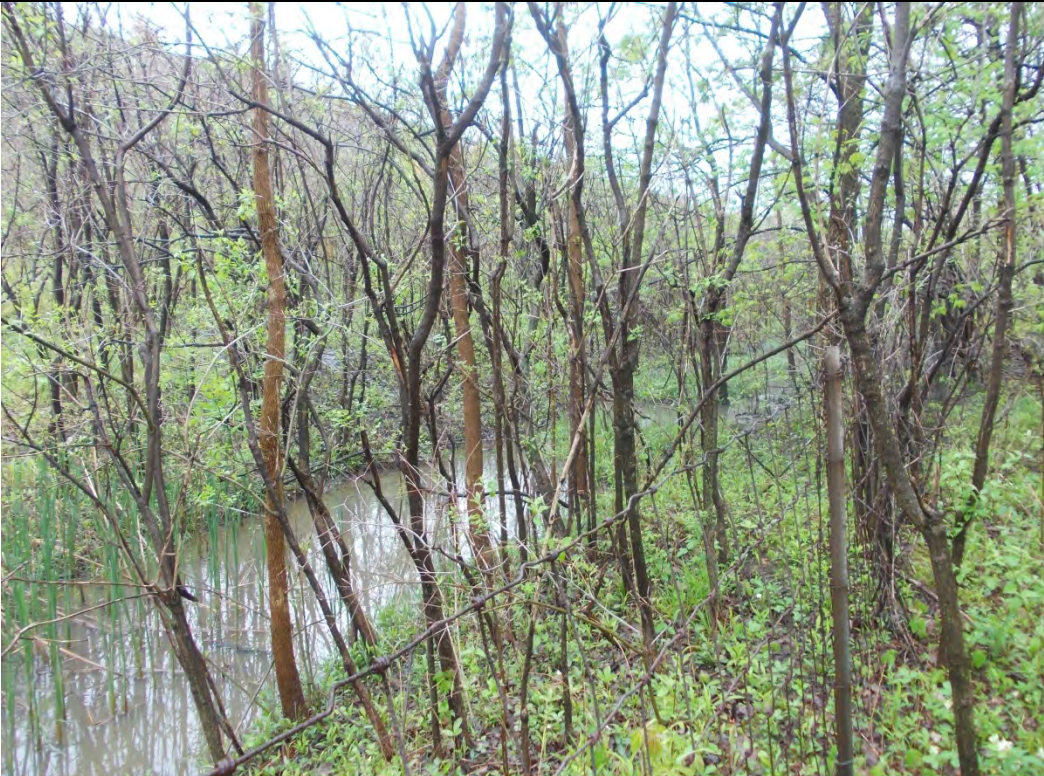
| Photo No. 18 | Date: 05/15/14 | |

| Direction Photo Taken: East | | |
| Description: Stream 2 located along the south side of Interstate 90. | | |
