Case No. 16-1871-EL-BGN

Icebreaker Windpower Inc.

- Exhibit X. Substation Geotechnical Report

RE: Geotechnical and Subsurface Exploration Report for the Proposed Electrical Substation for the Icebreaker Offshore Wind Demonstration Project, Cleveland, Ohio; LAE001.600.0005.

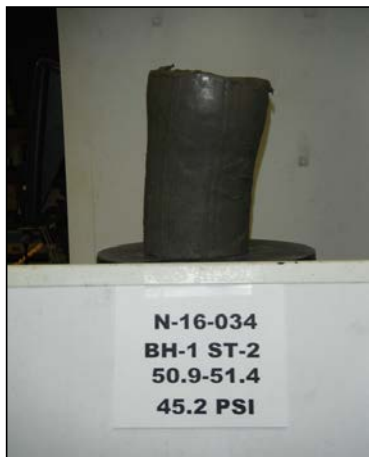
Failure Sketch

Effective Confining Stress, σ_3 : 45.2 psi	Deviator Stress @ Failure, $\Delta\sigma$: 2,323 psf	
	Axial Strain @ Failure: 15.03 %	
Strain Rate: 1.00 %/min	Major Principal Stress @ Failure, σ_1 : 8,832 psf

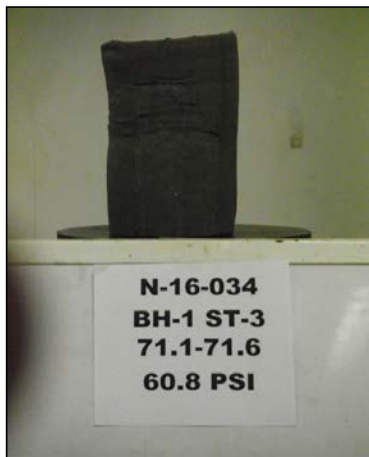
Failure Sketch

Effective Confining Stress, σ_3 : 60.8 psi	Deviator Stress @ Failure, $\Delta\sigma$: 2,603 psf	
	Axial Strain @ Failure: 9.07 %	
Strain Rate: 1.00 %/min	Major Principal Stress @ Failure, σ_1 : 11,359 psf

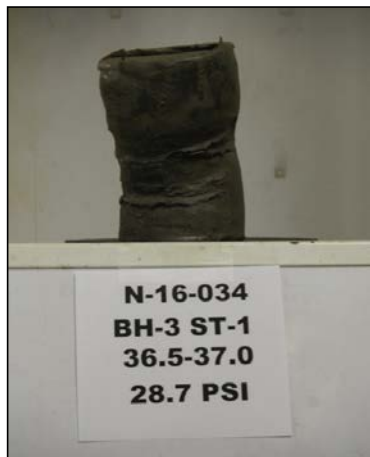
Failure Sketch

Effective Confining Stress, σ_3 : 27.8 psi	Deviator Stress @ Failure, $\Delta\sigma$: 263 psf	
	Axial Strain @ Failure: 4.99 %	
Strain Rate: 1.00 %/min	Major Principal Stress @ Failure, σ_1 : 4,266 psf

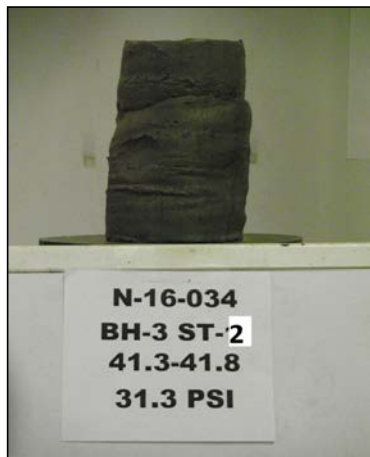
Failure Sketch

Effective Confining Stress, σ_3 : 31.3 psi	Deviator Stress @ Failure, $\Delta\sigma$: 348 psf	
	Axial Strain @ Failure: 8.21 %	
Strain Rate: 1.00 %/min	Major Principal Stress @ Failure, σ_1 : 4,855 psf

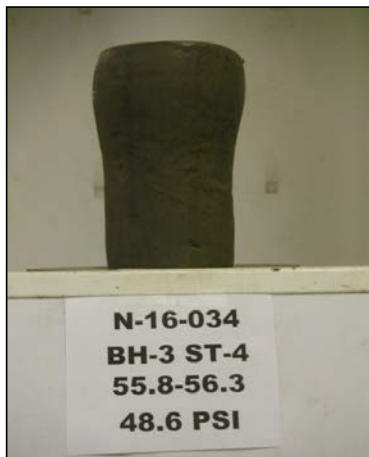
Failure Sketch

Effective Confining Stress, σ_3 : 48.6 psi	Deviator Stress @ Failure, $\Delta\sigma$: 1,986 psf	
	Axial Strain @ Failure: 15.02 %	
Strain Rate: 1.00 %/min	Major Principal Stress @ Failure, σ_1 : 8,985 psf

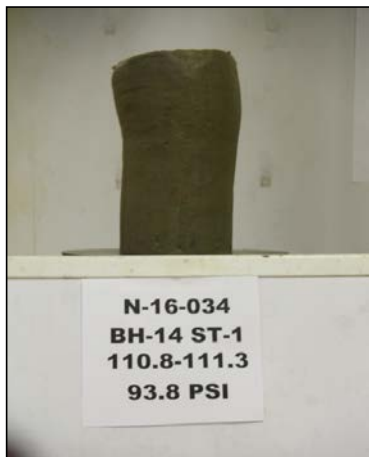
Failure Sketch

Effective Confining Stress, σ_3 : 93.8 psi	Deviator Stress @ Failure, $\Delta\sigma$: 2,109 psf	
	Axial Strain @ Failure: 9.89 %	
Strain Rate: 1.00 %/min	Major Principal Stress @ Failure, σ_1 : 15,617 psf

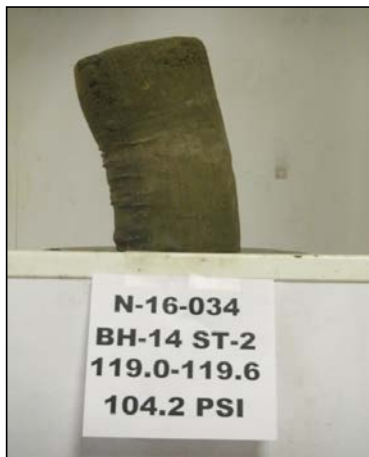
Failure Sketch

Effective Confining Stress, σ_3 : 104.2 psi	Deviator Stress @ Failure, $\Delta\sigma$: 943 psf	
	Axial Strain @ Failure: 13.34 %	
Strain Rate: 1.00 %/min	Major Principal Stress @ Failure, σ_1 : 15,948 psf

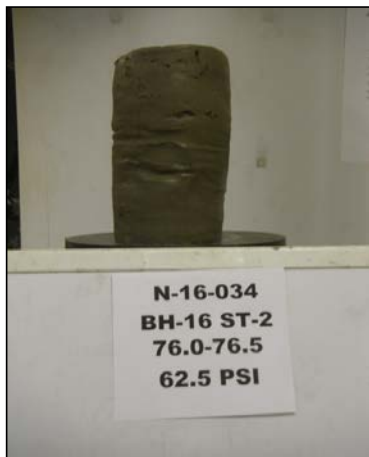
Failure Sketch

Effective Confining Stress, σ_3 : 62.5 psi	Deviator Stress @ Failure, $\Delta\sigma$: 763 psf	
	Axial Strain @ Failure: 15.01 %	
Strain Rate: 1.00 %/min	Major Principal Stress @ Failure, σ_1 : 9,764 psf

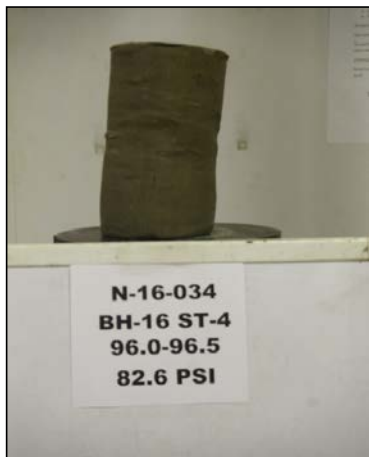
Failure Sketch

Effective Confining Stress, σ_3 : 82.6 psi	Deviator Stress @ Failure, $\Delta\sigma$: 939 psf	
	Axial Strain @ Failure: 14.79 %	
Strain Rate: 1.00 %/min	Major Principal Stress @ Failure, σ_1 : 12,834 psf

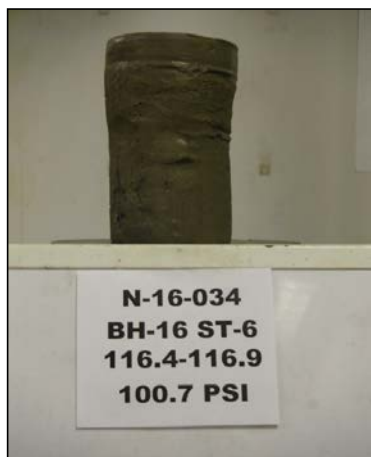
Failure Sketch

Effective Confining Stress, σ_3 : 100.7 psi	Deviator Stress @ Failure, $\Delta\sigma$: 758 psf	
	Axial Strain @ Failure: 15.00 %	
Strain Rate: 1.00 %/min	Major Principal Stress @ Failure, σ_1 : 15,259 psf

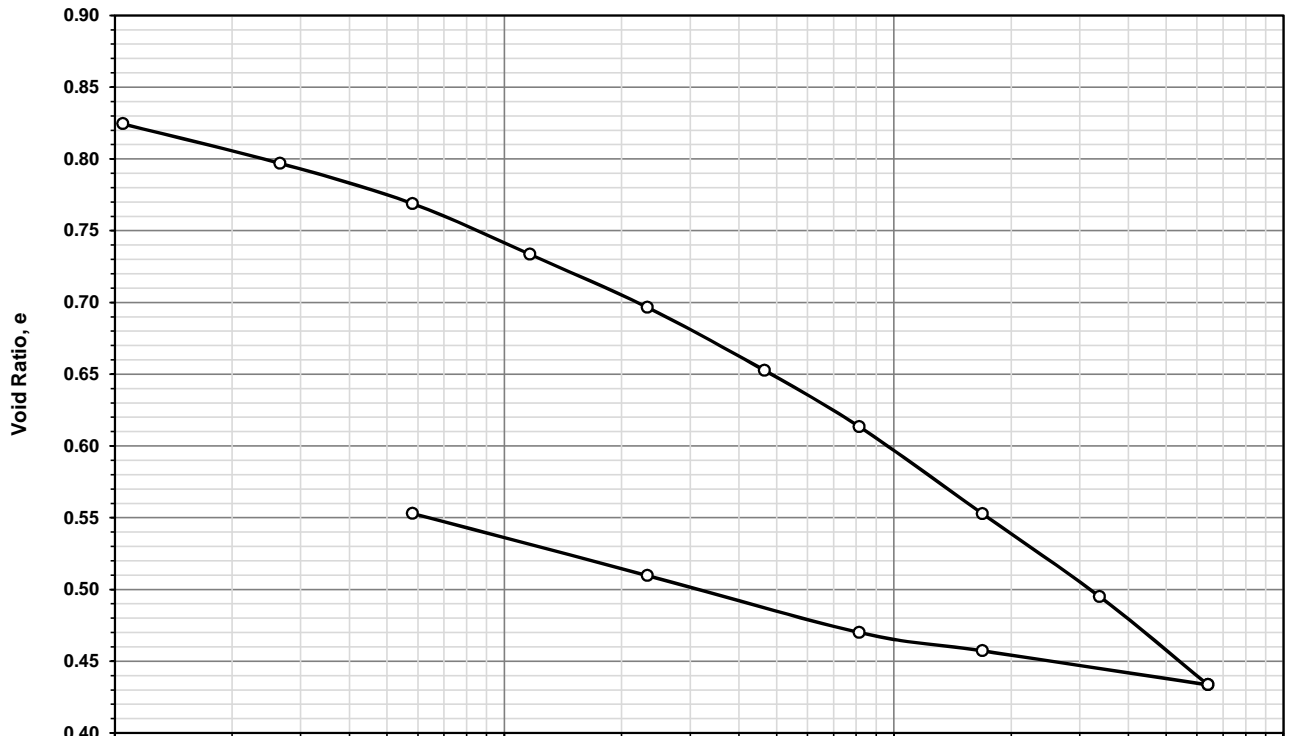
Physical Characteristics	L.L.	P.L.	P.I.	Gravel%	C. Sand%	F. Sand%	Silt%	Clay%
	37	20	17

Natural		γ_d (pcf)	γ_{sat} (pcf)	σ_{vo}' (psf)	S_G	e_o	σ_p' (psf)	c_c	c_r
S_o	w_o								
101.3%	31.7%	90.4	119.3	5,528	2.67	0.844	3,346	0.300	0.059

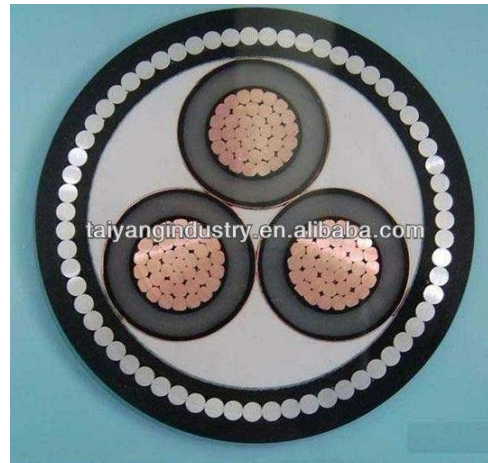
Figure 2. Example LEEDCo cable cross section

Although a manufacturer has not been chosen, the magnetic field generated by the line is governed by the voltage and current of the transmission cable and not the cable design. Calculation of the estimated magnetic field from the LEEDCo cable was done by one of the transmission cable contractors, JDR Cable Systems in 2013 (JDR, 2013). A maximum magnetic field density of 2 μ T was calculated for a load of 379 amps at a distance of 1 meter from the cable center. Note that this calculation was carried out at a slightly higher amperage than the LEEDCo proposed 345 amps. Even at 0.5m above the cable the magnetic field strength is only 8.5 μ T, which is considerably less than the earth's magnetic field strength (~50 μ T). An estimate of the magnetic field strength at various distances from the cable center is shown below is Figure 3.
