**LETTER OF NOTIFICATION FOR  
WAVERLY-WARE ROAD 138 KV TRANSMISSION LINE PROJECT**

Appendix C Ecological Resources Inventory Report  
February 3, 2017

**Ecological Resources Inventory  
Report**

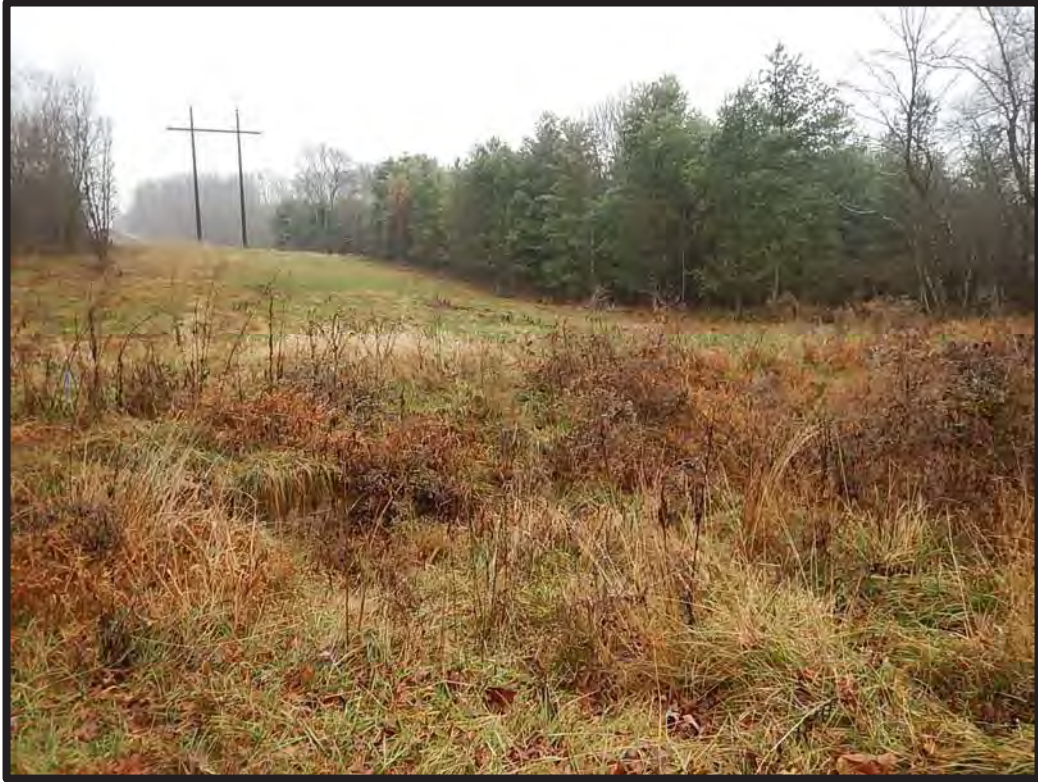
Figure 22. View of the shovel tested areas around structure 30.

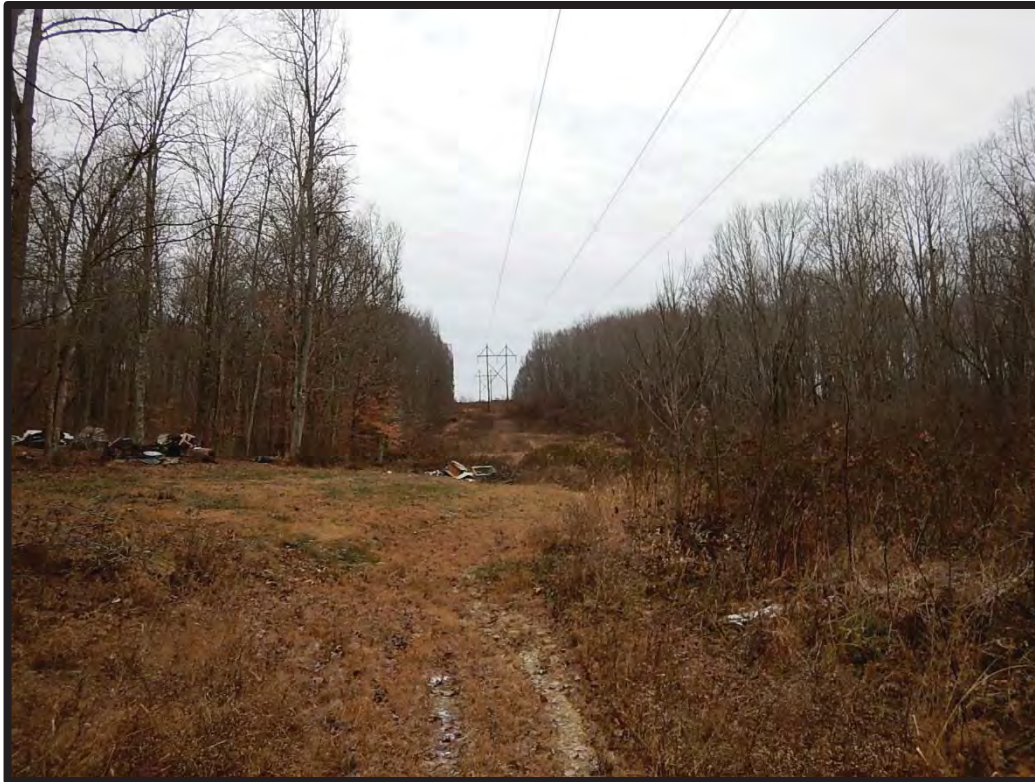
Figure 26. View of the shovel probed area near structure 23.

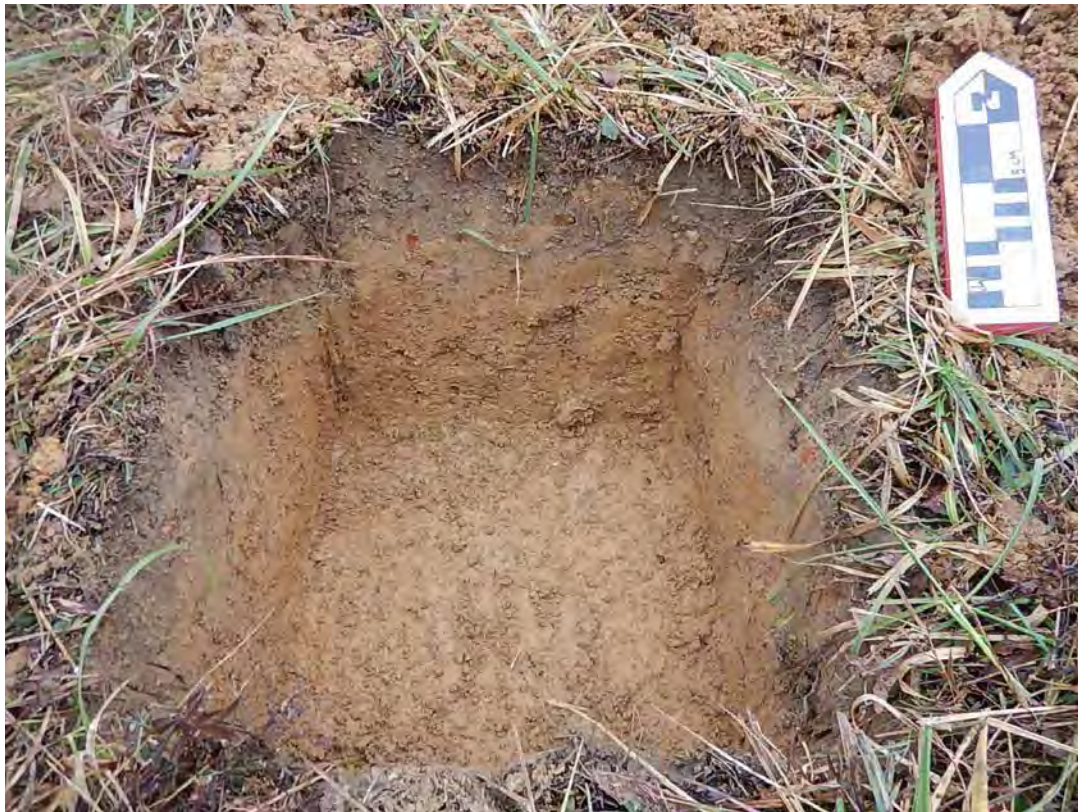
Figure 28. A typical shovel test unit excavated within the project.

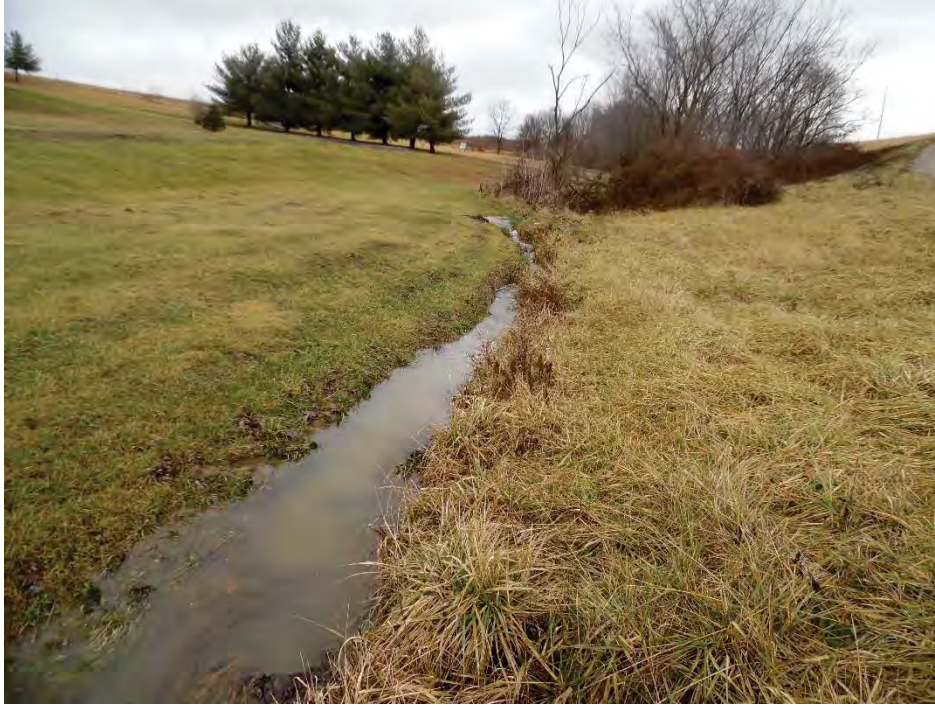
Photo Location 1. View of Stream 1. Photograph taken upstream/facing northeast.

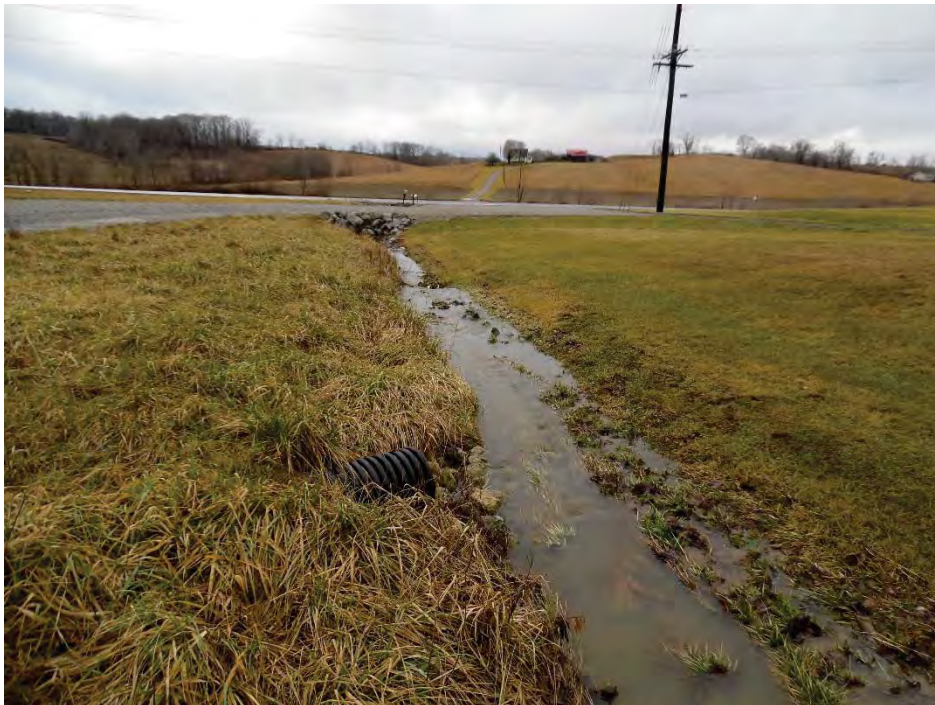
Photo Location 1. View of Stream 1. Photograph taken downstream/facing southwest.

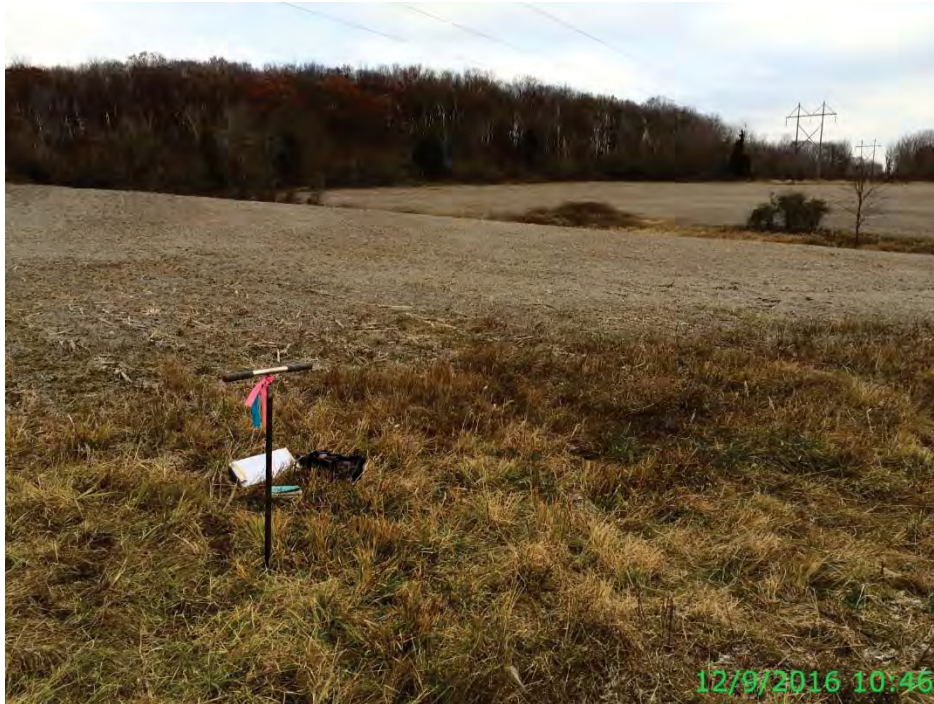
Photo Location 2. View of upland at wetland determination sample point (SP 1). Photograph taken facing northeast.

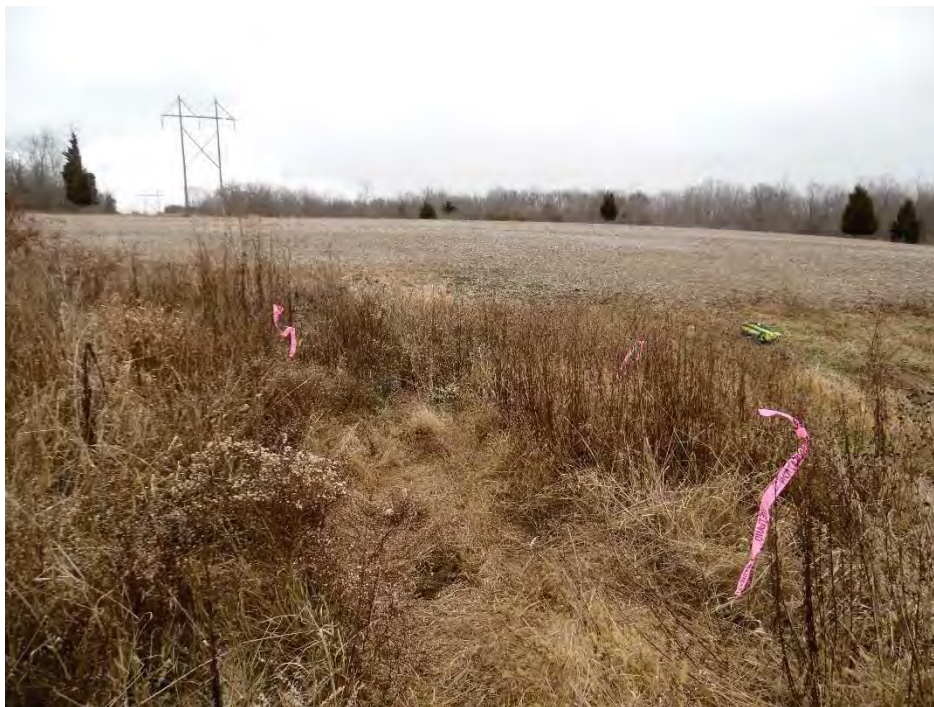
Photo Location 3. View of wetland determination sample point (SP 3) within Wetland 1. Photograph taken facing east.

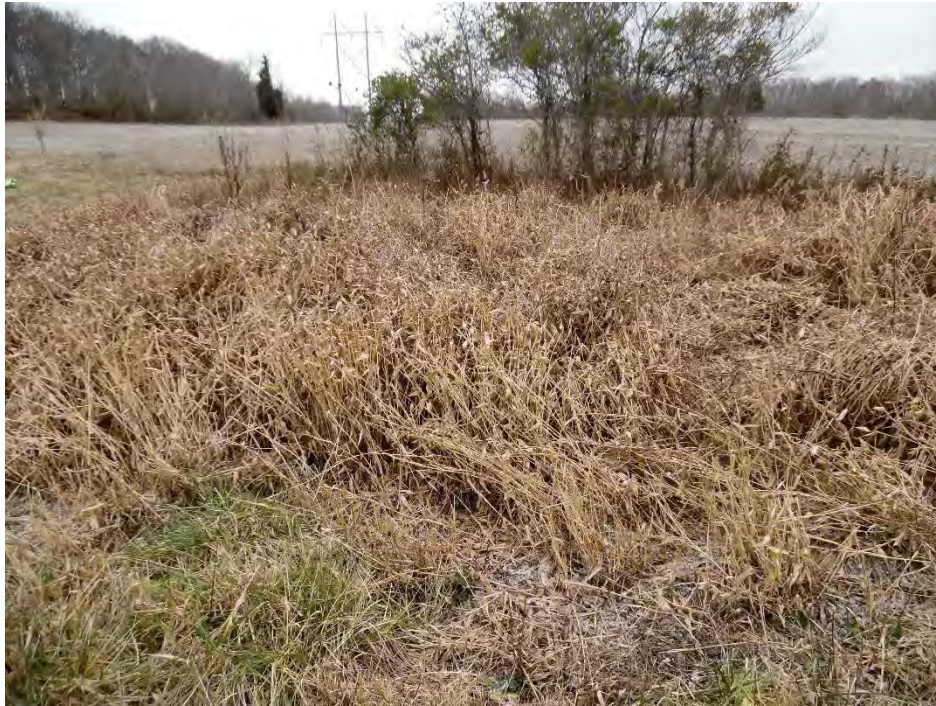
Photo Location 3. View of wetland determination sample point (SP 3) within Wetland 1.  
Photograph taken facing northeast.

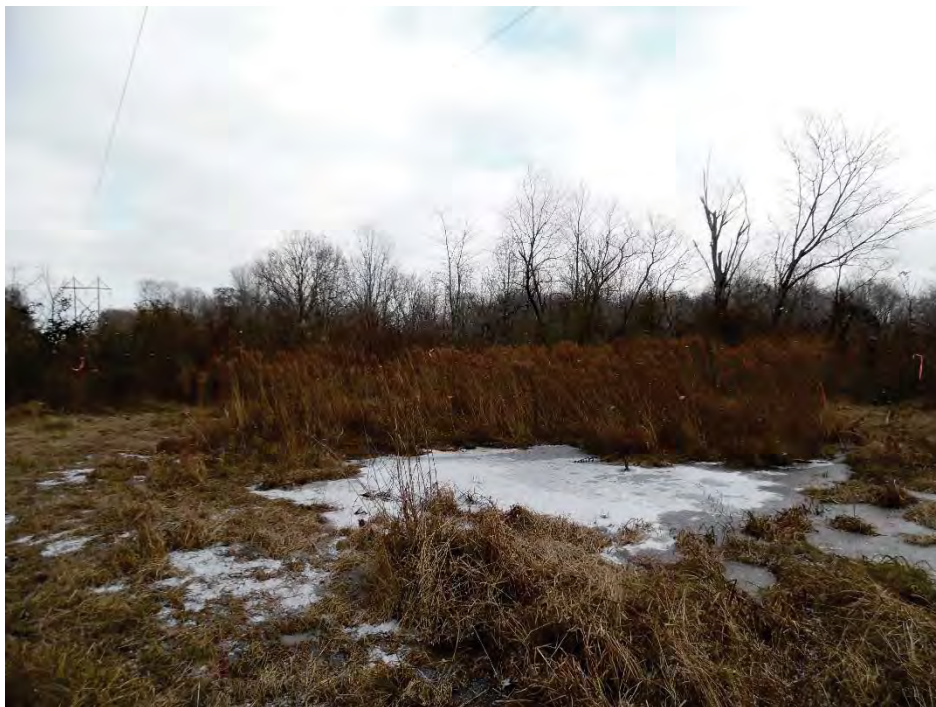
Photo Location 4. View of wetland determination sample point (SP 4) within Wetland 2.  
Photograph taken facing east.
