Wetland and Waterbody Delineation Report

Open Road Renewables, LLC

Hillcrest Solar Farm

Prepared for	Open Road Renewables, LLC
Project Name	Hillcrest Solar Farm
Project Number	E317501800
Project Manager	Ryan Rupprecht
Date	June 2017

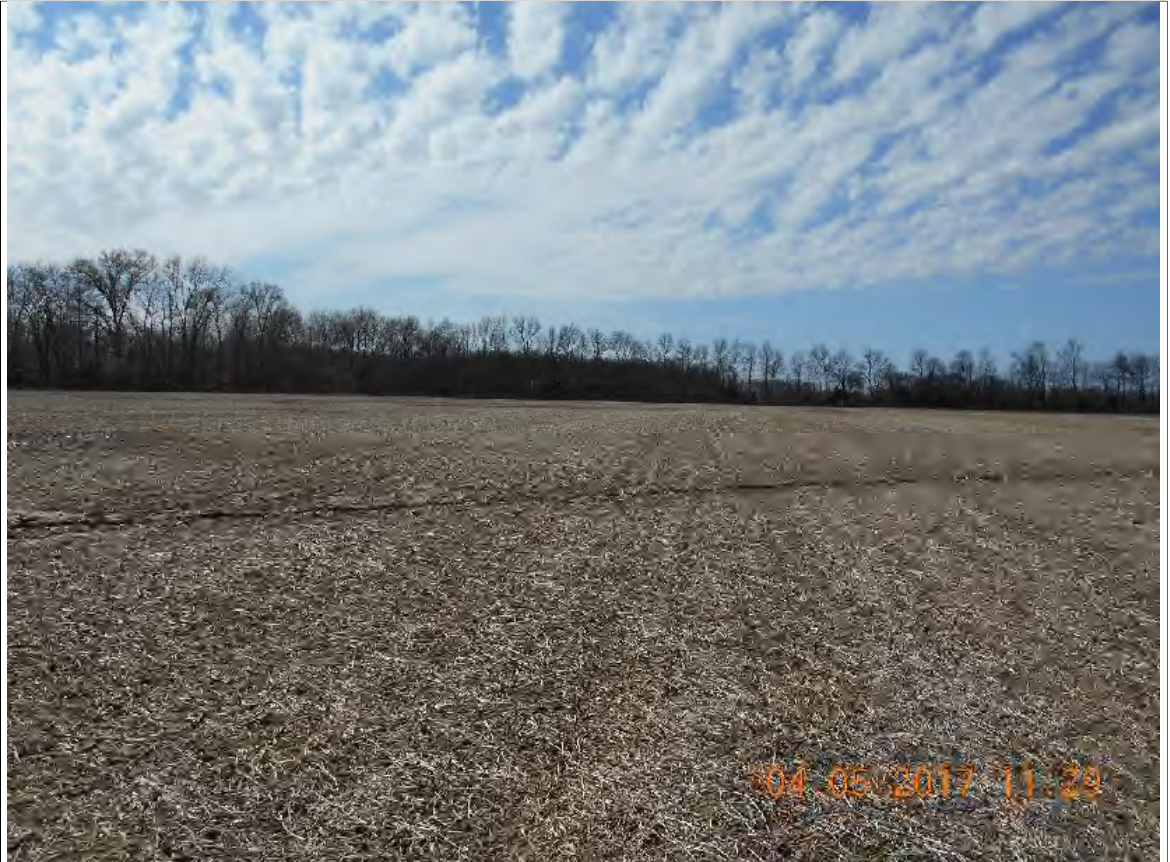
Description: Photo of typical agricultural area that dominated the Project Area. At the time of the survey, vast majority retained the debris from last season's harvest and had yet to be replanted for the upcoming spring season. Most fields were ringed with narrow strip of trees/windrow which served to identify property boundaries. The open fields were also typical for the upland locations near wetlands. Though having similar clayey soils, the hydrology and vegetation were no longer able to be classified as wetland supporting.

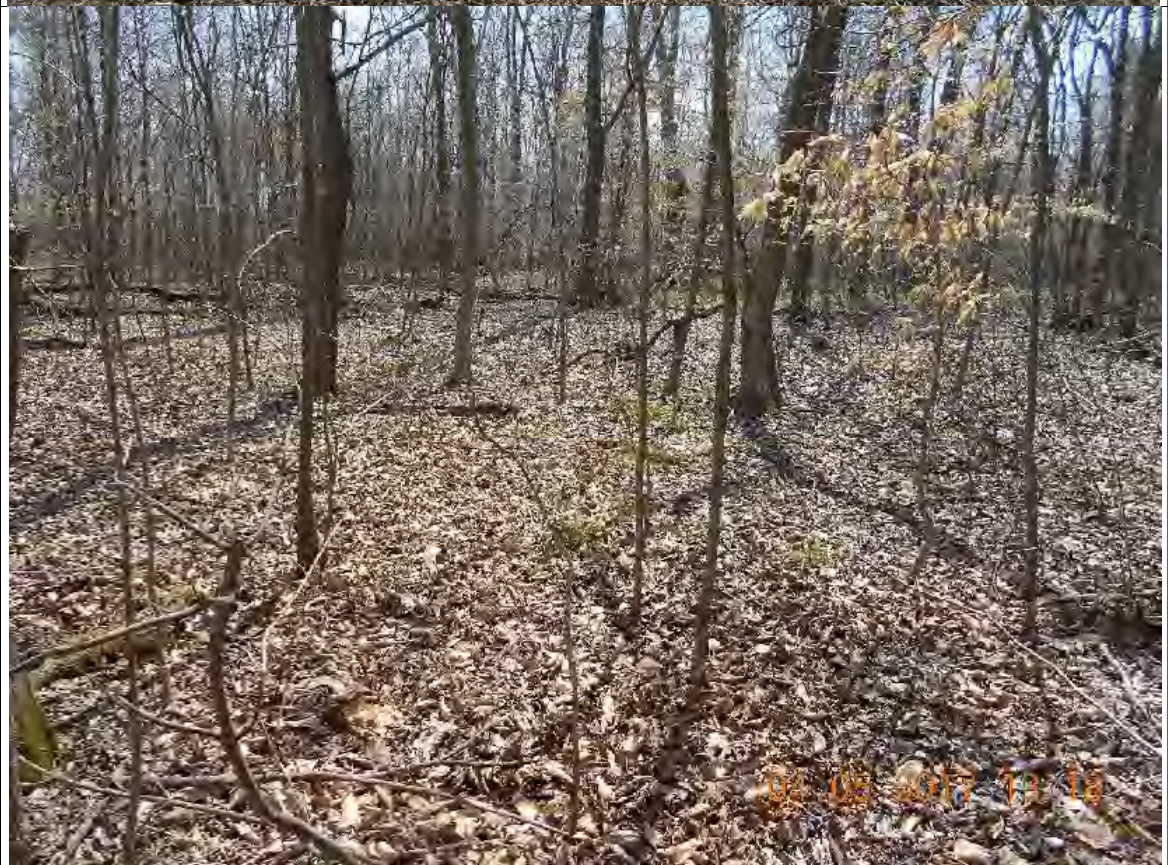
Photo: 226

Description: Photo of typical upland woodland conditions. Many of the woodlots, in the interiors, had minor shrub development and were relatively open. Species observed included Beech (*Fagus grandifolia*), yellow troutlily (*Erythronium rostratum*), oaks (*Quercus*) and maples (*Acer*).

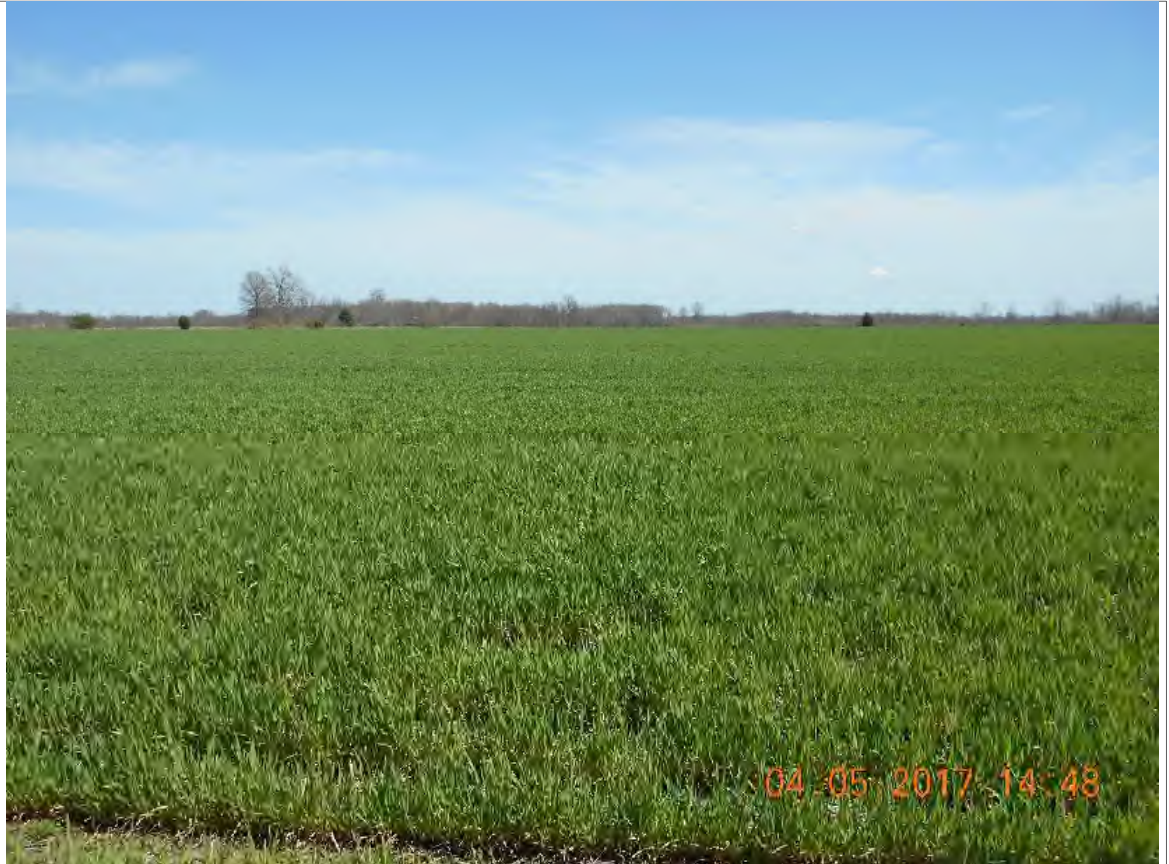
Photo: 243

Description: Photo of typical agricultural area that dominated the Project Area. Limited number of fields were actively planted with crops such as spring wheat.

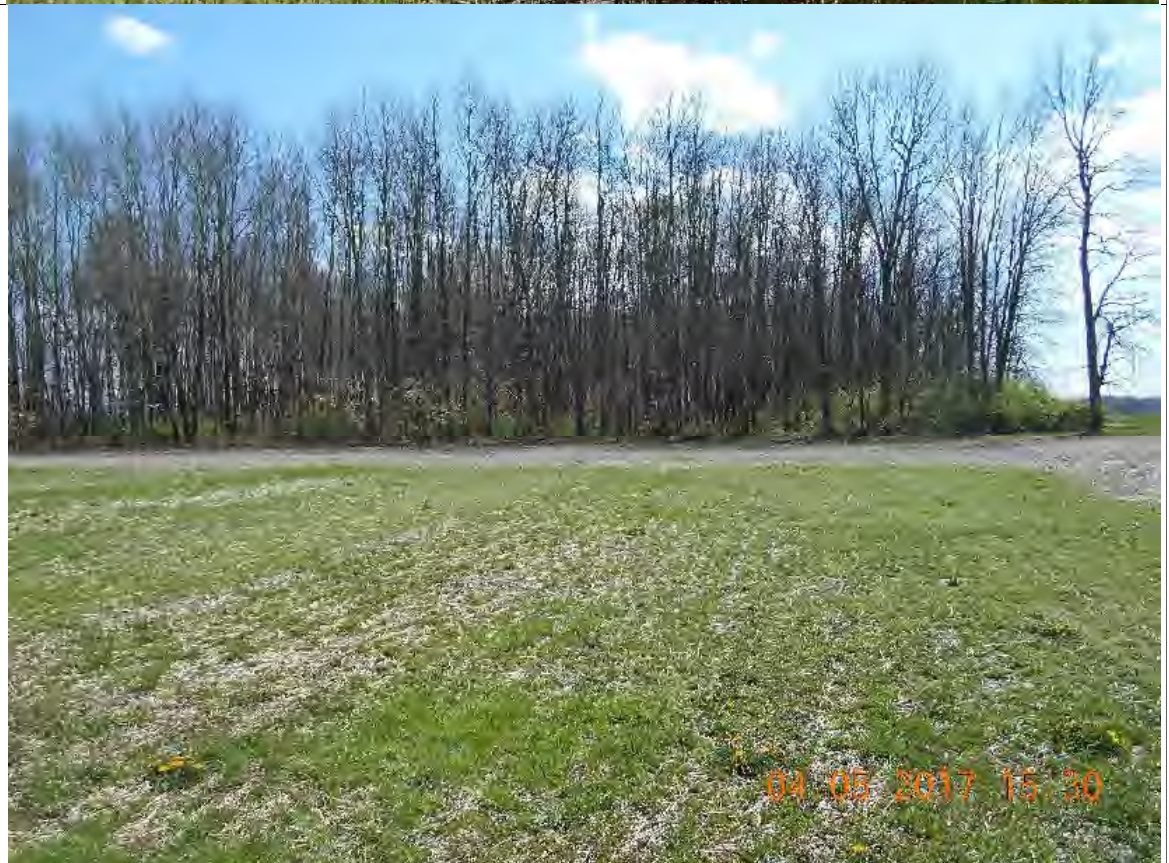
Photo: 252

Description: Typical photo of the interface between crop areas and isolated woodlots. Many of the woodlots were directly connected to the crop areas and had no buffer to the surrounding landuse. This type of interaction could prevent development of high quality habitat due to the constant impact of surrounding landuse (runoff and ground clearing disturbance).

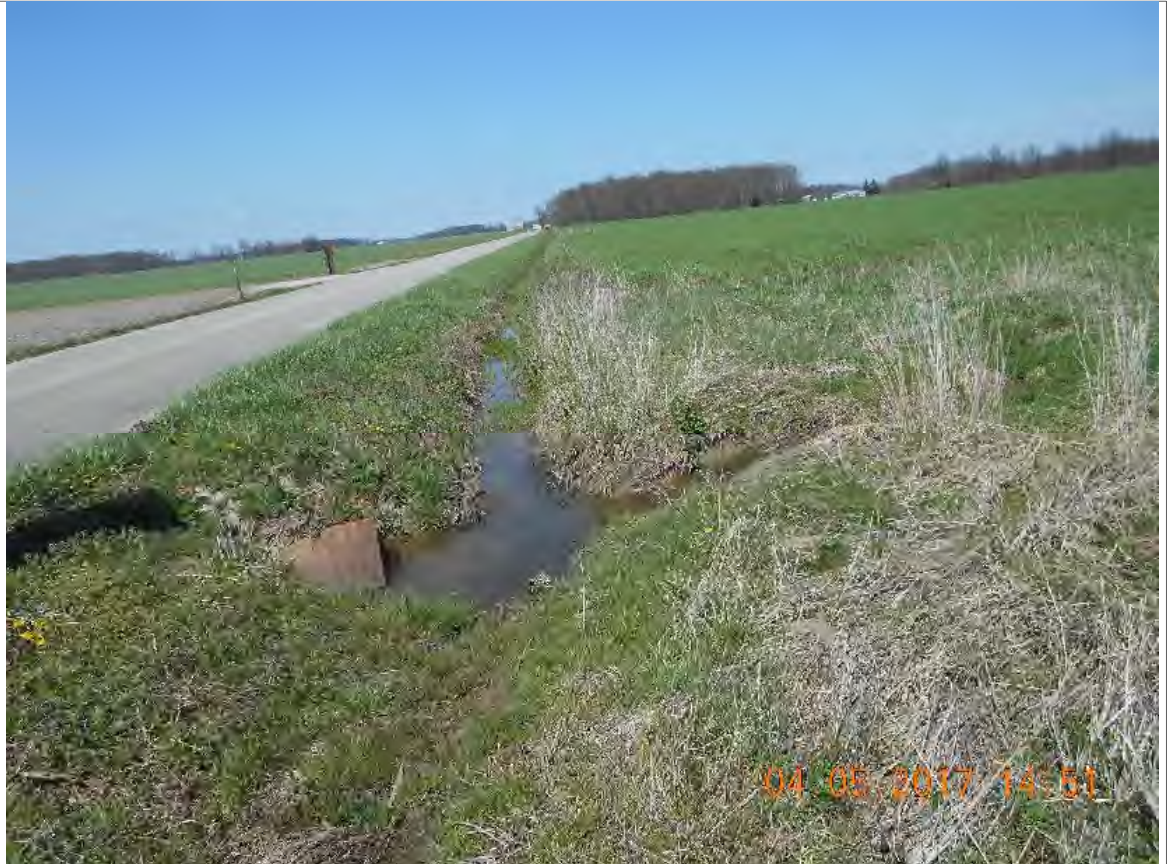
Photo: 247, DOH-022

Description: Photo of typical ephemeral modified waterbody, ditch DOH-022. Many of the ditches were man-made features designed to collect runoff from the nearby crop areas and transport offsite to allow for better crop growth. Many of the ephemeral ditches were suspected to have extended periods of dry channels since the primary source of hydrology was precipitation. Due to recent rains and saturated soils, all were flowing at the time of the survey.

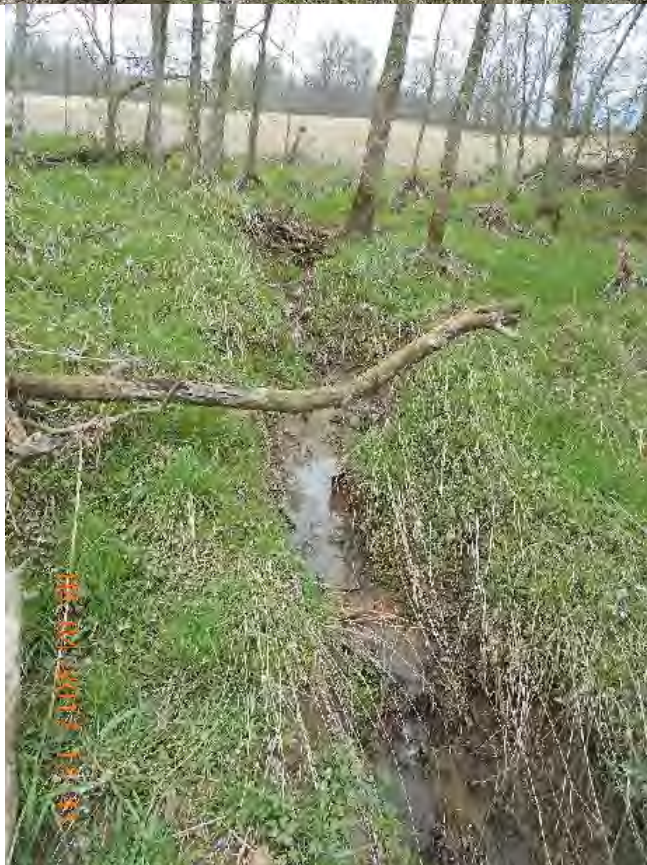
Photo: 159, SOH-003

Description: There were few natural ephemeral streams identified in the Project Area, due to the likely historic conversion to a ditch. Stream SOH-003 was considered ephemeral due to the poorly defined bed and bank and evidence indicating limited hydrology. It was expected that the primary source of hydrology was the crop area located upslope (just in the back of the photo). The channel showed no signs of manipulation, which is why it was identified as natural.

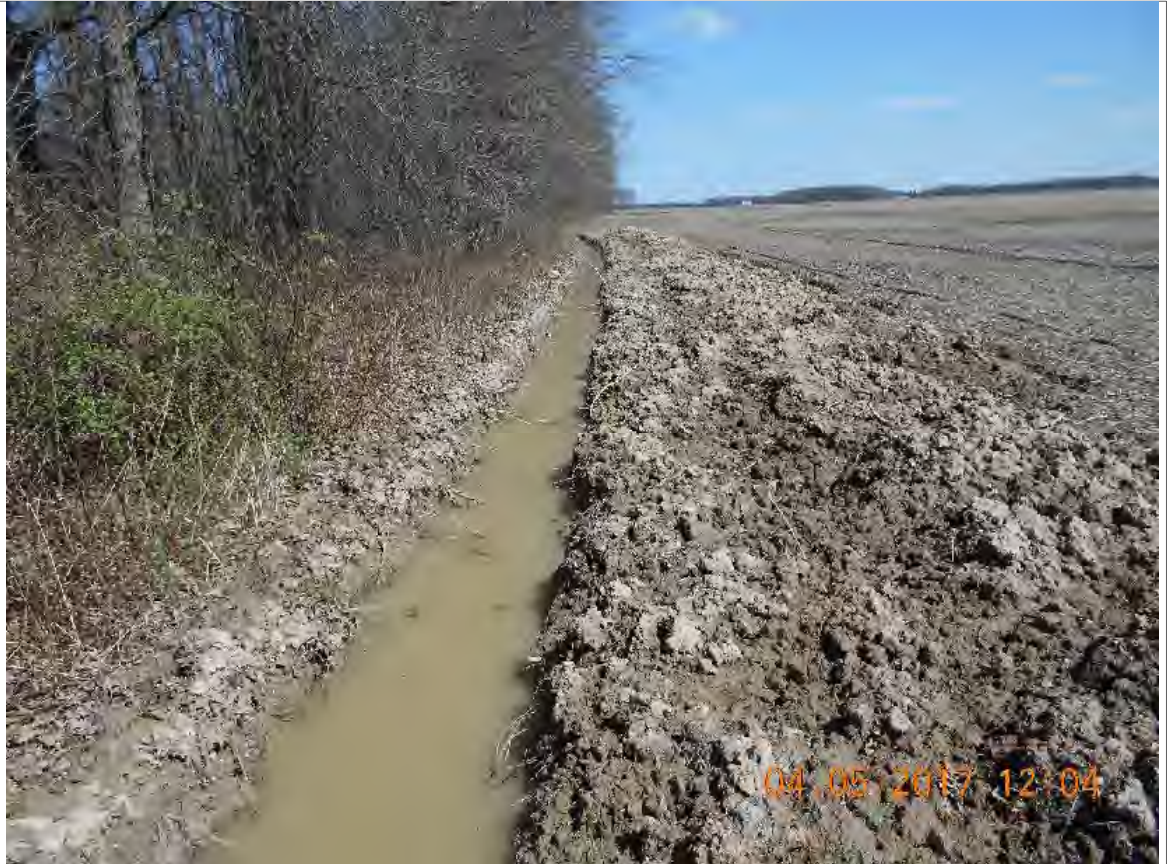
Photo: 217, DOH-015

Description: Photo of recently modified intermittent ditch, DOH-015. The ditch was recently excavated to help the crop area dry out to allow for planting. The sidecast material is still present. Elsewhere on the site, a large excavator was present. The ditch was relatively deep, about 1 foot, which would match the depth of the excavator's bucket. It was unknown if the ditch would remain as a 'permanent' feature along the crop edge or be filled in once the area had dried.

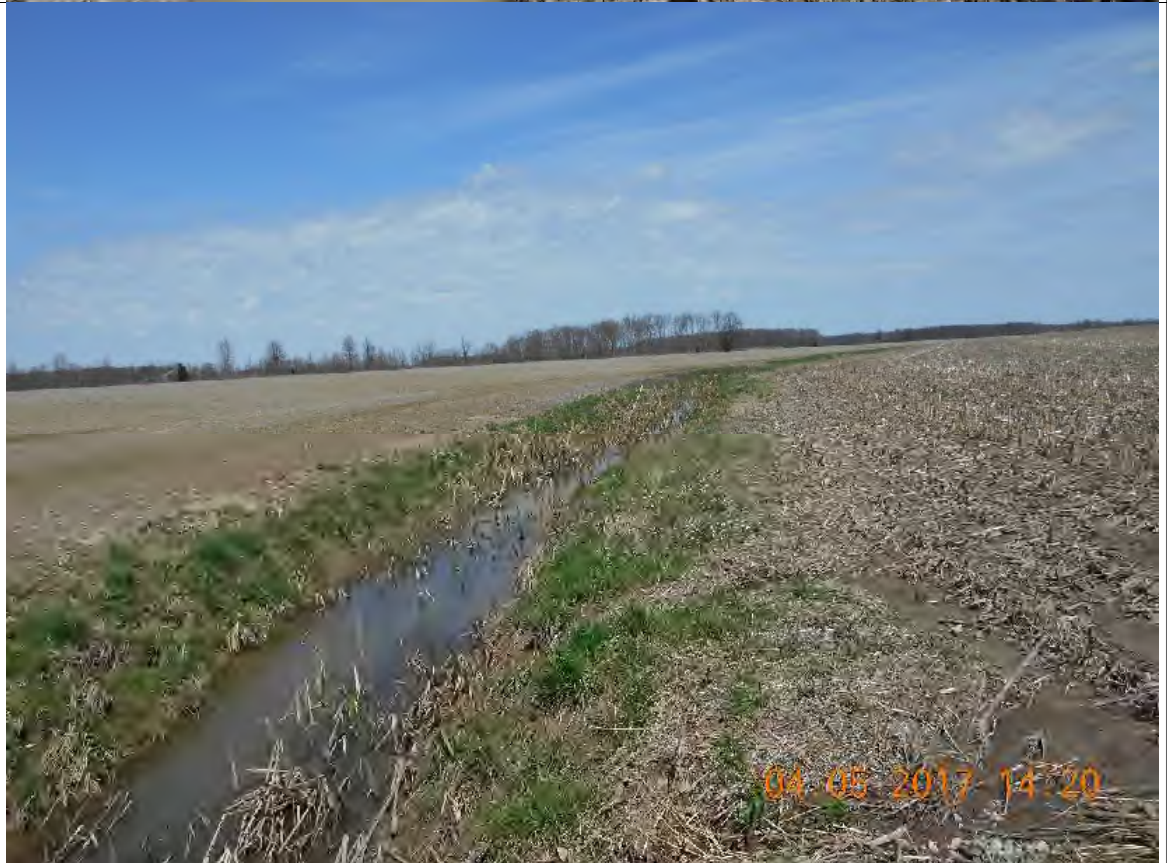
Photo: 237, DOH-020

Description: Ditch DOH-020 represented the typical modified intermittent ditch. It was a moderately sized agricultural ditch, with a trapezoidal cross section and sloped/vegetated banks. These types of ditches served to draw water from surrounding crop areas and provide improved growing conditions. Some of the ditches could go dry for periods of time, or have portions that were deep enough to always be wet due to groundwater infusion. The ditches often lacked significant vegetation along the banks due to seasonal mowing.

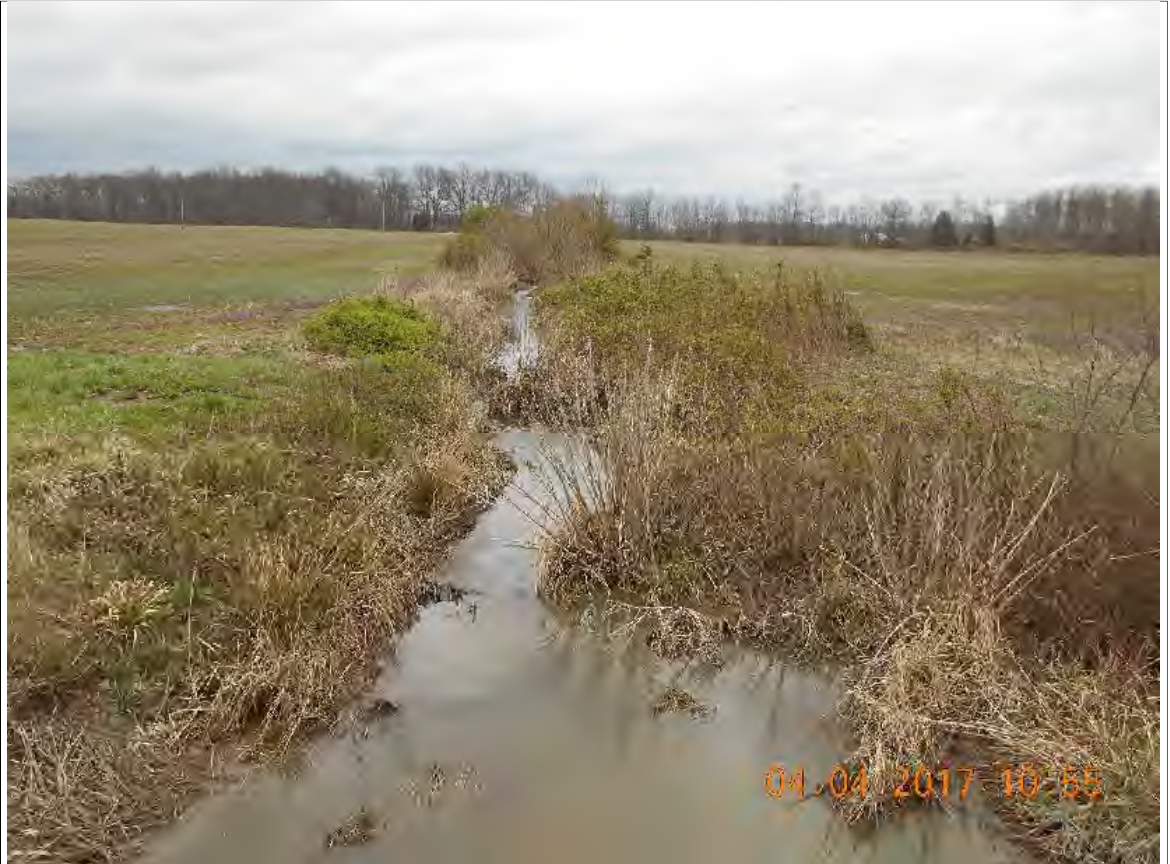
Photo: 136, DOH-002

Description: Photo of modified perennial ditch, DOH-002. Some of the ditches in the Project Area were identified as perennial, and likely were the modified courses of historic streams. The perennial ditches often exhibited more well developed vegetation on the banks, though some areas appeared to still be seasonally mowed. Vegetation along the banks was predominately weedy species though, including blackberries (*Rubus*), multiflora rose (*Rosa multiflora*), and grasses.

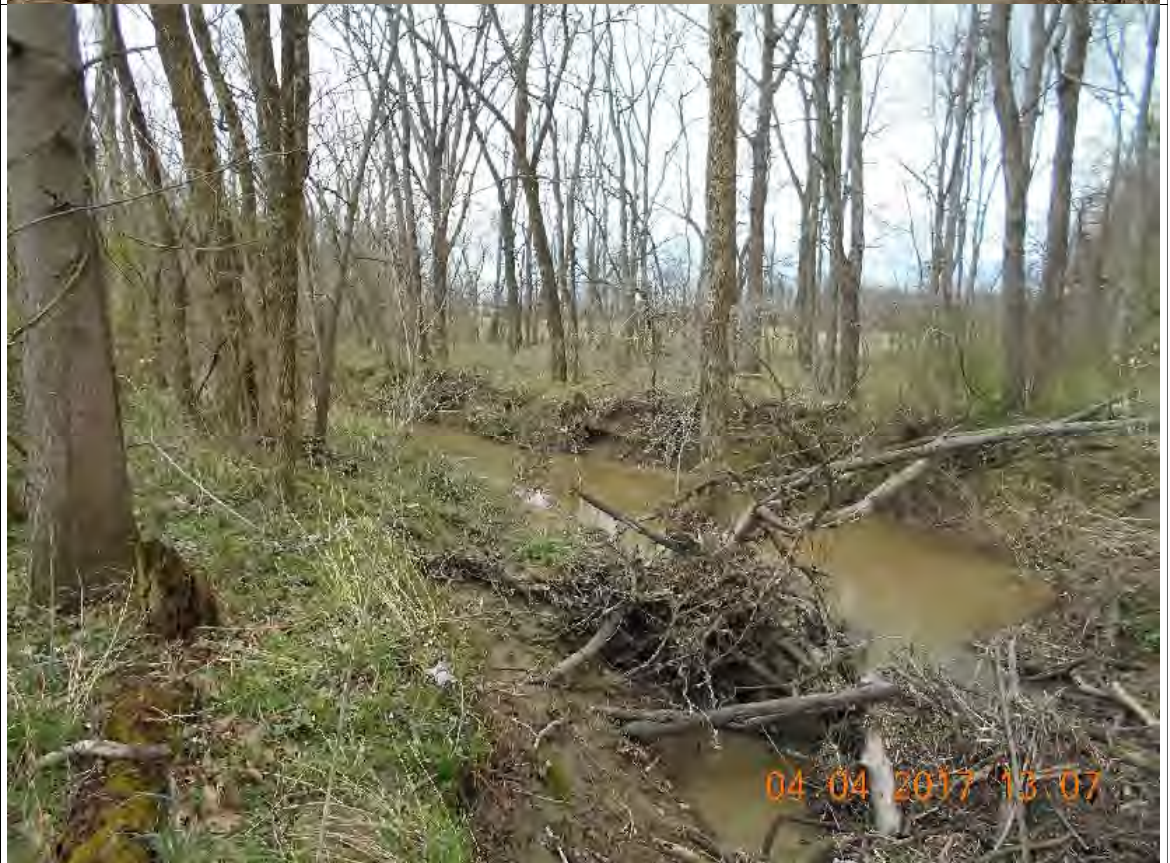
Photo: 155, SOH-002

SOH-002 is a delineated portion of Sterling Run, which flows south through the Project Area to the west of Moon Road. The stream was relatively wide, with a top of bank width of approximately 40 feet and a bankfull width of 18 feet. During the survey, the water depth was estimated to be 3 feet or greater in some pooled areas. The depth and width resulted in the stream being scored moderately high on the HHEI, while the mature forest riparian buffer and mix of substrates led to it being identified as the only Class III waterbody in the Project Area. No fish were observed due to the high turbidity, but it is likely that some smaller minnows (normally tolerant of turbid waters) are present. It is unlikely that mussels are present, and none were observed during survey. The vegetation along the banks and riparian buffer are similar to those found along SOH-001.

Description: Photo of perennial stream, SOH-002 which is a delineated portion of Sterling Run. The stream exhibited minimal signs of any modification, and was considered natural. The stream was wide at approximately 40 feet at top of bank., with pools of water estimated to be approximately 3 feet deep. The substrate within the stream was more varied, with higher amounts of gravel, cobble, and sand compared to the ditches which were primarily silty clays. Due to turbidity, no fish were observed swimming in the area.

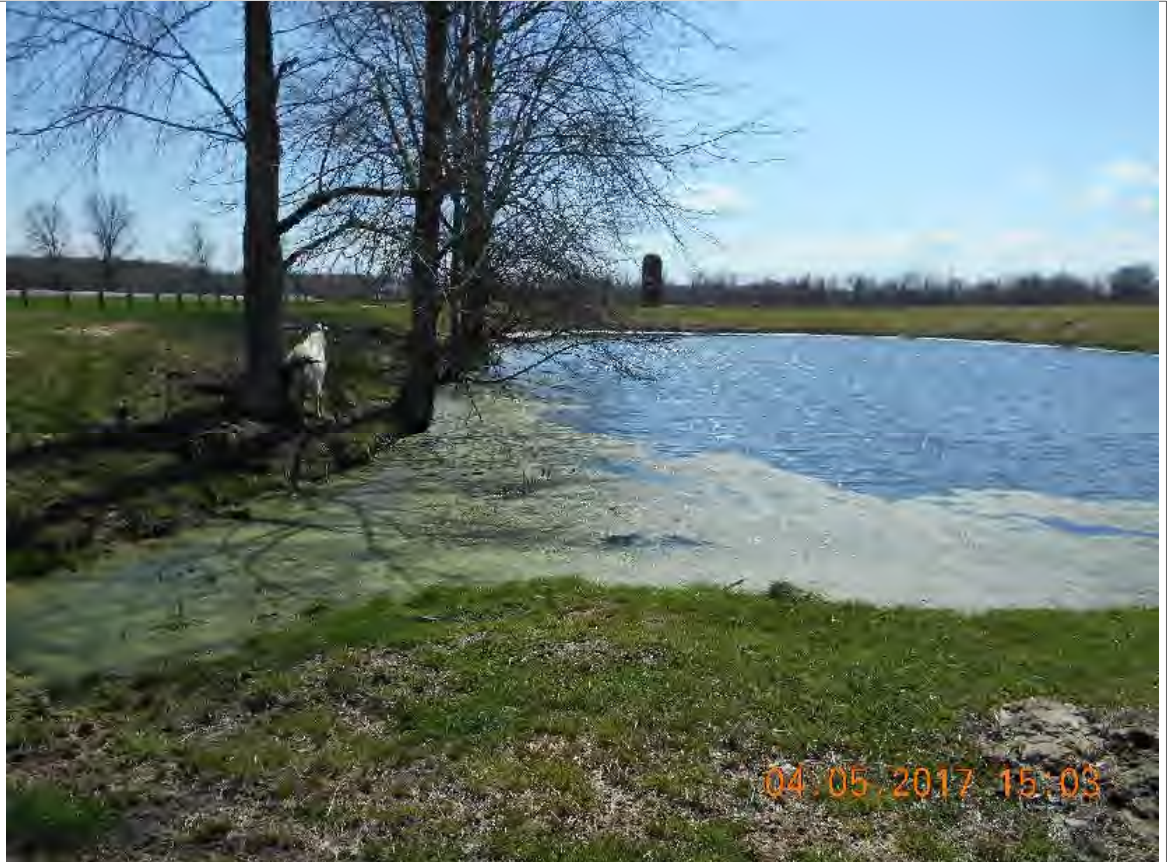
Photo: 248, POH-003

Description: Photo of modified perennial pond POH-003. The 0.21 acre pond was located inside of livestock enclosure, goats, and appeared to be used primarily for needs of the livestock. Due to the lack of riparian habitat along the edges and mowing of grasses, field teams did not observe any significant wildlife using the pond other than the livestock.

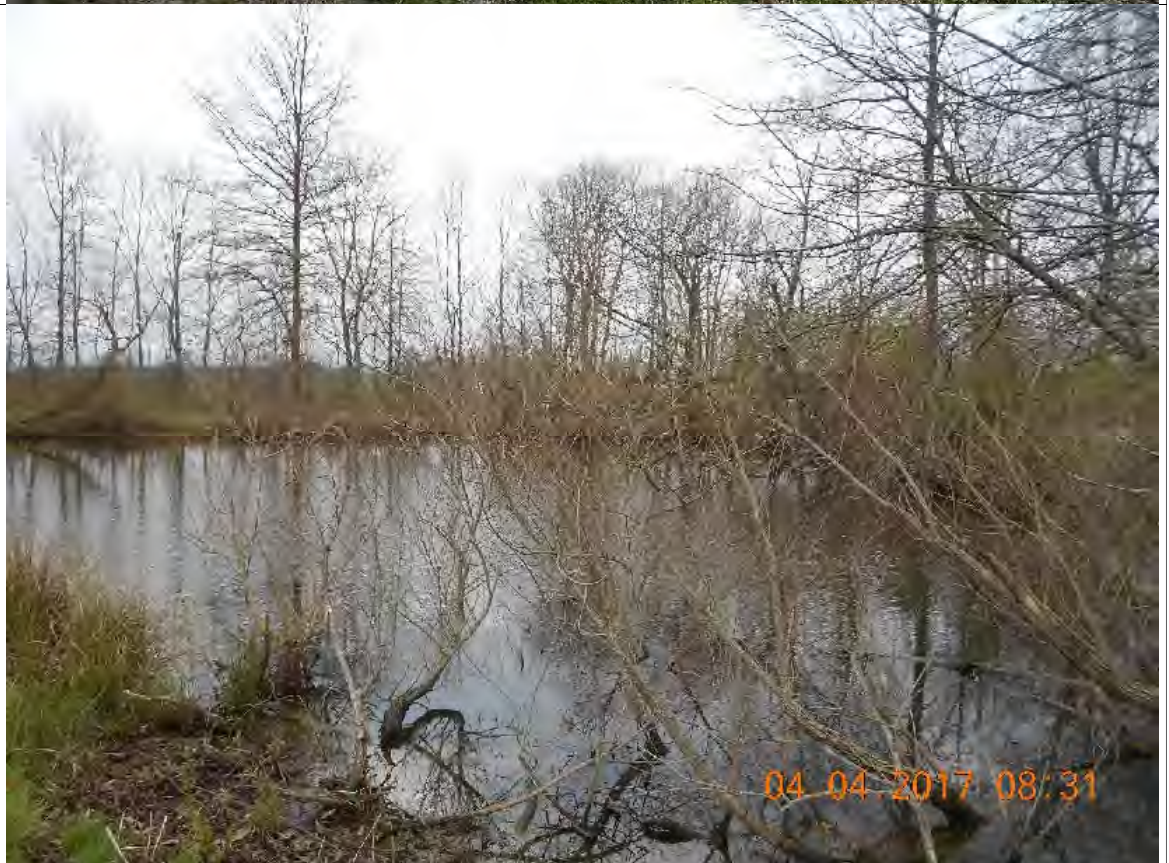
Photo: 106, POH-002

POH-002 is another man-made impoundment of water that measures approximately 0.20 acres and is located just south of Mount Road. The pond appears to be man-made due to its triangular shape and straight edges. During the survey, numerous frogs and several painted turtles (*Chrysemys picta*) were observed within the pond.

Description: Photo of perennial pond POH-002. The feature was suspected of being a man-made impoundment due to the straight edges of the feature, but it did appear to be utilized by various wildlife, though no RTE. During the survey, field teams observed several painted turtles, numerous tadpoles and frogs, and mallards in and near the water.

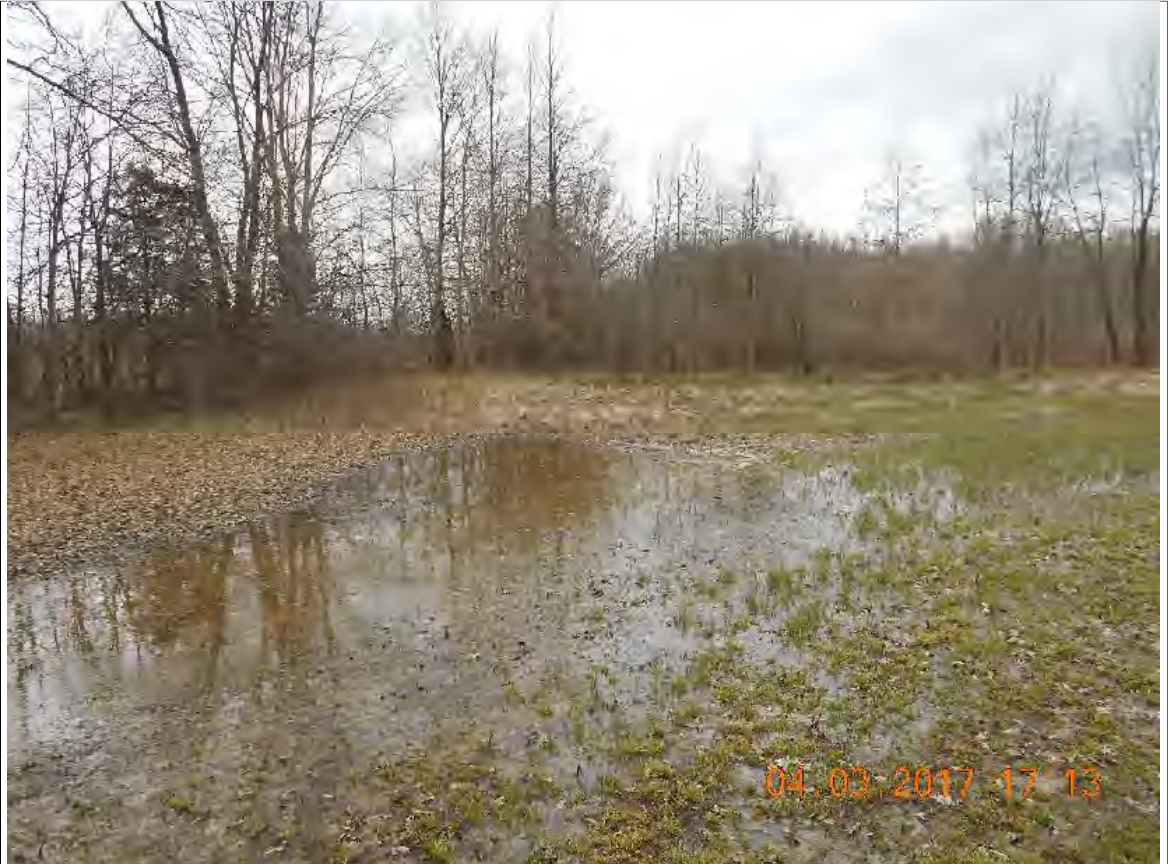
Photo: 87, WOH-001

WOH-001 is a relatively large, 8.59-acre wet meadow complex that extends into a scrub/shrub field to the west. The bulk of the wetland is located along the edge of active farm field in a parcel south of Mount Road. There was high saturation of clay soils, and a prevalence of common rush (*Juncus effusus*) throughout the area. Conditions indicate that the wetland may include some hummocky areas (potentially historic till piles or tire ruts from previous activity) that do not retain wetland conditions year round because they contained isolated stands of broomsedge (*Andropogon virginicus*) (a FACU species). However, during the survey the majority of the wetland had pools of standing water, saturated low chroma clayey soils, crayfish burrows, and rush species throughout.

Description: Photo of emergent portion of the wetland WOH-001. Wetland WOH-001 occupied the edges of an active agricultural area. At the time of the survey, the ground was saturated and standing water was observed in depressional areas. Clumps of common rush (*Juncus effusus*) were observed throughout in addition to wide spread crayfish burrows.

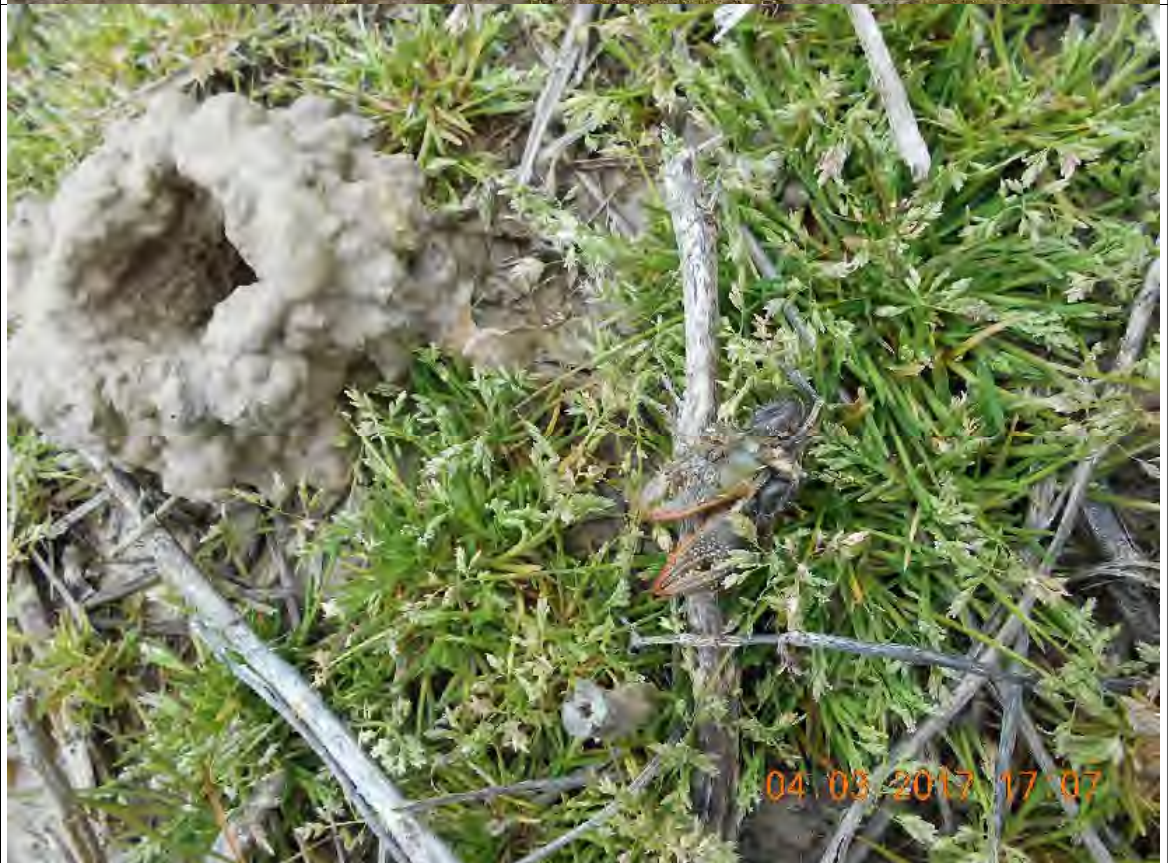
Photo: 84, WOH-001

Description: Typical photo of crayfish burrow and evidence of recent predation. Crayfish burrows and saturated clay soils were common in the areas of WOH-001 nearest to the field.

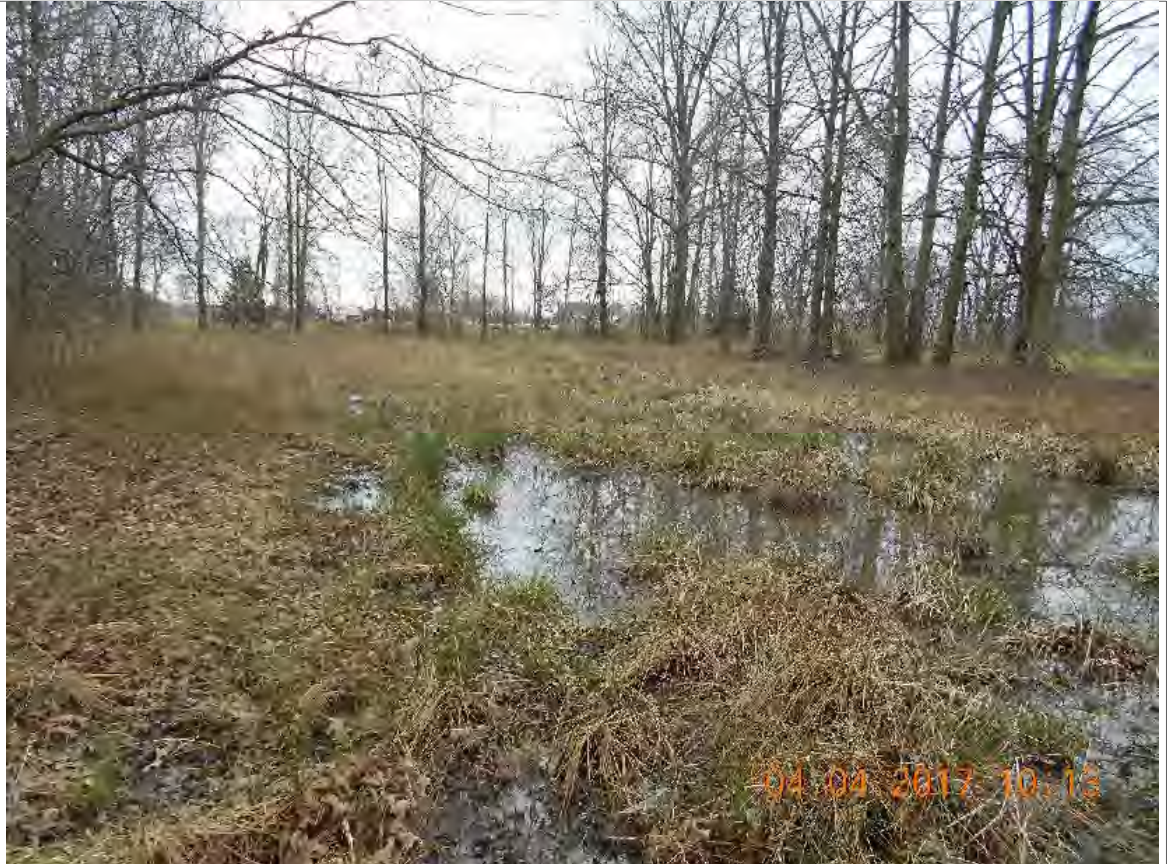
Photo: 129, WOH-005

Description: Wetland WOH-005 was typical of the emergent wetlands which appeared to have developed in recently abandoned/fallow fields. The wetlands were dominated by quick growing herbaceous species such as rushes and sedges, and had widespread pools of standing water on top of saturated clay soils. The lack of any significant shrubby vegetation, and recent aerial imagery, indicate the area was historically farmed and may still be manipulated if seasons are dryer than usual.

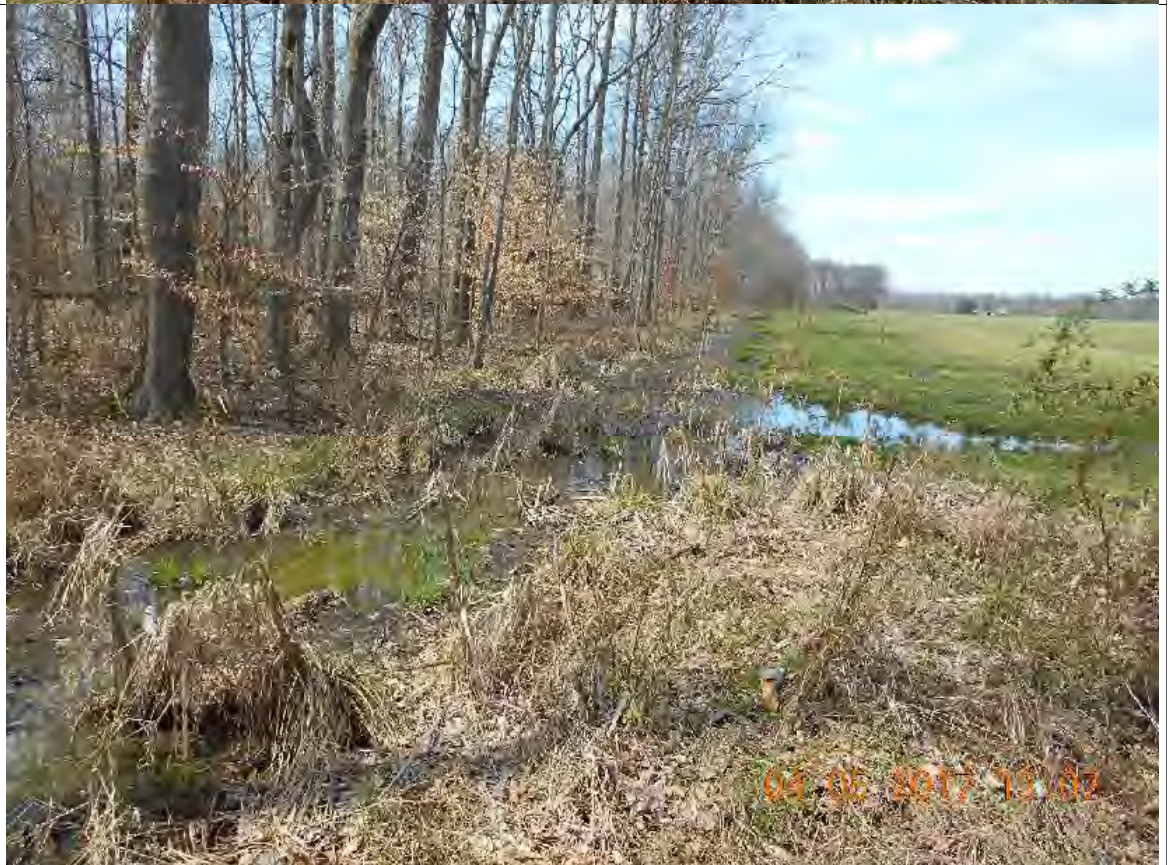
Photo: 223, WOH-007

Description: Wetland WOH-007 appears to have developed in a blocked drainage ditch that ran along the side of an active pasture area. Due to the deposition of sediment and woody debris at the western end, water has been retained for extended periods of time within the wetland. This improved hydrology has allowed for cattail to colonize the area. The boundaries of the wetland were relatively distinct, with the wooded area being predominately upland species.
