CASE No. 17-2502-GA-BLN
PIR 751 MILLERTON STREET SE AND MARIETTA AVENUE SE
CANTON TOWNSHIP, STARK COUNTRY, OHIO
12-INCH HIGH PRESSURE PIPELINE REPLACEMENT

RE: *Field Summary Report*—PIR 751 – Millerton Street SE and Marietta Avenue SE, Canton Township, Stark County, Ohio

PIR 751 - Millerton Street SE and Marietta Avenue SE
Pipeline Replacement Project
Canton Township, Stark County, Ohio

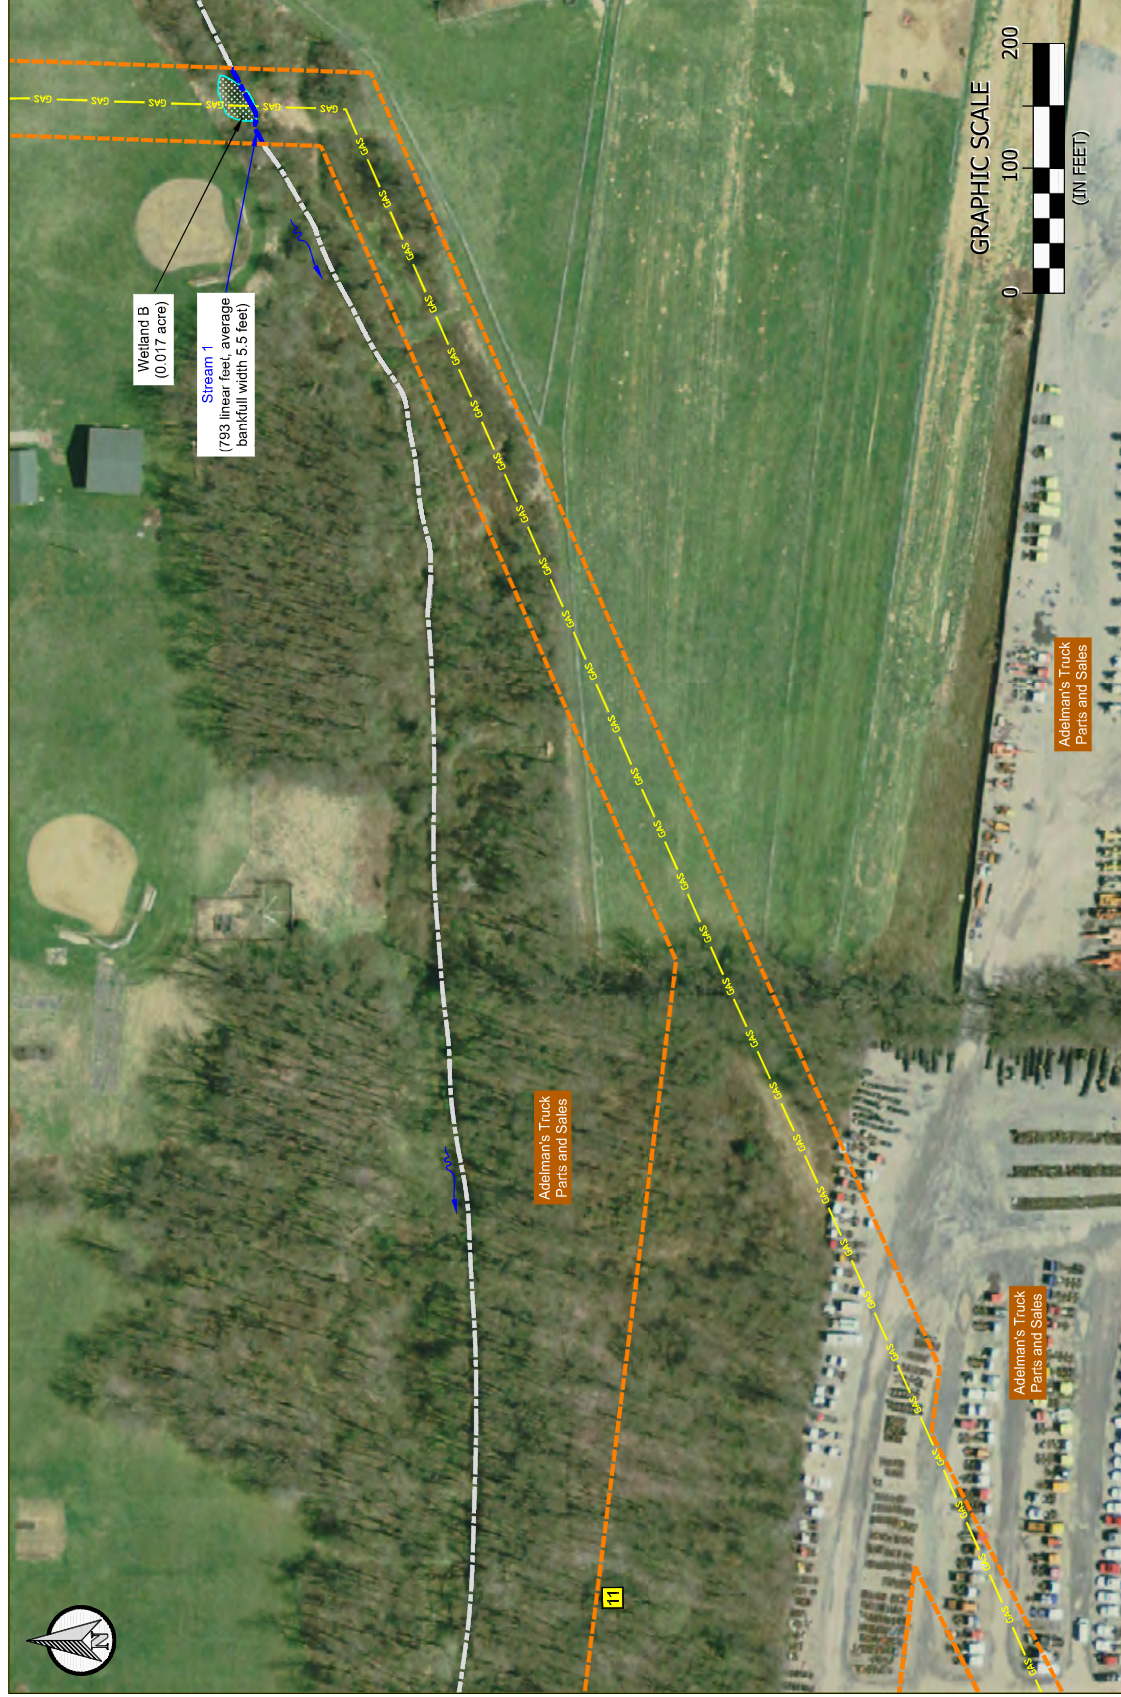
Map View 4 of 9

- 1 = Approximate study area
- = Perennial stream
- = Non-jurisdictional roadside ditch
- ~ = Direction of flow
- () = Existing culvert(s)
- = Non-jurisdictional swale
- = Existing gas line
- = Proposed gas line
- = Gas line stake
- 1 = Potential roost tree for the federally endangered Indiana bat (*Myotis sodalis*) and the federally threatened northern long-eared bat (*Myotis septentrionalis*)
- = Areas of wetlands delineated within study area (0.658 acre)

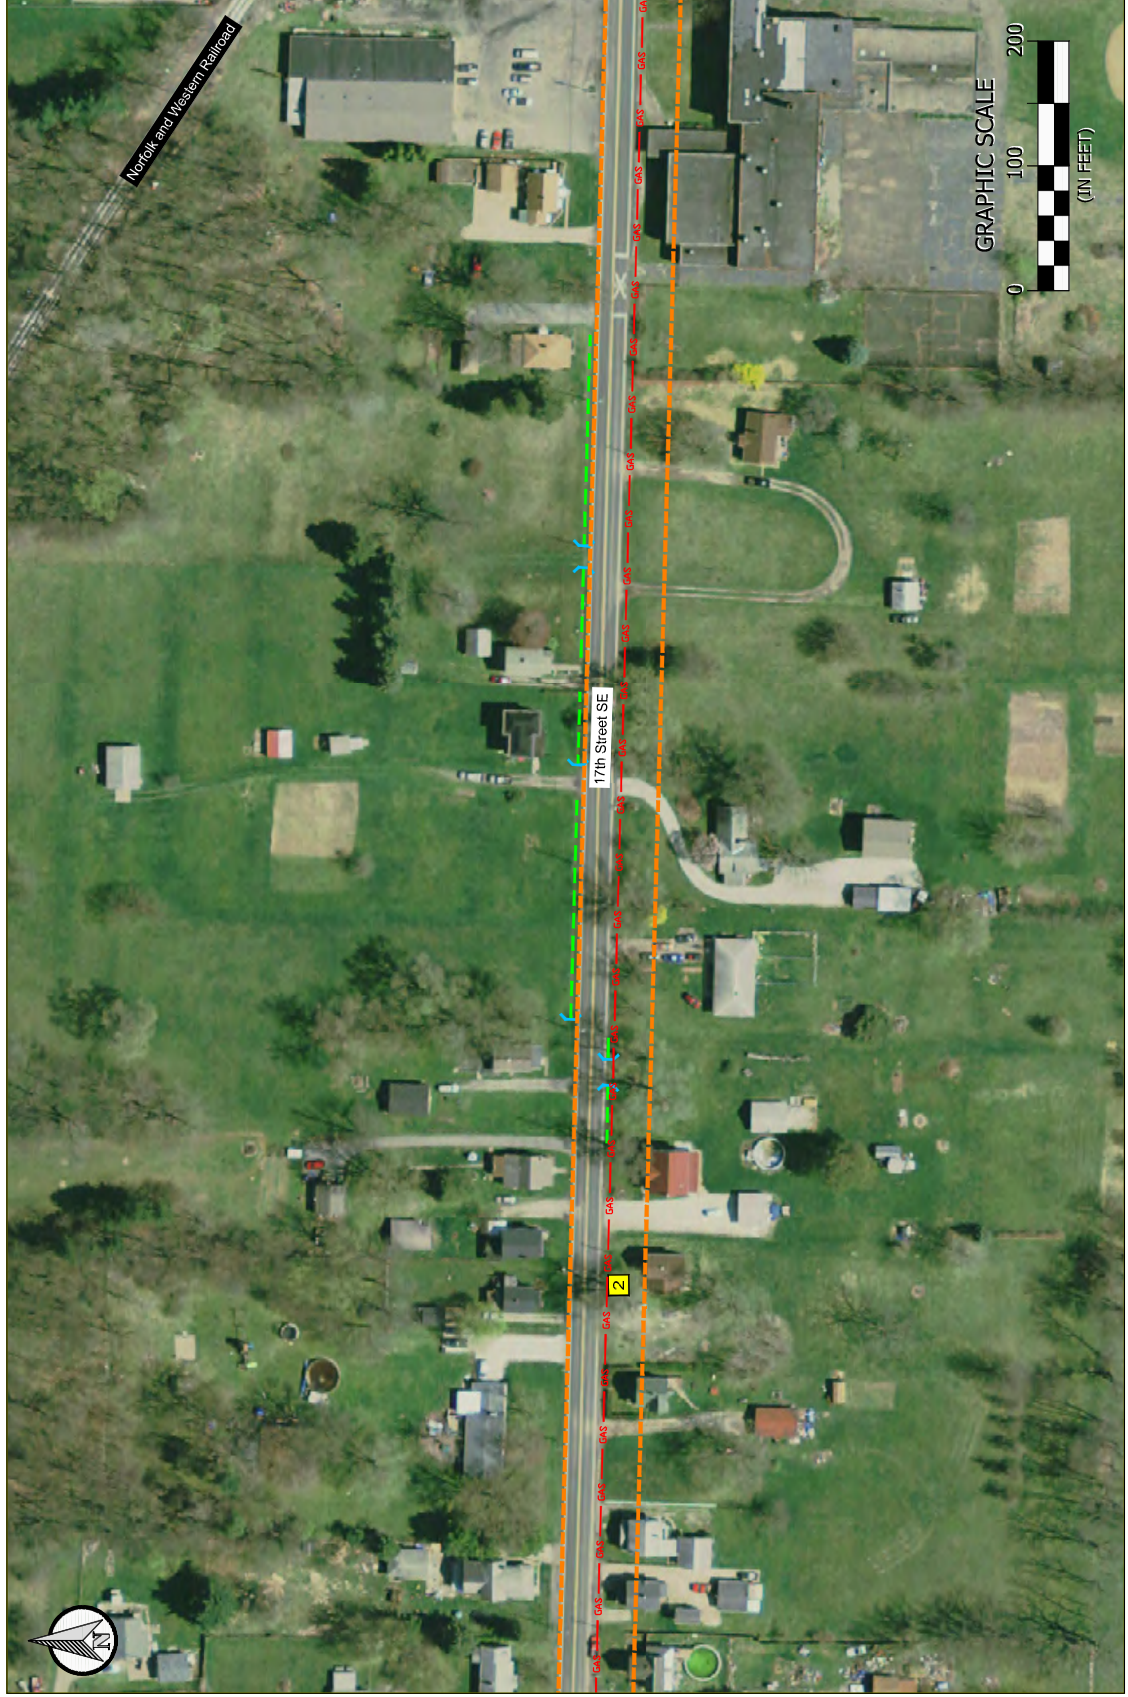
Map View **7** of **9**

- Approximate study area
- Perennial stream
- Non-jurisdictional roadside ditch
- Direction of flow
- Existing culvert(s)
- Non-jurisdictional swale

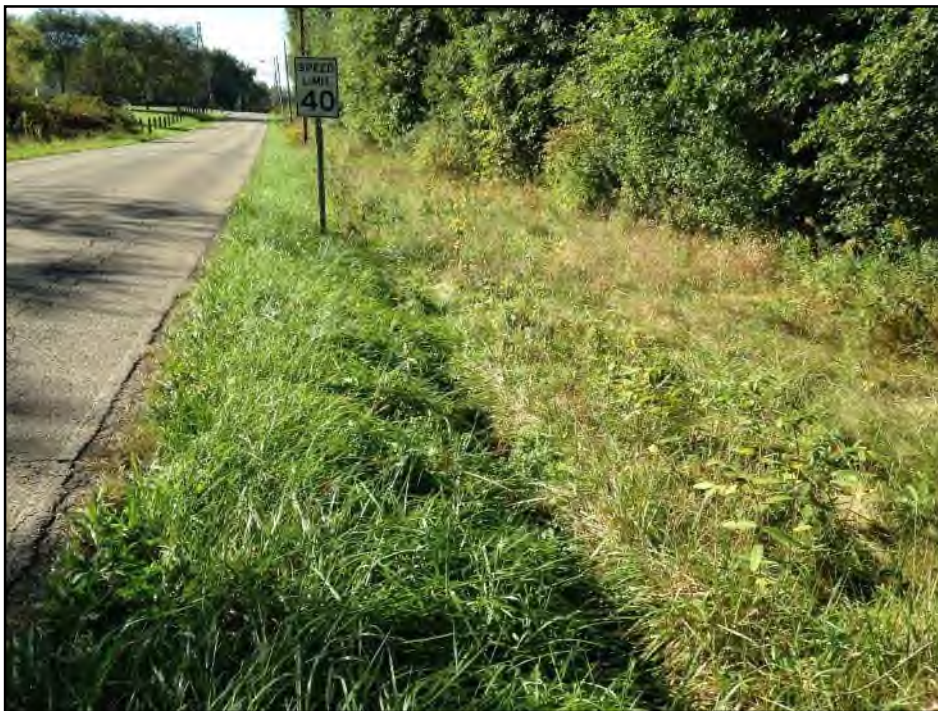
Photograph 6. Roadside ditches are located throughout the project area.

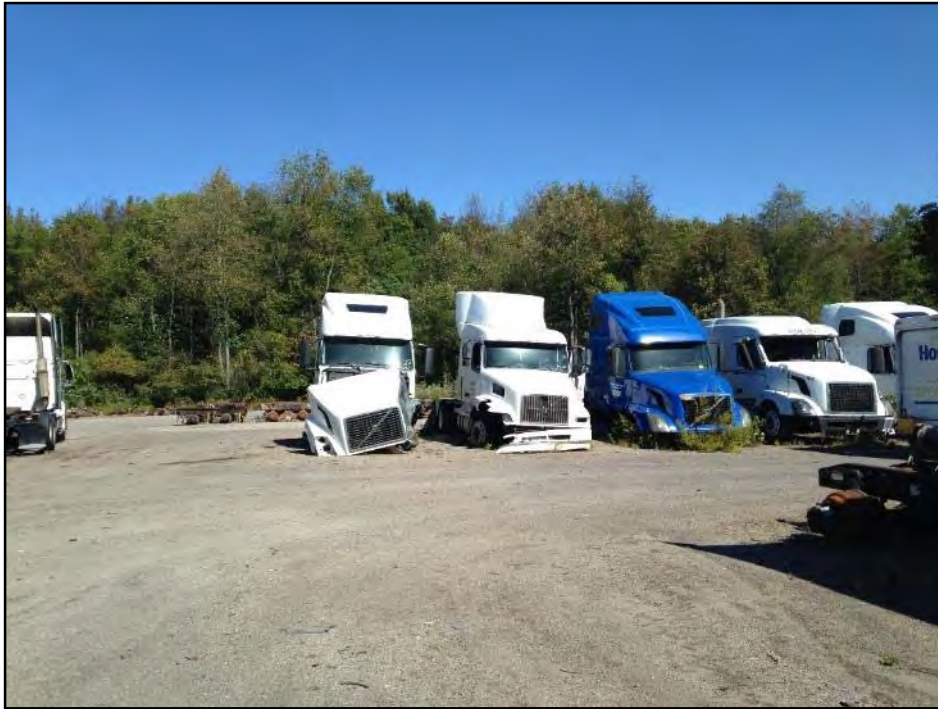
The project area was evaluated for potential habitat for these bats. No wooden structures occur in the project area. However, several areas of successional woods are located within the project area. A wooded stand approximately twelve (12) acres in size is located north of Adelman's Truck Parts. These woods are dominated by *Prunus serotina* (black cherry), *Quercus palustris* (pin oak), and *Juglans nigra* (black walnut). The approximate diameter at breast height (DBH) is nine (9) inches and the understory ranges from open to very dense, mainly composed of *Lonicera tatarica* (twinsisters), *Lonicera japonica* (Japanese honeysuckle), and *Rosa multiflora* (multiflora rose). Additionally, the riparian corridor of Stream 1 that flows through these woods may provide potential foraging opportunities for the bats.

Photograph 7. The undeveloped parcels located north of Adelman's Truck Parts and south of 19th Street SE, are primarily composed of successional woods.

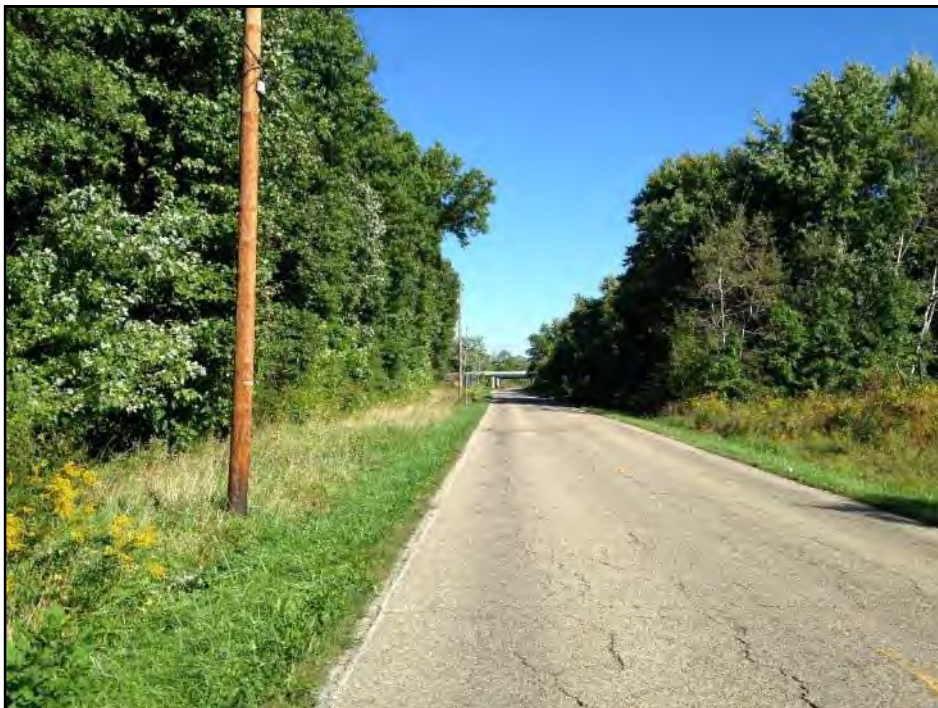
Successional woods are located within and extending beyond the northern end of the project area along both sides of Marietta Avenue SE. These stands include *Quercus palustris* (pin oak), *Acer saccharinum* (silver maple), *Q. alba* (white oak), *Prunus serotina* (black cherry), and *Ulmus americana* (American elm). The DBH of these stands ranges from six (6) to twelve (12) inches, and the understory is fairly sparse with some saplings and *Frangula alnus* (glossy false buckthorn). Wetland A, located within these stands, could provide foraging opportunities for the bats.

Photograph 8. Successional woods are located on both sides of Marietta Avenue SE at the northern end of the project area.

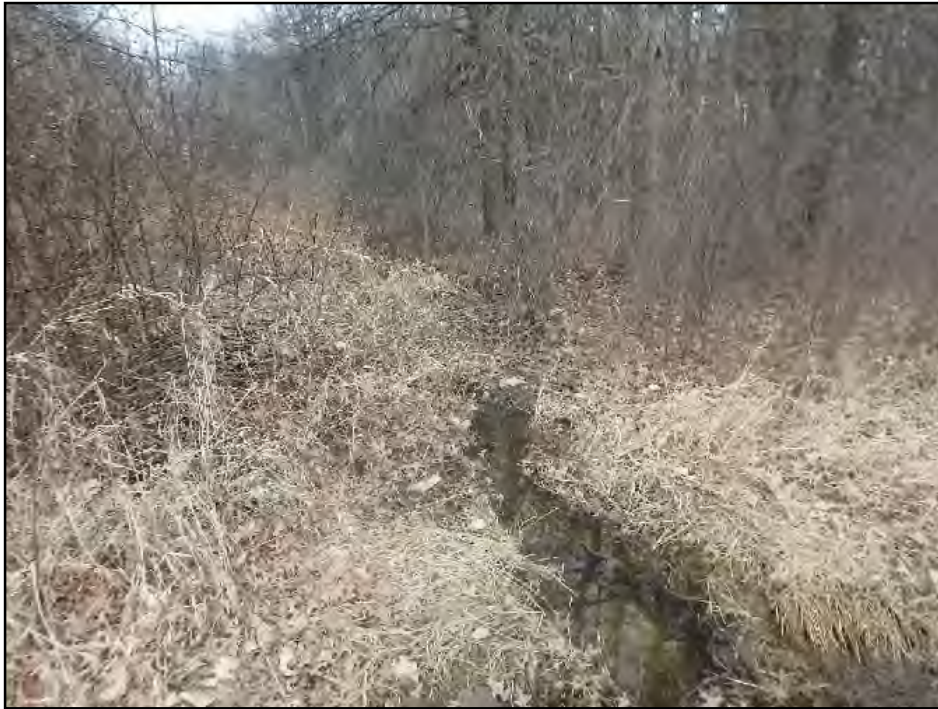
Wetland A has emergent, scrub/shrub, and forested vegetative communities; the 0.002 ac area of Wetland A within the project area is forested. This wetland is located east and west of Marietta Avenue SE, at the northern end of the project area; a culvert running beneath Marietta Avenue provides hydrological connection between the two areas of Wetland A. It has medium buffers (82 to <164 feet), and is bordered by an industrial plant to the south, a National Lime and Stone Distribution yard to the west, and by young successional woods to the east and north. This wetland is also dissected by Marietta Avenue SE. This wetland is regularly inundated, providing possible amphibian breeding habitat, and has numerous tussocks formed from *Scirpus cyperinus* (cottongrass bulrush). Wetland A received an ORAM score of 45.5, placing it within Category 2.

Photograph 9. Wetland A has forested vegetation within the project area.

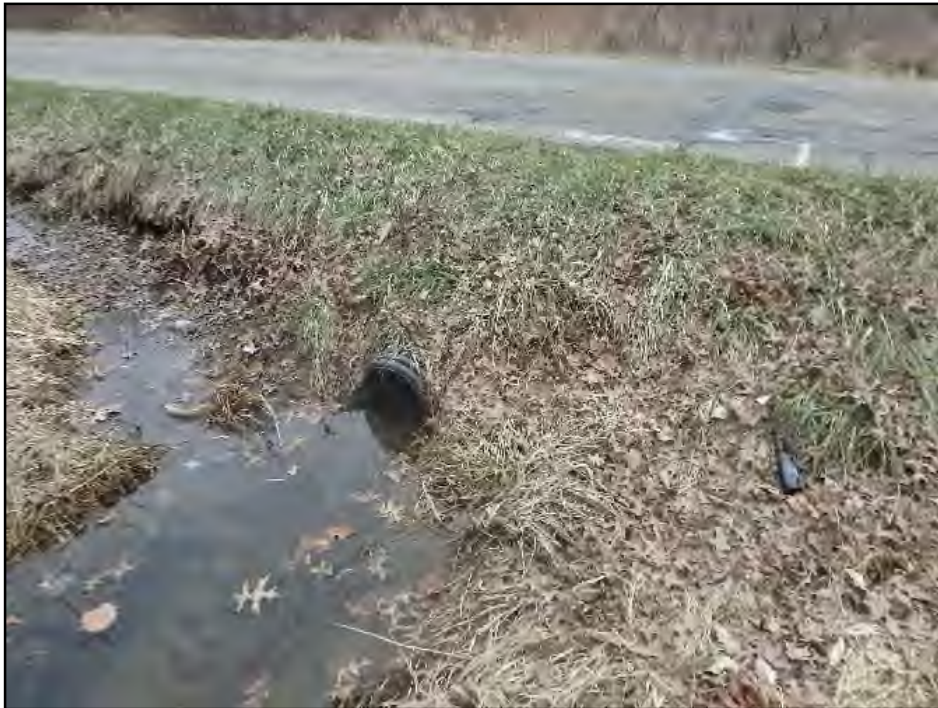
Photograph 10. A culvert running beneath Marietta Avenue connects Wetland A on the east and west sides of the street.

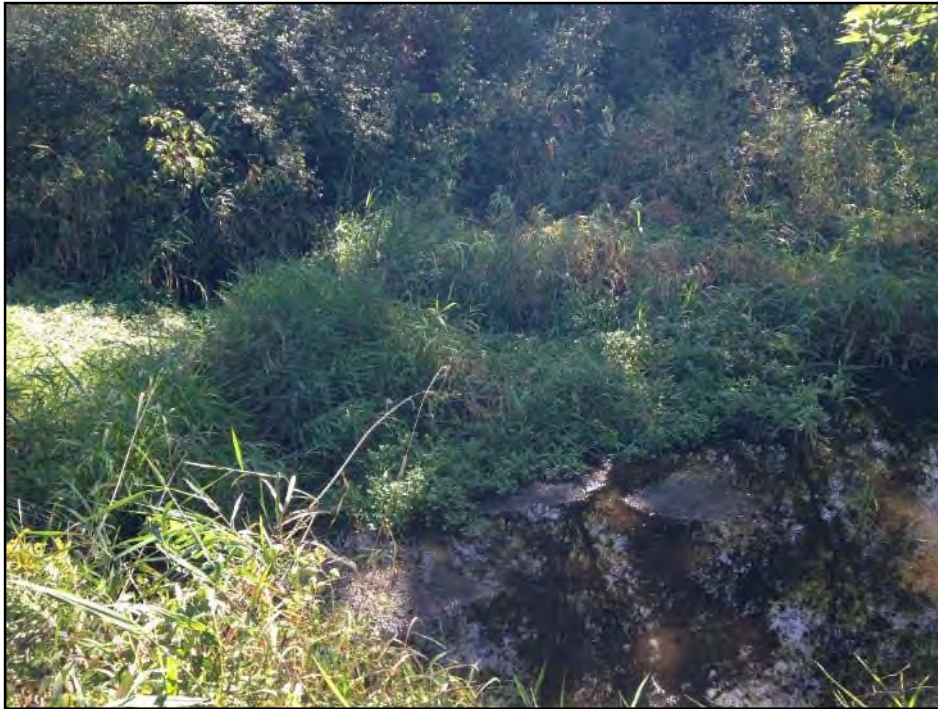
Wetland B is an emergent wetland located within the stream channel of Stream 1. It is located south of the intersection of 17th Street SE and Marietta Avenue SE. The wetland has narrow (32 to <82 feet) buffers and is surrounded by mowed grass fields. This wetland receives perennial surface water from Stream 1 and has a moderate cover of the invasive species *Phalaris arundinacea* (reed canary grass). Wetland B received an ORAM score of 25, placing it within Category 1.

Photograph 11. Wetland B, an emergent wetland, is located within the stream channel of Stream 1.

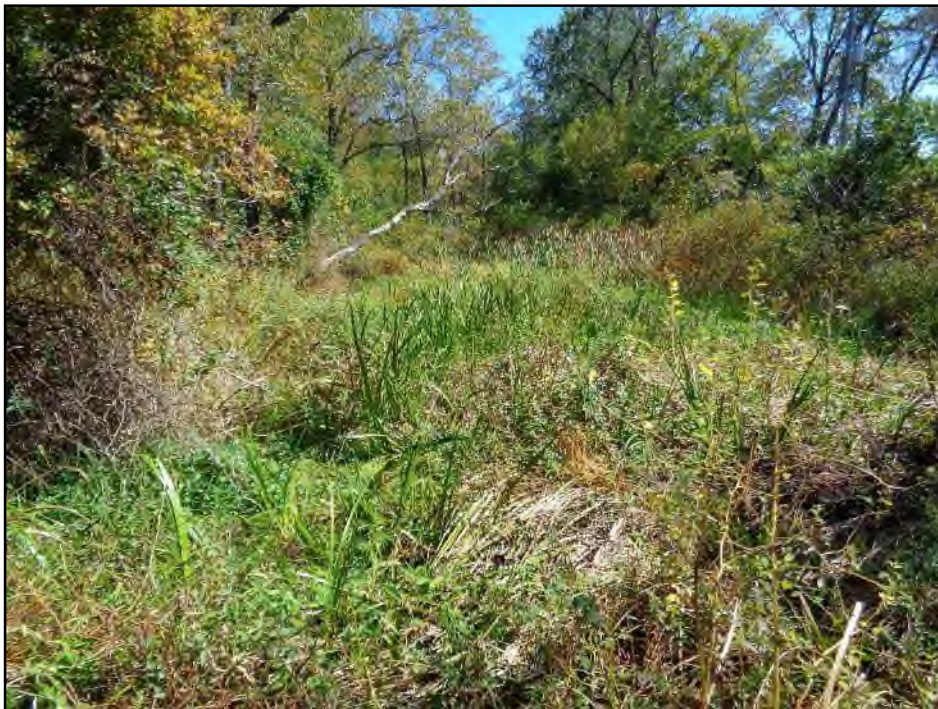
Wetland C is mainly an emergent wetland with some areas of scrub/shrub vegetation. It is located east of Waynesburg Drive SE within the undeveloped parcels north of Adelman's Truck Parts and Sales. This wetland extends along the riparian corridor of Stream 1, and receives seasonal intermittent surface water from the stream. Wetland C also receives groundwater as indicated by the presence of groundwater species including *Acorus calamus* (single-vein sweetflag). This wetland receives stormwater and toxic pollutants from Adelman's Truck Parts to the south. Wetland C received an ORAM score of 41, placing it within the Modified Category 2.

Photograph 12. Wetland C is located in the western part of the project area within the floodplain of Stream 1, and continues to extend off-site.

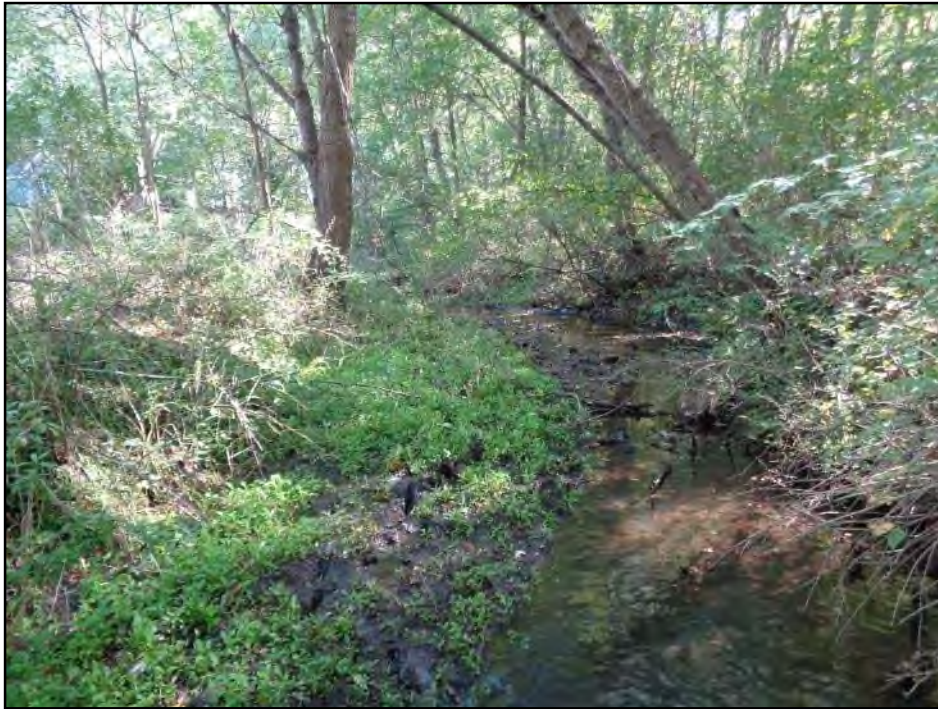
Photograph 13. Looking upstream, Wetland C is located along the banks and floodplain of Stream 1.

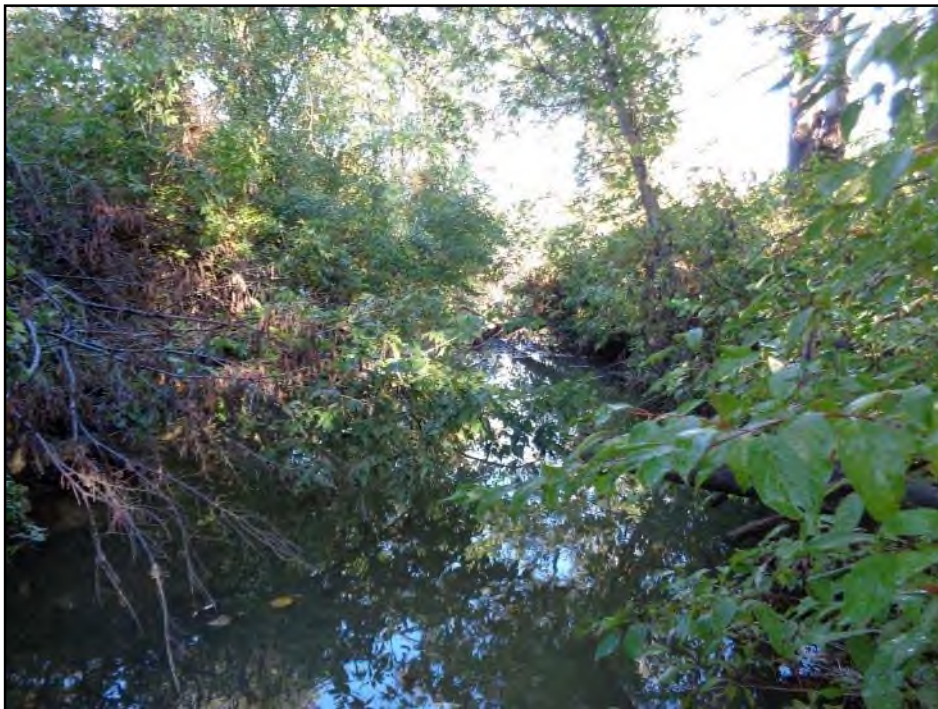
As the drainage area for Stream 1 is less than one (1) square mile, the HHEI was used to assess the habitat value of this stream. The stream crosses through the project area at two separate locations. The northern crossing is located south of the intersection of 17th Street SE and Marietta Avenue SE, south of the mowed recreational field. Wetland B is located within the channel of Stream 1 at this crossing. The second crossing is located north of Adelman's Truck Parts and Sales lot. Wetland C is located along the riparian corridor of Stream 1, within the second crossing of the stream in the project area. One (1) HHEI form was completed for Stream 1 as no significant changes to the character of the stream were observed between the two project area locations, other than a slightly increased amount of silt was observed at the first crossing. The substrate of Stream 1 is composed primarily of cobble and silt and the maximum pool depth was 20.3 centimeters. The surrounding floodplain is composed of immature forest, mature forest/wetland, and industrial development. Stream 1 has received a score of 66, using the HHEI protocol. This places it within the range of a Modified Class II primary headwater habitat stream.

Photograph 14. Stream 1 flows west through a forested area before draining to Stream 2 (Sherrick Run) outside the project area.

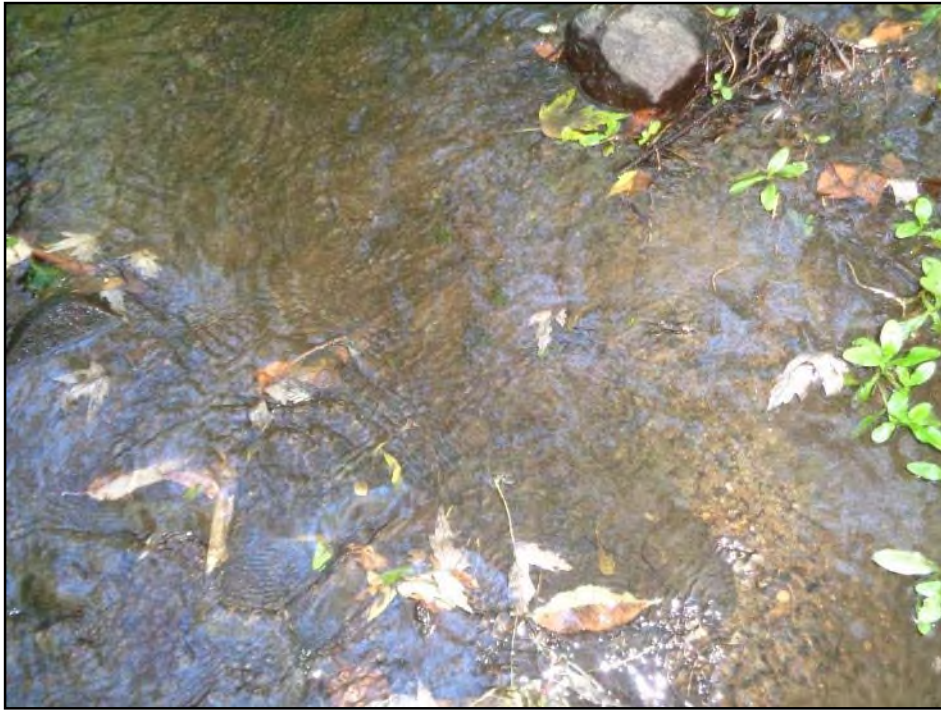
Photograph 15. The substrate of Stream 1 is dominated by cobble and silt.

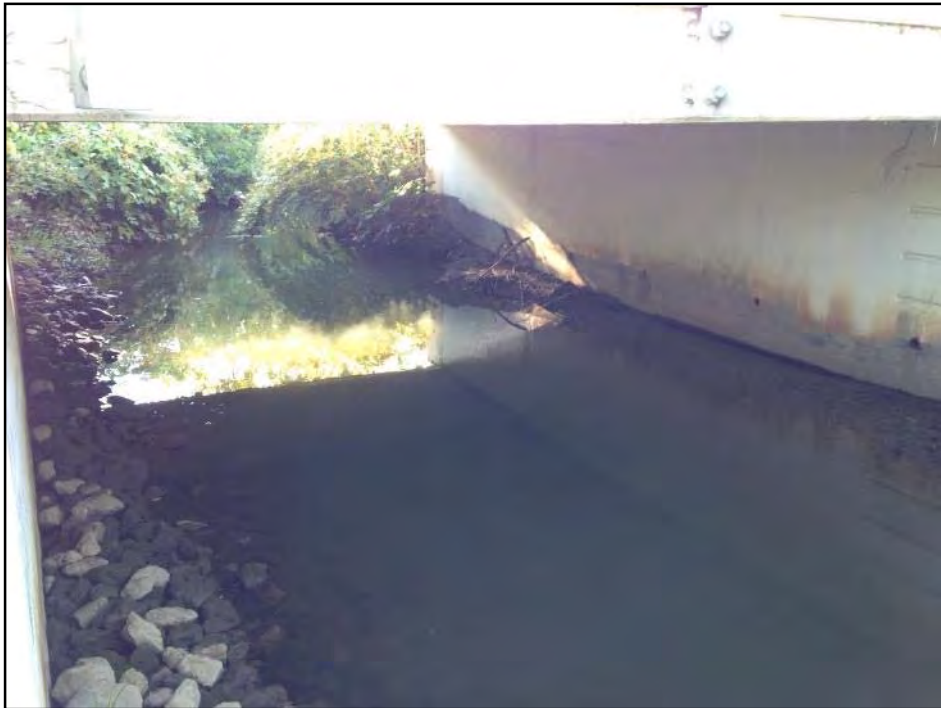
As the drainage area for Stream 2 (Sherrick Run) is greater than one (1) square mile, the QHEI was used to assess the habitat value of this stream. This stream crosses into the project area at two locations. The first is through the easement of Adelman's Truck Parts and Sales at the southwestern part of the project area (east of Waynesburg Drive SE) and the second is underneath a bridge crossing Waynesburg Drive SE. The substrate of this stream is composed primarily of cobble and silt. The stream has sparse (5->25%) instream cover from undercut banks, overhanging vegetation, and logs/woody debris. The stream is recovering from channelization and has very narrow to narrow riparian buffers (<5-10 meters) of wetland, young woods, and industrial development. This stream has received a score of 46.5, using the QHEI protocol. Based on this QHEI score, Stream 2 has the potential to attain the Modified Warmwater Habitat (MWWH) designation. Further, this reach of Sherrick Run has been designated as MWWH by the Ohio EPA based on physical, chemical, and biological evaluation per Ohio Administrative Code Chapter 3745-1.

Photograph 16. Stream 2 (Sherrick Run) flows north out of the project area under a bridge that crosses Waynesburg Drive SE.

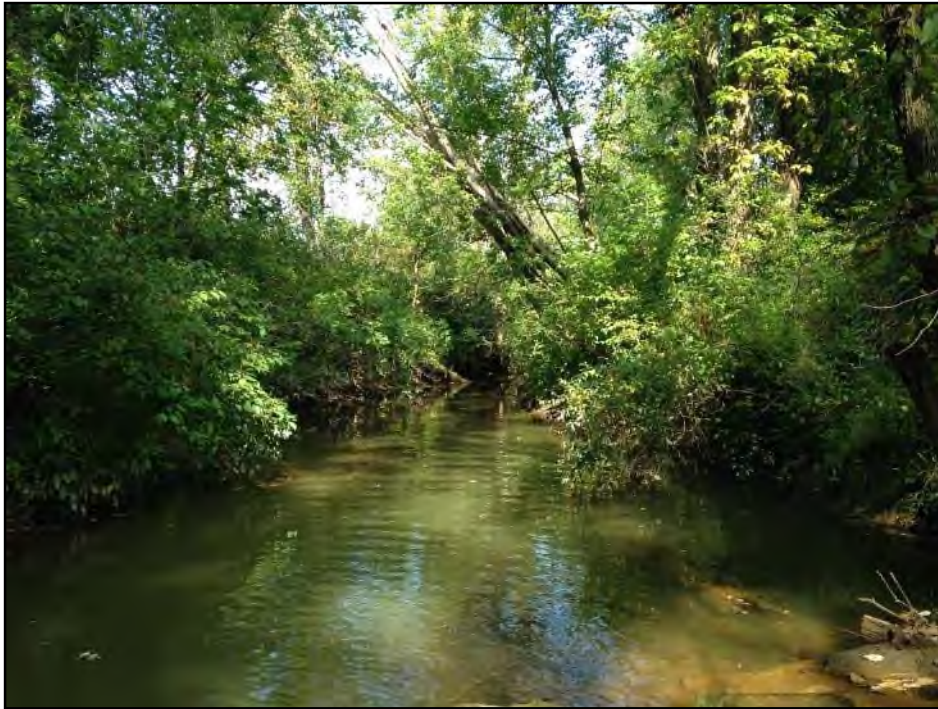
Photograph 17. Looking downstream of Sherrick Run there is a forested canopy before entering Adelman's Truck Parts.

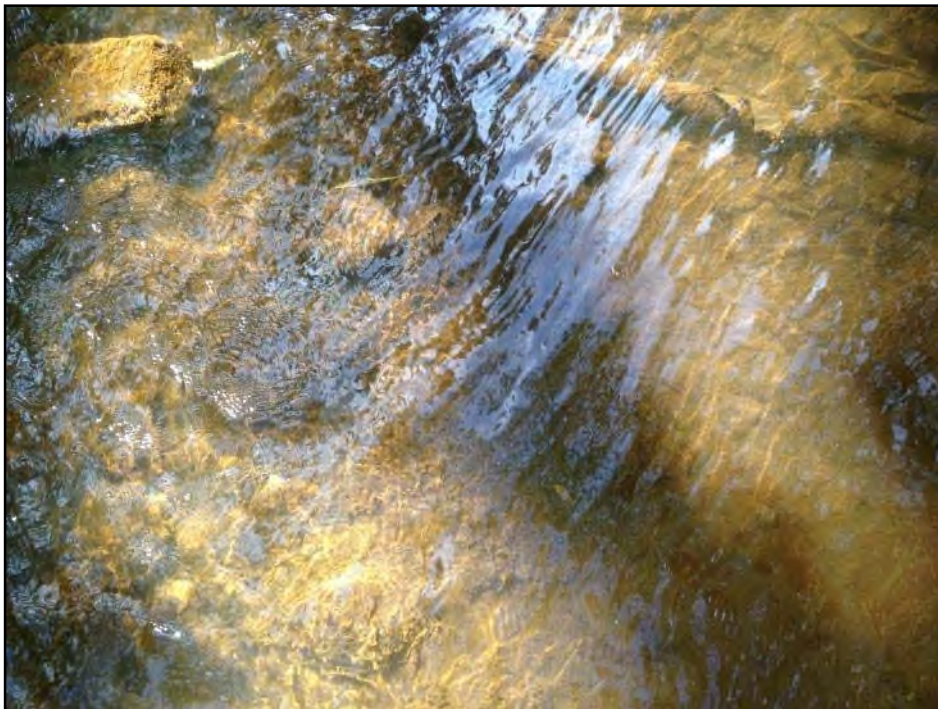
Photograph 18. The dominant substrate types of Stream 2 are cobble and silt.
