Re: PUCO Case No. 18-0156-EL-BLN
In the Matter of the Letter of Notification for the
Ginger Switch Repair and Upgrade Project

LETTER OF NOTIFICATION FOR Ginger Switch Repair and Upgrade Project

AEP Ohio Transmission Company, Inc.'s Ginger Switch Repair and Upgrade Project

AEP Ohio Transmission Company
Ginger Switch Replacement Project
Ross County, Ohio

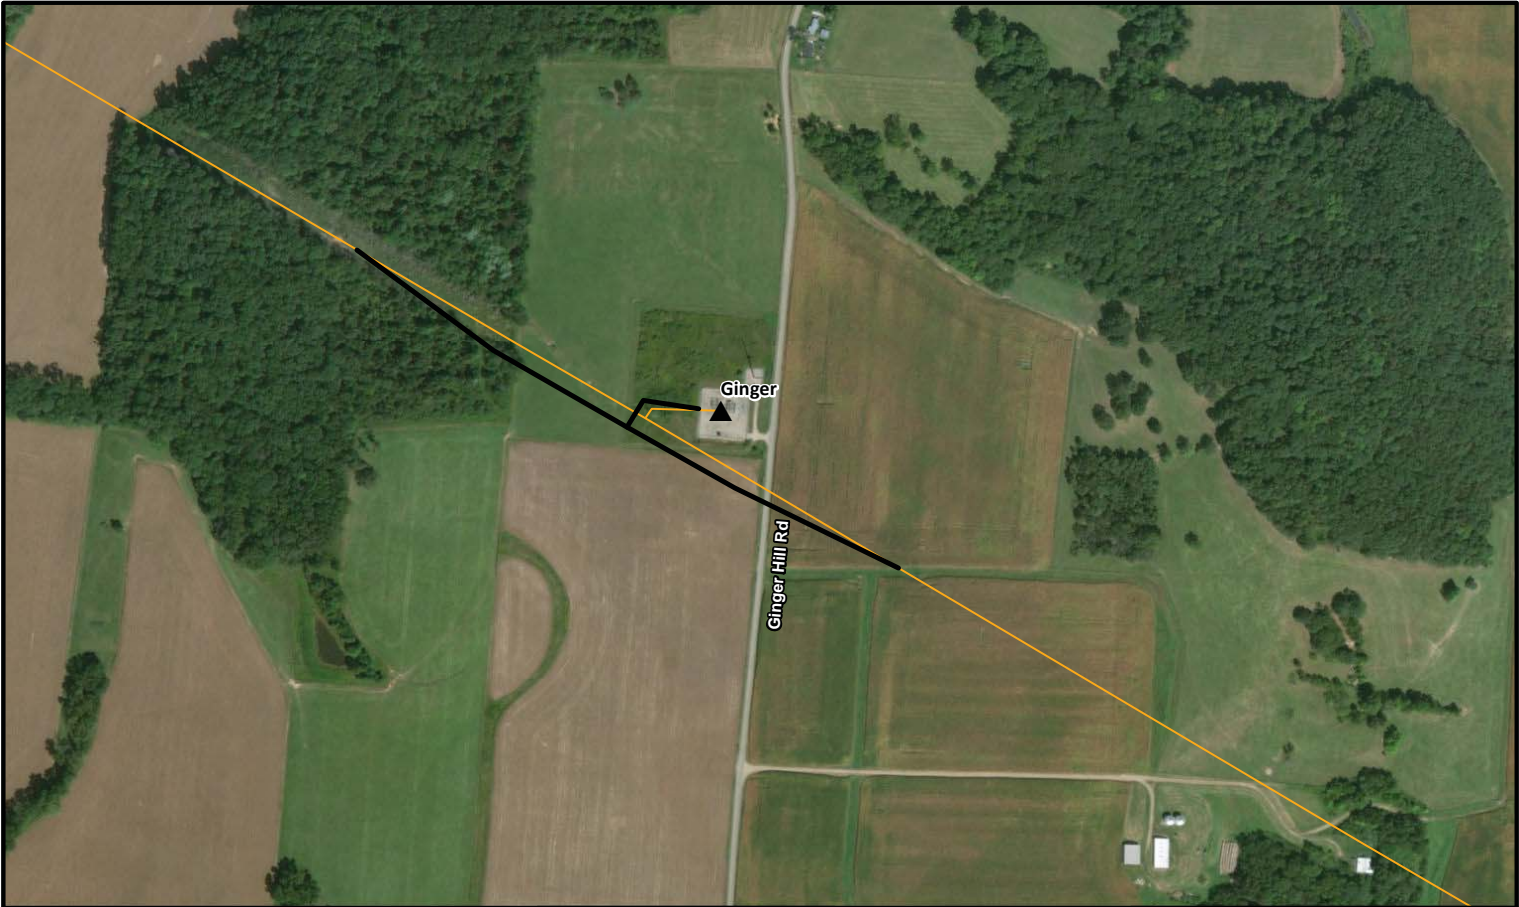
- ▲ Station
- Proposed 138 kV Line
- Existing Berlin-Ross 69kV Line

Ginger Switch 138kV Repair and Upgrade Project
0 250 500 1,000 Feet

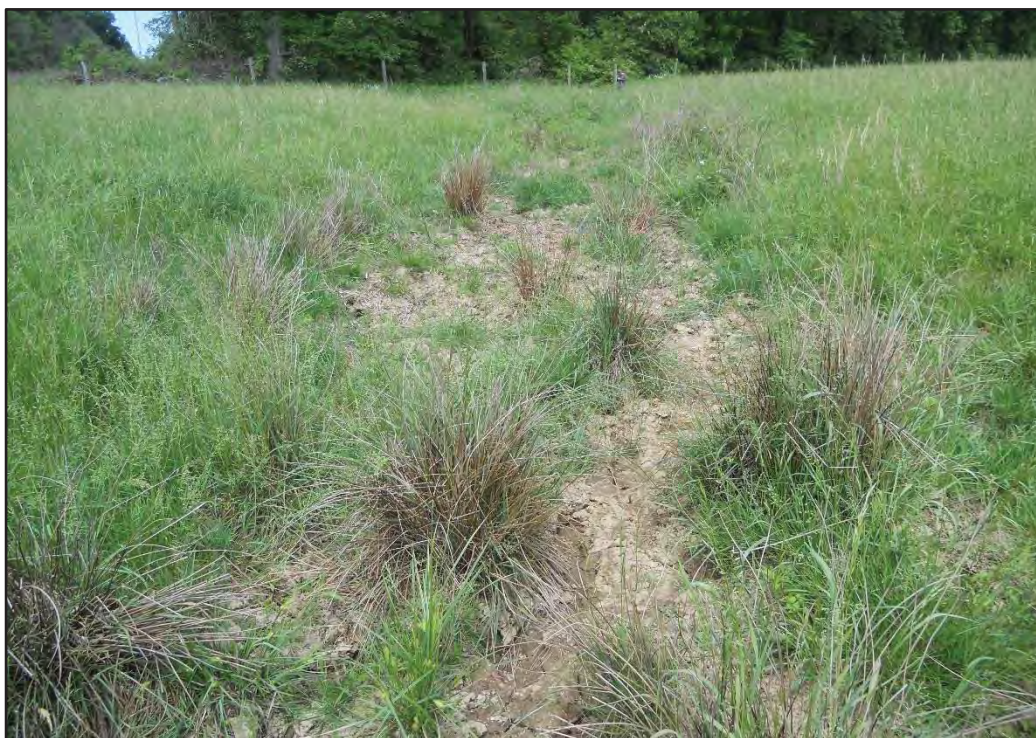
Photograph 1. Wetland W001-PEM-CAT1, Facing Northwest

Three PEM wetlands were identified and delineated within the study area. In order to document site conditions, USACE Data Forms were completed for each wetland and upland reference. Information on the delineated wetlands can be found in Table 1 and photographs of the wetlands are included in Appendix A.

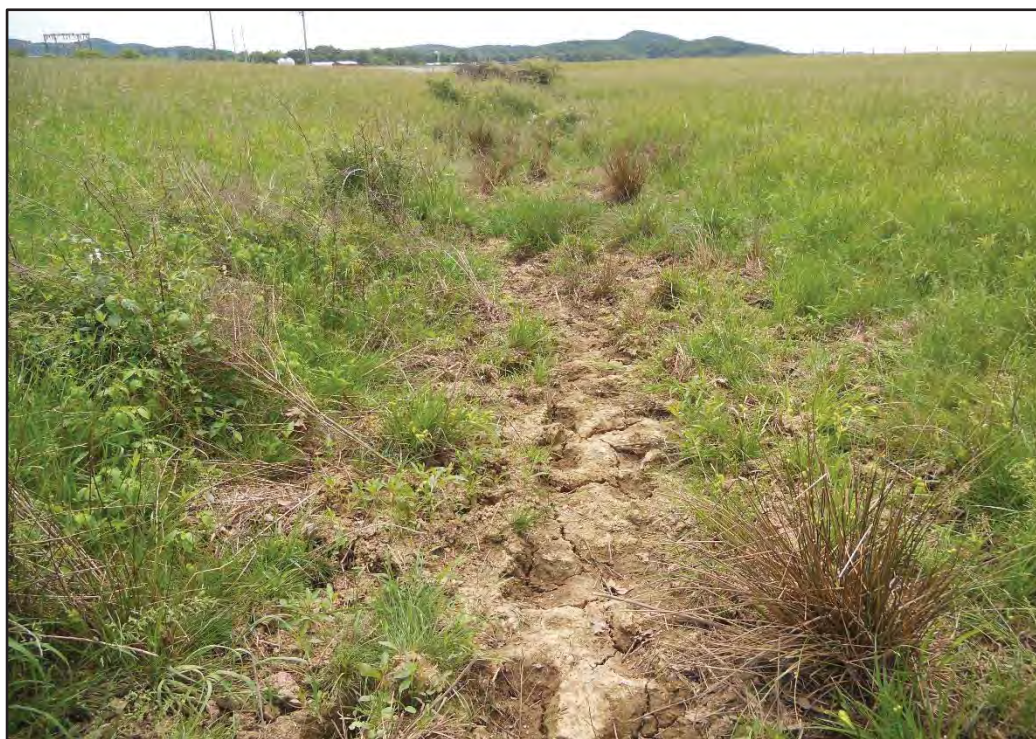
Photograph 2. Wetland W001-PEM-CAT1, Facing Southeast

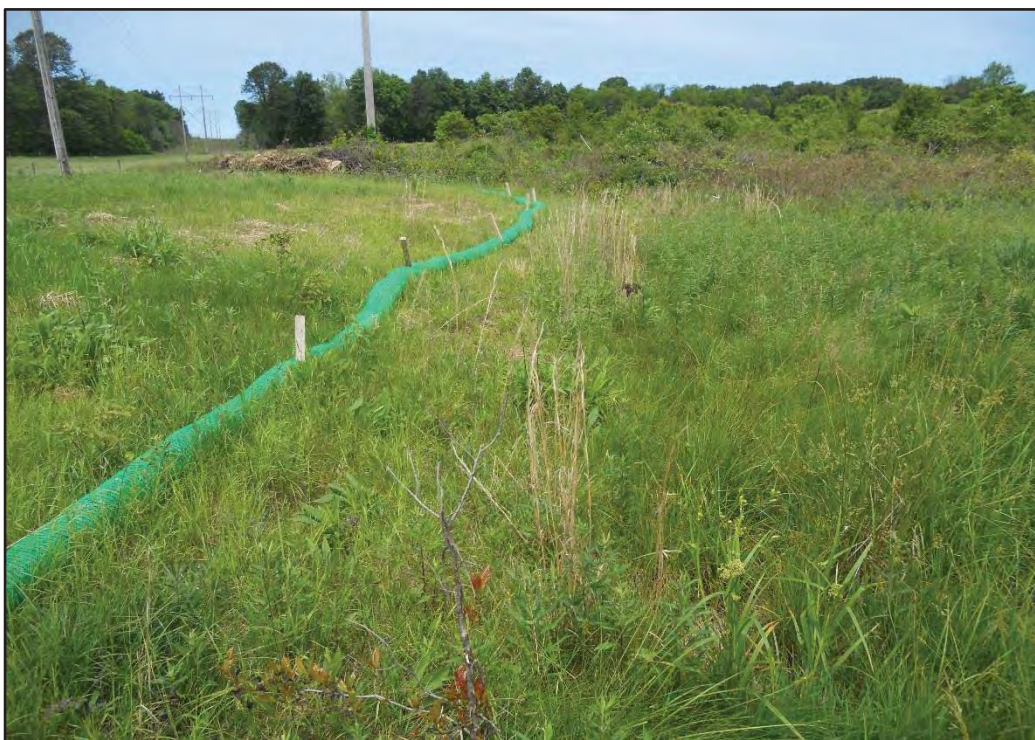
Photograph 3. Wetland W001-PEM-CAT1, Facing Northwest

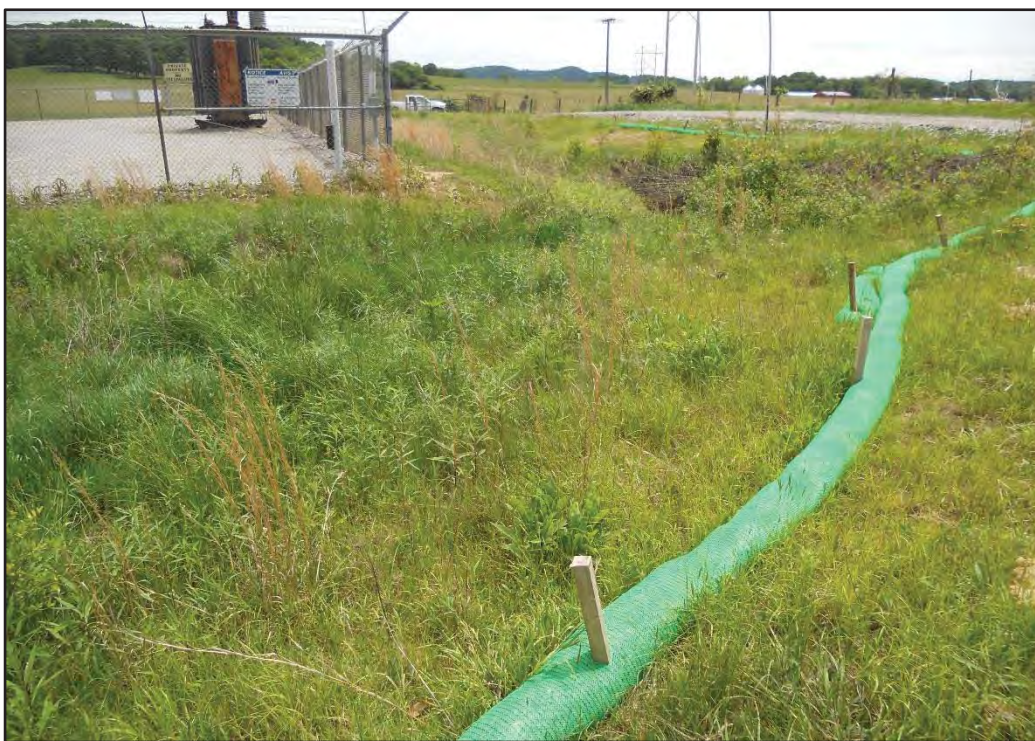
Photograph 4. Wetland W001-PEM-CAT1, Facing Southeast

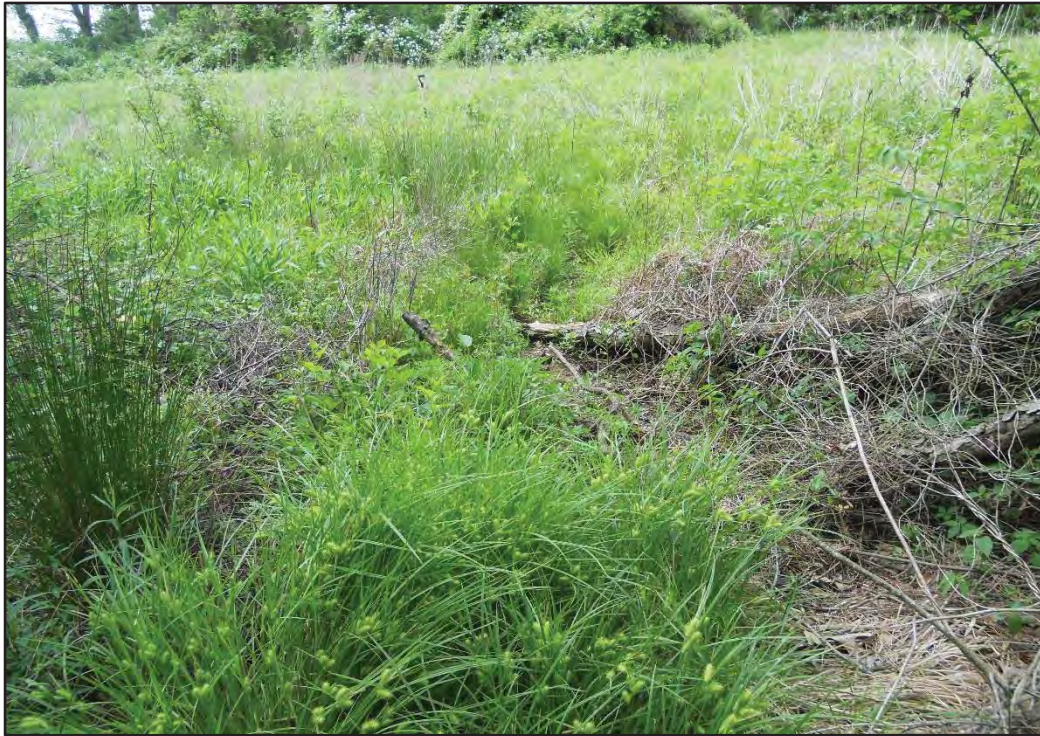
Photograph 5. Wetland W002-PEM-CAT1, Facing South

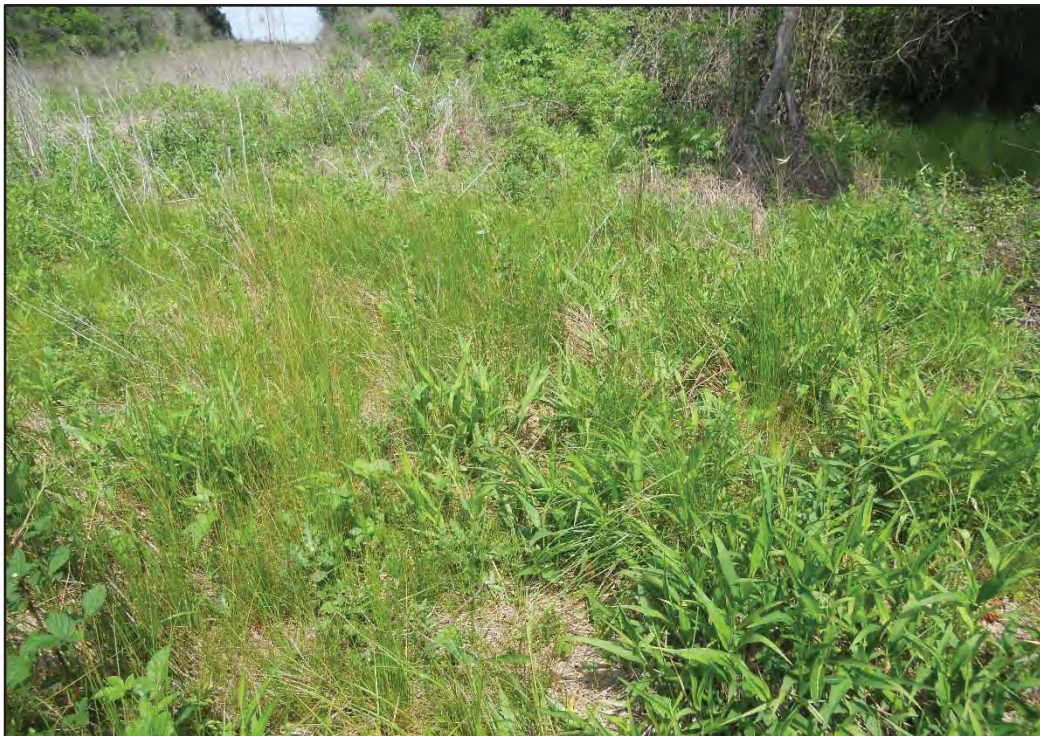
Photograph 6. Wetland W002-PEM-CAT1, Facing Northwest

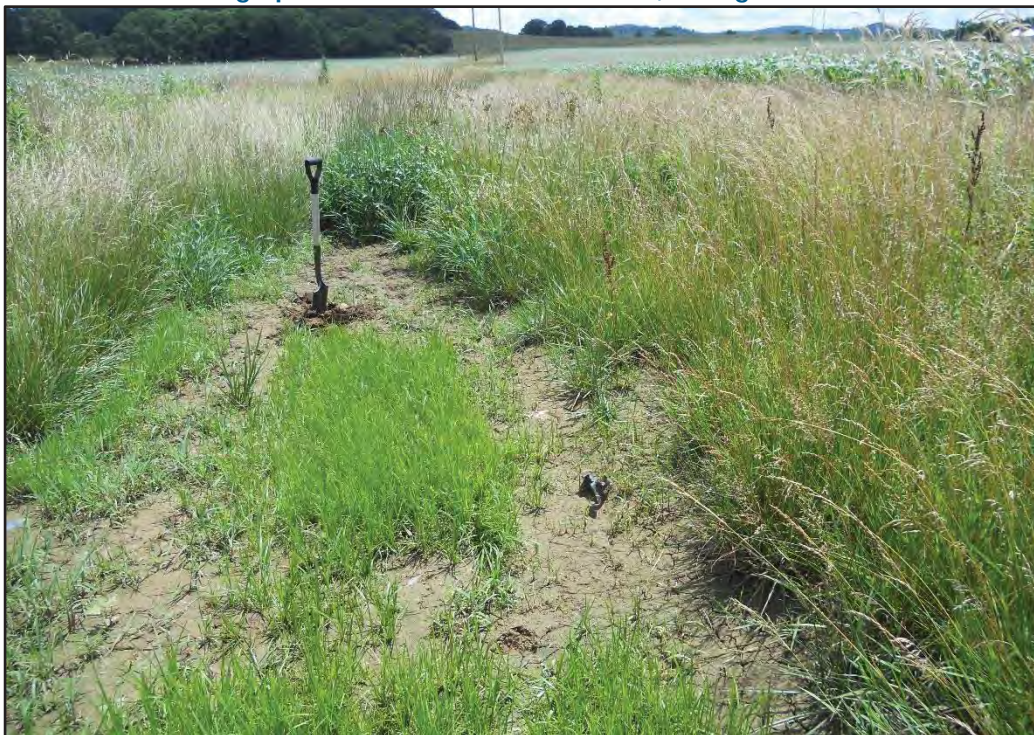
Photograph 7. Wetland W003-PEM-CAT1, Facing East

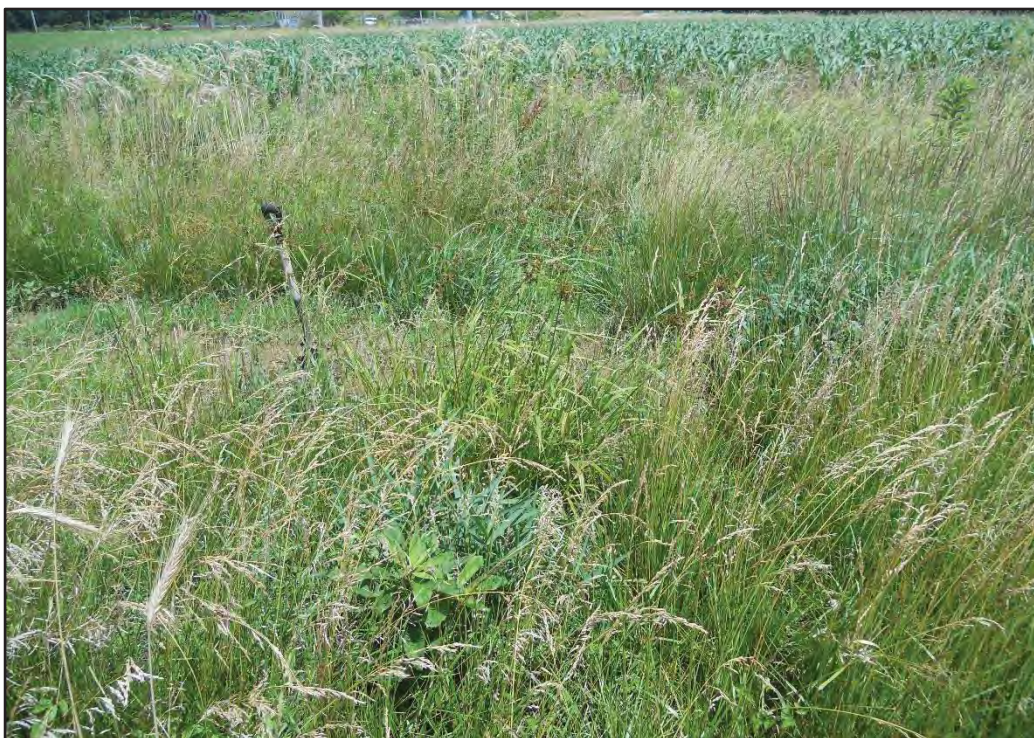
Photograph 8. Wetland W003-PEM-CAT1, Facing North

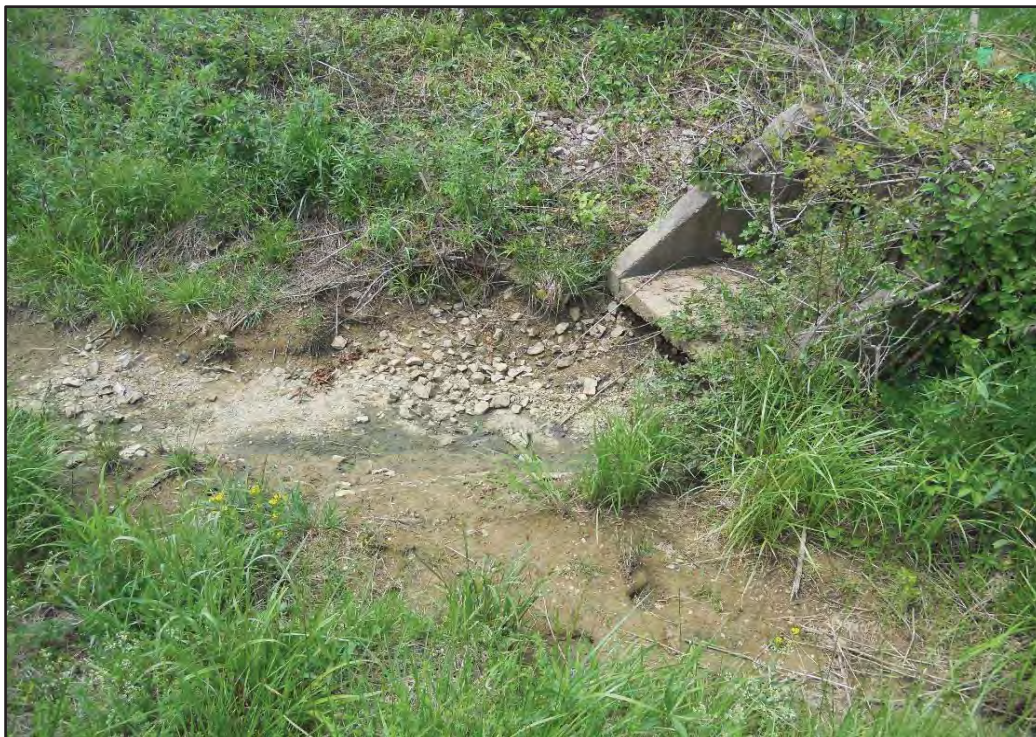
Photograph 9. Proposed Jurisdictional Ditch 001 at Culvert Outlet, Facing Southwest

One proposed jurisdictional ditch was identified. One ephemeral stream segment was also identified within the study area. Information on the delineated waterbody and its classification can be found in Table 2, and photographs of the identified stream are included in Appendix A.

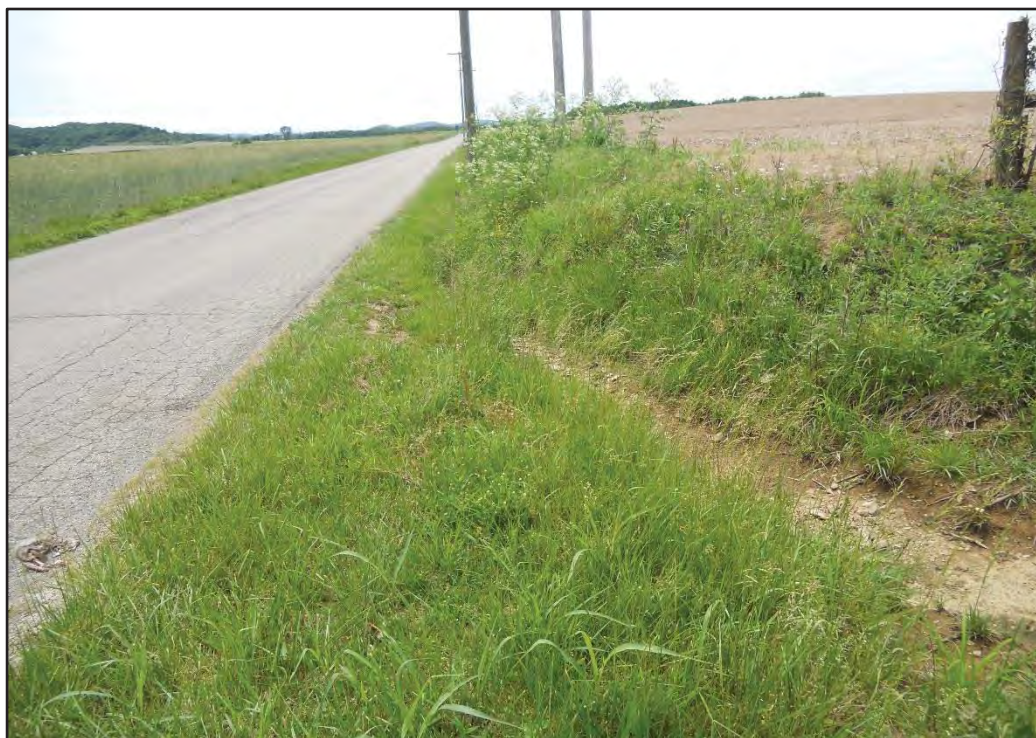
Photograph 10. Proposed Jurisdictional Ditch 001, Facing South

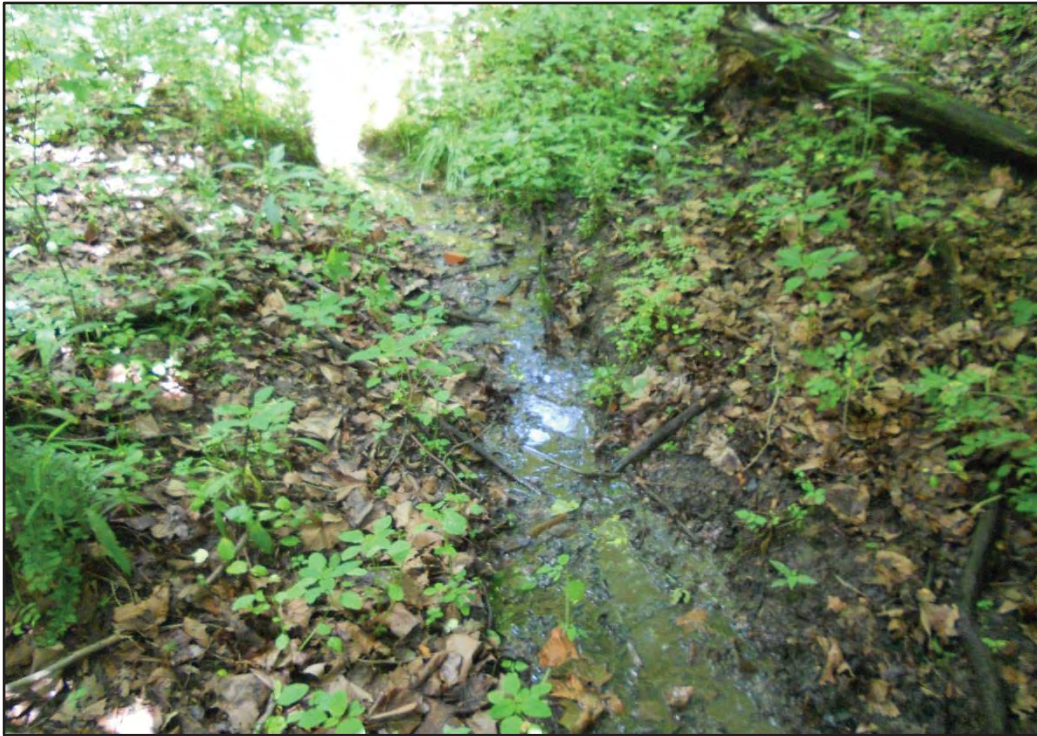
Photograph 11. Stream S001, Upstream, Facing Northwest

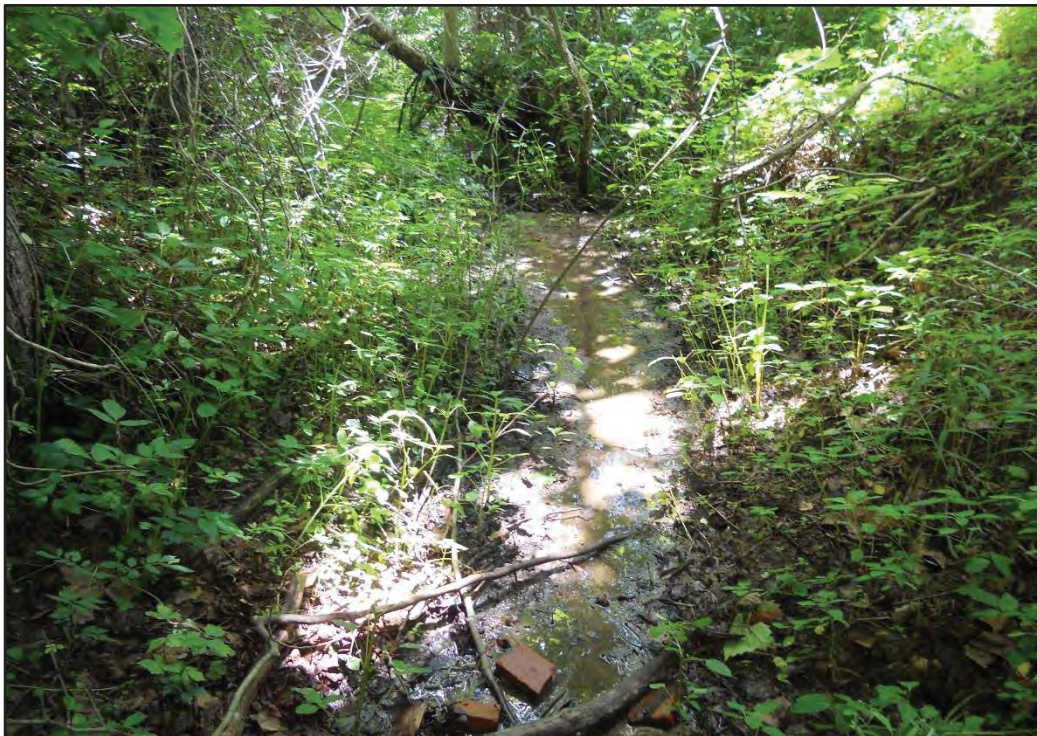
Photograph 12. Stream S001, Downstream, Facing Southeast
