Re: PUCO Case No. 18-1389-EL-BLN
In the Matter of the Letter of Notification for the
Howard-Fostoria and Howard-Bucyrus Center 138kV Transmission
Line Extension Project

Letter of Notification for Howard-Fostoria and Howard-Bucyrus Center 138kV Transmission Line Extension Project

PUCO Case No. 18-1389-EL-BLN

AEP Ohio Transmission Company, Inc. (AEP Ohio Transco) Howard-Fostoria and Howard-Bucyrus Center 138kV Transmission Line Extension Project

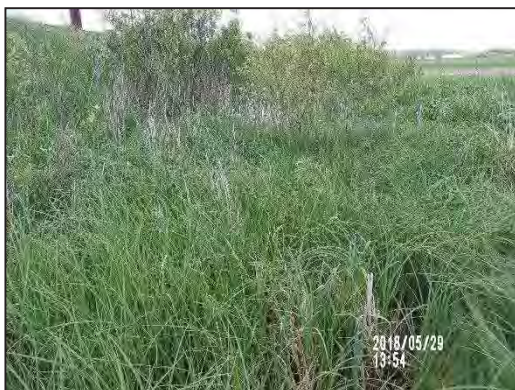
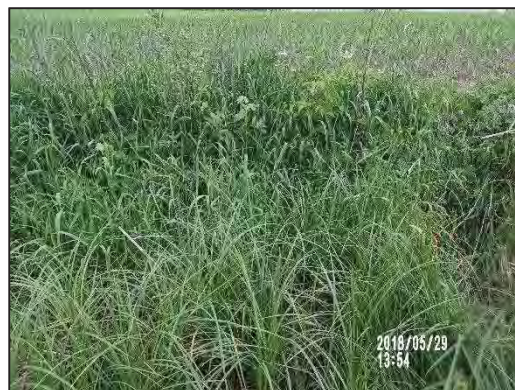
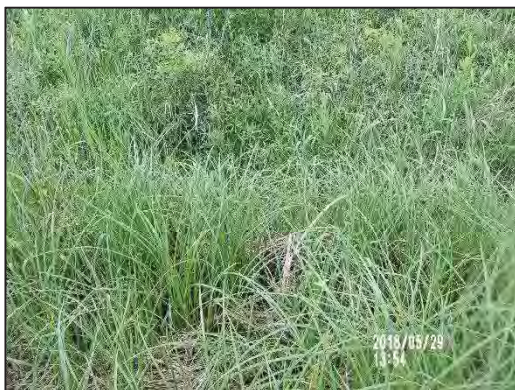
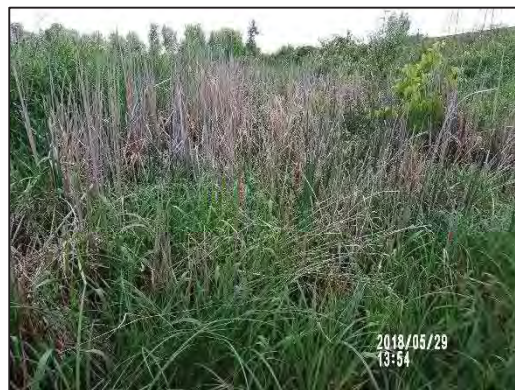
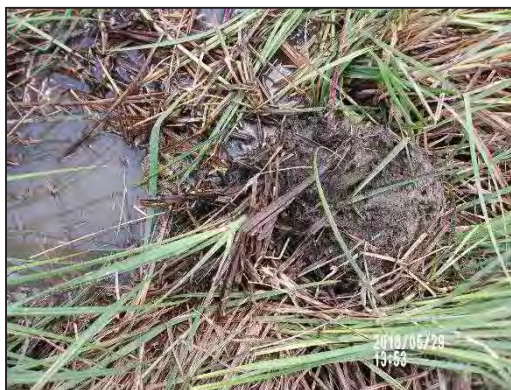
D1- DELINEATED WETLAND

PEM/PSS
wetland

Category 1

Facing Northeast

Facing Southeast

Facing Northwest

Facing Southwest

Soil Pit

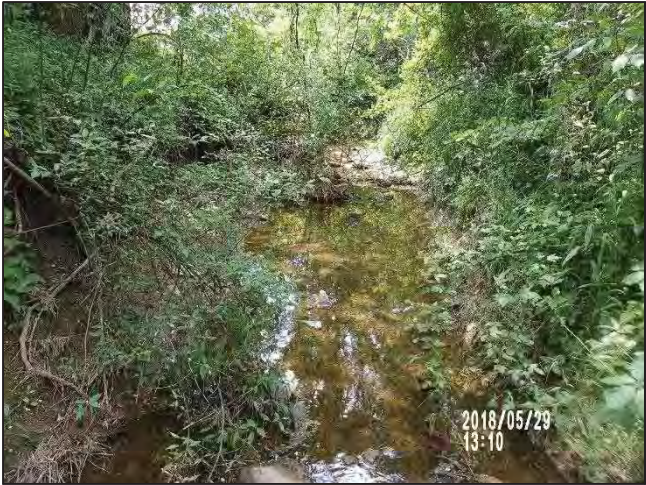
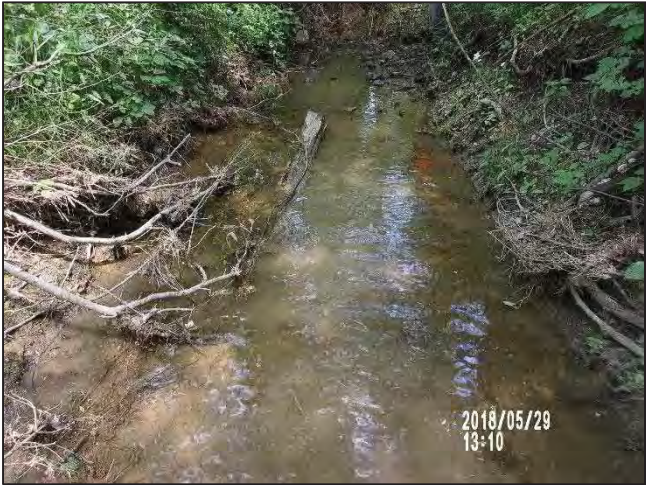
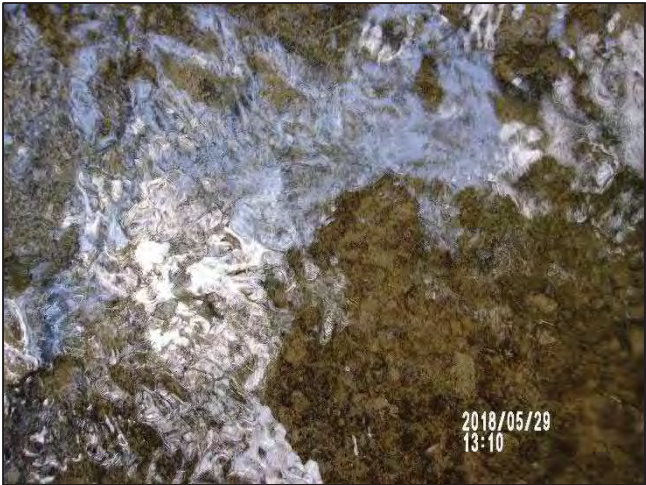
<p>Facing Upstream</p>

<p>Facing Downstream</p>

<p>Substrate</p>
Description: Stream 01 Intermittent Modified Class 2

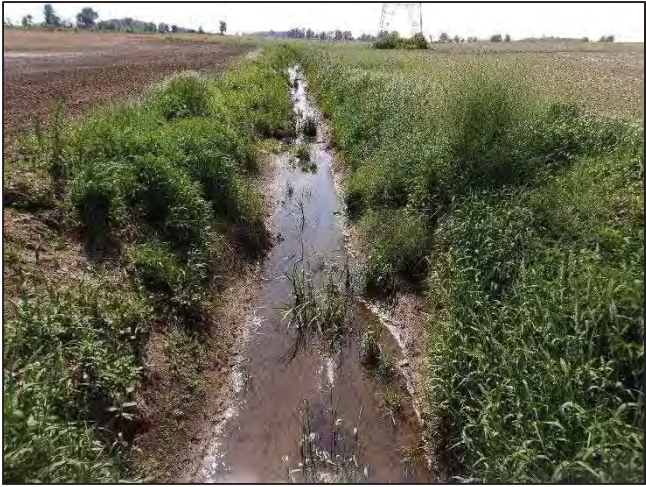
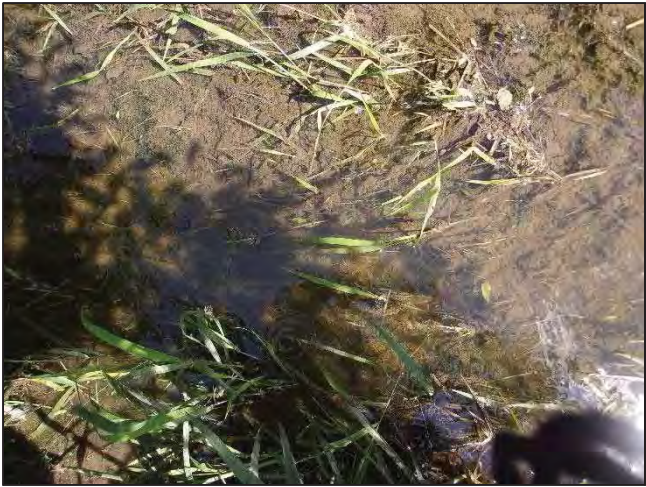
<p>Facing Upstream</p>   <p>Facing Downstream</p>

<p>Substrate</p>
Description: Stream 02 Intermittent Modified Class 2

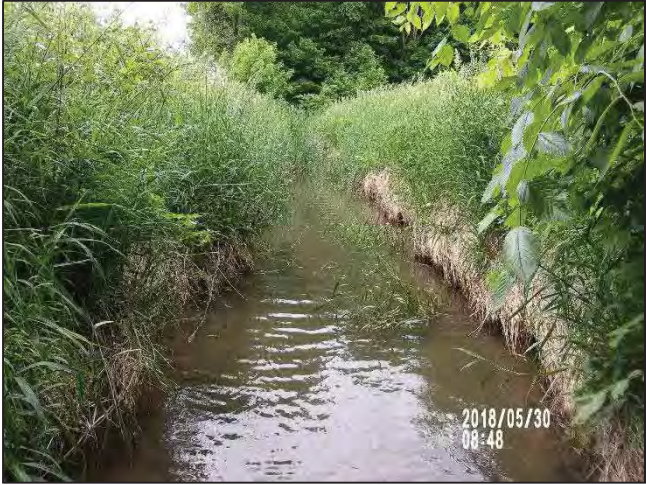
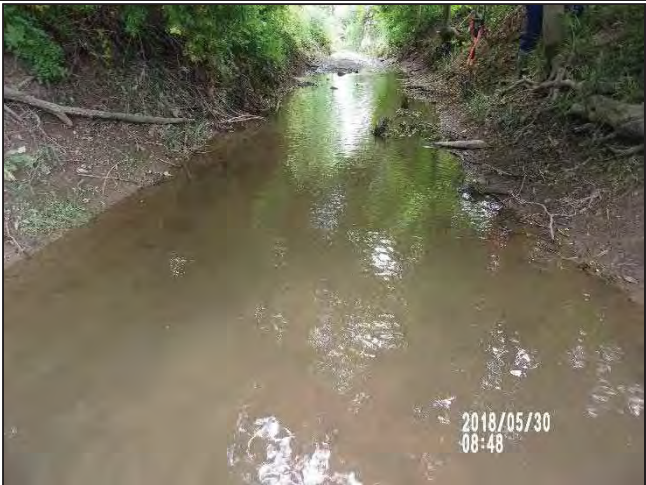
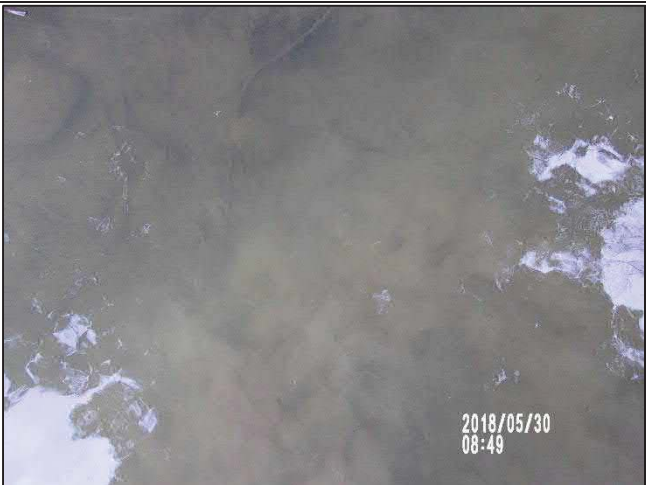
<p>2018/05/30 08:48</p>
Description: Stream 03 Perennial Modified Class 2

Facing Upstream
