**SITE PLAN**

**HECATE ENERGY  
HIGHLAND  
BUFORD, OH**

Hecate Energy Highland LLC  
Ohio Power Siting Board Application  
Exhibit G: Ecological Report  
Page 52

## **Buford, Highland County, Ohio**

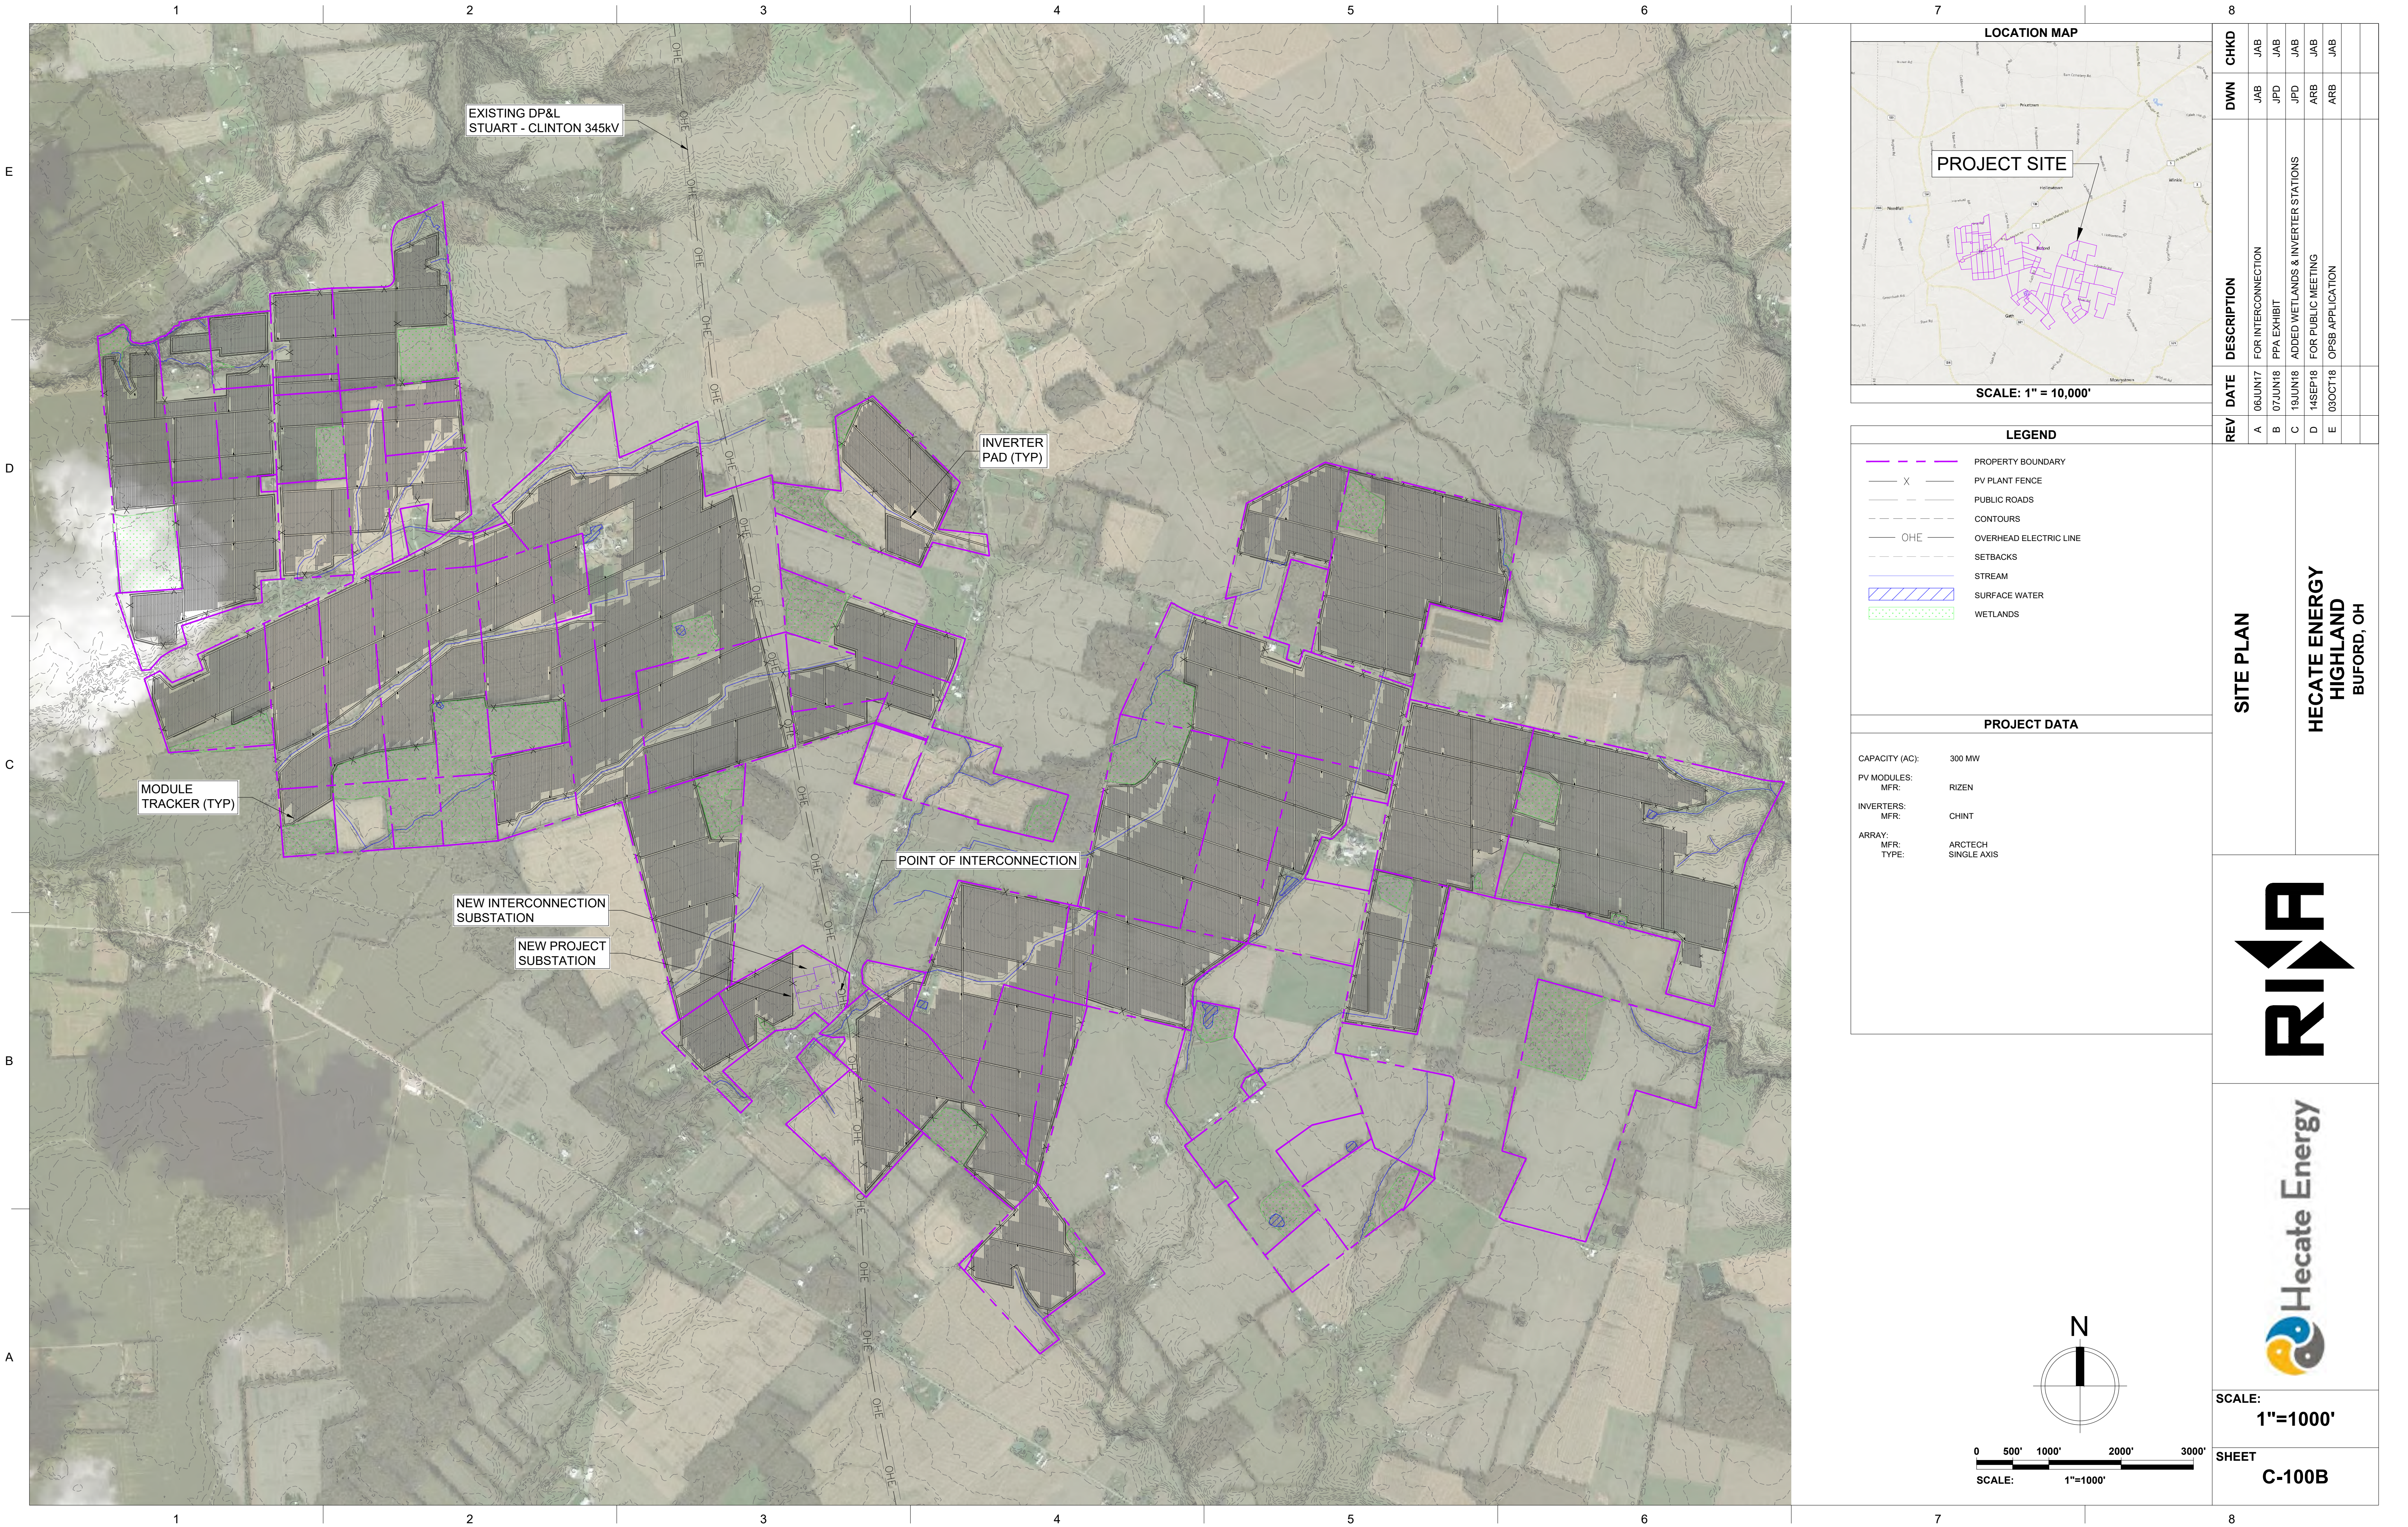
SHEET C-100B

PROJECT DATA	
CAPACITY (AC):	300 MW
PV MODULES: MFR:	RIZEN
INVERTERS: MFR:	CHINT
ARRAY: MFR:	ARCTECH
TYPE:	SINGLE AXIS

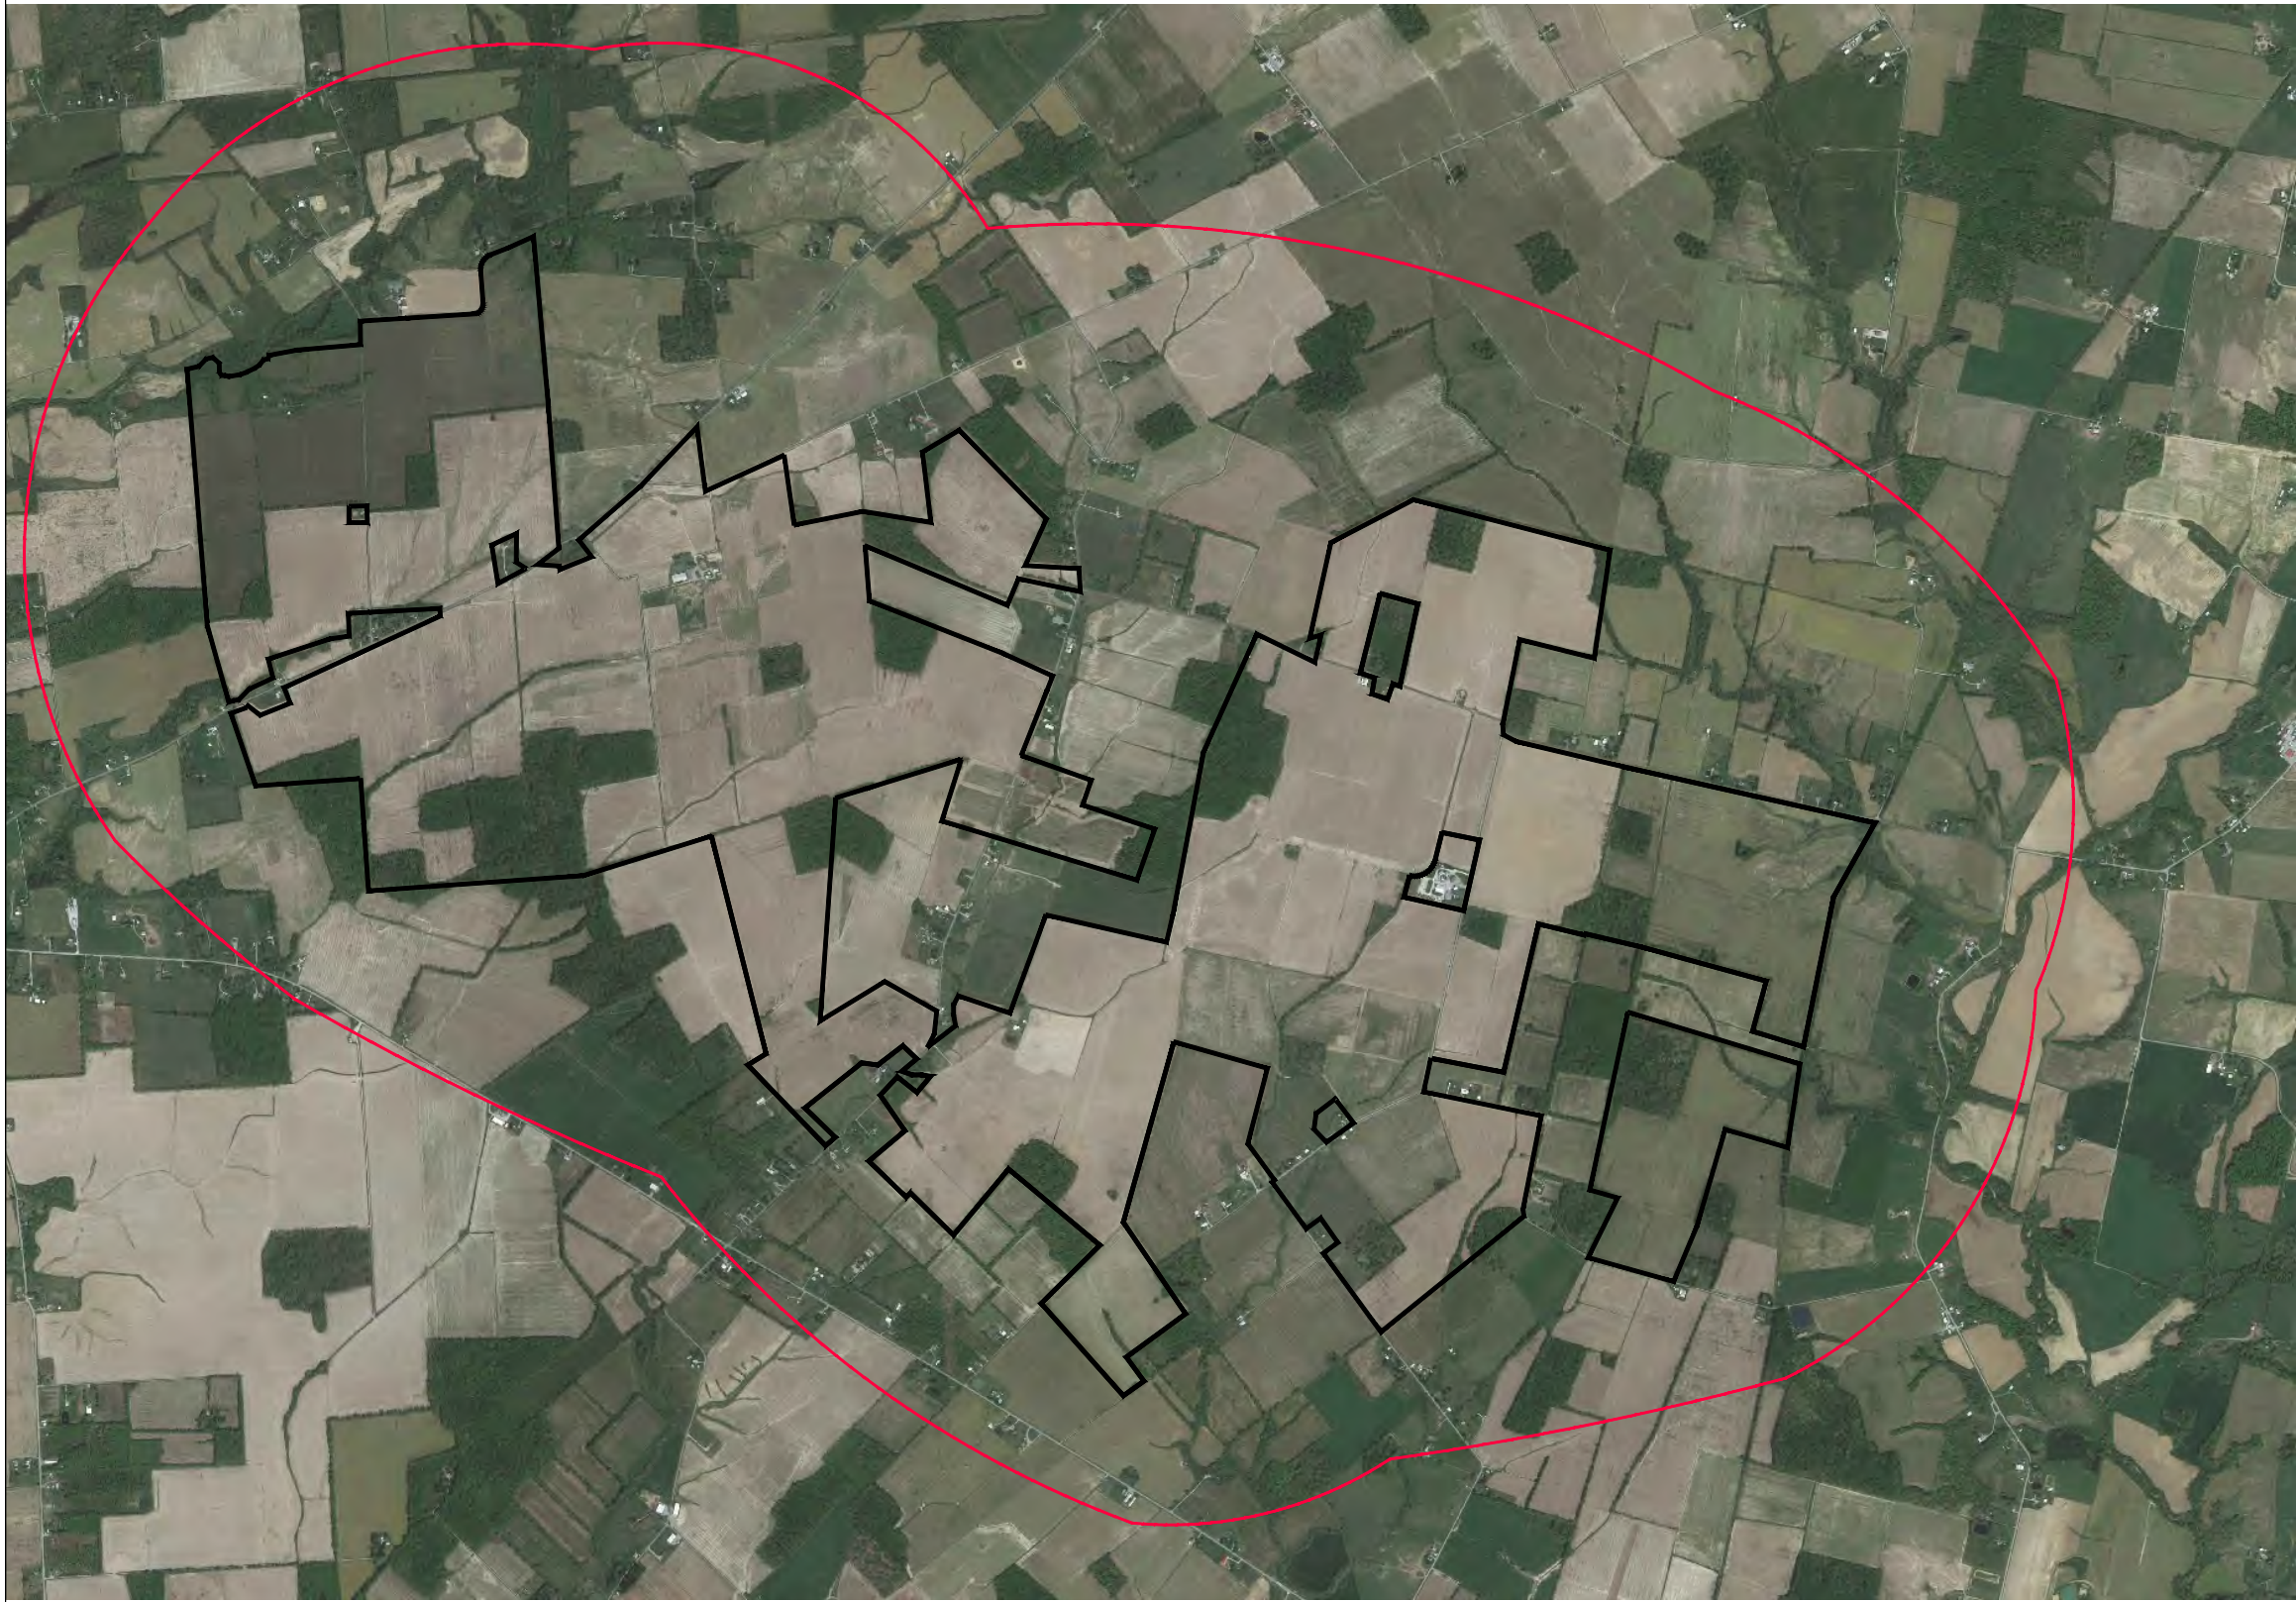
Project Mngr:	EK	Project No.	49187638	<div><b>Terracon</b> Consulting Engineers and Scientists 2105 Newpoint Place, Ste. 600 Lawrenceville, GA 30043 (770) 623-0755 (770) 623-9628</div>	WILDLIFE PRESERVES AND REFUGES MAP ECOLOGICAL RESOURCES ANALYSIS REPORT PROPOSED HIGHLAND SOLAR FARM STATE ROUTE 138 & HIGHLAND COUNTY ROAD 5 BUFORD, HIGHLAND COUNTY, OH	EXHIBIT  9
Drawn By:	JSL	Scale:	AS SHOWN			
Checked By:	MRF/EK	File No.	49187638-9-WILDLIFE			
Approved By:	EK	Date:	SEPT. 2018
