Wetland Delineation and Surface Water Study

Wood County 138kV Reinforcement Project

Wood County, Ohio

November 2018

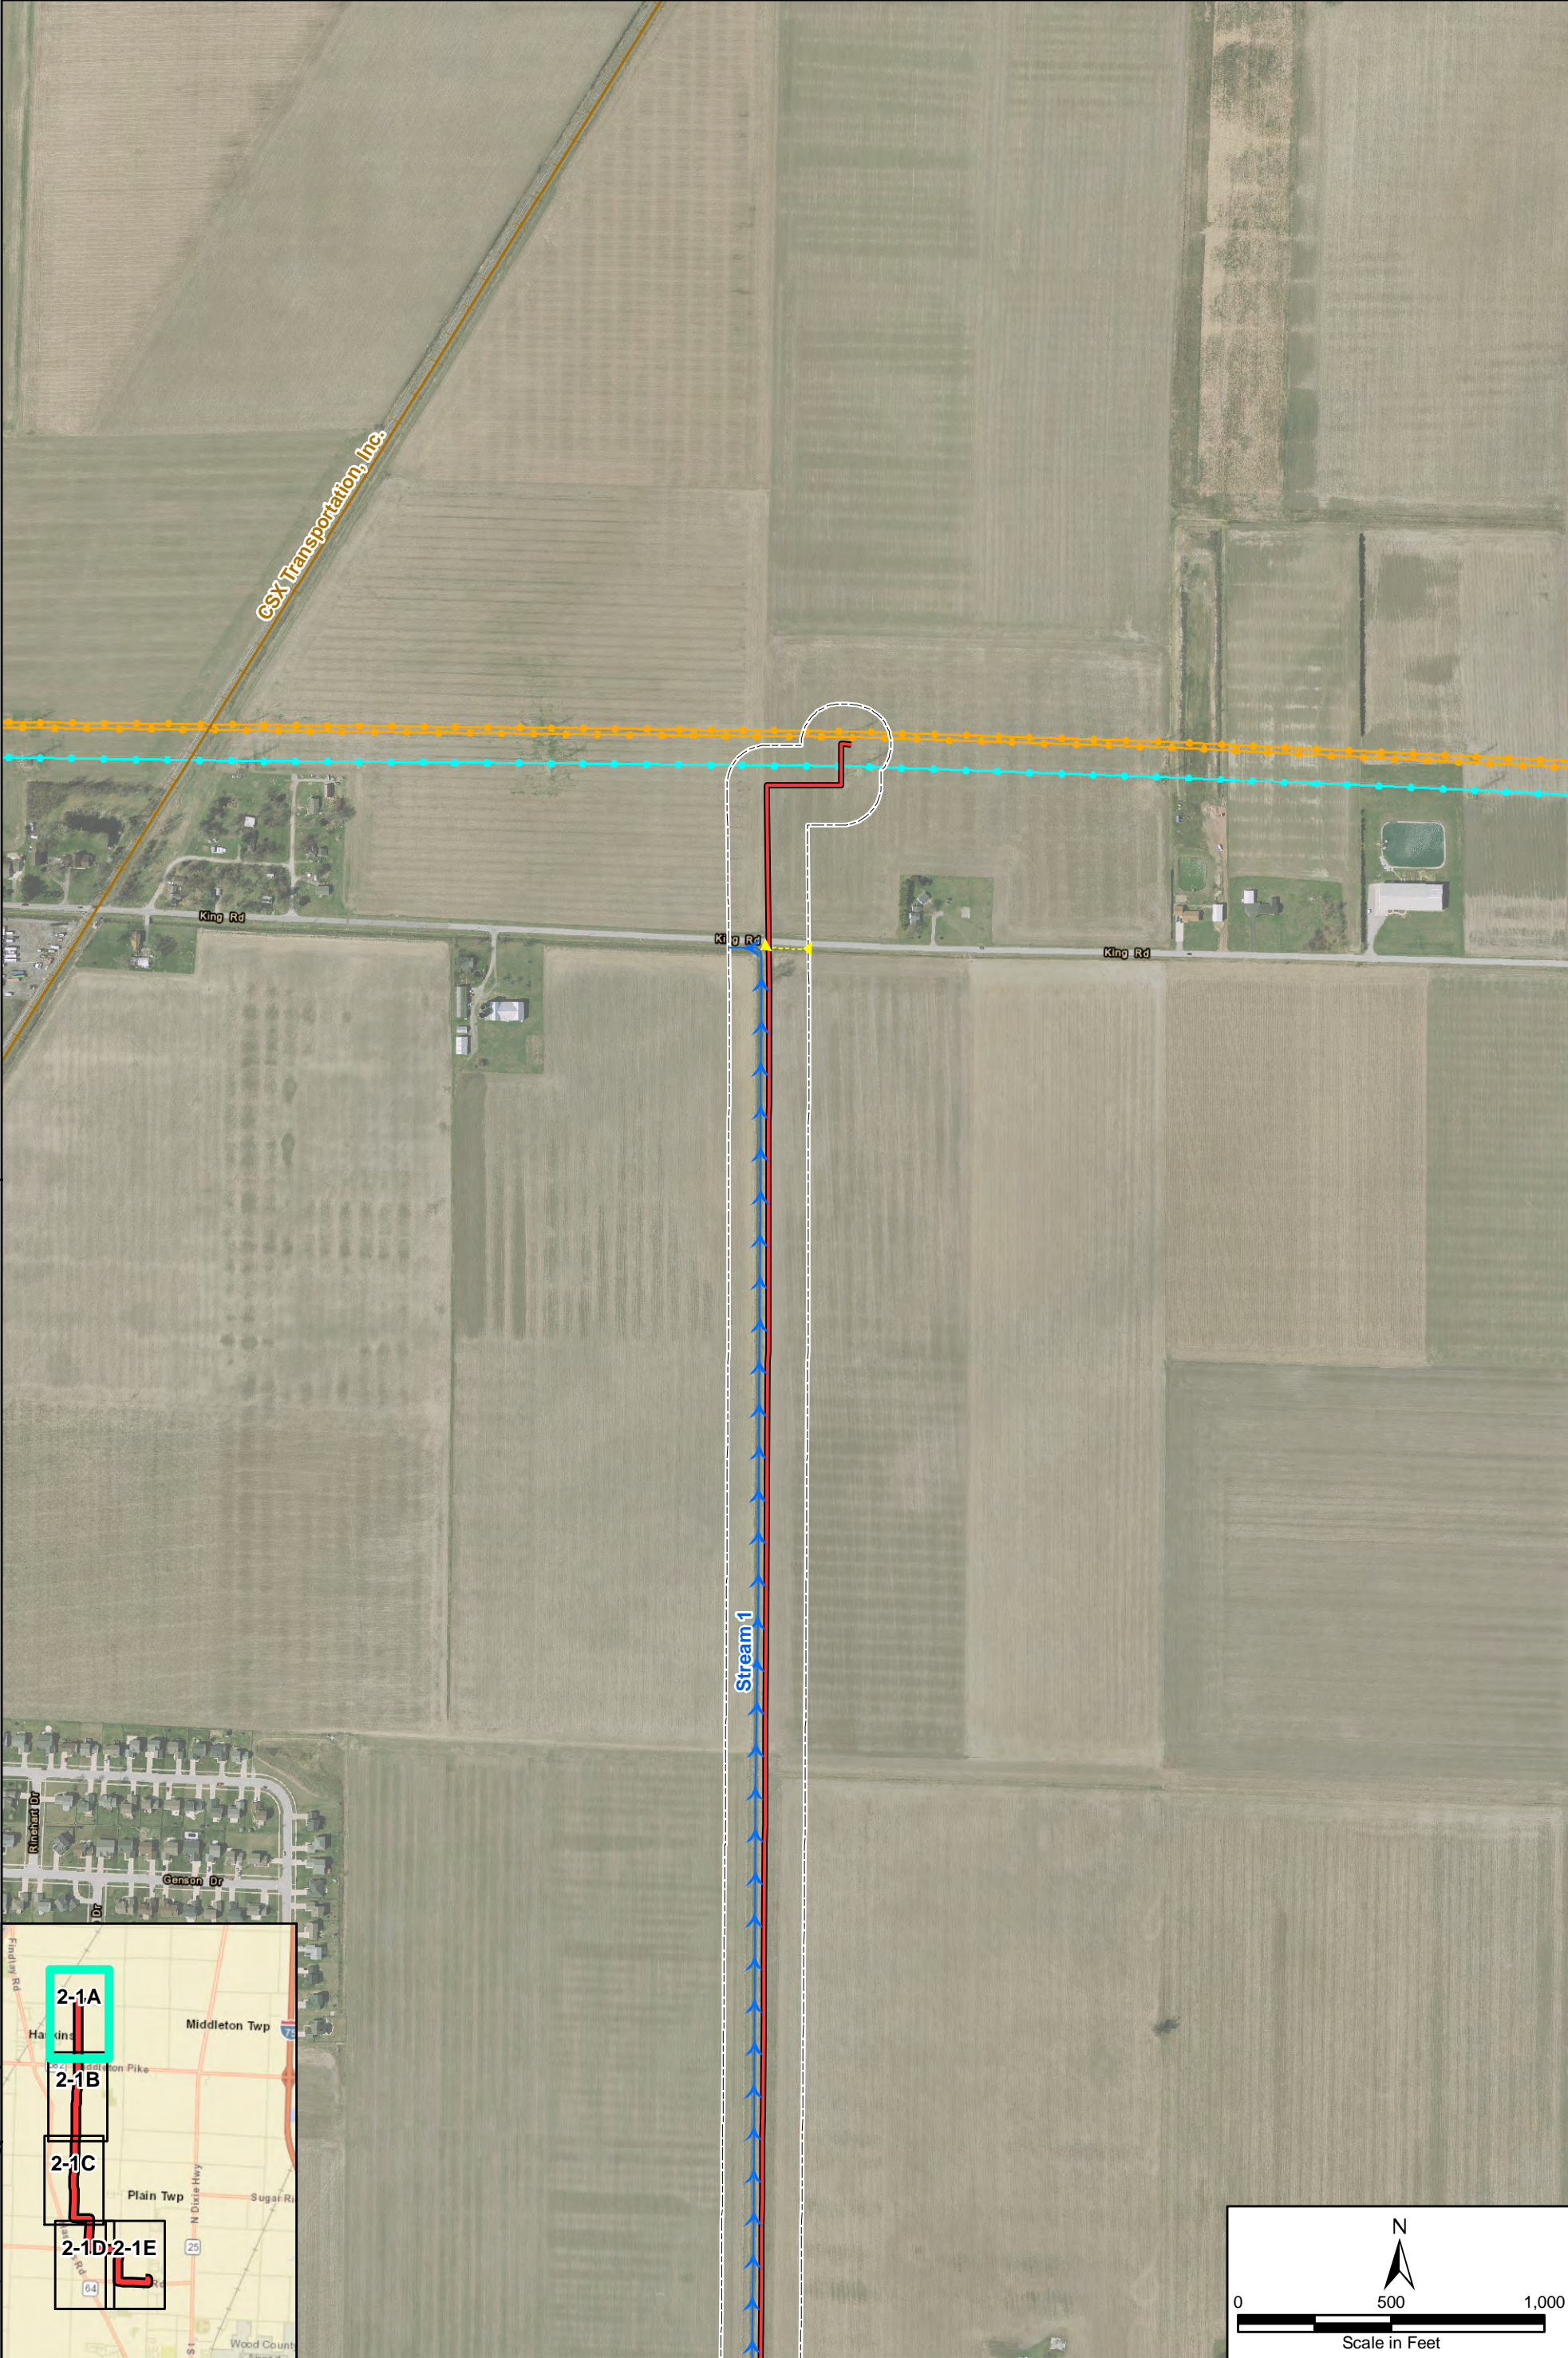
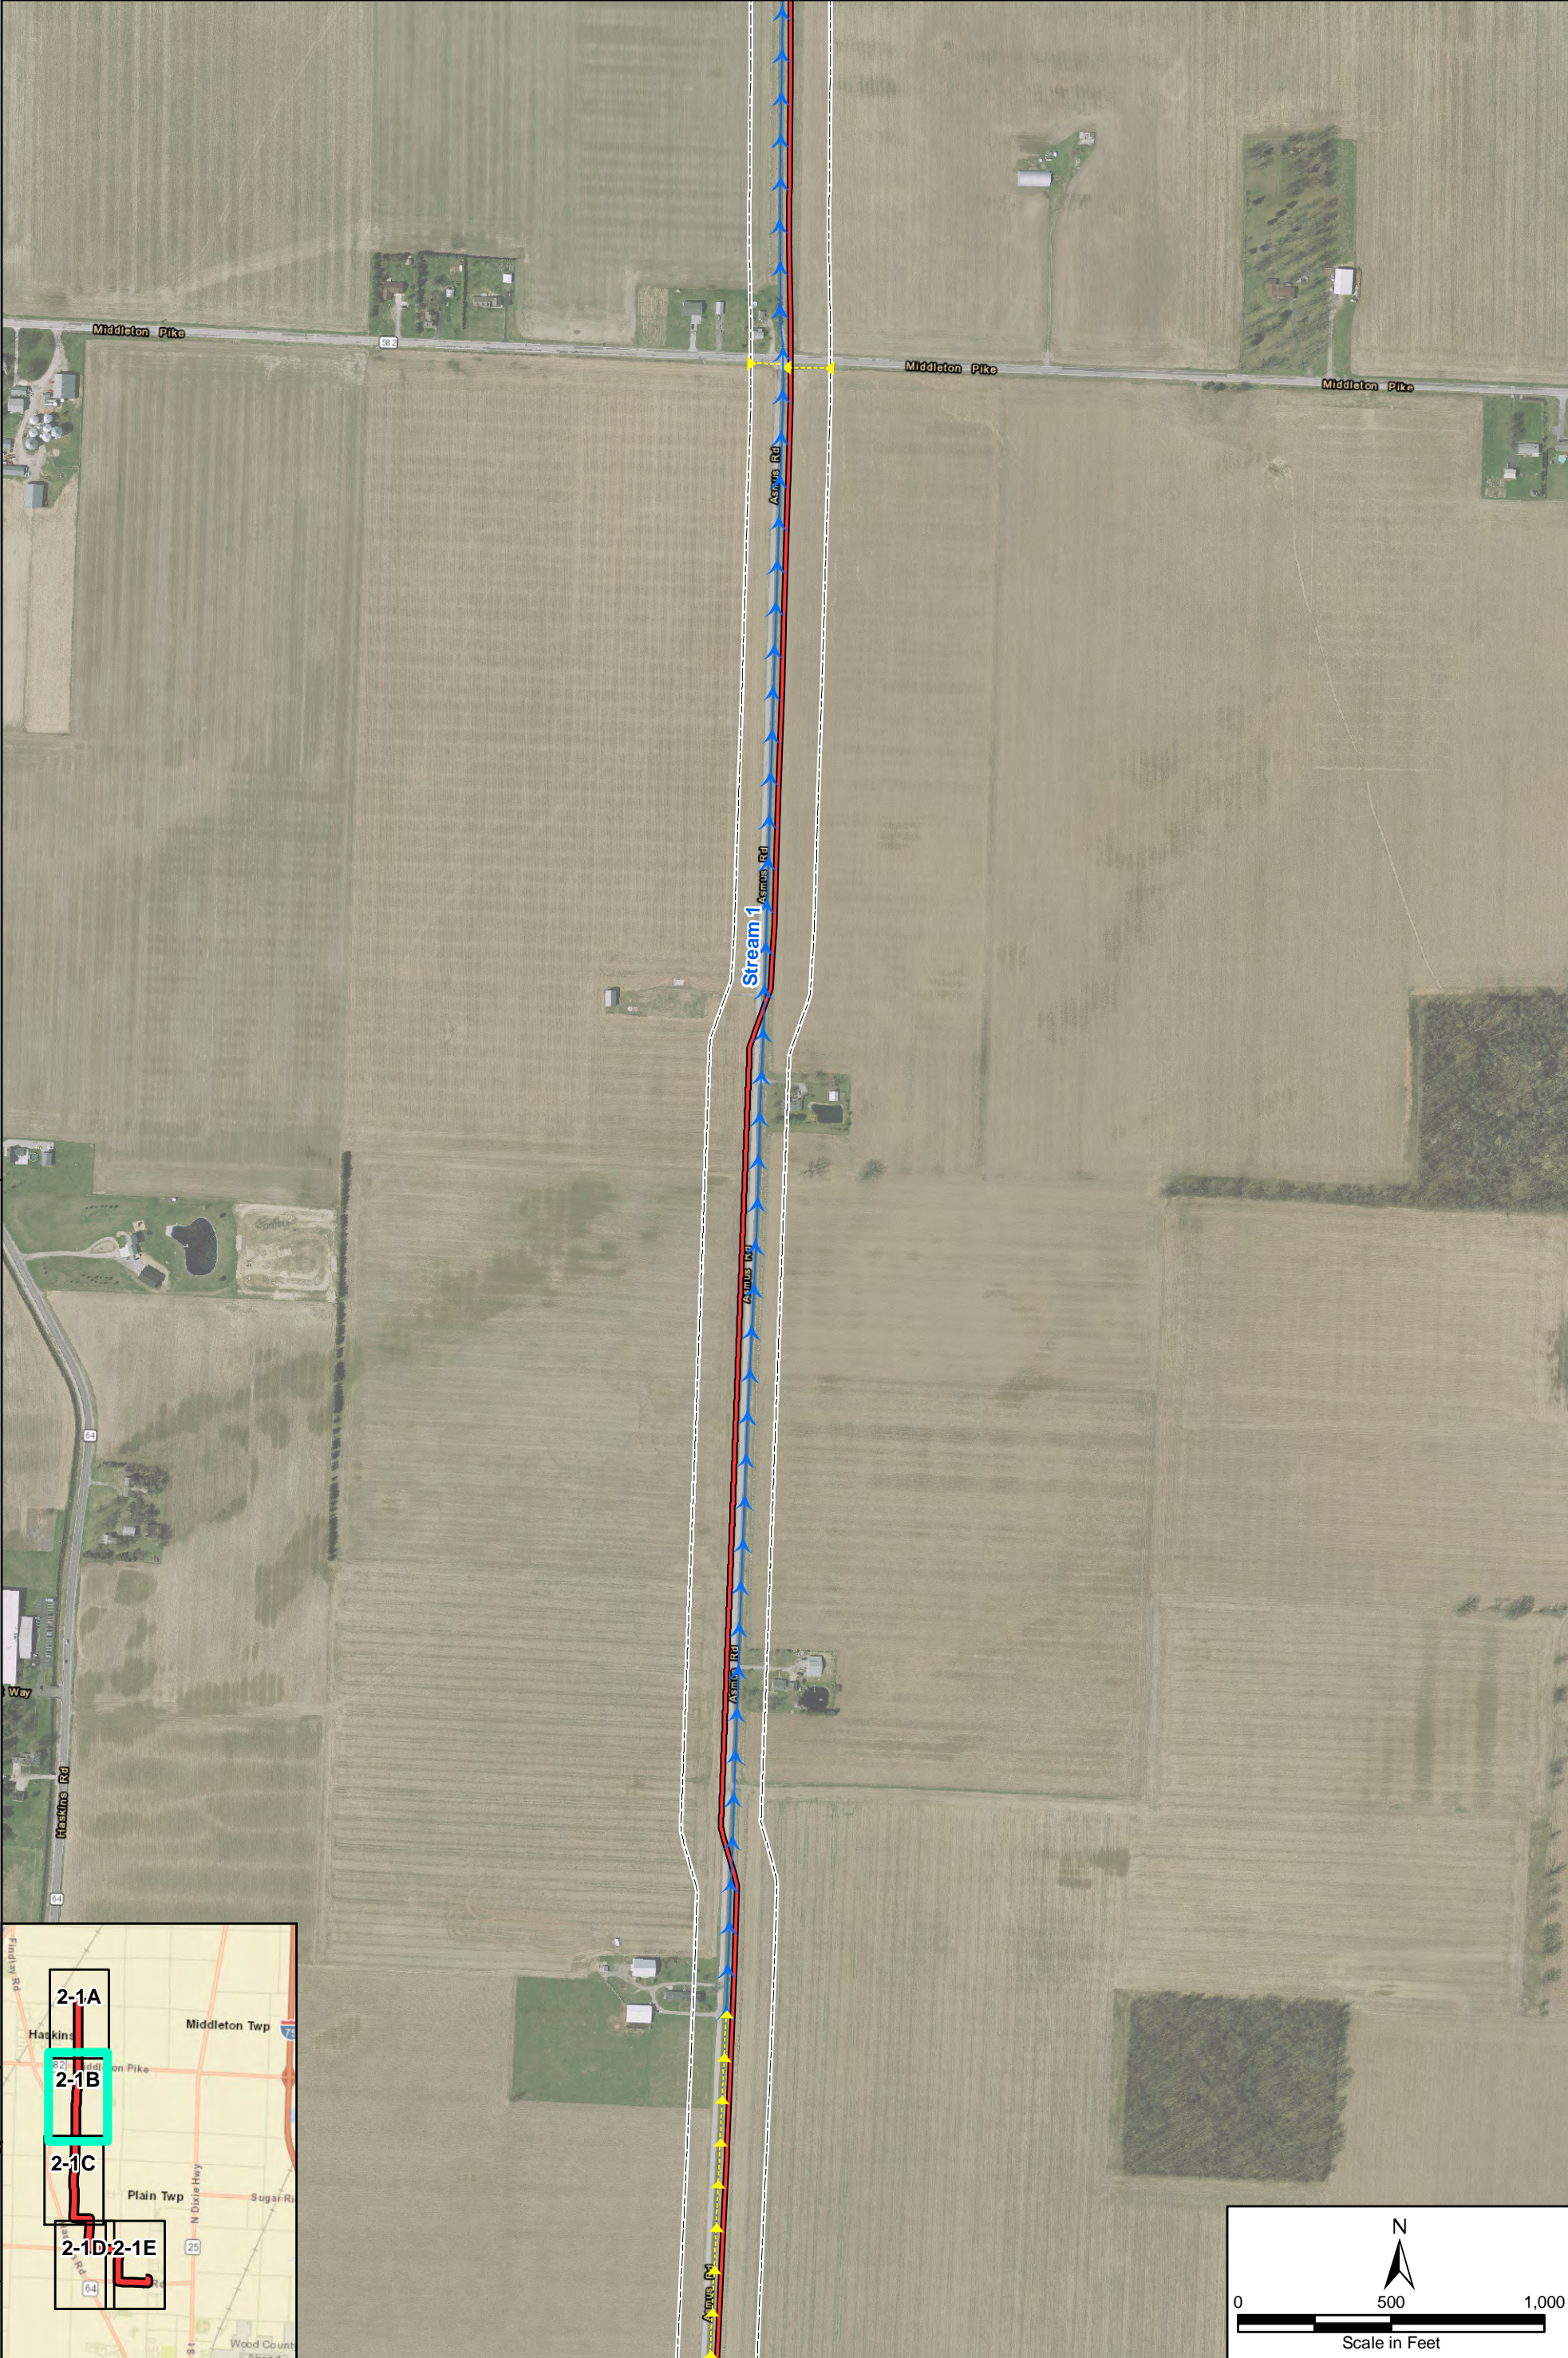
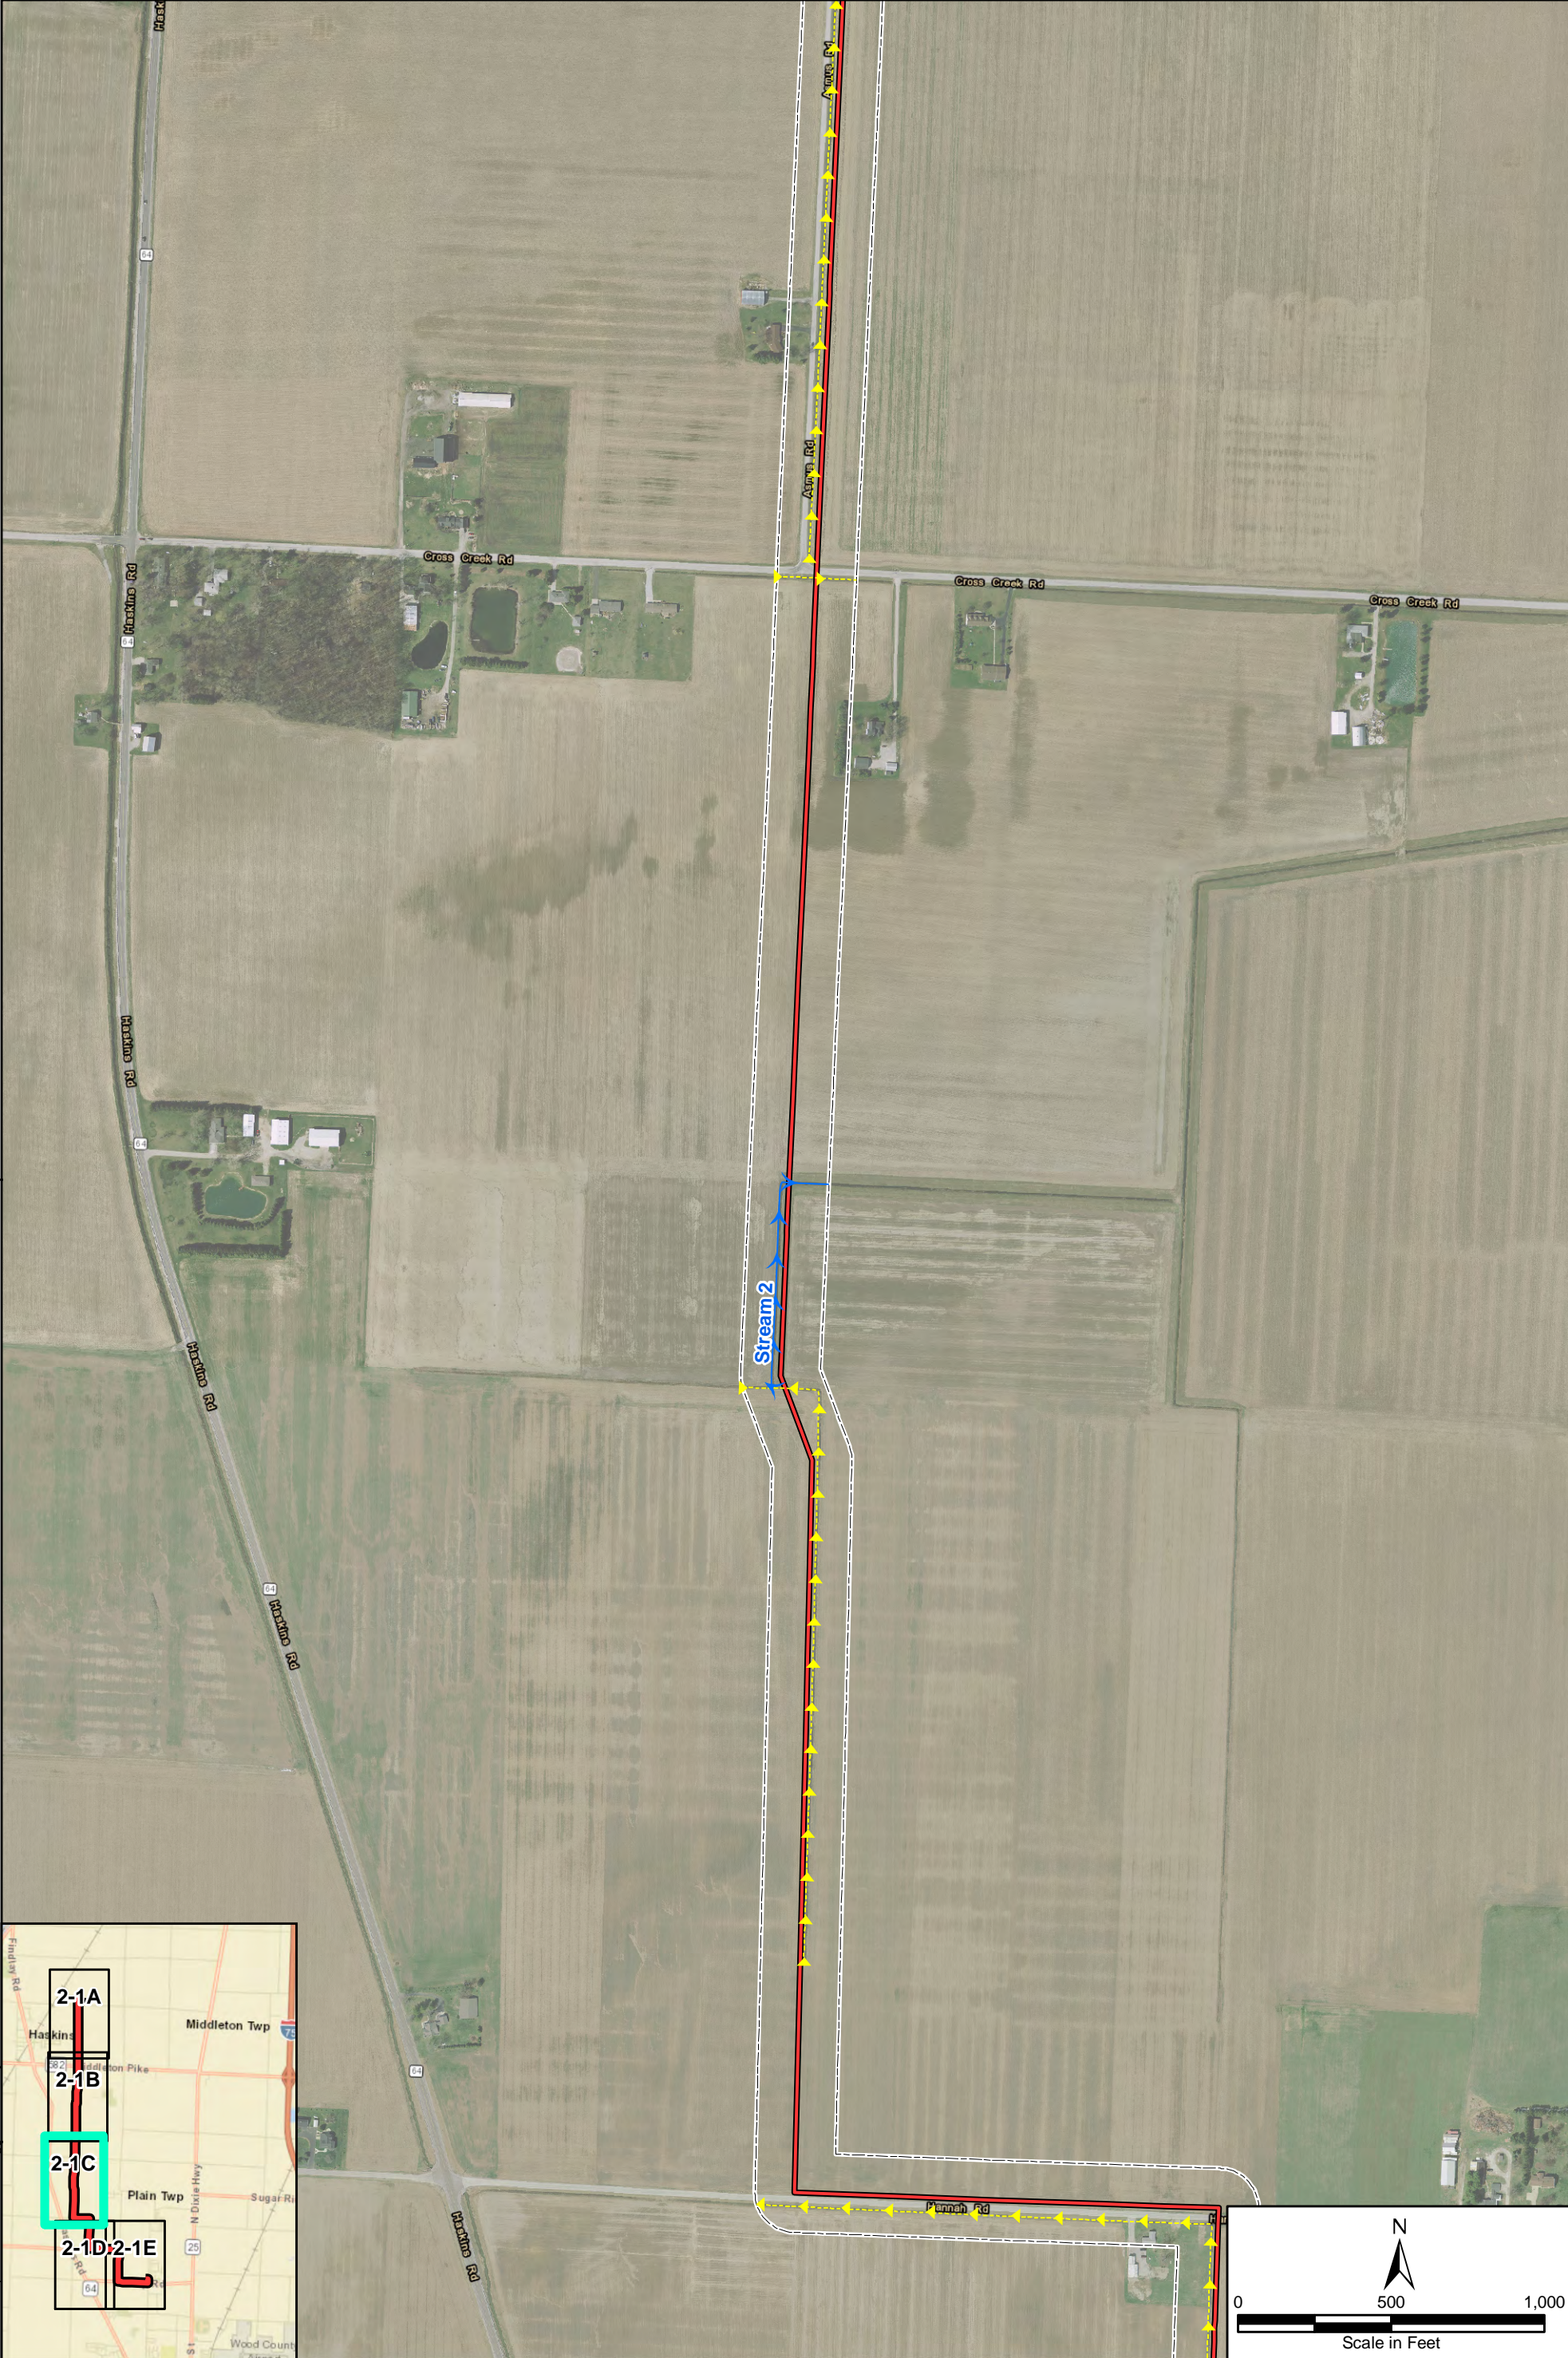
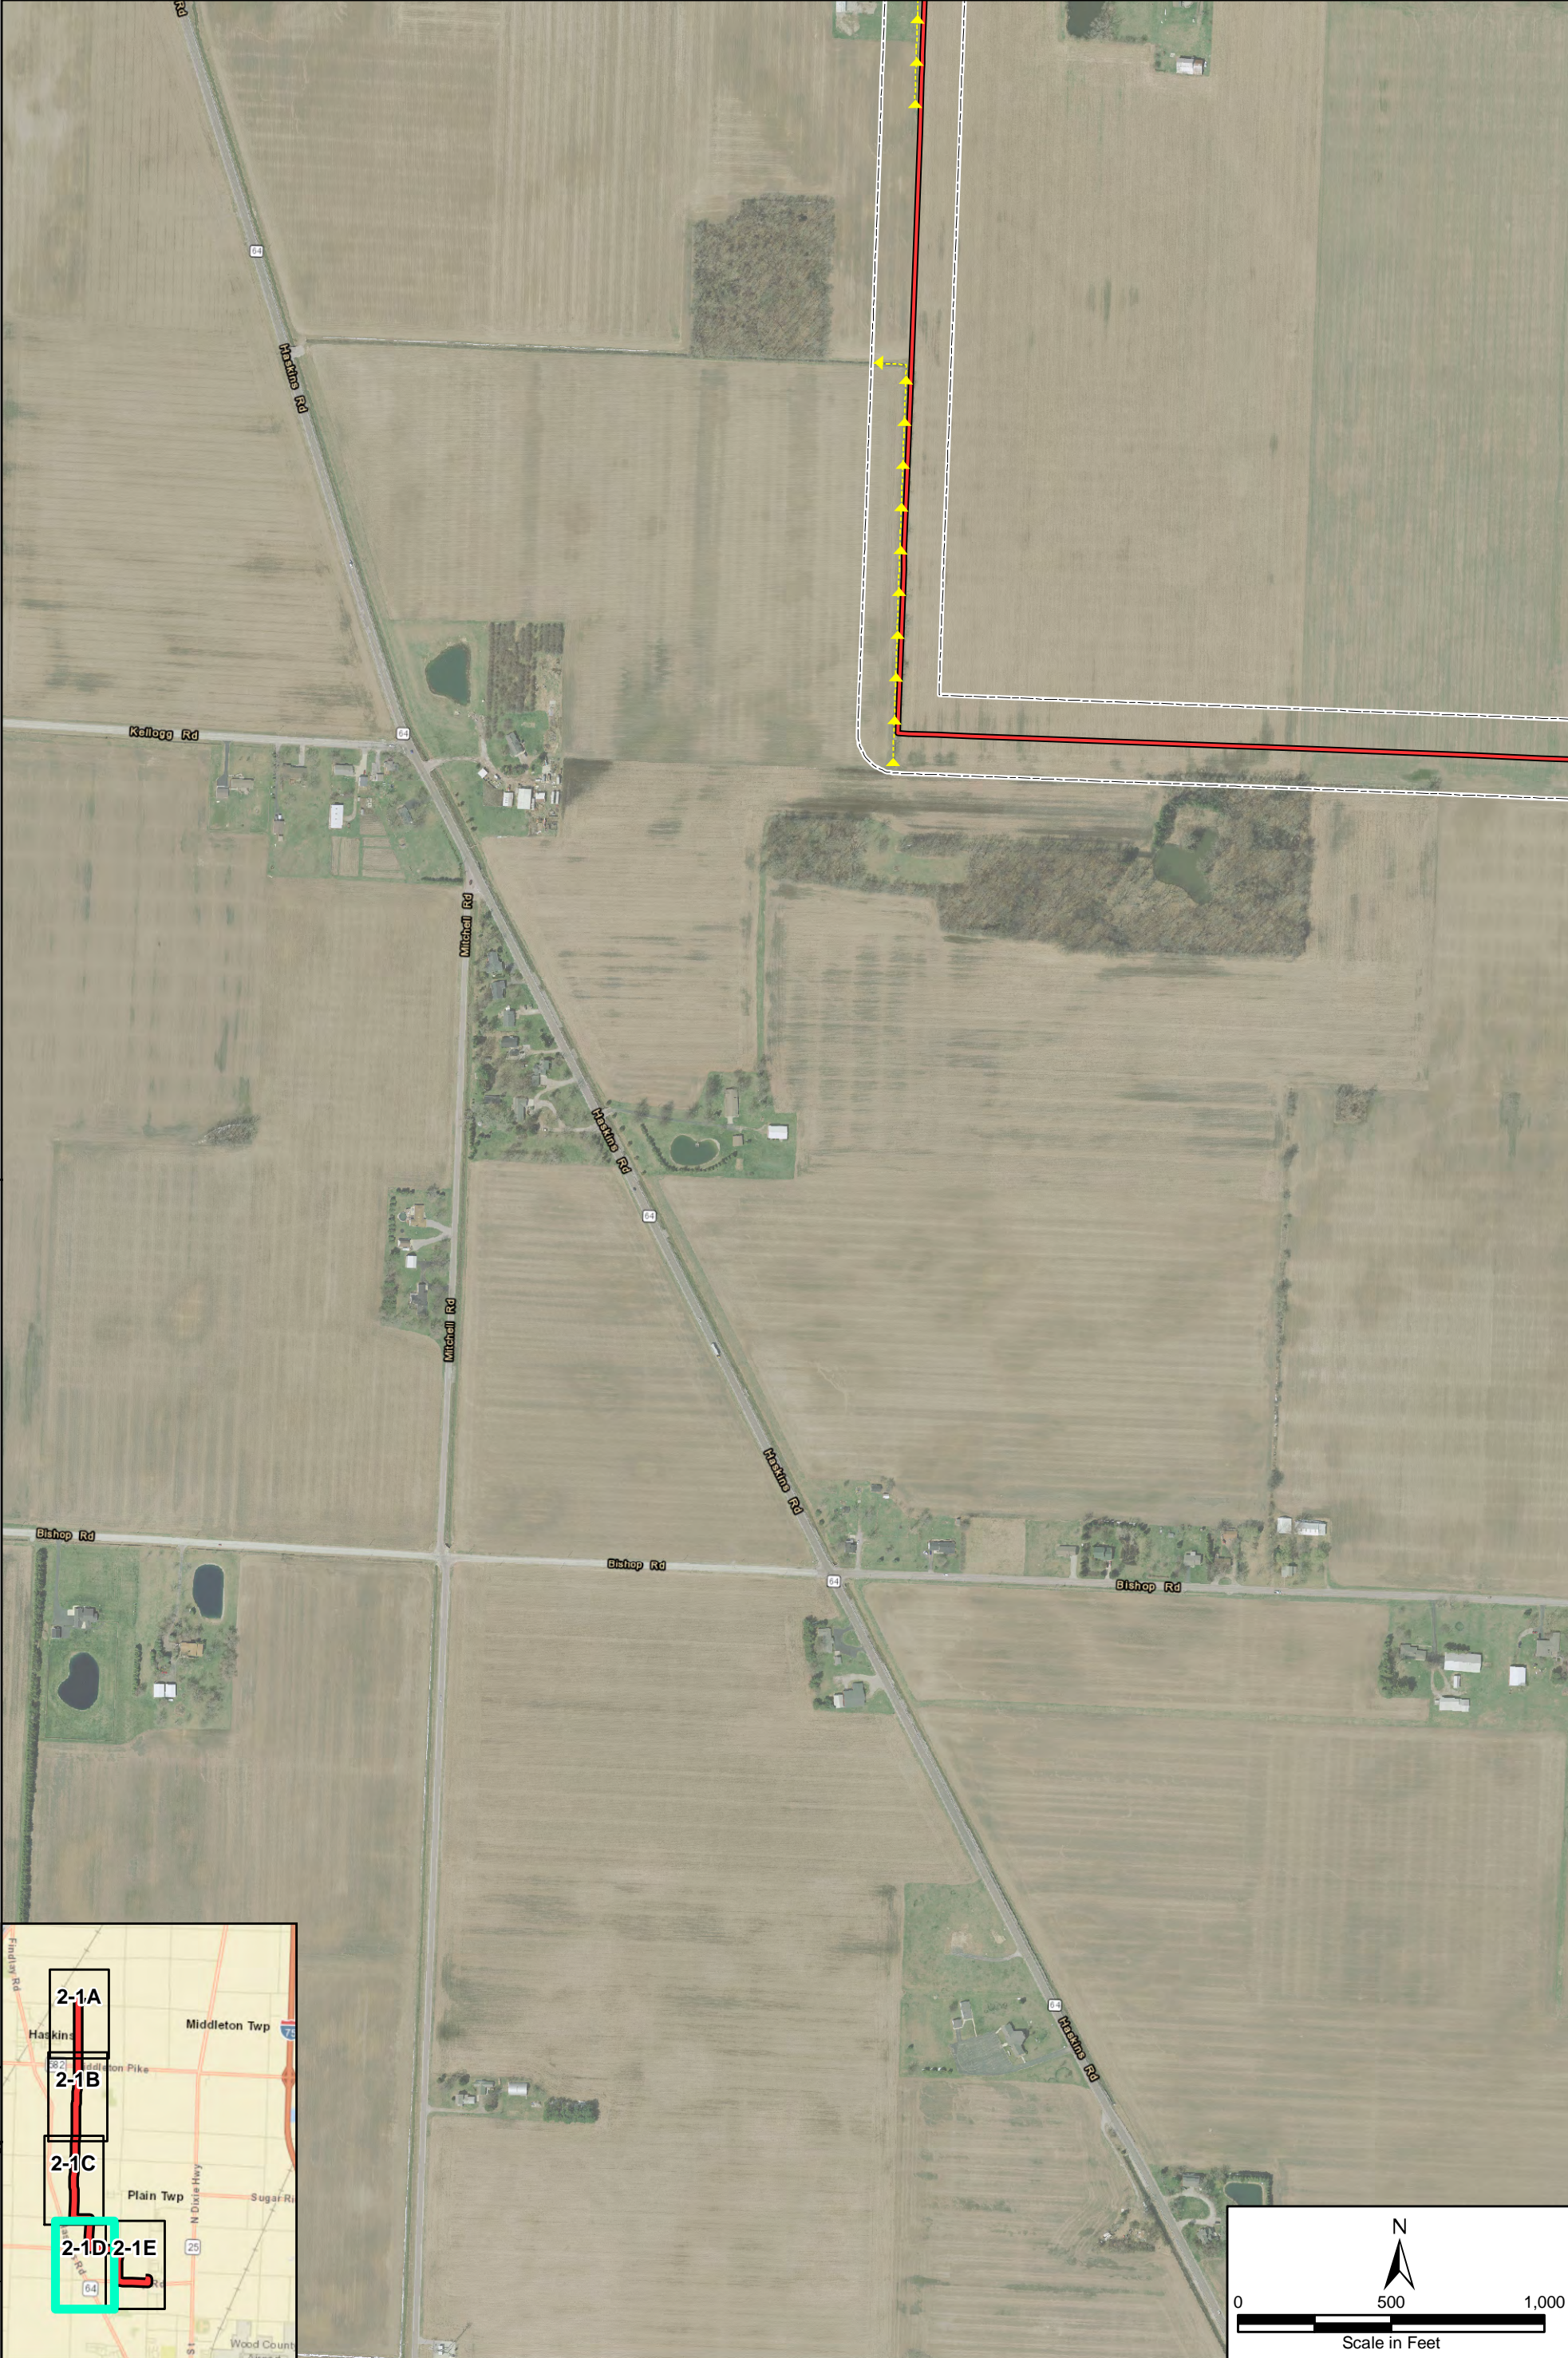
Based upon the field reconnaissance activities, four (4) streams and three (3) pond features were identified within the environmental survey area. No freshwater wetland features were identified within the environmental survey area. The streams were designated Stream 1, Stream 2, Stream 3 and Packer Creek and the ponds were designated Pond 1, Pond 2, and Pond 3. Delineated aquatic features are depicted on the Aquatic Features Location Map (**Figure 2**).
