Re: Case No. 18-1546-EL-BGN
Nestlewood Solar I LLC

A Survey for Kirtland's Snake (*Clonophis kirtlandii*) Habitats for the

Nestlewood Solar 1 Project,

**AMENDMENT TO WATERS OF THE US DELINEATION
AND ASSESSMENT FOR NESTLEWOOD SOLAR PROJECT
BROWN AND CLERMONT COUNTIES, OHIO**

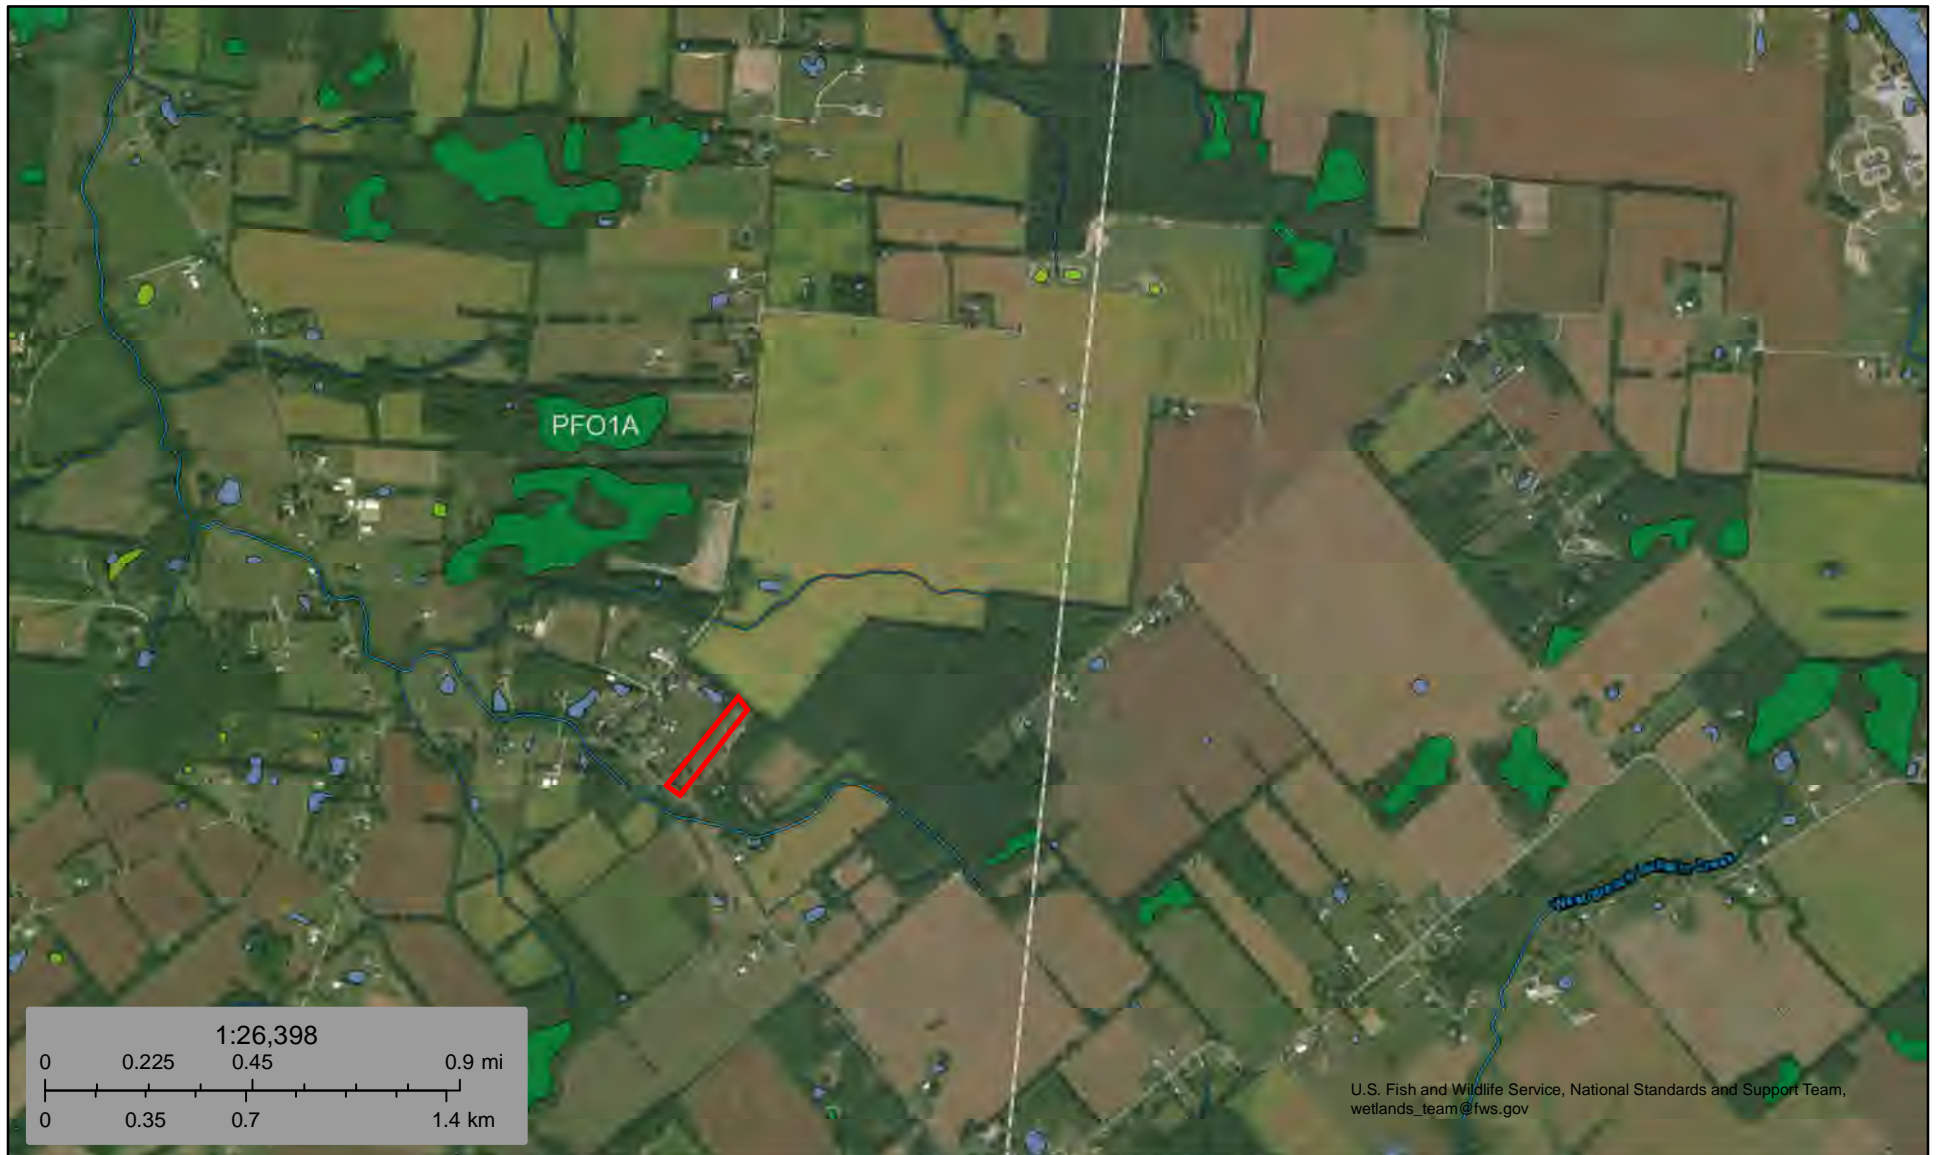
Background and Historical Information

A review of the NWI was conducted to determine the likely presence, location, size and type of wetlands that may be located on the subject property. NWI maps are compiled by the U.S. Department of the Interior, Fish & Wildlife Services (USFWS). These maps outline existing wetlands and deep-water habitats on individual (USGS) topographic maps. NWI maps are prepared by stereoscopic analysis of high-altitude aerial photographs obtained during the following years: 2002, 2005, 2010, and 2015. The aerial photographs typically reflect conditions during the specific year and season when they were taken.

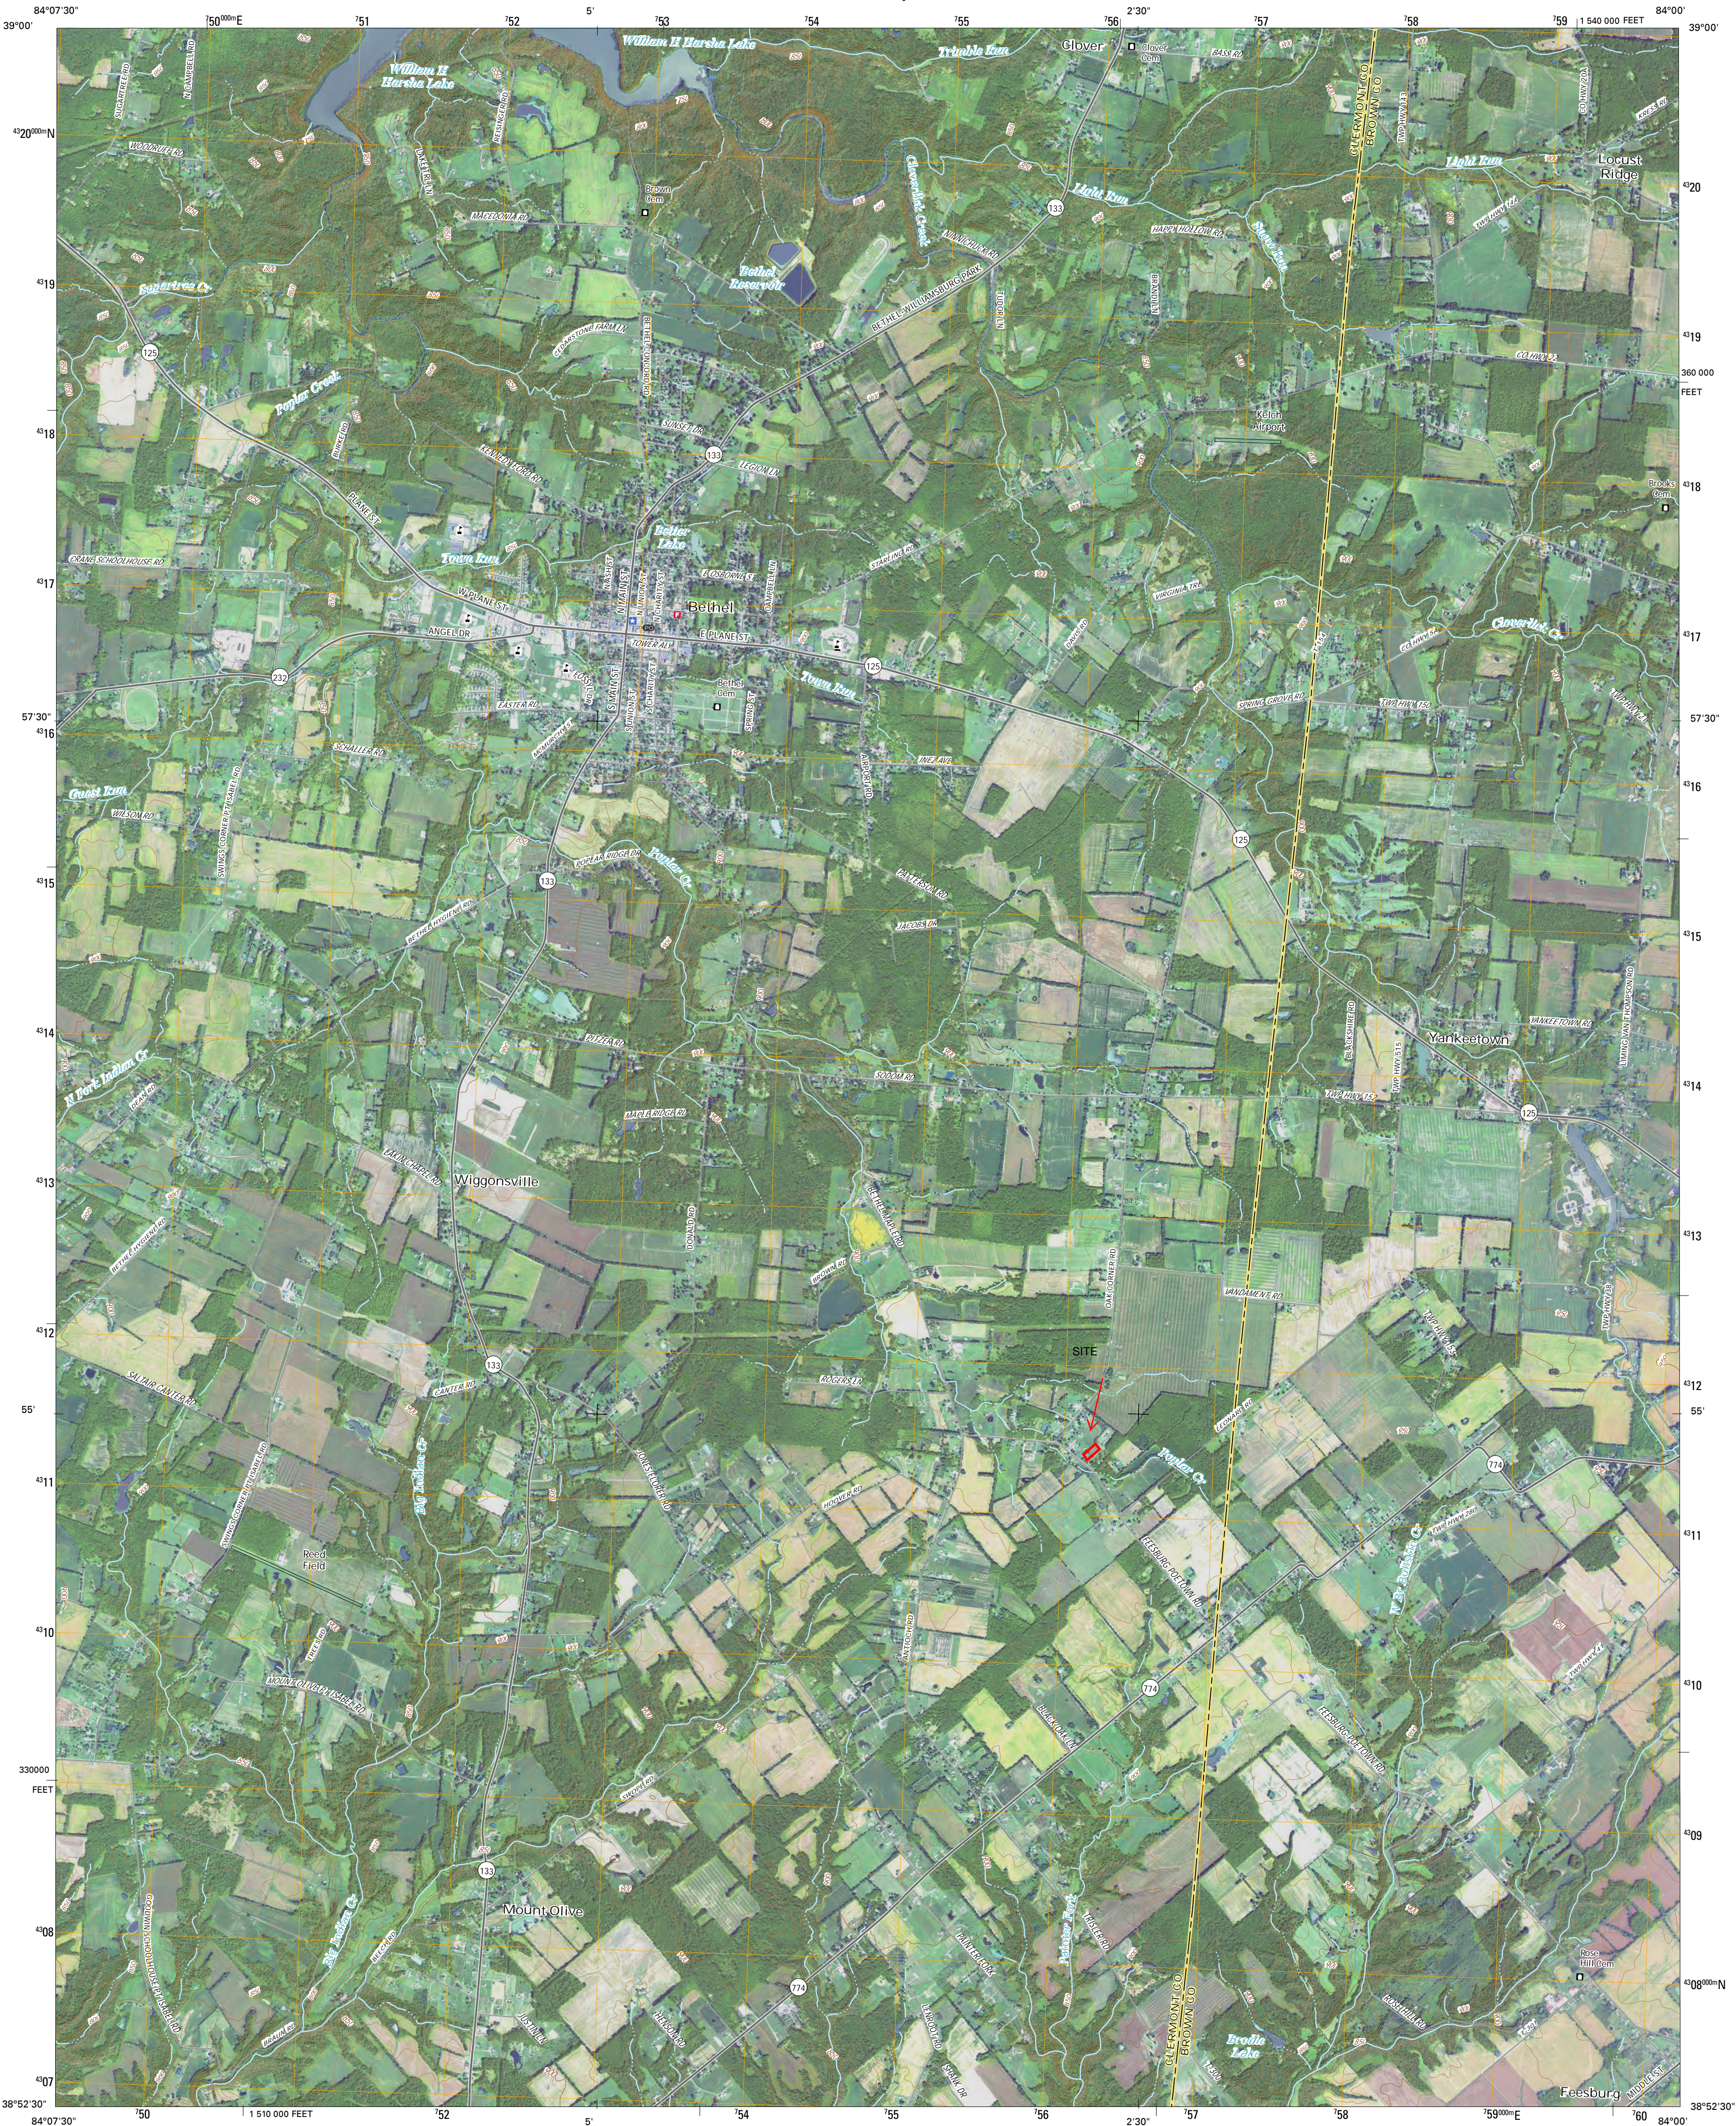
BETHEL QUADRANGLE
OHIO
7.5-MINUTE SERIES

The Project Area is situated east of Bethel Maple Rd, north of Leonard Road, and south of Oak Corner Road. The elevation on the Project Area is approximately 935-feet above mean sea level. Wetlands are not indicated on the map. One blue line water feature

(stream) is shown, identified as Poplar Creek, just west of the area investigated. This stream eventually drains into the Little Miami River via Big Indian Creek.

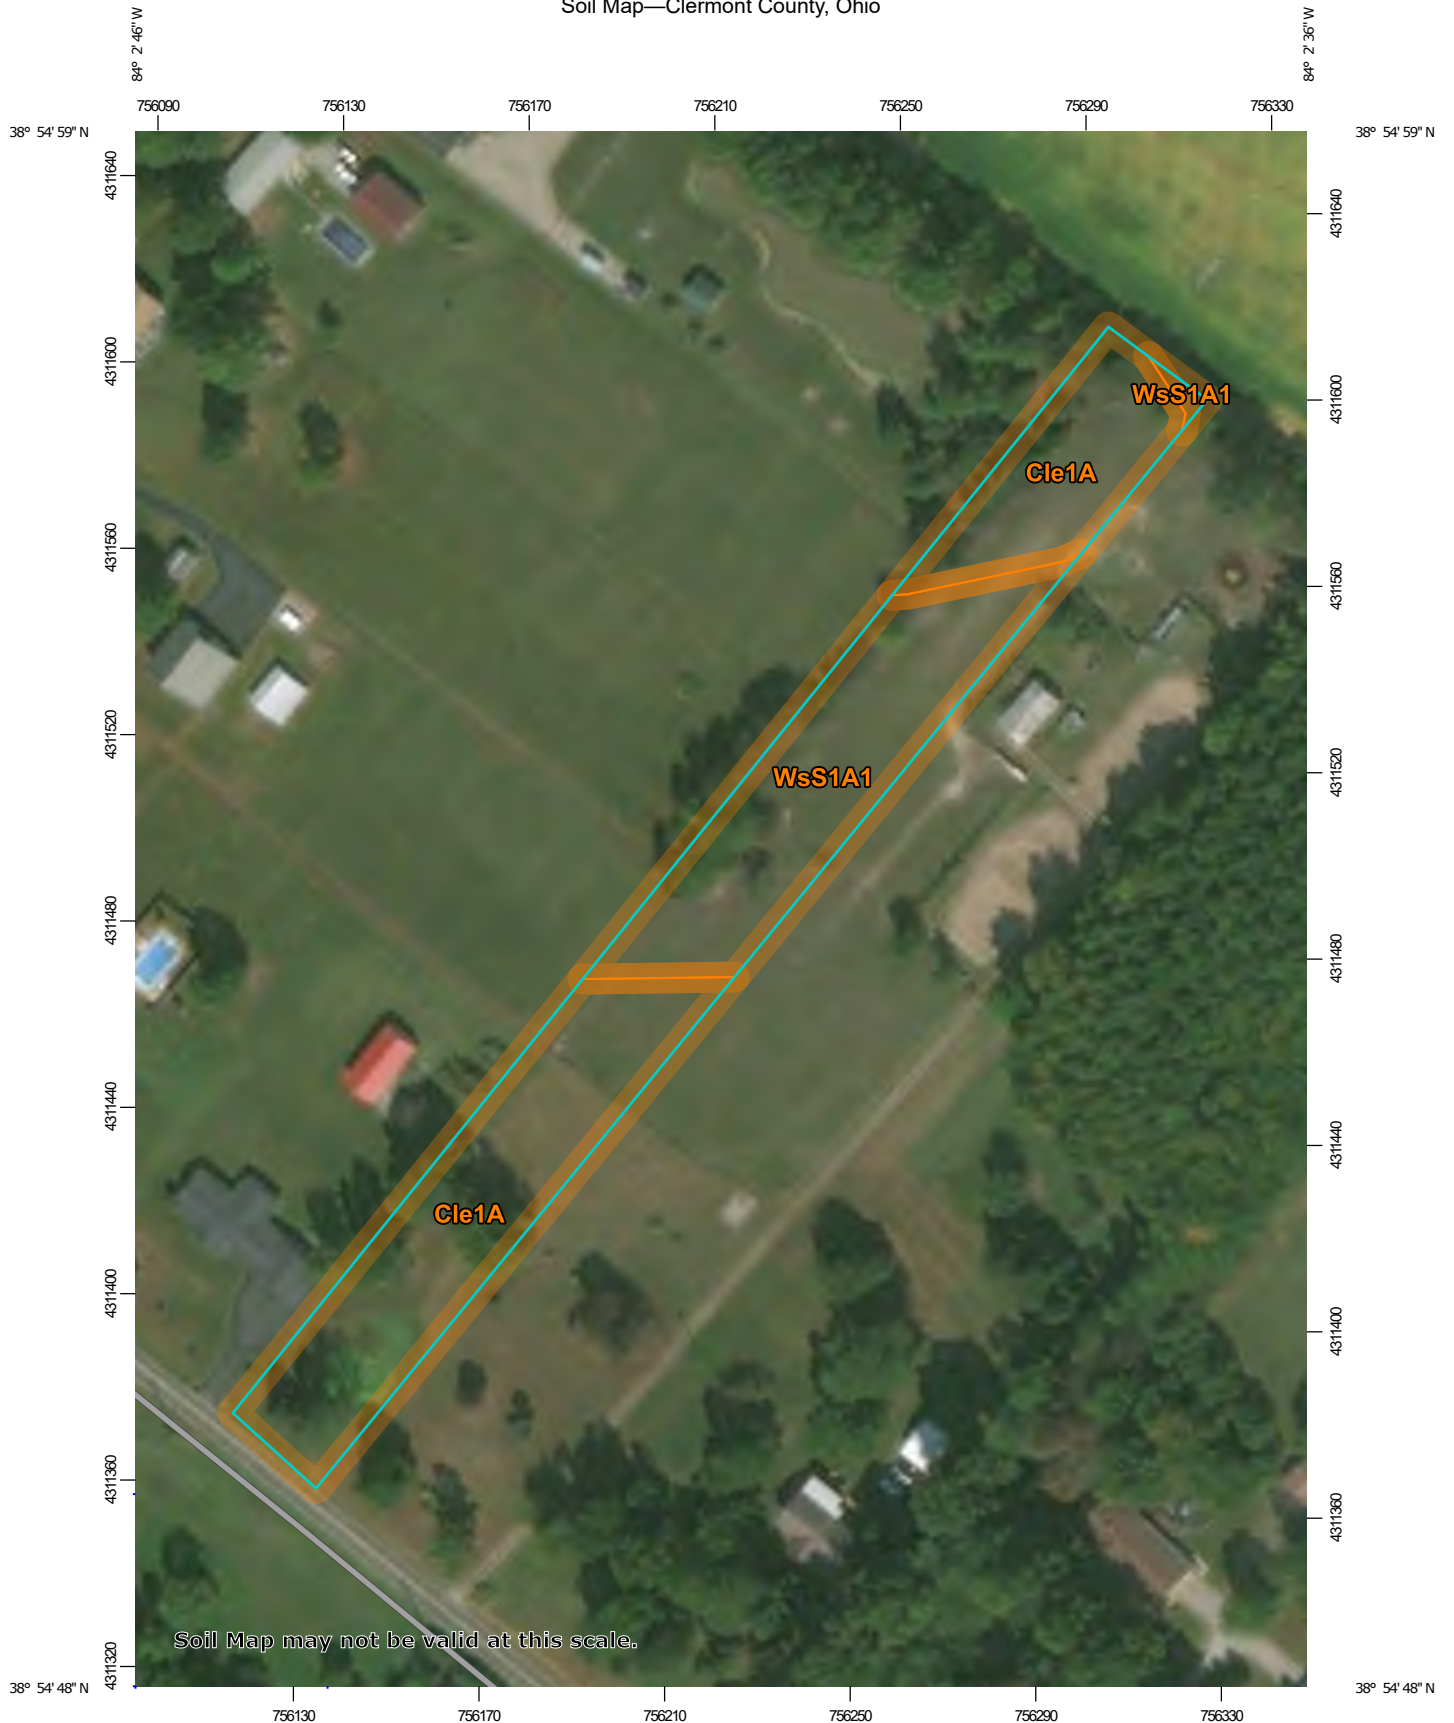
Soil Map—Clermont County, Ohio

The *Soil Survey of Clermont County, Ohio* depicts four soil series within the Project Area. Relevant information for the mapped soil types is included below:

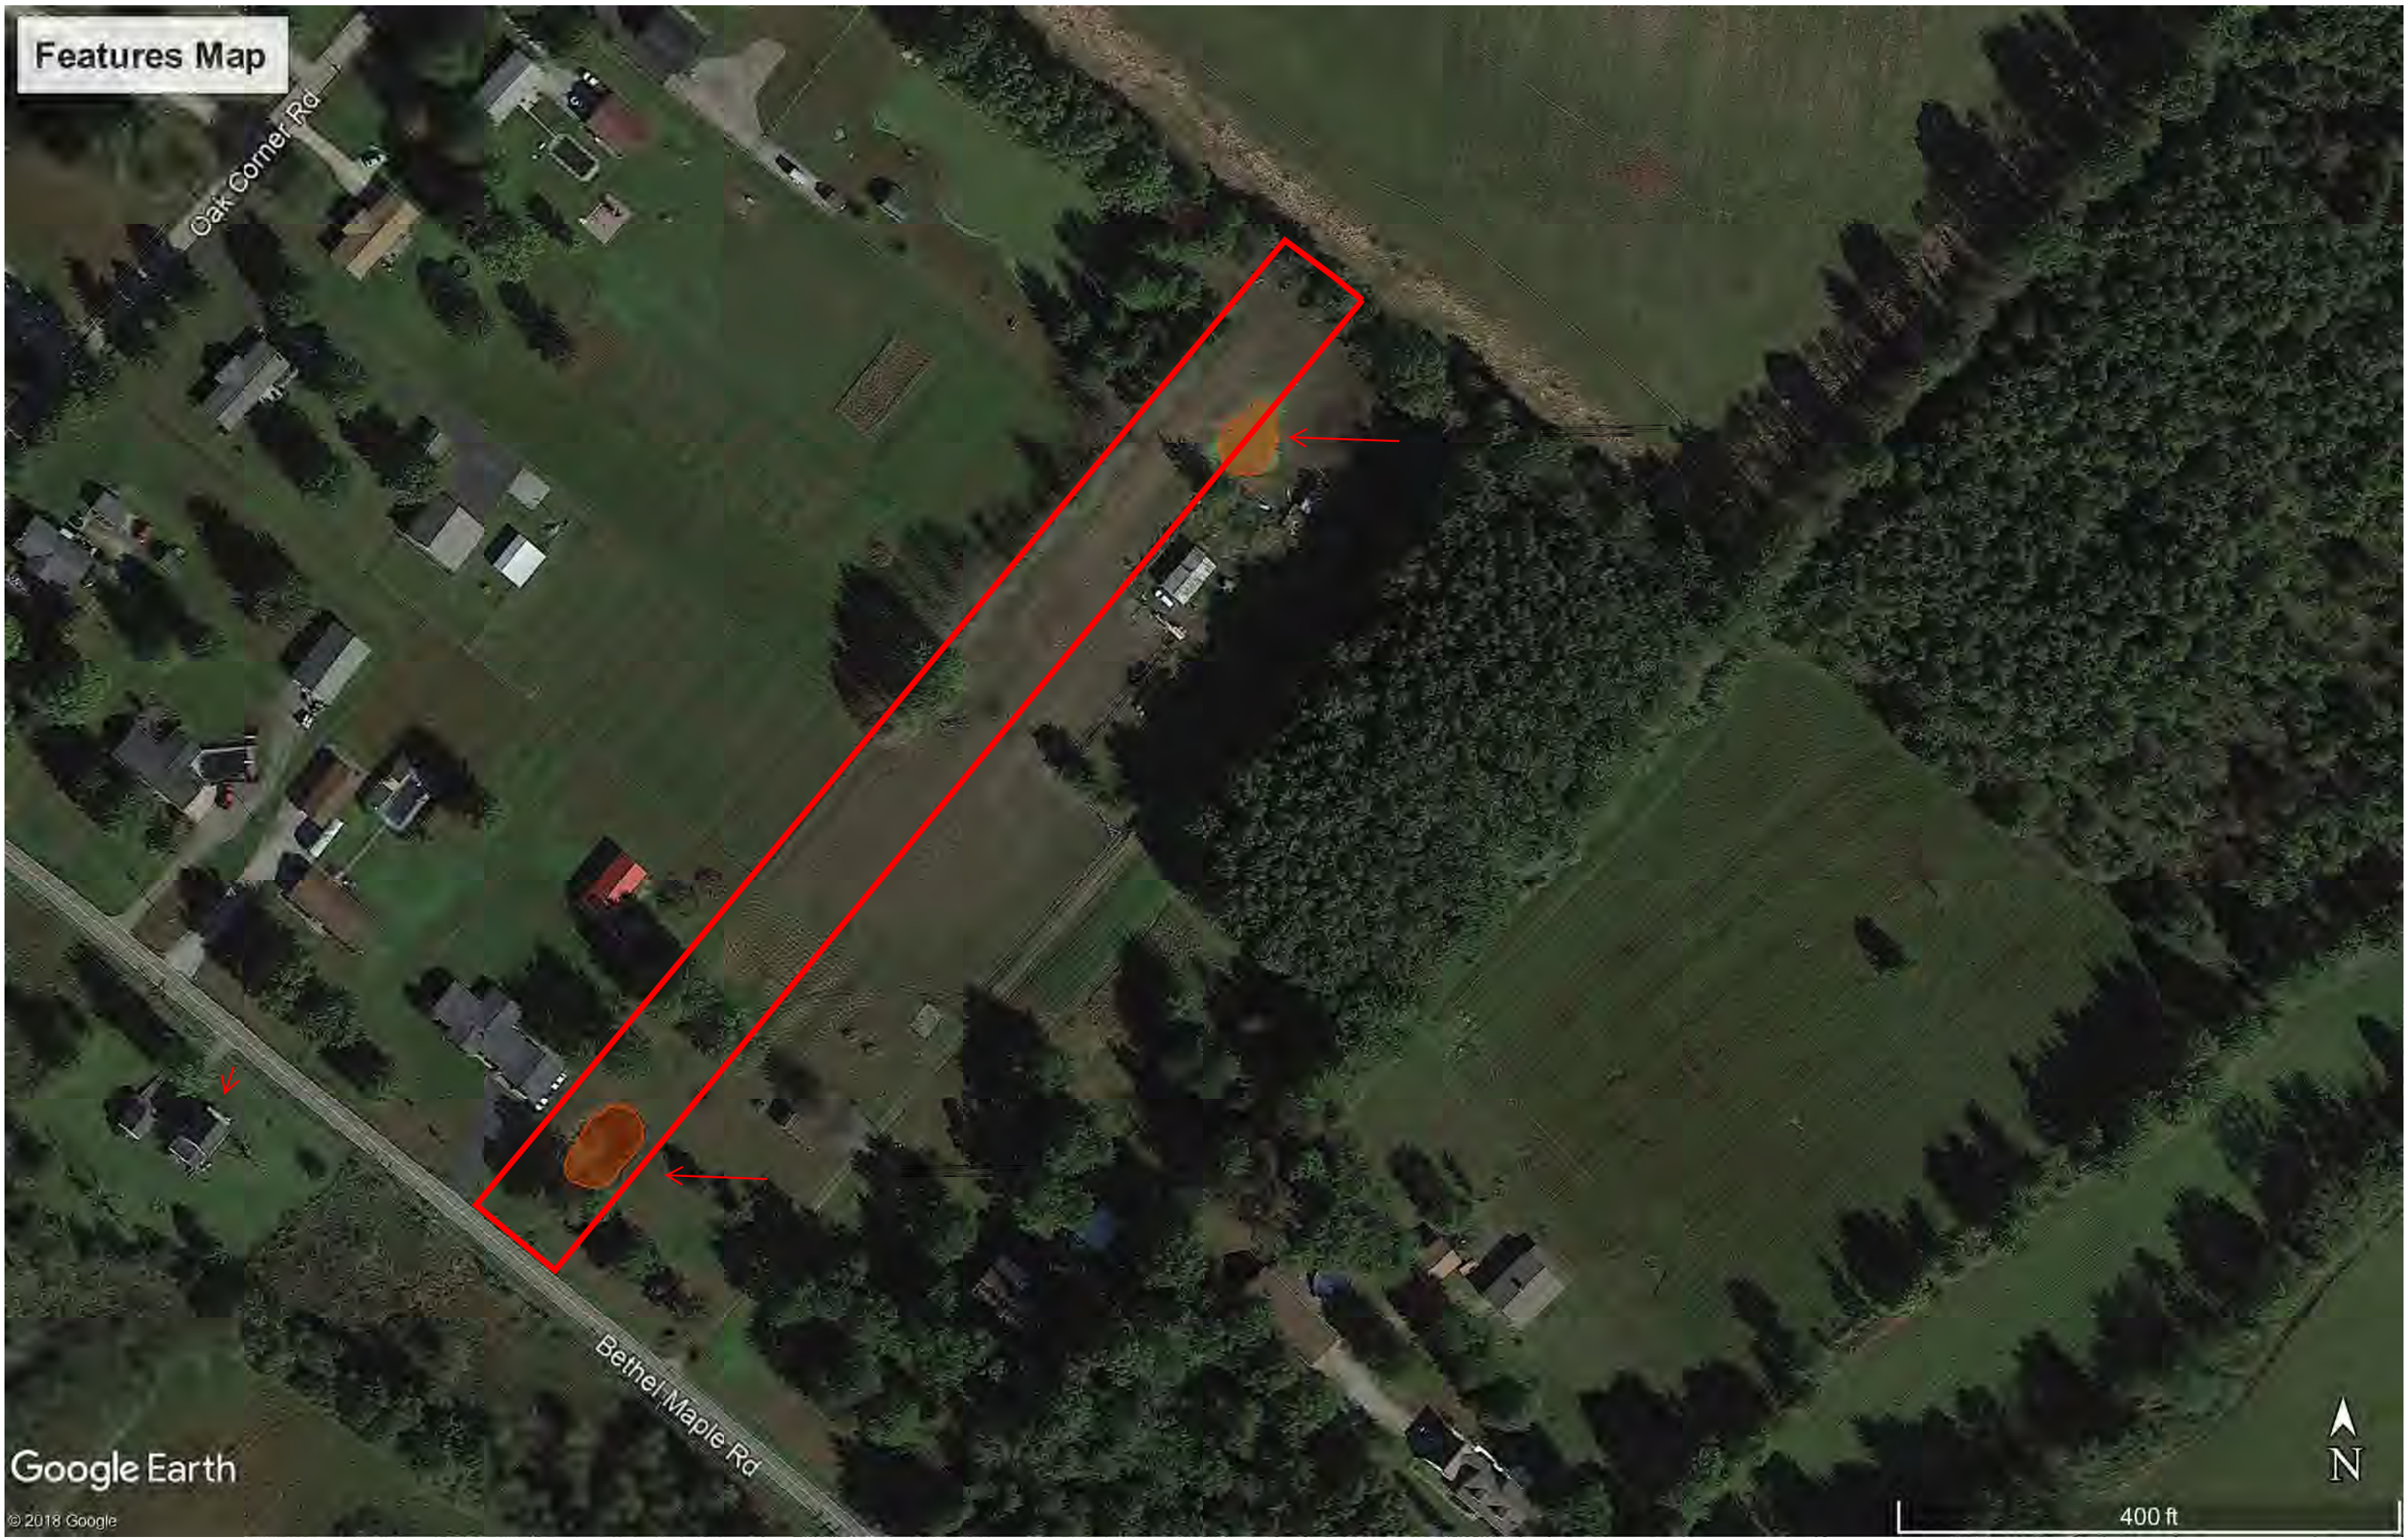
Features Map

Site reconnaissance revealed the majority of the Project Area was mowed/maintained and used for cattle grazing. No wetlands were delineated. Two open water ponds were observed in the Project Area. The above referenced features are identified on the *Features Map* provided in Appendix C. A discussion of the features situated in the Project Area follows.

The open water features were observed in the potential easement area along Bethel Maple Road with connectivity to Poplar Creek. They both totaled 0.1 acres in aerial extent.

In conclusion, the majority of the 1.9 acre Project Area is mowed/maintained, and no wetlands were observed or delineated. The ponds are both considered to be WOUS and jurisdictional because of their connection to the on-site Poplar Creek which drains to the off-site Big Indian Creek, that eventually drains into the Little Miami River.

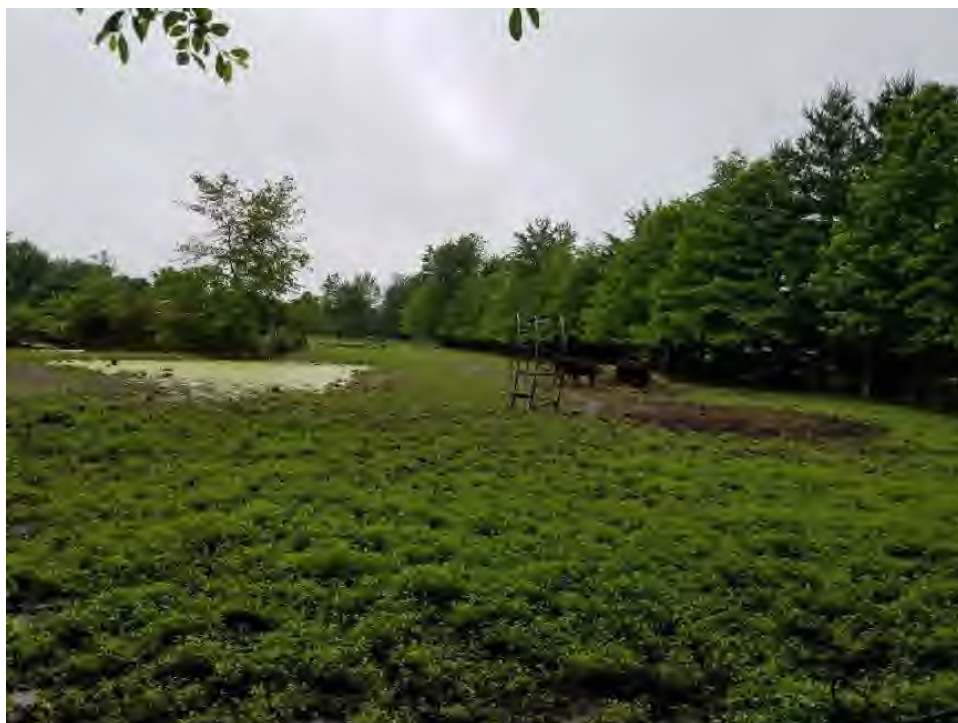
Photograph 1 Looking southwest from northeast side of Property, note small open water pond

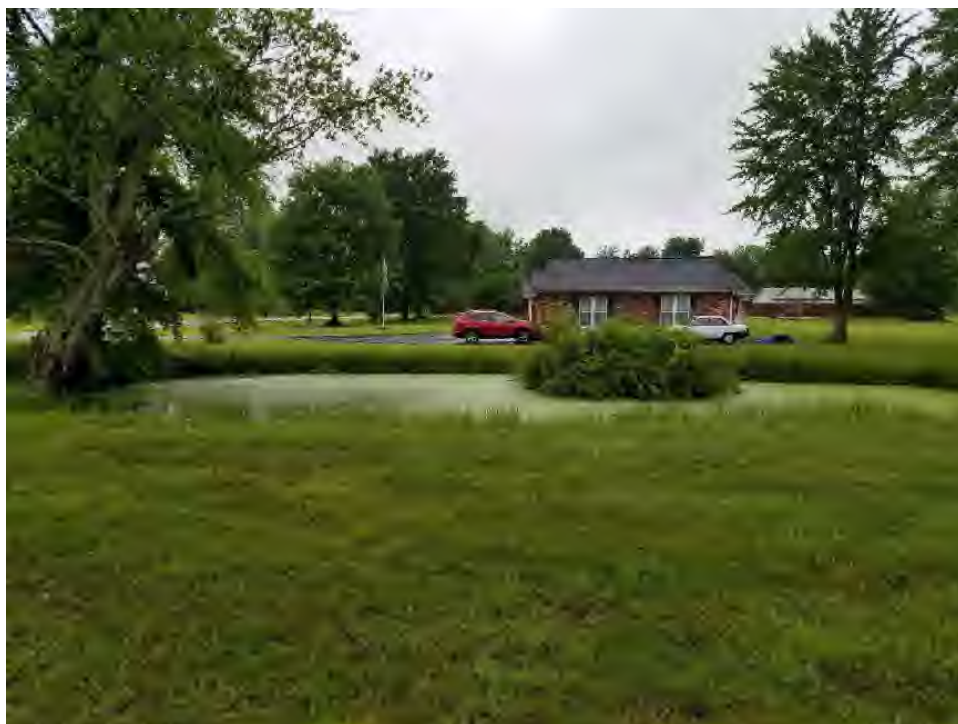
Photograph 2 Looking northwest to open water pond on southwest side of Property

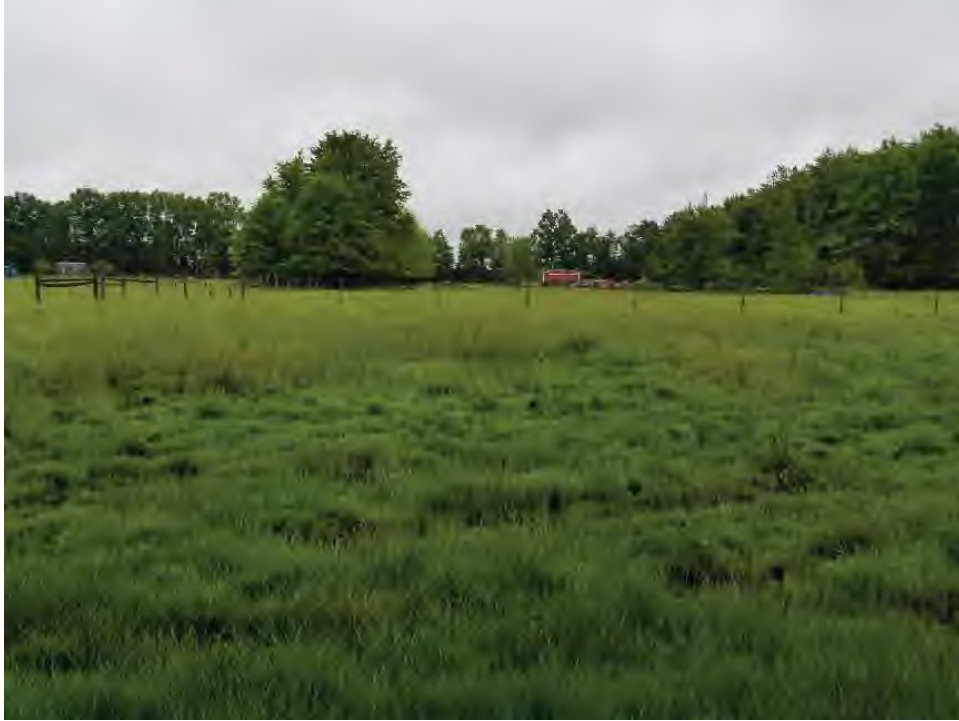
Photograph 3 Looking northeast between open water ponds
