Wetland and Waterbody Delineation Report

Hardin Wind LLC

Scioto Ridge Transmission Line

Prepared for Hardin Wind LLC
Project Name Scioto Ridge Transmission Line
Project Number E319500401
Project Manager Ryan Rupprecht
Date August 2019

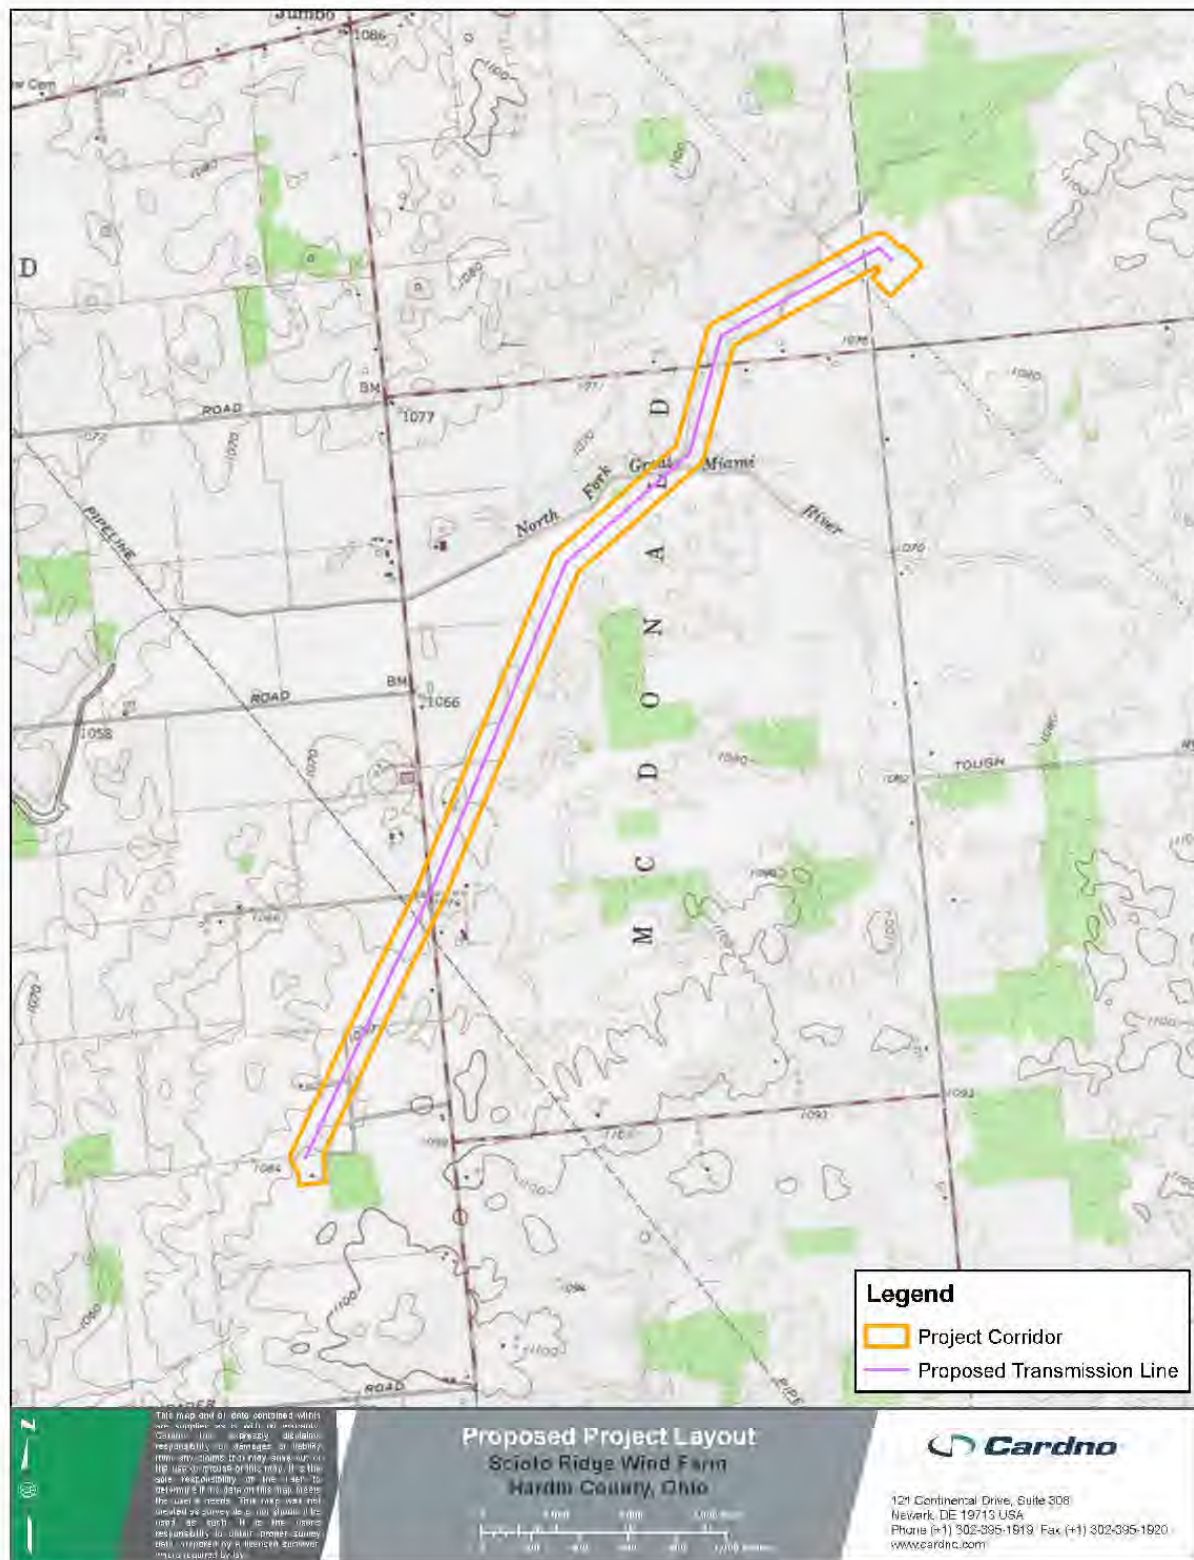
Figure 1.1 Project Overview

Hardin Wind LLC proposed construction of the Scioto Ridge Transmission Line (the Project) in Hardin County, Ohio to the Ohio Power Siting Board (OPSB) under case 13-1768-EL-BTX in 2013. On March 17th, 2014 the OPSB certificated the Scioto Ridge Transmission Line Project. As certificated, the Project involves construction of a 345 kilovolt (kV) transmission line and Point of Interconnect Substation within a 120-foot right-of-way (ROW) extending approximately 5 miles to connect the Scioto Ridge wind Farm Collector Substation to the Point of Interconnect Substation. The Project will deliver power from the Scioto Ridge Wind Farm to American Electric Power's East Lima – Marysville 345kV Line. For this Wetland Report, Cardno reports on the desktop and field delineations within the Project Corridor (200-feet on either side of proposed infrastructure). The Project Corridor consists of 156.28 acres in McDonald Township, as shown in Figure 1.1.

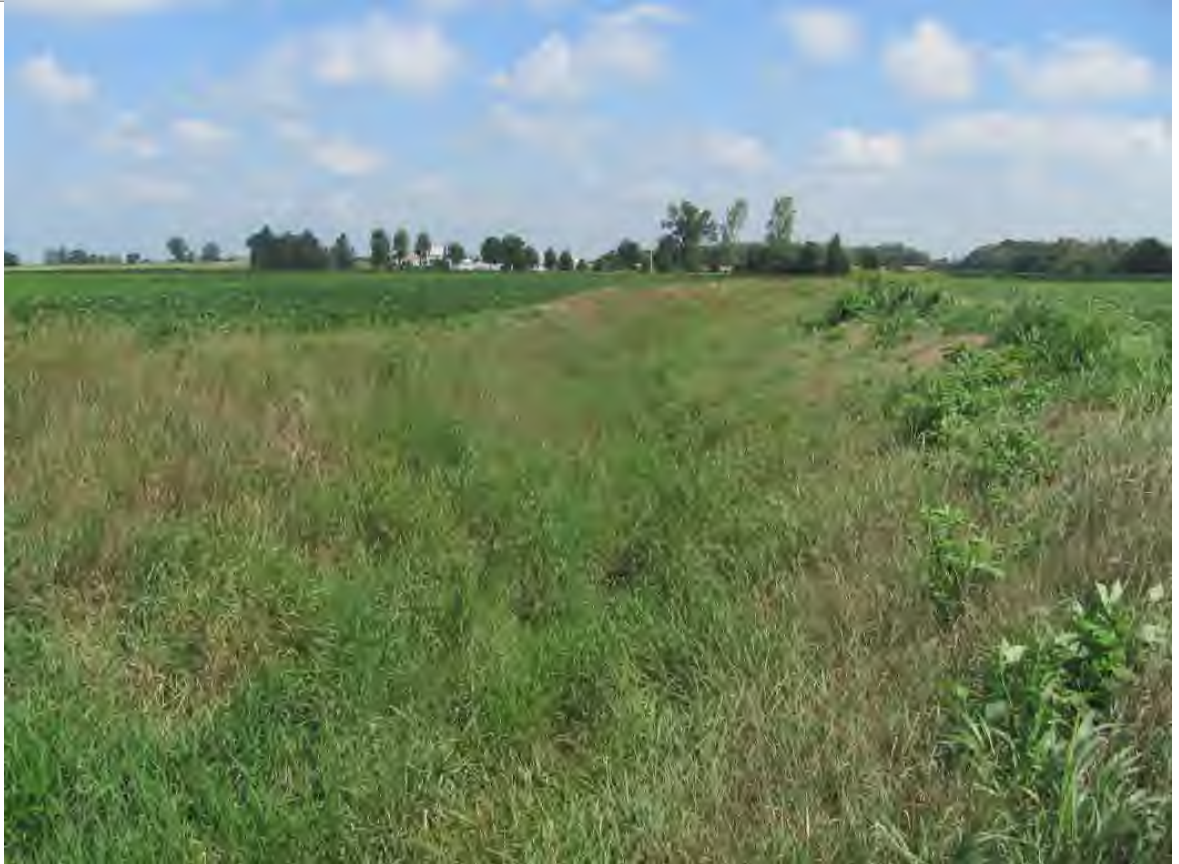
Description: Typical conditions along SOH-034 which was located between two active crop areas with grassy banks. Vegetation along banks obscured several field tiles that were draining into feature.

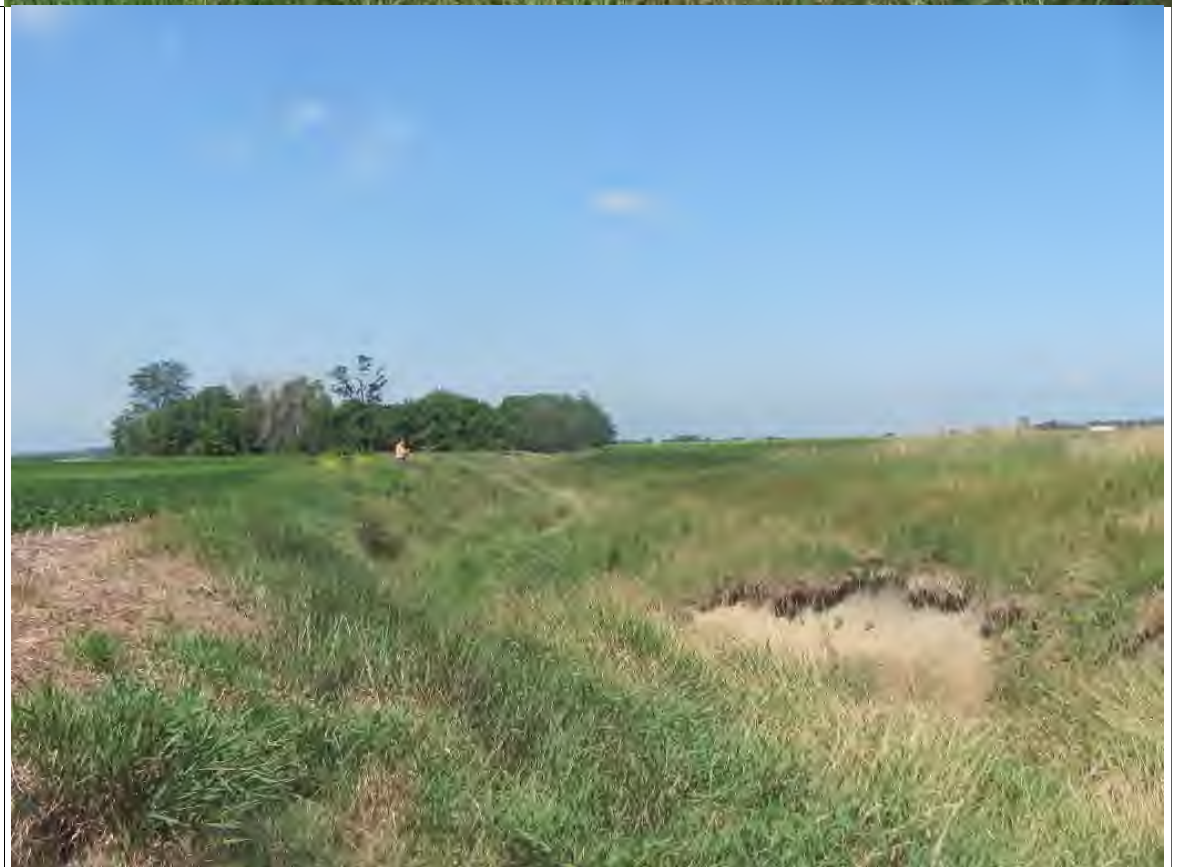
Photo: SOH-018 Typical

Description: Typical conditions along stream which was located between two active crop areas with grassy banks. Vegetation along banks obscured several field tiles that were draining into feature.

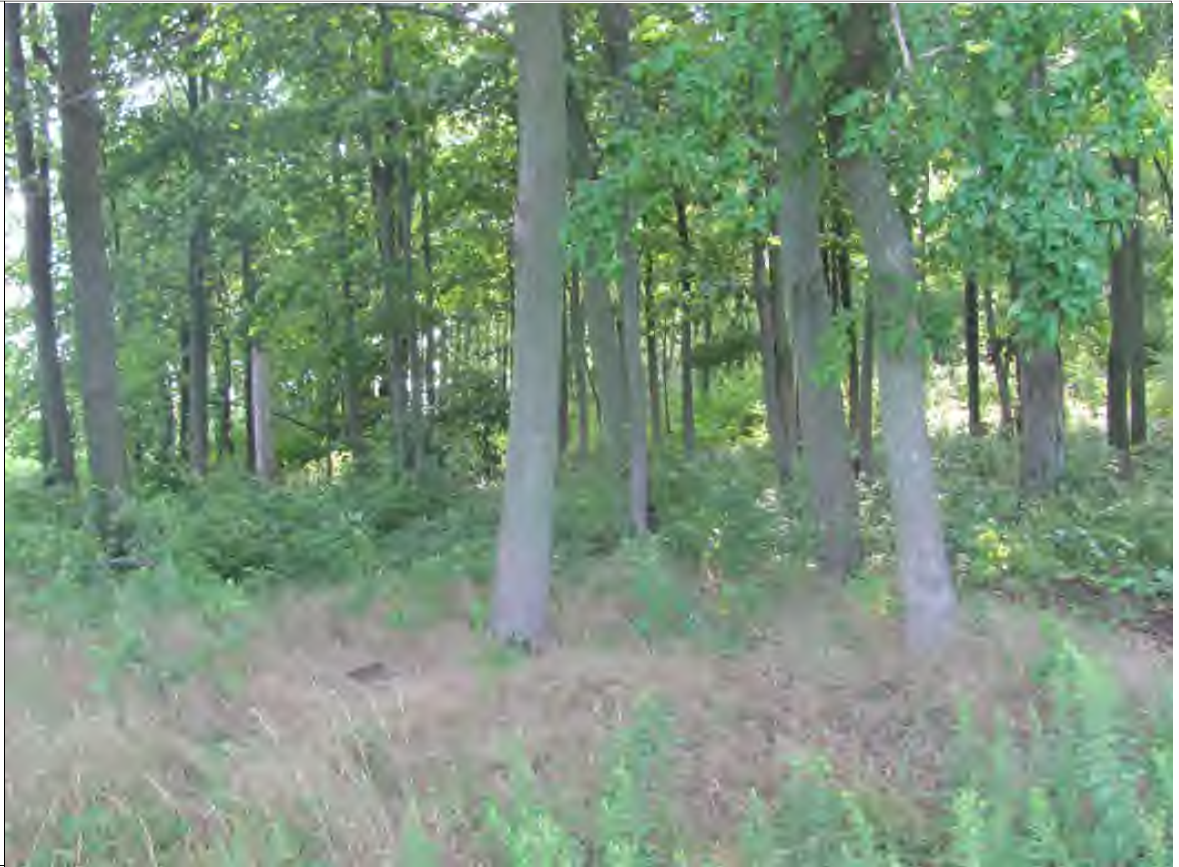
Photo: Habitat Typical

Description: Photo of a woodlot (near SOH-018) with no evidence of wetlands that had been previously mapped as potential wetland. No wetlands were found during field verification. Many of the potential sites exhibited similar compositions of upland species and lacked hydrology.

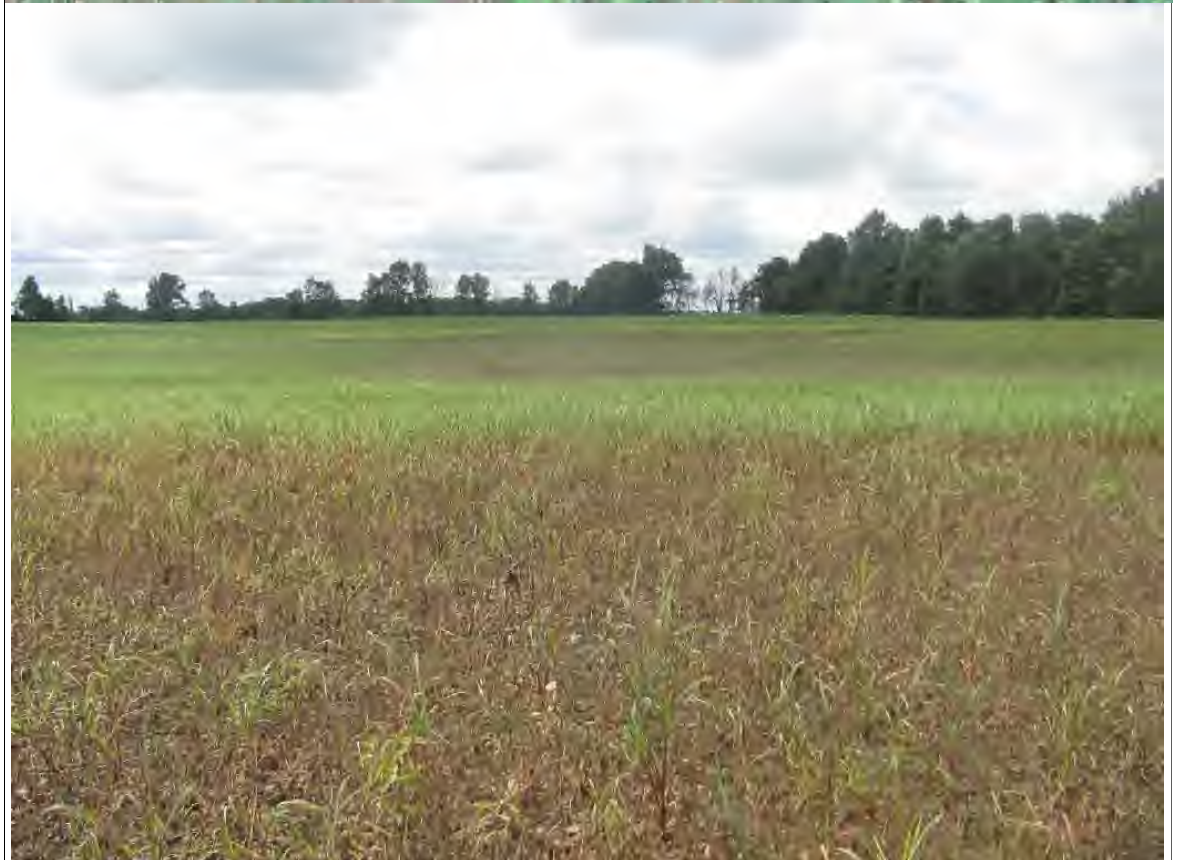
Photo: Habitat Typical

Description: Typical farm conditions during the time of the survey. The Project Corridor is dominated by active crop areas such as this. The crops grown likely cycle between corn/soy/wheat depending on market conditions and crop rotation schedule.
