## **Wetland and Waterbodies Delineation Report**

**Marysville Connector Pipeline  
Project**

Wetland and Waterbody Delineation Report

December 10, 2019

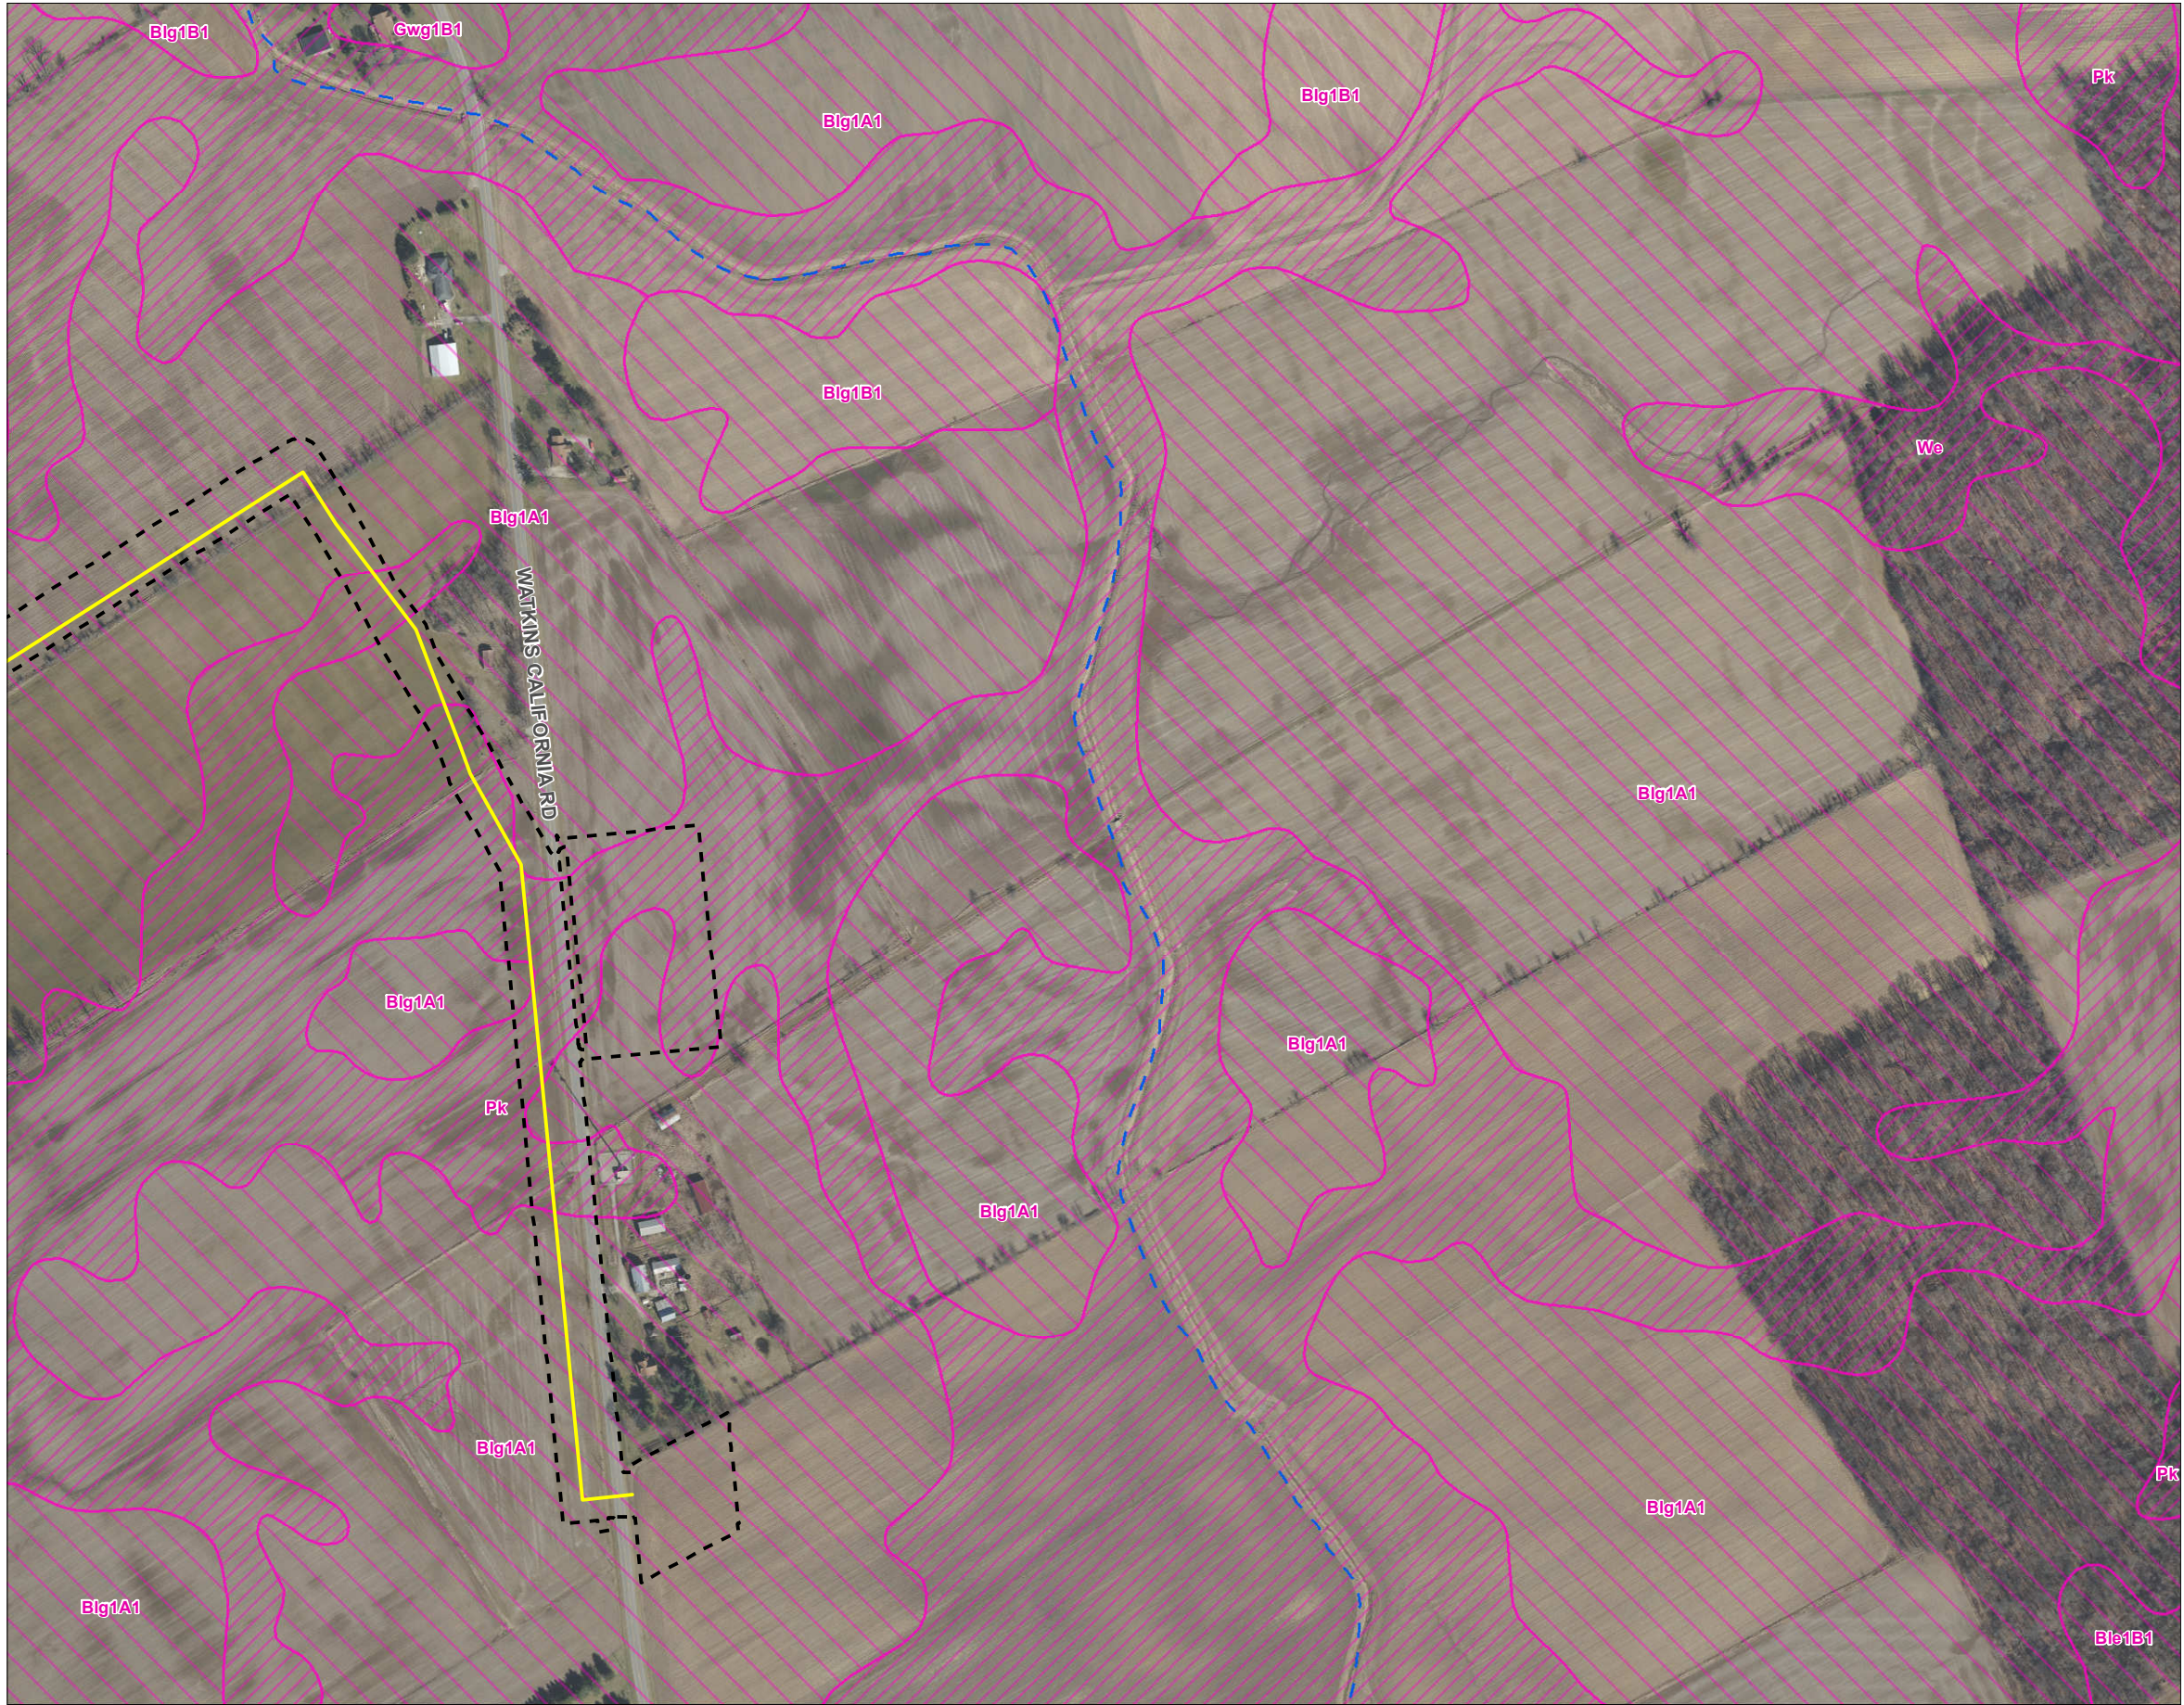
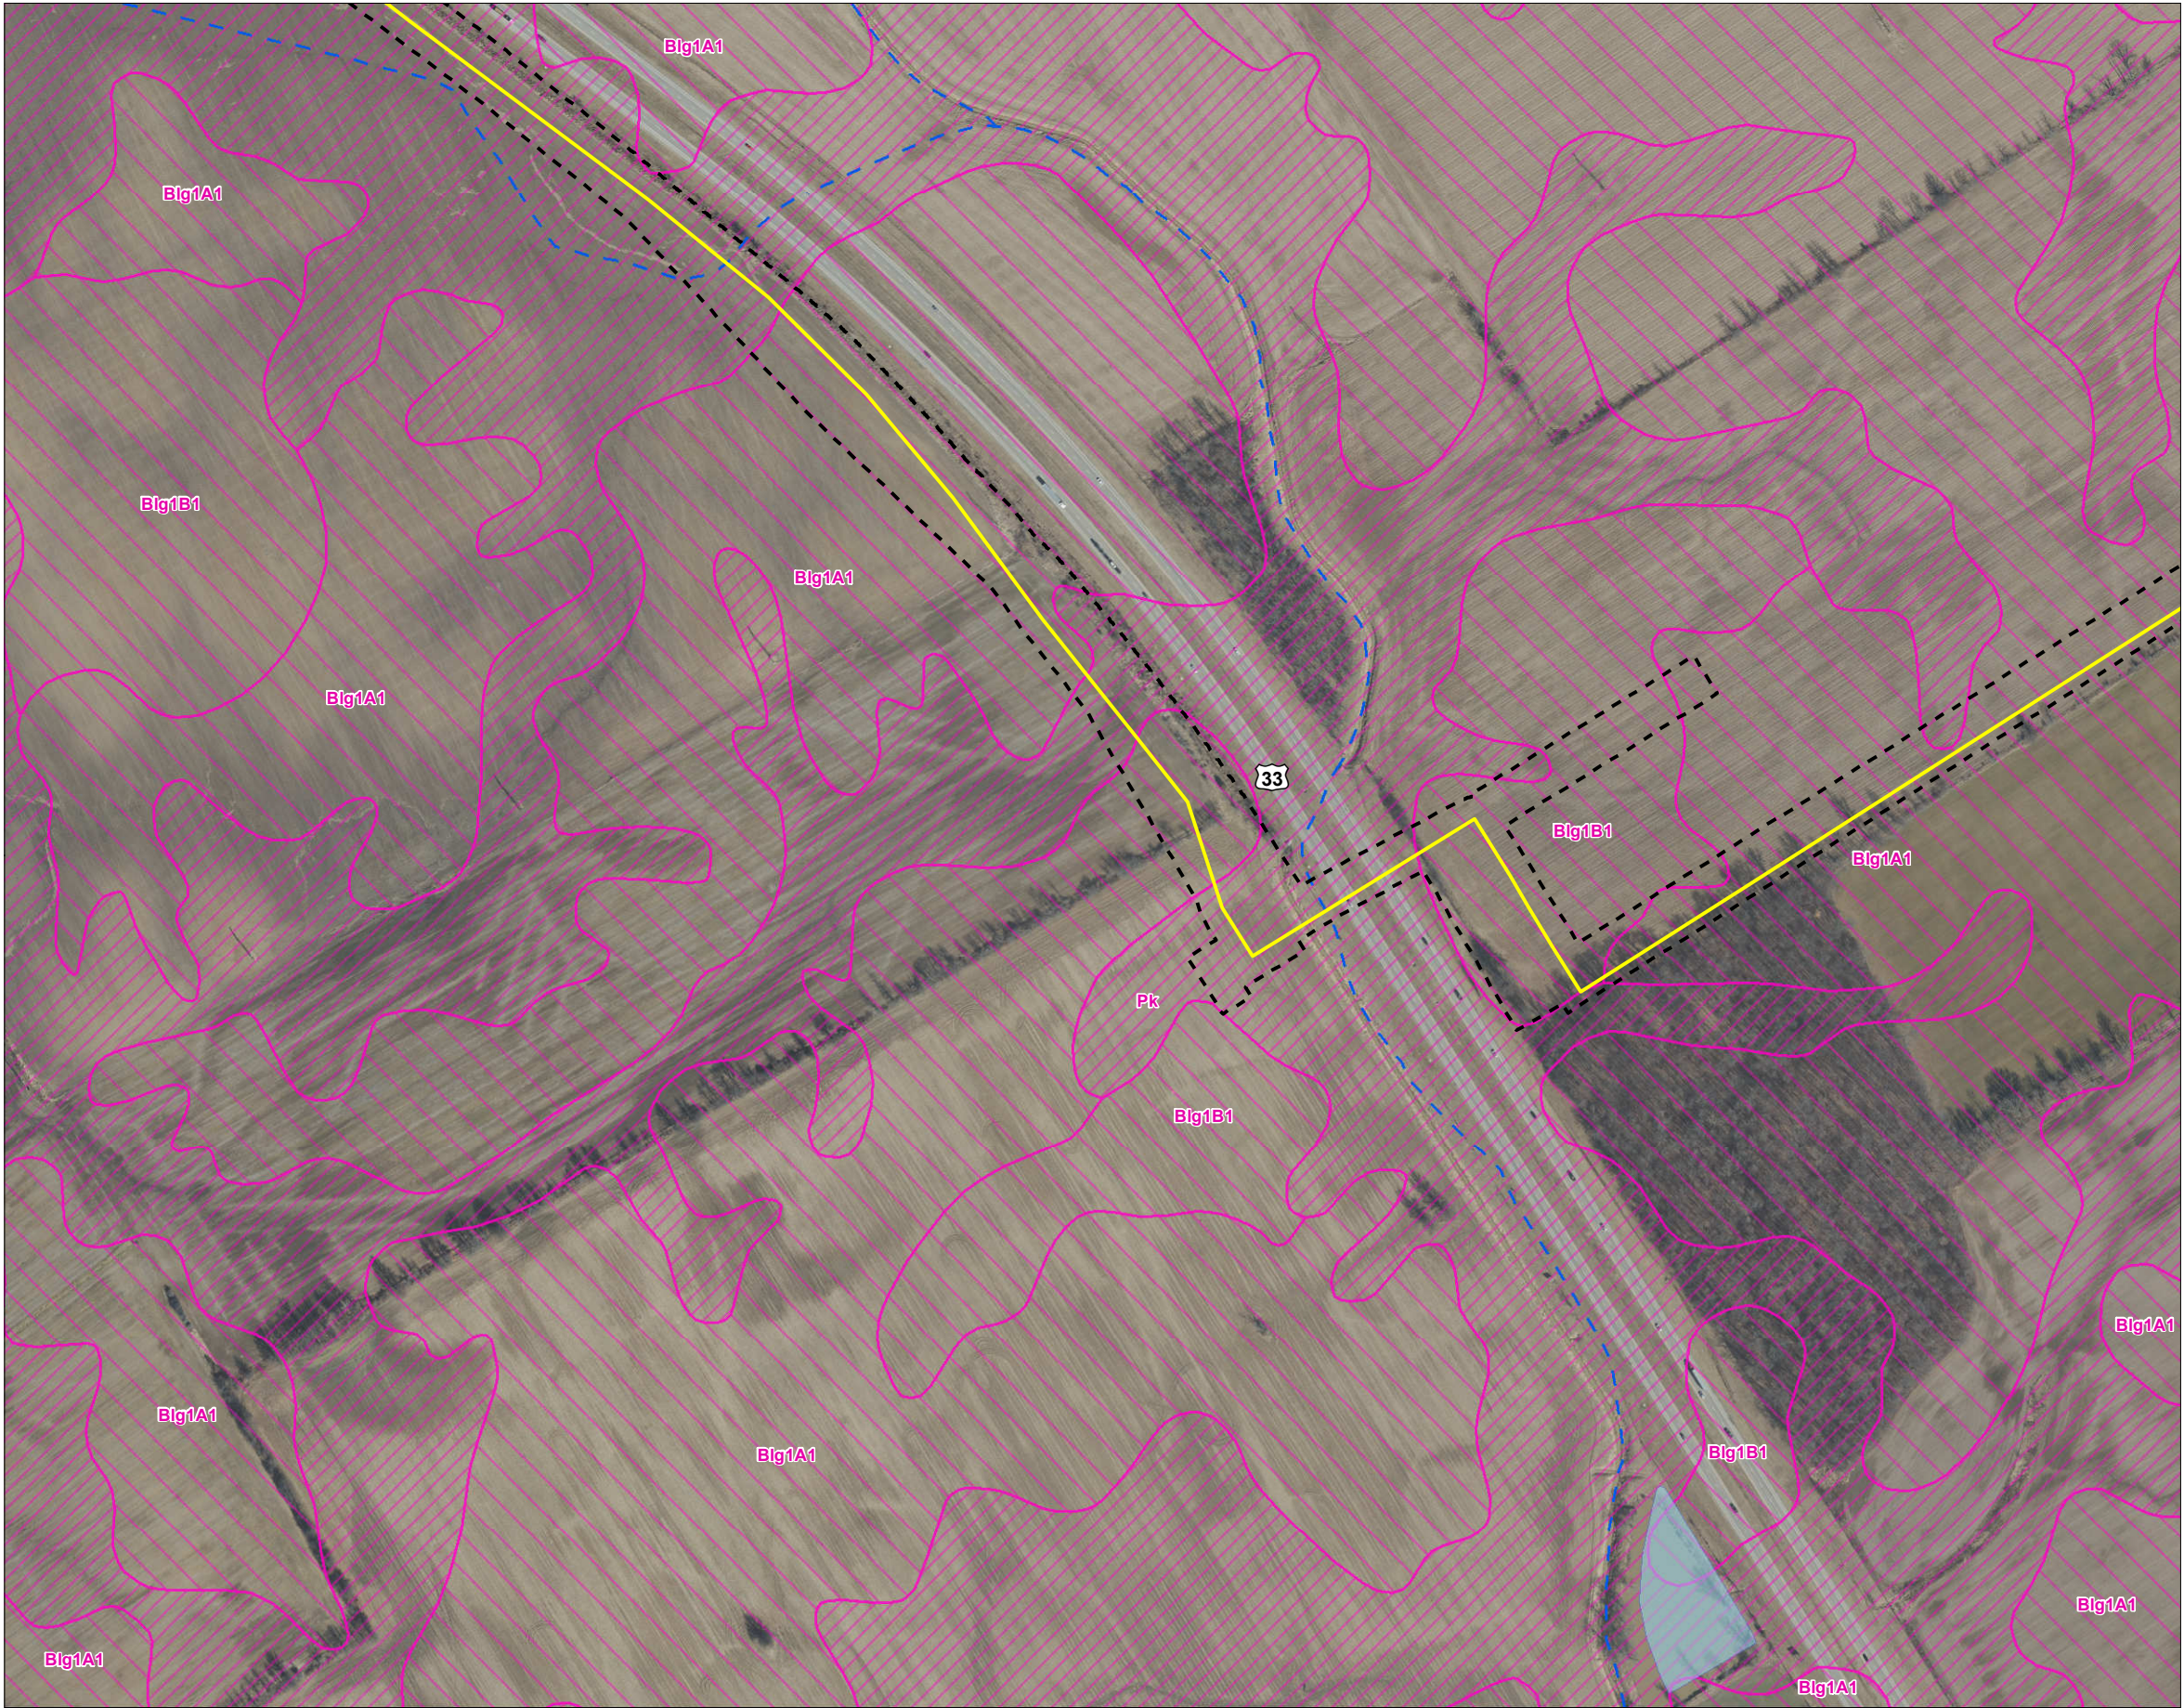
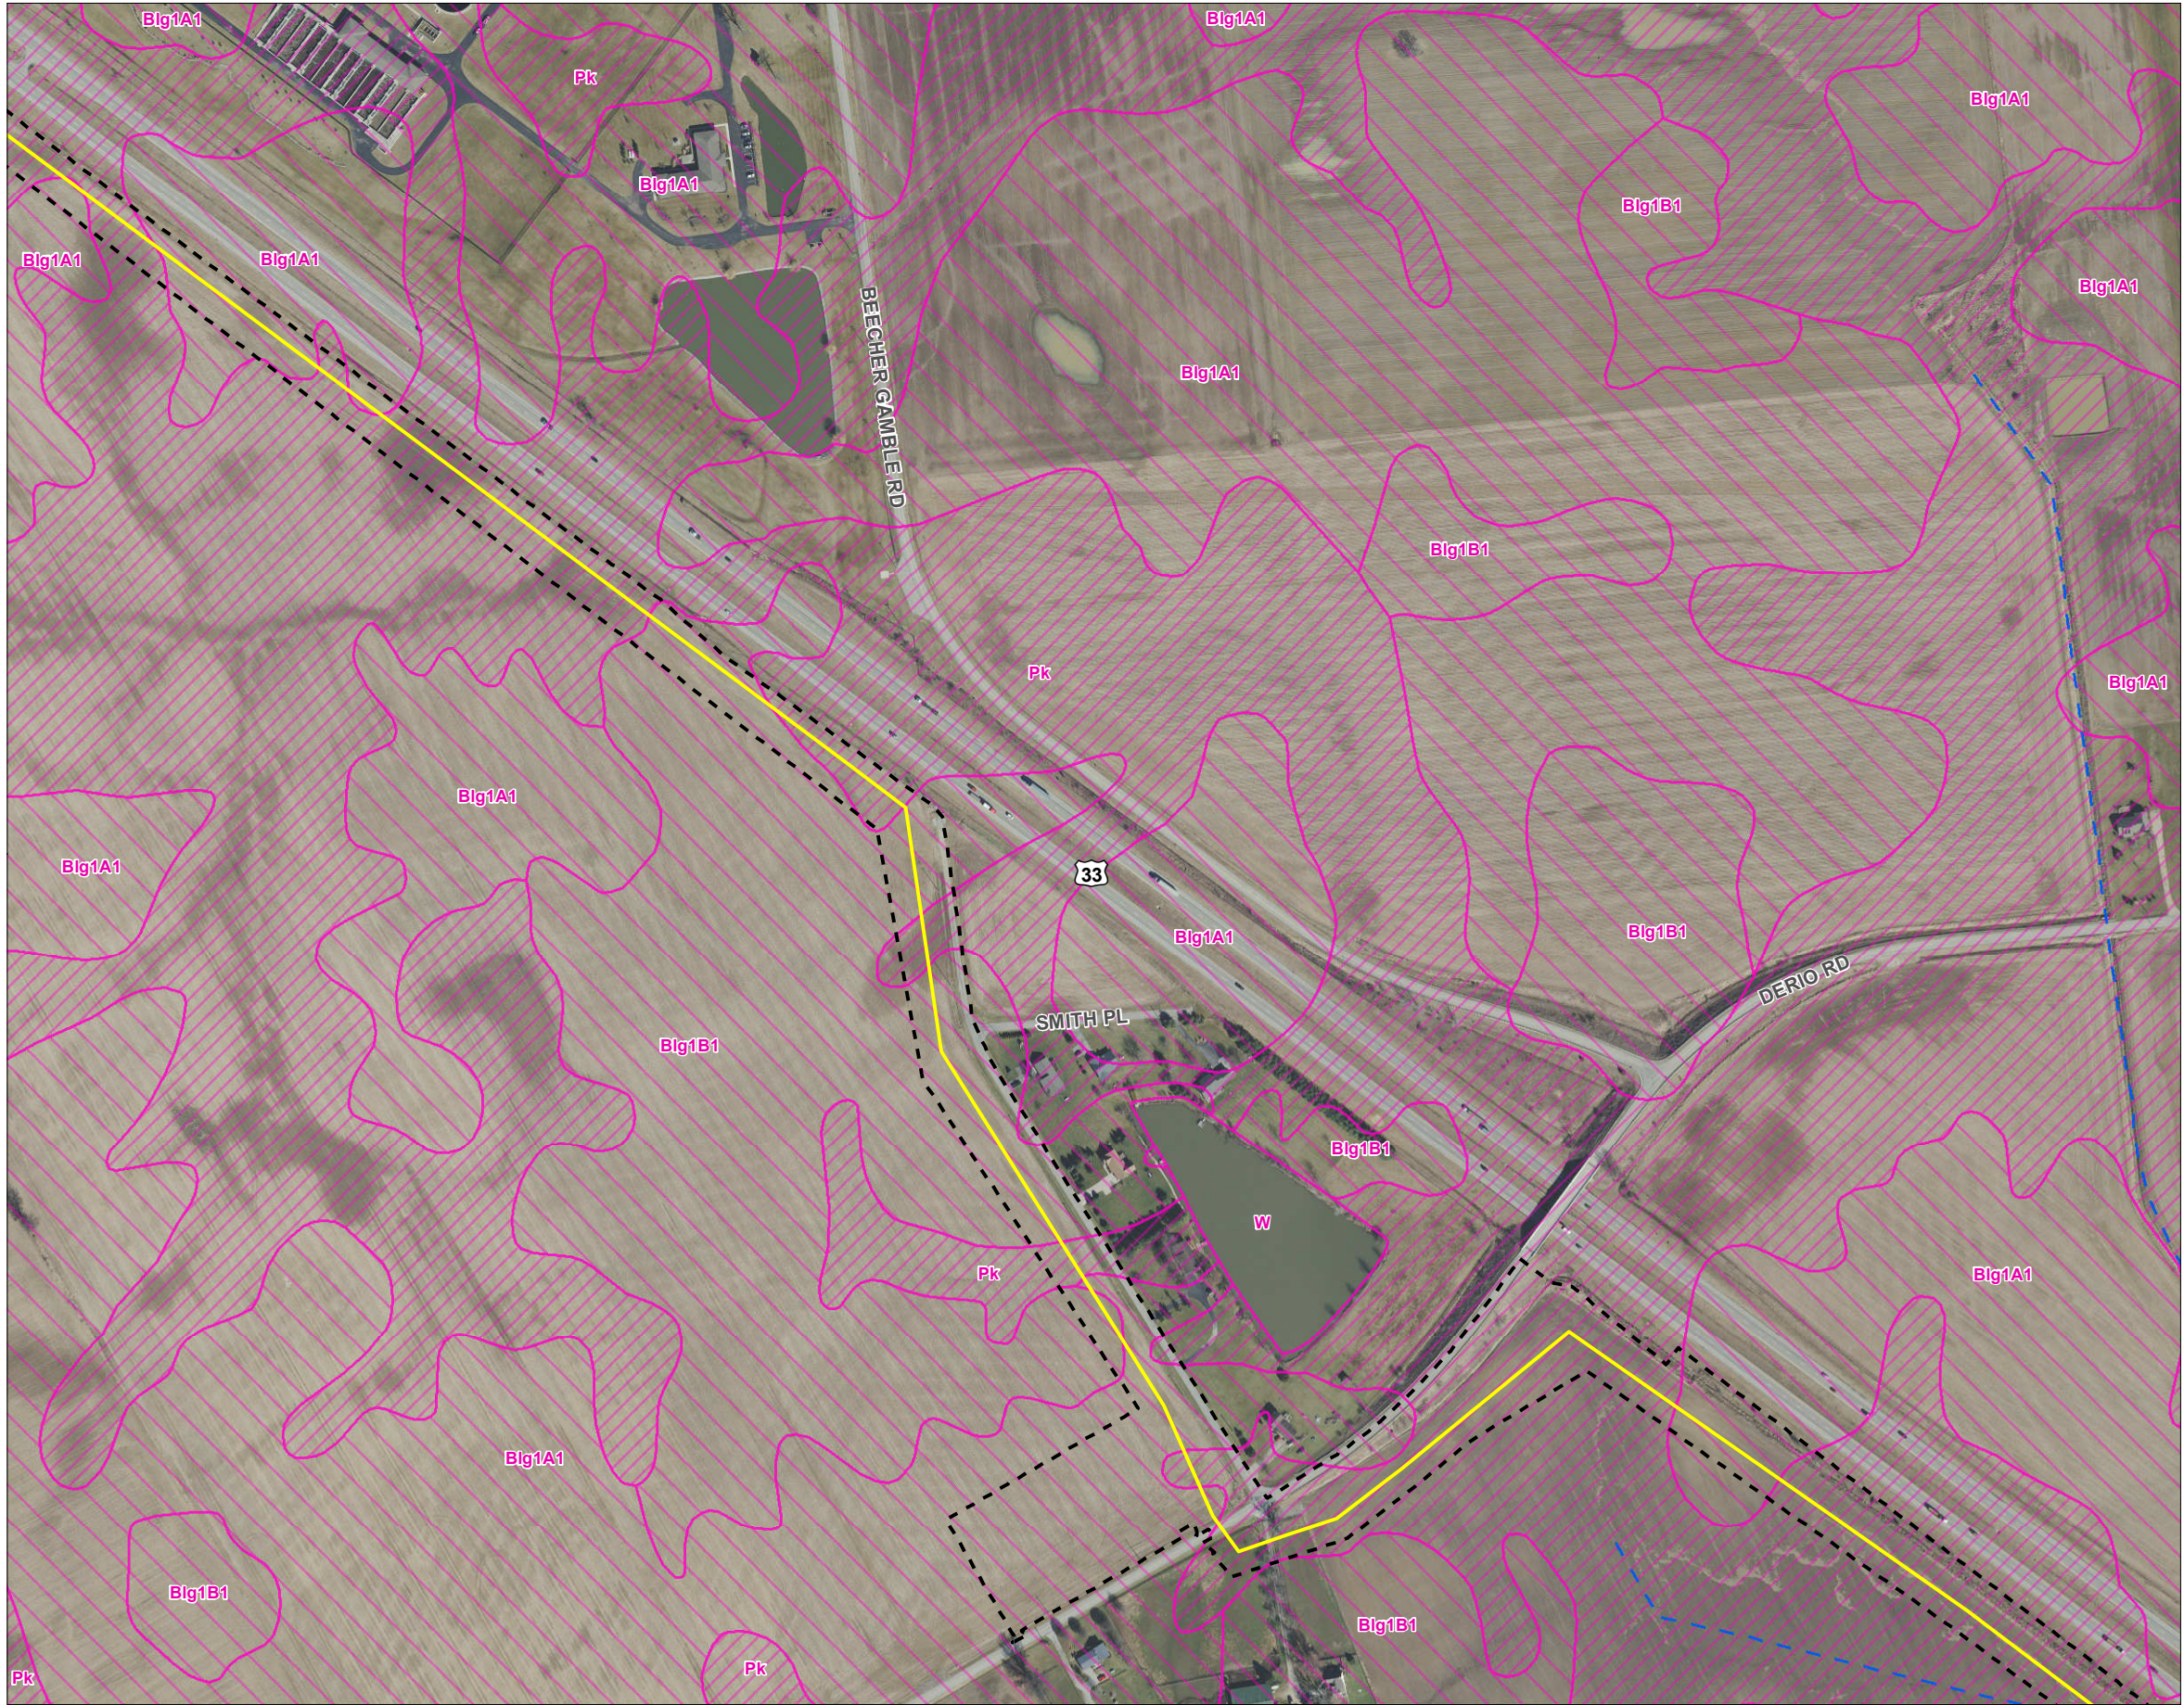
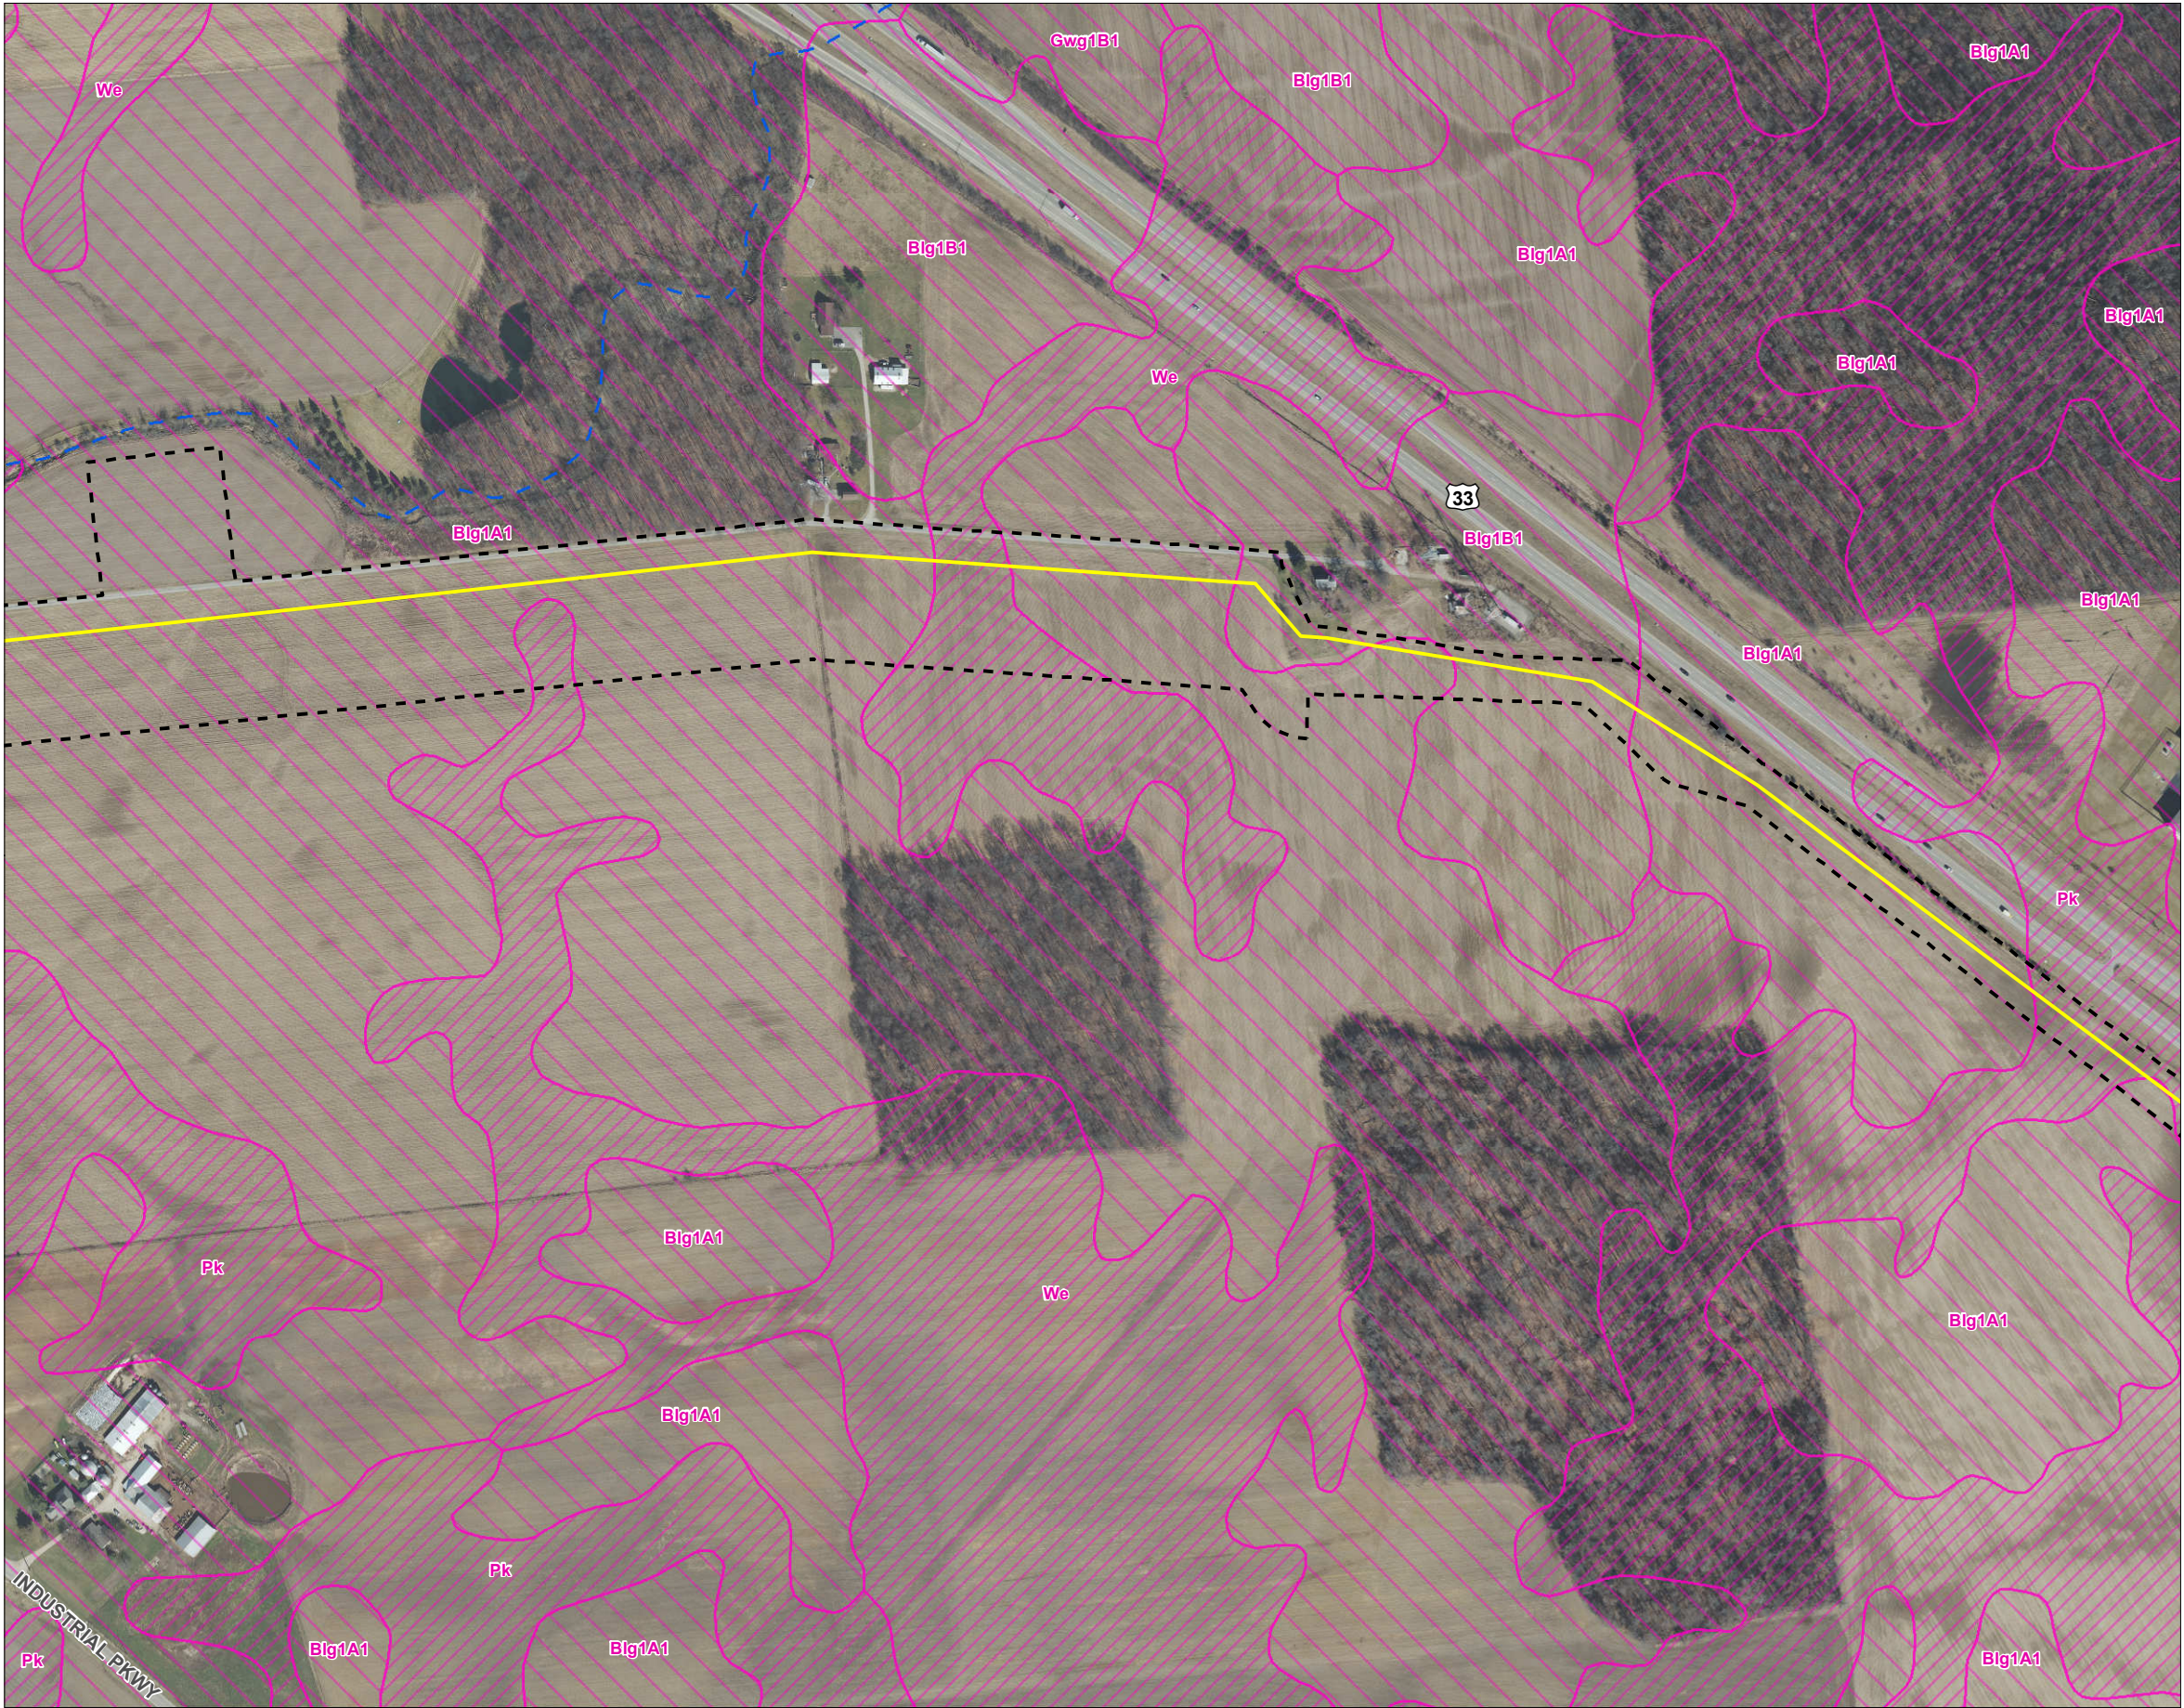
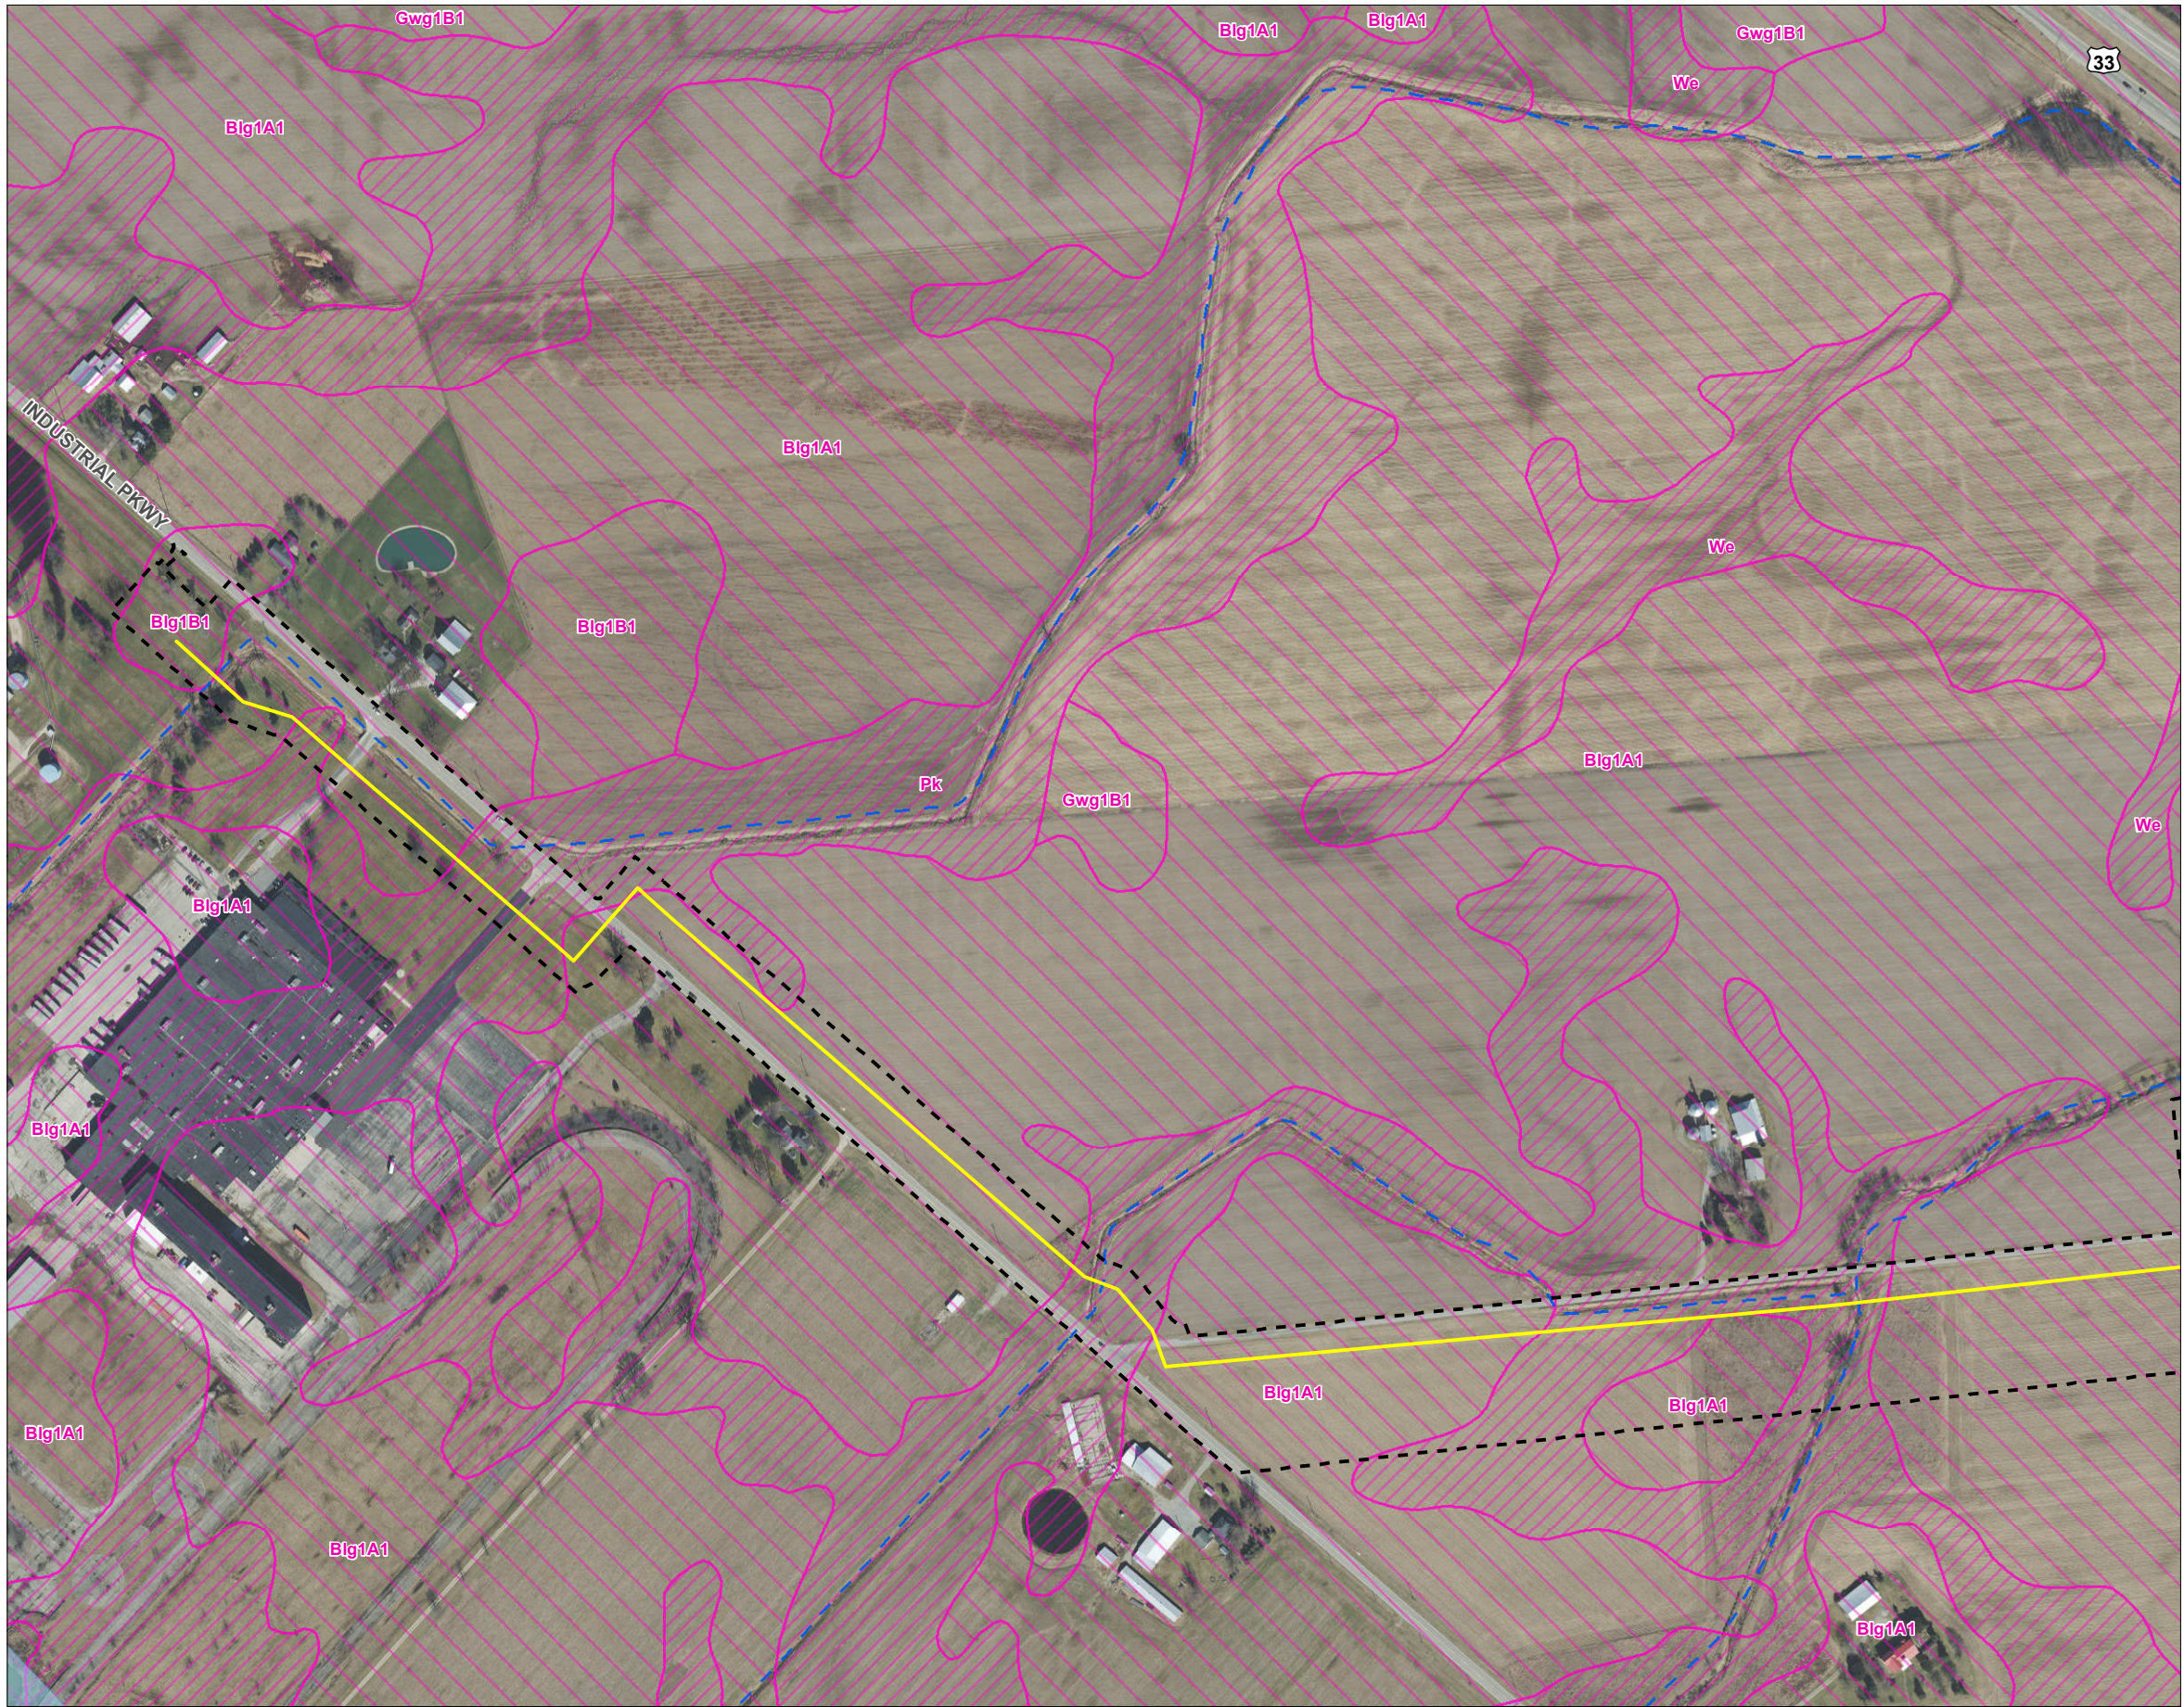
Figure No.  
**2**

Title  
**NRCS Soil Survey Data and Hydric Ratings**

The Soil Survey of Union County, Ohio (USDA 1975) and the Natural Resources Conservation Service (NRCS) Web Soil Survey were consulted to assess soil types within the Project area (USDA, NRCS 2010). A copy of the soil map is included in Appendix A, Figure 2. Soils within the Project area with respective acreages and percentages are included in Table 1. All four soils listed within the Project area were considered to be hydric as shown in Table 1.

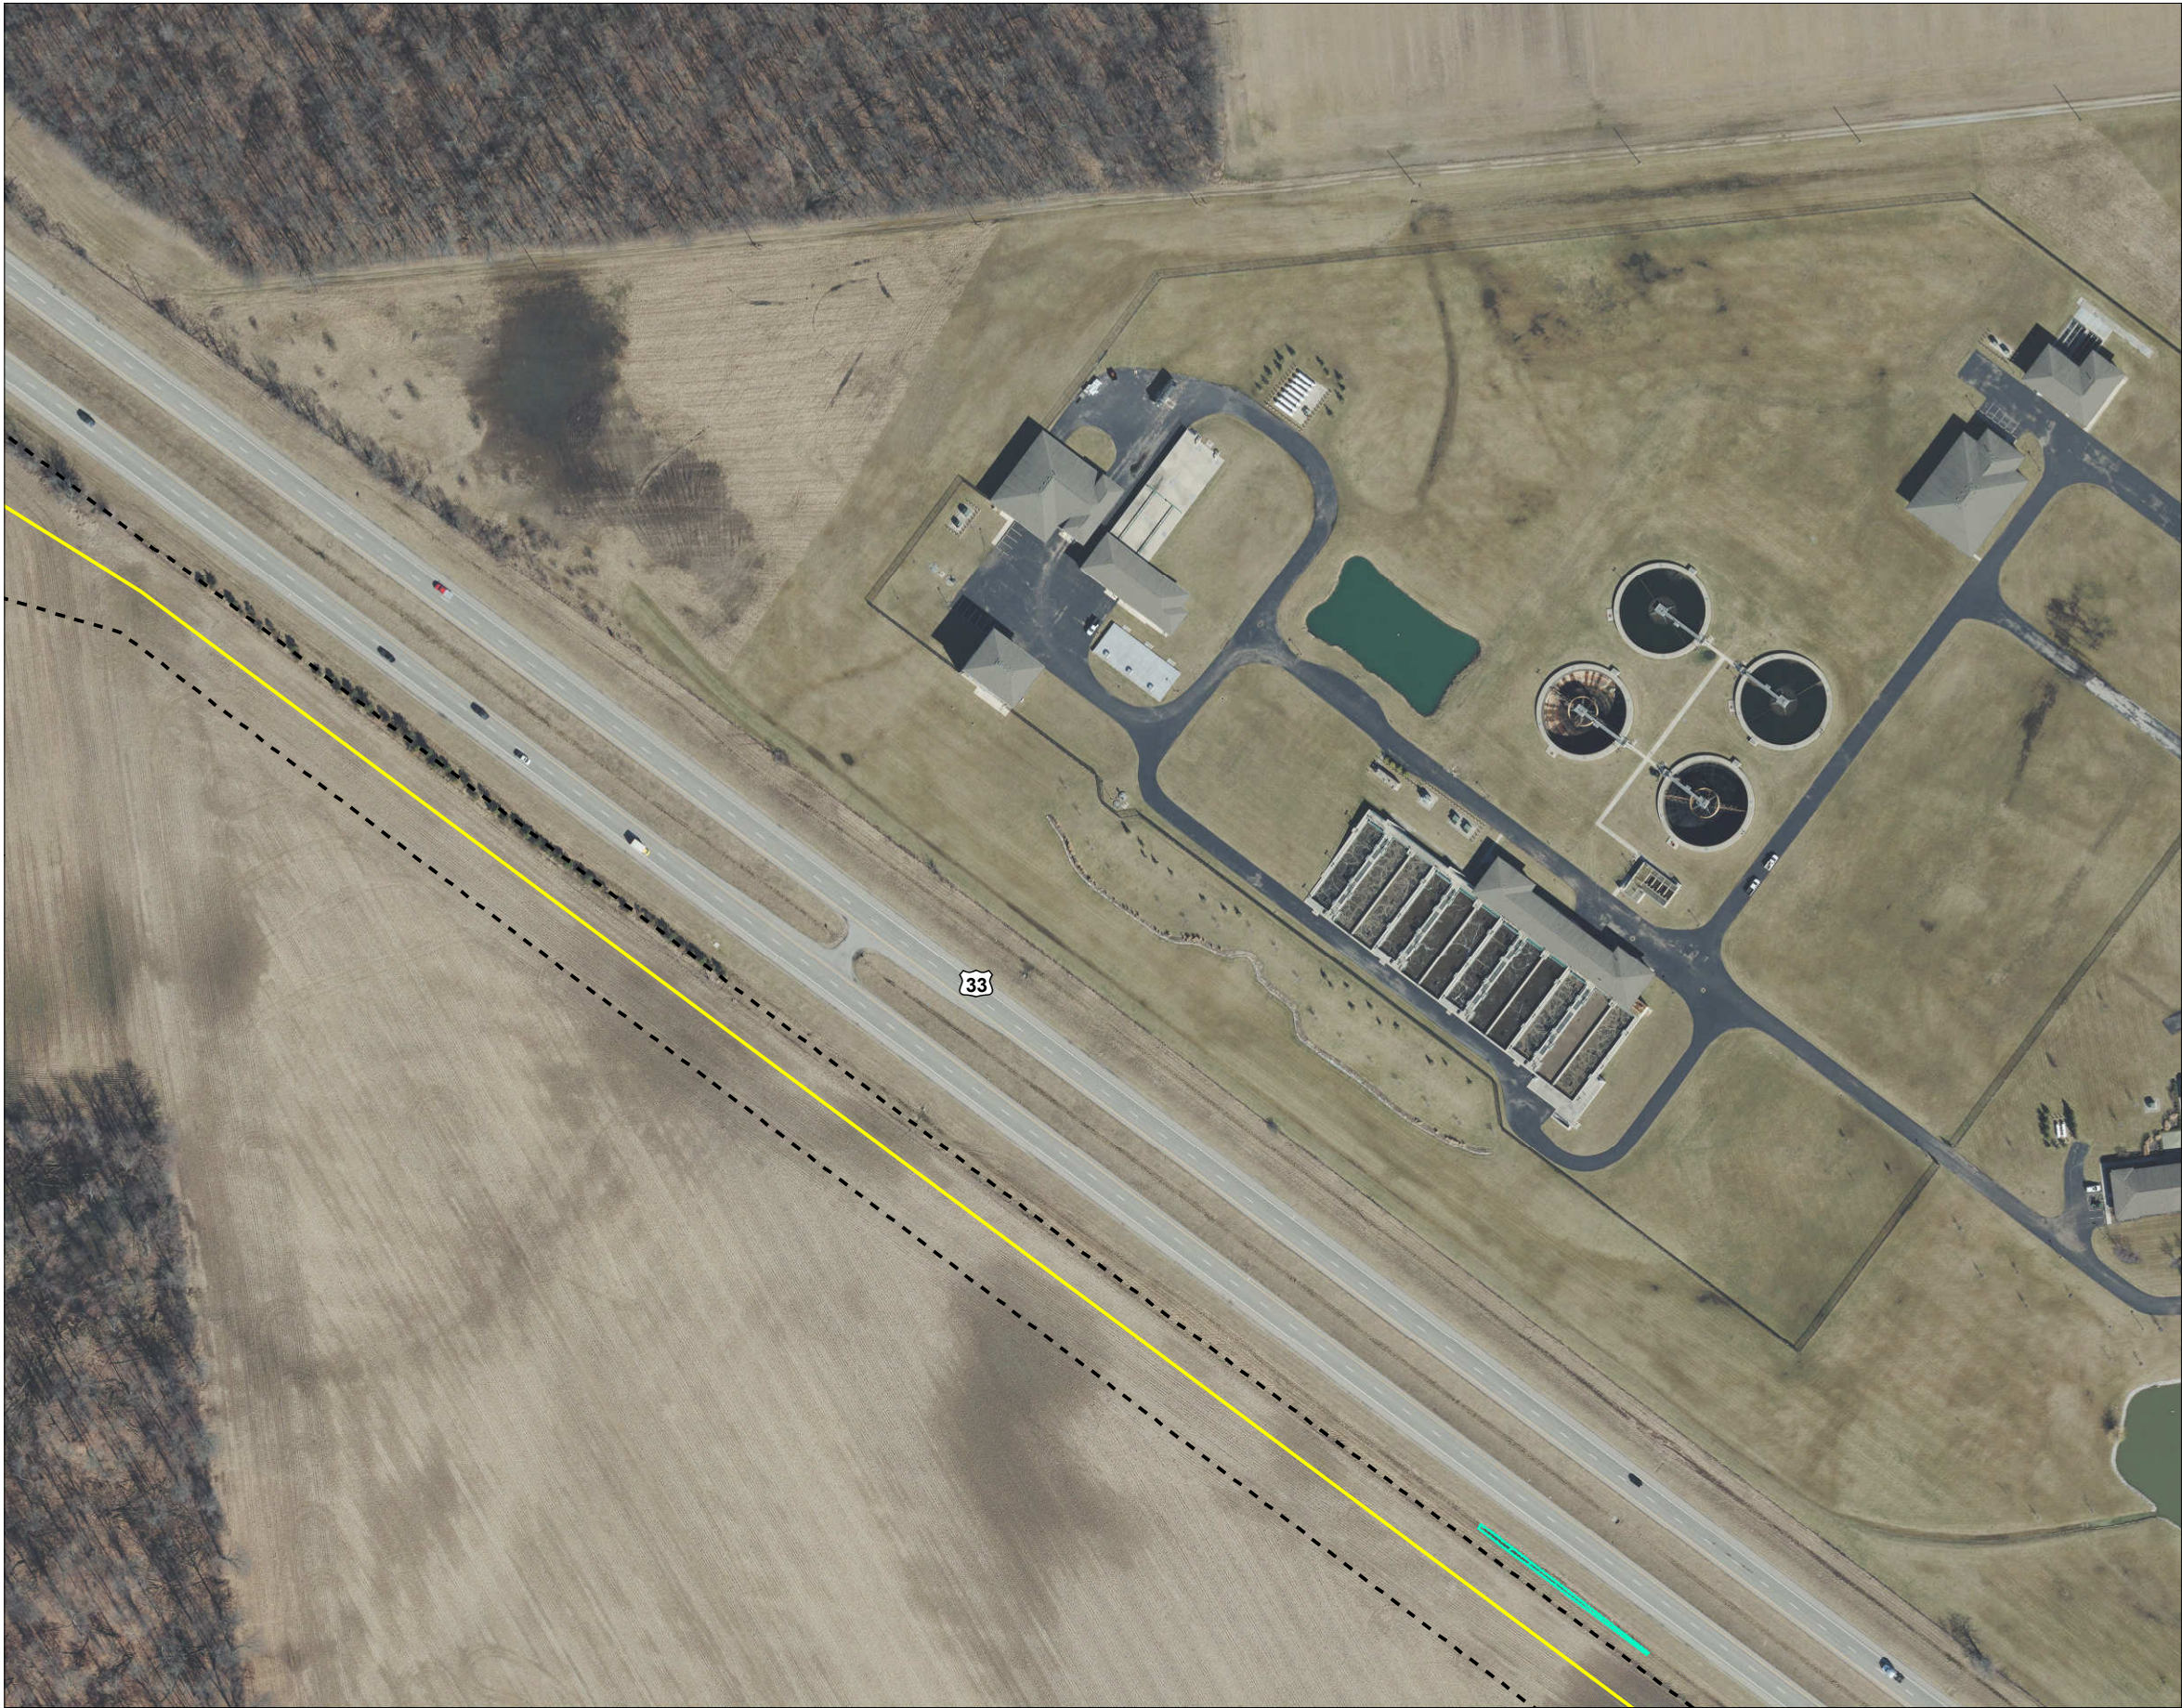
Figure No.  
**4**  
Title  
**Wetland and Waterbody Delineation Map**

Client/Project  
Columbia Gas of Ohio  
Marysville Connector Pipeline Project  
Wetland and Waterbody Delineation

Four wetlands were identified within the Project area, totaling approximately 0.96 acre (Appendix A, Figure 4). Appendix B contains the WDF and ORAM forms for the wetlands identified within the Project area. Representative photographs of the wetlands are provided in Appendix C. The wetlands are described below and summarized in Table 2.

Four streams were identified within the Project area, totaling approximately 751 linear feet (Appendix A, Figure 4). Appendix B contains the QHEI and HHEI datasheets. Representative photographs of the streams are provided in Appendix C. The streams are described below and summarized in Table 3.
