## **Wetland and Waterbodies Delineation Report**

**Marysville Connector Pipeline  
Project**

Wetland and Waterbody Delineation Report

December 10, 2019

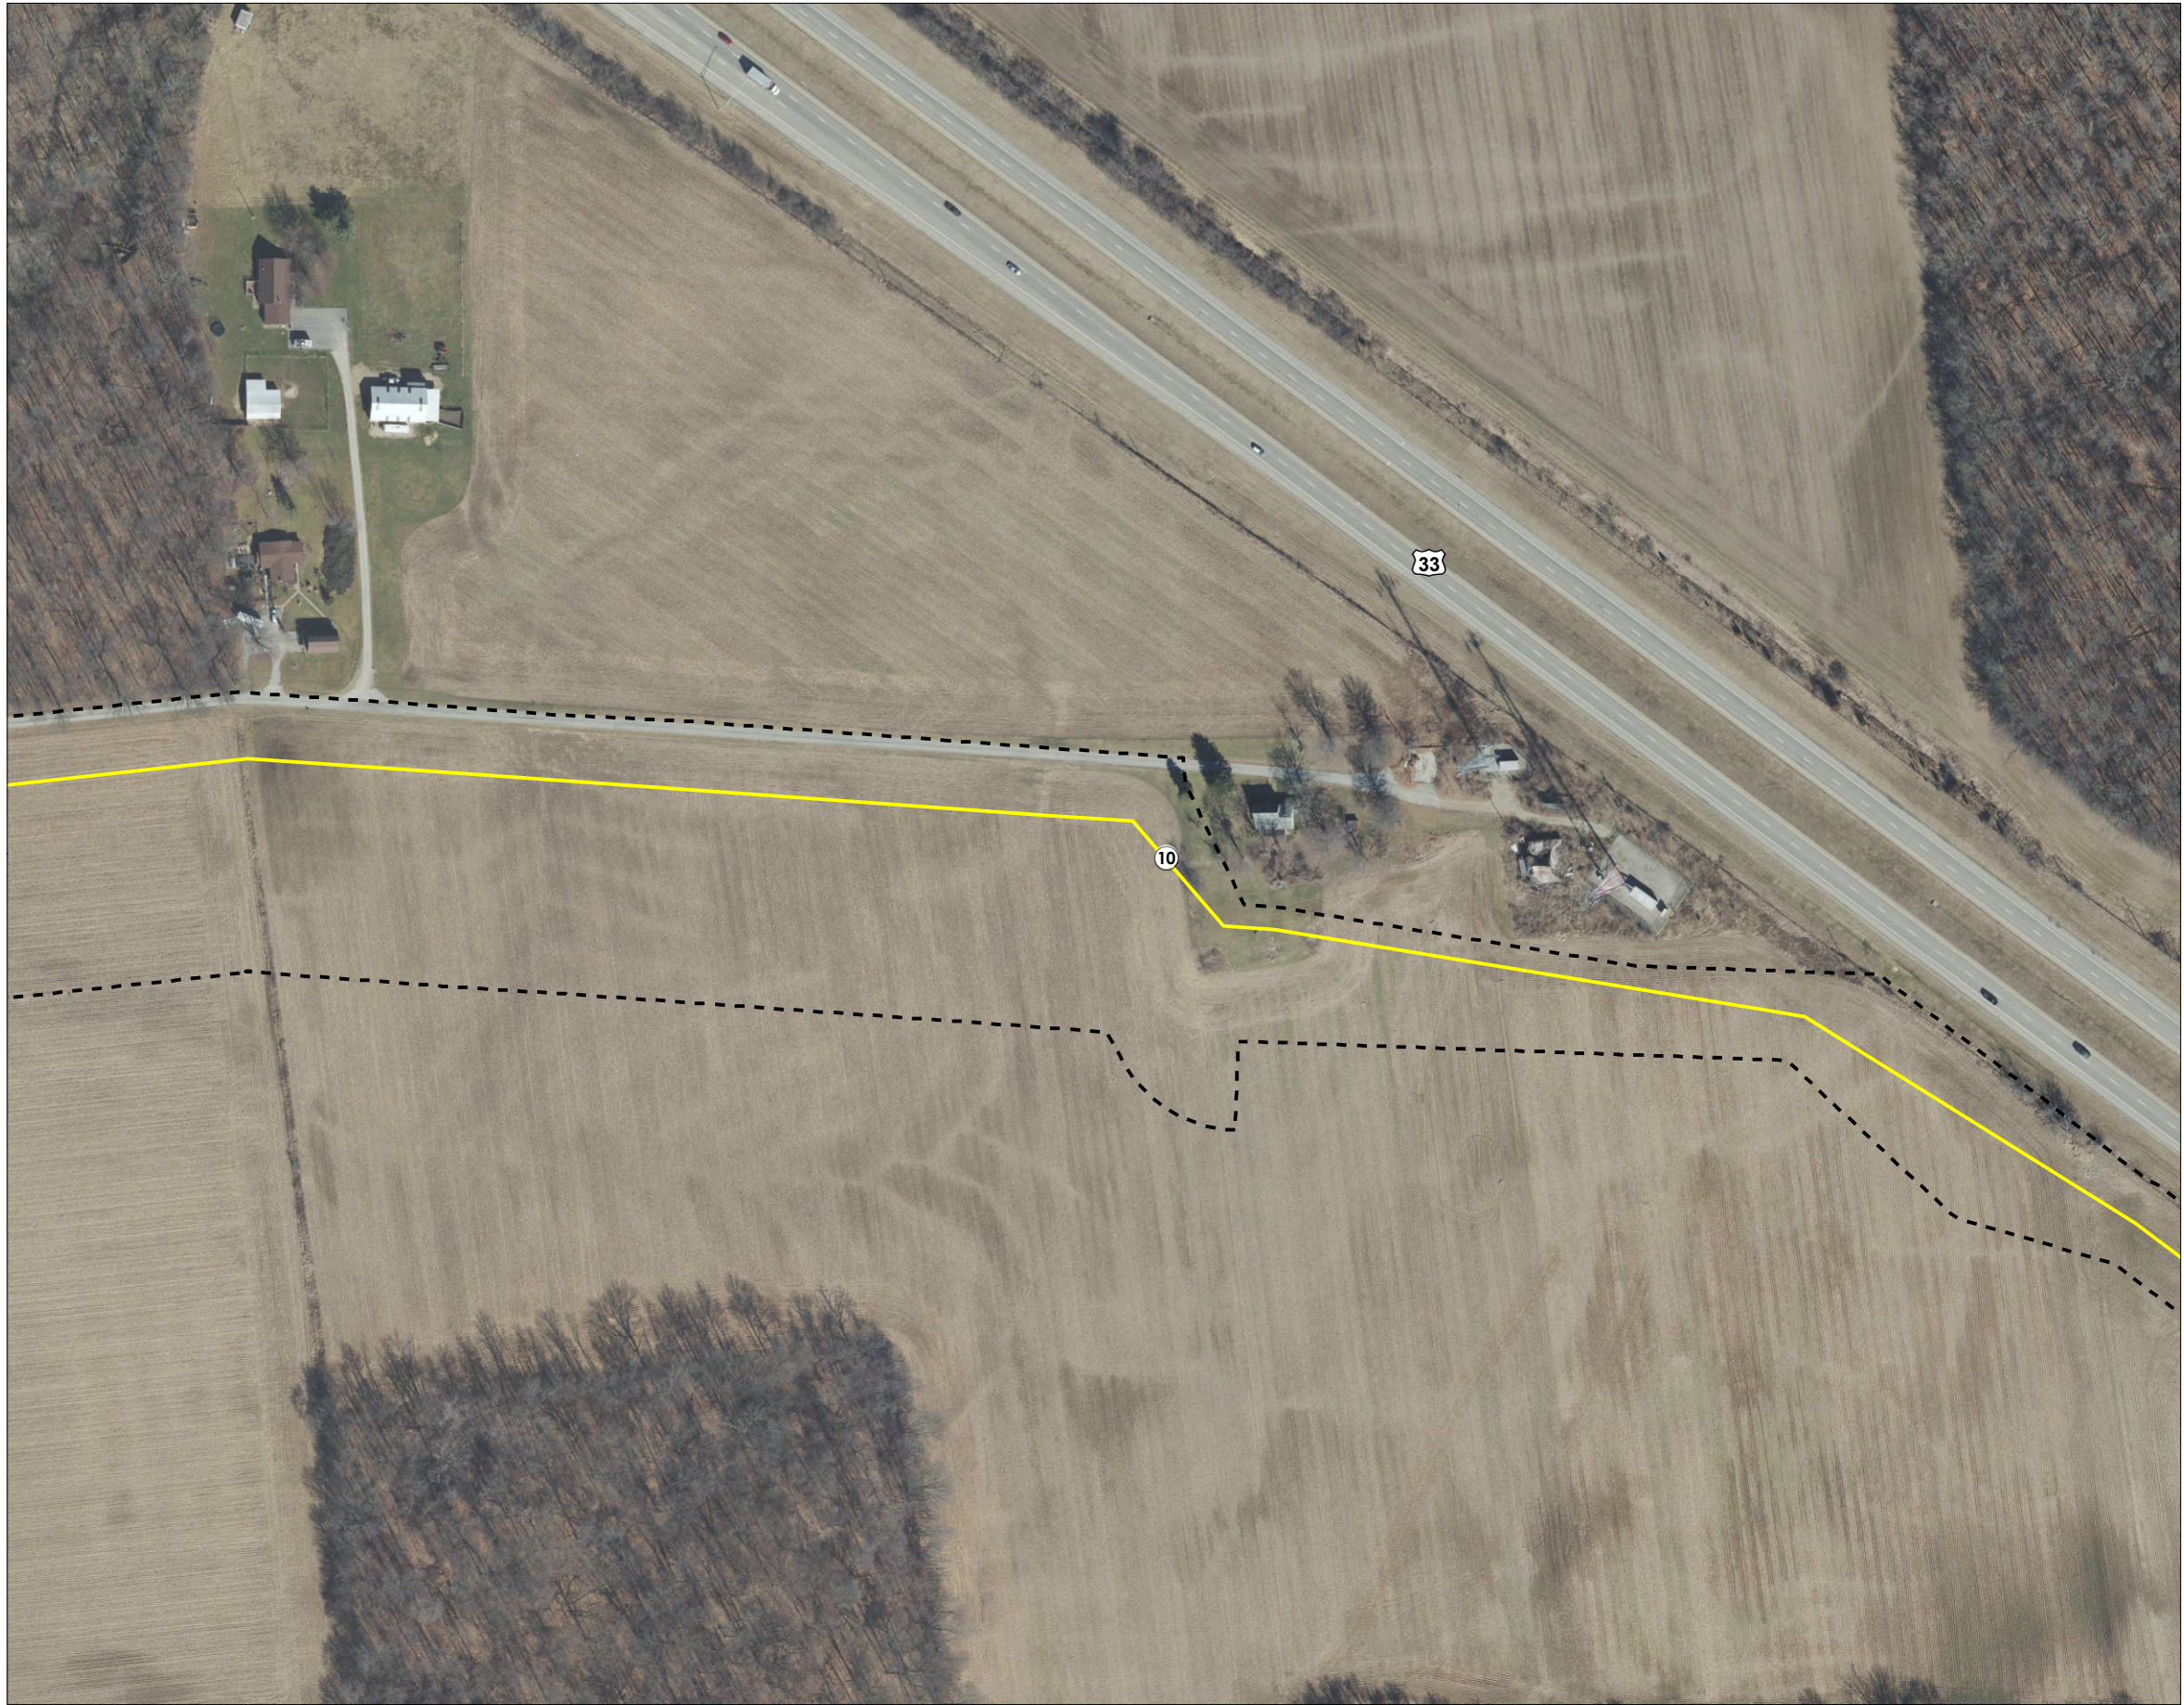
Figure No.  
**4**  
Title  
**Wetland and Waterbody Delineation Map**

Client/Project  
Columbia Gas of Ohio  
Marysville Connector Pipeline Project  
Wetland and Waterbody Delineation

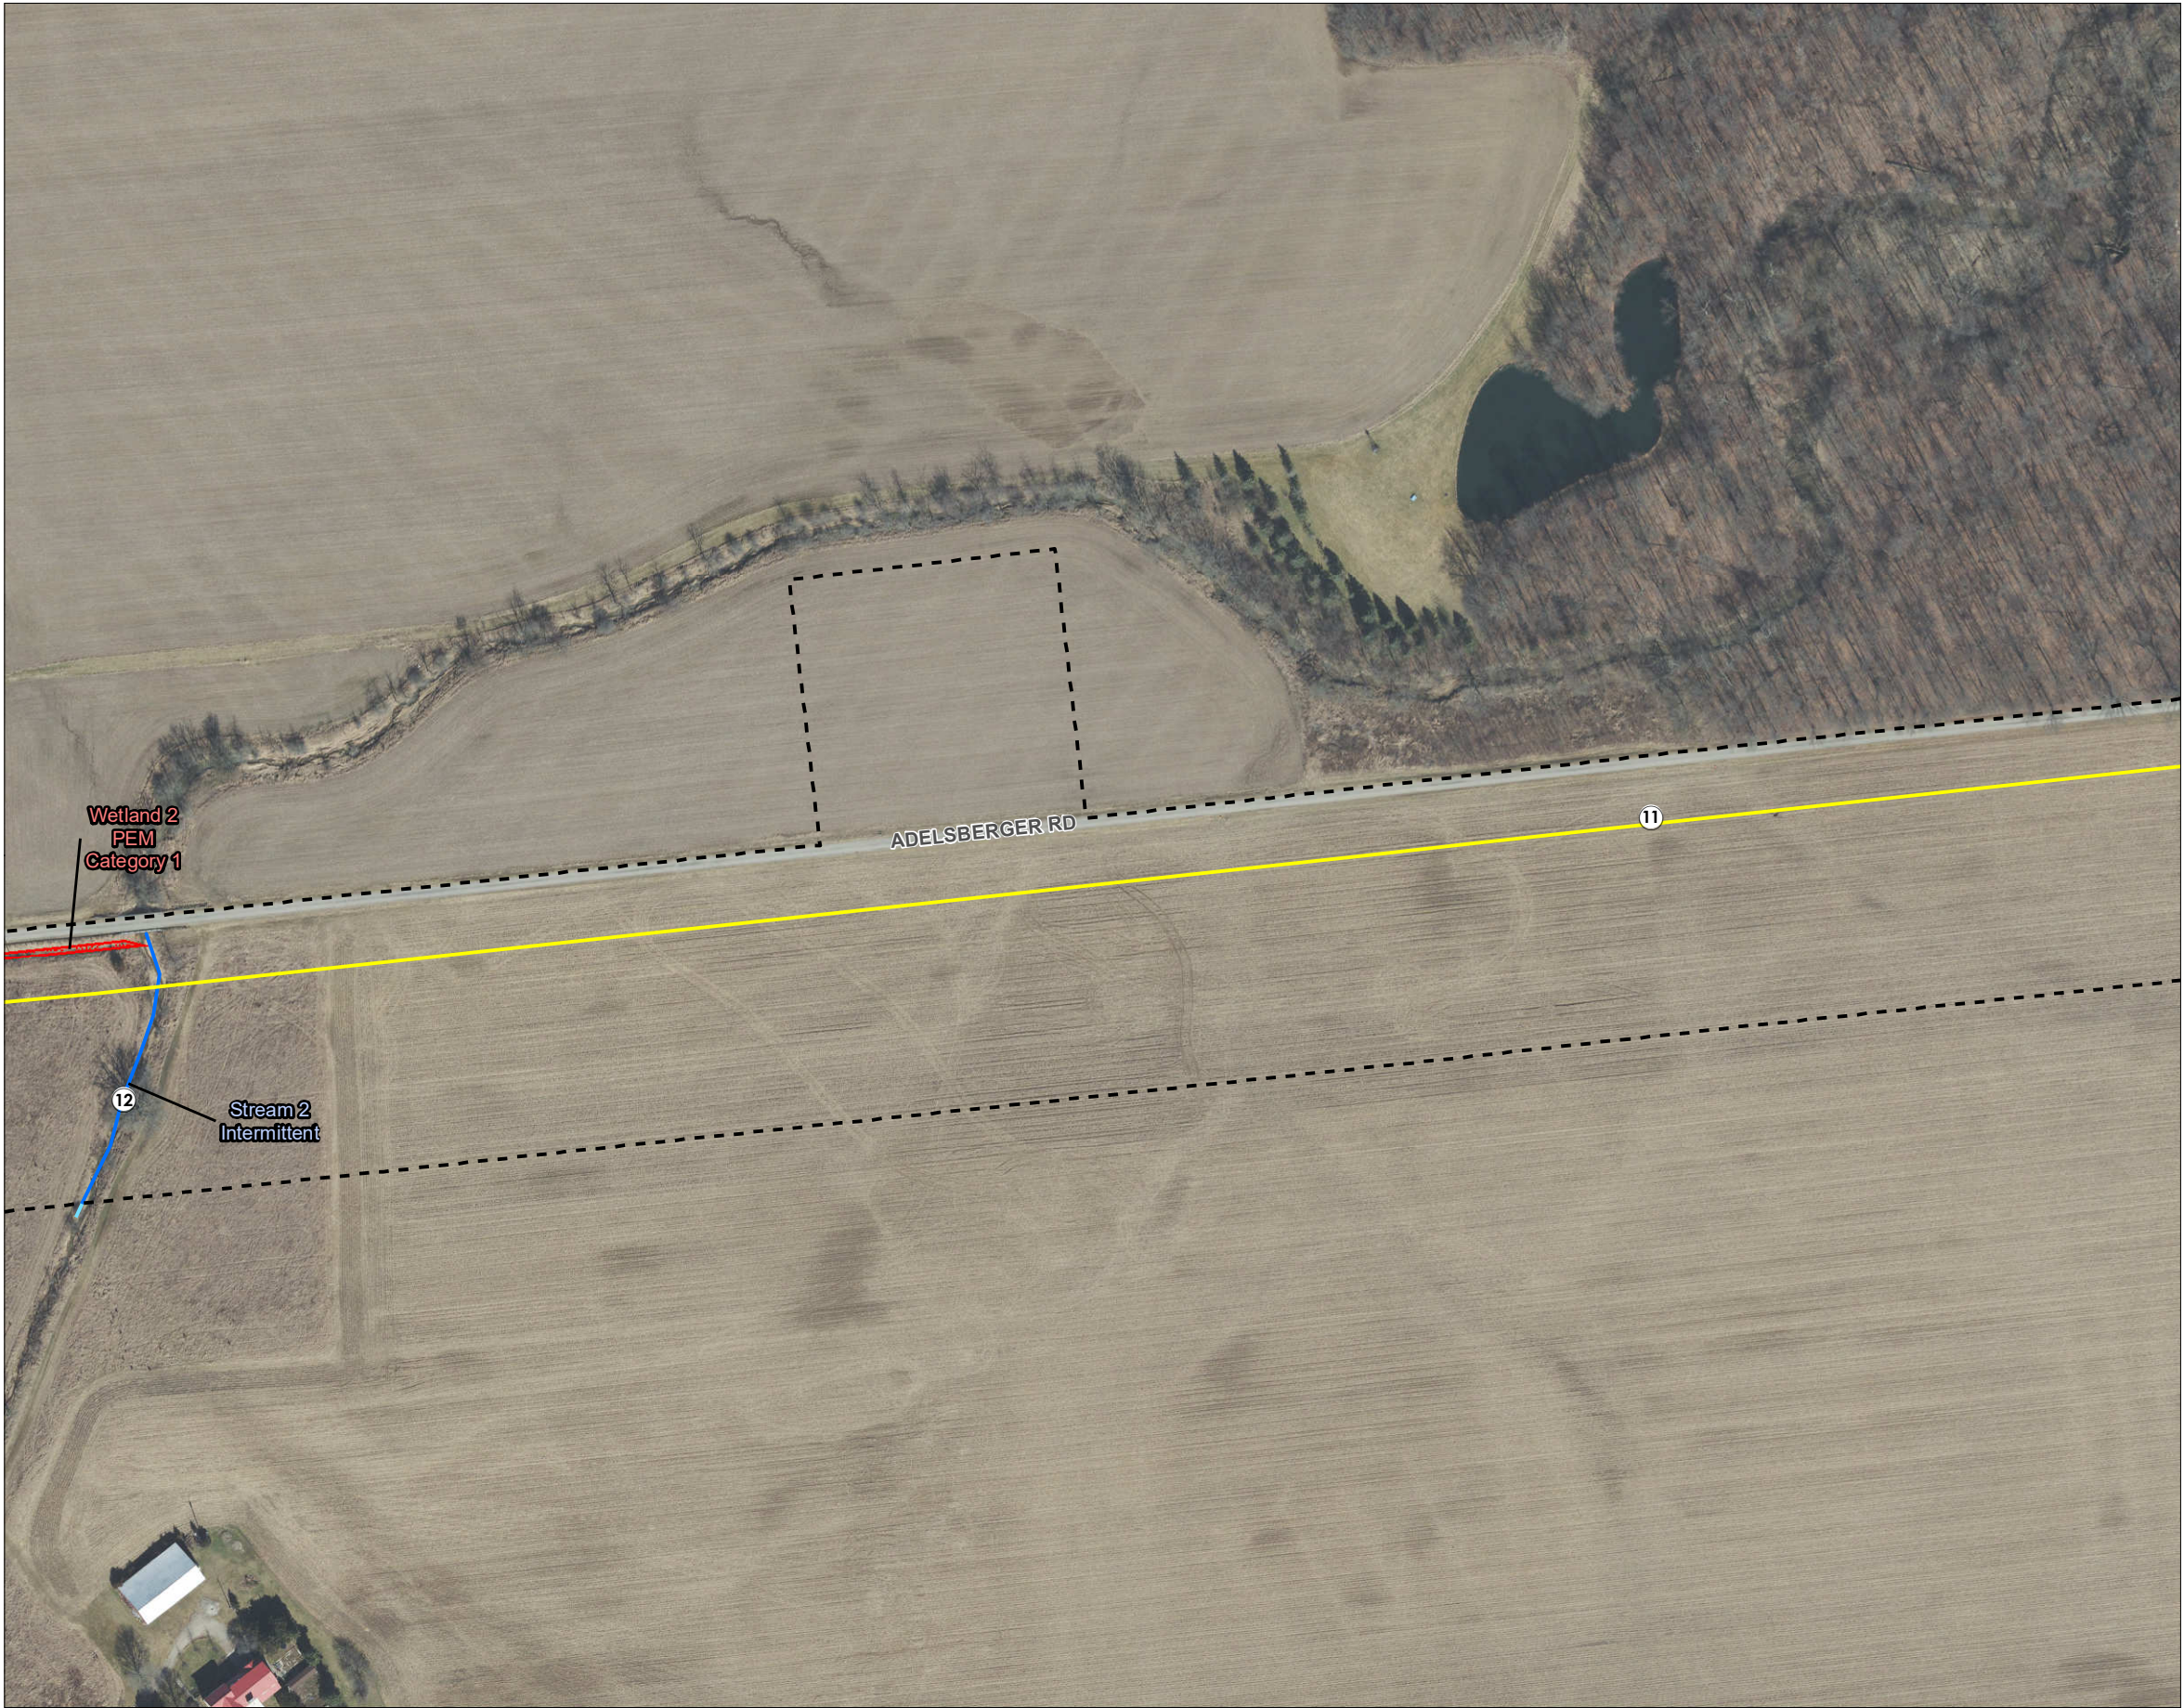
Figure No.  
**4**  
Title  
**Wetland and Waterbody Delineation Map**

Client/Project  
Columbia Gas of Ohio  
Marysville Connector Pipeline Project  
Wetland and Waterbody Delineation

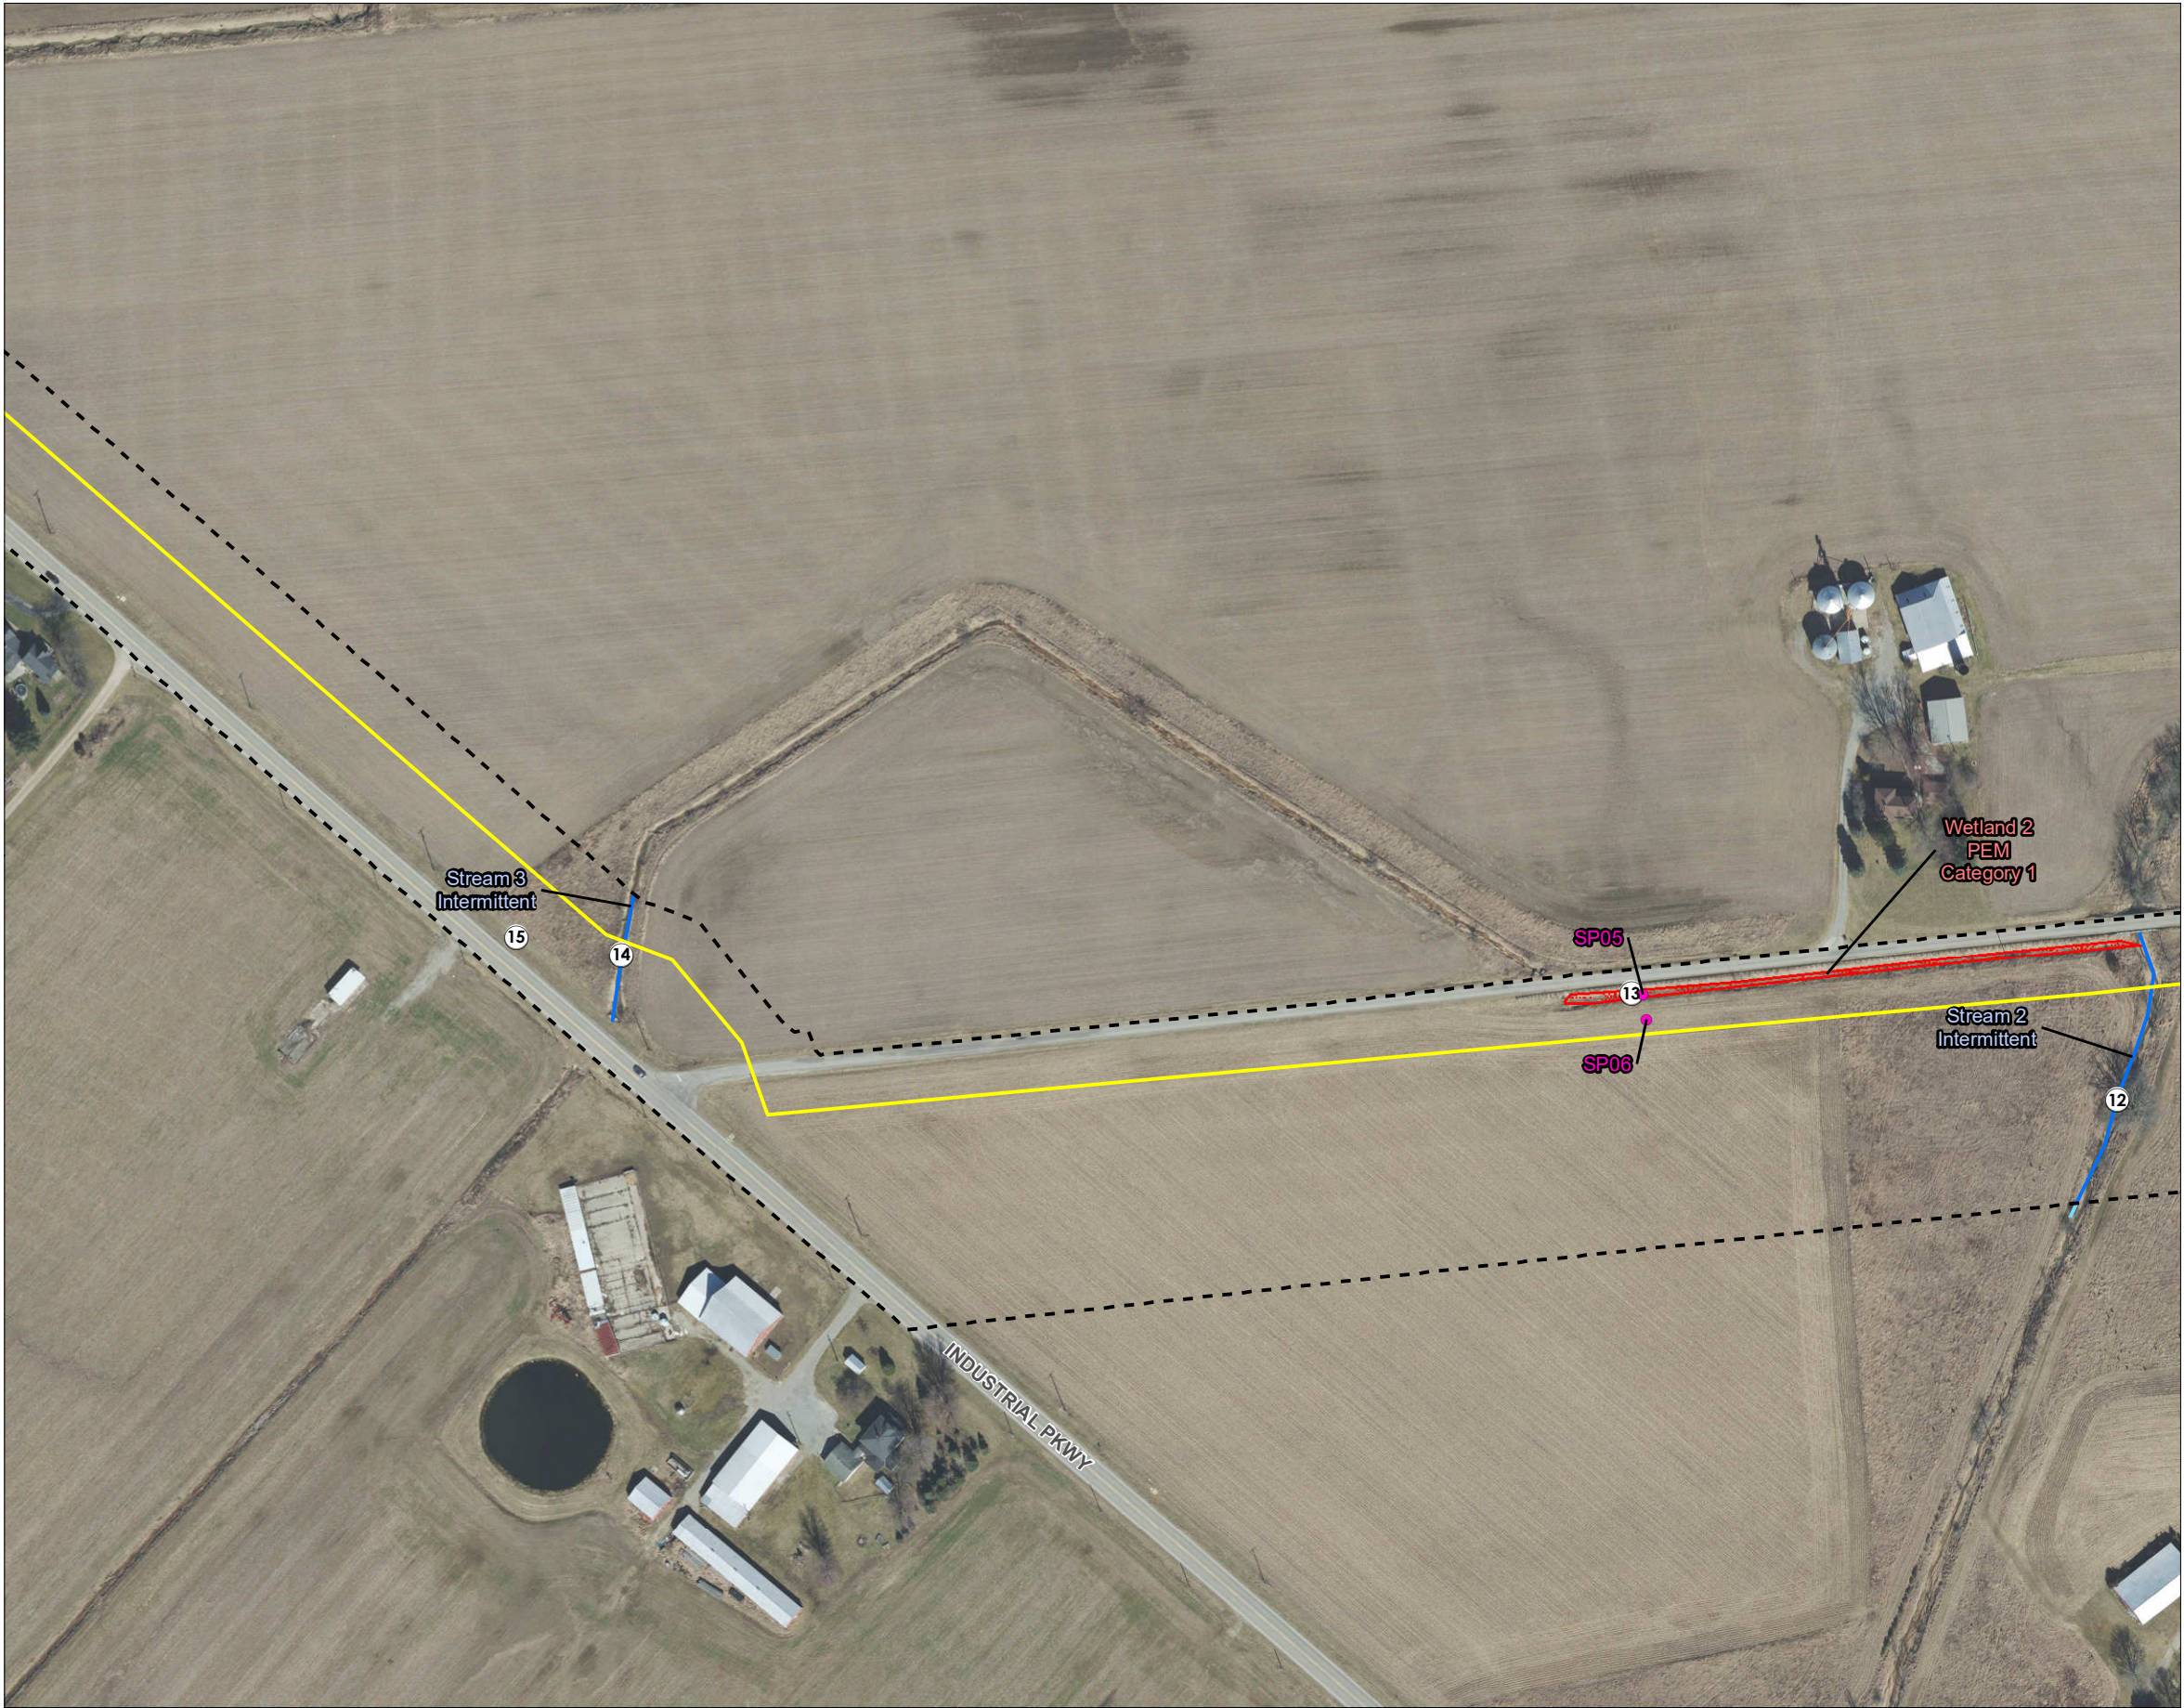
Figure No.  
**4**  
Title  
**Wetland and Waterbody Delineation Map**

Client/Project  
Columbia Gas of Ohio  
Marysville Connector Pipeline Project  
Wetland and Waterbody Delineation

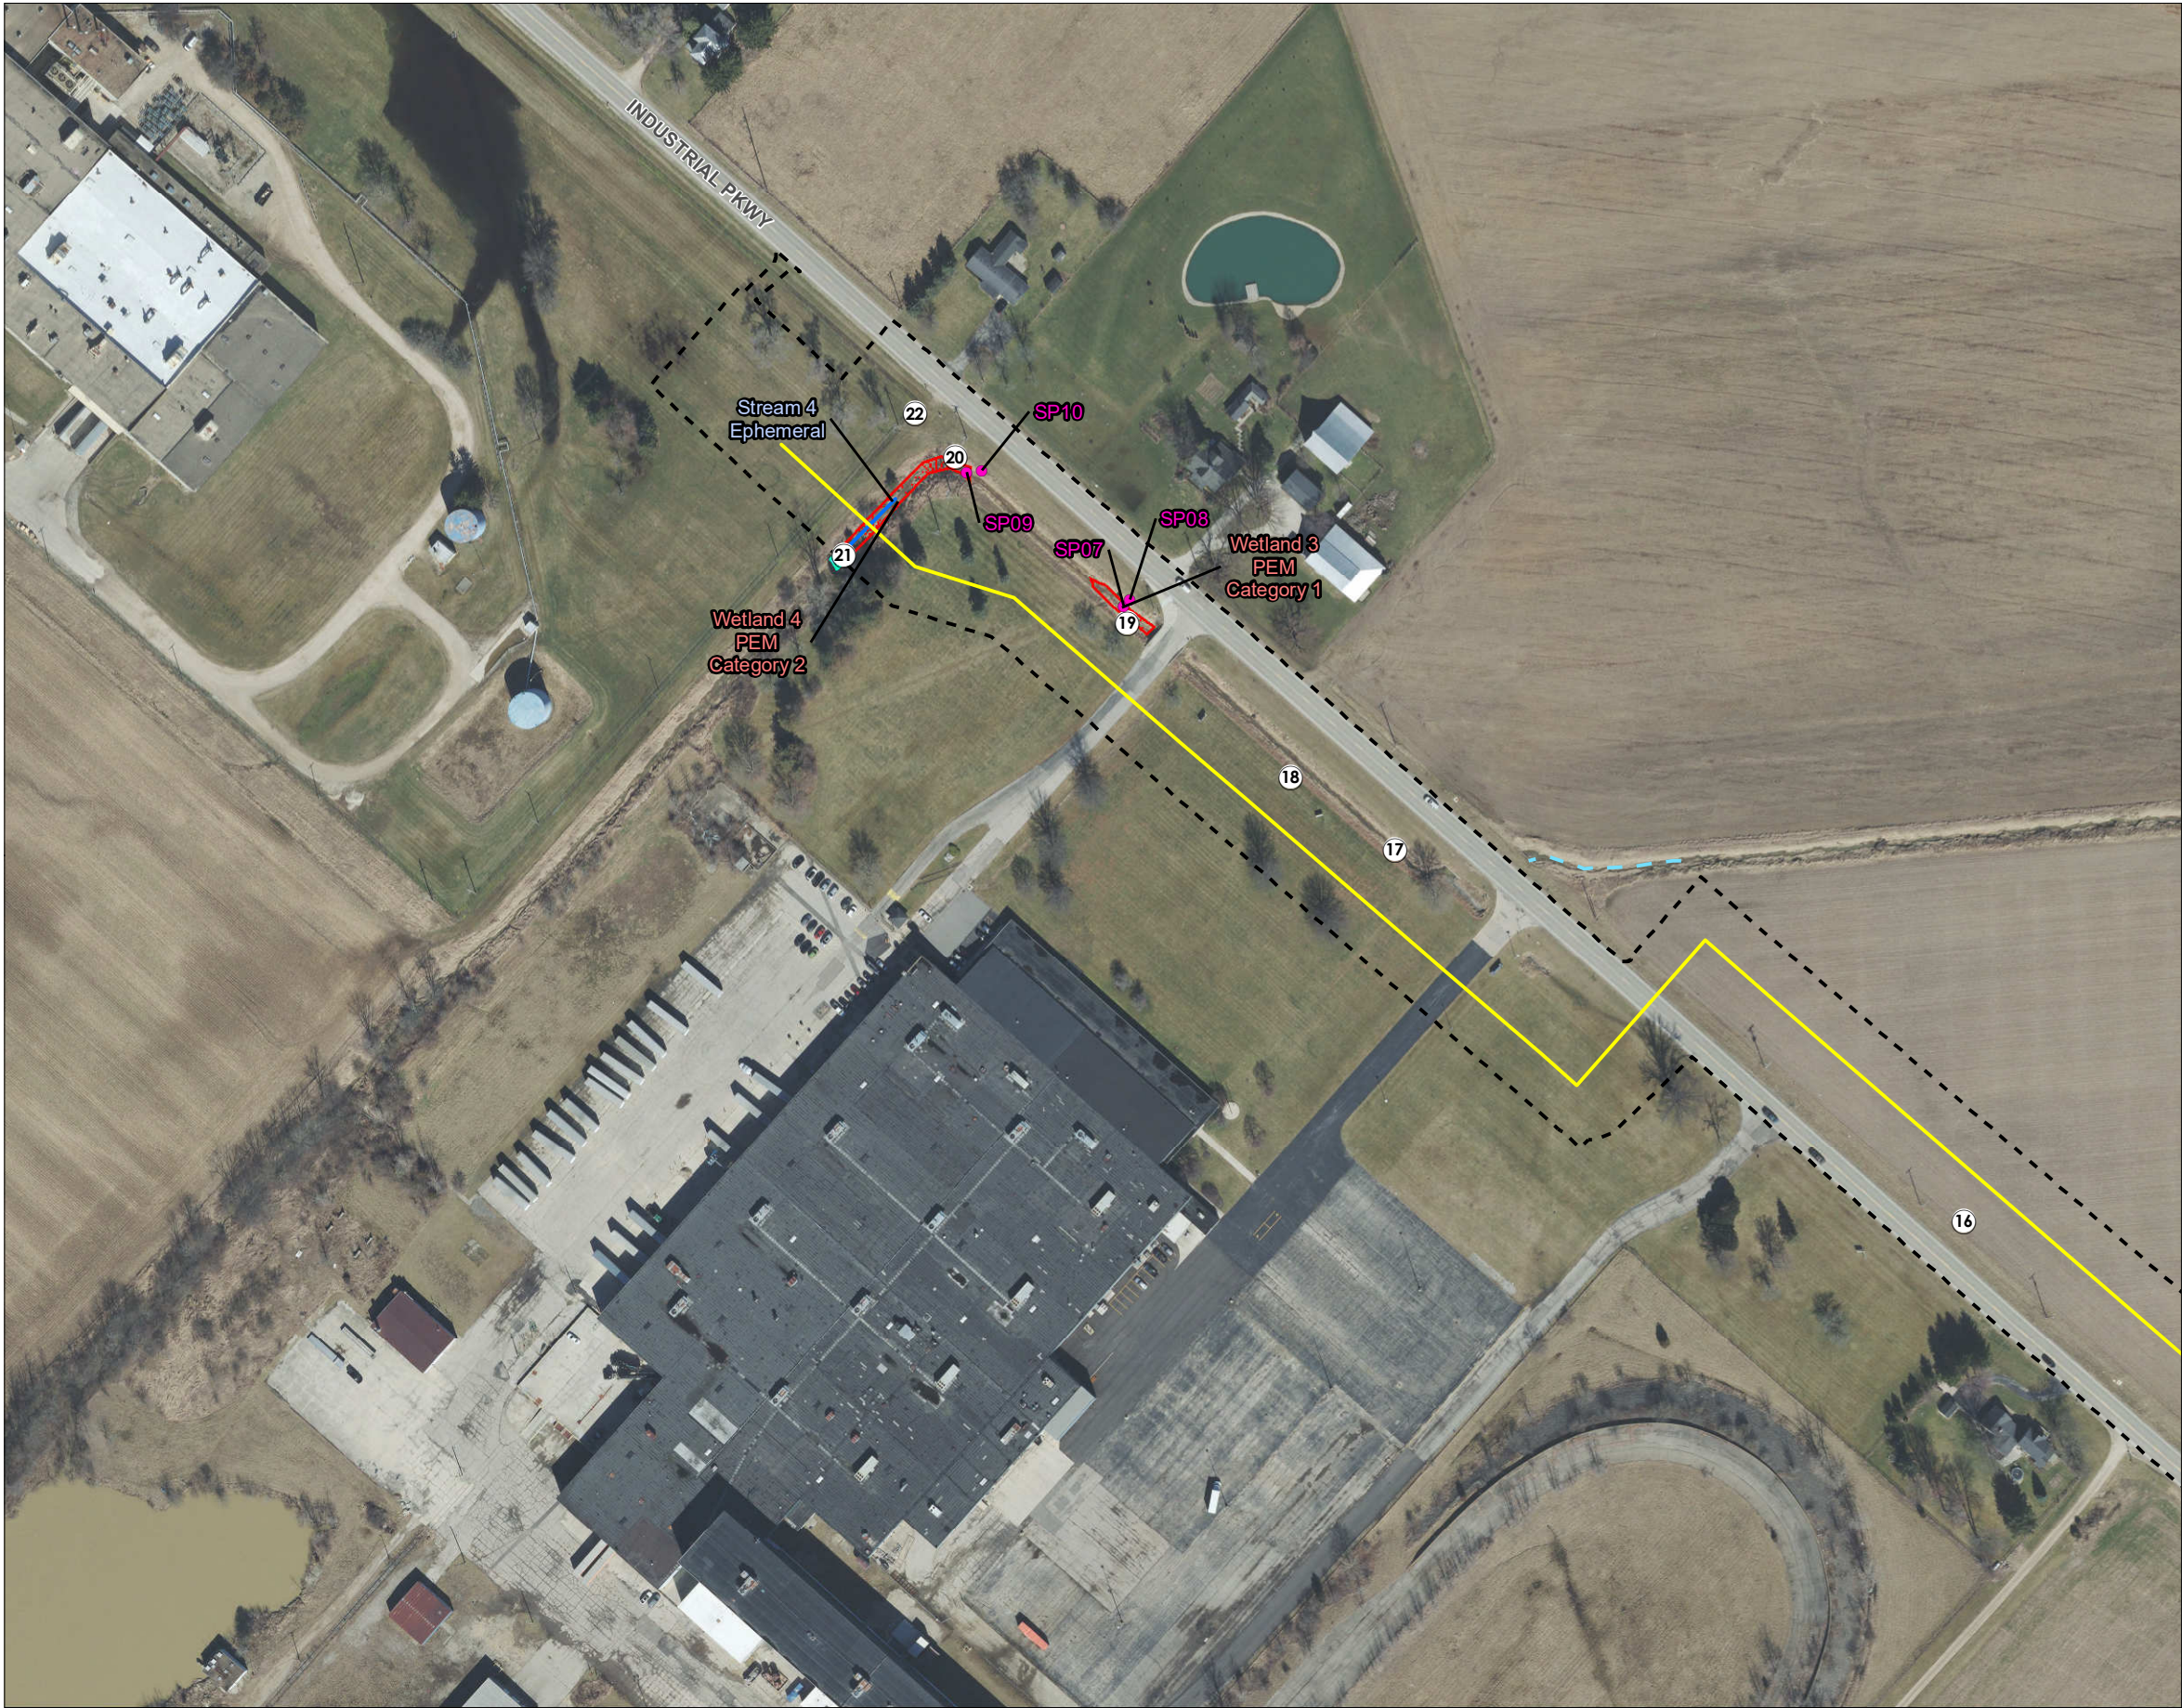
Figure No.  
**4**  
Title  
**Wetland and Waterbody Delineation Map**

Client/Project  
Columbia Gas of Ohio  
Marysville Connector Pipeline Project  
Wetland and Waterbody Delineation
