Shawtown Switch  
Project

FIGURE 3  
WETLAND DELINEATION AND  
STREAM ASSESSMENT MAP

**APPENDIX A****U.S. ARMY CORPS OF ENGINEERS UPLAND FORM**

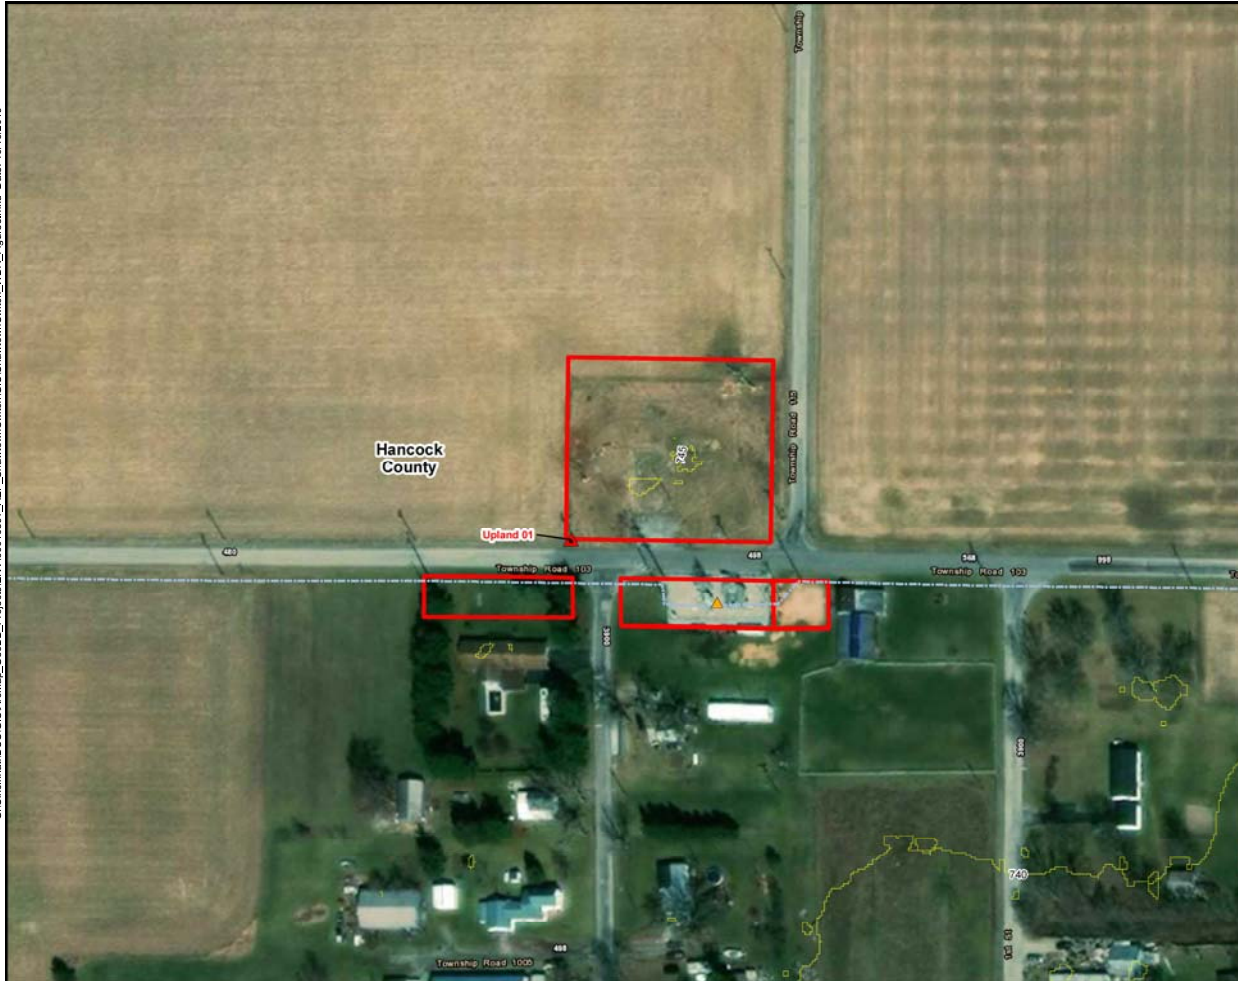
- ▲ Station
- Existing Transmission Line
- - - 5-ft Contour
- ▭ Project Survey
- ▲ Upland Data Point

The ecological survey of the Project area did not identify any wetlands, streams, or ponds. One upland data point was recorded.

The reported results of the ecological survey conducted by AECOM on this Project are limited to the areas within the Project survey boundary provided in Figures 1, 2, and 3. Areas that fall outside of the Project survey boundary were not evaluated in the field and are not included in the reporting of this survey.
